Analysis And Evaluation Of A Radioactive Waste Package Retrieved From The Atlantic 3800-Meter Low-Level Radioactive Waste Disposal Site

Prepared for the U.S. Environmental Protection Agency

P. Colombo, M.W. Kendig, M. Fuhrmann
Environmental and Waste Technology Center
Department of Nuclear Energy, Brookhaven National Laboratory
Upton, New York 11973

August 1993

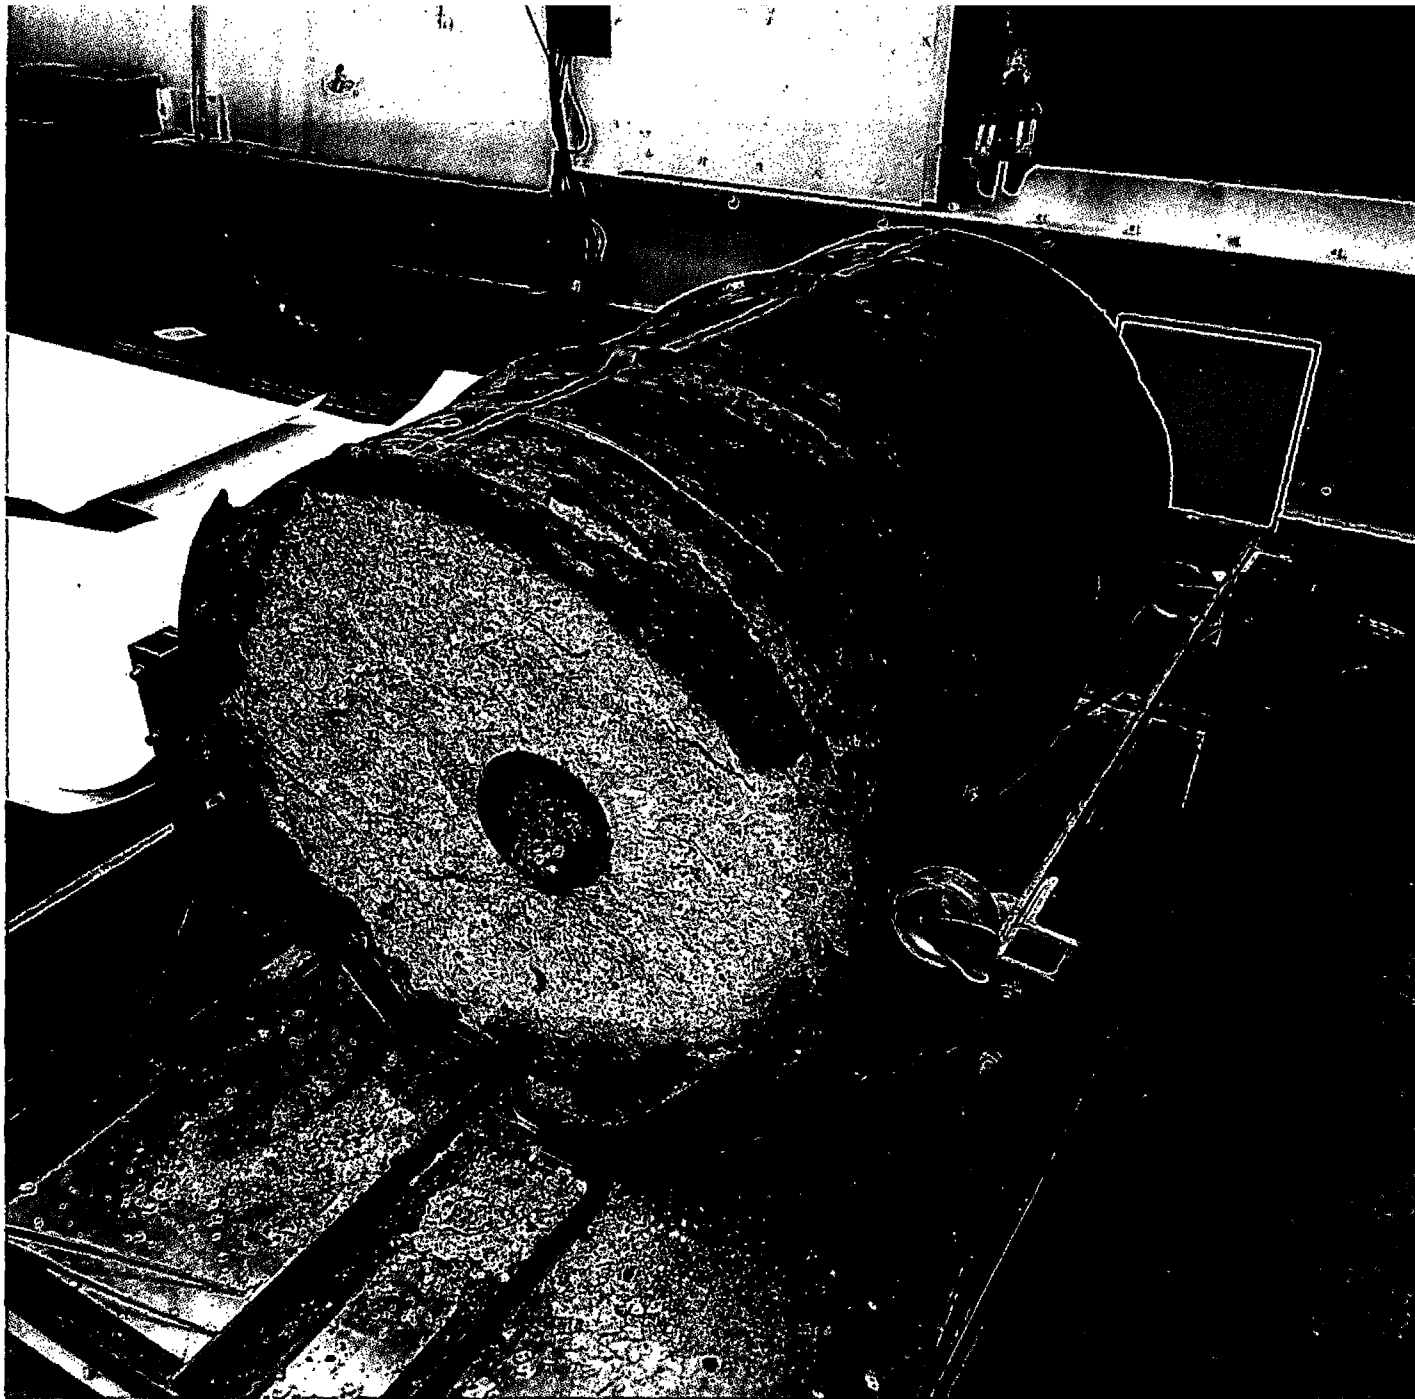
Figure 8a Shows an exposed mild steel pipe which ran the entire length of the container and the weathered concrete surface.

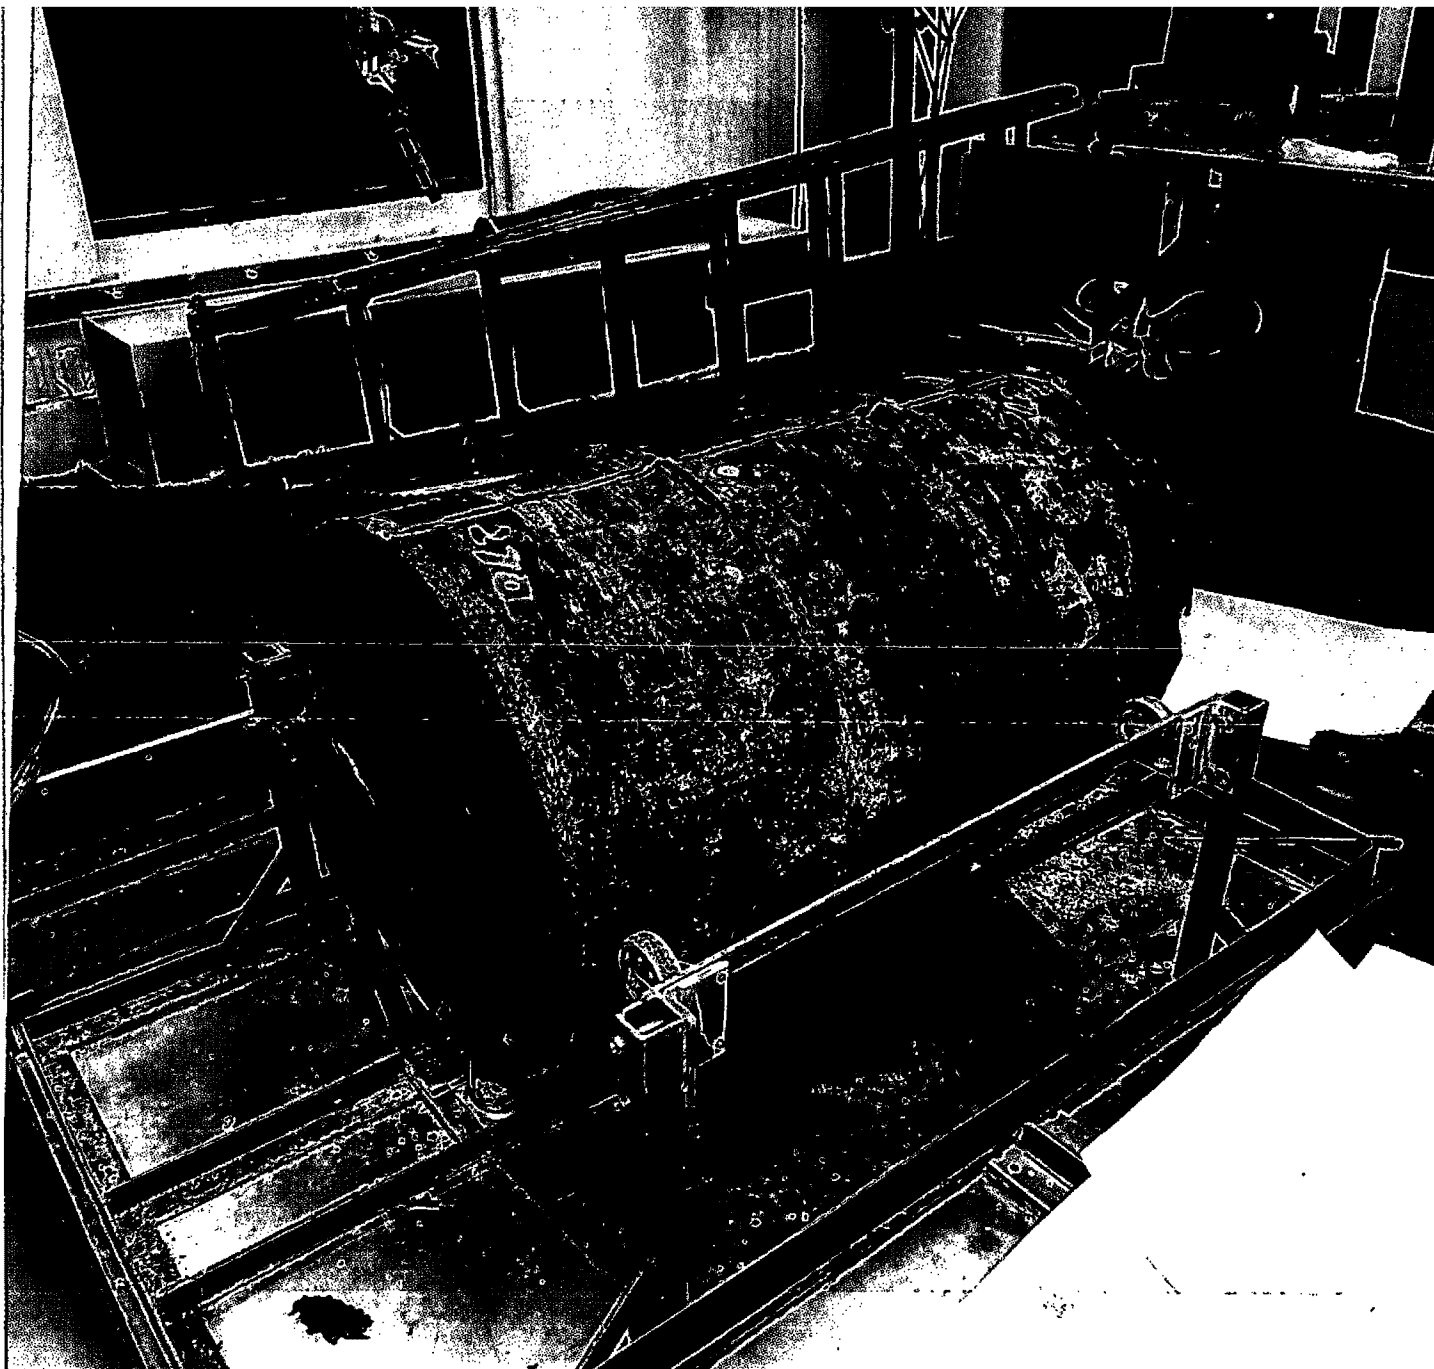
Figure 8b Overall view of the container showing the bottom side and the "markings" on the sea side.

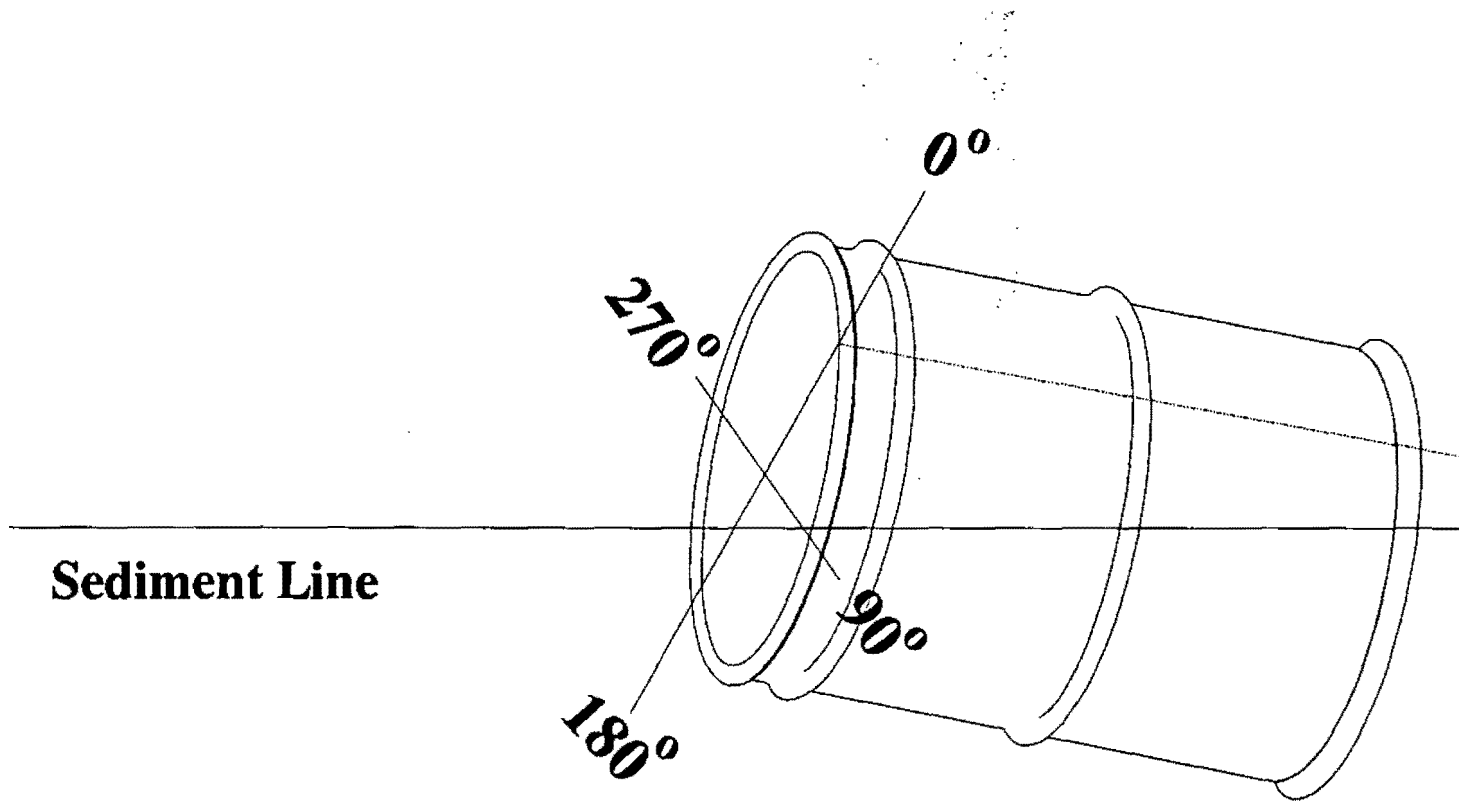
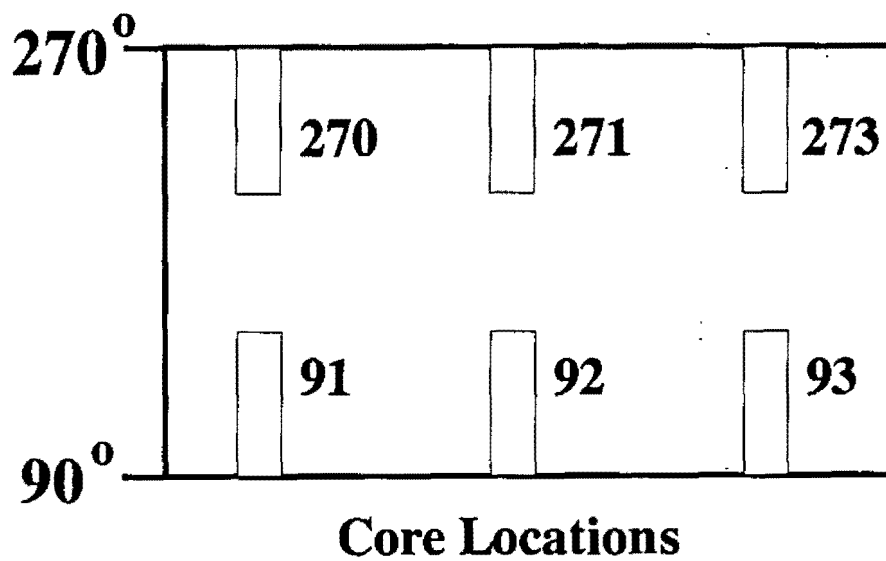
Figure 9a Orientation of the waste package.

Figure 9b Position of cores taken from the concrete waste form for analysis.

After removal of the mild steel container for corrosion studies, cores were taken of the concrete waste form to determine the types, quantities and distribution of contained radioactivity. Cores were taken from three locations along each of the 90° and 270° longitudinal axes extending to depths that approached the position of the embedded steel pipe. Orientation of the waste form and positions of the cores taken from it are shown in Figures 9a-9b.

The concrete waste form was cored by a Target^{*} concrete saw with a dual-speed motor (500/1000 rpm) on a swivel base. Impregnated diamond core bits (2-1/4 inch diameter) were used to produce two-inch diameter cores. Although water is normally used during concrete coring to both lubricate and to flush out debris, it was not used during this coring in order to minimize spraying and accumulation of contaminated liquid waste. Instead, a commercial teflon spray was periodically applied to lubricate the outside of the coring bit. This equipment and procedure was successfully used to obtain cement cores as previously reported [1,2]. However, due to the nature of the concrete composition (Table 2) and the lack of integrity, it was not possible to obtain satisfactory core samples for determining mechanical properties such as compressive strength. Based on its behavior, the compressive strength of the concrete waste form was estimated as <800 pounds per square-inch (5.515 MPa).

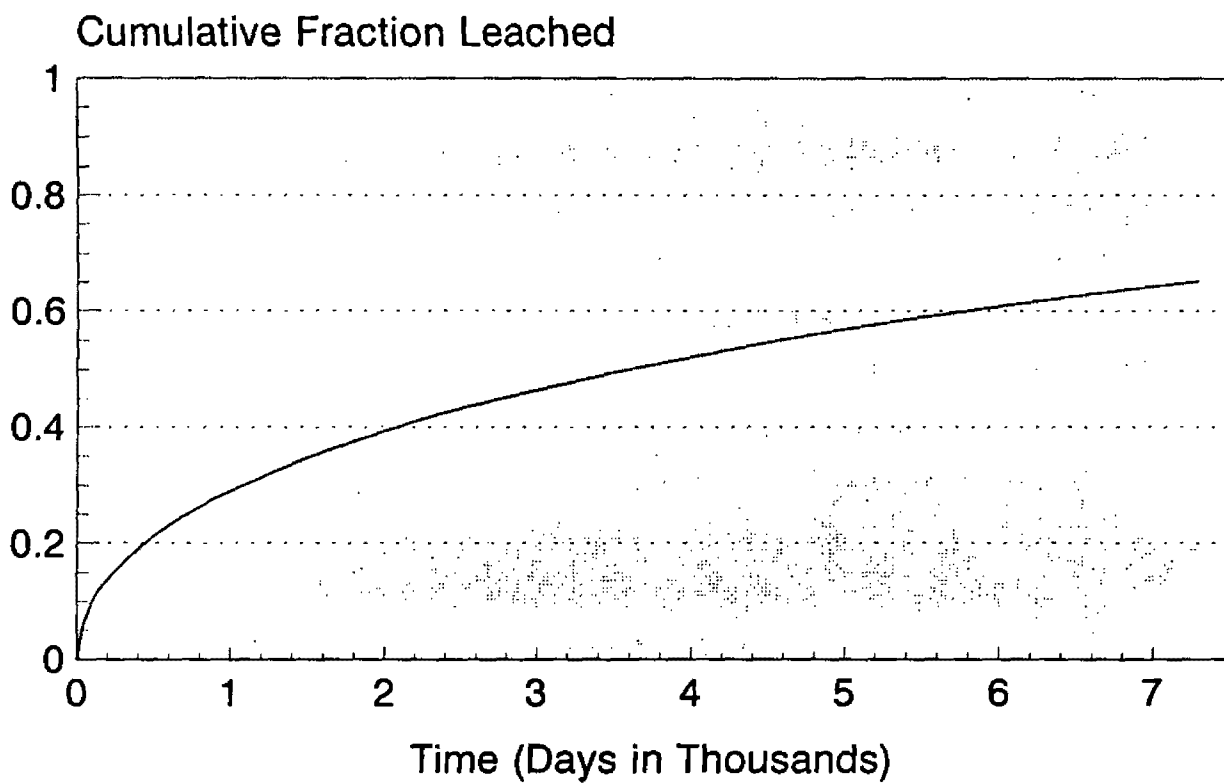
Leached in Sea Water
 $De = 1.07 \times 10^{-7} \text{ cm}^2/\text{sec}$

Figure 10 Modeled leaching of Cs-137 from a cement waste form; release after 20 years in water is 65.3%.

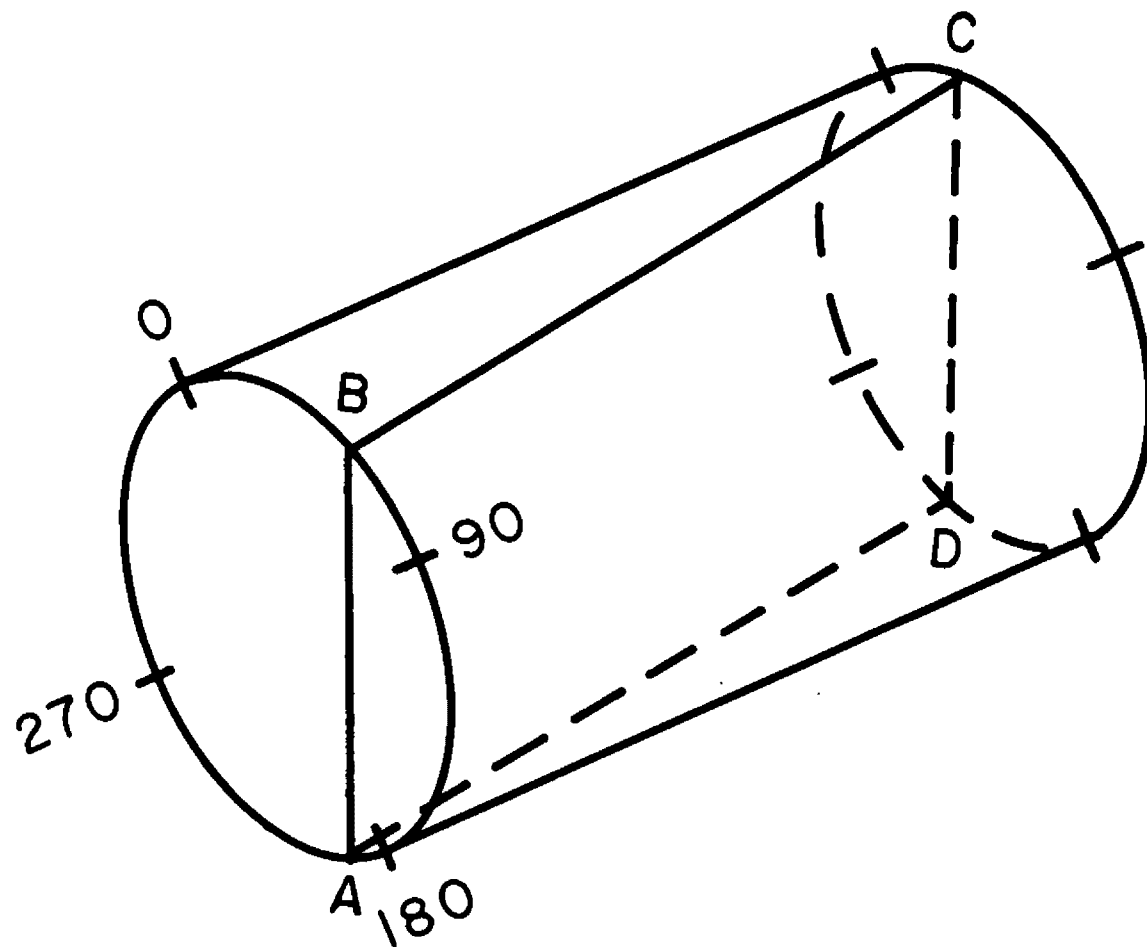
As a result of visual inspection, one could see evidence of greater attack on the mud-buried portion than the side exposed only to the water. Figure 11 shows a schematic of the container and indicates how the container rested in the bottom sediment. As illustrated in Figure 11, the sediment intersects the package at the line ABCD corresponding to respective coordinates: $(x,r,\theta)=(0,28.6\text{ cm},25^\circ)$, $(82.6\text{ cm},28.6\text{ cm},56^\circ)$, $(82.6\text{ cm},28.6\text{ cm},190^\circ)$, $(0,28.6\text{ cm},200.4^\circ)$. The arc's B, 90° , A and C, 90° , and D represent the portion of the container exposed to the sediment. Figure 8b shows a clear transition between the attached sediment side at angles less than 190° and the protected region corresponding to angles greater than 190° . Figure 12 shows a closer view of the difference between the sediment side, which exhibits severe general corrosive attack, and the more protected sea side. The corrosive

Figure 11 Schematic of mud-line on the container.

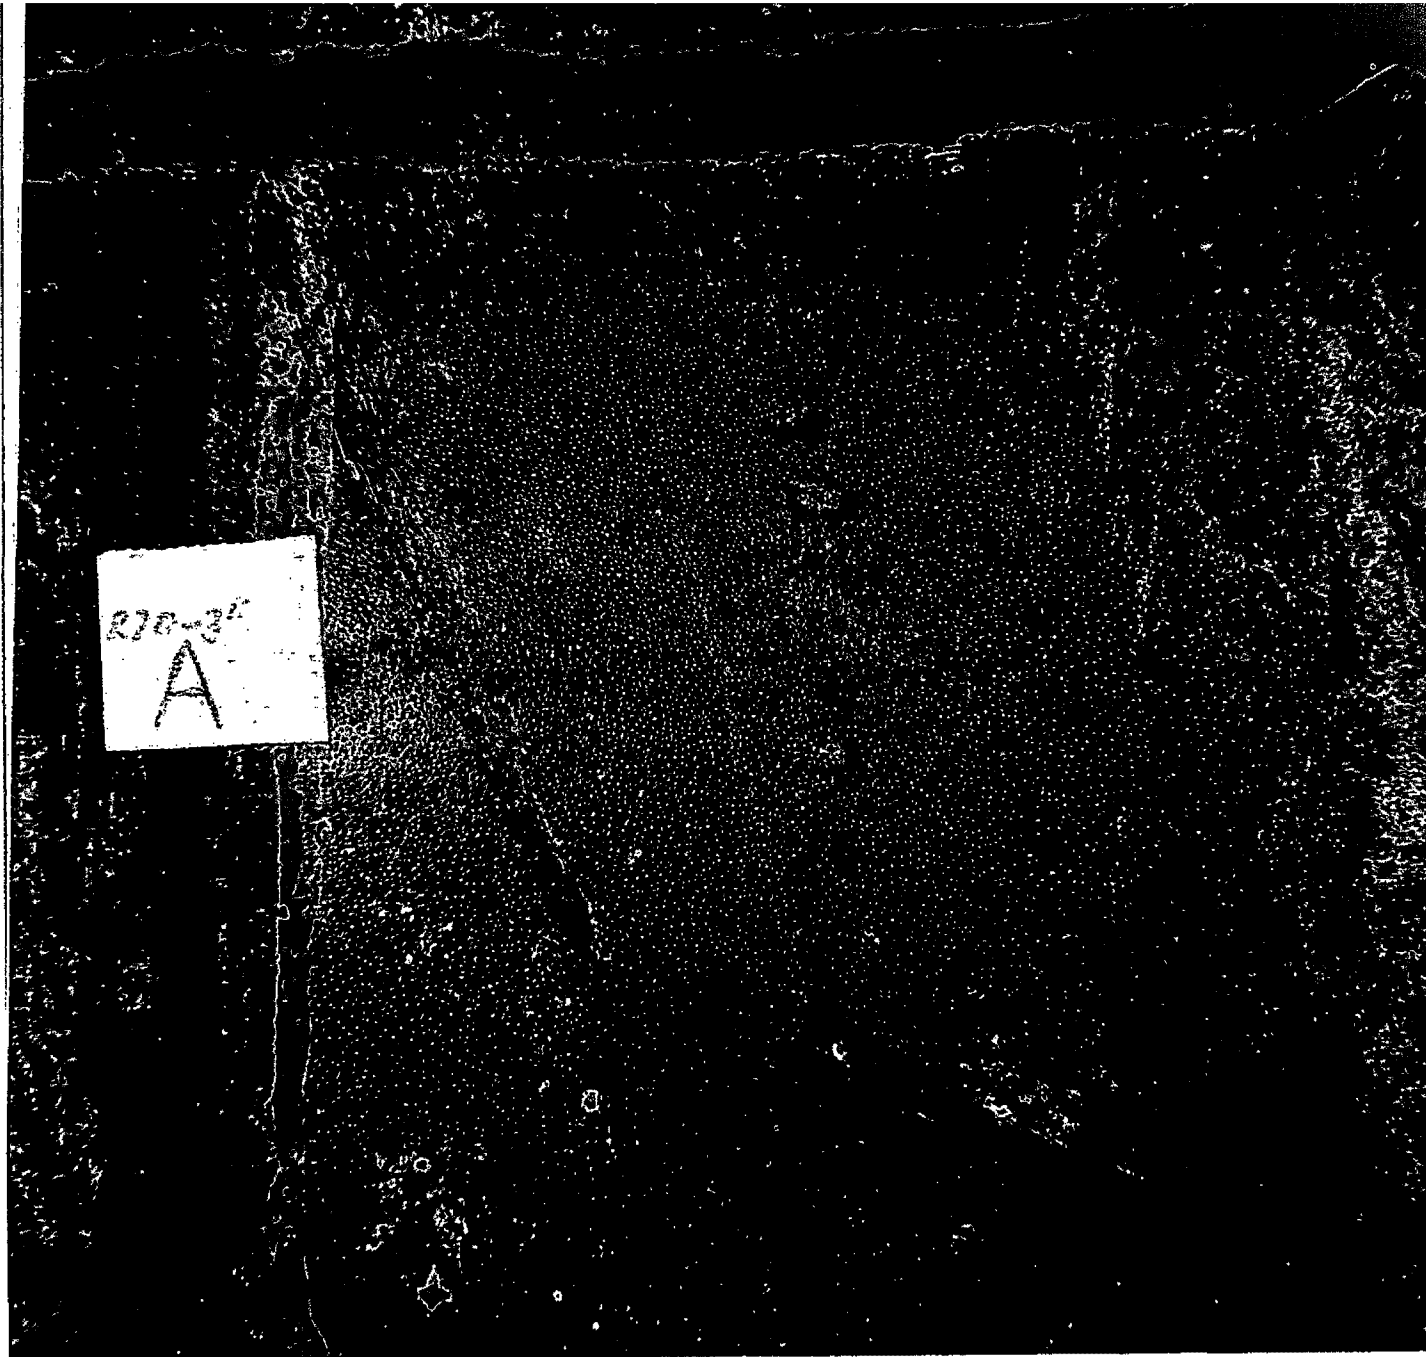
Figure 14 Blistering of an apparent "coating" on the sea side of the container.

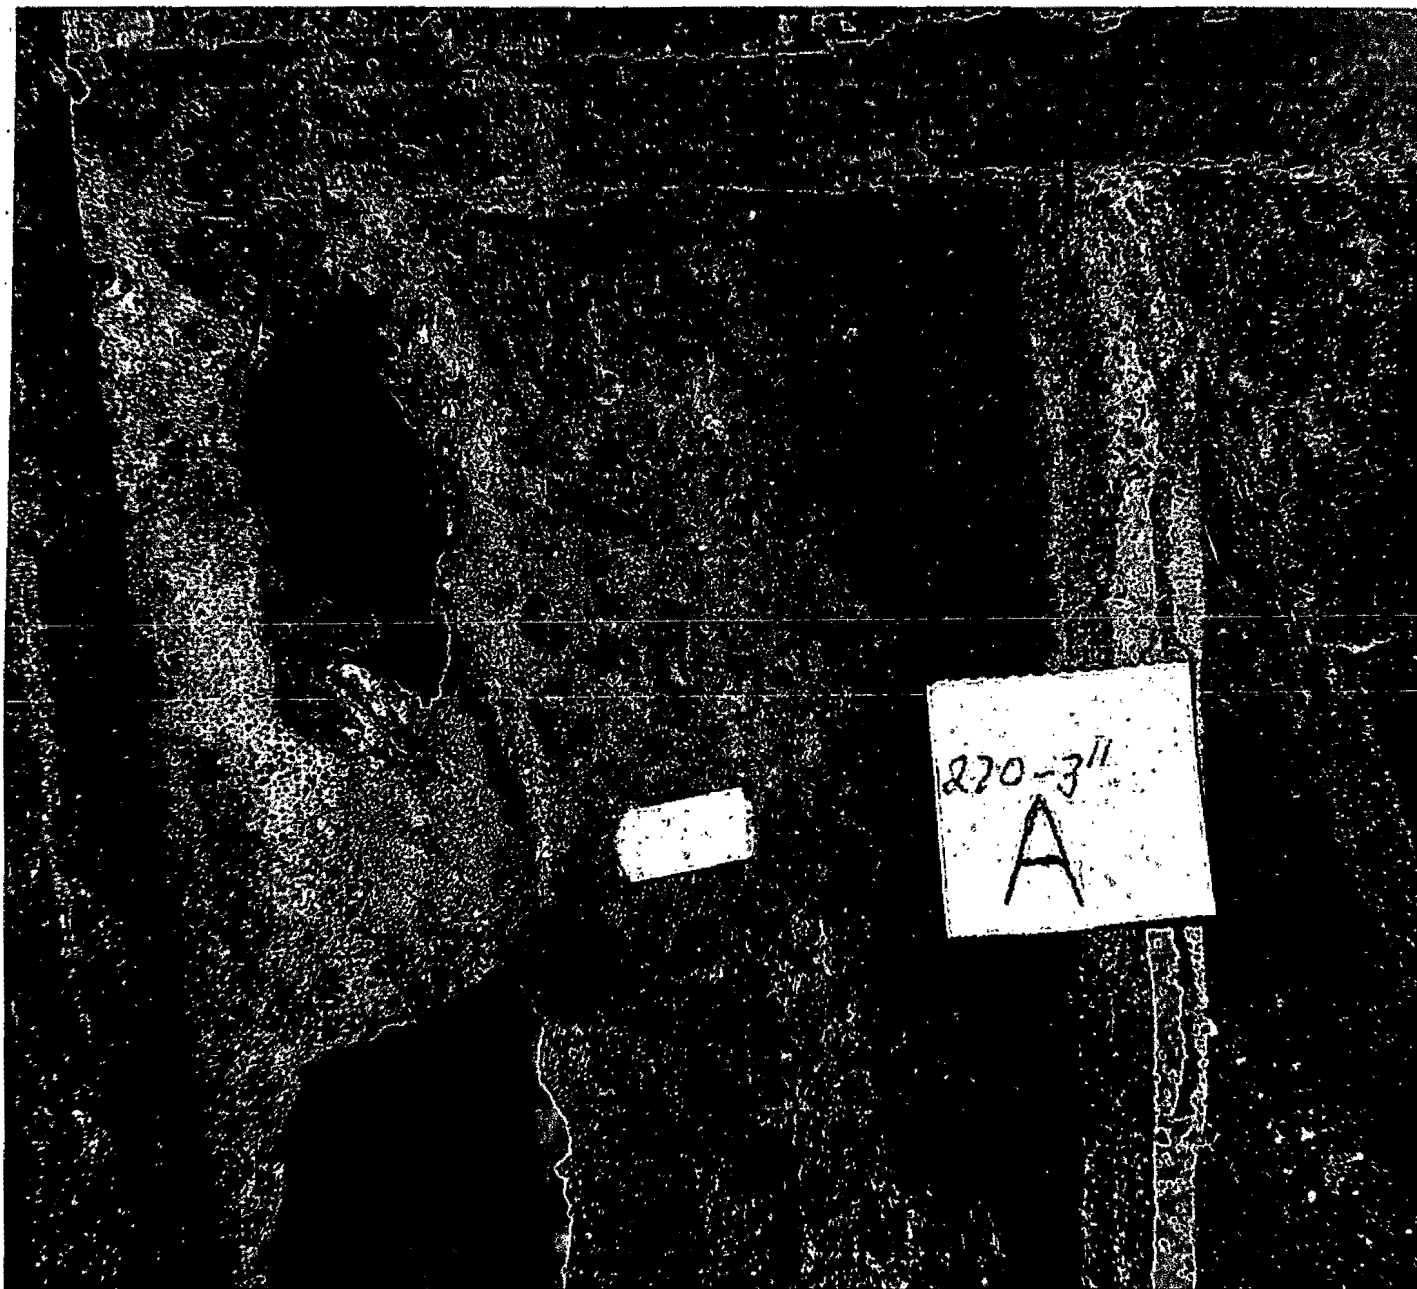
Figure 15 also shows the perforation that occurred at the end of the container, which exposed the concrete. A closer view of this attack is seen in Figure 17. This rapid attack on the rim perforated the container at the sea and sediment-buried sides as well (Figure 18).

Figure 17 Close view of rim perforations.

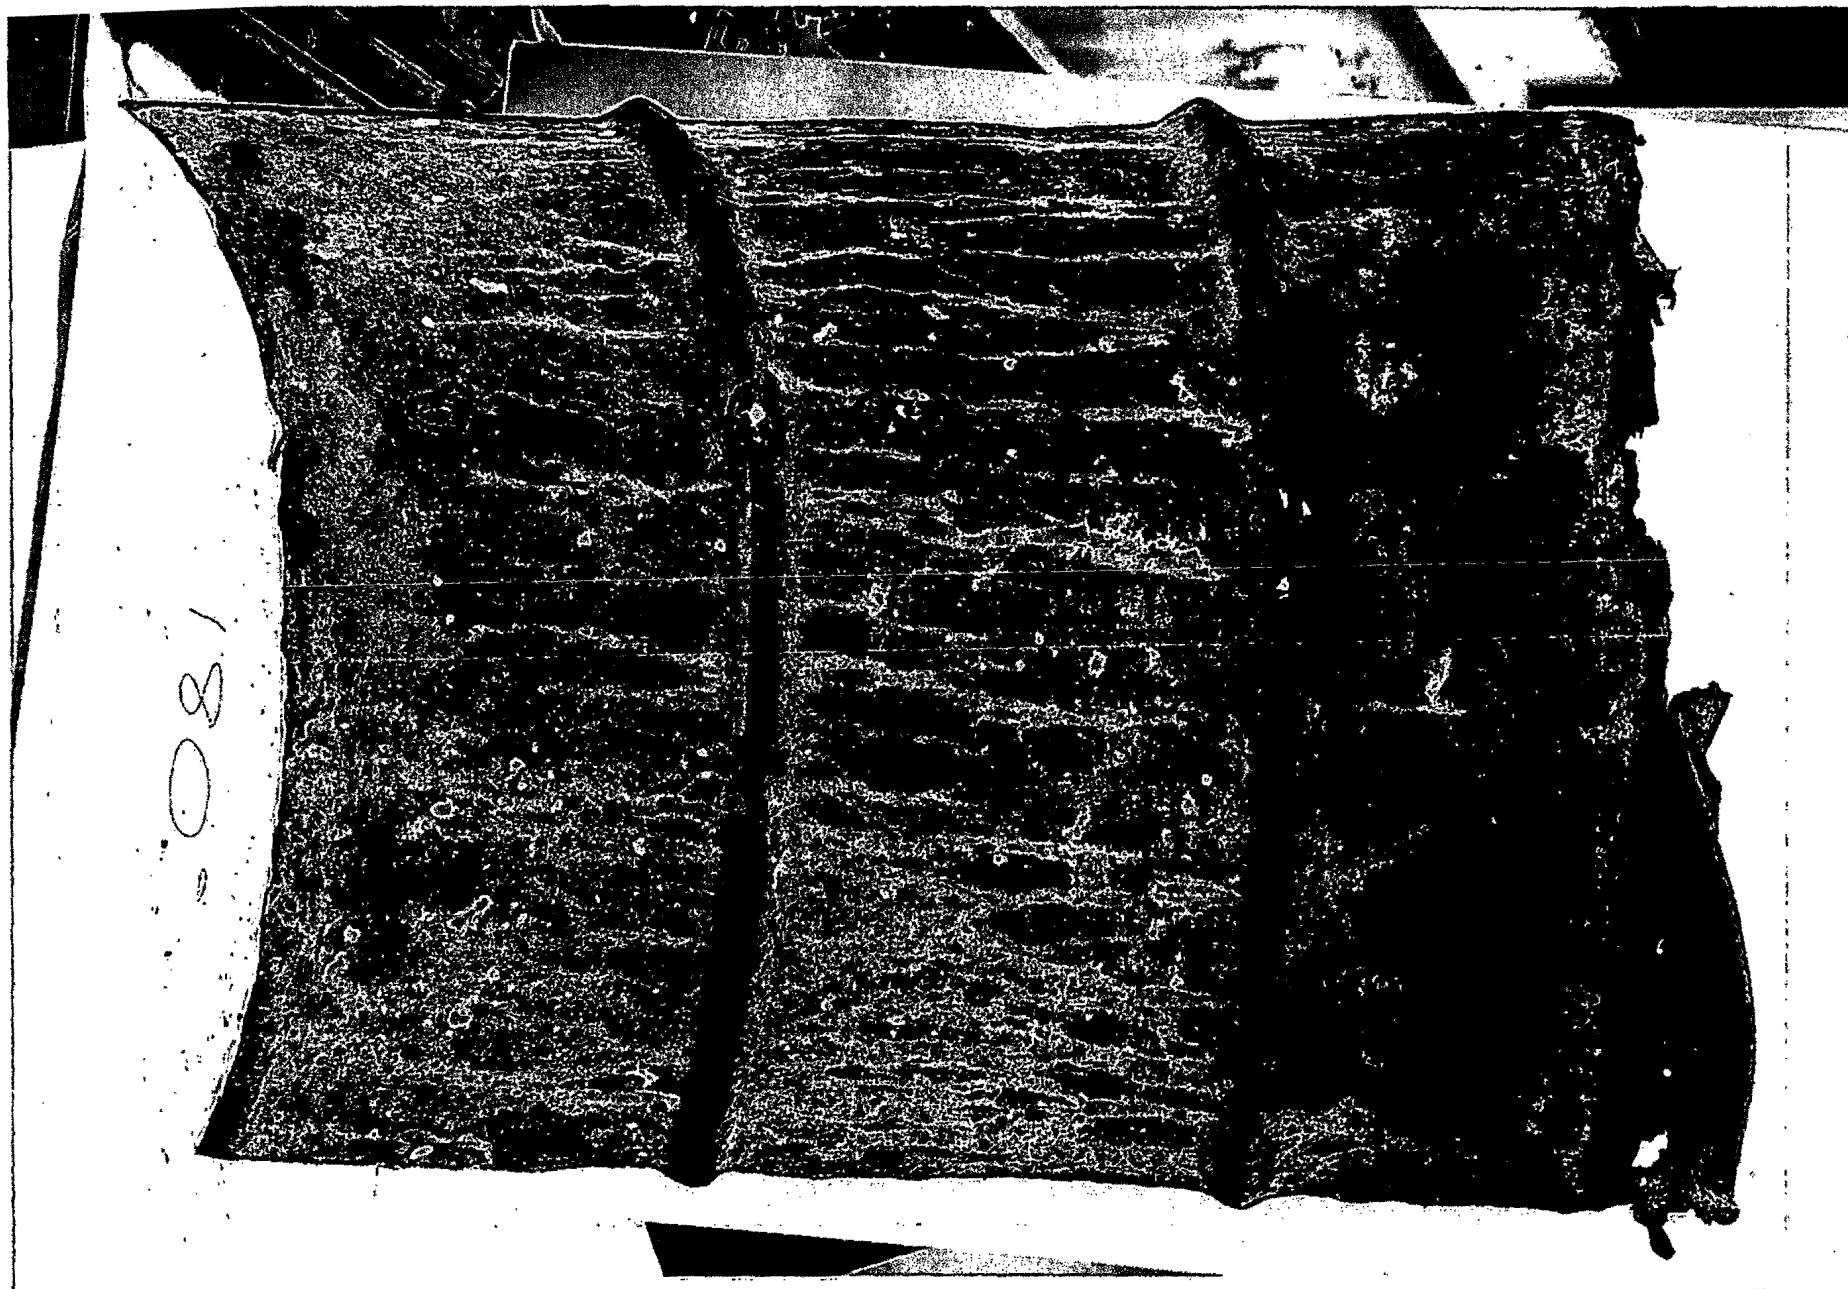
After extracting two strips, one from the sea side at 270° and one from the sediment side at 90° , two shells of the carbon steel sheath remained. Photographs of the inside of the shells appear in Figures 19a through 19c. Instances of perforation appear at the top of the container near the rim at the chimes and at the mud line. However, the perforation is less than 1 percent of the total sheath area, a somewhat better protection than was observed for the containers retrieved from the Atlantic 2800-meter site and the 900-meter Farallon Islands site [1,2] with respect to high localized attack.

Figure 19a Photograph of inner side of sheath after removal from concrete. Perforations appear near rim of the chimes and at the mudline.

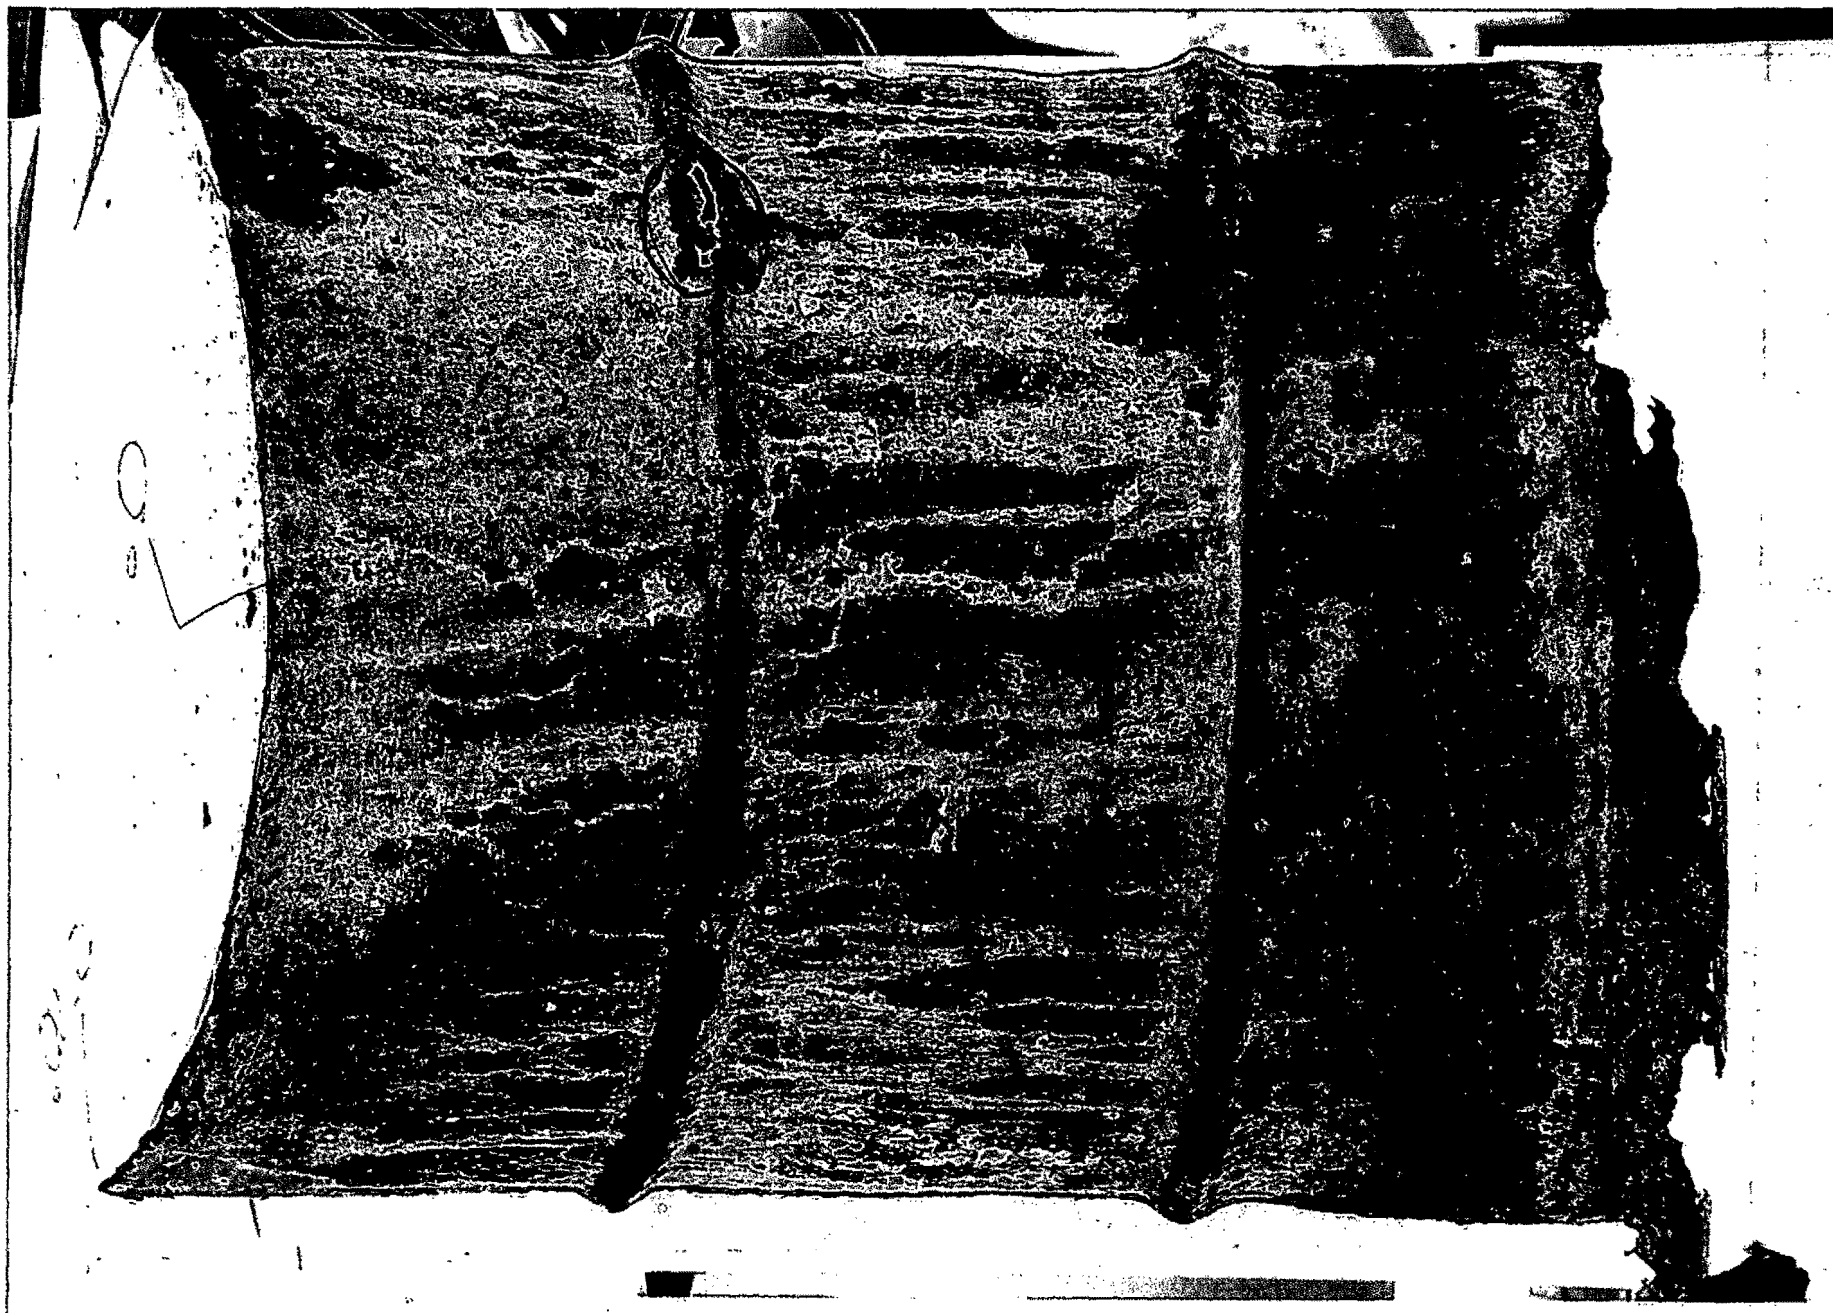
Figure 19b Inner side of sheath showing perforations at the top of the container, at the chimes and at the mudline.

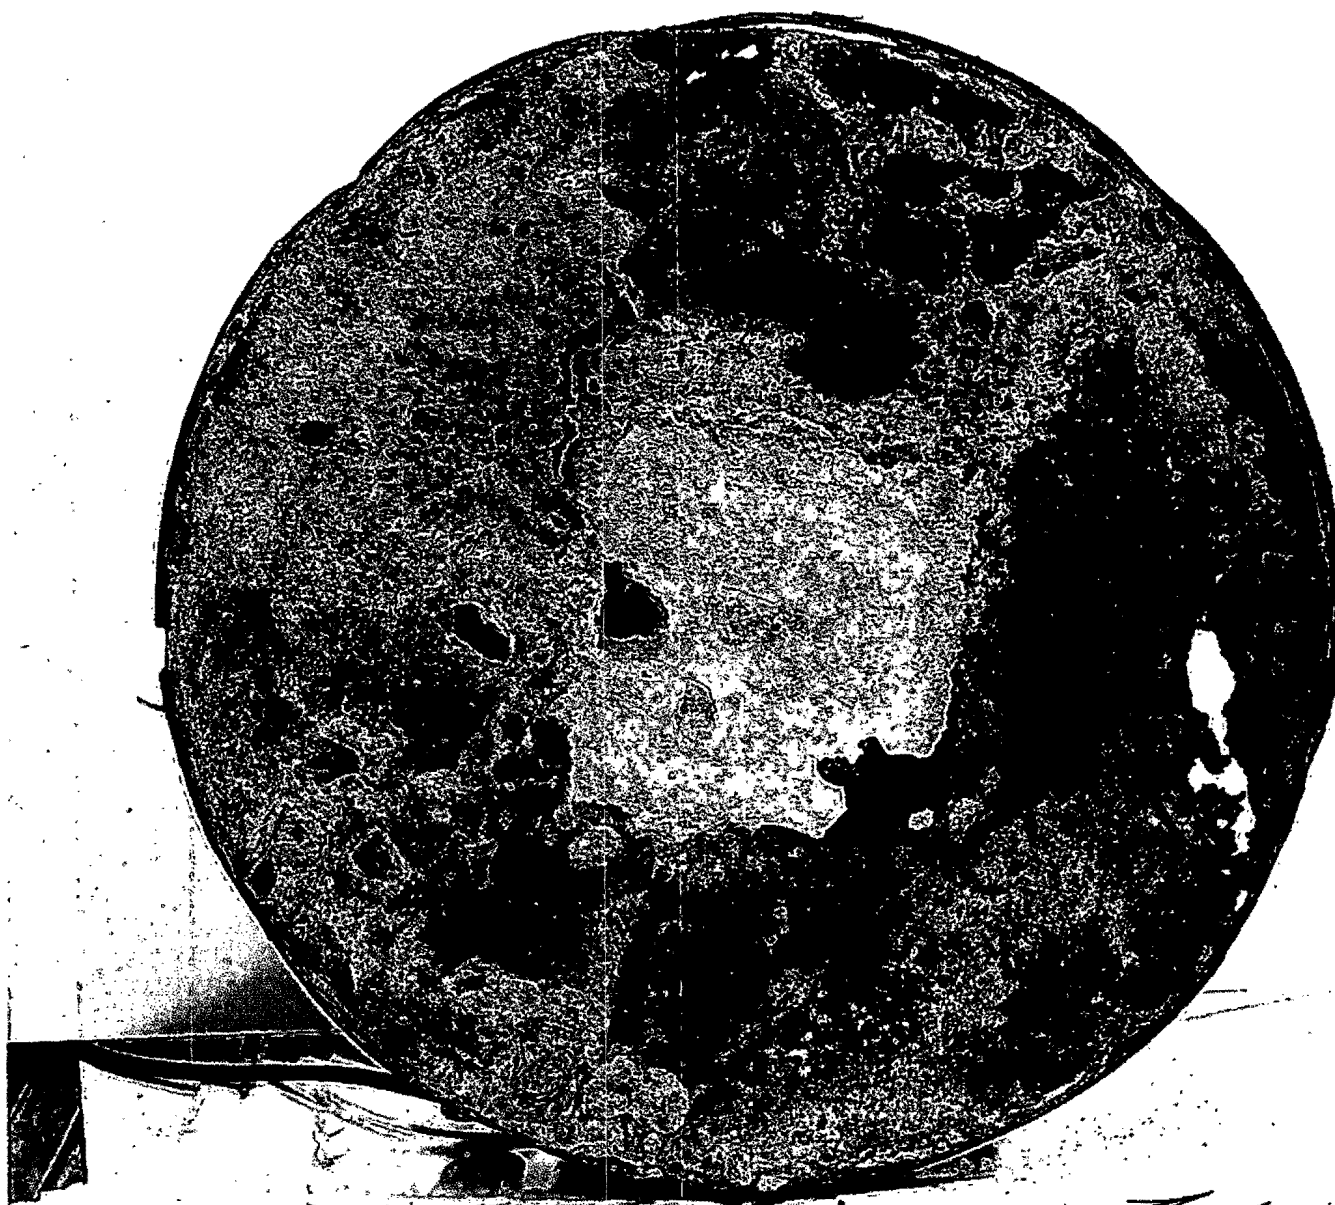
Figure 19c Inside bottom of container showing perforations below the sediment line.

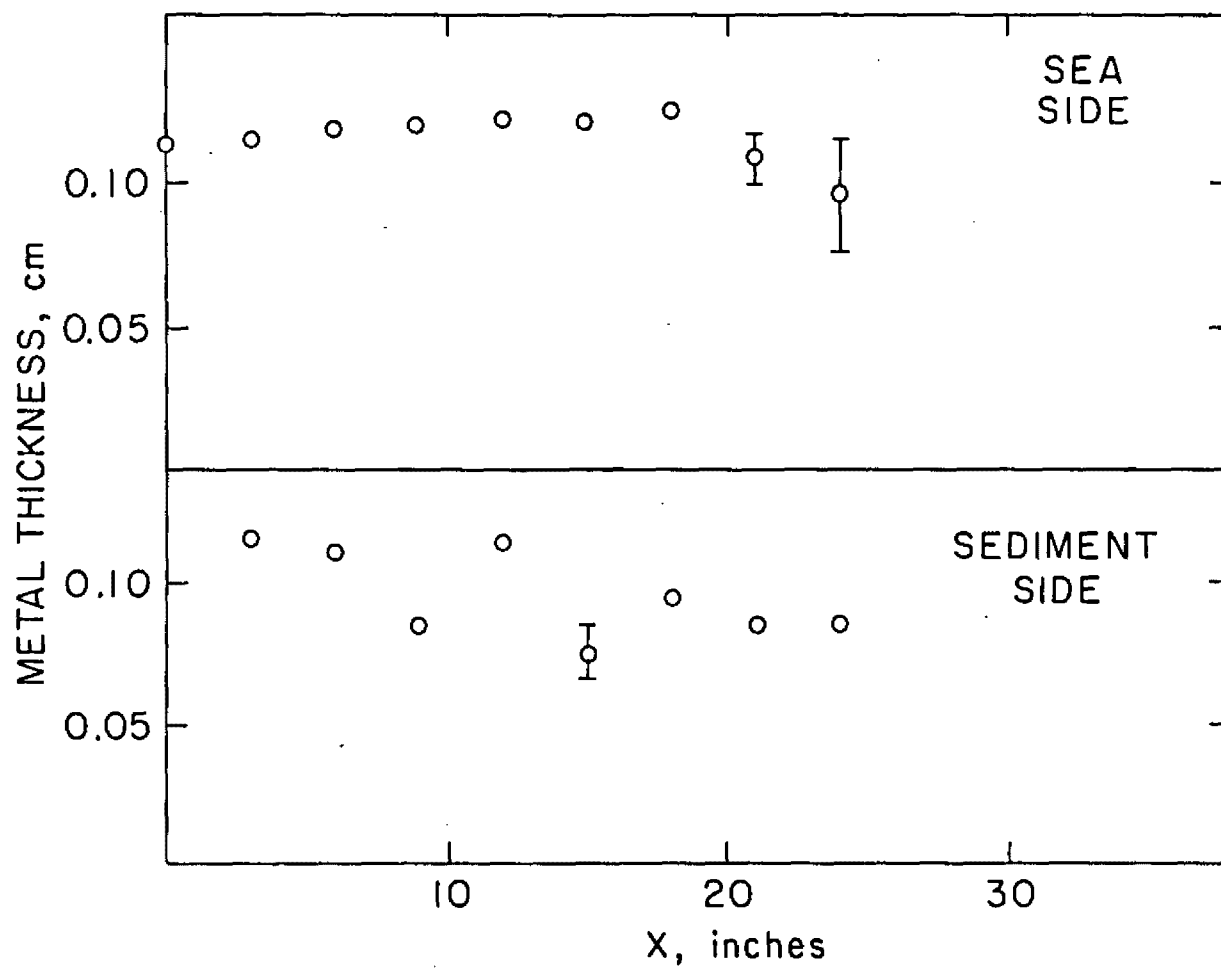
Figure 19d Plot of thickness of sheathing material vs. longitude.

where T is the time in the environment, taken as 20 years for this specimen. This gives a calculated corrosion rate of 0.015 ± 0.002 mm/year or 0.0006 ± 0.0001 in/year. The sea side exhibits an average corrosion rate too small to be determined by this macroscopic technique. One must keep in mind that these corrosion rates are based on the assumption of a constant rate over the period of time involved and should only be used as a means of comparing the different samples. Table 5 shows a comparison of the corrosion rates calculated for this container with the previous two retrieved from other Atlantic and Pacific radioactive waste disposal sites.

1. The sediment side showed greater general corrosion than the sea side, with a rate of 0.015 mm/yr vs. $< .005$ mm/yr for the sea side. This corresponds to a time of 42 years to cause 50 percent loss at the sediment side.
2. Nevertheless, the corrosion rate of the sediment side was close to that of empirically determined zero-oxygen limit.
3. The general corrosion rate of the sediment side fell under that for the package retrieved from the 2800-m Atlantic site.

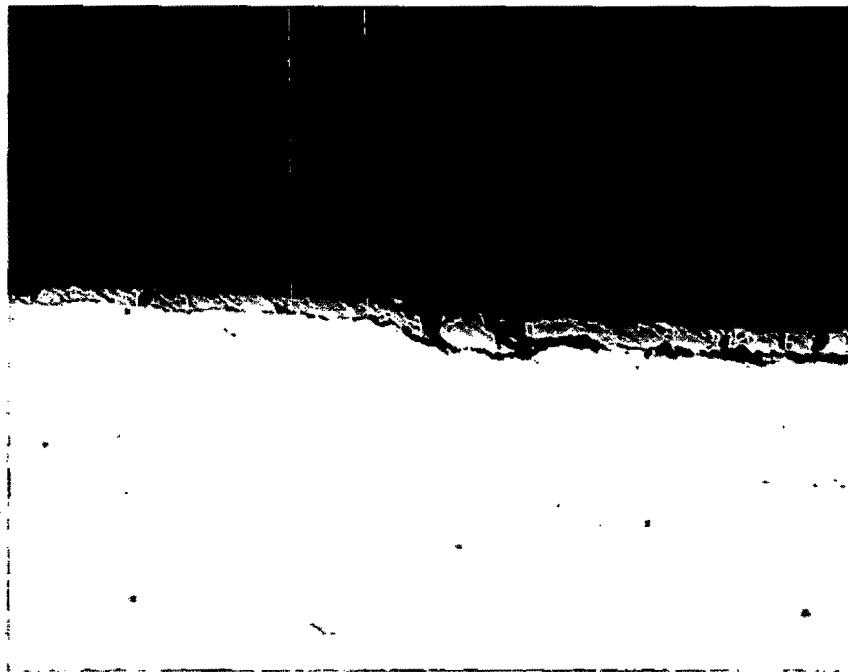
At the concrete/metal interface, the 5 to 7- μ film or "coating" remains continuous and adheres to the metal. However, on the environment side of this particular sample the 5 to 7- μ film or "coating" also remains continuous even over regions where a thick scale growth has produced a pit, Figure 21a. The scale growth on the pit exhibits cracks and voids, but the 5 to 7- μ initial film or coating remains, with the exception that a break appears above the center of the pit. In addition, a deposit lies over this 5 to 7- μ film or "coating" and contains compounds of aluminum and calcium, as shown in Figure 21b.

Figure 20a Optical photomicrograph of the metal/concrete interface from the well-protected portion of the container.

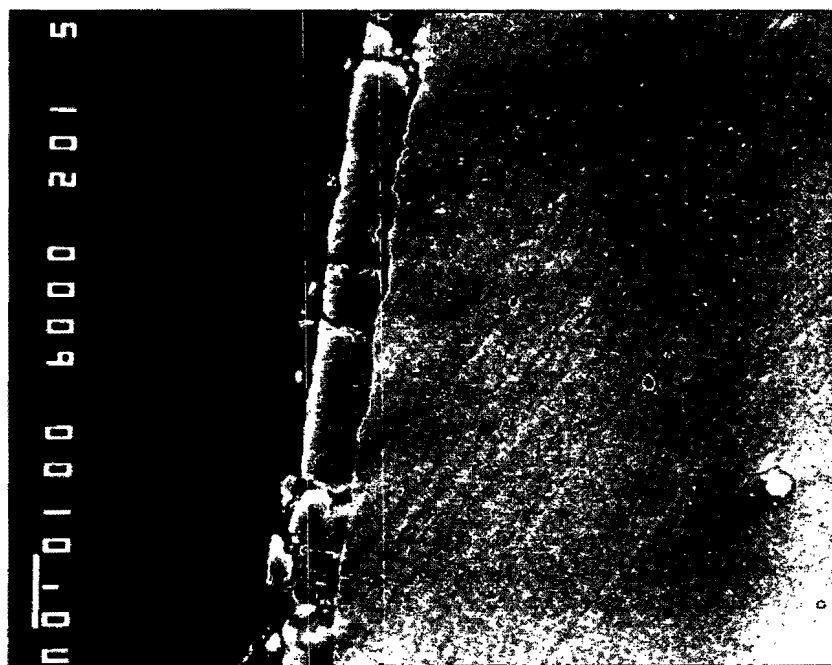
Figure 20b SEM corresponding to the same area as 19a.

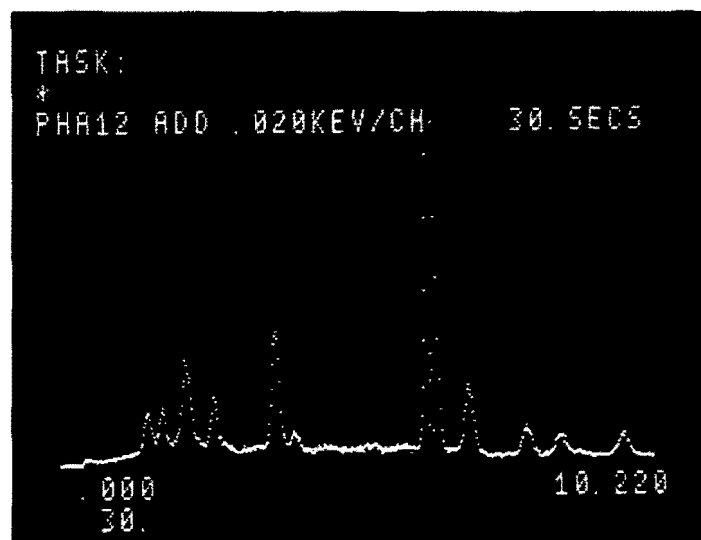
Figure 20c Energy Dispersive Spectroscopy (EDS) of deposits (Ca, Al, Cl, etc.) on the inner coating of the container sheath.

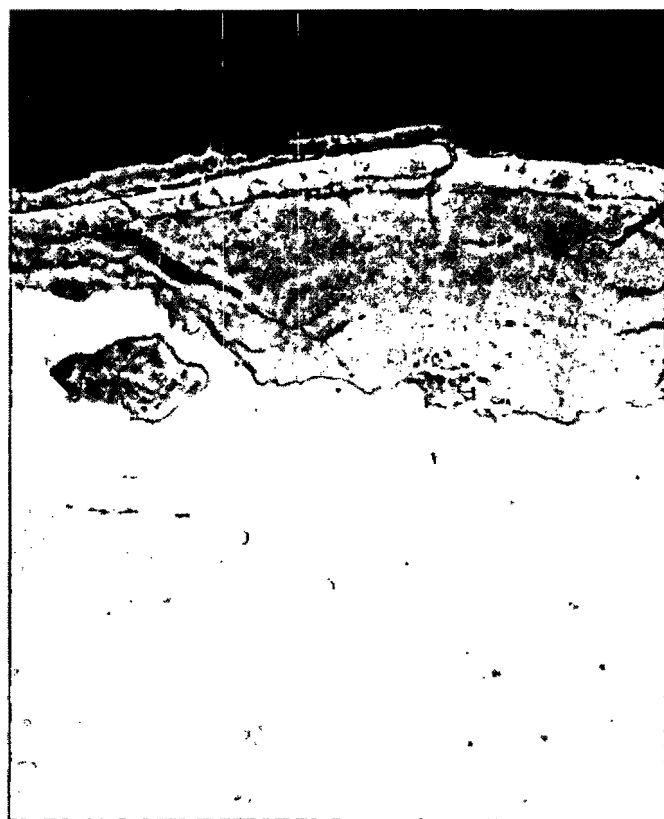
Figure 21a SEM photograph of a pit initiated on the sea side of the container at $R=11.25$, $x=21$ cm, $\Theta=270^\circ$.
