Analysis And Evaluation Of A Radioactive Waste Package Retrieved From The Atlantic 3800-Meter Low-Level Radioactive Waste Disposal Site

Prepared for the U.S. Environmental Protection Agency

P. Colombo, M.W. Kendig, M. Fuhrmann
Environmental and Waste Technology Center
Department of Nuclear Energy, Brookhaven National Laboratory
Upton, New York 11973

August 1993

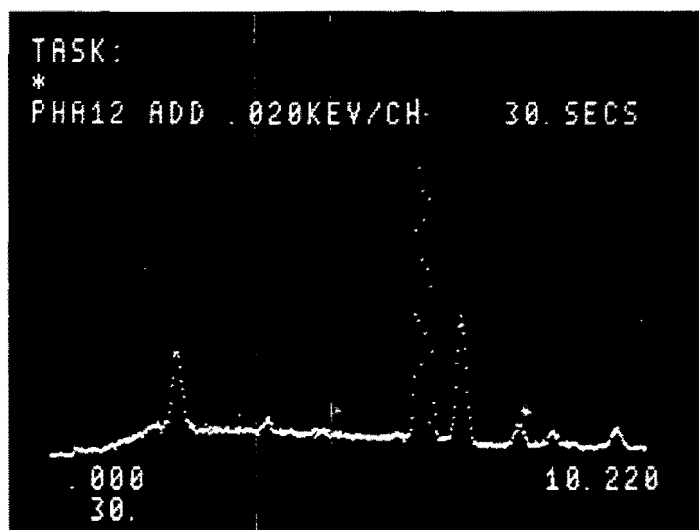
At the concrete/metal interface, the 5 to 7- μ film or "coating" remains continuous and adheres to the metal. However, on the environment side of this particular sample the 5 to 7- μ film or "coating" also remains continuous even over regions where a thick scale growth has produced a pit, Figure 21a. The scale growth on the pit exhibits cracks and voids, but the 5 to 7- μ initial film or coating remains, with the exception that a break appears above the center of the pit. In addition, a deposit lies over this 5 to 7- μ film or "coating" and contains compounds of aluminum and calcium, as shown in Figure 21b.

Figure 21b EDS of scale above $5-7\mu$ film or "coating" showing Al and Ca compounds.

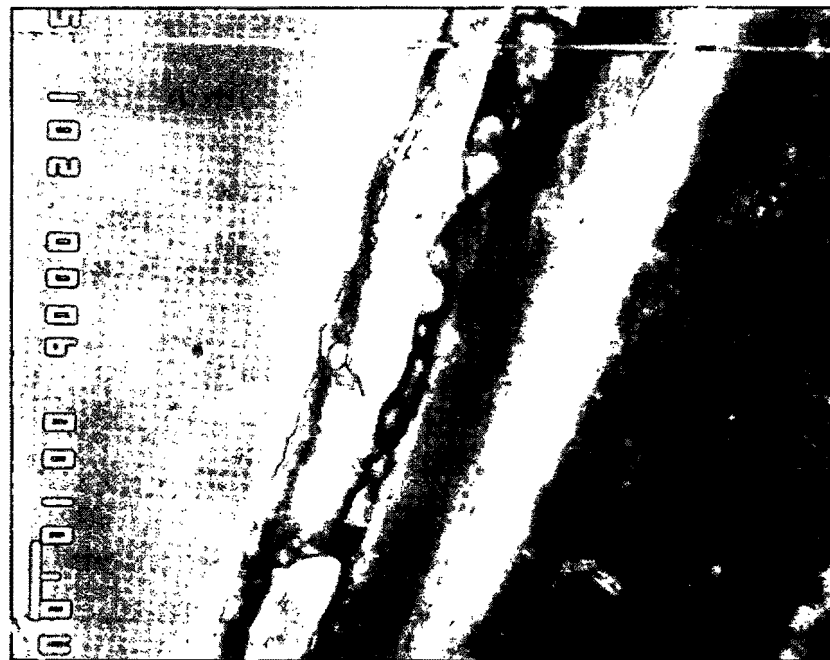
In a case where the thick, predominately calcium deposit remains, little corrosive attack has occurred. Also observed for this case, magnesium has concentrated in a layer closest to the 5 to 7- μ film under the outer calcium-rich deposit (Figures 22a and 22b). As shown by a considerable body of experimental data,

Figure 22a SEM showing the distribution of elements in the scale formed on the sea exposed side of the well-protected region of the container.

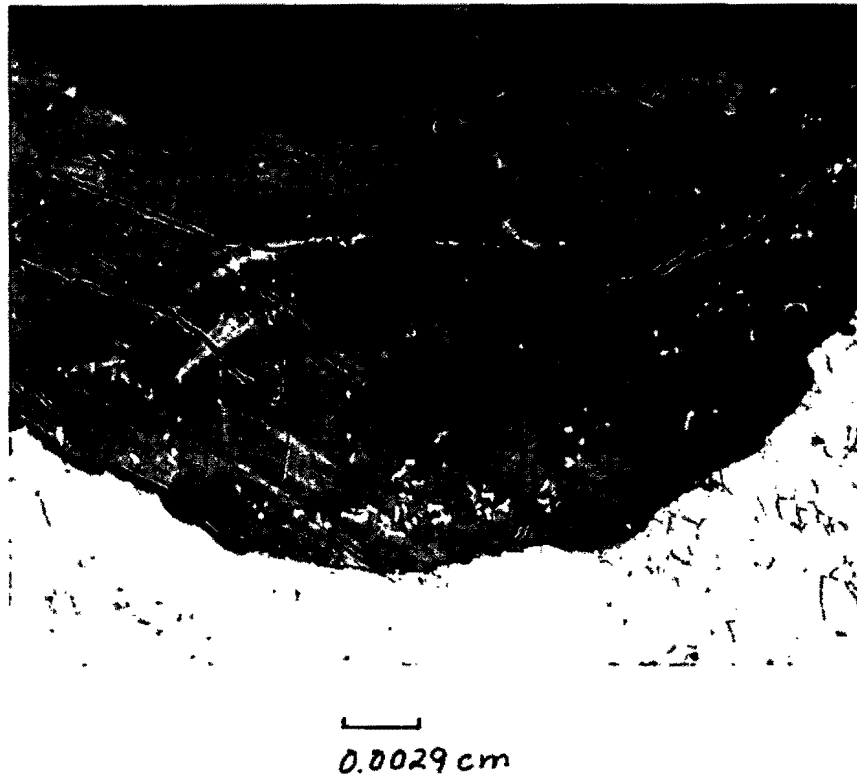
Figure 23a Optical photomicrograph of an oxide-filled pit on the sea side of the container.

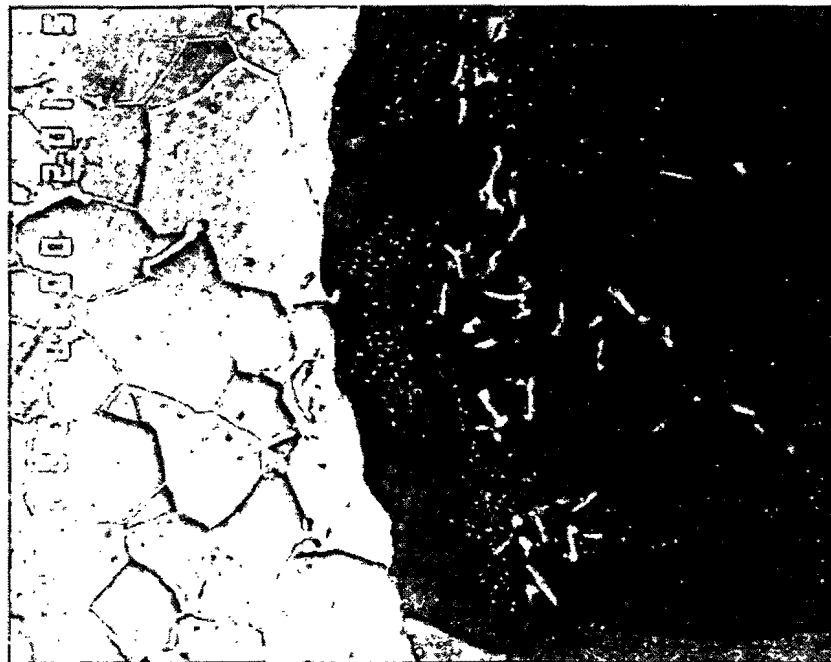
Figure 23b SEM photograph of the same area showing metallic "Ghosts."

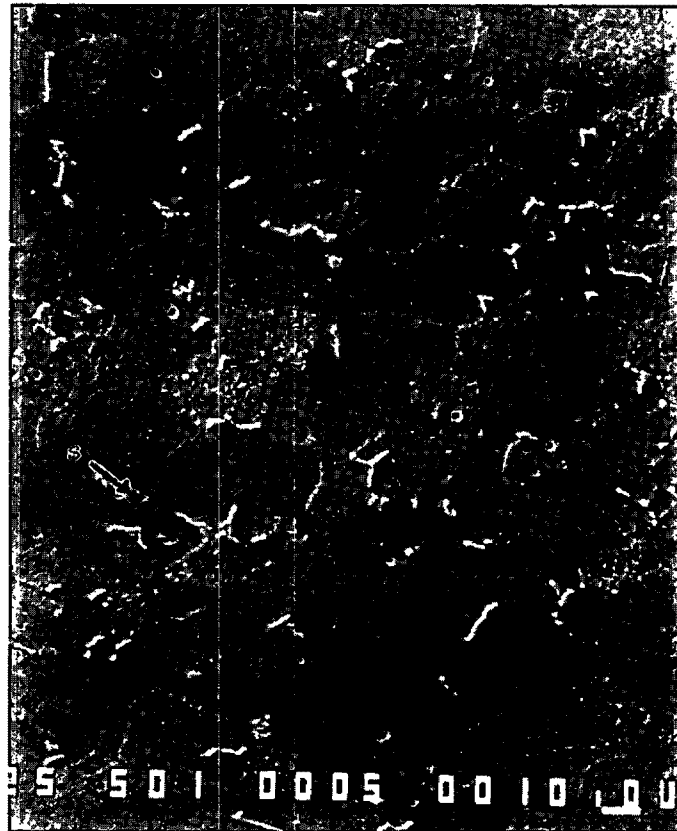
Figure 23c SEM photograph of inclusions and precipitates in the metal.

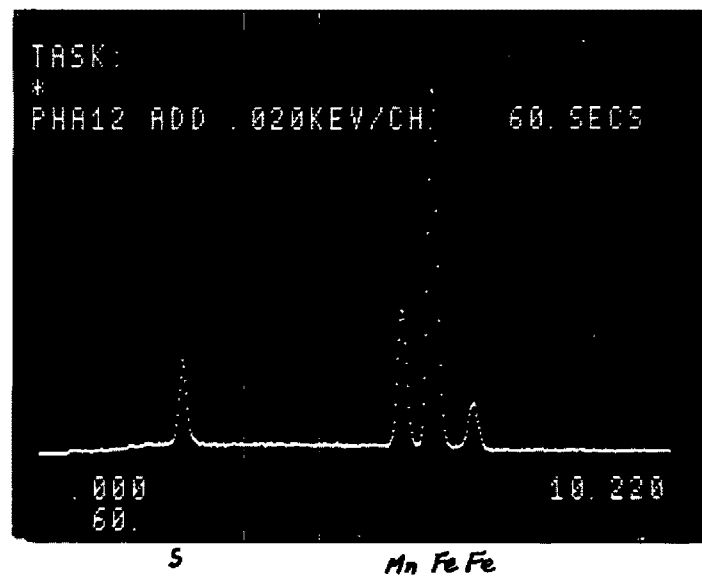
Figure 23d EDS analysis of inclusions and precipitates of the metal and the MnS inclusion.

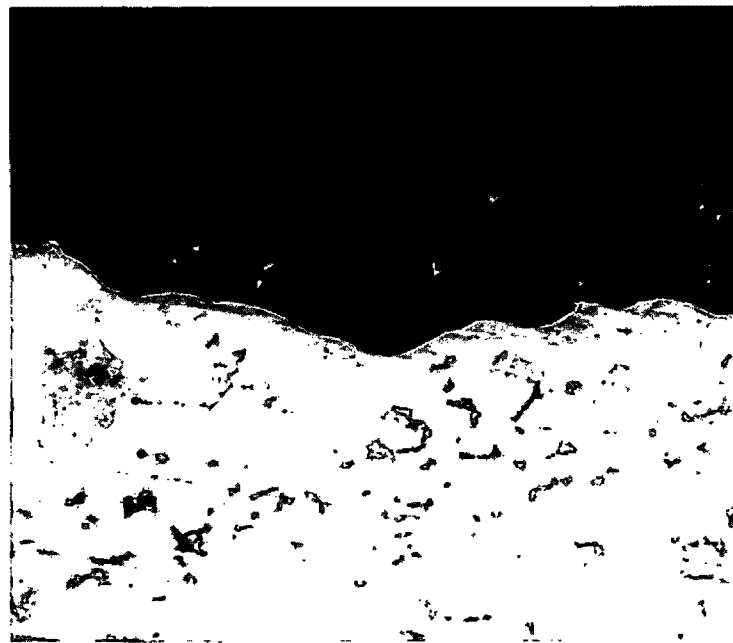
While the ocean-exposed surface of the container provides regions of high protection, its sediment side showed the greatest metal loss resulting from general attack. This attack takes the form of a general pitting. The base of a typical pitted region in a sample taken from ($x=38.1$ cm, $\theta=90^\circ$) shows the morphology of the attack (Figure 24). In contrast to the side above the sediment, this surface has porous, loosely adherent scale. The scale also contains some of the carbide "ghosts."

Figure 24 Optical photograph of severe attack on a sample taken from the sediment side at $x=38.1$ cm, $\Theta=90^\circ$

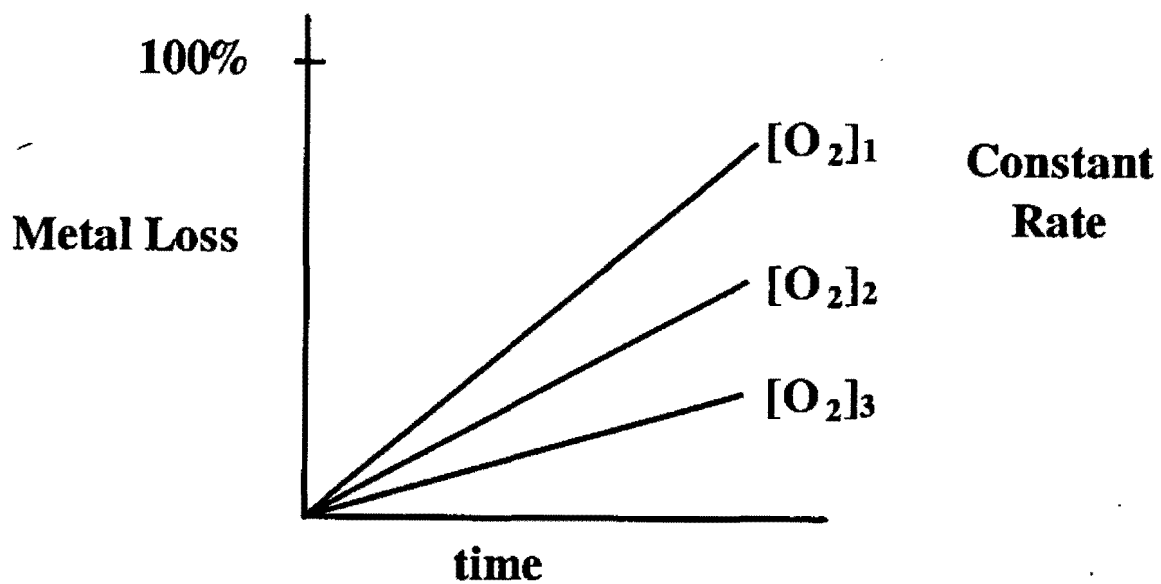
Figure 26a Schematic of metal loss vs. time assuming a constant corrosion rate.

1. The loss of metal as a result of corrosion is greater on the sediment side than on the sea side. Assuming a constant rate (Figure 26a), the calculated rate is 0.015 ± 0.002 mm/yr. This corresponds to a 50 percent reduction of wall in 42 years. The general loss of the sea side is within the error of the measurement of average wall thickness.
2. An apparent coating and Ca^{2+} or Mg^{2+} precipitates appear to inhibit the respective initiation and propagation of corrosion for this material in this environment.
3. High local attack appears at chimes and at the rim of the concrete-exposed end, where loss of concrete to metal adhesion occurs.

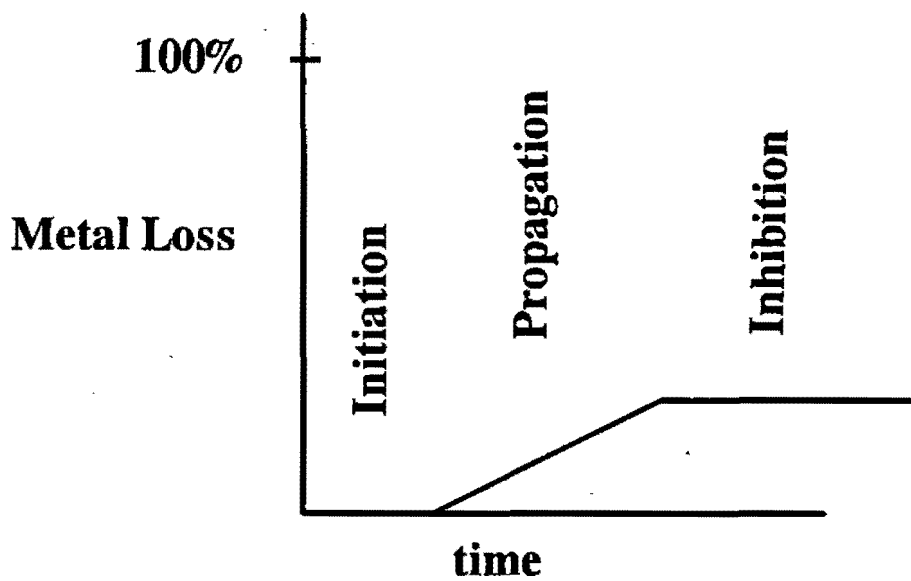
Figure 26b Schematic of generalized corrosion kinetics.

Clearly, there are many factors involved that protect the container sheath from corrosion, since metal loss probably follows a law similar to the schematic in Figure 26b.
