EPA-600/2-76-022

APOLLO COUNTY PARK WASTEWATER RECLAMATION PROJECT Antelope Valley, California

by
Harvey T. Brandt and Richard E. Kuhns
County Engineer Department
Los Angeles County, California 90012

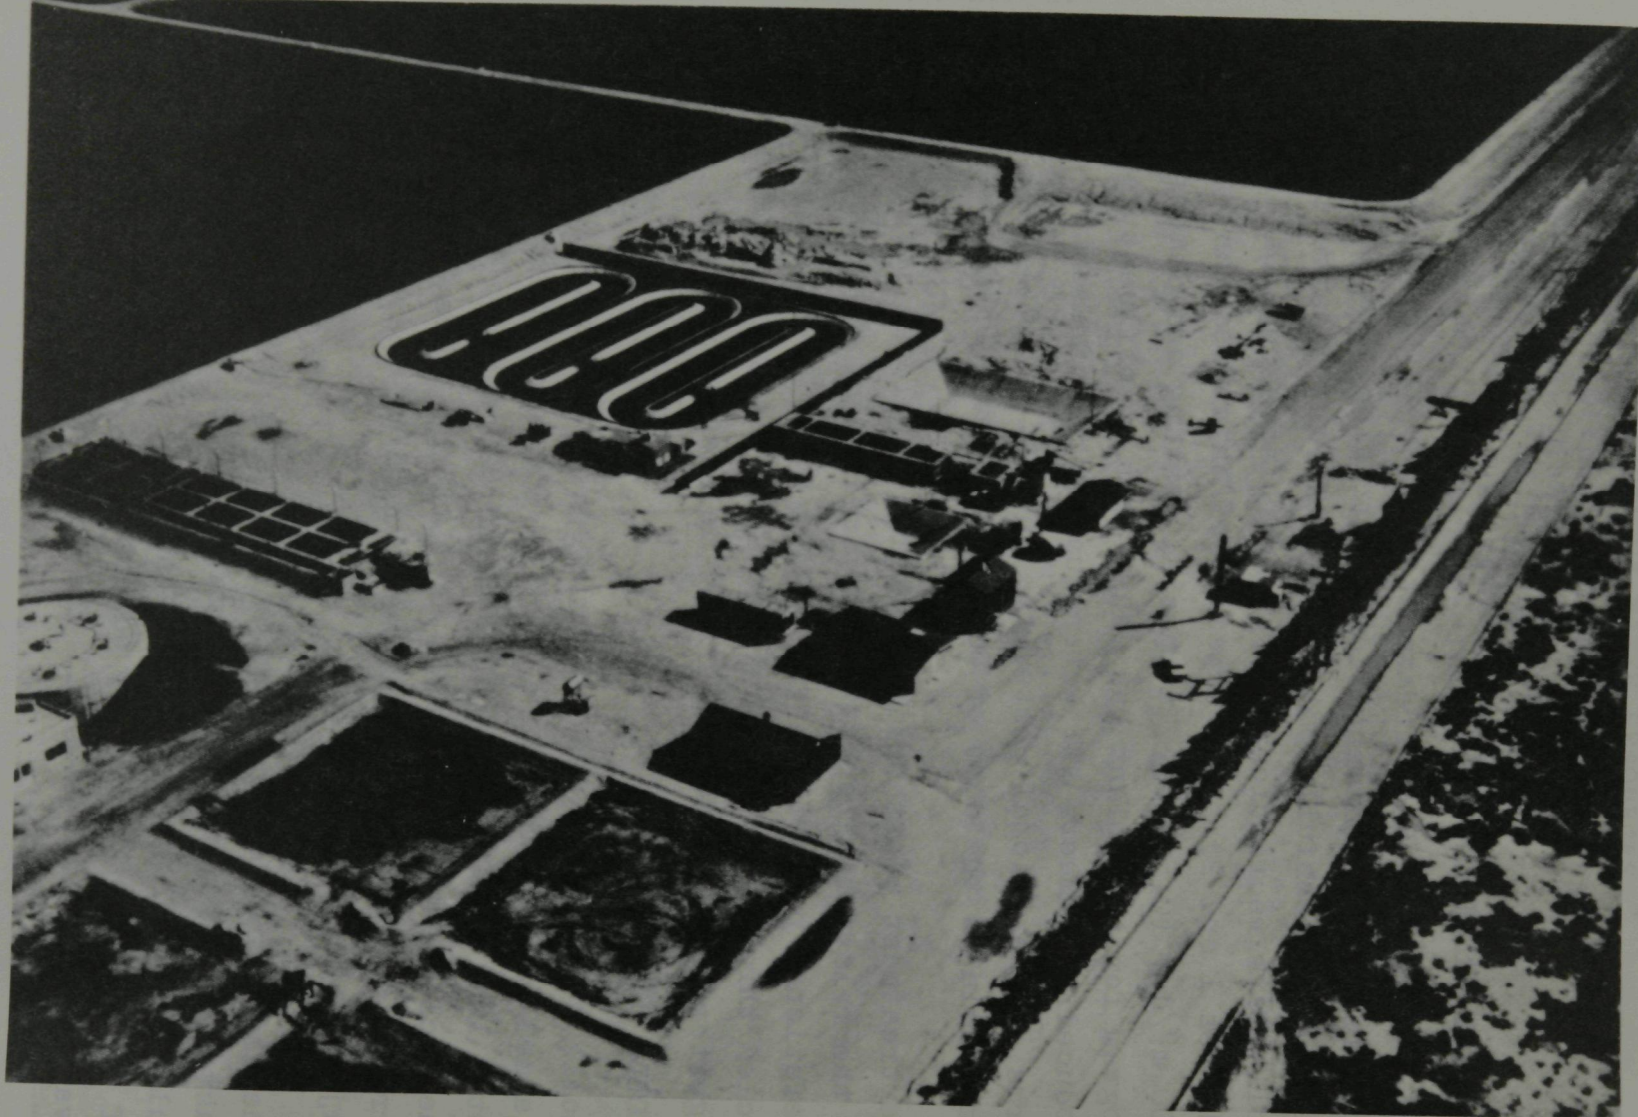
Figure 1 WATER RENOVATION PLANT
LOS ANGELES COUNTY SANITATION DISTRICT NO. 14

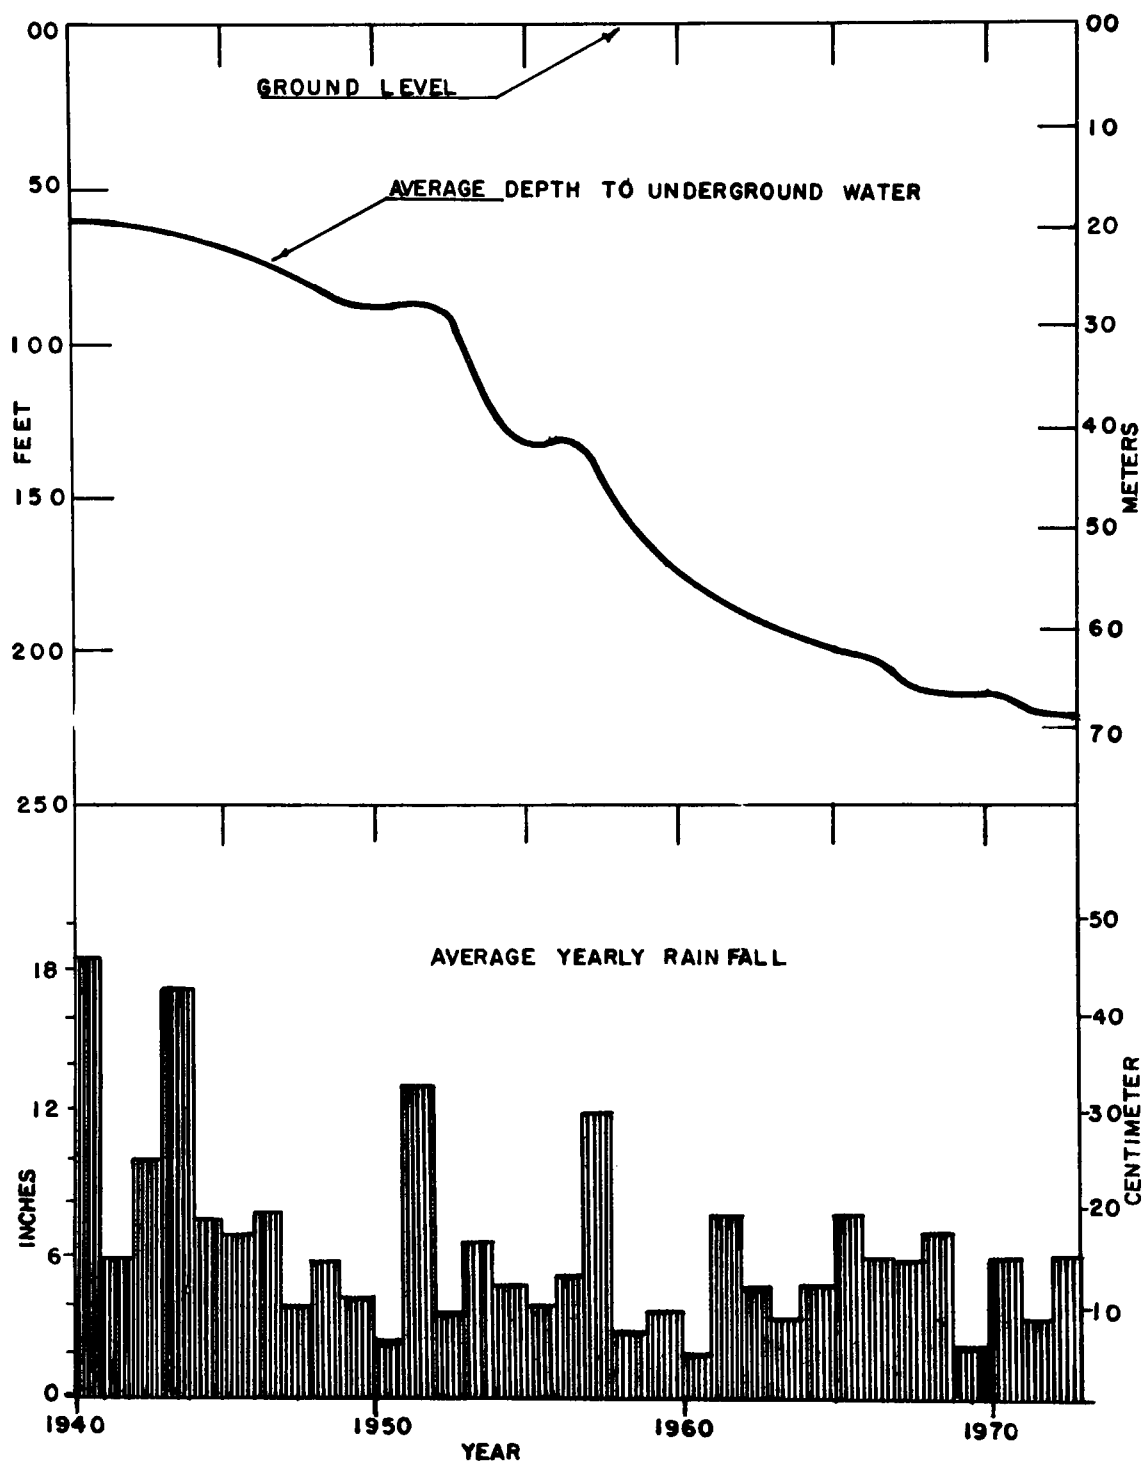
Figure 4
 STATIC GROUND WATER LEVEL AND YEARLY RAINFALL
 IN ANTELOPE VALLEY AREA

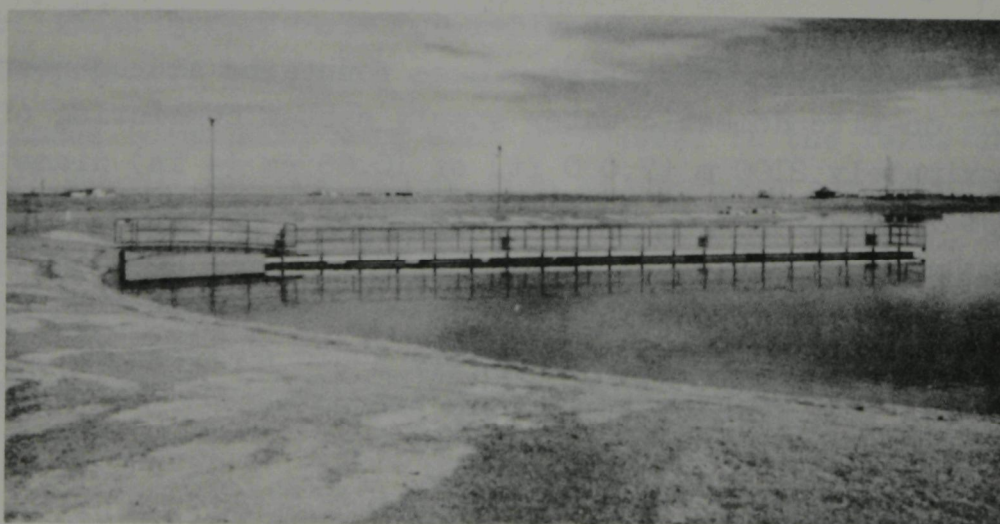
Figure 28 FISHING PIER AT PARK
