Oil Spill

Bahia Sucia, Puerto Rico

18 March 1973

Environmental Effects¹

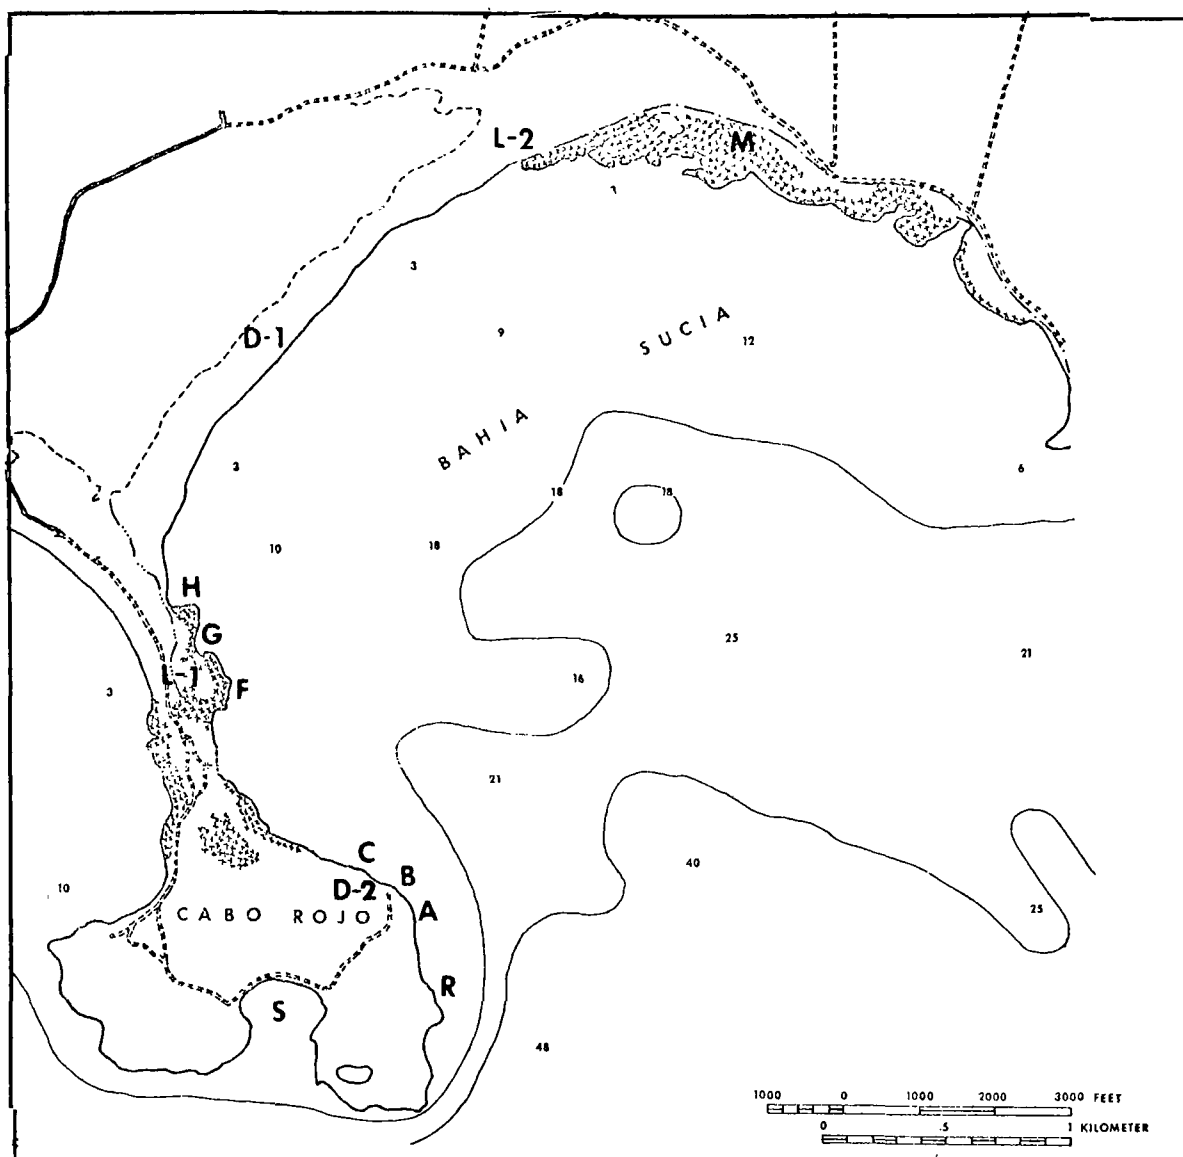
Figure 2: Location of Oil-contaminated Sampling Stations in Bahía Sucia, Puerto Rico

A Short Thalassia
 B Thalassia flats
 C Long Thalassia
 D-1 Main Beach area
 D-2 Small Beach area
 F South mangrove
 G Silt mangrove

H North mangrove
 L-1 Western lagoon
 L-2 Crab lagoon
 M Upper mangrove area
 R Rocky shore
 S Shark Bay

The west shore of Bahia Sucia was chosen for intensive study in Surveys I and II. The specific study areas shown in Figure 2 include short Thalassia beds (A), Thalassia flats (B), long Thalassia (C), and the south (F), silt (G), and north (H) mangroves which were mentioned in the previous section. The corresponding control areas were located well east of the westward drifting oil (Y,Z Figure 1). Physical parameters of temperature, salinity, dissolved oxygen, and specific gravity were measured at each station (see Table 1).

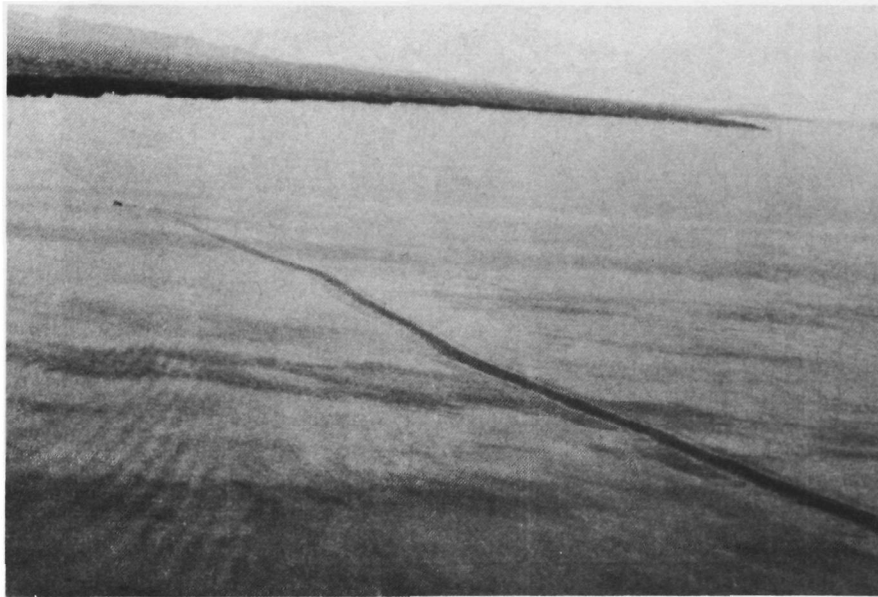
Figure 3: Photo of a Boat Path through Oil-covered Water in Bahia Sucia. The photo was taken during the afternoon of 31 March 1973. The dark line is oil-free water. This view is towards Punta Molina.

line is a trail made in the otherwise oil-covered water by a small boat. The view is across the Bahia towards Punta Molina. Some weathered oil could be seen at the high tide line on the eastern side of Punta Molina.

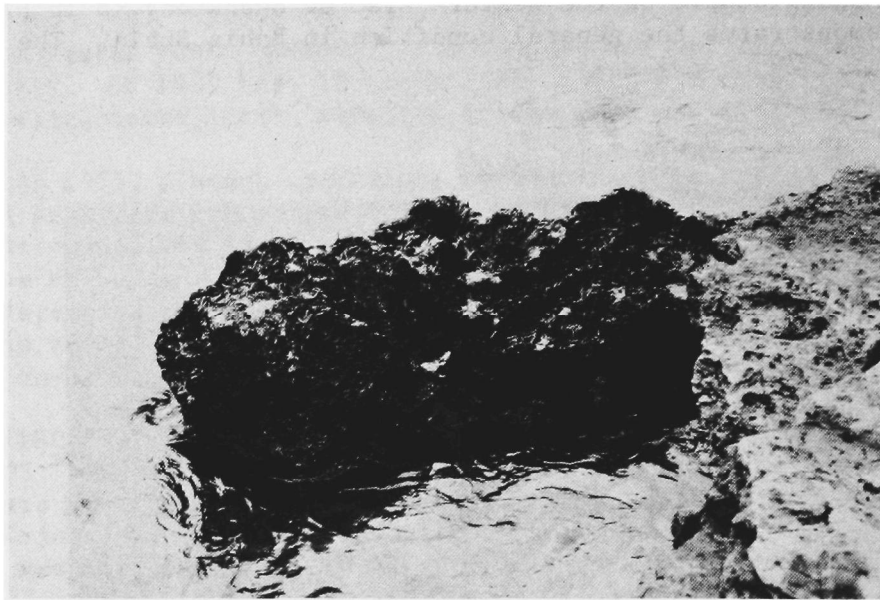
Figure 4A: The Rocky Shore Zone at Cabo Rojo. Photo taken on 25 March 1973. Pitted rock rubble at the base of the cliffs.

The rocky shore zone, R in Figure 2, along the seaward section of the western shore of Bahia Sucia is primarily limestone cliffs. The rock rubble at the base of the cliffs is both pitted and eroded (Figure 4A).

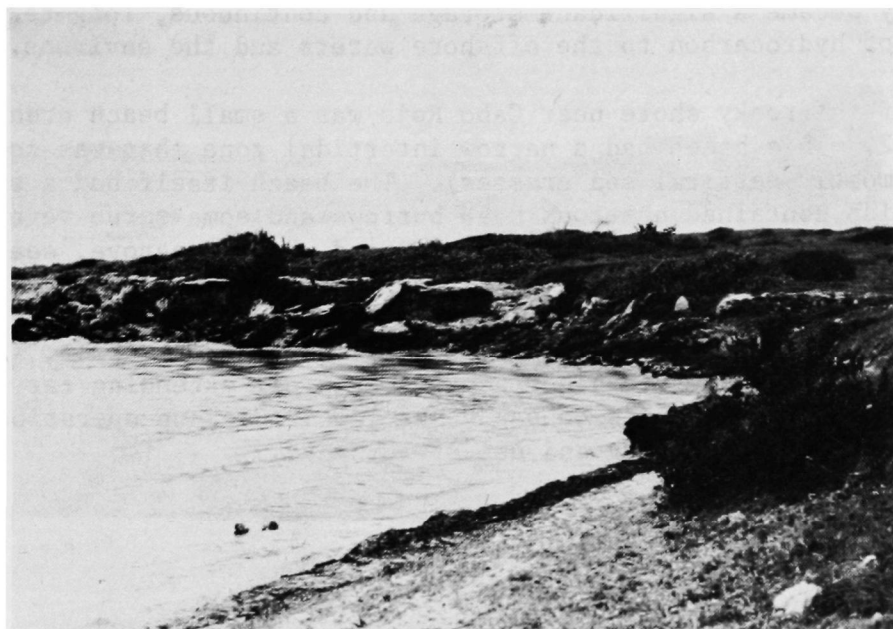
Figure 4B: The Rocky Shore Zone at Cabo Rojo. Photo taken on 25 March 1973. Oiled rocks in the north end of the rock zone.

An oil-free zone extended along this shore from the tip of Cabo Rojo to a point 400 m north along Bahia Sucia. Beyond this point, the vertical faces of the cliffs were covered with a thick band of oil. The width of the band varied from one to three meters, depending on the extent of the splash zone. Figure 4B illustrates the conditions along the oiled rocky shore line.

The surface of the water washing the rocks in the oiled zone was heavily coated with oil. The oiled rocks were devoid of visible signs of life, except for subtidal algae. It was not clear whether this condition resulted naturally from the exposed nature of the habitat, or from the presence of oil.

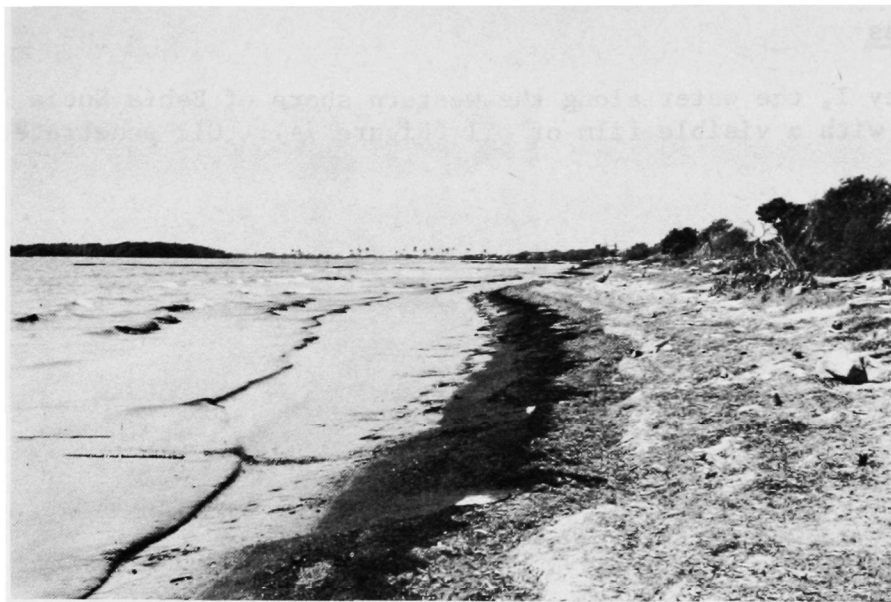
Figure 5: Beach Scene in Bahia Sucia - Survey I. Photo taken on 26 March 1973. There is extensive litter and oil-covered water just off shore.

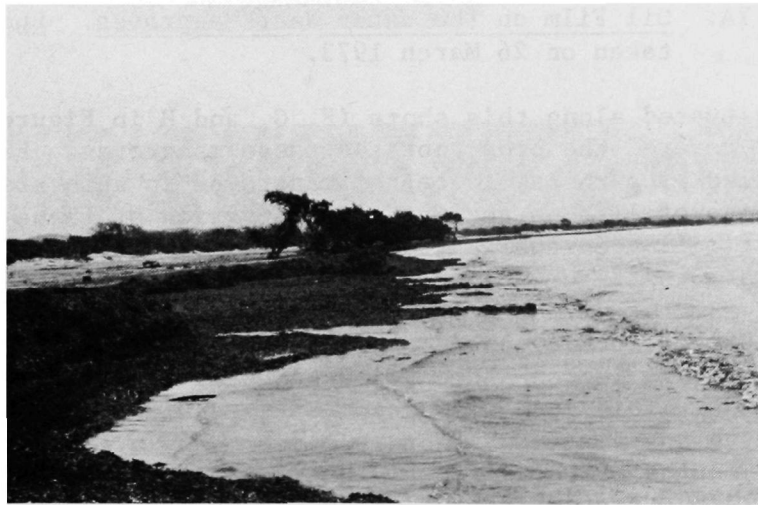
Figure 6: Northward View of Beach Area during Survey II. Photograph taken on 1 July 1973.

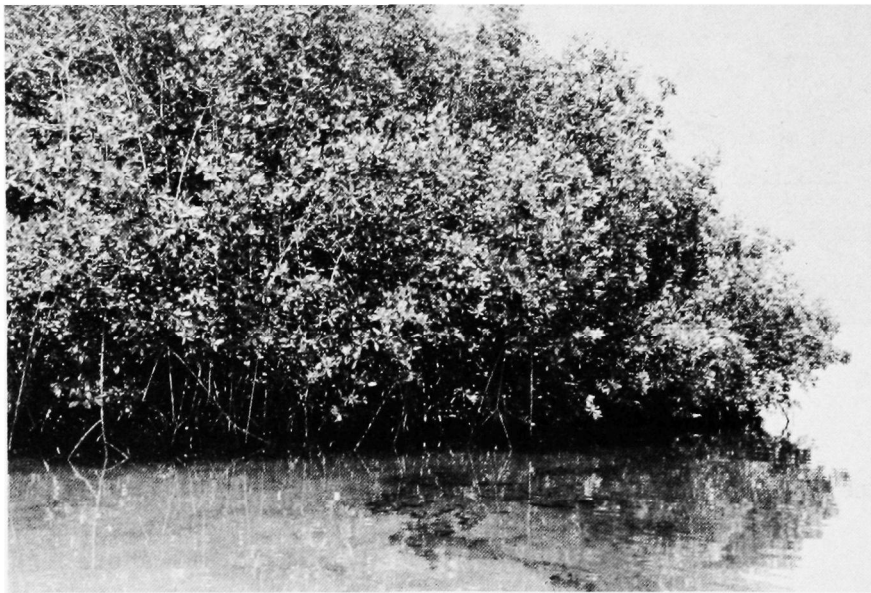
Figure 7A: Oil Film on the Water Near Mangroves. Photo taken on 26 March 1973.

In Survey I, the water along the western shore of Bahia Sucia was covered with a visible film of oil (Figure 7A). Oil penetrated a man-

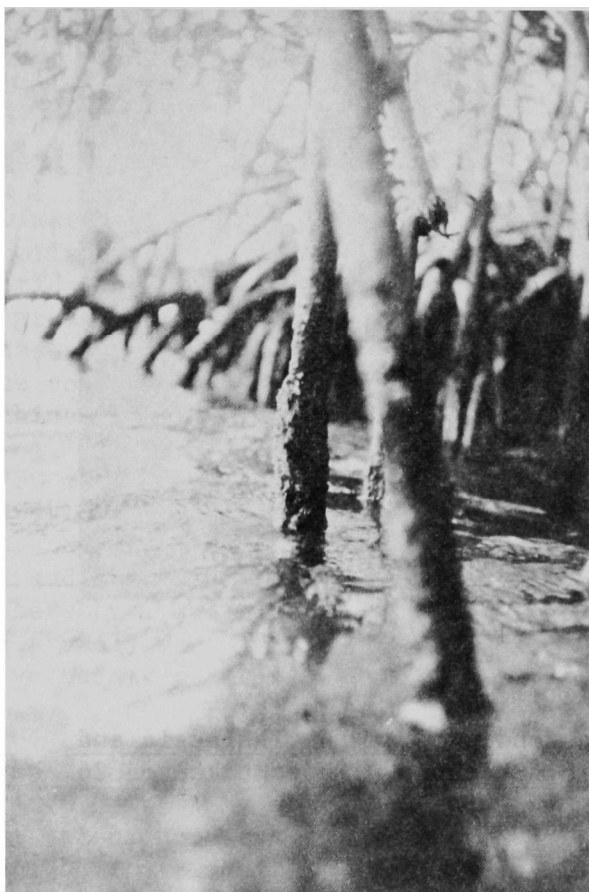
Figure 7B: Intertidal Re-
gion of Prop
Root Zone of
the Red Man-
grove. Survey
I at Station H.
Photo taken on
26 March 1973.

grove area situated along this shore (F, G, and H in Figure 2) and a layer of oil covered the prop roots of these mangroves. Figure 7B shows the oiled prop roots of the red mangroves in this area. There was no visible sign of life on the intertidal portion of these prop roots and the oil floating on the water surface was too thick to allow subtidal observations (Figure 8A).

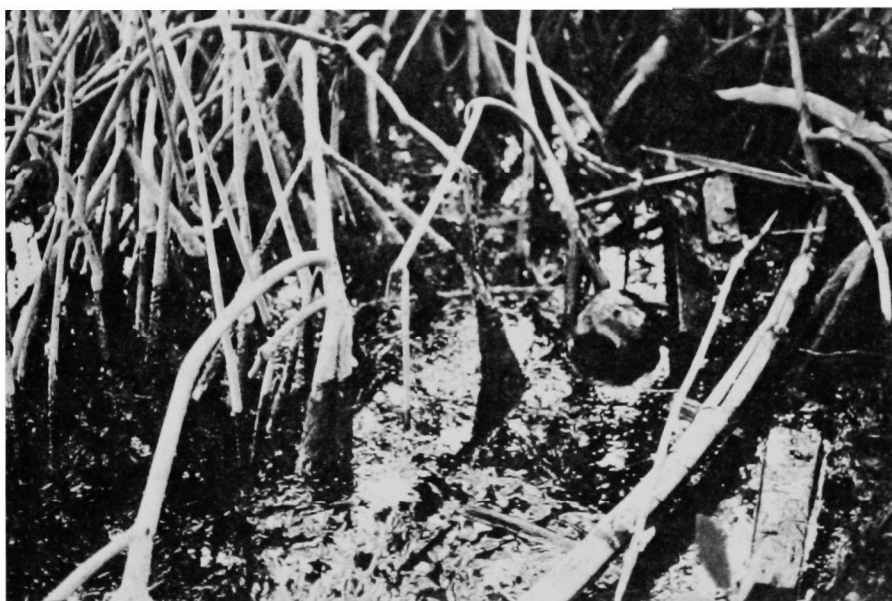
Figure 8A: Oil in Red Mangroves at Station G (Silt Mangrove),
Survey I. Photograph taken on 27 March 1973.

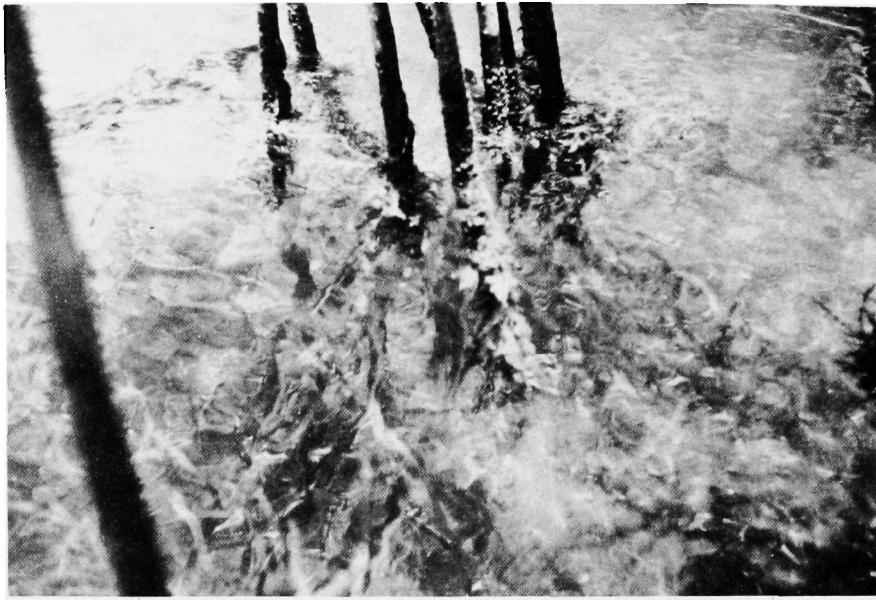
Figure 8B: Characteristic Condition at the Thalassia and Mangrove Control Stations. Photo taken on 26 March 1973.

There was a lagoon located behind this mangrove area, L-1 in Figure 2. Oil penetrated this lagoon and covered both the water surface and the intertidal zone. This zone was densely packed with crab burrows. We did not observe any dead crabs nor were there any signs of fresh diggings at the mouths of the burrows. Unoiled mangroves and Thalassia beds were selected east of Bahia Sucia. These areas are designated by Z and Y in Figure 1. Conditions in this control region are shown in Figure 8B.

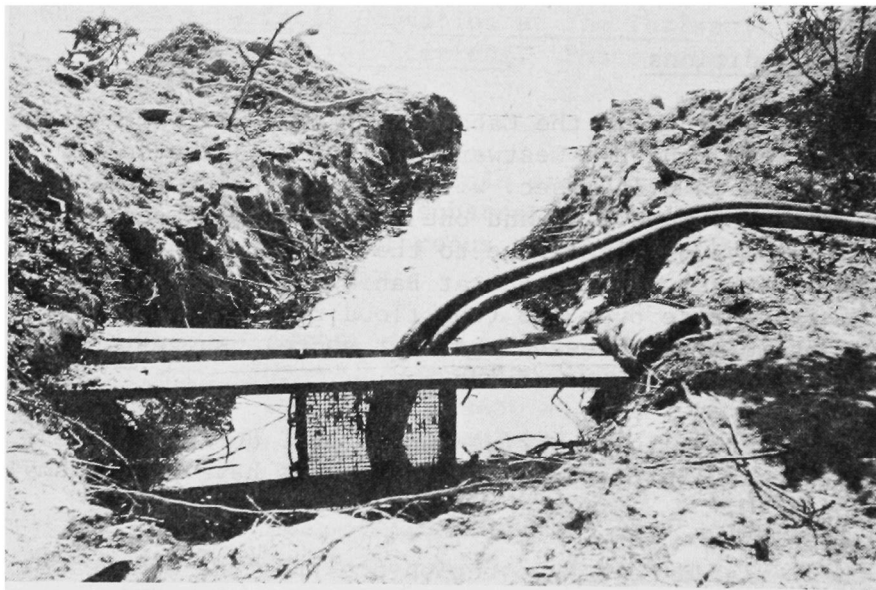
Figure 9: Trench-pit System for Oil Recovery. Photo taken on 26 March 1973.

1. Trenching and pits are efficient methods of oil recovery, and can be improved by lining the trenches and pits to prevent oil seepage into subsurface sand.
2. More boom should be employed to prevent oil drifting with unexpected wind shifts, and to corral the oil as quickly as possible.
3. Beach harrowing and sorbents are very inefficient and possibly detrimental to biota.
4. Short-term biological assessment should begin promptly after a spill, and must be followed by later assessments to determine if immediate effects are important or lasting.
5. Follow-up studies should be done to determine the long-term effect of oil on the various communities in the Cabo Rojo area.

The removal procedure consisted of trenches cut into the beach at right angles to the shoreline. Oil flowing into these trenches was pumped directly into tanker trucks (Figure 9). This method was an effective and ingenious way of removing a large portion of floating oil blown against the beach by prevailing winds.

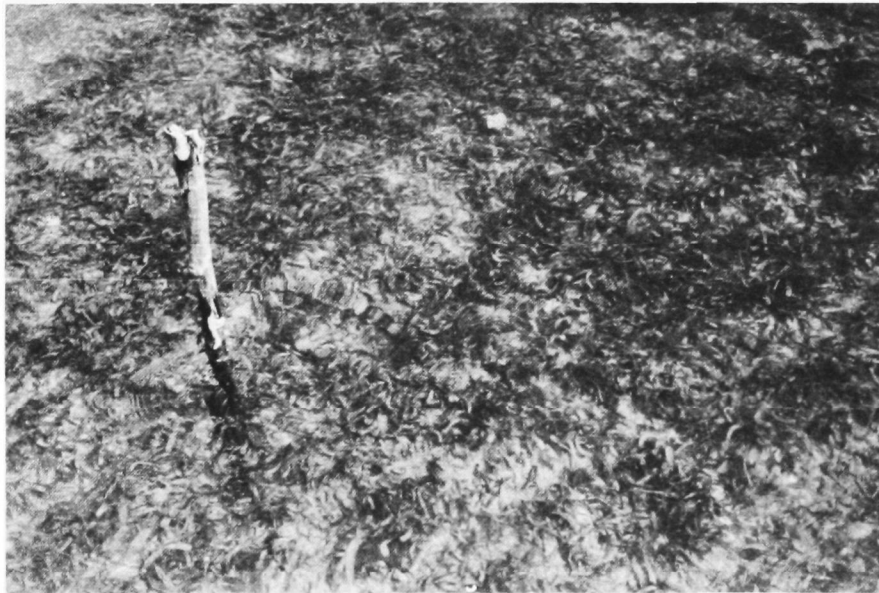
Figure 10: Sampling Station in Short Thalassia Beds - Survey I. Photo taken on 27 March 1973.

The three Thalassia study areas represented the seagrass beds typical of Bahia Sucia. The southernmost station, Figure 2, was dominated by short Thalassia. The grass was at an average depth of 15 cm below the surface (Figure 10). Station B, the Thalassia flats, had numerous sandy depres-

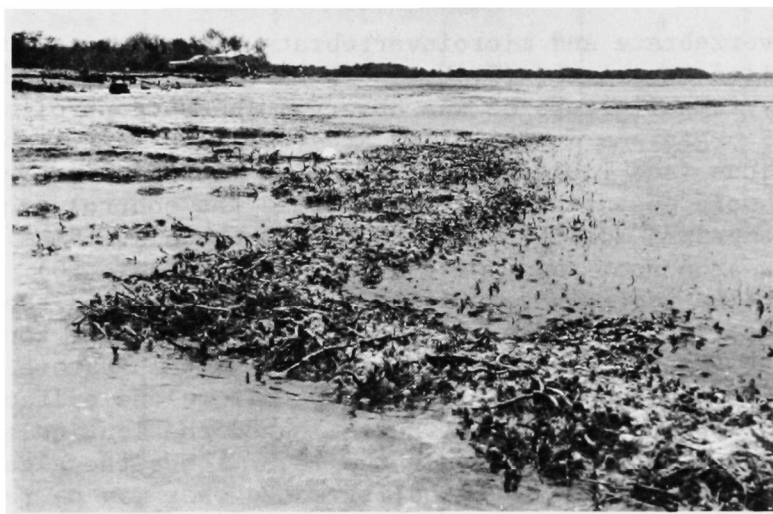
Figure 11: Thalassia Beds During Survey II. Photo taken on 1 July 1973.

Between surveys there appeared to be a general decline in the appearance of the oiled Thalassia beds. It appeared that a large amount of the grass had died and had been washed away, leaving more numerous and extensive pits of loose sand than were present on the first survey. The death of turtle grass was evident by the extensive windrows of dead blades washed up on the beaches and lying on the bottom at the edges of the mangroves on Survey II. Furthermore, exposed roots and rhizomes lined the edges of the sand pits suggesting that a great deal of erosion had taken place with the death of the grass following the oil spill.

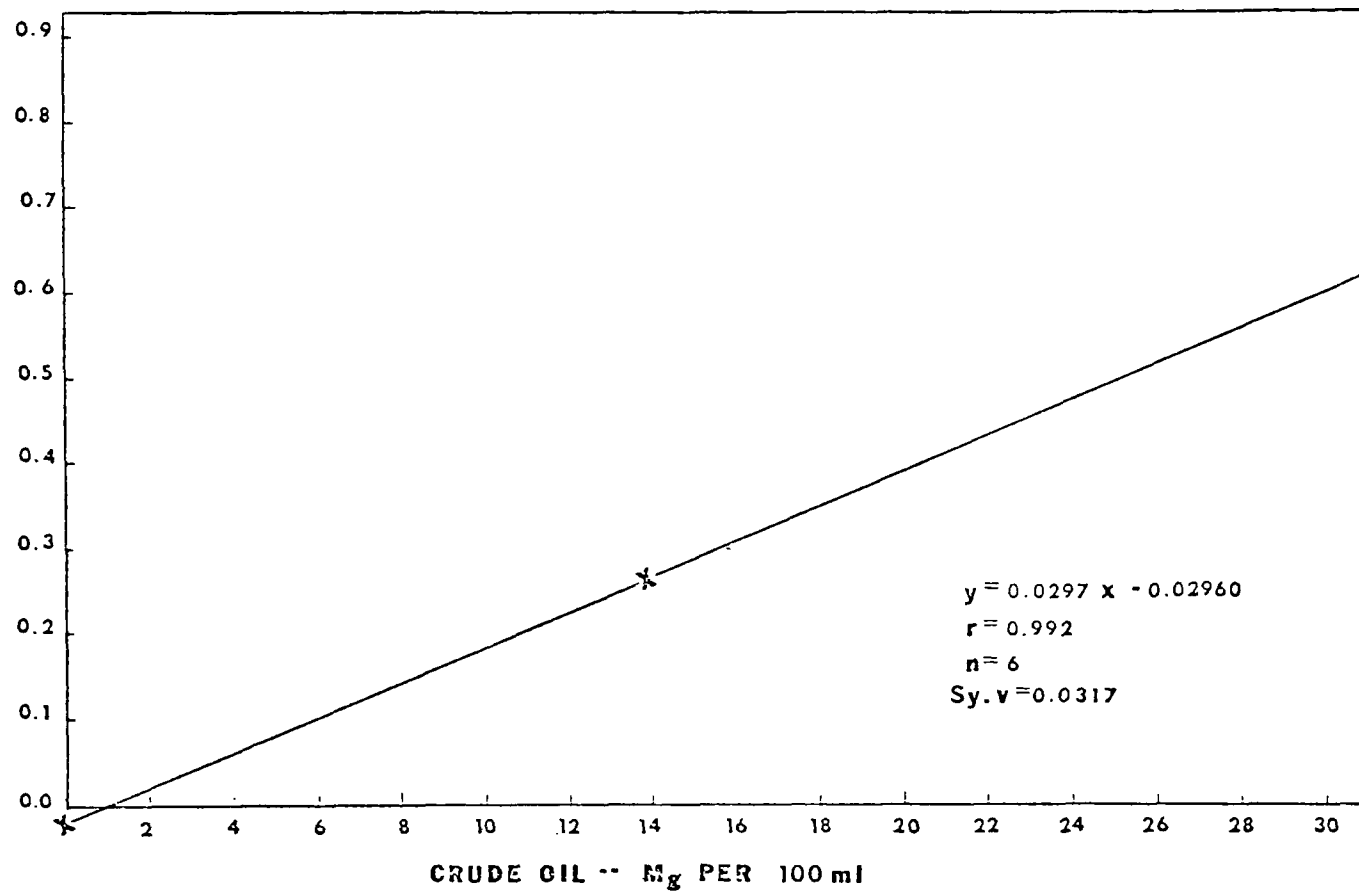
Figure B-1: Calibration of Infrared Spectrophotometer Using Dilutions of Crude Oil from the Beach at Bahia Sucia

Dilutions of 2.0, 4.0, 10.0, 16.0, 20.0, and 30.0 mg per 100 ml (Figure B-1) were used to calibrate the instrument on the same day that the samples were run. The concentration of oil in the samples was then read directly from the standard curve. The standards were tested before and after passing them through the anhydrous sodium sulfate to test the recovery rate which was found to be 100 percent.
