**EPA-600/2-78-017**  
**February 1978**

# **EVALUATION OF THE REFUSE MANAGEMENT SYSTEM AT THE JERSEY CITY OPERATION BREAKTHROUGH SITE**

Jack Preston Overman and Terry G. Statt  
Hittman Associates, Inc.  
Columbia, Maryland 21045

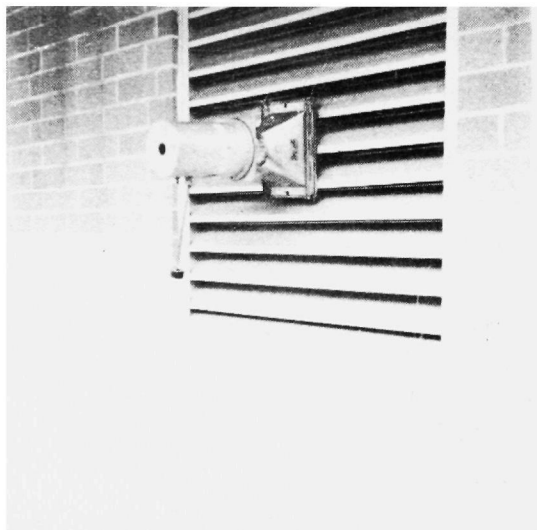
FIGURE 10. Sampling of airborne particulates of the system exhaust air by a high volume sampler

The levels of total airborne particulates were measured by high volume samplers as depicted in Figures 9, 10, and 11. The exhaust air and ambient air were sampled continuously. The system air inside the collection hopper was sampled between PTC cycle operations. The results for the particulate sampling tests are reported in Table 9.

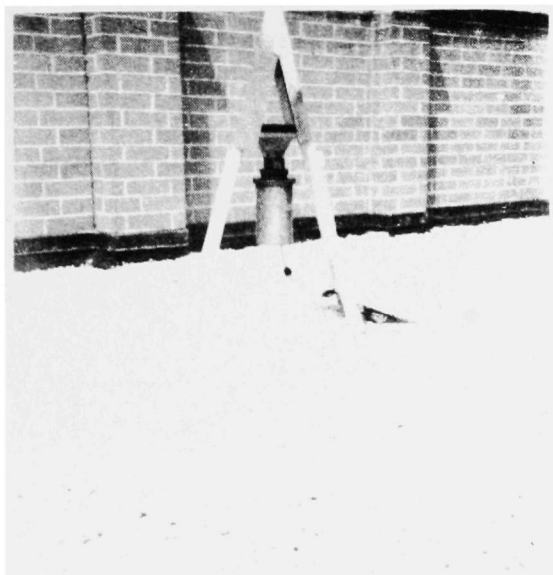
FIGURE 11. Sampling of airborne particulates in ambient air by a high volume sampler.

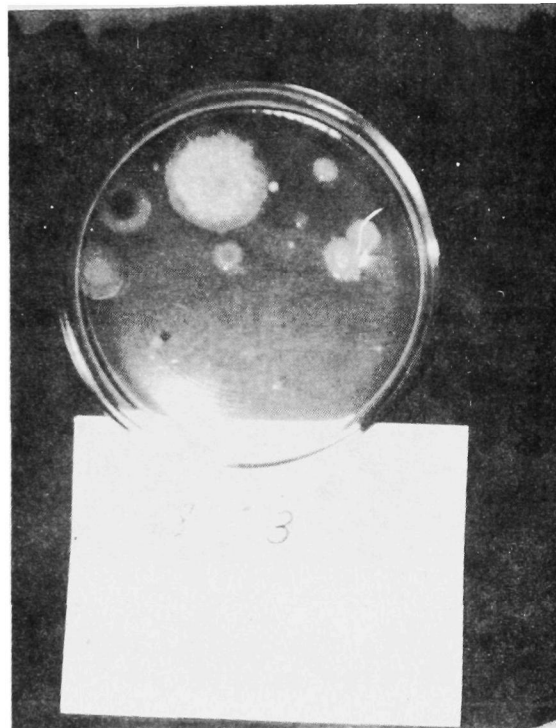
FIGURE 14. A typical stage from the viable particle sampling test after the incubation period showing colonies.

The sampling of viable particles was conducted with an Andersen 2000 six-stage sampler. An independent laboratory performed the media preparation, incubation, and colony counts. Figures 12 and 13 show viable particle sampling of the collection air and ambient air. Figure 14 shows a typical stage after the incubation period. The results of the tests are presented in Table 10.

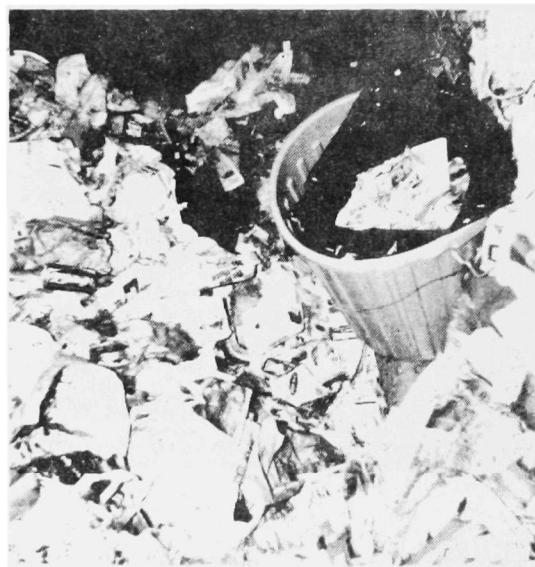
FIGURE 15. Sample of refuse being collected during the solid waste characterization test.

The refuse was weighed in trash cans and sorted into the ten categories as shown in Figures 15, 16, and 17. The composition of the solid waste is reported in

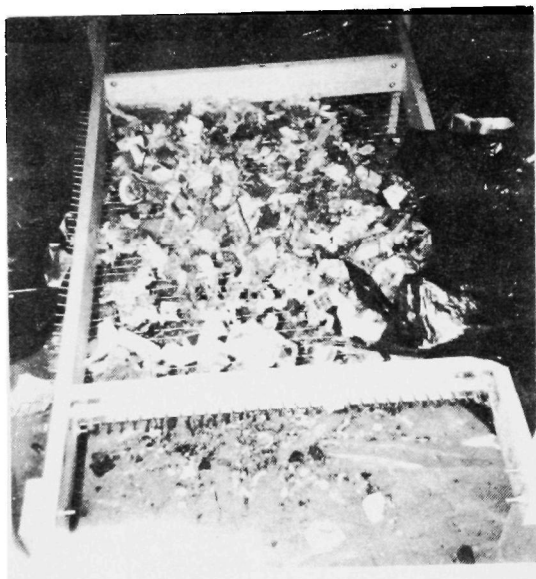
FIGURE 16. Sieve used to separate the refuse. All refuse which fell through the sieve was classified as fines.

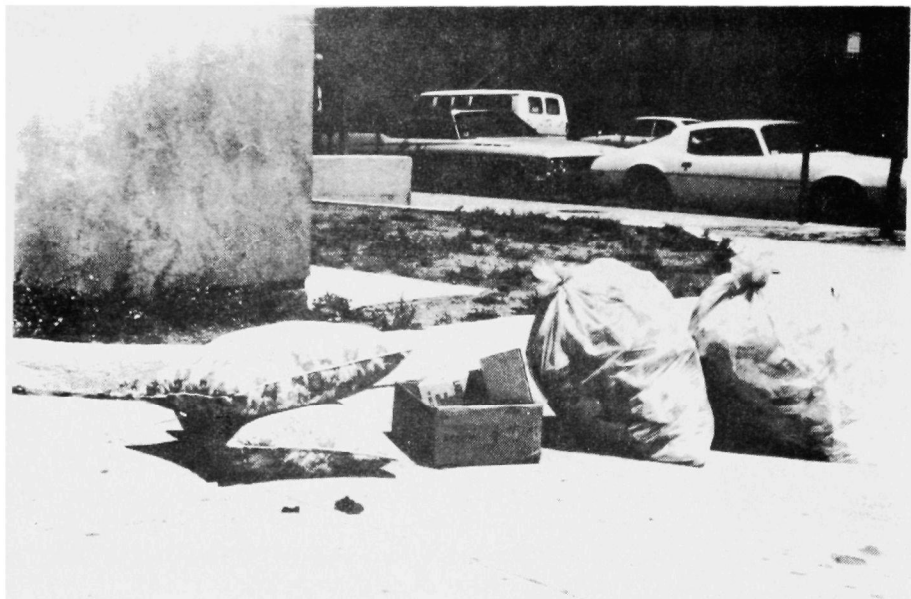
FIGURE 23. Two feather pillows, cardboard boxes, and plastic bags filled with loose newspaper successfully transported by the system during the load capacity test.

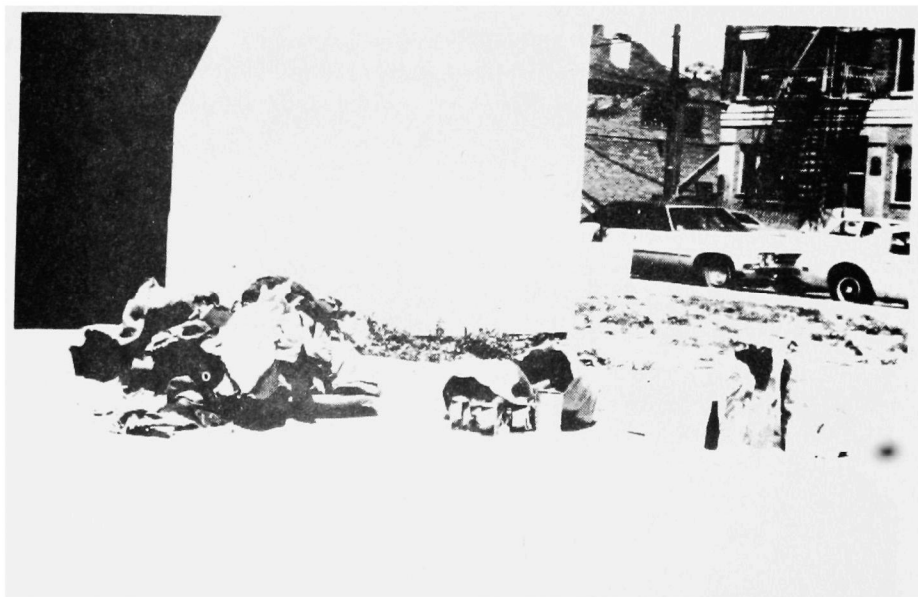
FIGURE 24. Test samples of rags, cans, wood blocks, and glass bottles successfully collected by the PTC system during the load capacity test.

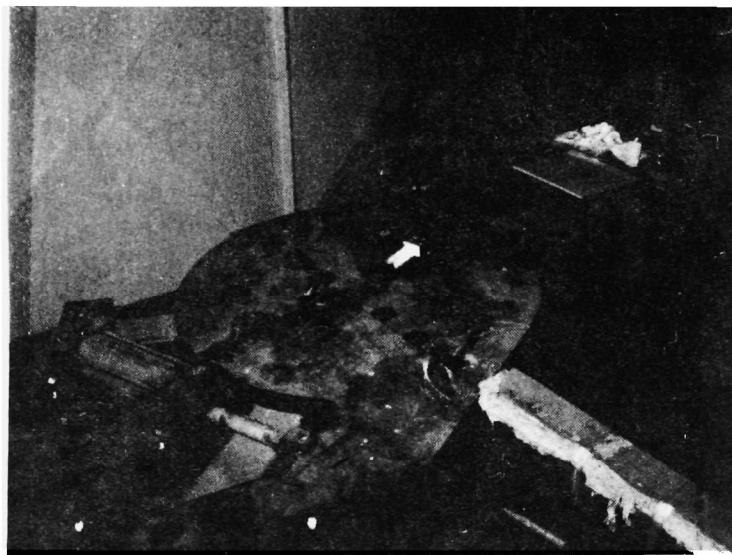
FIGURE 38. Surface impressions of discharge valve plates.

The discharge valve plates also showed signs of wear. The top surfaces were heavily dented and scratched as shown in Figures 36 and 37. To find the extent of this wear, surface impressions were made of the valve plates (see Figures 38 and 39). A typical dent of the following dimensions, 0.146 inch long and 0.014 inch deep, is illustrated in Figure 40.

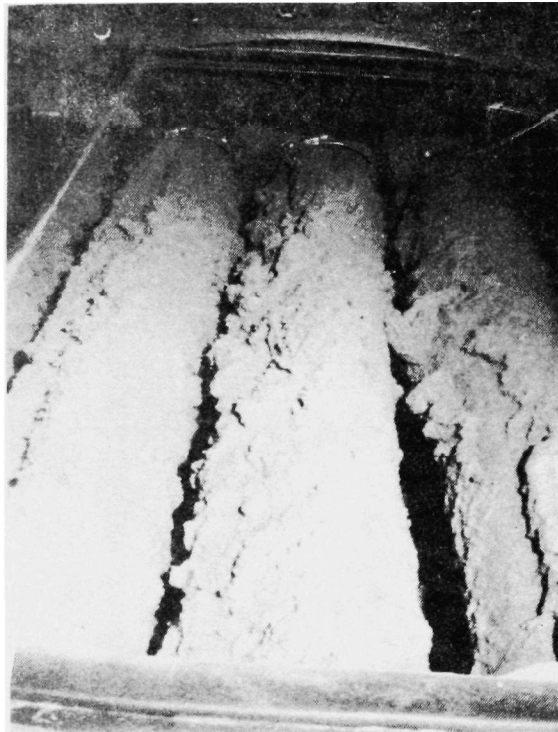
FIGURE 53. Filter bags inside the dust collector after 15 months of operation with air shaker equipment and filter globe valve not working.

into a drain, the valve merely collected it and clogged. To alleviate this problem, the rotary valve was removed and a plywood board was placed over the opening at the dust collector base, as seen in Figure 52. The air shaker apparatus was turned off, and the dust particles gathered on the felt filters. Figure 53 shows the filter bags at the end of the monitoring program. Dust particles have coated the bags in layers 1 to 1-1/2 inches deep. The layers are loosely held and any air movement will disturb the dust.

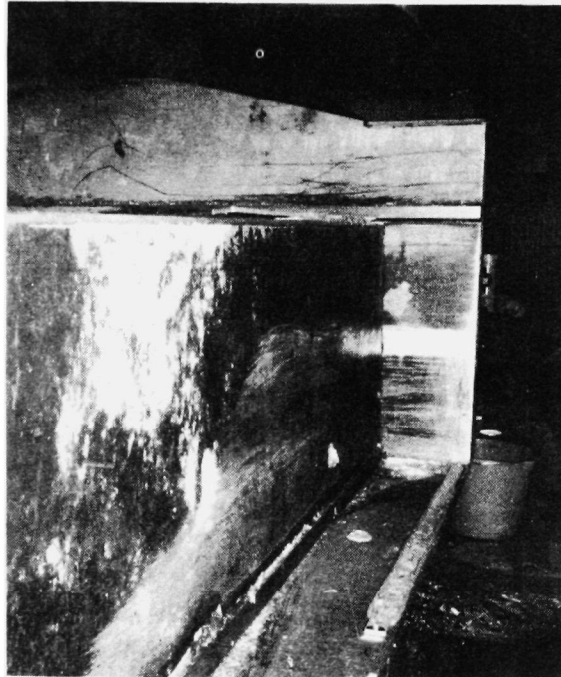
FIGURE 55. Surfaces of compactor and ram showing series of fine parallel scratches.

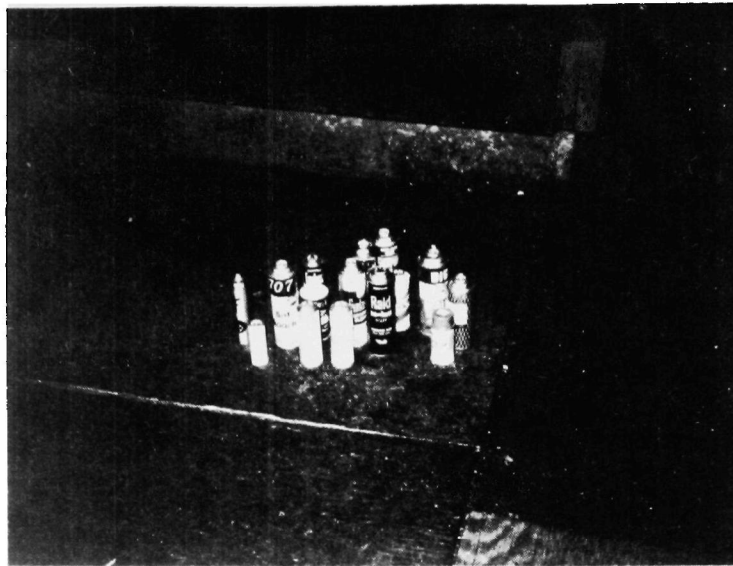
These types of solid waste could damage the system and injure the personnel. However, tenants did dispose of aerosol cans; and there were no problems in the ability of the system to safely collect these cans. Figure 74 shows a sample of the aerosol cans which were collected by the PTC system.

FIGURE 74. A sample of the aerosol cans that were safely collected by the PTC system.

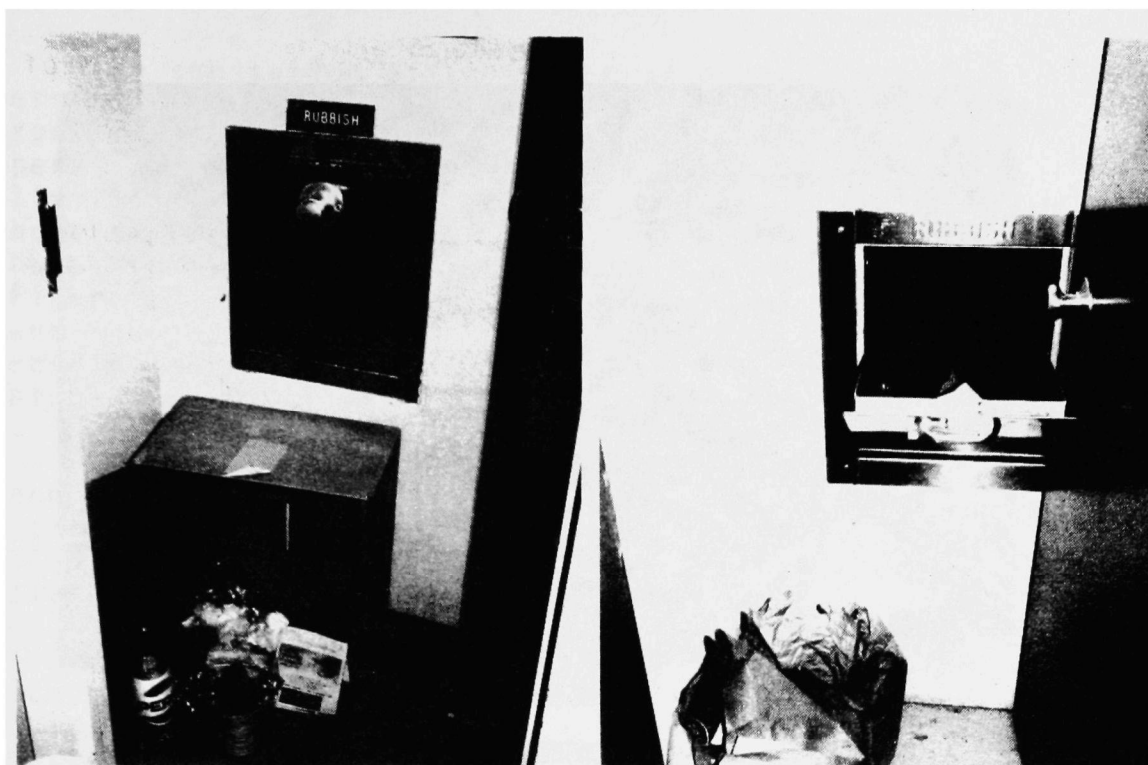
As was the customary procedure, some refuse such as large bulky items, cardboard boxes, glass bottles, and newspaper, were left at chute charging stations (Figure 81) and at designated pick-up areas outside the buildings. The site management provided a daily collection service for these items. Thus, the effects of litter, odor and vermin were minimal. However, the charging stations at the Descon Concordia and Camco buildings did have roaches. It was reported by the site management, that the roaches would first appear in the kitchens of new tenants and migrate over to these charging stations.

FIGURE 81. Refuse left at the charging stations which was collected daily by site personnel.

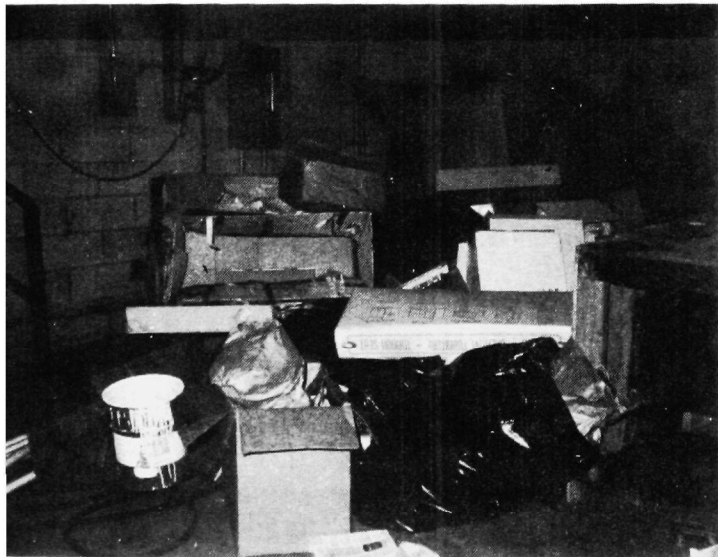
FIGURE 83. Bulk solid waste left in the compactor room, even though an open-top 25-cubic yard container is provided for this waste.

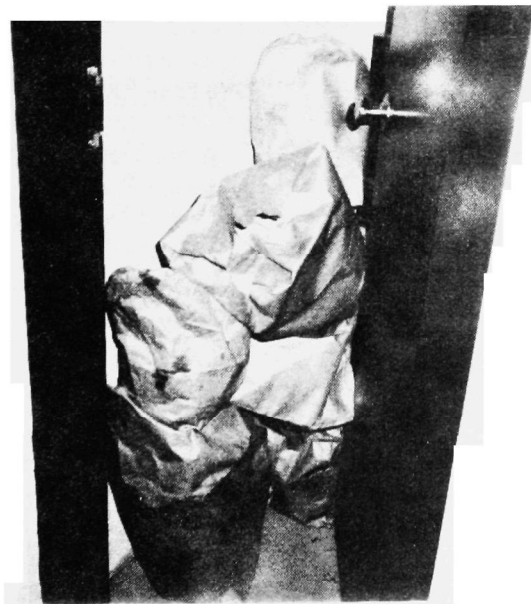
FIGURE 86. A typical chute charging station filled with refuse during a prolonged system malfunction. Note that the door is only partially open because of additional refuse behind the door
