EPA-660/2-73-035

Joint Construction Sediment Control Project

EPA-660/2-73-035
April 1974

JOINT CONSTRUCTION SEDIMENT CONTROL PROJECT

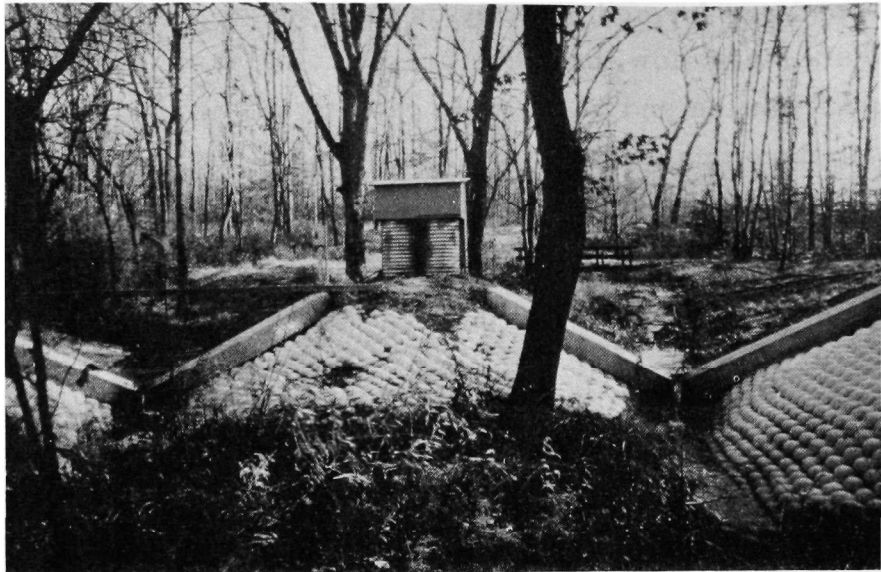
Figure 5. Double Gaging Station

The tandem stream gages (farthest upstream) (Figure 5) are precali-brated, broadcrested, V-notch weirs developed and tested by the U. S. Department of Agriculture. The concrete weir caps have 2:1 side slopes

and were poured and formed directly on steel sheet piles driven a minimum of six feet below the elevation of the stream channel. Earth berms extend from the end of the weir caps to the limit of the calculated 50-year, post-development floodplain.

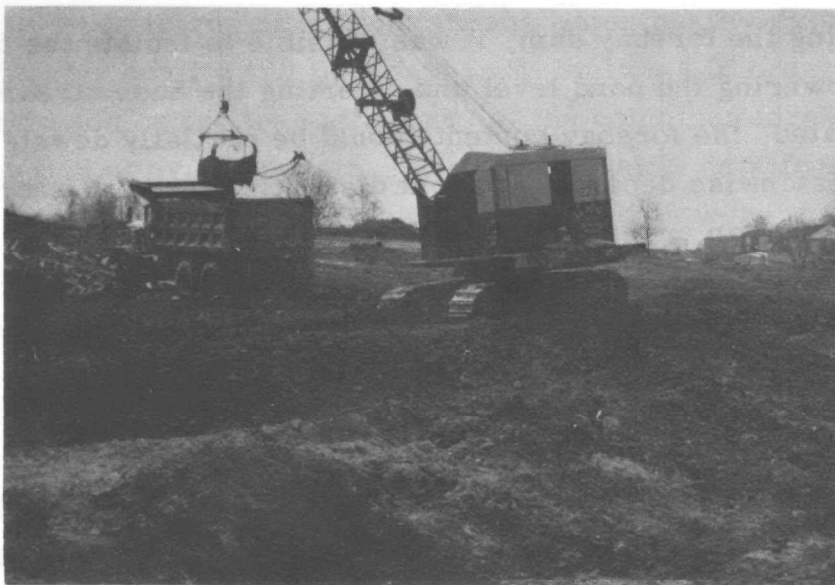
Figure 19. Conventional Dragline - Dump Truck Operation

Sediment was removed from the forebay by conventional dragline and loaded directly onto conventional dump trucks. Figure 19 illustrates the conventional drag line-dump truck operation. The drag line operation proved to be time-consuming and inefficient because the bucket frequently spilled sediment material before it could be loaded.
