ELKINS MINE DRAINAGE POLLUTION CONTROL DEMONSTRATION PROJECT

EPA-600/7-77-090
August 1977

ELKINS MINE DRAINAGE
POLLUTION CONTROL
DEMONSTRATION PROJECT

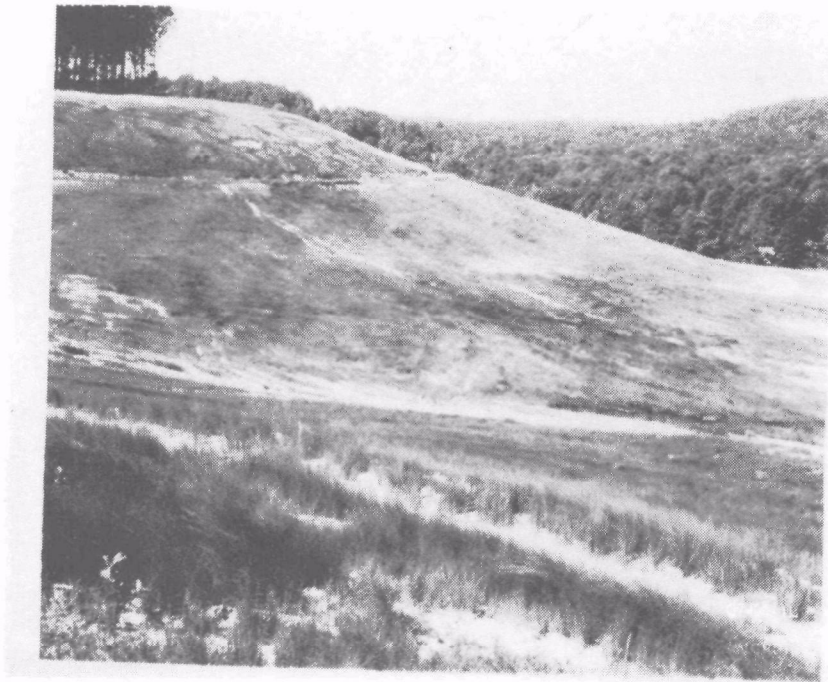
Backfills on the surface mines were of three types: contour, pasture, and swallowtail. For a contour backfill (Figures 26 and 27), the spoil was graded back as close as possible to the original contour of the land. Usually the top of the highwall was pushed down to complete the backfill. For a pasture backfill (Figures 28 and 29), the spoil was graded to form a small slope away from the highwall and the highwall was sound. The swallow-tail backfill (Figures 30 and 31), was similar to the pasture backfill except that a waterway was constructed parallel to the highwall. The waterway was located away from the highwall to allow water to drain over the outer slope at specified low points on the backfill. Where possible, soil low in acidity was hauled in and placed on top of the backfill to facilitate revegetation and reduce acid production. Most of the

Figure 26. Contour backfill - Area 27.

Figure 27. Typical contour backfill.

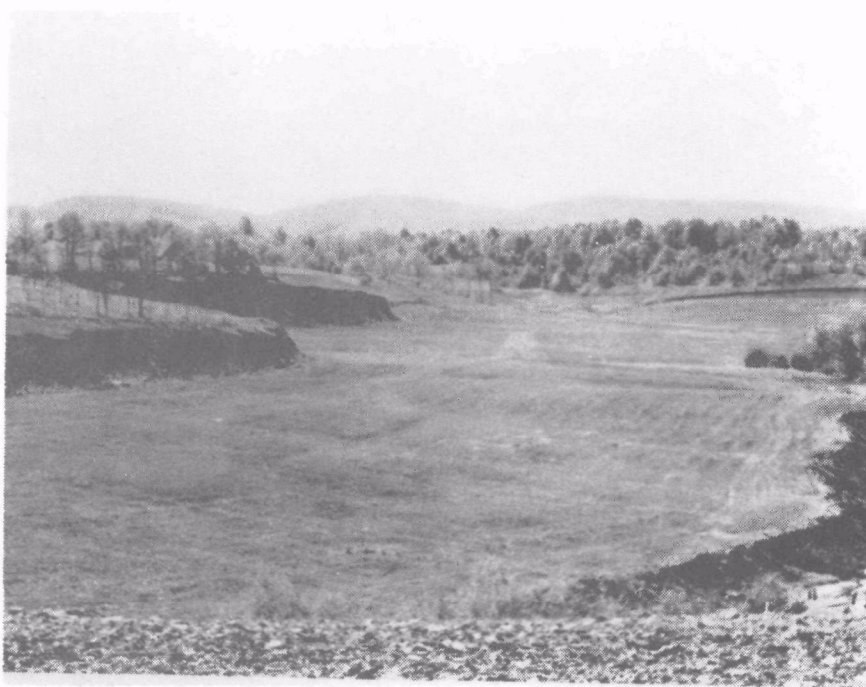
Figure 28. Typical pasture backfill.

Figure 29. Pasture backfill - Area 3.

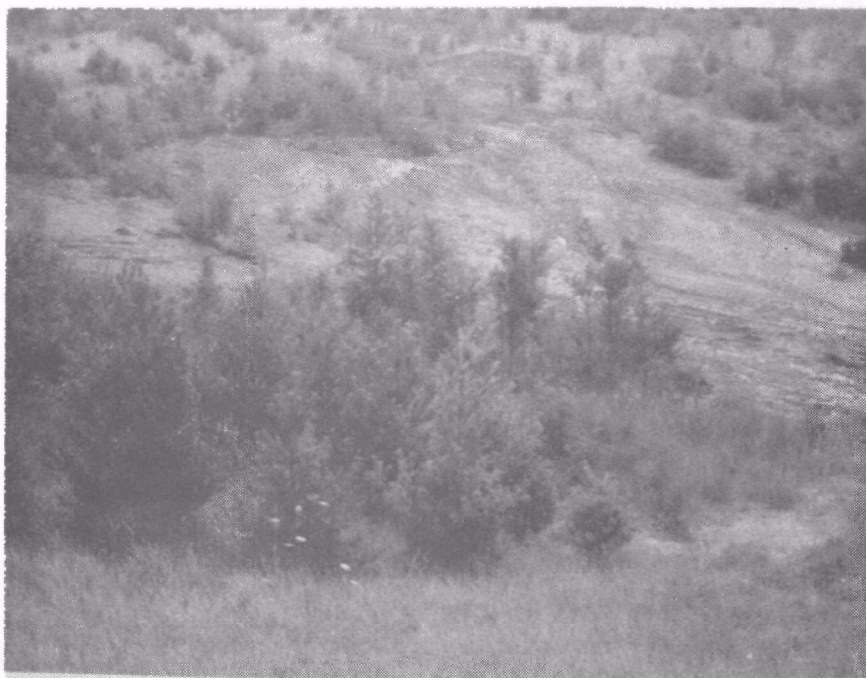
Figure 38. Grass killed by acid water seeping from leaking clay seals - Area 27.

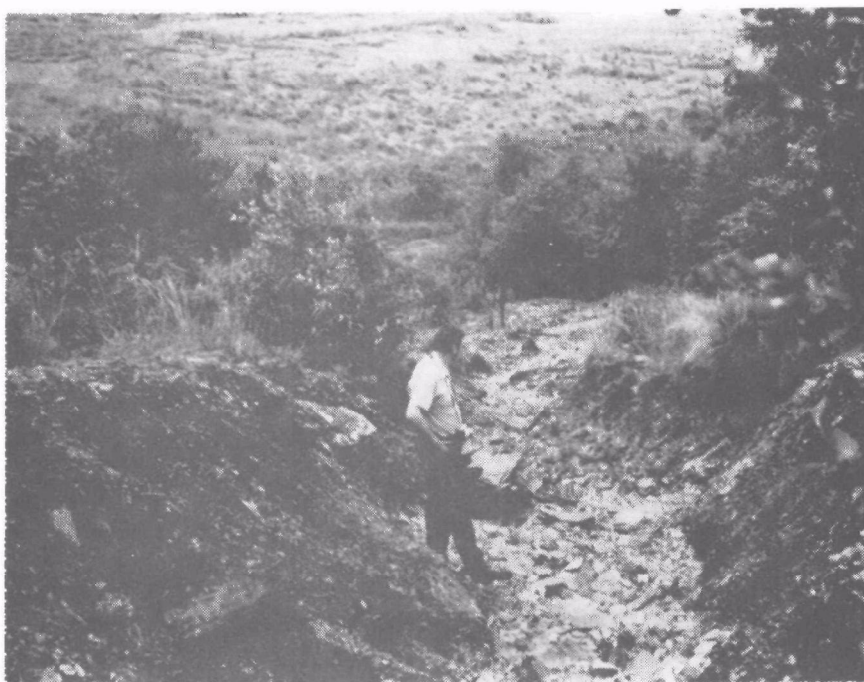
Figure 39. Gully formed where water from a grassed waterway was discharged over the outslope of a fill area - Area 2.
