Evaluation of a Commercial Vacuum System for the Removal of Asbestos

R.W. Welker, D.F. Finn, J.D. Stockham, and R.P. Hancock

IIT Research Institute 10 West 35th Street Chicago, Illinois 60616

U.S. ENVIRONMENTAL PROTECTION AGENCY
Office of Research and Development
Washington, DC 20460

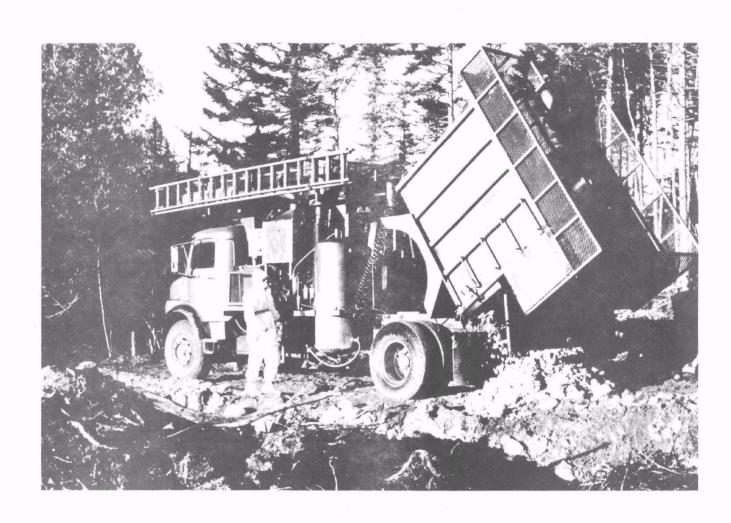
Figure 9. Photo of truck in dumping position.

The vacuum truck is shown in the dumping position during asbestos disposal in Figure 9. The sources of airborne asbestos during dumping are numerous. A puff of aerosol was observed as the receiving chamber was canted. After dumping, the back surfaces of the truck were significantly contaminated with the asbestos-water slurry. The operator sprayed the truck with water in an attempt to remove the asbestos contamination. A visible aerosol was formed by the jet of water impinging on the truck surface; some asbestos undoubtedly was carried away by this spraying procedure. A heavy mist of water would probably produce less impingement aerosol and be more effective in decontamination. A wipe sample was taken of the outside surface of the door following decontamination. Analysis by PLM of this sample revealed asbestos fibers which had not been removed during washdown.
