# TRW Charged Droplet Scrubber Corrosion Studies

**EPA-600/7-79-017**

**January 1979**

The report primarily presents the results of corrosion studies undertaken by TRW Energy Management Division to provide definitive data concerning the corrosive nature of coke oven waste heat flue gas and its effect on wet type electrostatic precipitators (ESP) and specifically on the TRW/Charged Droplet Scrubber (CDS).

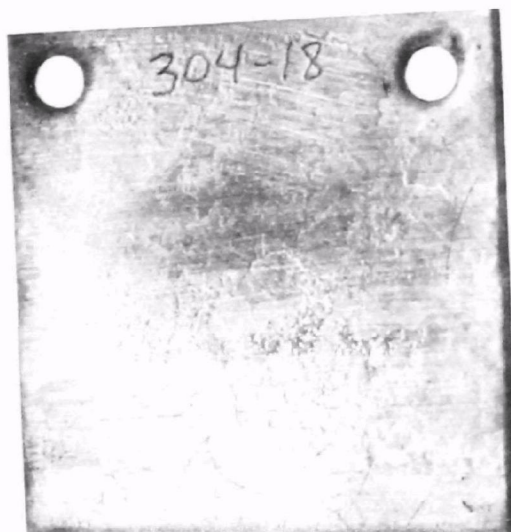
Figure 25. Coupon 304-17 (left) and 304-18 (right). Severe pitting attack with 304-17 showing cracks in heavily pitted regions. Micrograph showing section through pitted area. Lower casing.

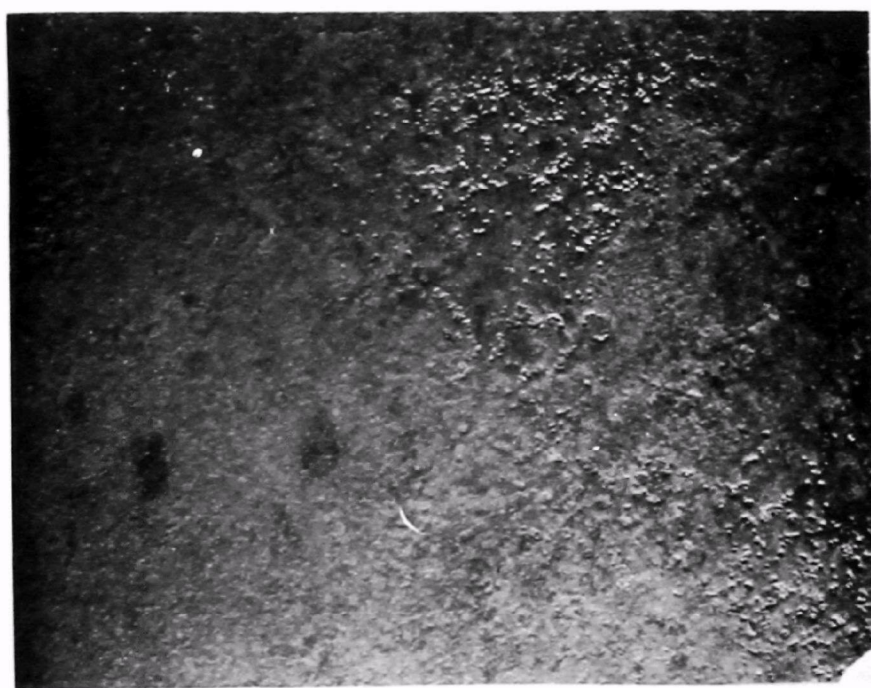
Figure 28. Coupon 316-19. Some pitting attack. Upper casing.

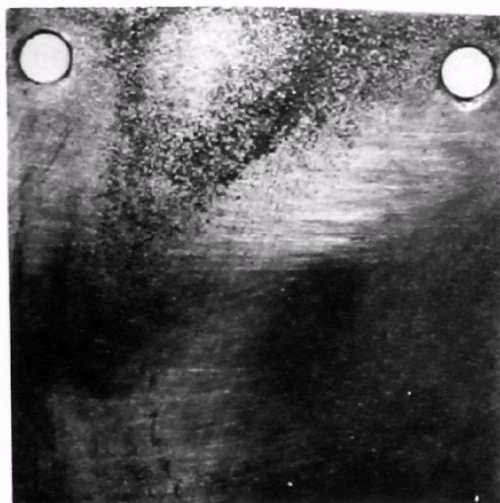
Figure 29. Coupon Ni-1. Severe pitting attack has occurred over entire surface. Lower casing.

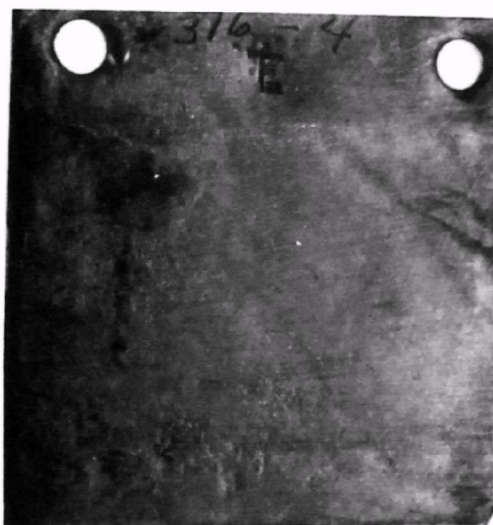
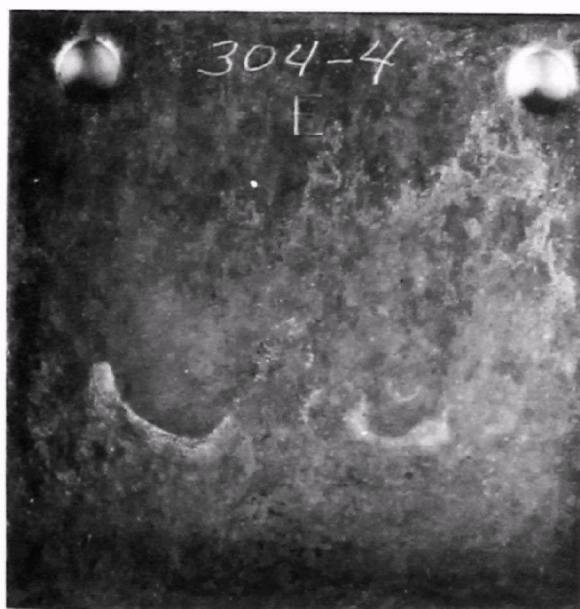
Figure 40. Coupons 316-4E (left) lower casing and 304-4E (right), upper casing. EA 919 epoxy coating has failed exposing substrate.

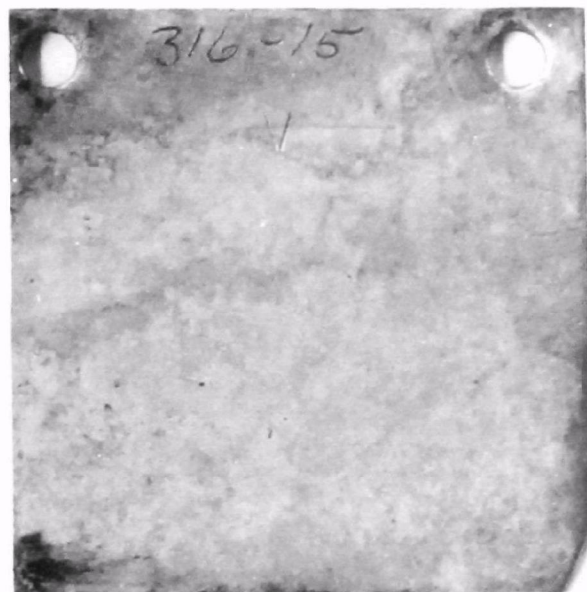
Figure 42. Coupons 316-14W (left) lower casing and 216-15W (right) upper casing. Coating failed exposing substrate.

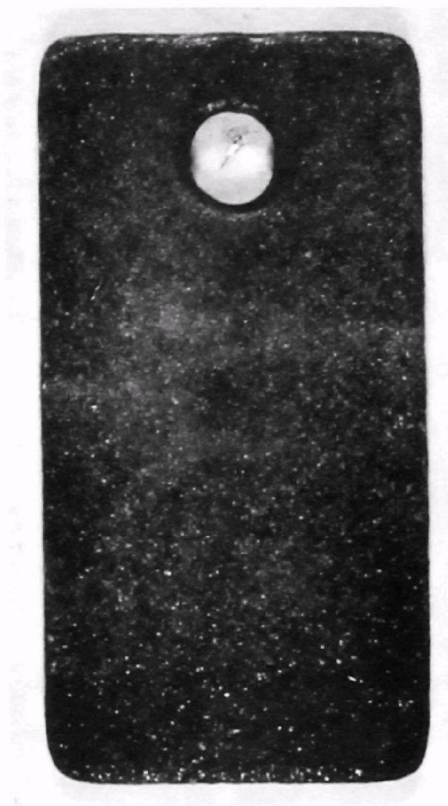
Figure 48. Steel coated with glass flake filled polyester (ceilmate)  
Surface has been etched by the gases.

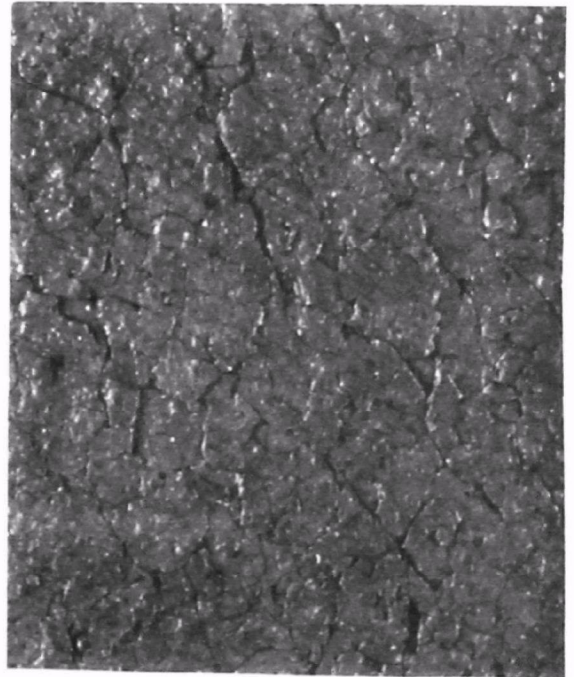
Figure 50. Coupon 316-NB. Neoprene elastomer liner shows surface cracking (checking). Lower casing.

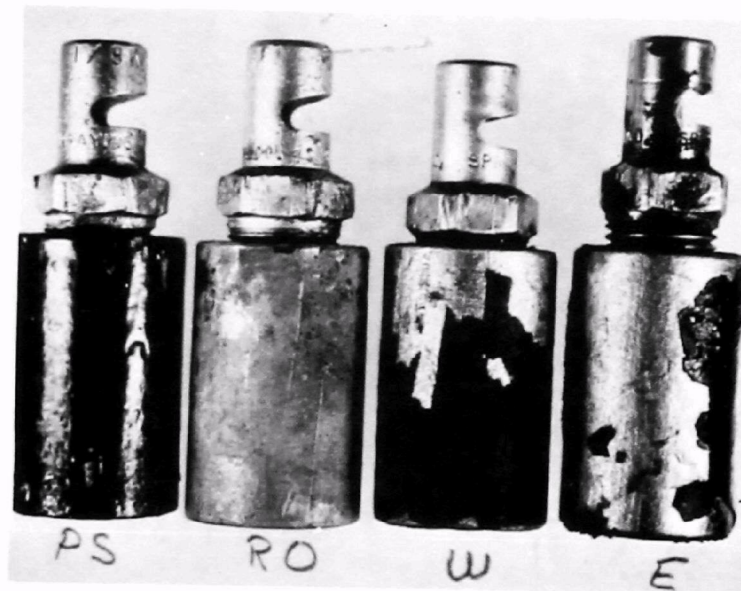
Figure 51. Water spray nozzle couplings from upper casing. Couplings are coated with polyphenylene sulfide (PS), alkyd (RO), vinyl (W) and epoxy (919). The PS coating was intact (although damaged during the removal operation). The other coatings failed.

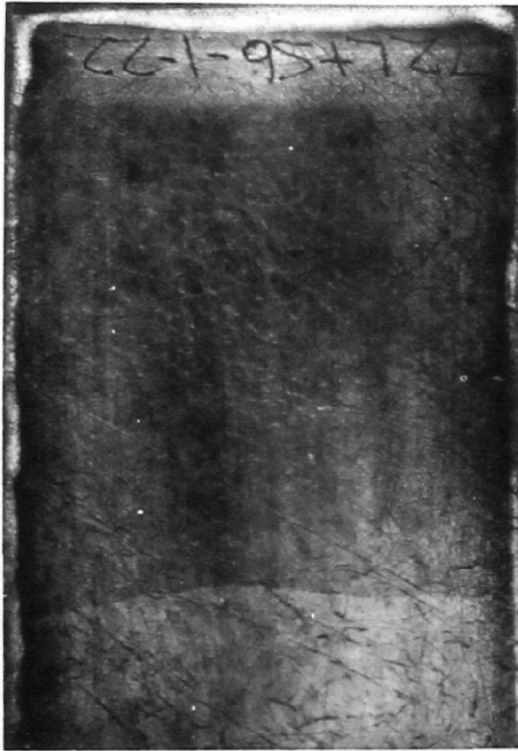
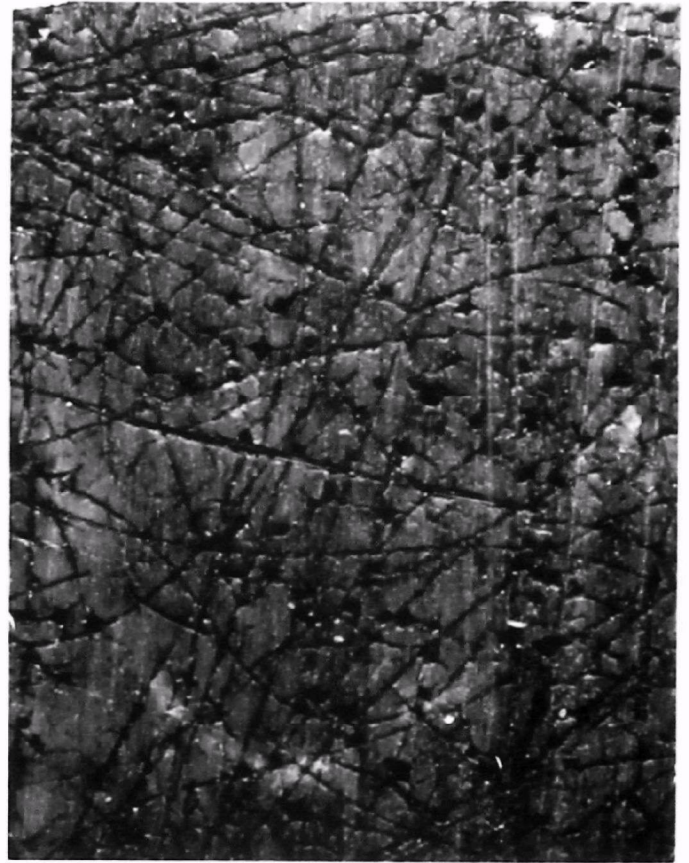
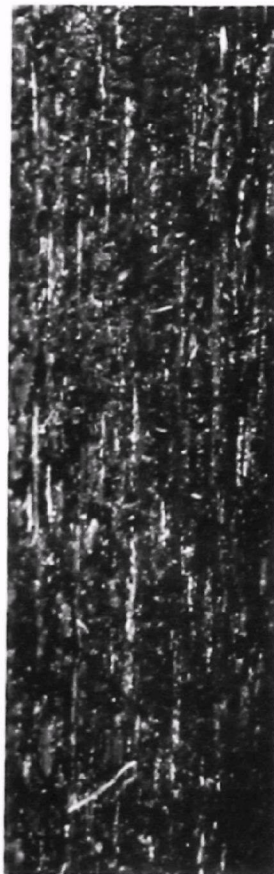
Figure 55. Coupon ASH7241-29 IPA polyester. Surface etching, cracking and pitting. Lower casing.

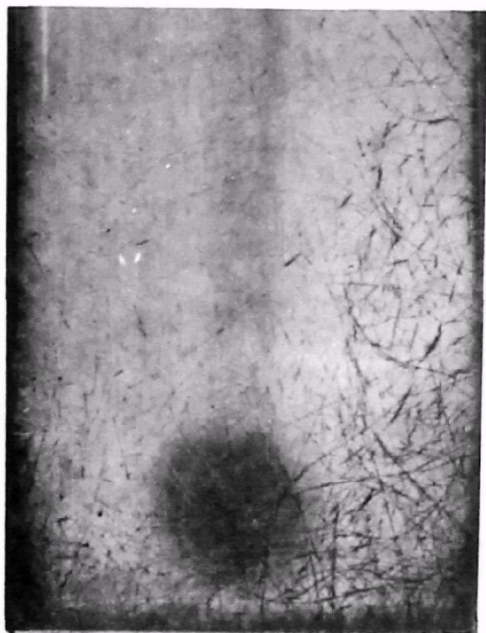
Figure 56. Coupon ASH 197/3-5 polyester. Surface etching, pitting and crazing. Lower casing.

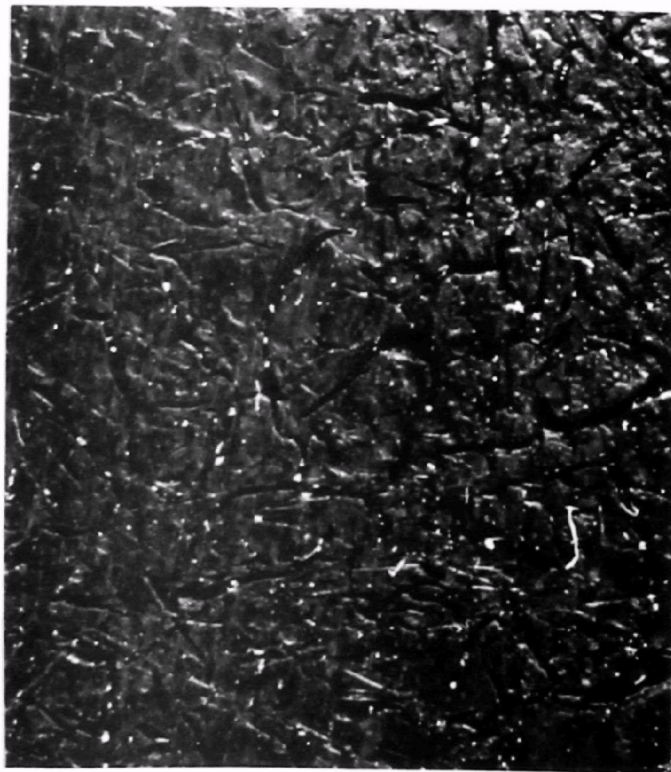
Figure 59. Coupon AT580-1 bisphenol vinylester. Surface cracked and etched. Lower casing.

The polyesters showed degrees of degradation ranging from surface etching to delamination as shown in Figures 52 through 58. The vinylester panel showed some surface etching and edge attack, Figure 59. The furans also

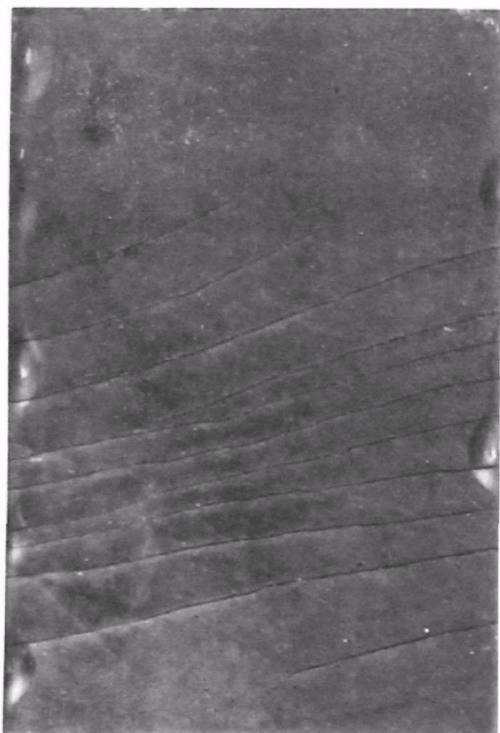
Figure 60. Coupons ASH800-28 furan (left) and ASH800FR-20 flame retarded furan. Surface cracking, checking and pitting. Lower casing.

showed surface etching and edge attack, Figure 60. The polybutadiene panel discolored and showed some minor pitting near the edge, Figure 61.
