DAIRY MANURE MANAGEMENT METHODS

WASHINGTON STATE UNIVERSITY

PREPARED FOR
OFFICE OF SOLID WASTE MANAGEMENT

1974

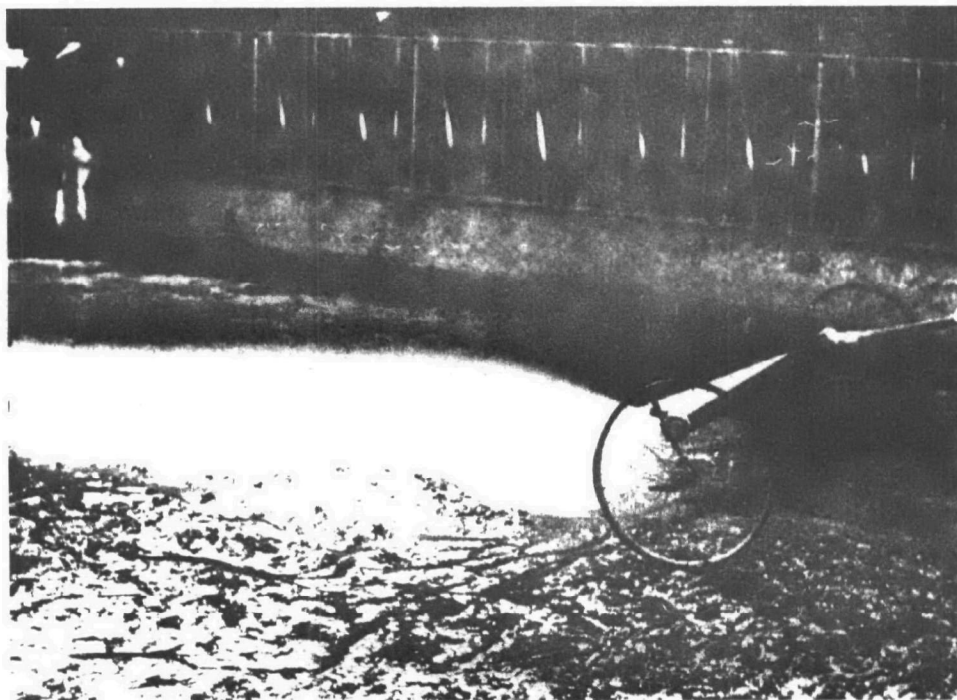
Figure 3. Drilled Orifice "Hydraulic Broom" During Early Manure Flushing Experiments

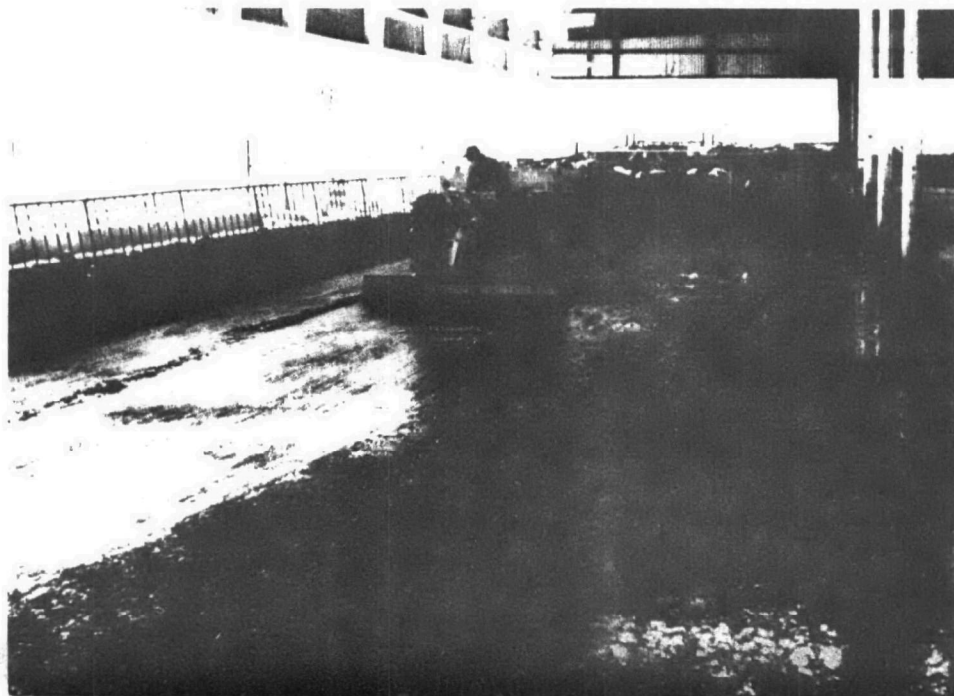
Figure 7. Nylon-Bristled Manure "Scraper" Operating on Main Surface of Holding Pen A

The pens, mangers, and service alleys were arranged so that freshly cut green chopped forage could be mechanically discharged directly from the field forage wagons to the manger along the entire length of a pen. When baled hay was fed, it could also be hauled on a truck in the service alley, broken open, and placed directly into the mangers. The cubed hay from bulk storage or silage from the large bunker-type silo were loaded into a mechanical forage box and mechanically discharged to the manger. An inclined grill of pipe work along the pen-side of the mangers (visible to the left in Figure 7) reduced the

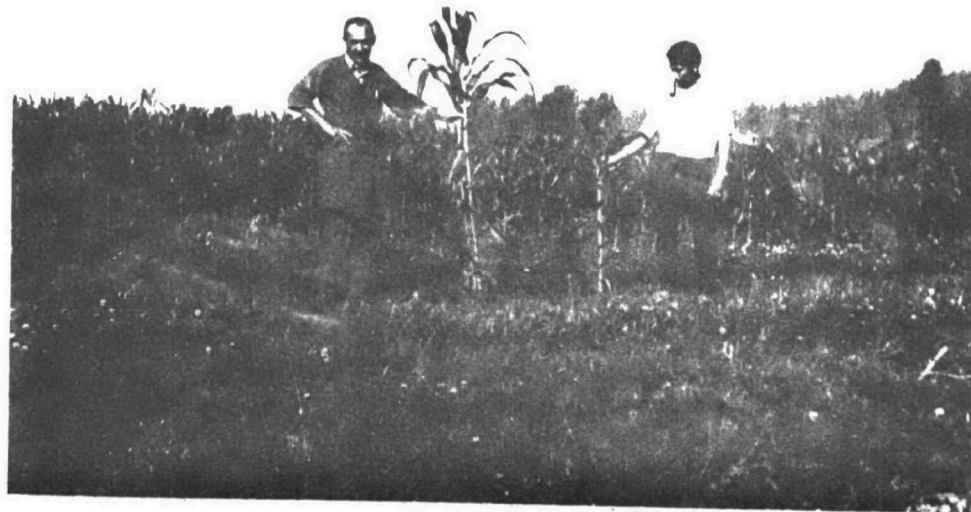
Figure 20. Comparison of Whole Corn Stalks.
Left=Manured Test Plots, Right=Commercial Fertilizer

Figure 20 shows a typical corn stalk from the manured circle on the left side and one from the commercially fertilized test plot on the right. In Figure 21, the larger ears show the earlier maturity achieved on the manured plot as compared to the small slow maturing ears from the commercial fertilizer plots.
