REVIEW OF
**SANTA BARBARA CHANNEL
OIL POLLUTION INCIDENT**

REVIEW OF THE SANTA BARBARA CHANNEL
OIL POLLUTION INCIDENT

DEPARTMENT OF INTERIOR
FEDERAL WATER POLLUTION CONTROL
ADMINISTRATION

July 18, 1969

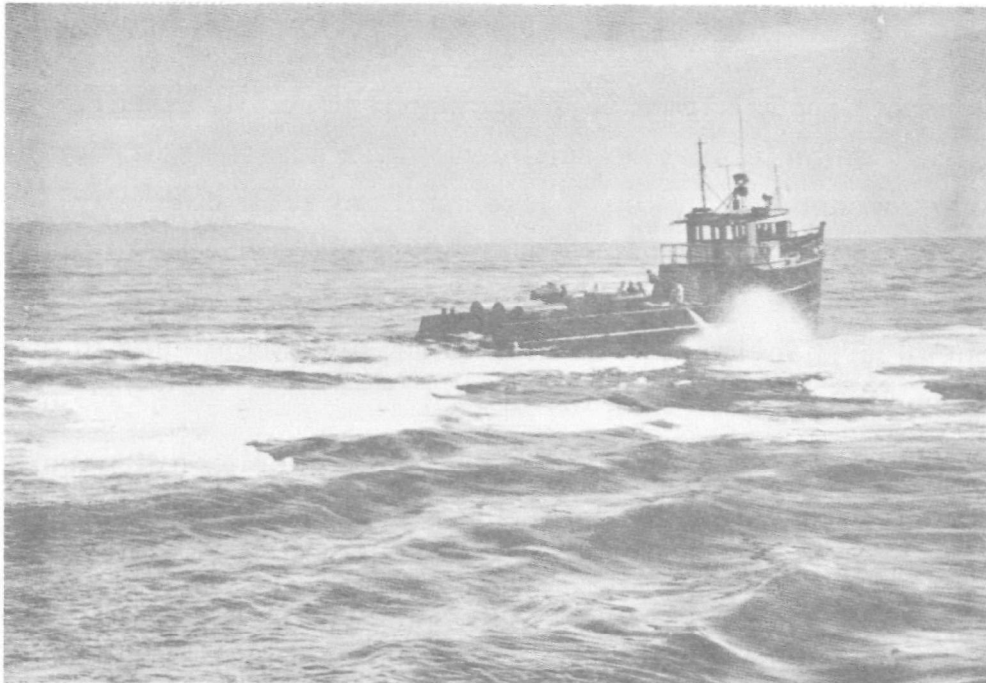
FIGURE 6.4. Workboat Distributing Chemical Dispersant (Courtesy of Santa Barbara News Press)

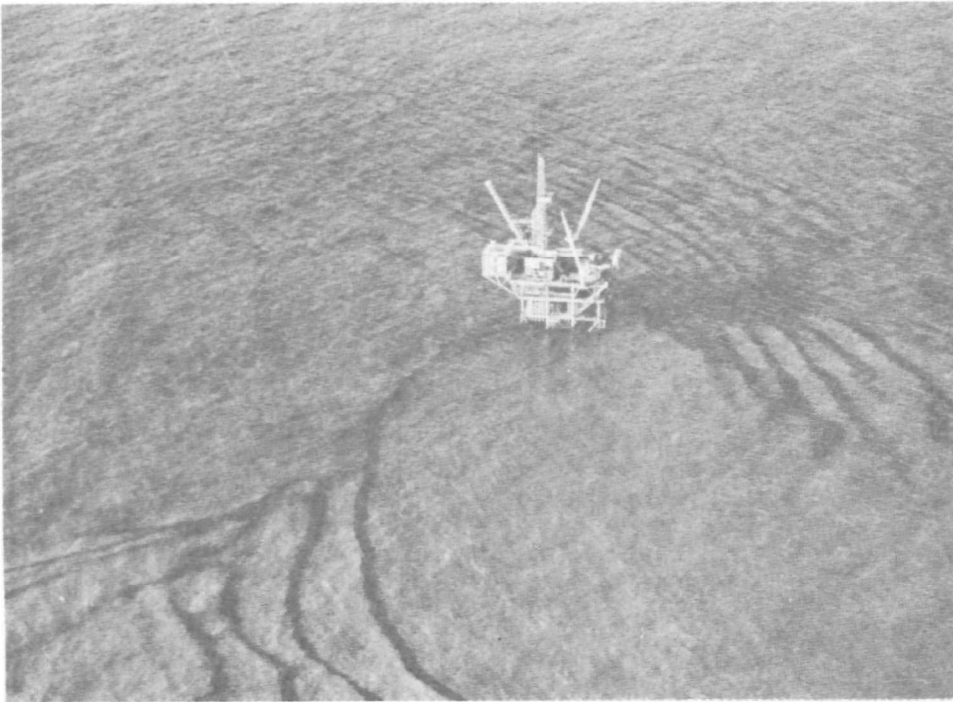
FIGURE 6.5. Oil Distributed in "Ropes and Windrows"
(courtesy of Santa Barbara News Press)

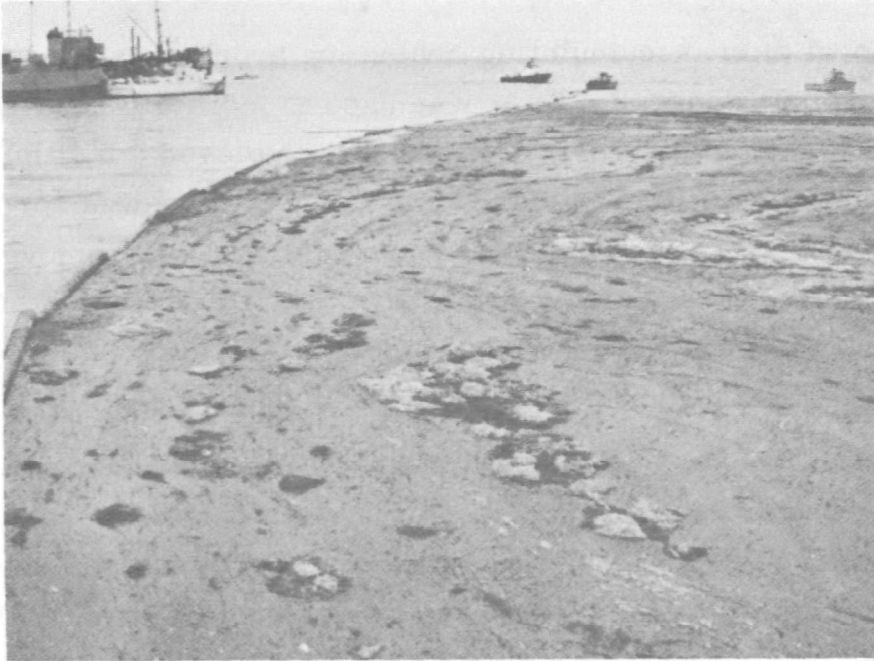
FIGURE 6.9. Straw Being Used Behind Log Boom for Oil Absorption
(courtesy of Santa Barbara News Press)

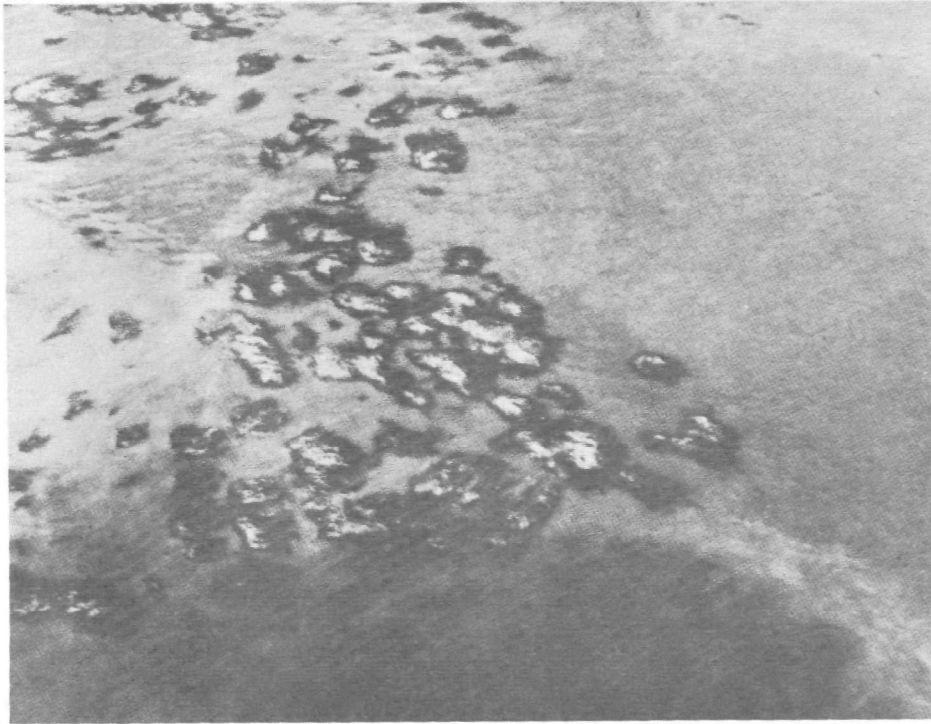
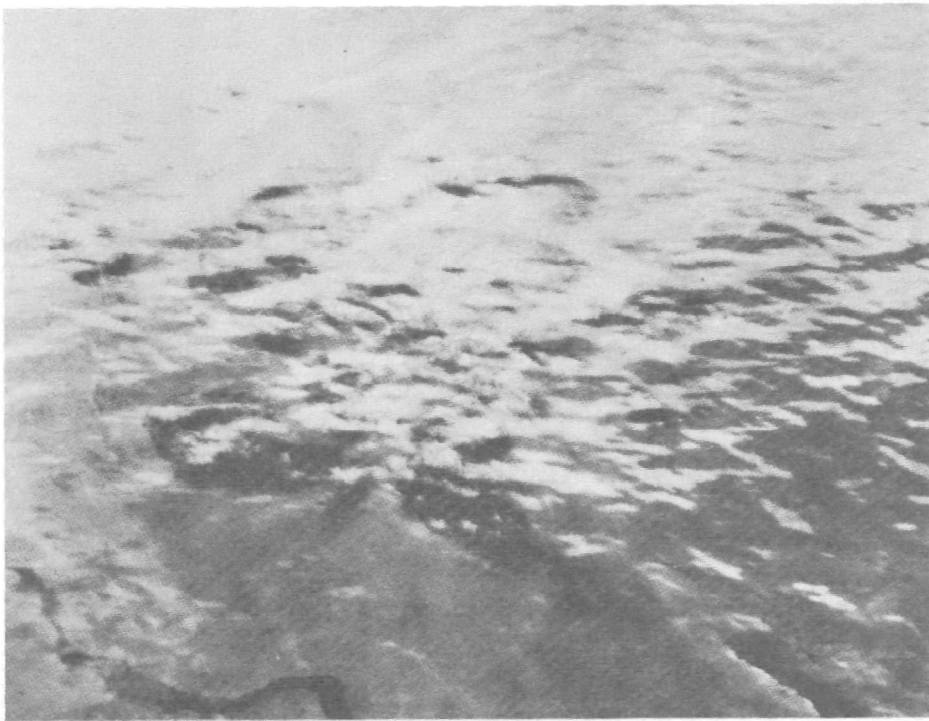
Photographs taken from a plane showed good definition of oil intermingled with kelp (Figure 7.1). Good contrast in this case was obtained using Infrared Ektachrome Film with either the K-2 (yellow) or 25A (red) filter.⁽²⁾

FIGURE 7. 1. Infrared Ektachrome - Contrast of Oil and Kelp

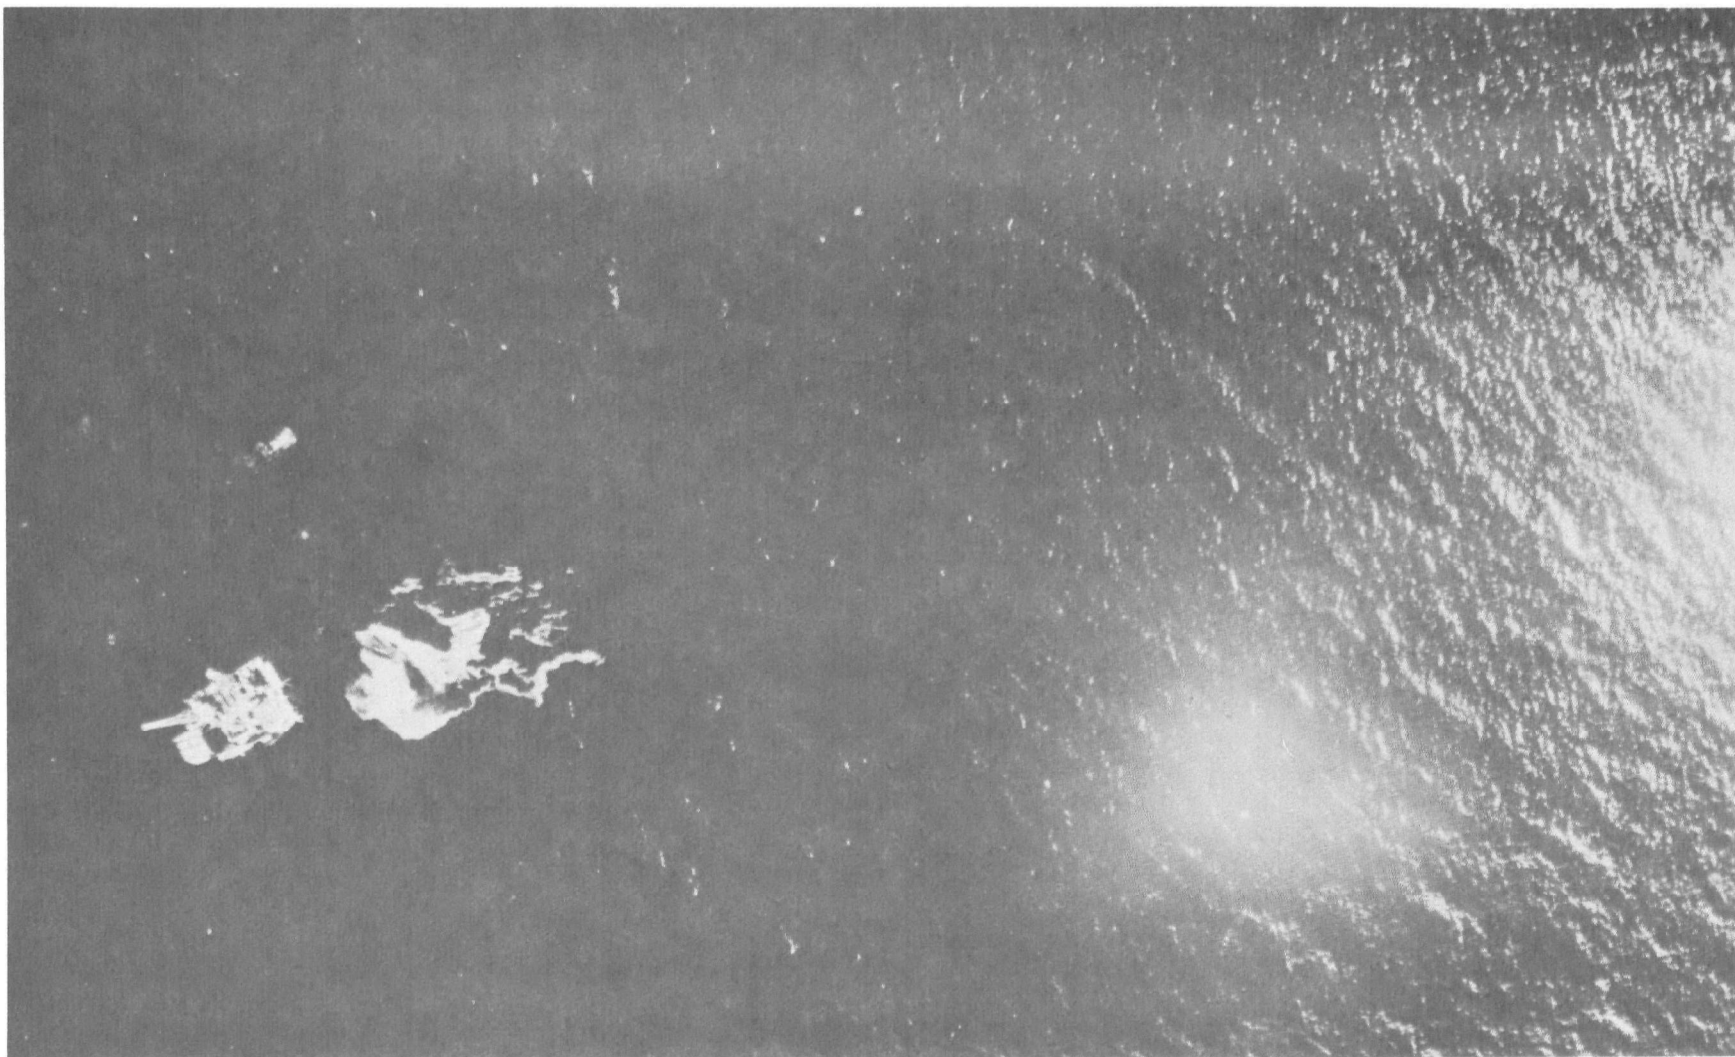
FIGURE 7.2. Aerial Photography Panchromatic Film - K-2 Filter

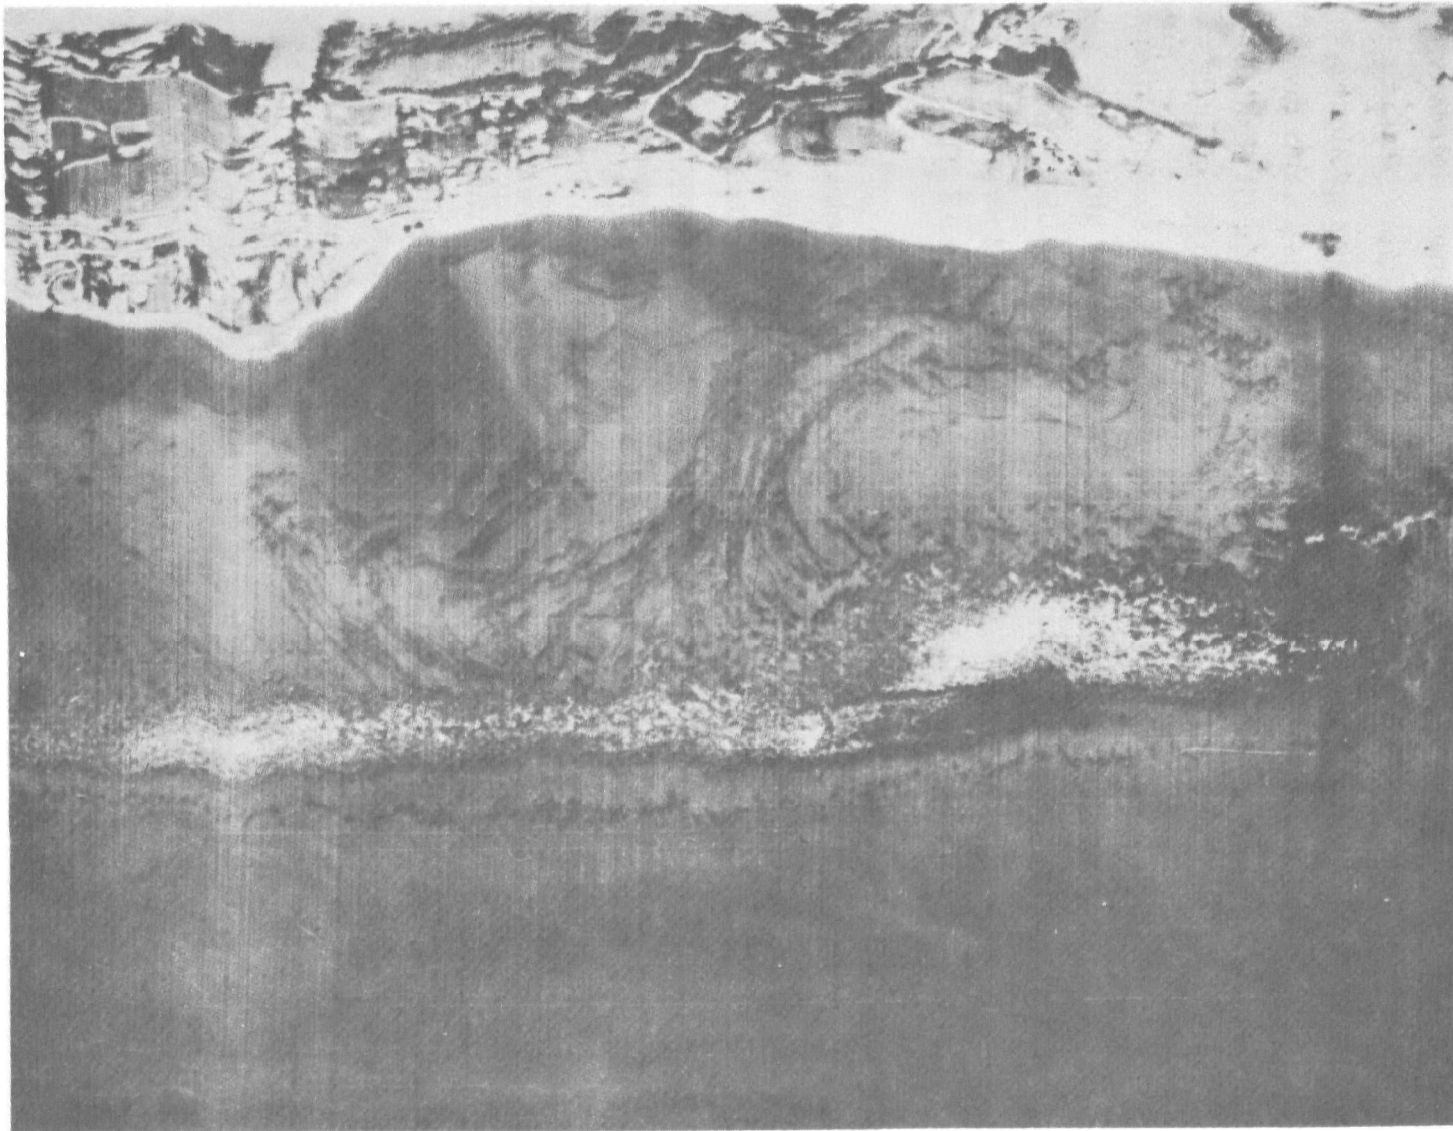
FIGURE 7.7. Thermal Infrared (8-13 μ) Image Illustrating the Contrasting Hot Returns of Surficial Fronding Kelp and the Colder Streaks of Oil

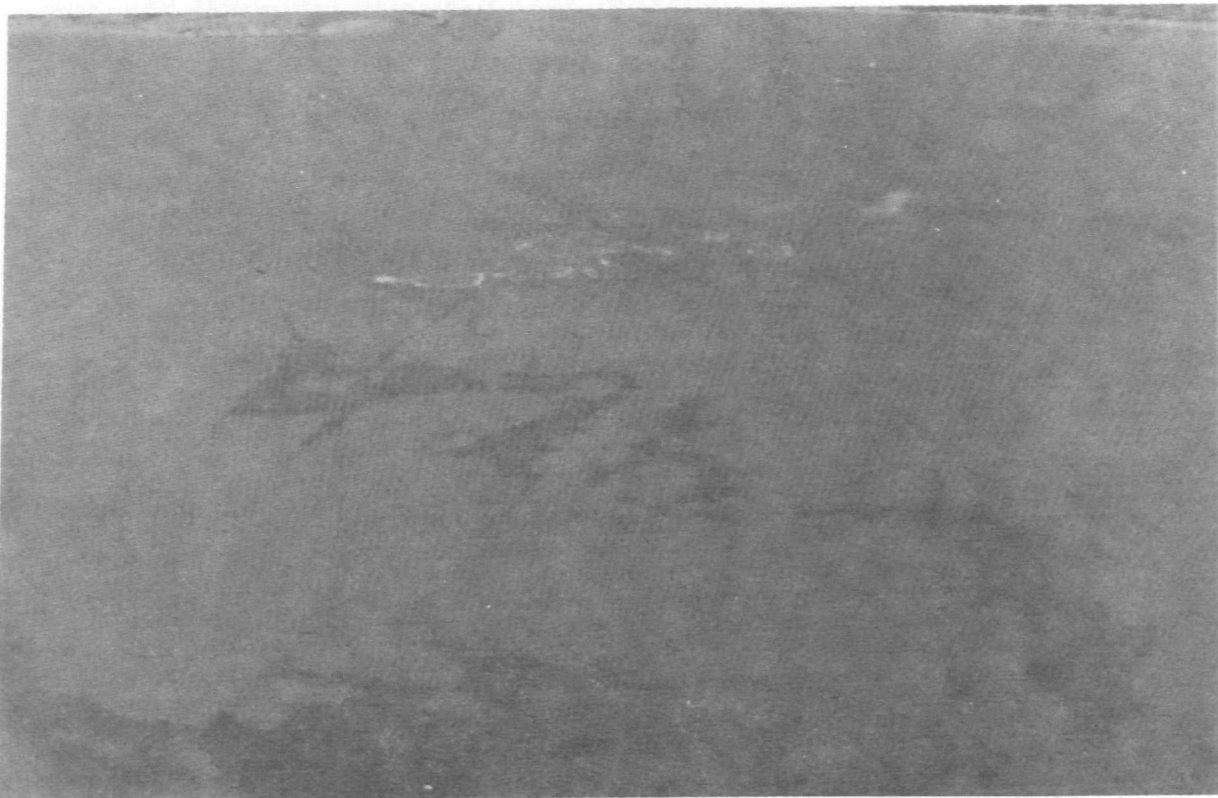
FIGURE 8.4. Oil "Windrows and Ropes" Santa Barbara Harbor in Upper
Left, Boat Spreading Straw or Dispersant, 26 February, 1969.

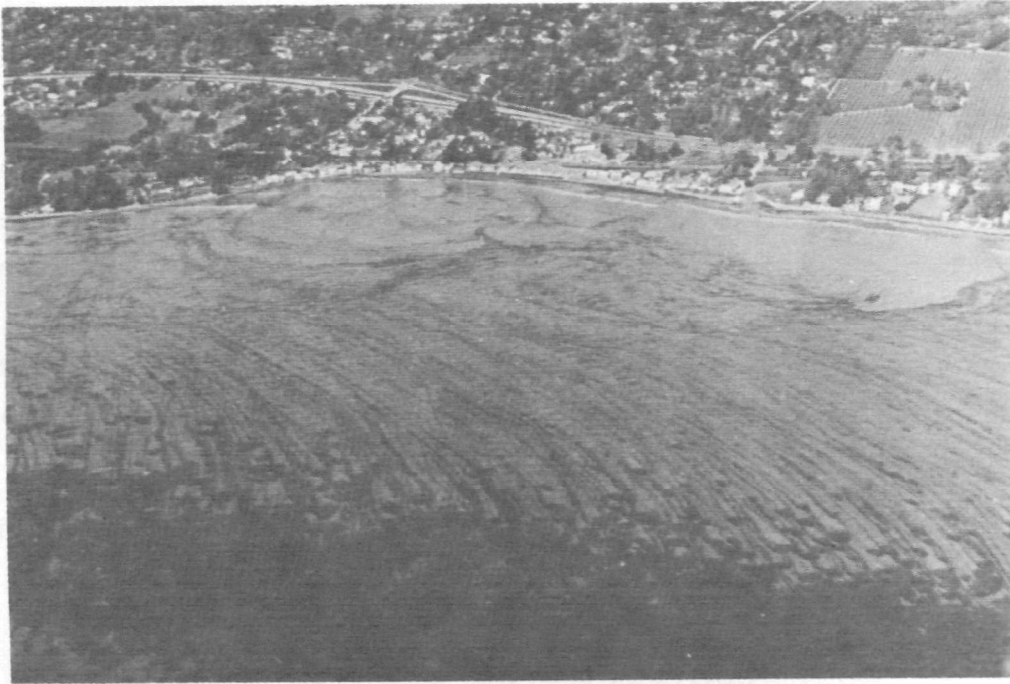
FIGURE 8.5. Oil Streamers Emerging from Kelp Beds (courtesy of U. S. Coast Guard)

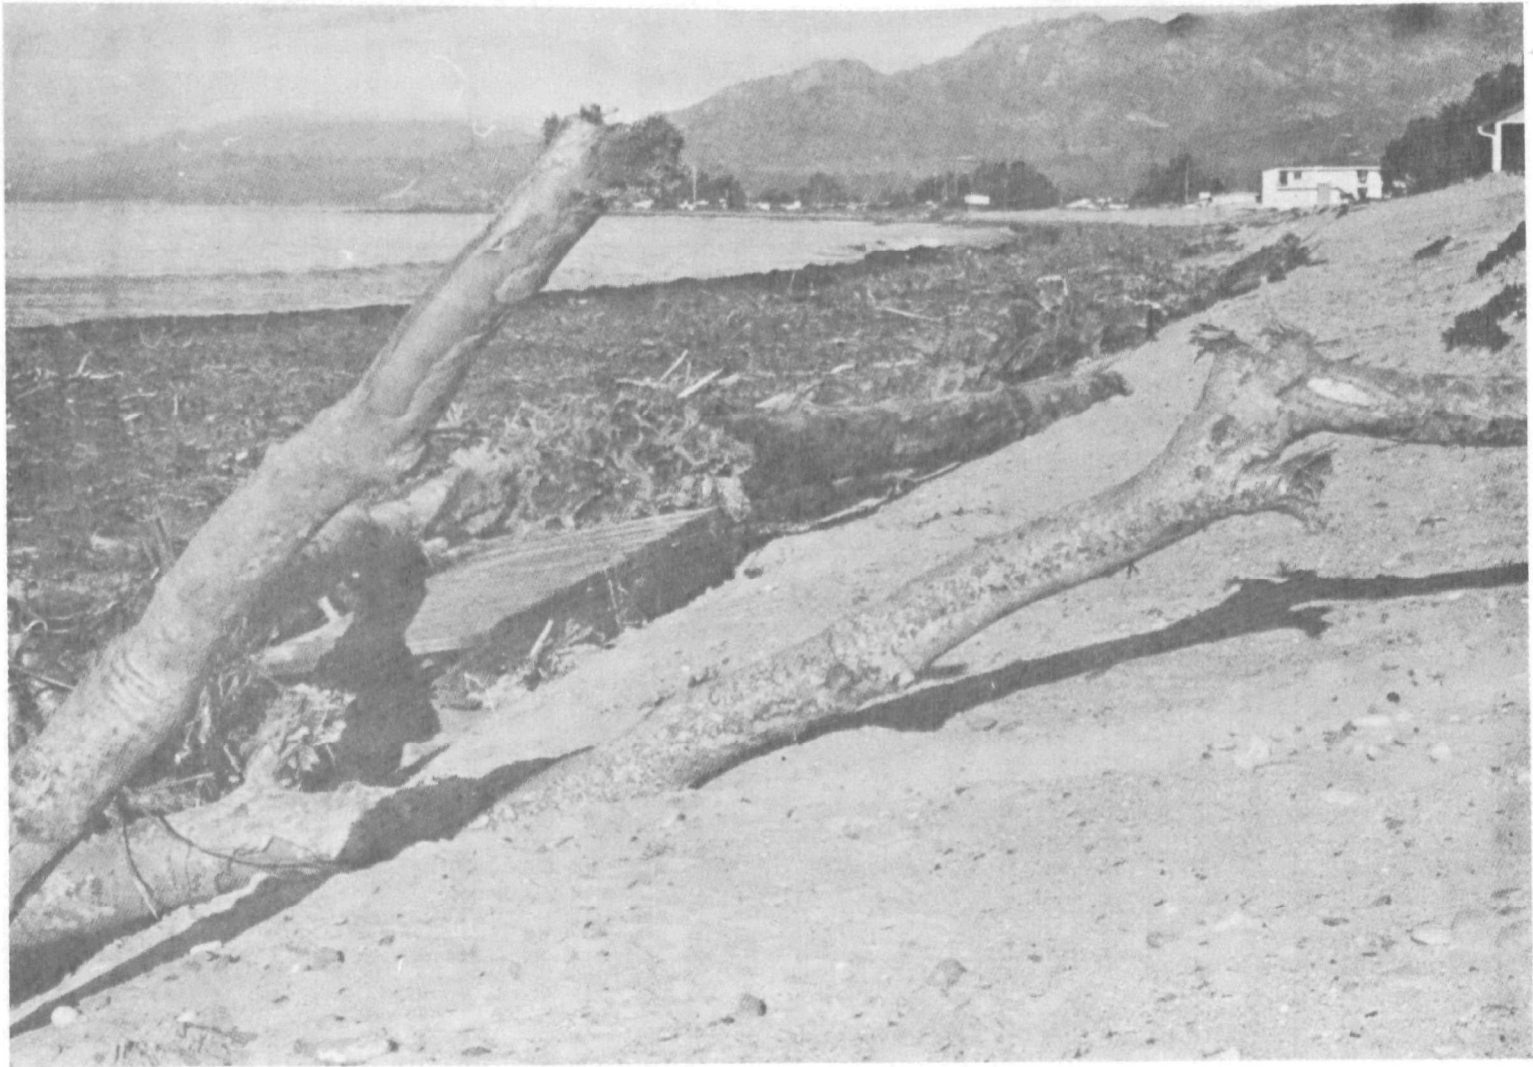
FIGURE 9.1. Storm Debris on Beach Near Santa Barbara

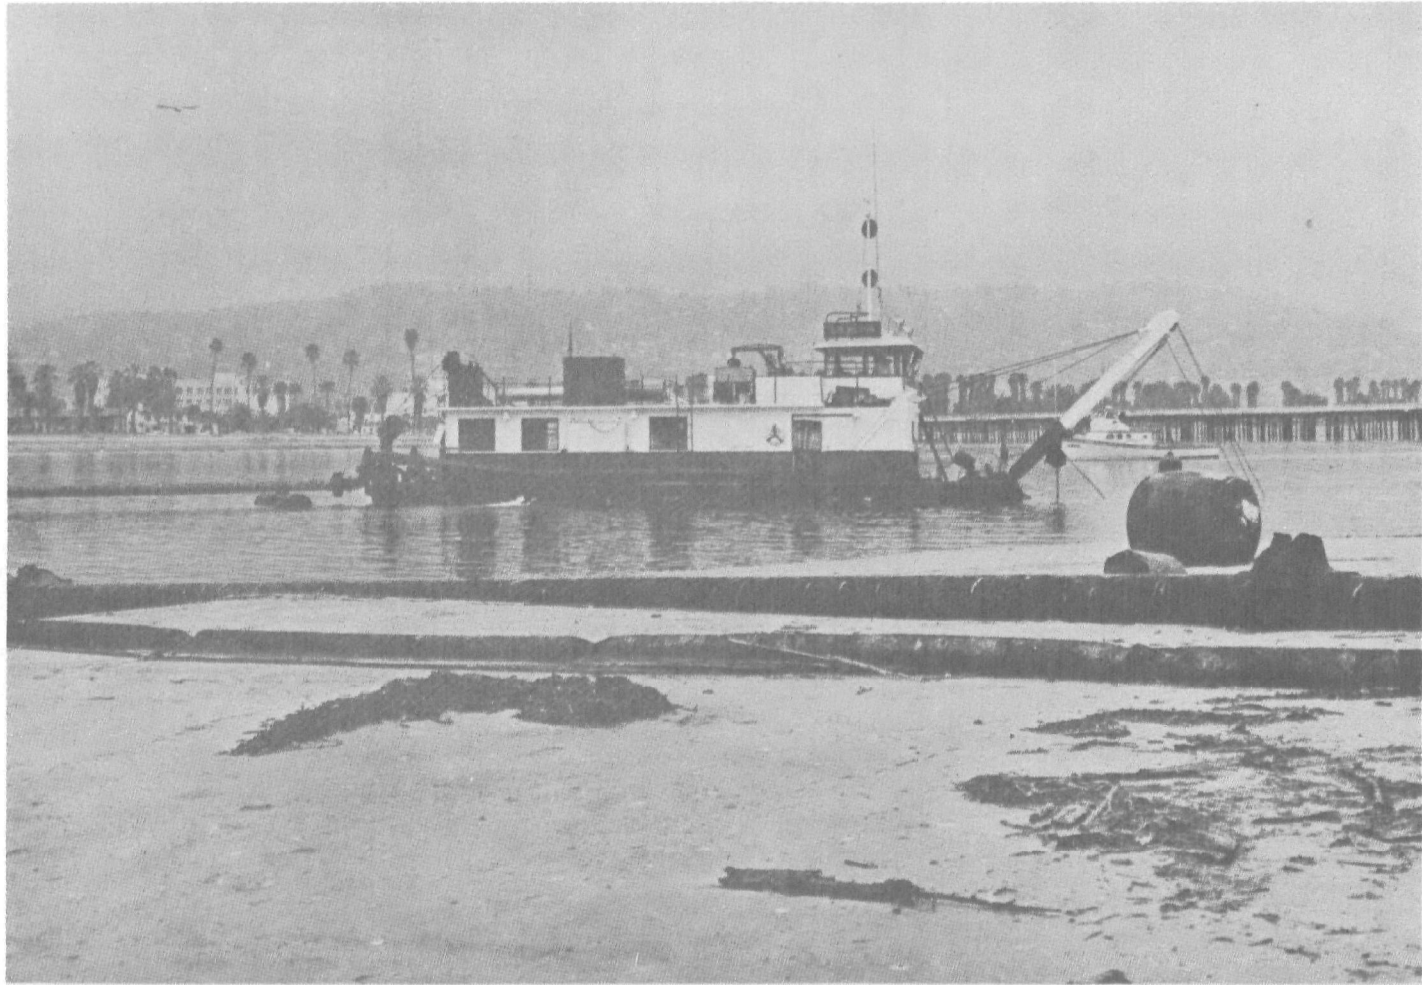
FIGURE 9.3. Santa Barbara Harbor Dredge Maintenance

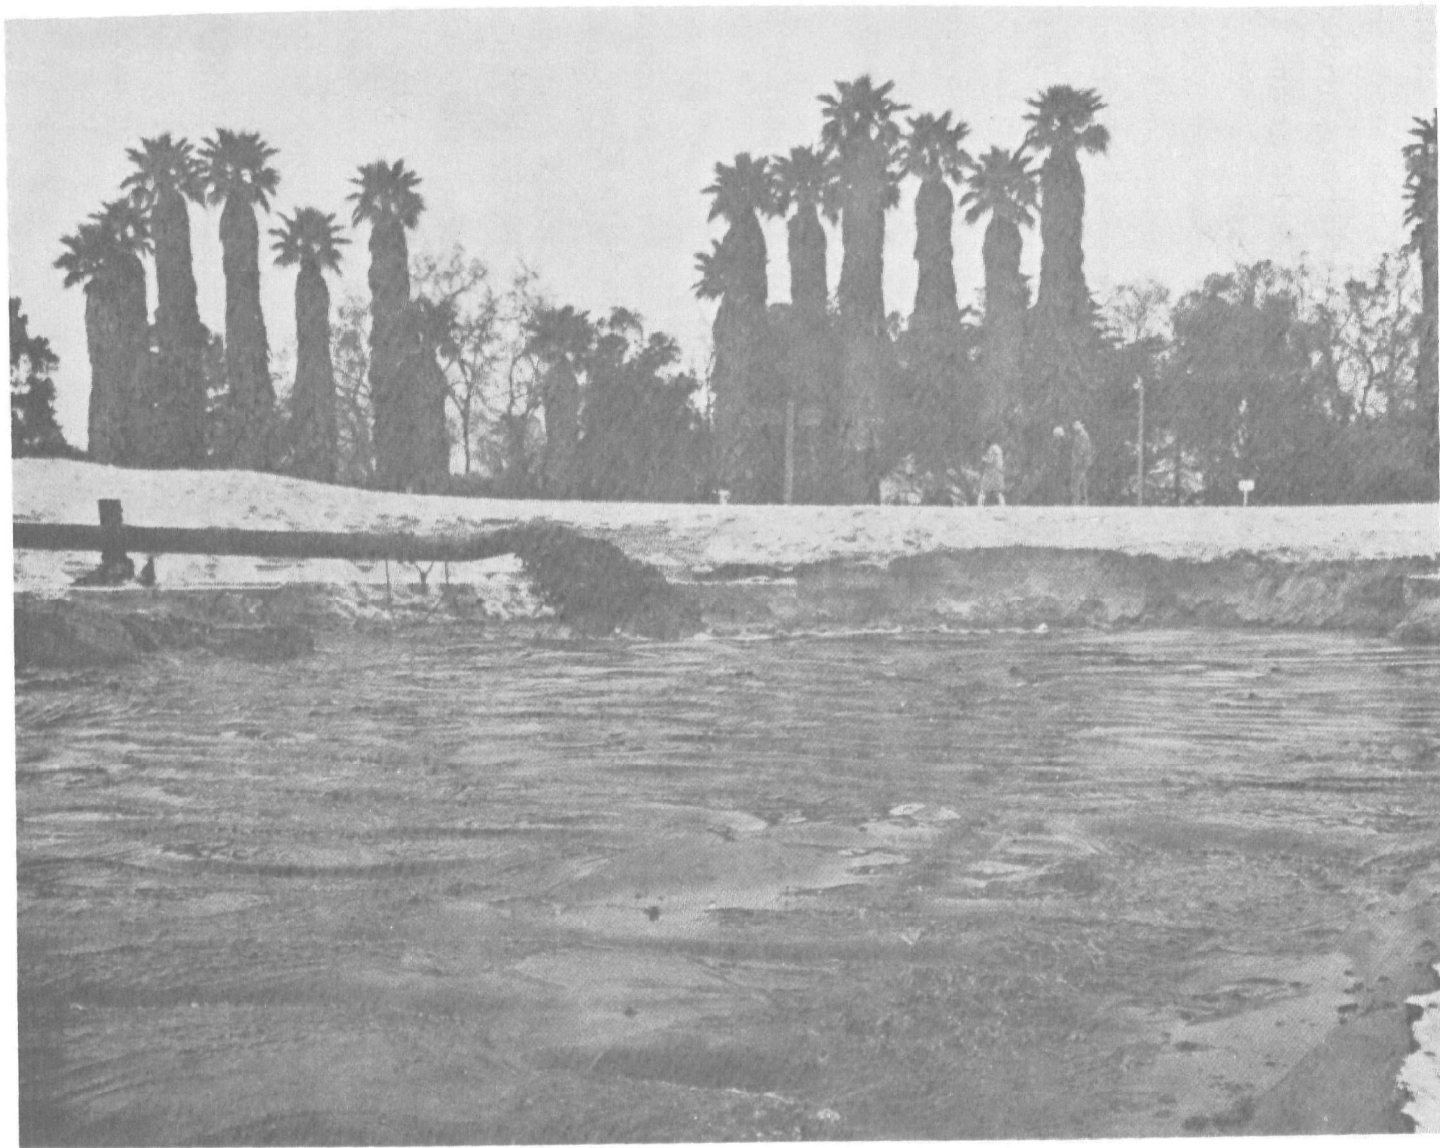
The dredge discharge (Figure 9.5) contained an undeterminable amount of oil, even if it was removing accumulated sand from an area where the beach surface appeared clean. Thus, the presence of the buried oil will be witnessed for some time into the future as the dredge redeposits it further down the coast. This source of further oil pollution on previously cleaned beaches did not appear severe during observations in late March.

FIGURE 9.5. Santa Barbara Harbor Maintenance Dredge Discharge

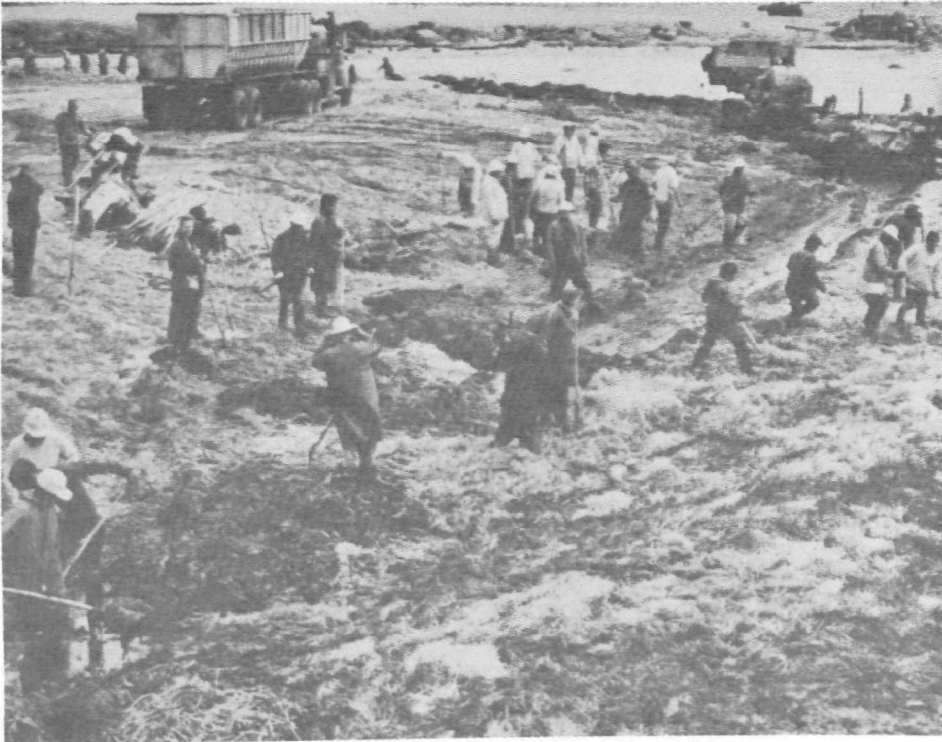
FIGURE 10.1. Application and Removal of Straw on Beaches (courtesy of Santa Barbara News Press)

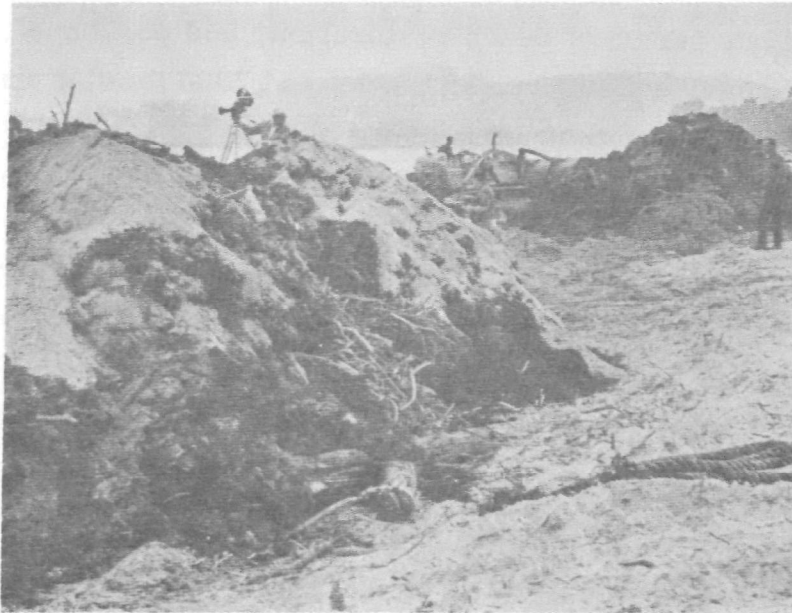
FIGURE 10.2. Oiled Straw and Debris (courtesy of Santa Barbara News Press)

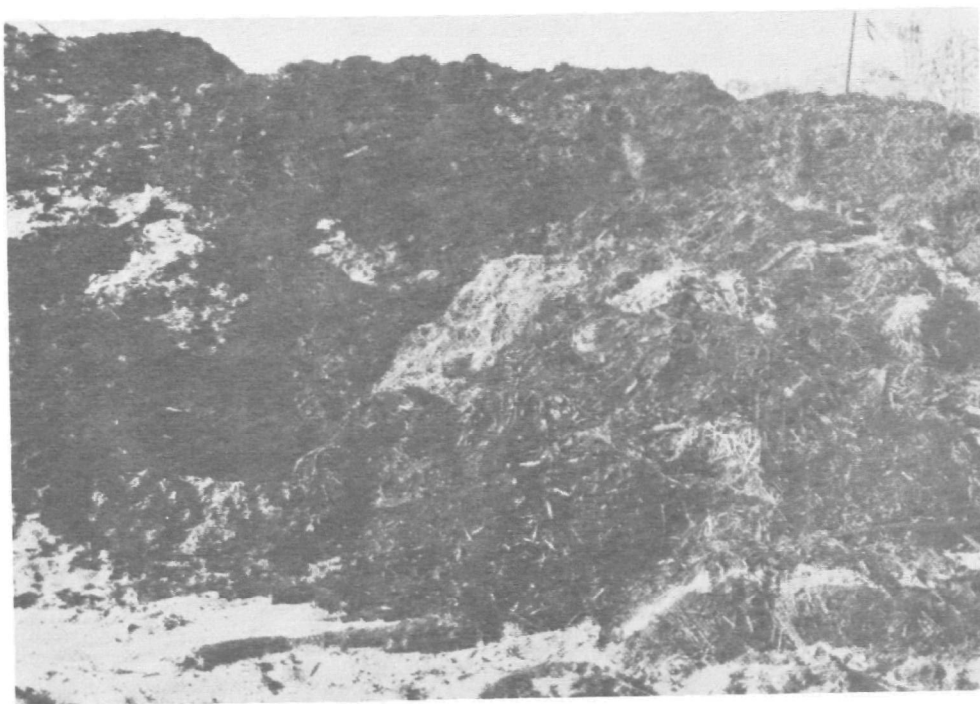
FIGURE 10.3. Oiled Straw

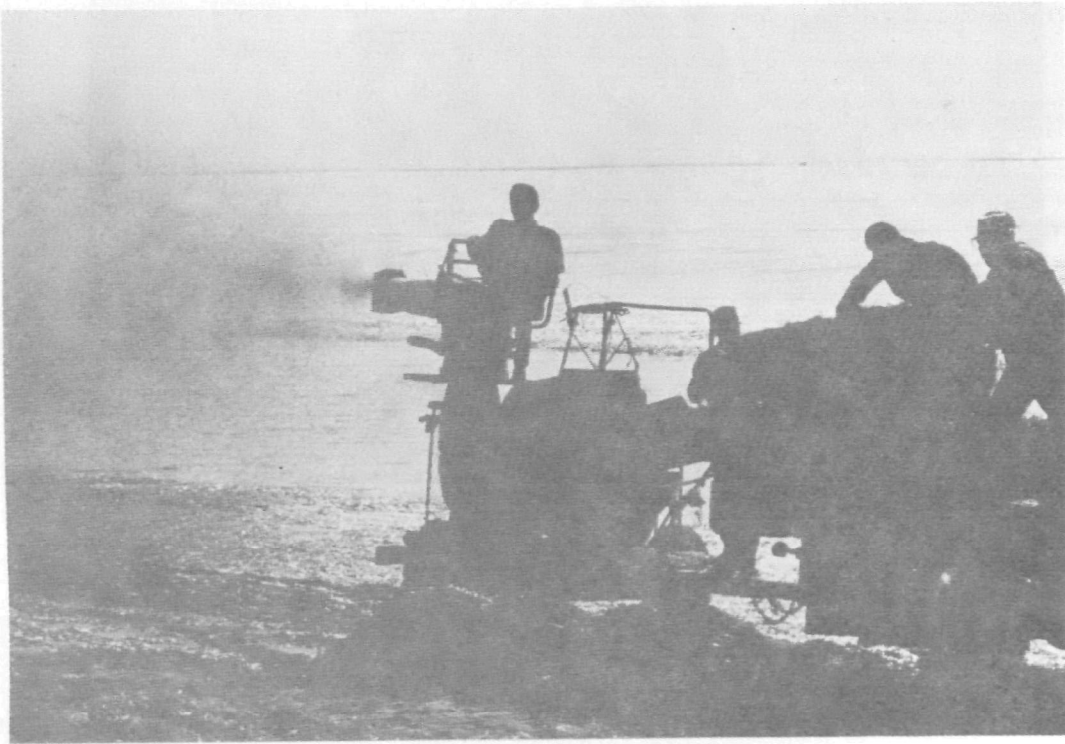
FIGURE 10.5. Power Mulcher Spreading Straw

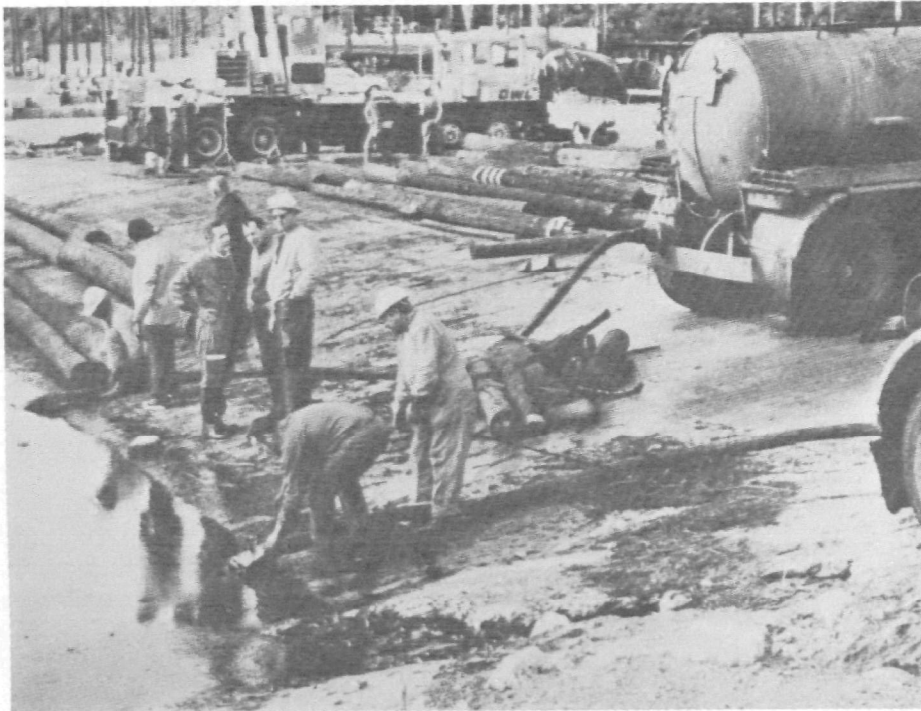
FIGURE 10.7. Removal of Oil from Santa Barbara Harbor Using Vacuum Trucks

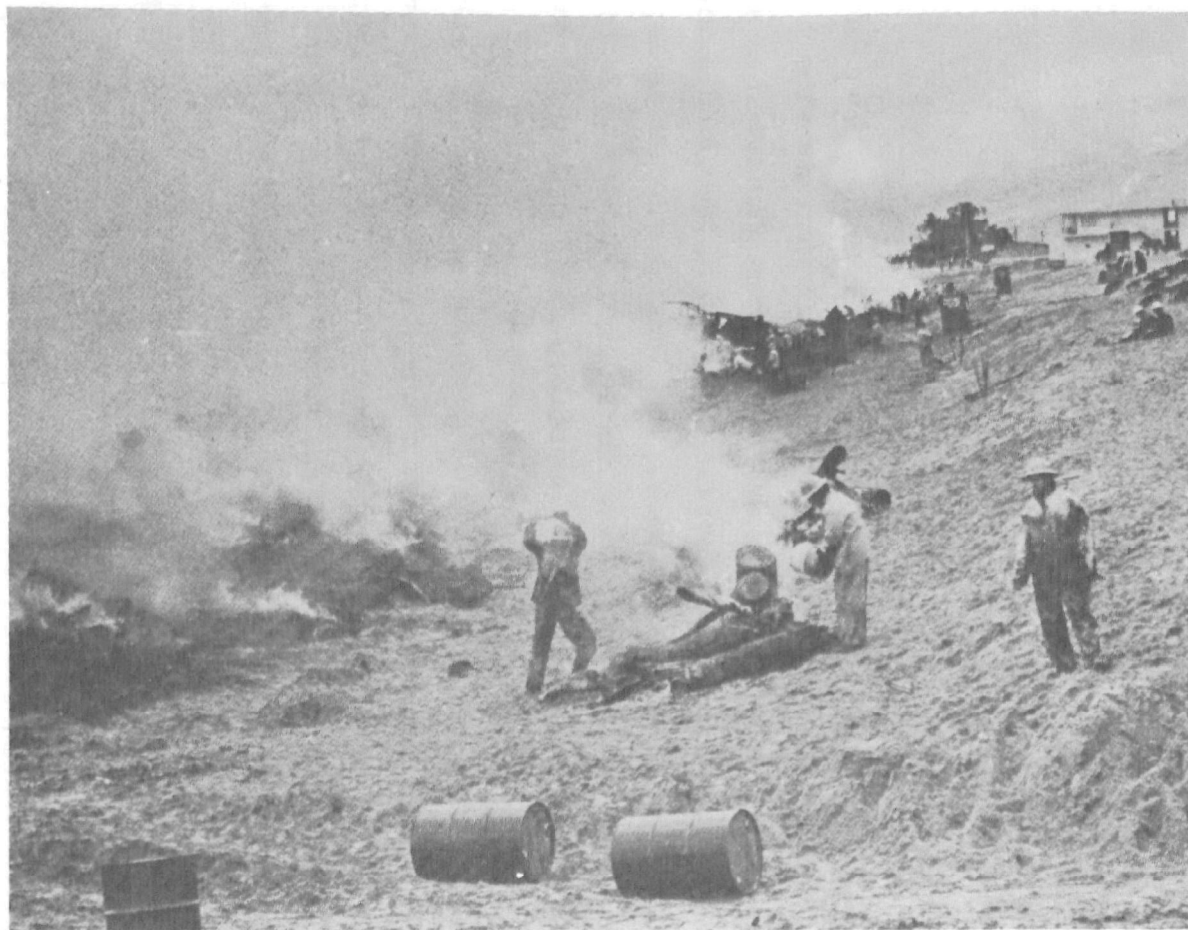
FIGURE 11.1. Burning Operations on Beach (courtesy of Santa Barbara News Press)

It is evident that in-place burning attempts in the event of future incidents must consider the unexpected complexities introduced by nature (such as storm debris) and the possible need for mobile high temperature
