EPA 600/D-81-067,
February 1981

Evaluation and Control of Asbestos-Cement Pipe Corrosion

Michael R. Schock, Gary S. Logsdon, and Patrick J. Clark

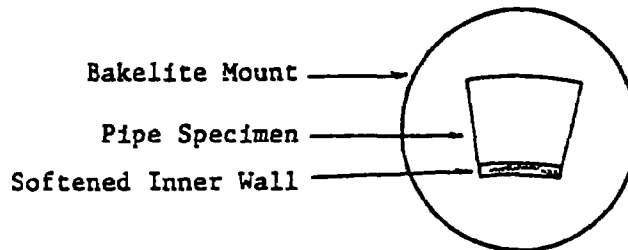
Pipe segments were mounted in cylindrical bakelite mounts about 3.1 cm in diameter and 2.3 cm high, with the pipe segment oriented so that the cross section of the pipe wall was visible.

This orientation permitted observation of both the interior and exterior walls of the pipe. Mounts are polished with progressively finer materials, ending with #600 grit or aluminum oxide polish.

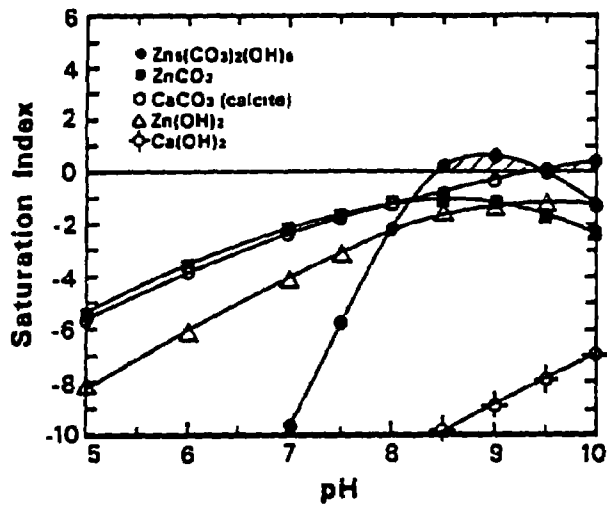
Figure 1. Saturation index diagram for model system H9 (see Table 3).

SI > 0. If the solid is undersaturated SI < 0, and if the solid is exactly at saturation, SI = 0. Figures 1 - 4 show example SI diagrams for the system compositions given in Table 3.

By examining the areas where the curves are above the SI = 0 line, a domain of pH is given where pipe protection can be predicted. SI diagrams can often be prepared for general classes of waters, and a relatively small number of diagrams can be used to cover a wide range of concentration extremes that would likely be encountered, and therefore they can yield a large amount of semi-quantitative information on the occurrence and identity of pipe coatings.

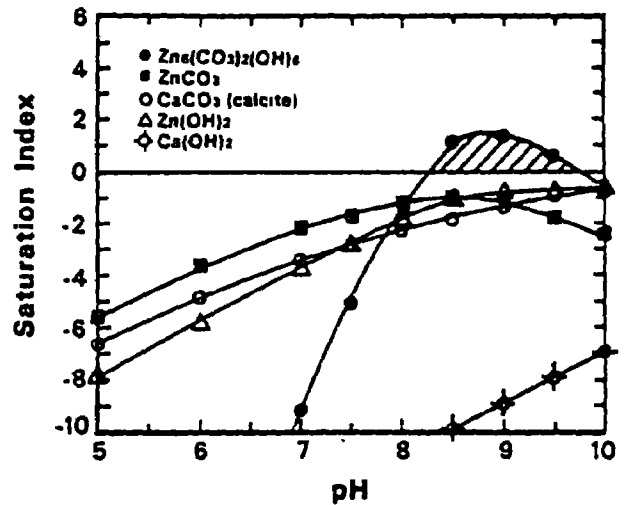
Figure 4. Saturation index diagram for model system H15 (see Table 3).

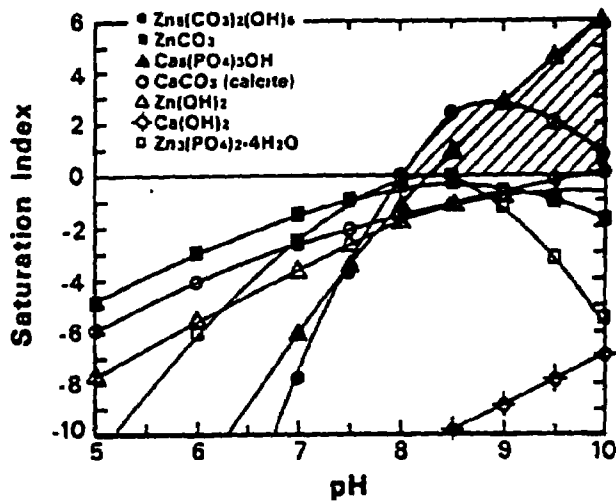
Figure 2. Saturation index diagram for model system H10P (see Table 3).

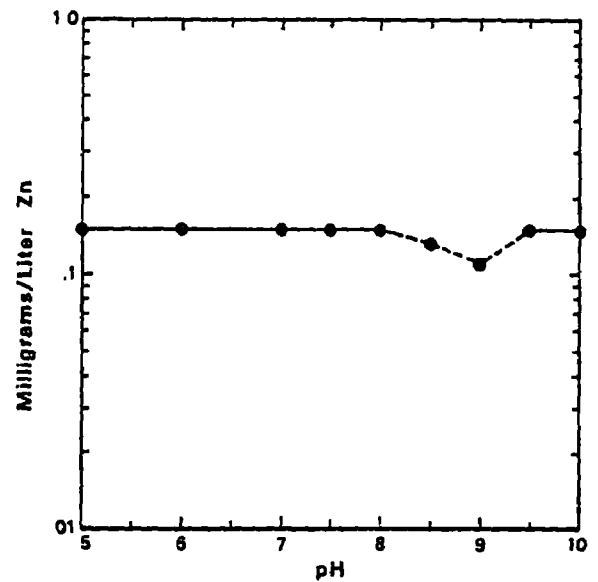
Figure 5. Precipitation diagram for zinc in model system H9 (see Table 3).

Precipitation diagrams were calculated by the same computer program, by "allowing" supersaturated solid phases to precipitate to their saturation levels.⁽³⁾ While it is just as easy to plot the concentration of each solid phase versus pH, a plot of total dissolved constituent concentration(s) versus pH was selected. Figures 5 - 8 illustrate the Precipitation diagrams corresponding to the previously given SI diagrams. The selection of dissolved total constituent concentration as the variable to plot versus pH was made because it is representative of the practical situation of the addition of known concentrations of soluble corrosion-control compounds. The minimum dosage level is easily estimable, by observing the dissolved concentration of the constituent of interest (zinc or ferric iron, in this case) in the pH region where precipitation would be taking place.

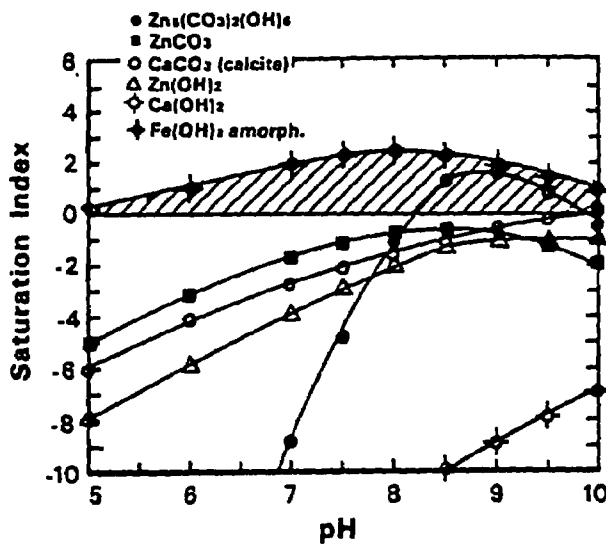
Figure 3. Saturation index diagram for model system H11 (see Table 3).

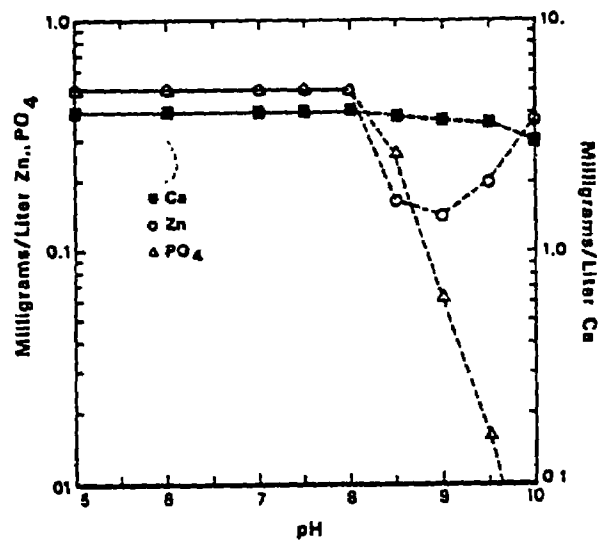
Figure 6. Precipitation diagram for zinc, calcium and orthophosphate in model system H10P (see Table 3).

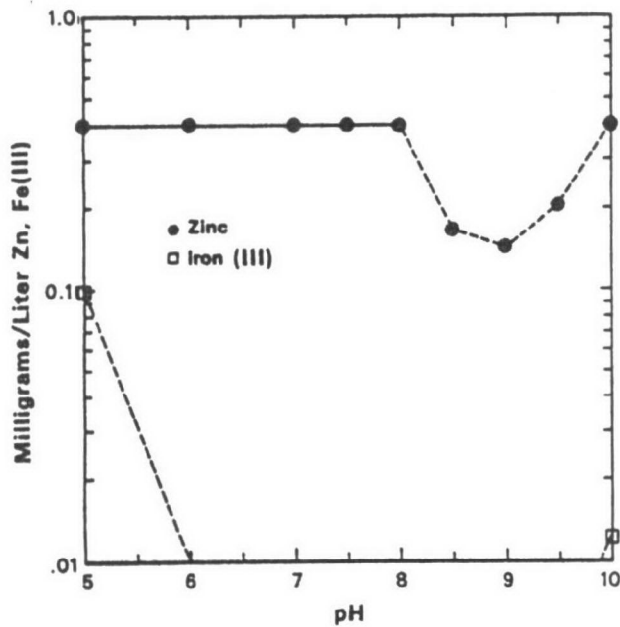
Figure 7. Precipitation diagram for zinc and iron (III) in model system M11 (see Table 3).

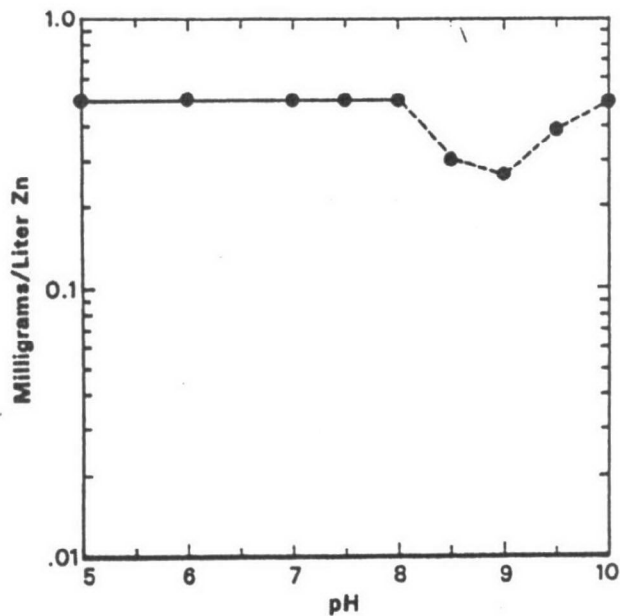
Figure 8. Precipitation diagram for zinc in model system M15 (see Table 3).

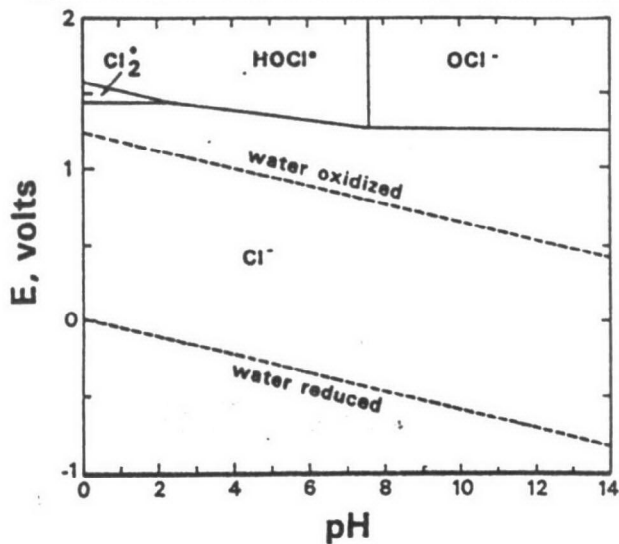
Figure 9. Potential - pH diagram for some metastable chlorination species at 25°C with dissolved activities of 1.0 mg/L as Cl-. Data is from reference 3.

Table 7 shows how various saturation indices can be used to predict protection or deterioration of pipe. It is necessary to either know or estimate the redox potential of the water in order to determine the saturation states of solids possessing more than one stable valence state in drinking water. A value of the redox potential representing moderately oxidizing conditions was chosen in Table 7, for all waters that were chlorinated. The interrelationship of the redox potential, pH and the domain of water stability to chlorination species is shown in Figure 9.

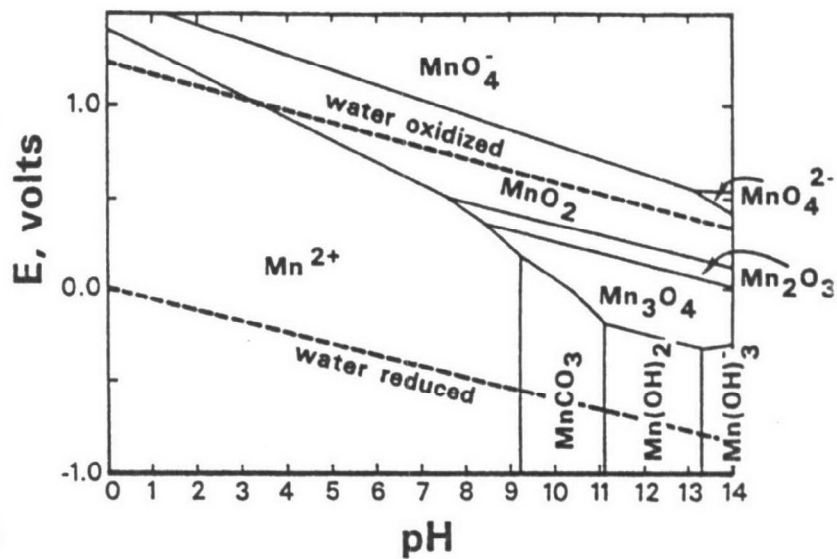
Figure 10. Potential - pH diagram of manganese in carbonate - containing water at 25°C. Stability fields are shown for dissolved manganese species activities of 0.05 mg/L and dissolved carbonate species activities of 40 mg/L as CaCO₃. Data is from reference 3.

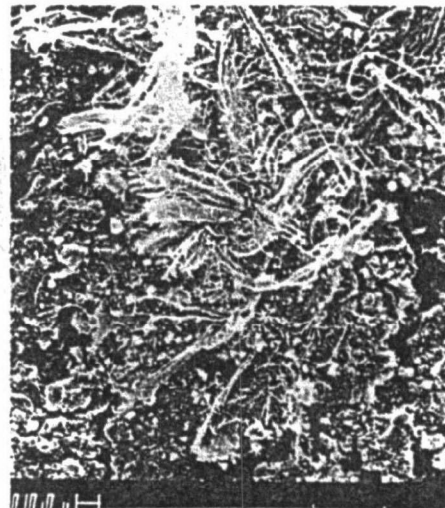
Figure 11. Scanning electron micrograph of the pipe coupon from DWRD experiment 1 showing exposed fibers (see Tables 1 and 2). Iron and aluminum are constituents of the cement matrix.

The following examples of the use of SEM-EDXA to evaluate A/C pipe condition are taken from three DWRD experiments and one field study. Experiment 1 was a "control" experiment in which no inhibitors were added. The micrograph (Figure 11) shows fibers present and some pitting of the surface. The EDXA analysis (Figure 12) shows a large peak for silicon compared to that of calcium. The difference in peak size may be caused by leaching of the calcium, an interpretation consistent with the calcium increase that was observed in solution.⁽³⁾ Also important is the magnesium, the presence of which may indicate exposed chrysotile fibers at the pipe surface. The magnesium peak has frequently shown up in analyses of corroded pipe and it is seldom present in EDXA scans of non-corroded pipe.

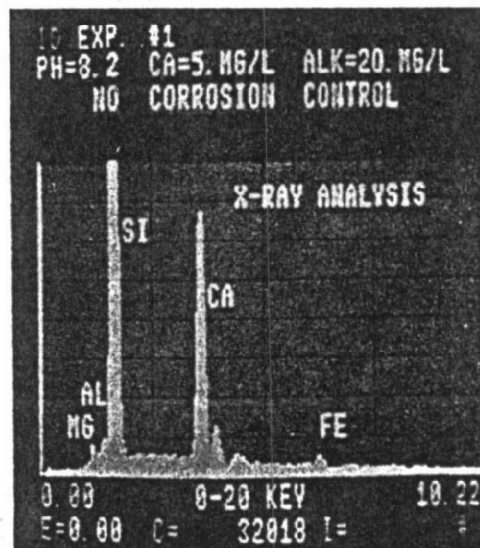
Figure 12. EDXA analysis of the pipe coupon from DWRD experiment 1 (see Tables 1 and 2).

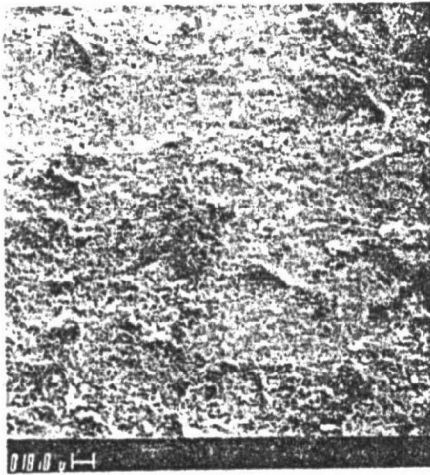
Figure 13. Scanning electron micrograph of the pipe coupon from DWRD experiment 2 showing a uniform surficial coating (see Tables 1 and 2).

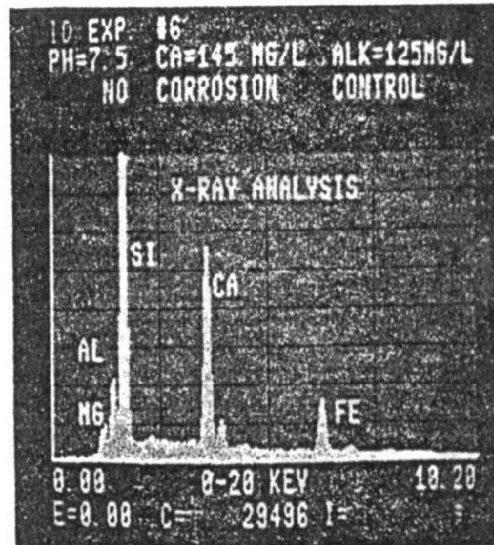
Figure 16. EDXA analysis of the pipe coupon from DWRD experiment 6 (see Tables 1 and 2). Iron and aluminum are constituents of the cement matrix.

Experiment 6 shows some pitting and exposed fibers in the micrograph (Figure 15). Here, again, the presence of a strong magnesium peak (Figure 16) seems to demonstrate the deterioration of the pipe and the presence of fibers on the surface. An important factor here is that pipe was shown to deteriorate even when the water was kept just slightly under calcite saturation. The expense of adjusting many naturally-soft waters to maintain a state of calcium carbonate saturation, coupled with the undesirability of the harder water to many consumers may necessitate the use of other treatment methods, such as zinc addition and pH adjustment.

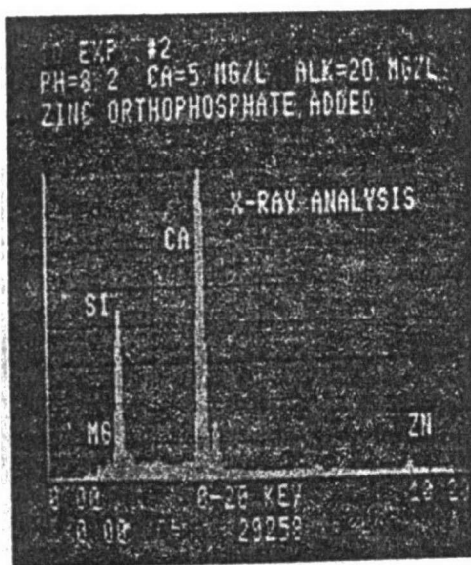
Figure 14. EDXA analysis of the pipe coupon from DWRD experiment 2 (see Tables 1 and 2). Note the presence of zinc, but not of phosphorous.

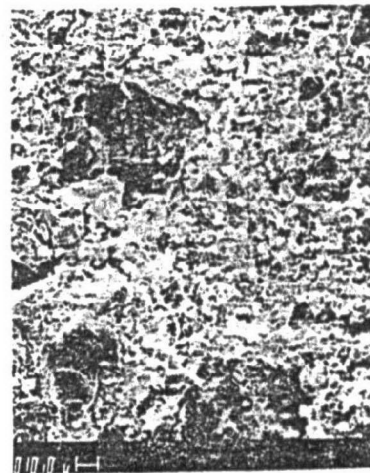
Figure 17. Scanning electron micrograph of a remote pipe section in a DWRD field experiment. Note the appearance of pitting resulting from pipe dissolution.

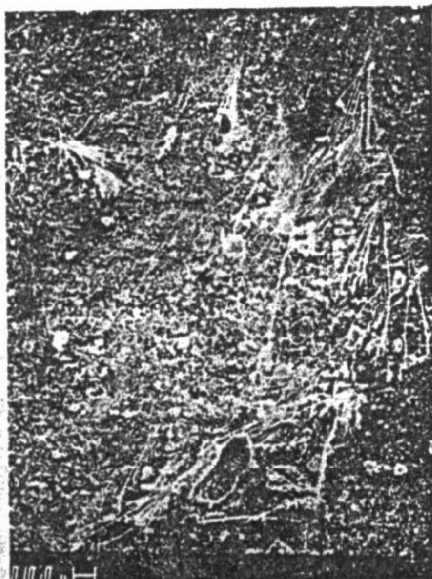
Figure 15. Scanning electron micrograph of the pipe coupon from DWRD experiment 6 showing some exposed fibers (see Tables 1 and 2).

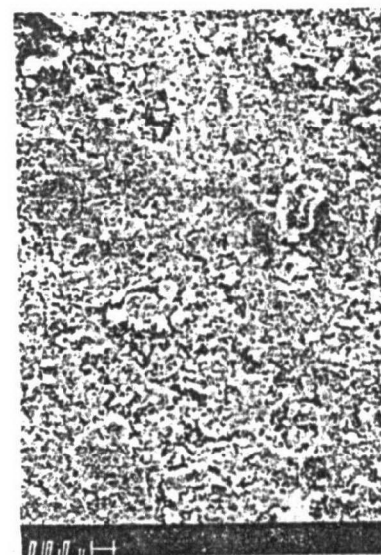
Figure 18. Scanning electron micrograph of a pipe section from a DWRD field experiment, showing substantial coating by a zinc compound.
