# Demonstration of a Graywater Management Project at a Community-Level on the Island of Puerto Rico

**Demonstration of a Graywater Management Project  
at a Community Level on the Island of Puerto Rico**

Evelyn Huertas<sup>1</sup>, Exel Colón<sup>2</sup>, Thomas P. O'Connor<sup>3</sup>

REGIONAL APPLIED RESEARCH EFFORT  
OFFICE OF RESEARCH AND DEVELOPMENT  
UNITED STATES ENVIRONMENTAL PROTECTION AGENCY  
EDISON, NEW JERSEY 08837

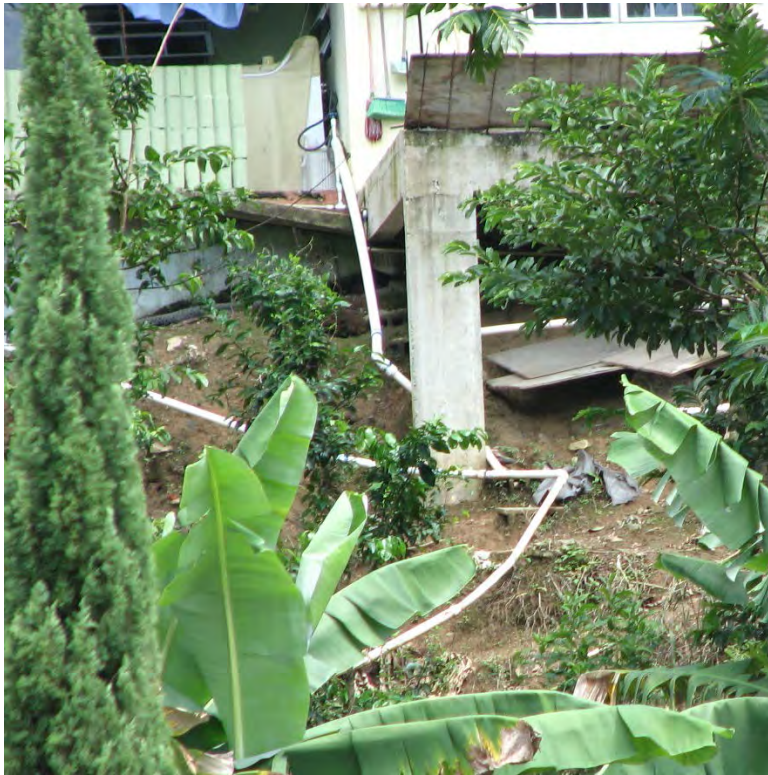
Figure 1-1 Example of graywater collection for discharge (white PVC piping) for a typical residence

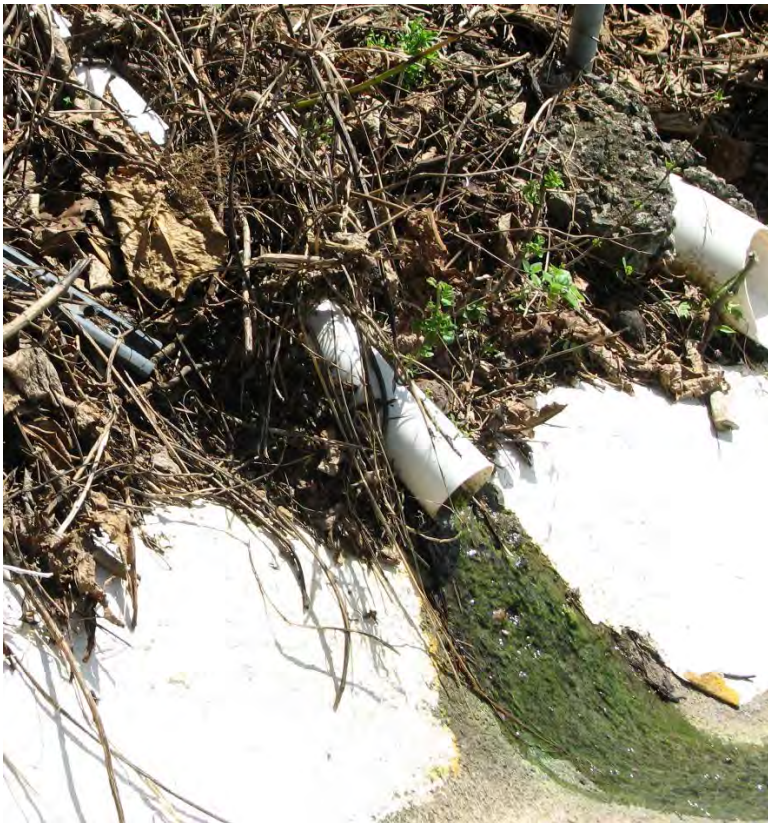
Figure 1-2 Typical graywater discharge to stormwater drainage system (street gutter).

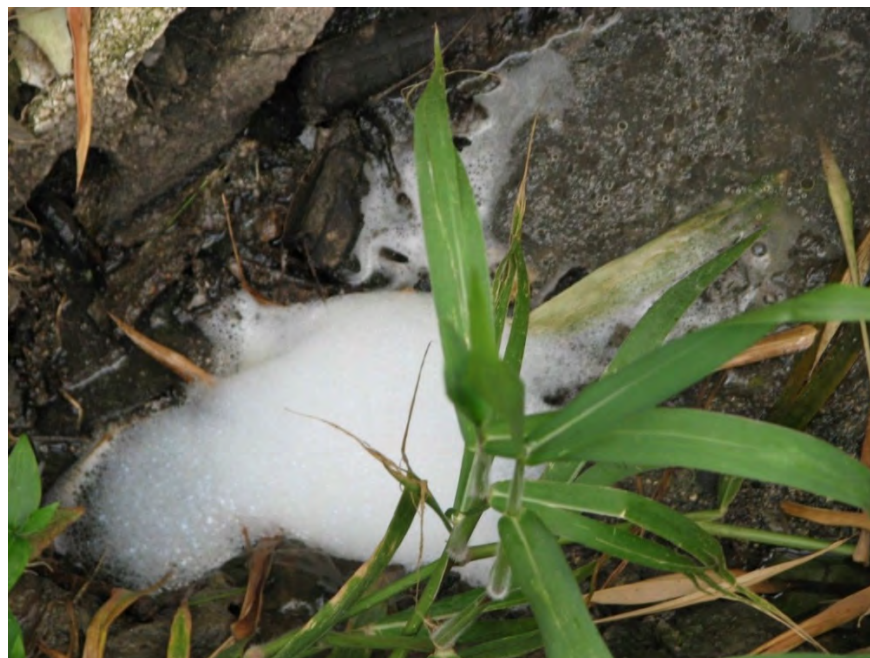
Figure 1-3 Graywater discharge causing foam in stormwater drainage system.

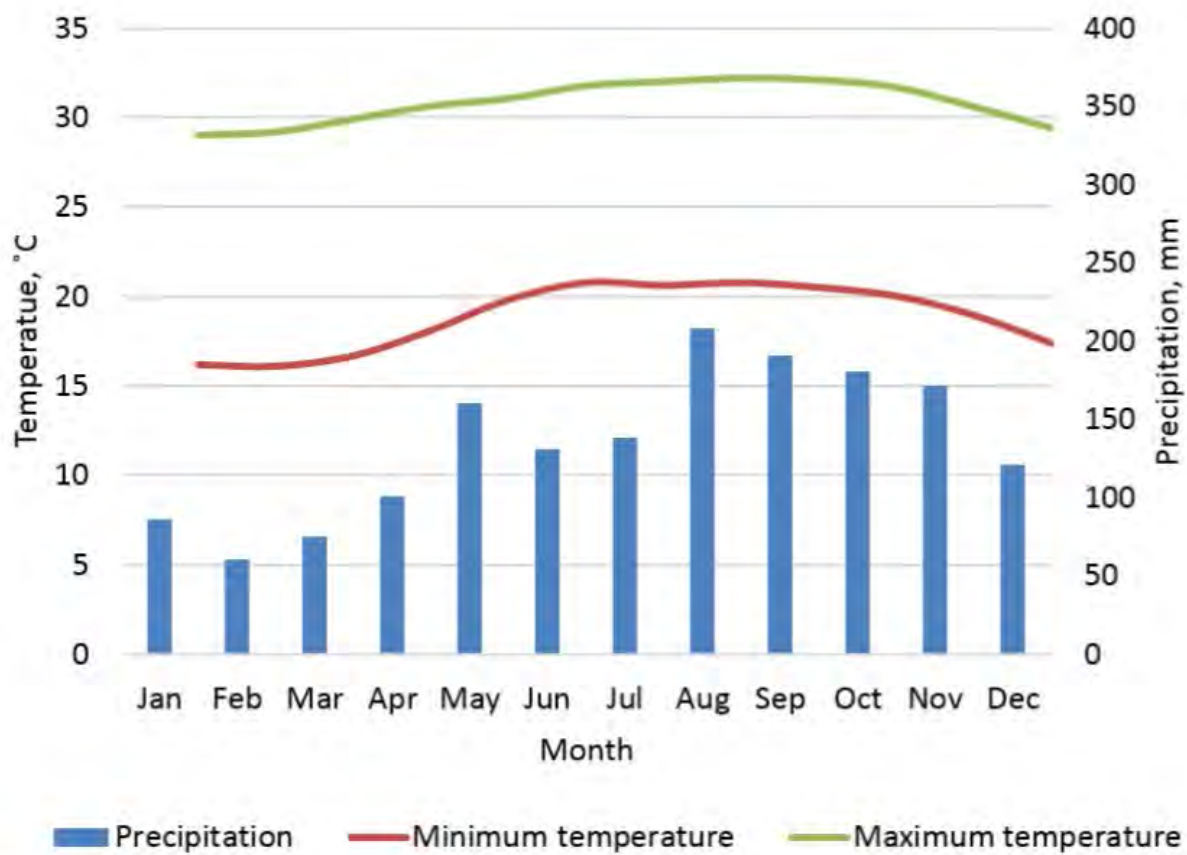
Figure 2-4 Temperature and precipitation averages in the Gurabo substation, 1981-2010 (NOAA-NWS, 2015)

The climate of Gurabo is classified as semi-tropical (Grupo Editorial EPR, 2009) with two temperature zones, a tropical zone in the plains and temperate zone in the mountains. The average temperature is approximately 25 °C though the average maximum daily temperatures increases to over 32 °C from July to September. Precipitation is abundant, with an annual average of 1700 mm of rain (NOAA, 2015); the mean monthly rainfall is provided in Figure 2-4. During hurricane season (June 1 – October 31) winds blow from east to west.

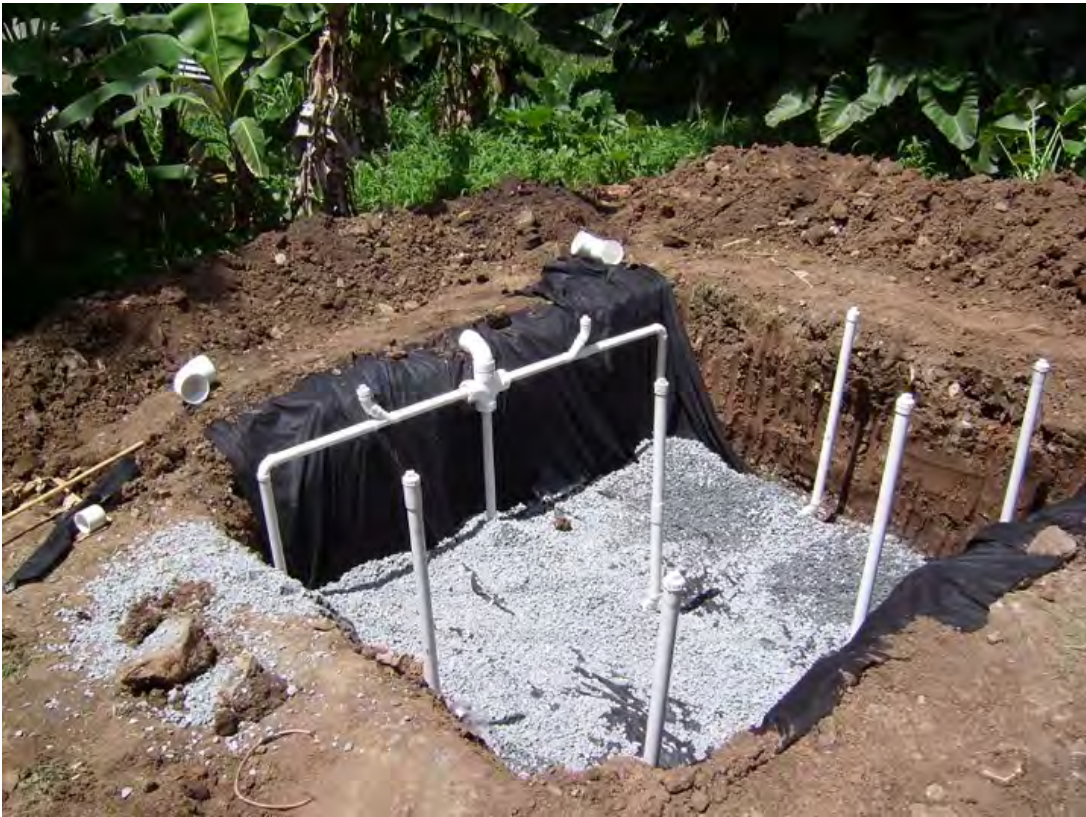
Figure C-2 Piping scheme in the excavation and gravel in the bottom

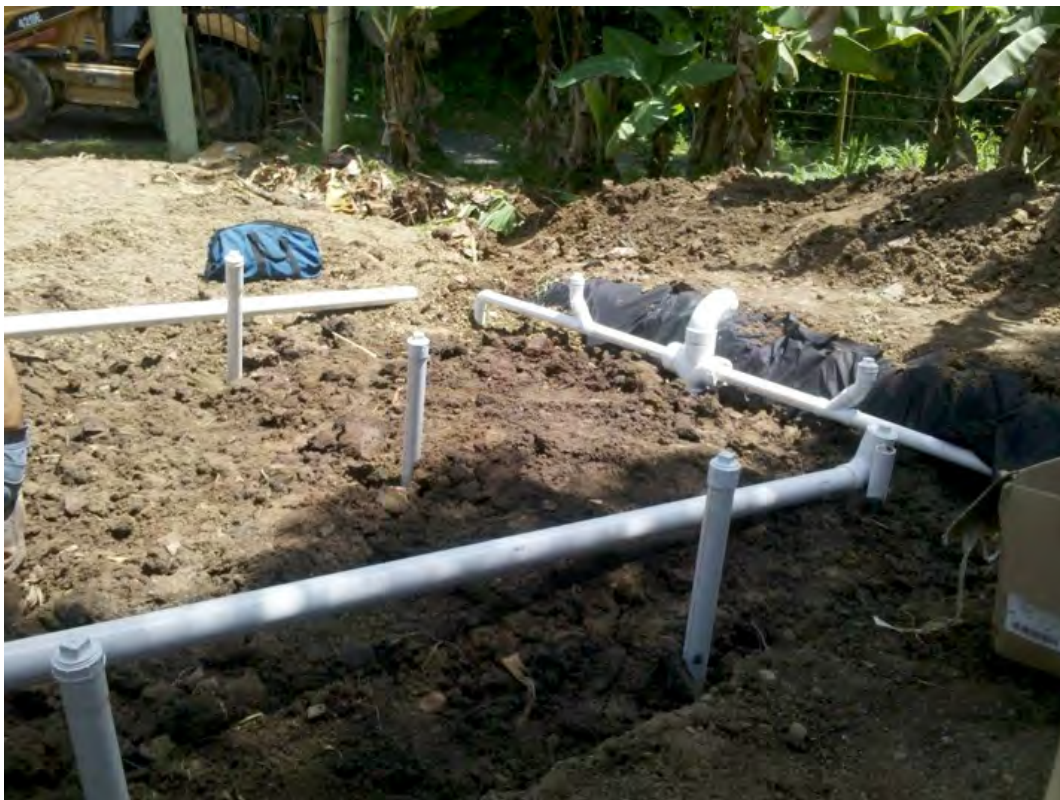
Figure C-4 Pipe installation of the graywater garden

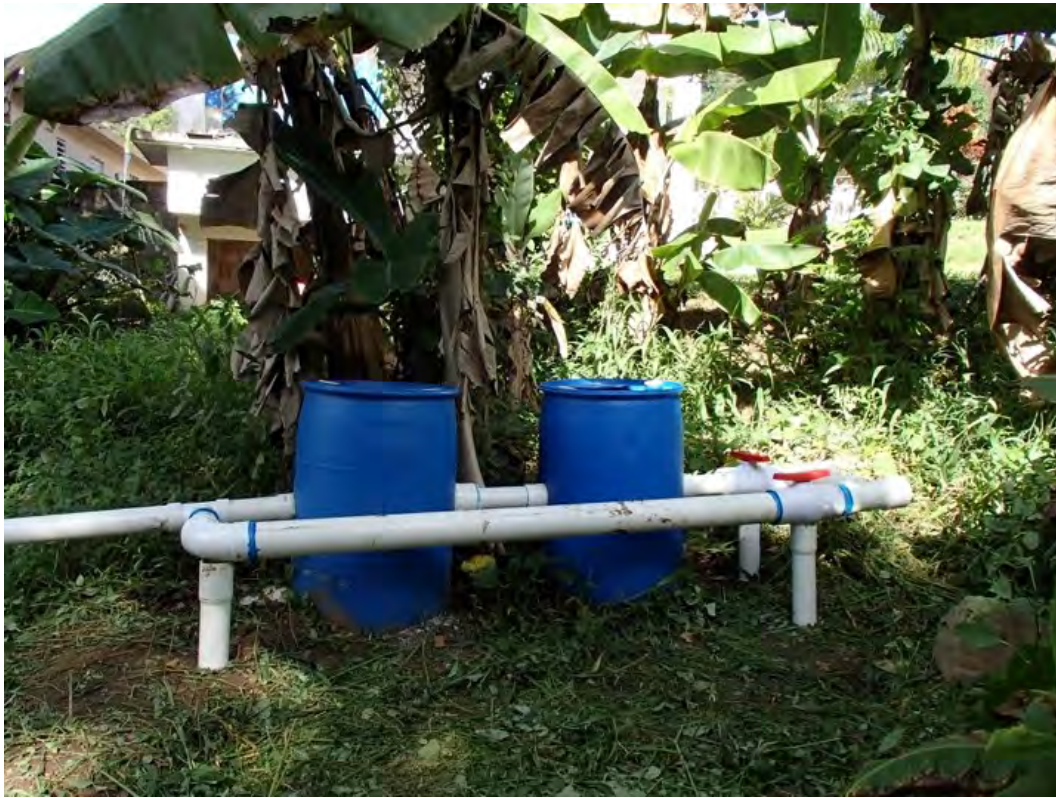
Figure C-11 Pre-treatment units of the graywater garden

Finally, the initial pretreatment configuration comprised of two 200-L plastic drums to trap grease and screen influent was replaced with a 1000-L intermediate bulk container (IBC) to facilitate maintenance and increase storage capacity to reduce impacts due to surges of graywater. The timer valves installed at the lower exit of the screening 200-L plastic drum to regulate the entrance of graywater to the garden were not well coordinated with the times and duration of the influent water, therefore, the screen tank operated most of the time in overflow mode and the desired control of the valves was overridden. Table 3-2 shows the timeline of construction and all modifications as well as the dates of the sampling events.

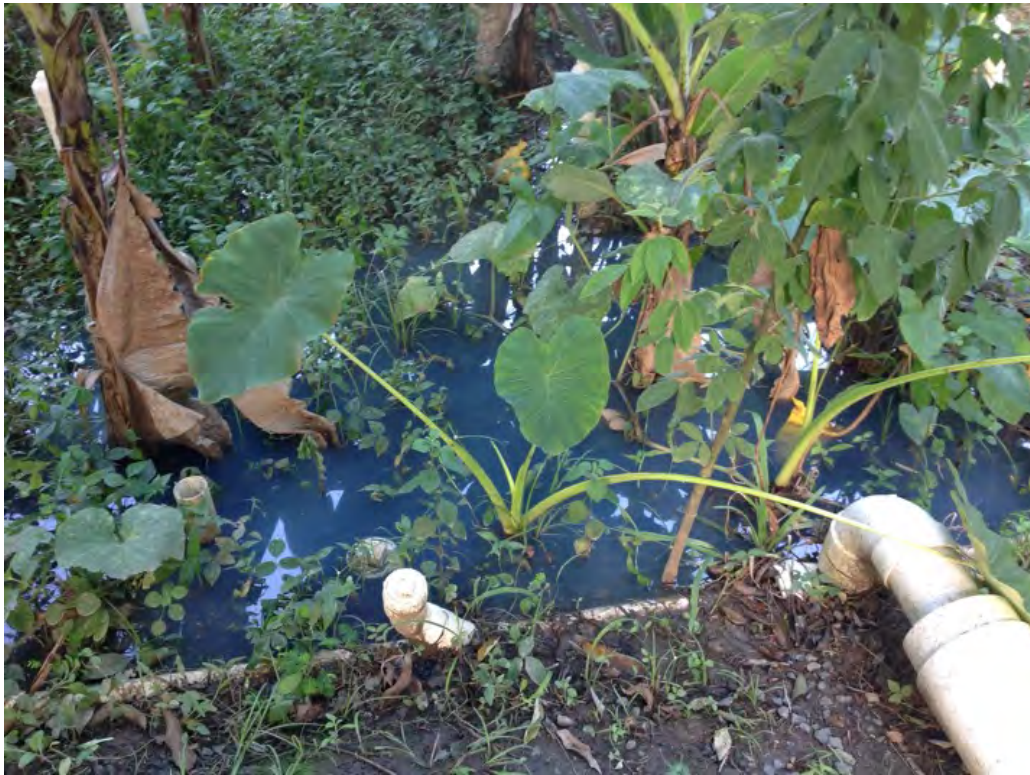
Figure C-21 Surface ponding in the garden

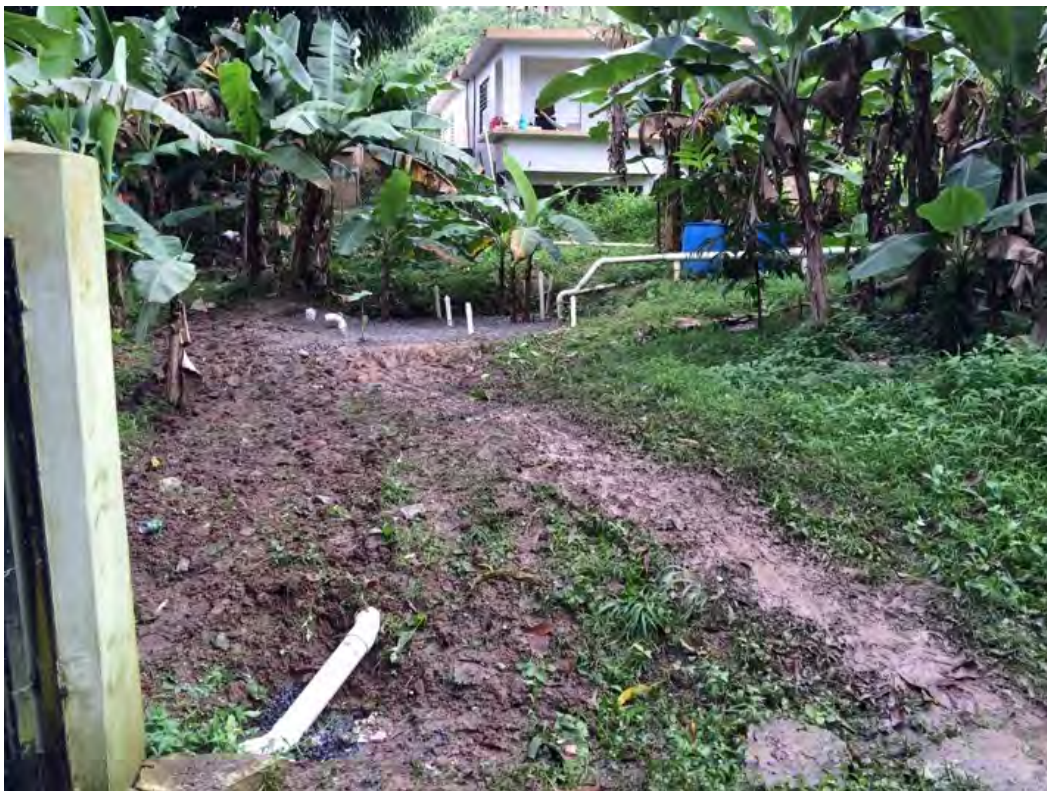
Figure C-22 Installation of French drain

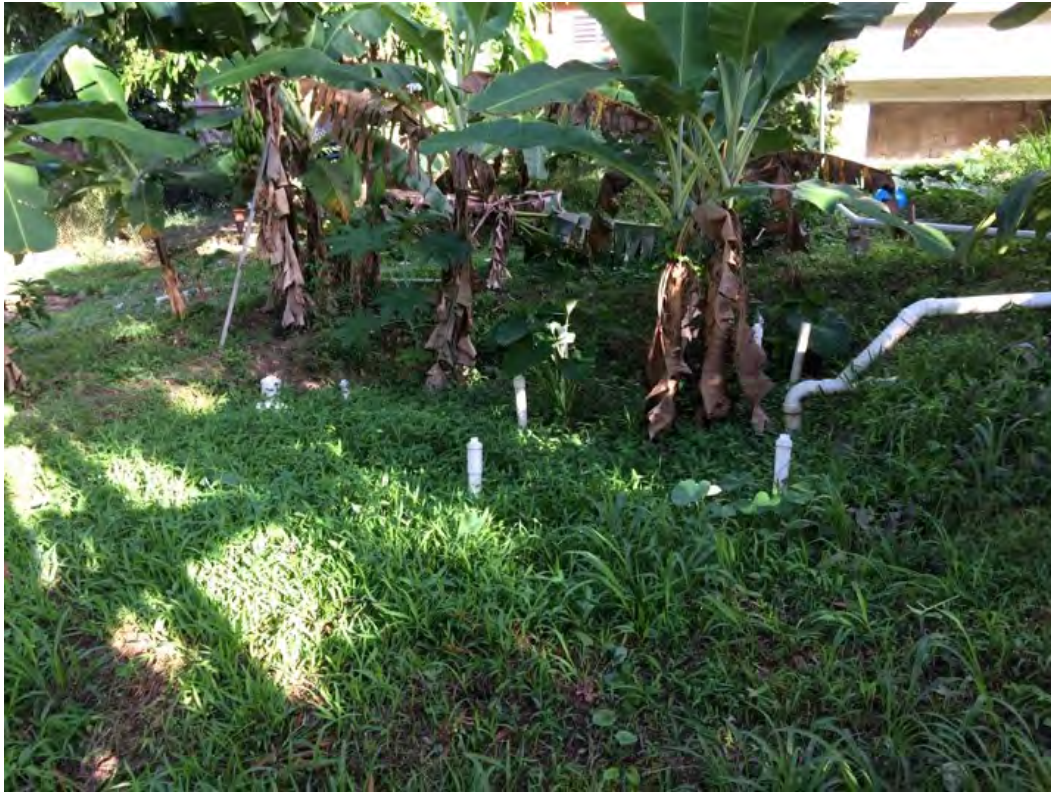
Figure C-27 View of the graywater garden with remaining plantain (*Musa* spp.) plants

As previously noted, the site was subject to shading. Only a few plantain plants were left until the end of the project (see figure Appendix C-27), while the rest of the existing vegetation was removed. The replacement plants did not provide an immediate benefit to the study. Siting future graywater gardens in sunnier locations and providing long-term maintenance of plants in the garden with periods of harvesting and replanting would contribute to greater evapotranspiration and pollution removal. A graywater demonstration project performed in Colorado (EPA, 2012), had such a high period of evapotranspiration during the summer months that there was no observed effluent from this two stage wetland system. This graywater wetland was lined, due to strict water usage laws in Colorado, so that effluent concentrations were returned to the sanitary sewer. The Colorado graywater system had better removals overall, but had intermittent flows and was subject to much less annual precipitation and drier, less humid conditions. During winter periods, there was a rise in the pathogen indicators of the Colorado graywater system that would have necessitated further treatment if the purpose was to reuse the graywater. Any graywater garden or wetland system will be subject to climatic conditions and the interaction of vegetation with climatic conditions. For future projects in Puerto Rico, it is recommended to use more of both *Musa* sp. and *Xanthosoma* sp. plants in sunnier locations to better evaluate the full evapotranspiration potential.
