WATERSHED PROGRESS: Hot Creek Watershed Mimbres River Basin

Since 1991, the U.S. EPA has been promoting the watershed approach as a mechanism to achieve the next generation of water protection. The focus on watersheds, or drainage areas, provides people living there a meaningful context in which to identify problems and solutions. Below is a description of the Hot Creek Watershed where the watershed approach is making a difference.

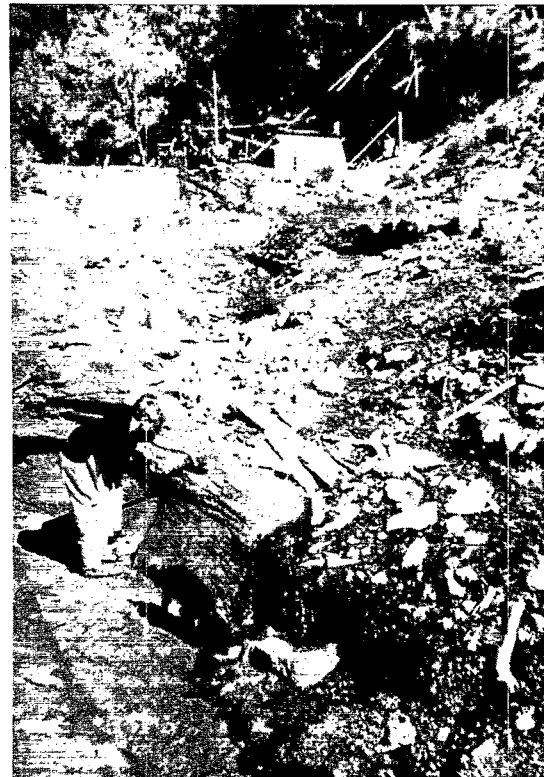
Metal loading problems in the upper reaches of the watershed originated primarily from concentrated sources in mine wastes. (The region was heavily mined for zinc and lead from the 1880s through the 1960s.) In fact, concern about the transport of metals from the inactive Royal John Mine originally motivated watershed residents to organize and seek the help of the New Mexico Environment Department (NMED) Nonpoint Source Program ("the State").

Photo: Royal John Before Restoration

The State has conducted an extensive watershed investigation with the help of interested citizens, identifying several sources of nonpoint pollution. The group confirmed that the most concentrated sources of metal loading to Hot Creek were associated with the inactive Royal John Mine. Sparse vegetative cover in the rugged upland range was also identified as a wide spread problem leading to increased turbidity (cloudiness of water). Concentrated cattle waste was also a problem, particularly in shallow pools, and resulted in algae blooms and reduced dissolved oxygen. Further, the dirt road system in the watershed was found to be a conduit and concentrator of storm runoff, as well as a source of sediment.

The goal of stabilizing the principle source of metals in the watershed has been accomplished. To restore the stream channel below the Royal John, the Gila National Forest identified several design alternatives through the National Environmental Policy Act process. A wide range of interested parties, including the citizen watershed association, participated in the design selection process. The final design included restoration of the stream channel, site seeding and mulching to encourage re-
