Mine Waste Technology Program

Underground Mine Source Control Demonstration Project

Abstract

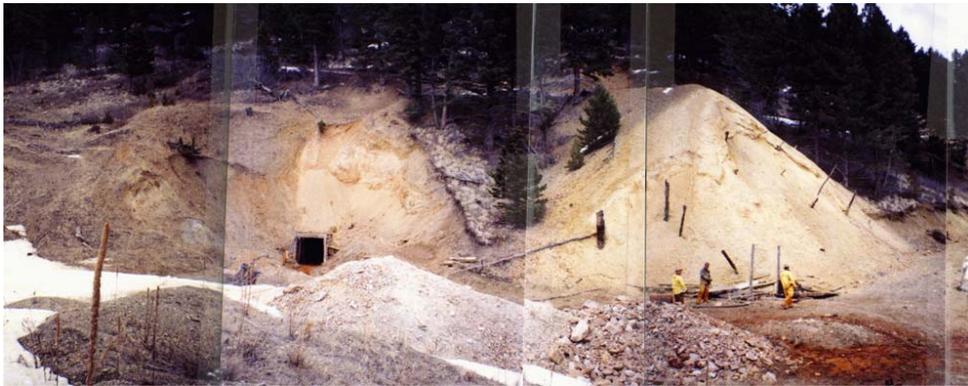
Figure 1-3. Photo of the Miller Mine upper and lower workings.

Mine hazards at the Miller Mine site include two open adits, several waste dumps, numerous structures in various stages of disrepair, and discarded equipment. Approximately 12,000 cubic yards of disturbed material and waste rock are associated with the Miller Mine site (Figure 1-3.)

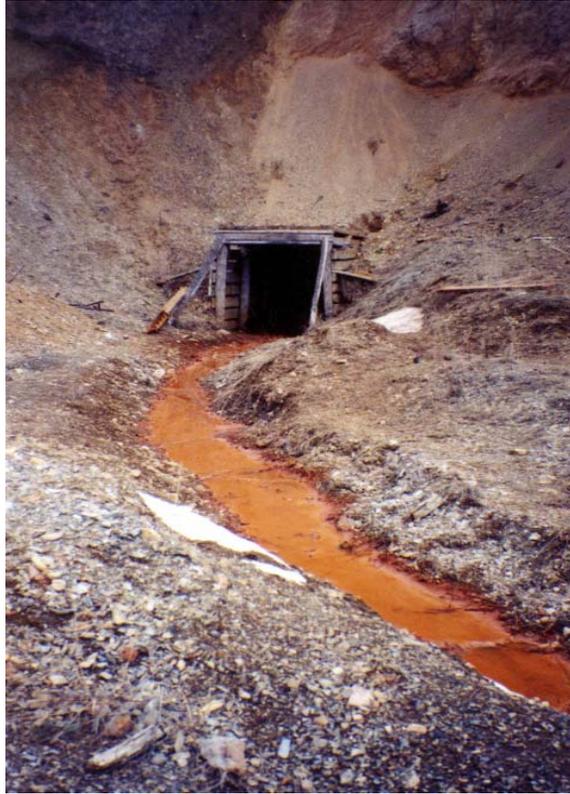
Figure 1-4. Photo of the Miller Mine lower adit discharge prior to implementation of the source control technology.

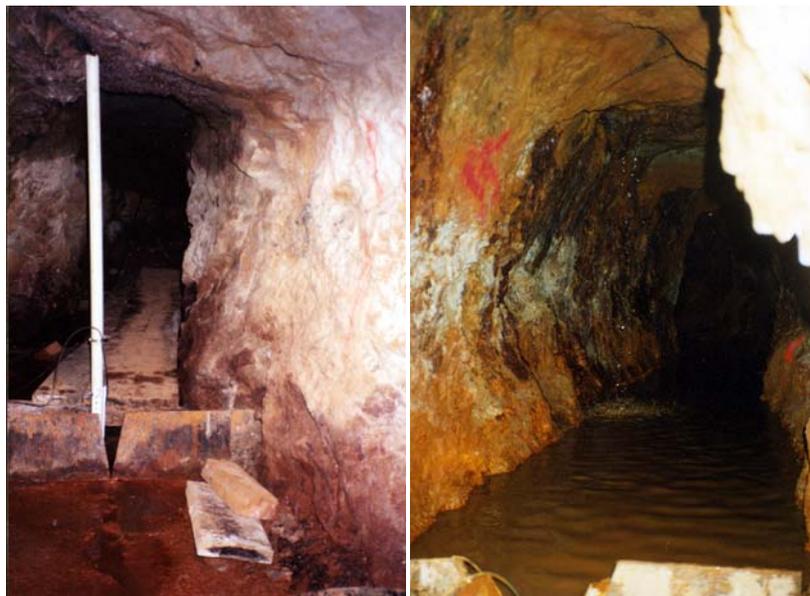
Figure 1-5. Areas of AMD at the Miller Mine prior to the application of the technology.

The objective of the Phase III field demonstration emplacement was to inject an innovative source control material into the rock fracture system and reduce or eliminate AMD by limiting the infiltration of water through hydraulic connections associated with the fracture system at the Miller Mine. The source control material was injected in order to fill and seal fractures that acted as hydraulic conduits, to reduce the amount of water infiltrating the underground workings, to prevent water from coming in contact with oxidized host rocks, and ultimately, to reduce or eliminate the generation of AMD and mobilization of heavy metals. Figure 1-5 provides a visual depiction of areas of AMD at the Miller Mine prior to the application of the technology.

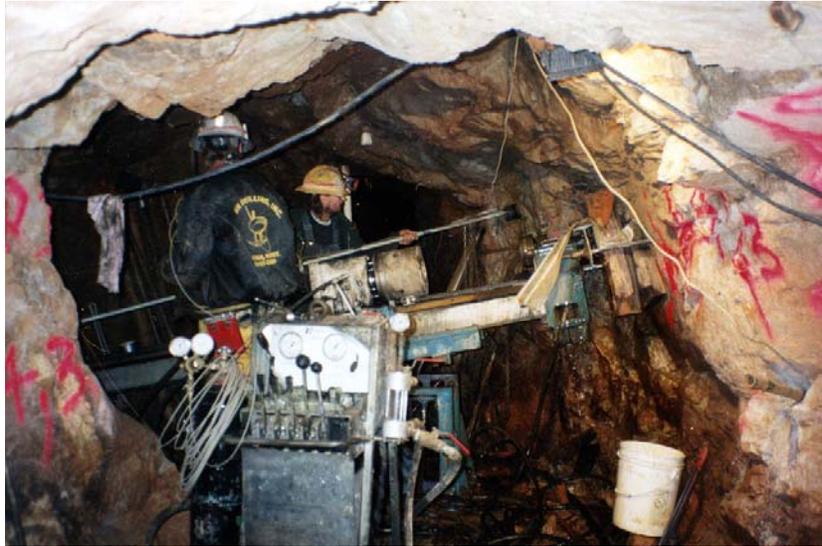
Figure 3-1. The drilling/gROUTING subcontractor placing an inflatable packer system into the grout hole for dye and water injection testing.

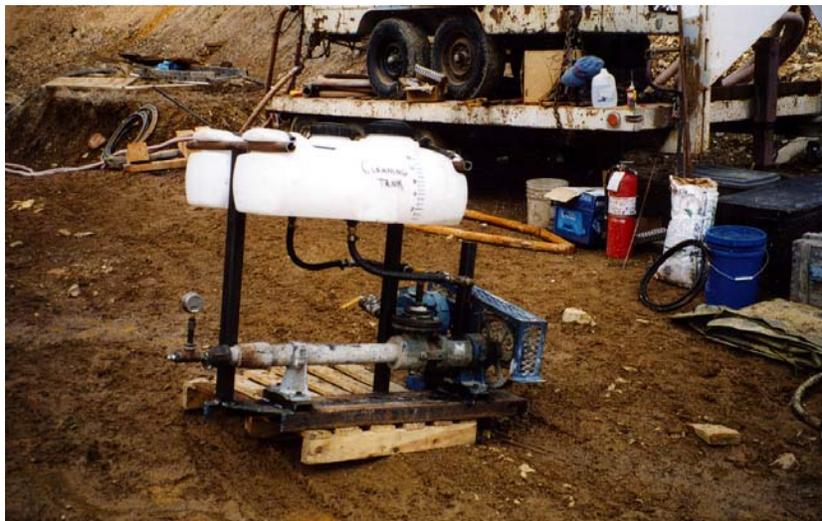
Figure 3-2. Photograph of the grout pump, tanks, and flowmeter system for the Stage I grout injection in 1999.

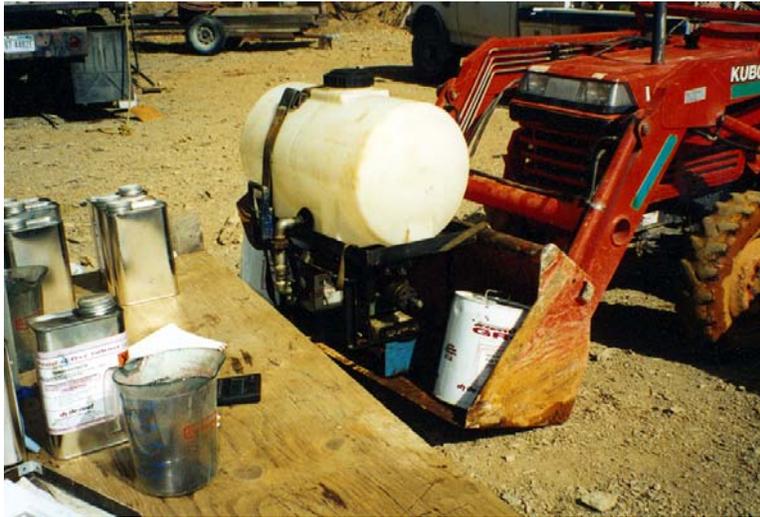
Figure 5-2. Kubota tractor that transported the grout and grout equipment into the abandoned underground workings of the Miller Mine.

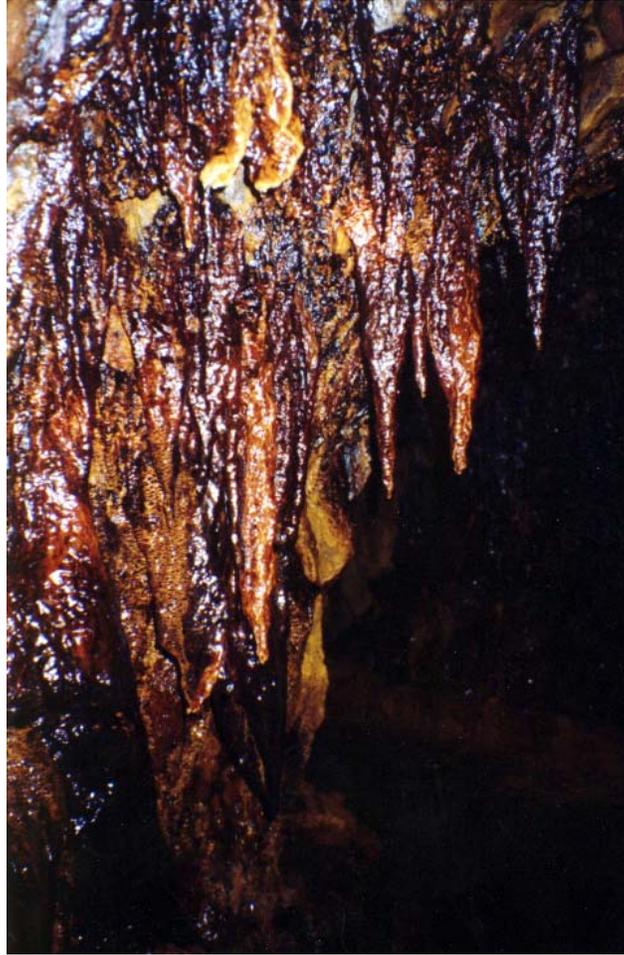
Figure 5-3. Iron oxide stalactites in the W1 drift, which were areas where flow through the fractures required grouting.
