United States Environmental Protection Agency
Office of Municipal Pollution Control

ASSESSMENT OF THE BIOLAC^R TECHNOLOGY

Contract No. 68-C8-0023

September 1990

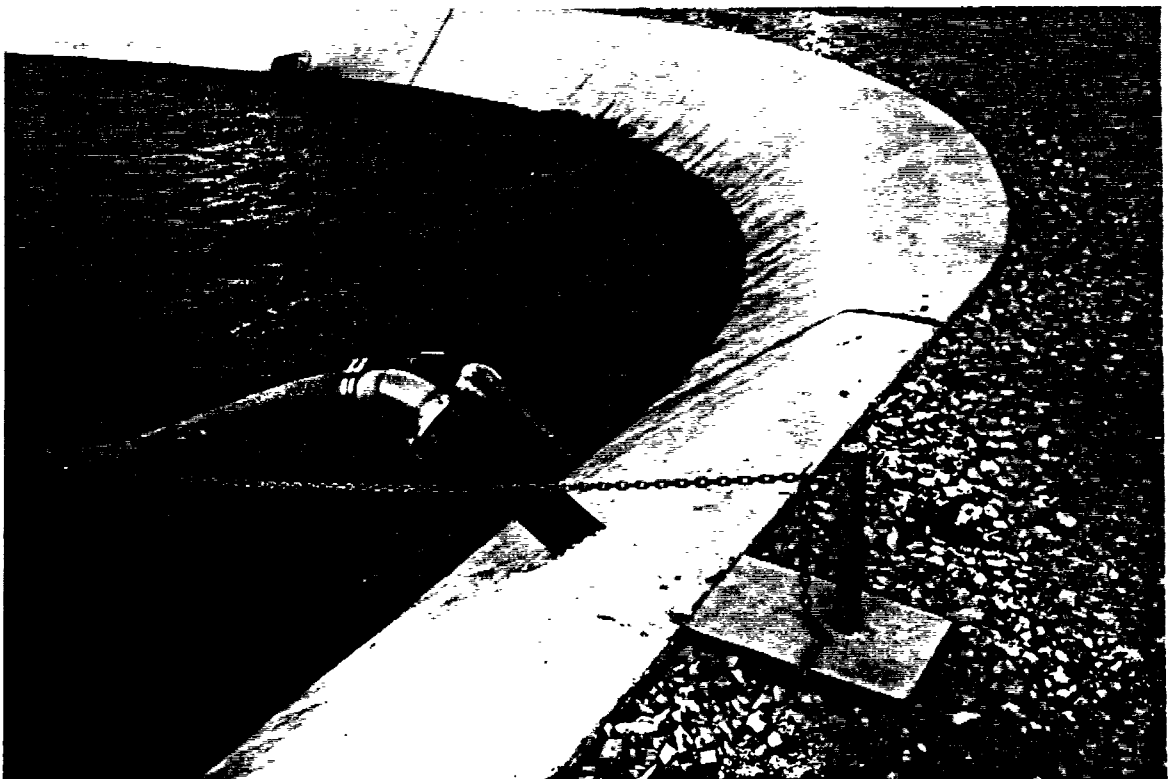
Refer to Figures 12, 13, 14 and 15:

- A. Influent to effluent view of the Biolac System. Aeration basin foreground, integral clarifier in back of the aeration basin and the polishing basin in the background.
- B. Closeup of the anchoring system and header assembly. Chain length controls the aeration chain tension and subsequently the aeration chains lateral range of motion. Air header assembly includes a butterfly valve (large

handle) for air flow control and an air bleed valve (smaller handle) for unchaining the aeration chain.

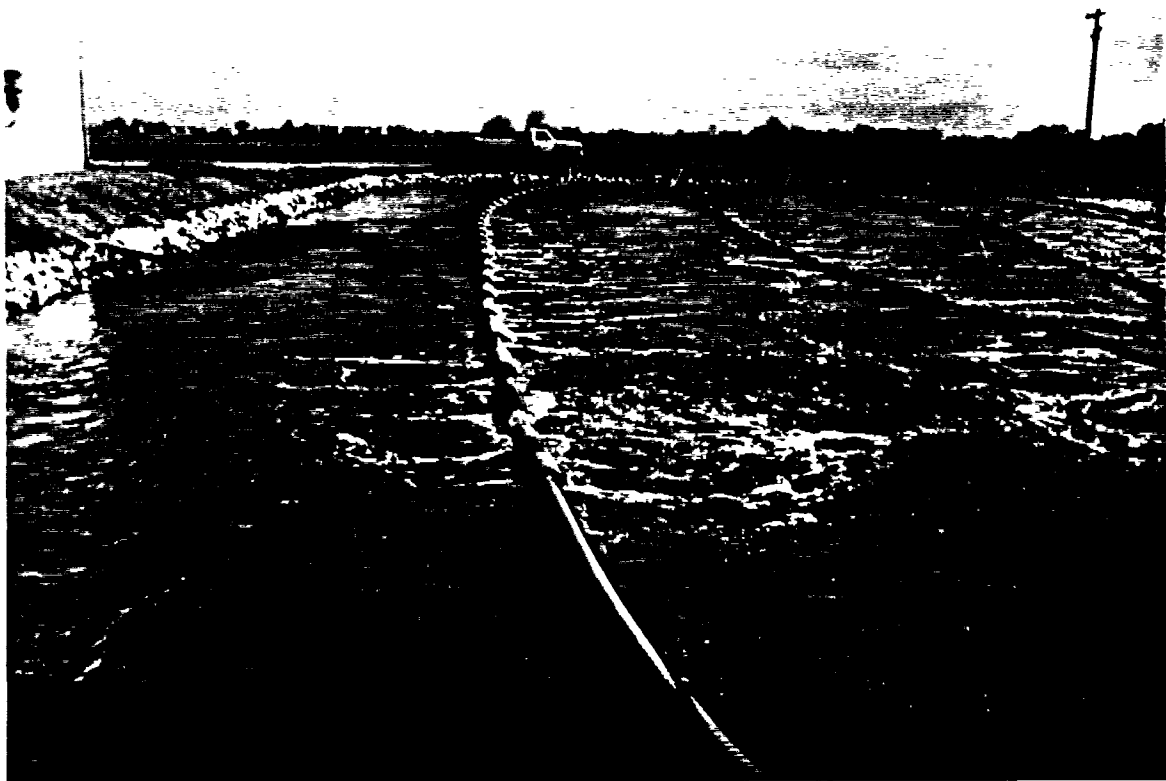
Refer to Figures 18, 19, 20 and 21:

- A. Blower silencers. Screens were installed to reduce filter clogging. Metal mesh filters are used; these are brushed and washed regularly (North).
- B. Integral clarifier. Note the curtain and rake drive cable (North).
- C. Effluent trough and rake drive enclosure (installed by plant) (North).
- D. Last aeration chain in basin; closest to 3 integral clarifiers (West).
- E. One of three integral clarifiers at the West plant. Steel angle bracing was installed to minimize lateral movement of the long effluent trough.
- F. Aeration chain. Localized boiling indicated diffuser problem (West).
- G. Structure used for air lift pump blower noise control at the South Plant.
