## Project Summary

# Evaluation of a Containment Barrier for Hazardous Material Spills in Watercourses

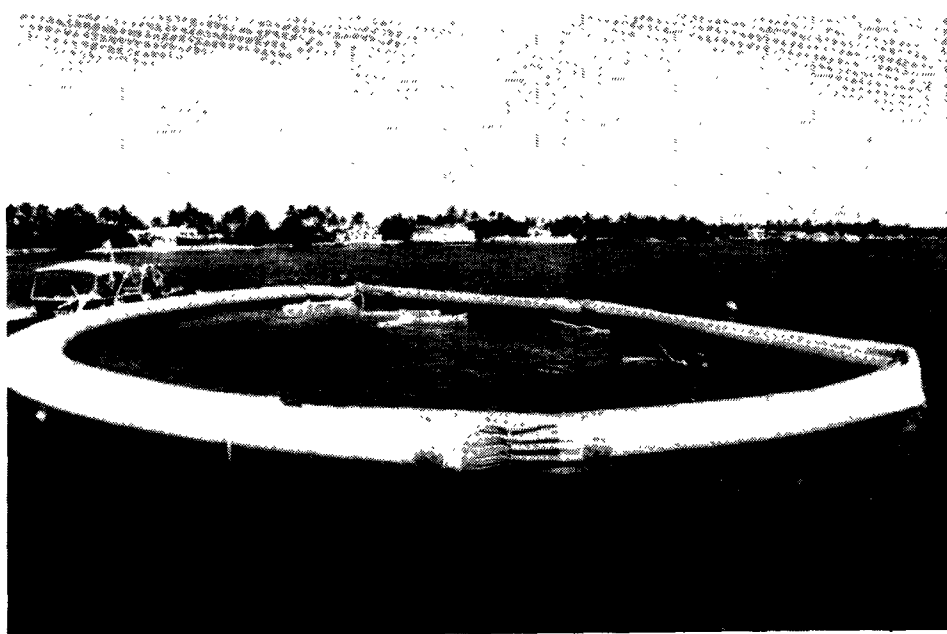
**Figure 1.** Fully-inflated barrier.

The barrier is constructed of a highly flexible, fiber-reinforced plastic material that can be deployed around a spill source such as a sunken barge, rail car, or tanker truck containing concentrated insoluble hazardous materials that pool on or near the bottom of the waterbody. Incorporated into the barrier are an air-inflated flotation collar that supports the barrier and a liquid-filled bladder that

seals the bottom of the barrier to the bottom of the waterway in which the barrier is deployed. The ends of the barrier are laced together before deployment to give the cylindrical shape needed for the confinement of a spill. Figure 1 shows the barrier fully inflated on the water surface.
