CORROSION STUDIES IN MUNICIPAL INCINERATORS

SOLID WASTE RESEARCH LABORATORY

**CORROSION
STUDIES
IN
MUNICIPAL
INCINERATORS**

1972

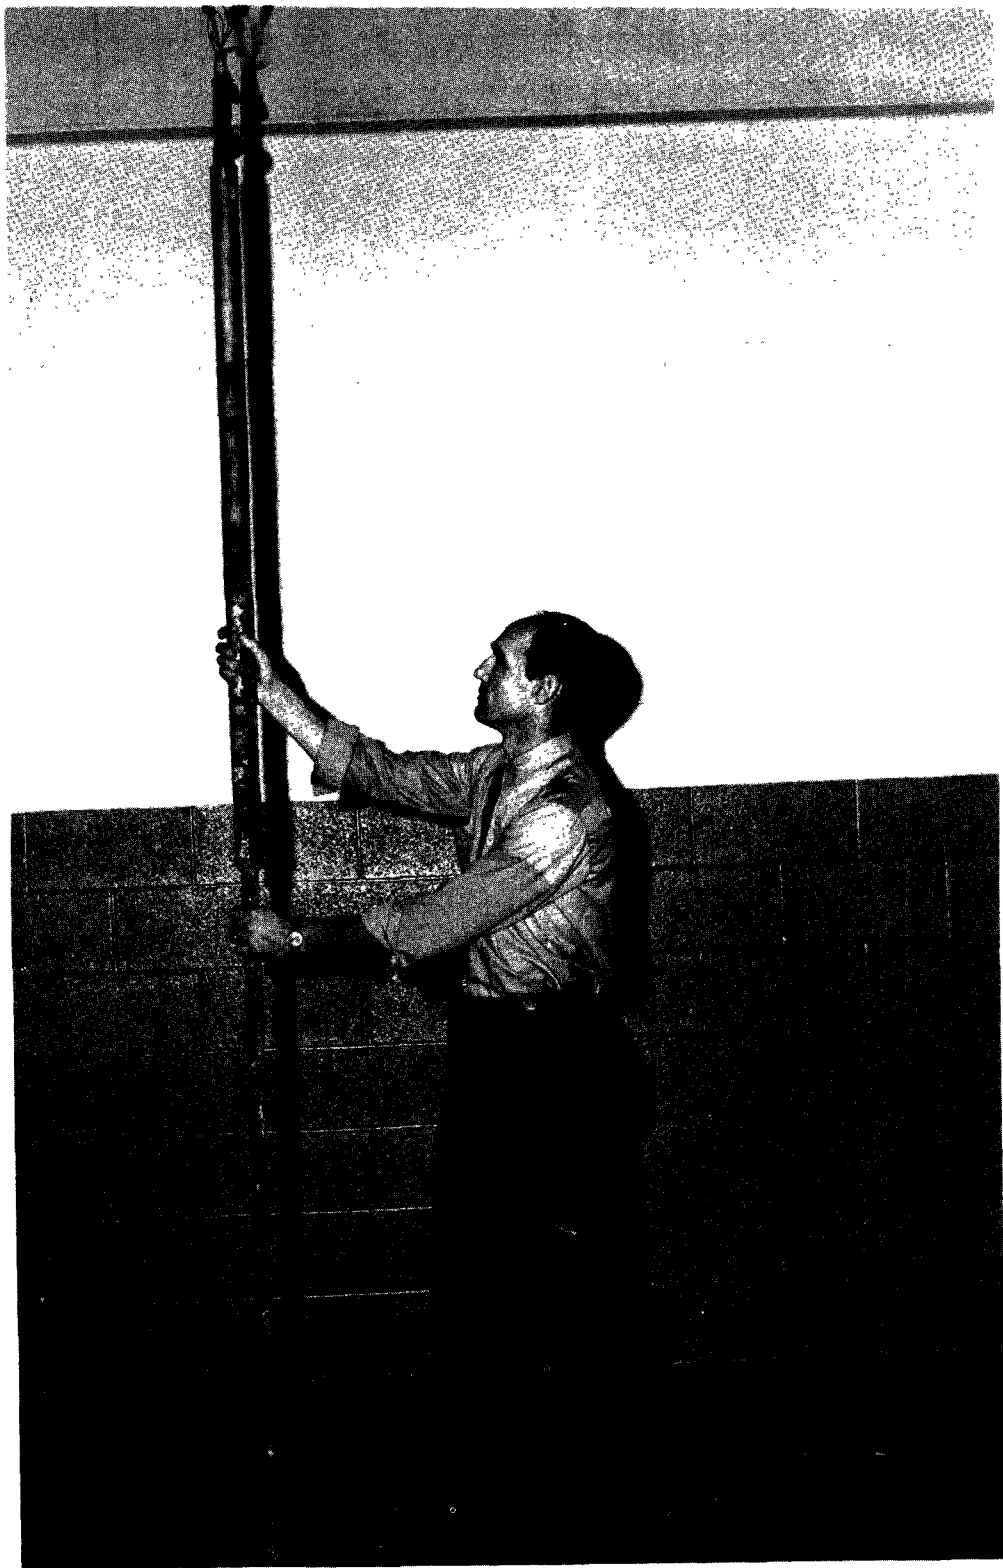
FIGURE 1. CORROSION PROBE AFTER REMOVAL OF DEPOSIT
Cold end at top. Specimens begin just above the left
hand of the operator and extend downward.

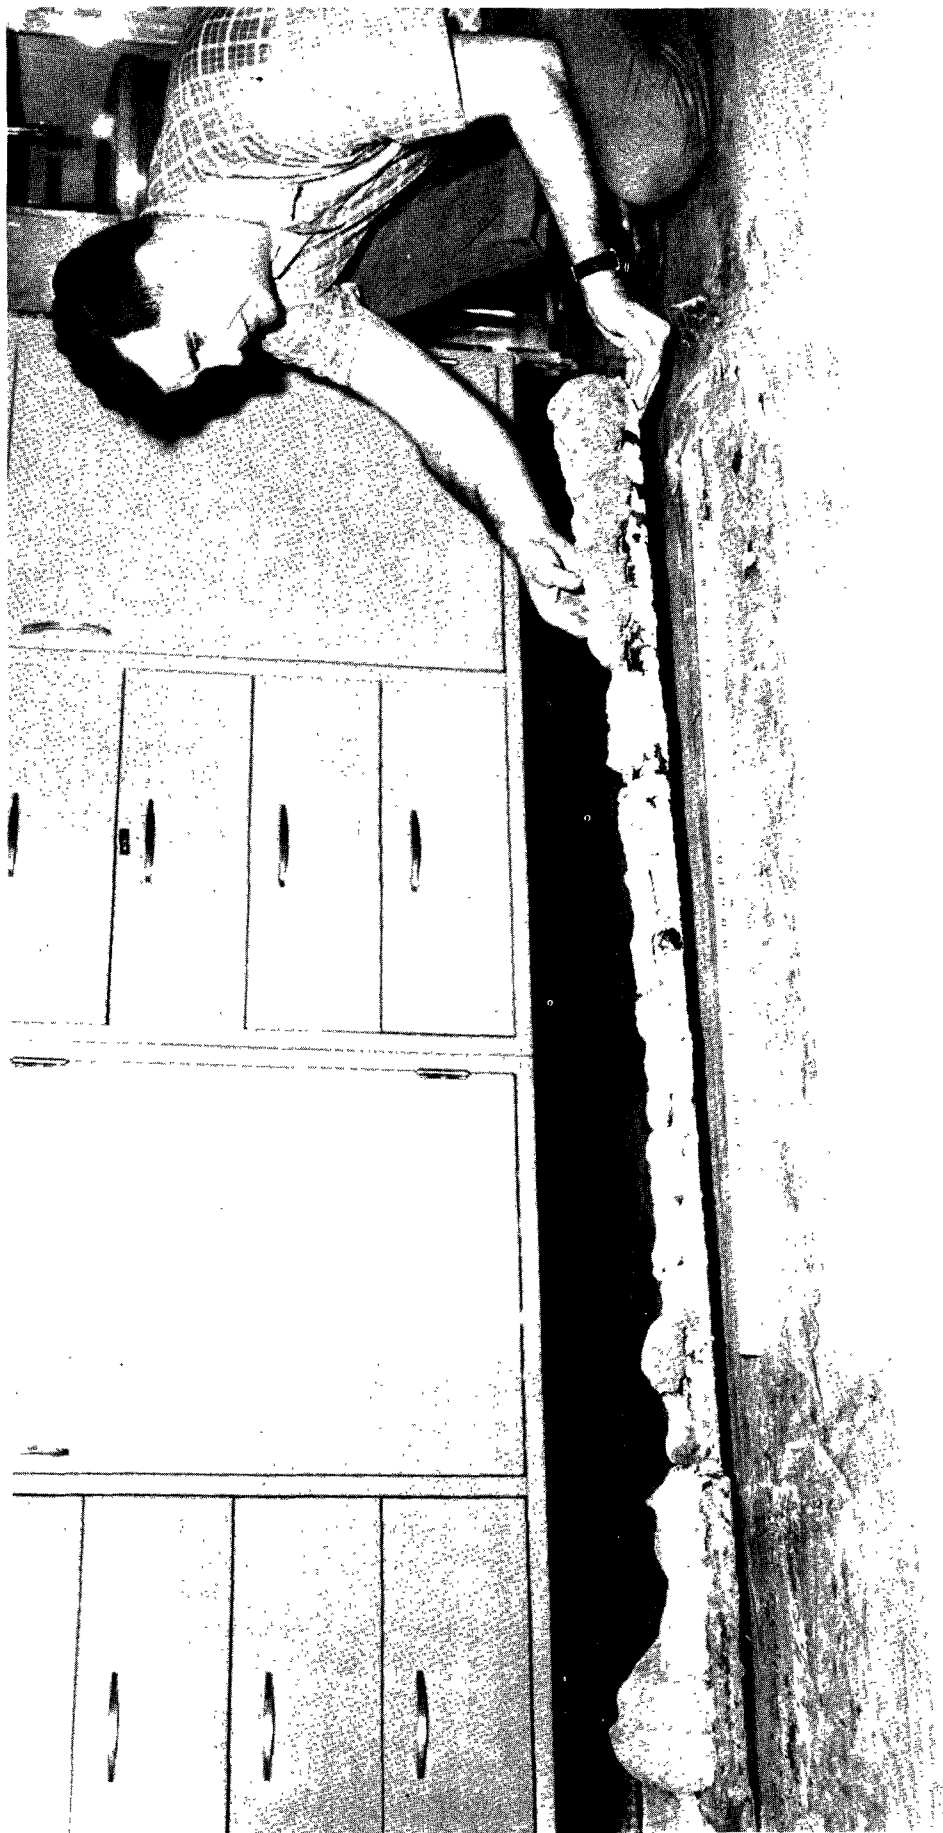
FIGURE 6. PROBE 9 FROM INCINERATOR AT MIAMI COUNTY SHOWING DEPOSIT

The water-cooled section of the probe is to the left in the photograph.

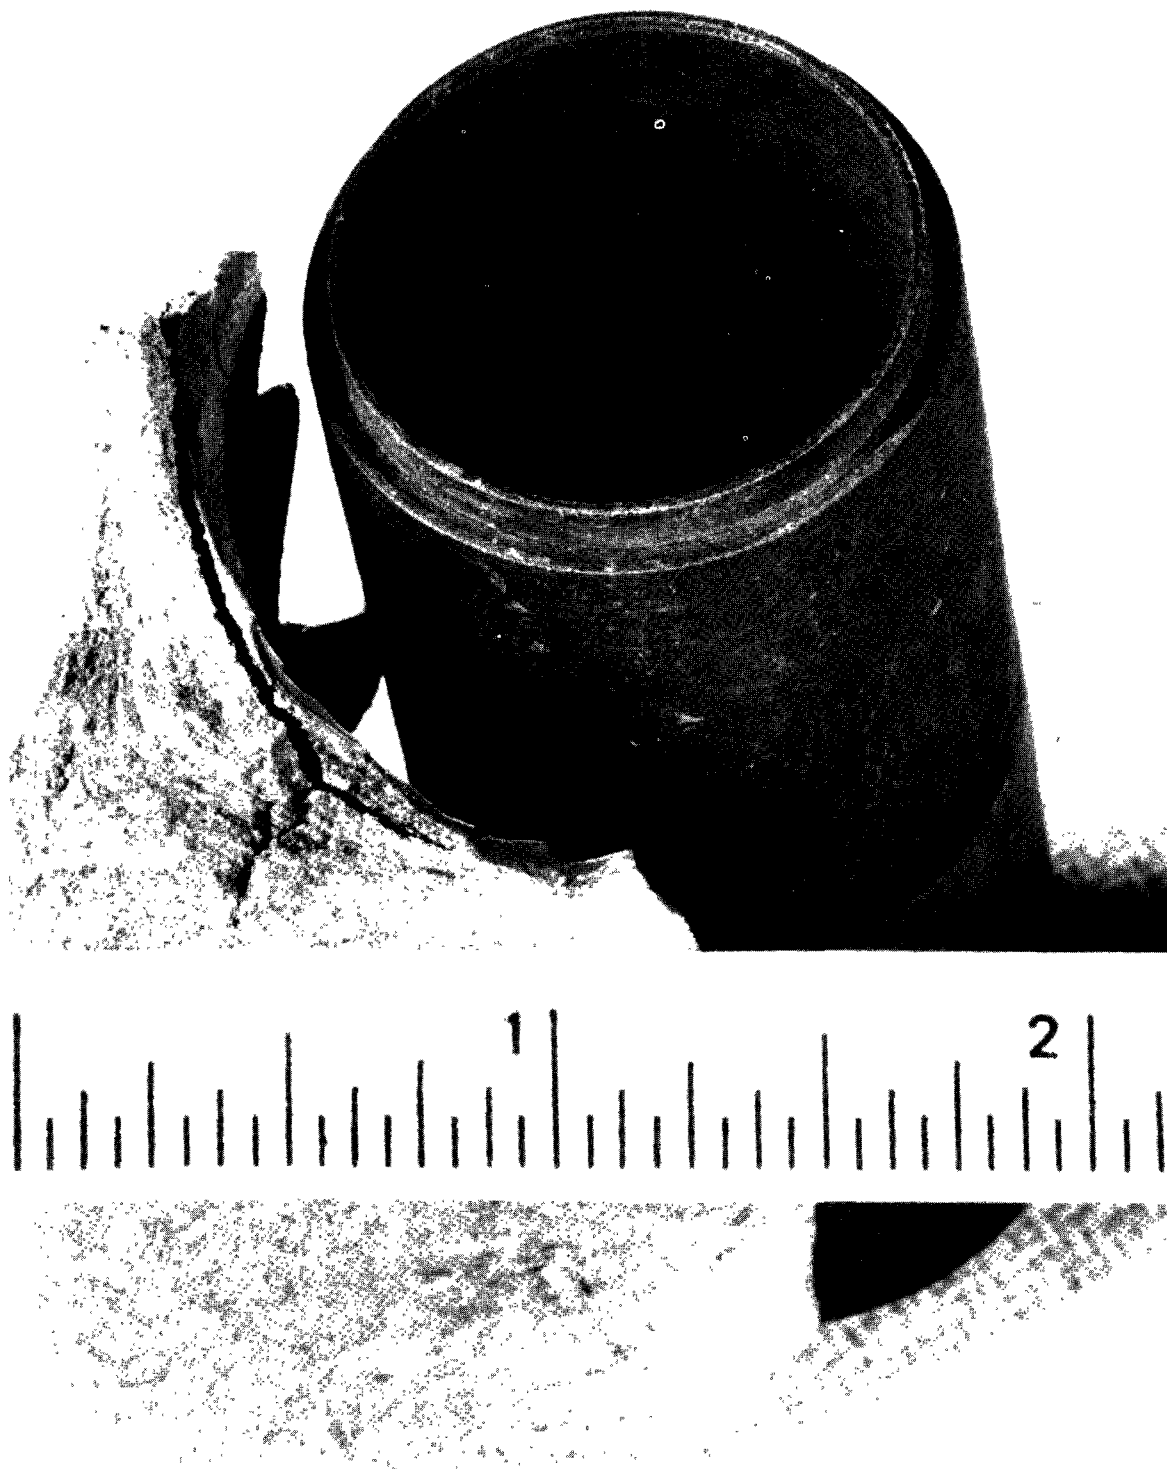
FIGURE 7. DEPOSIT AND SCALE AS REMOVED FROM SPECIMENS 16 AND 17 OF PROBE 4
The metal-tube specimens shown have been descaled.

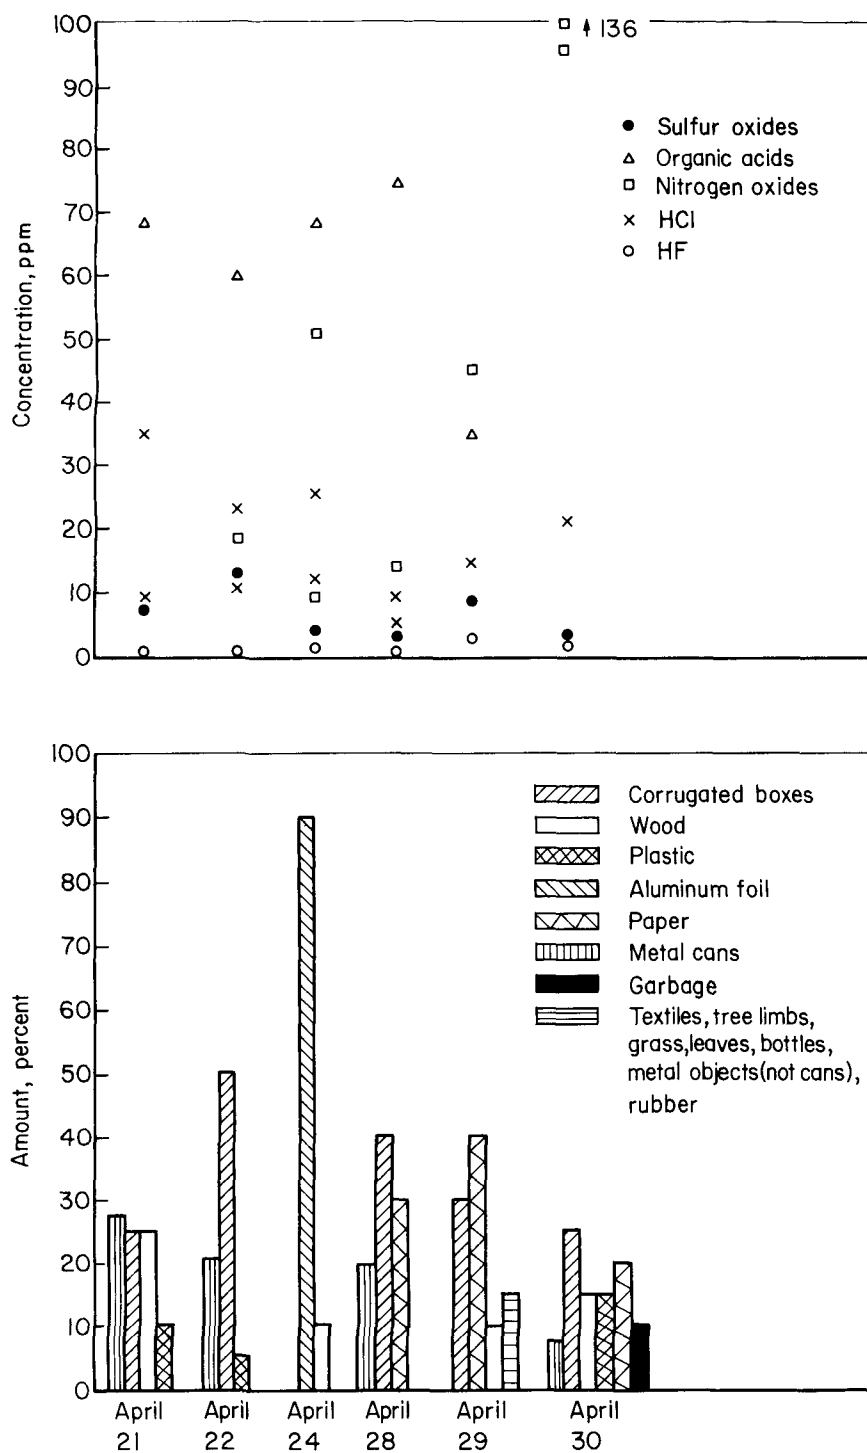
FIGURE 13. COMPARISON OF FURNACE-GAS COMPOSITION AND SOLID WASTE AT MIAMI COUNTY INCINERATOR

Materials in quantities of less than 5 percent are not included on the bar graphs, so the totals for each day are slightly less than 100 percent.

- (1) Organic acids were the predominant component on four of the days; on these days, corrugated boxes, paper products, or wood were present in large amounts.
- (2) The amount of HCl found was significantly below the 100 ppm level which was observed on several other occasions. The presence of 5 to 10 percent of plastics in the waste did not cause any large increase in HCl concentration. The type of plastic being burned was not identifiable, however.
- (3) The very small amount of HF detected on these days agrees with that found on other occasions, and probably is typical.
- (4) The large amount of nitrogen oxides observed on the last day may be related to the fact that this was the only day on which garbage was present in a notable amount.

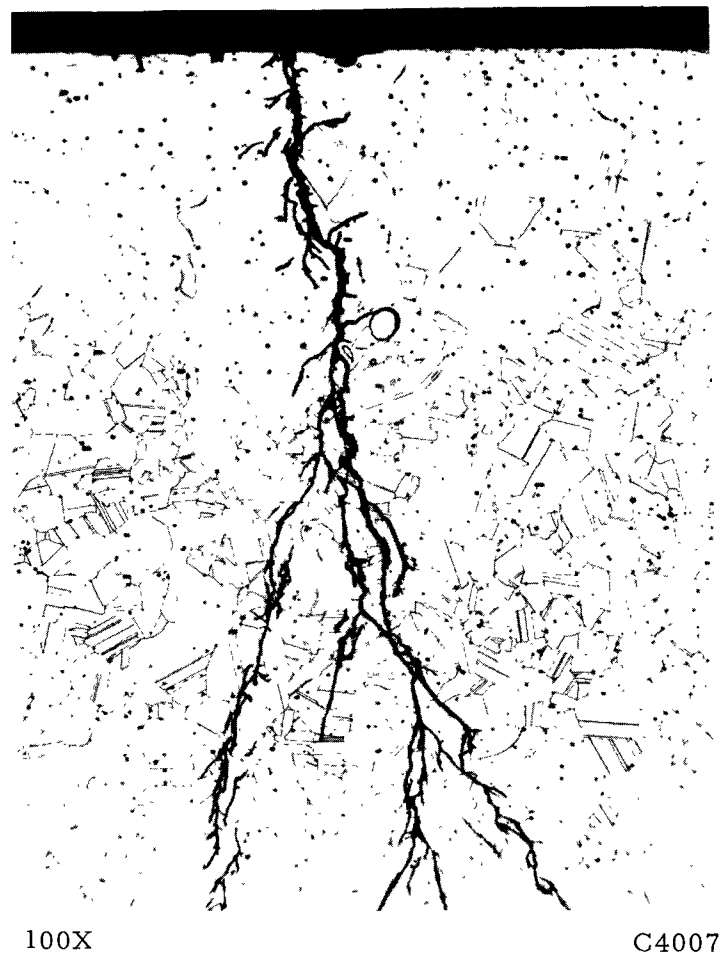
FIGURE 21. STRESS CORROSION CRACK IN C-RING OF TYPE 310 STAINLESS STEEL EXPOSED TO INCINERATOR DEPOSIT UNDER HUMID CONDITIONS

The cracking is largely transgranular.

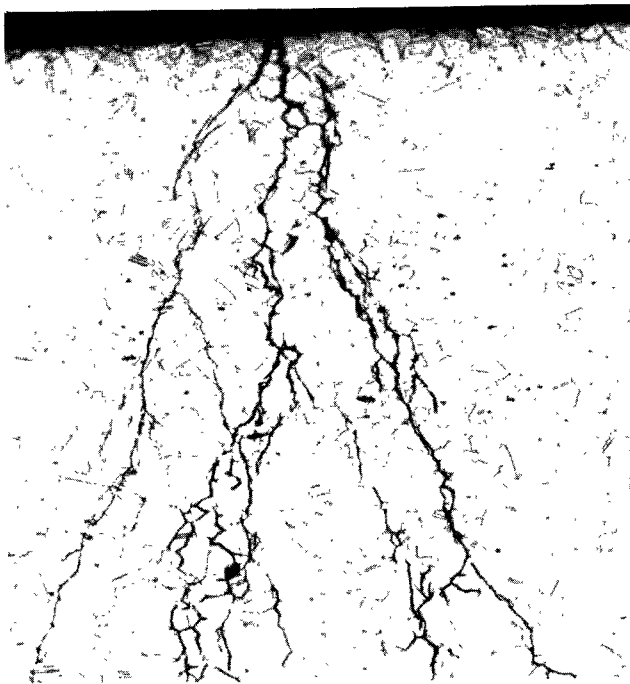
7X C-3937
a. Sensitized 2-1/2 Hours at 1200 F

7X C-3938
b. Unsensitized

100X C-3939
c. Photomicrograph of Sensitized Specimen

100X C-3940
d. Photomicrograph of Unsensitized Specimen

FIGURE 22. STRESS-CORROSION CRACKS RESULTING FROM EXPOSURE OF STRESSED TYPE 304 STAINLESS STEEL TO MOIST INCINERATOR DEPOSIT AT 170 F
