# **Impregnation of Concrete Pipe**

# IMPREGNATION OF CONCRETE PIPE

Southwest Research Institute  
8500 Culebra Road  
San Antonio, Texas 78228

Program 11024 EQE  
Contract #14-12-835  
June 1971

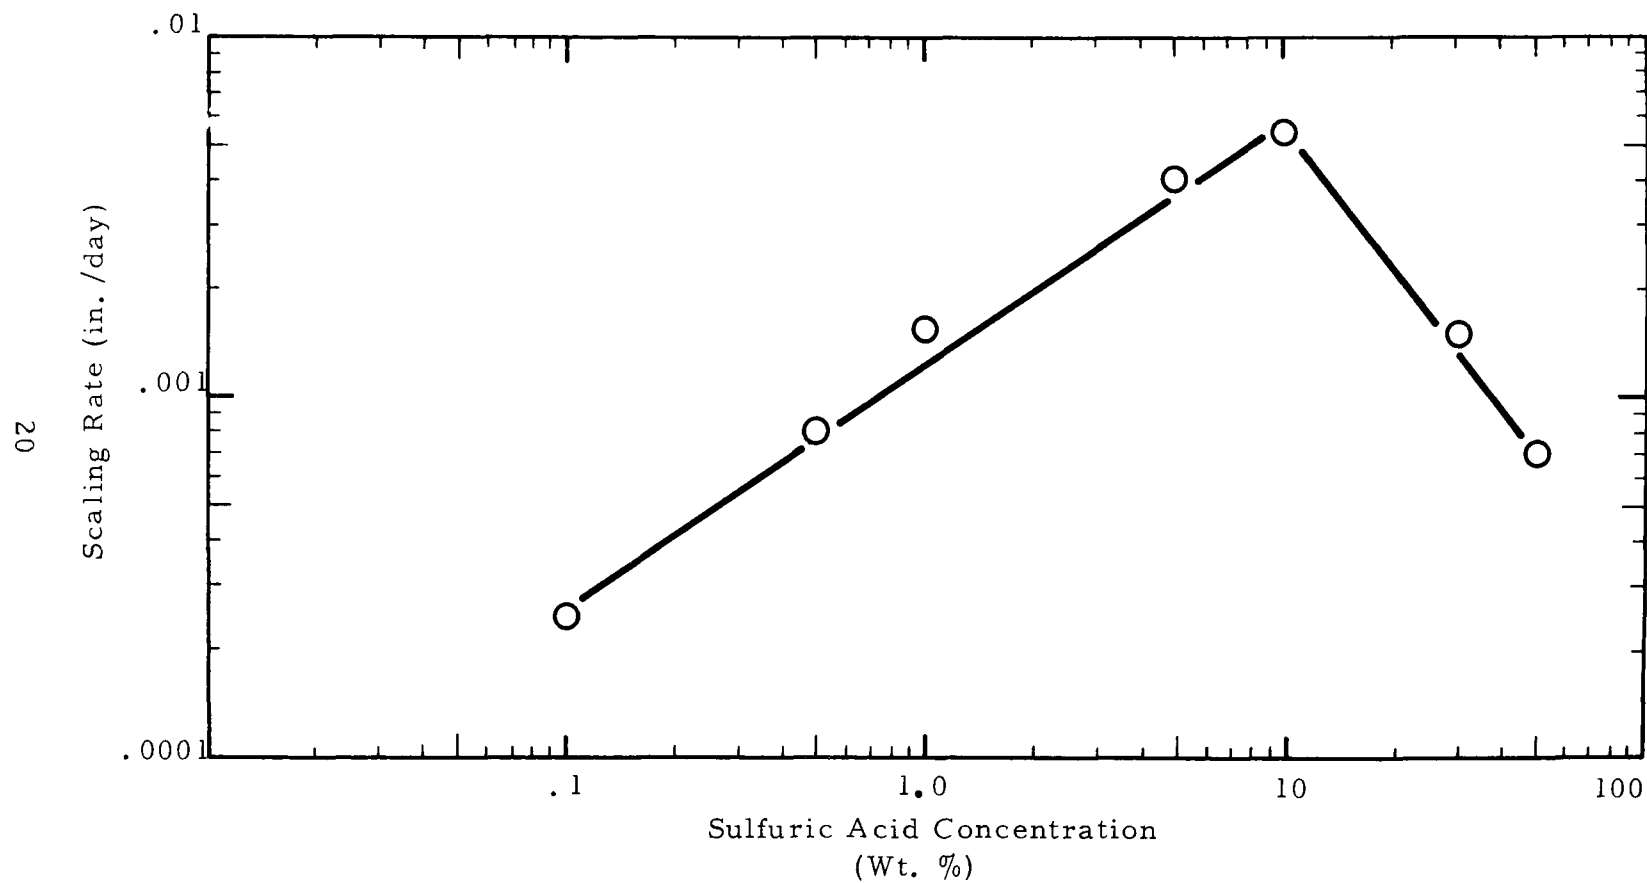
Figure 6. Scaling of Concrete Pipe as a Function of Sulfuric Acid Concentration

Scaling rate as used throughout this report to determine corrosion rate, is a measure of the erosion of the concrete pipe wall reported as in. /day. Laboratory experiments were conducted wherein different acid concentrations were evaluated for a 3-day exposure period. Figure 6 plots the scaling rate versus sulfuric acid concentrations and shows a maximum rate of approximately 10% concentration of sulfuric acid. Although the 98% sulfuric acid attacked the limestone aggregate, it did not attack the mortar. The 0.5, 1, 10, 30, and 50% solutions preferentially attacked the mortar, whereas the 0.1% sulfuric acid attacked both the limestone aggregate and mortar at about the same rate.
