EPA-460/3-75-003-a April 1975

FTP/SHORT CYCLE CORRELATION TESTING FOR 207 (b) IMPLEMENTATION CATALYST EQUIPPED VEHICLES VOLUME 1

Olson Laboratories, Inc. 42l East Cerritos Avenue Anaheim, California 92805

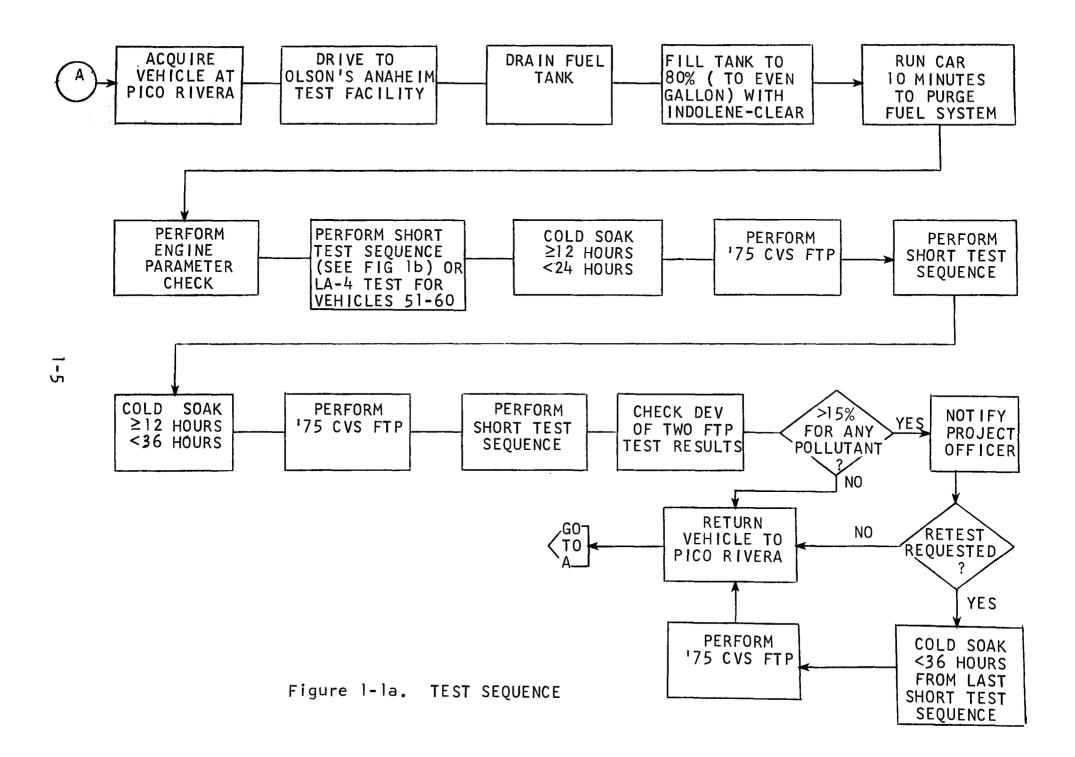
Figure 1-1b. TEST SEQUENCE - SHORT

The short test sequence consists of the following tests and soak periods in the order shown (also see Figure 1b):

- 1) Soak 6 minutes
- 2) Clayton Key Mode (Idle in drive)
- 3) Soak 6 minutes
- 4) Federal Three-Mode (Idle in neutral)
- 5) High-Speed Unloaded Test (2500 rpm)

- 6) Soak 6 minutes
- 7) Federal Short-Cycle
- 8) Soak 6 minutes
- 9) New Jersey/New York Composite Cycle
- 10) Defect Test for specific vehicles during final short test sequence

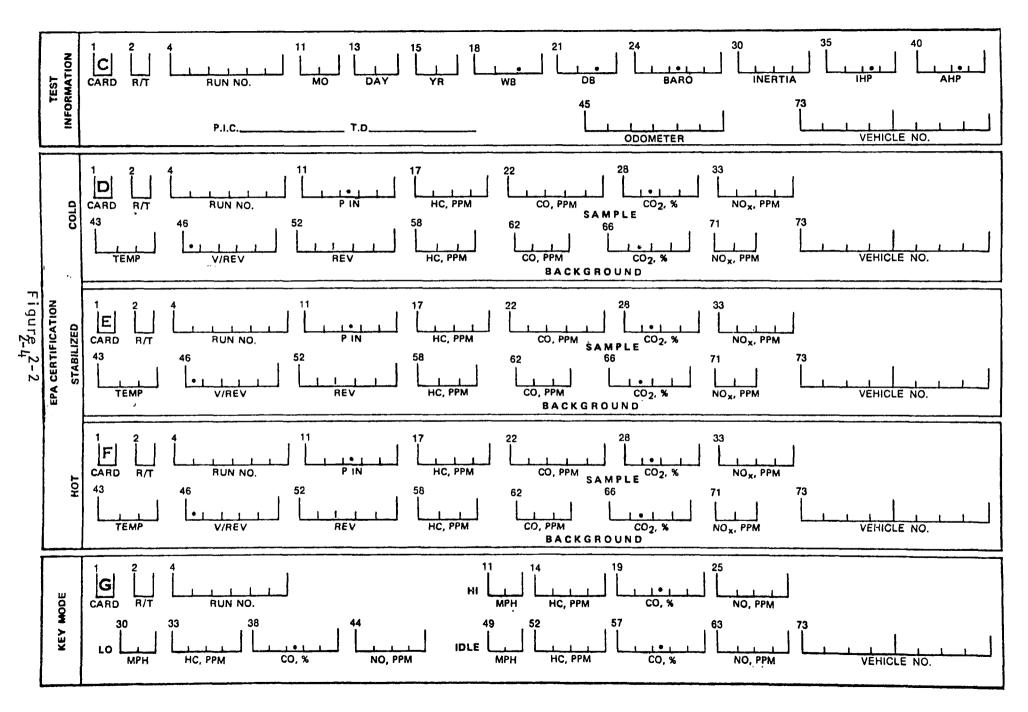
Exhaust emission test results include ambient temperature, barometric pressure, humidity, mass emissions in each bag from the FTP and each CVS sampled short test, and concentration emissions from each mode for all other short tests. (See Figures 2-2 and 2-3.) NO_X is reported as NO₂ both as measured and corrected for relative humidity. The humidity correction factor was calculated from a method provided by EPA dated March 8, 1974.
