Control of Mine Drainage from Coal Mine Mineral Wastes

CONTROL OF MINE DRAINAGE
FROM COAL MINE MINERAL WASTES

PHASE II

POLLUTION ABATEMENT AND MONITORING

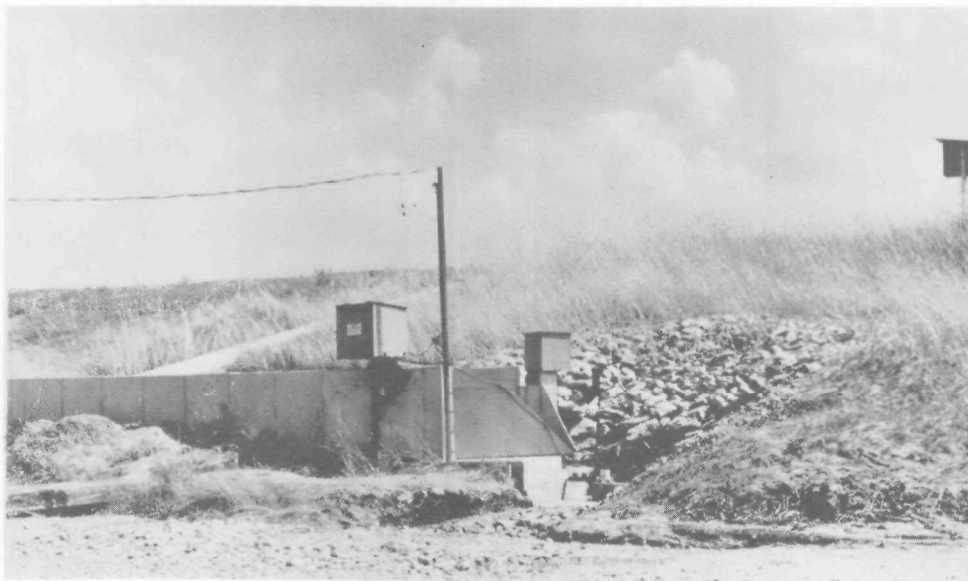
FIG. 2, MONITORING STATION AT FLOW POINT I

During the grading and covering of the refuse pile, a water quality monitoring system was included in the restoration program. A graded earthen peripheral ditch was constructed around the entire refuse pile to collect all the runoff and direct it to a single monitoring station at a point near Walker Creek. Monitoring systems were also constructed near each bowl or test plot to collect and direct the runoff from the test plot into the monitoring station. Each system included a concrete-paved ditch leading from the test plot and sloping downward into the monitoring station. Each monitoring station consisted of a concrete collection box, a stainless steel flume, stage recorder, and a recording conductivity meter (Figure 2). The objective was to provide an automated system for collecting runoff data to be used in evaluating the effectiveness of the abatement measures.

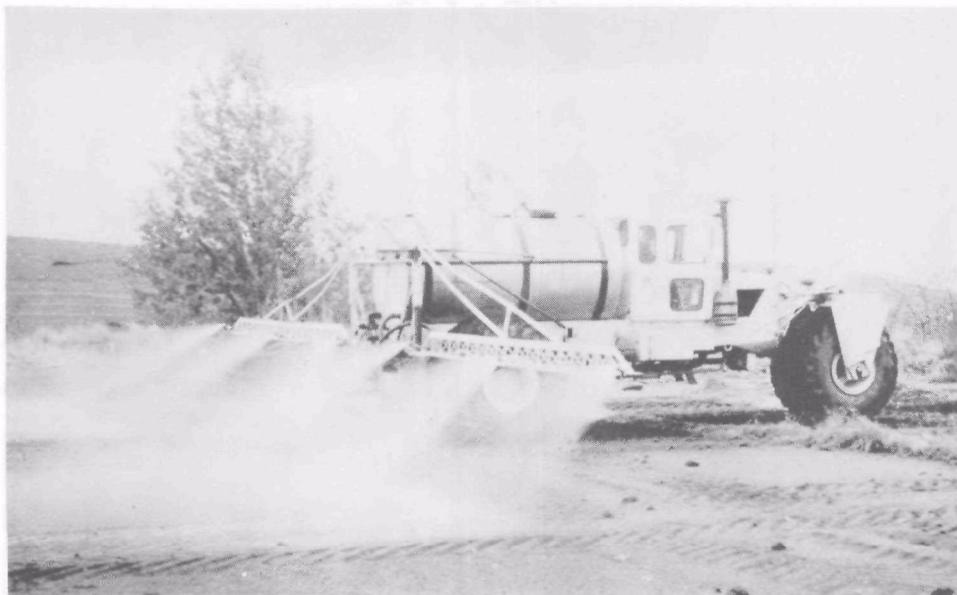
FIG. 4 TREATING SLURRY LAGOONS WITH COHEREX

The remainder of the slurry lagoons, occupying approximately 13 acres, was treated with a commercially available chemical stabilizer, "Coherex".* Test Plot 17, established during Phase I, provided encouraging data to justify a trial on a much larger scale. This material, a petroleum-based, non-toxic, emulsion-type liquid, was delivered to a siding near the project site in a railroad tank car. It was then transferred into small tank trucks and hauled to the site. Next, it was diluted by mixing with water, 1 part Coherex and 6 parts water, transferred into a smaller tank truck equipped with spray bars and applied to the surface at a rate of approximately 5,000 gallons of mixture per acre. The tank truck was equipped with oversized tires in order to traverse the slurry lagoon area. Its normal function was to apply liquid fertilizer on low, swampy farmlands (Figure 4).

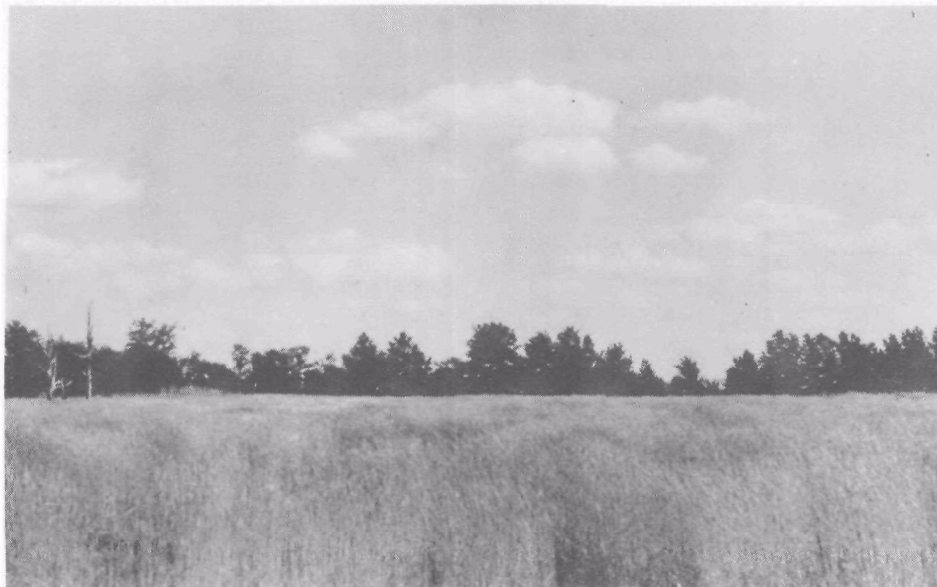
**FIG. 6 GRASS COVER ON SLURRY LAGOONS
NEW KATHLEEN MINE**

The slurry lagoons were treated somewhat differently. Soil testing of the slurry lagoon material and Test Plot 16, established during Phase I, indicated the possibility of establishing a grass cover directly on the slurry lagoons without the addition of any earth cover. Accordingly, approximately 19 acres were treated with agricultural limestone applied at a rate of 15 T/acre and disked in to a depth of 6 inches. This was followed by the application of 11-17-23 fertilizer at 800 lb/acre and lightly disked into the surface material. A grass mixture consisting of 15% perennial rye, 30% Kentucky fescue, 15% Reed canary grass, 5% Ladino clover, and 35% Balboa rye was sowed over the area at 130 lb/acre. Straw mulch applied at 1½ T/acre completed this operation.

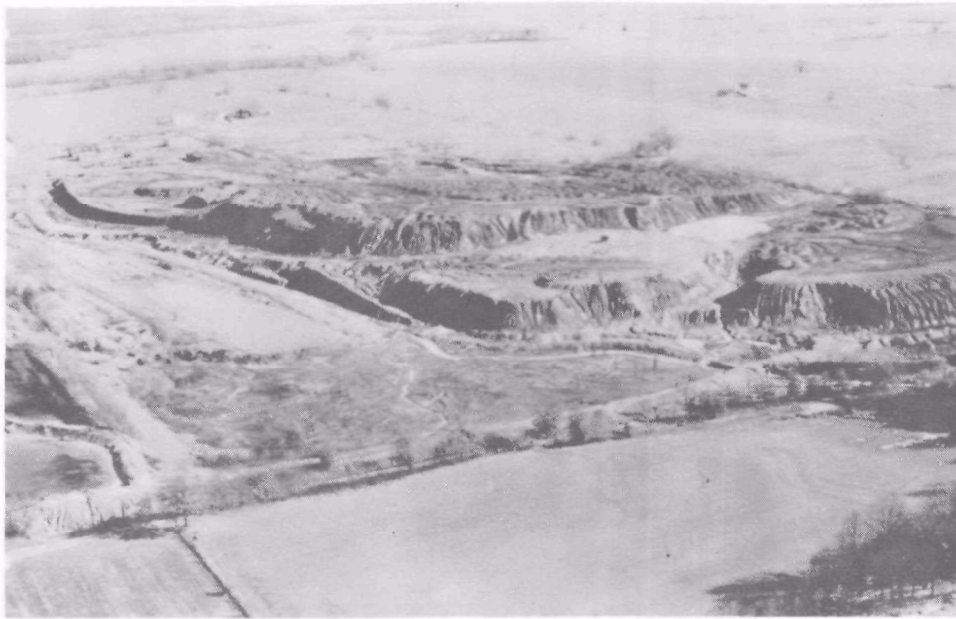
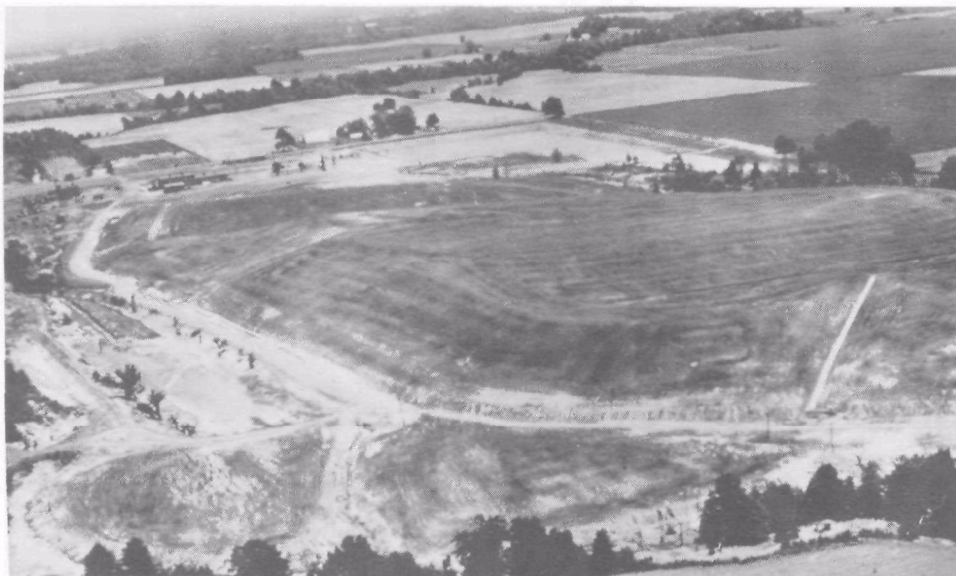
Figure 7 and Figure 8 are aerial photographs of the New Kathleen Mine site showing the refuse pile before and after restoration.

**FIG. 7 REFUSE PILE – BEFORE RESTORATION
NEW KATHLEEN MINE – MAY, 1969**

**FIG. 8 REFUSE PILE – AFTER RESTORATION
NEW KATHLEEN MINE – MAY, 1972**

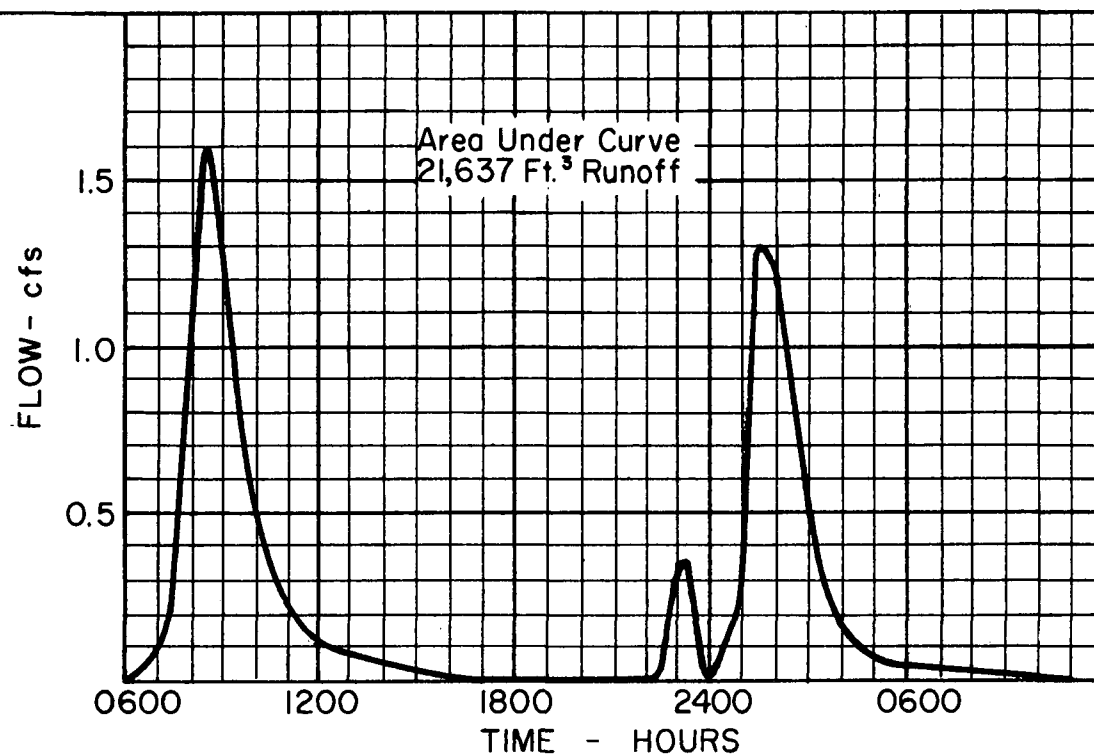
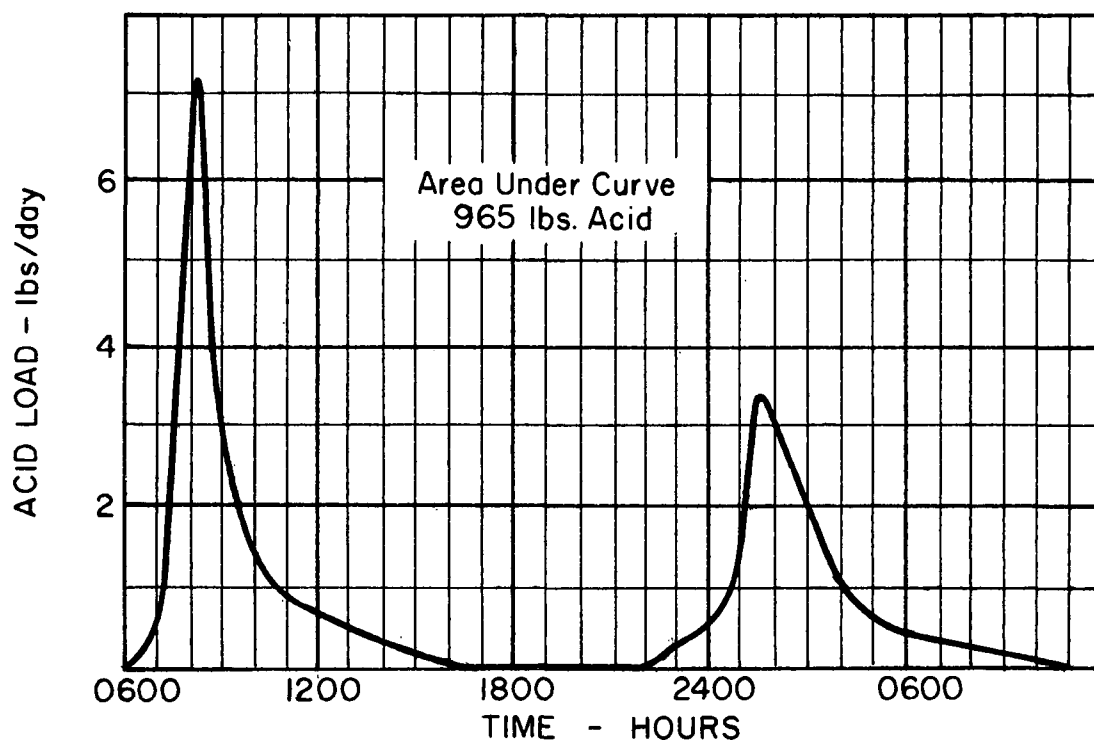
FIG. 10 HYDROGRAPHS, MAR. 1-2, 1972, FLOW POINT 4

A total of eight storms were monitored at Flow Point 4 and the data condensed and compiled in a similar manner. A summation technique was then used in estimating an average acid formation rate for the entire refuse pile. Table III, Acid Formation Rates from Flow Point 4, presents data for the individual storms together with the final calculation used in making the estimate

FIG. 10A RUNOFF VOLUME

FIG. 10B ACID LOAD
