EPA-R2-72-007

Aerial Surveillance Spill Prevention System

AERIAL SURVEILLANCE SPILL PREVENTION SYSTEM

Contract No. 68-01-0140
Project 15080 HOK

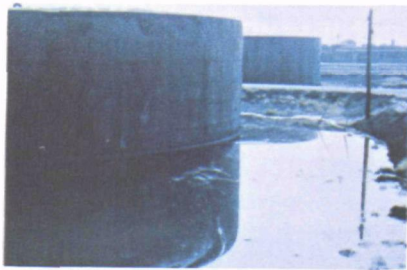
a) Ground truth photograph

Multiband flights were flown over a bulk storage area for asphalt and residual fuel oil. Asphalt and residual fuel oil storage can be identified by black, sealed-roofed, round tanks. A ground truth photograph of such a tank obtained on an initial ground truth mission is shown in Fig. 3a. Figure 3b is a 70 mm aerial color photograph of the asphalt bulk storage area. This area is also located approximately one mile from the major waterway and does not directly represent a potential or real threat. The value of the multiband flights in this area was in the positive identification of asphalt spills through contrast enhancement. These results can be applied to other areas adjacent to an inland waterway in order to determine whether an undefined spill, and thus the spill source, constitutes a real or potential threat.

Figure 3 Asphalt bulk storage area

Positive ground asphalt spills are noted in areas A, B and C. Ground truth teams had identified a leaky asphalt tank in this area. Figures 3c to 3f are photographs of the bulk storage area recorded with film/filter combinations 2403/32, 2403/35, 2424/35, and 2424/99, respectively. There appears to be little difference between the use of filter 32 and filter 35 with either film type 2403 or type 2424. A look at the spectral responses of these filters shows that filter 32 passes more of the visible spectrum (300 to 520 nm) than filter 35 (320 to 460 nm). Since oil and asphalt have a strong reflectance in the ultraviolet and blue spectral regions, the asphalt imagery obtained with filter 32 is expected to be slightly darker than that obtained with filter 35 as evidenced in Figs. 3c and 3d. A comparison of Figs. 3d and 3e reveals that better asphalt-to-background contrast is achieved with film/filter combination 2424/35 than with 2403/35. This is due to the near-infrared (700 to 850 nm) background return recorded by film type 2424.

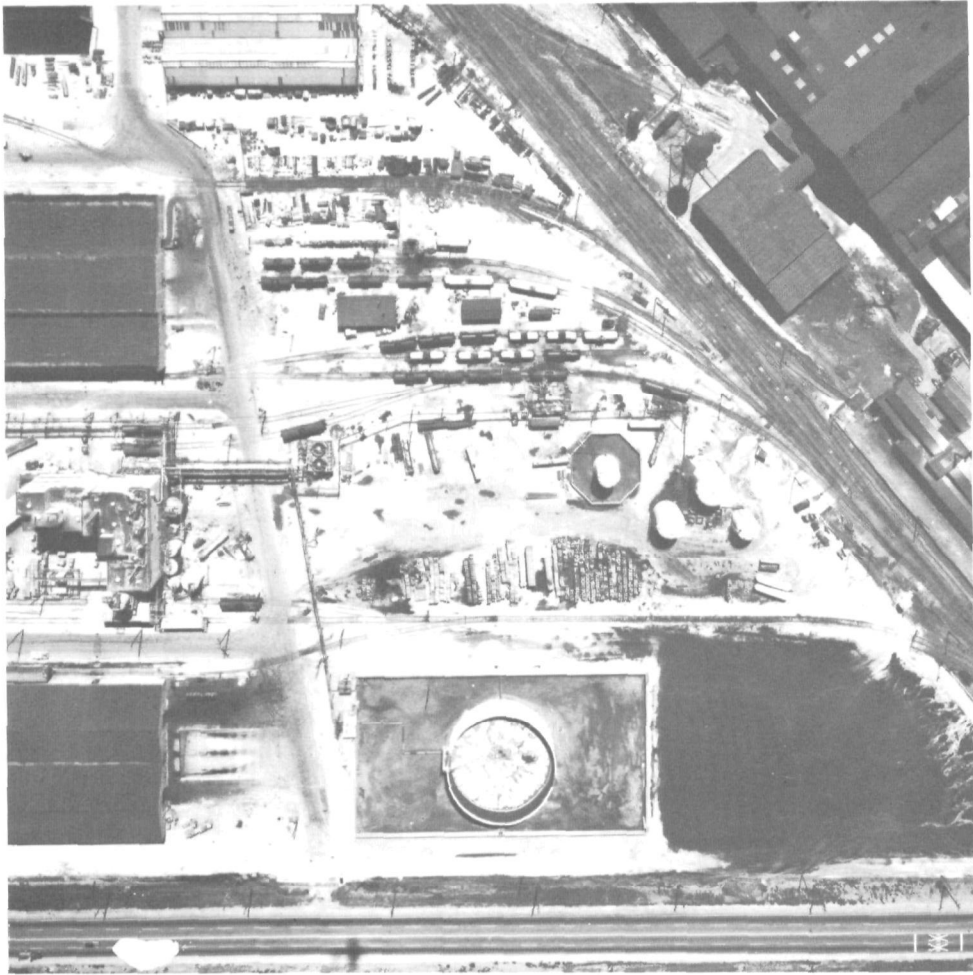
Figure 6 Baseline imagery of chemical plant tank storage

The part of a chemical plant shown in Fig. 6 is a storage area dominated by the benzene storage tank. The floating top tank is approximately 105 ft in diameter and 30 ft high. In this photograph, the floating tank top has descended approximately half way down the tank. The tank volume is estimated at 52,000 bbls. The tank is surrounded by an 8 ft high cement dike enclosing an area 286 ft long and 153 ft wide. The area is clean and well tended although there was evidence of a liquid, which could be water, on the ground. One major and one minor pipeline are connected to the tank and run above ground.

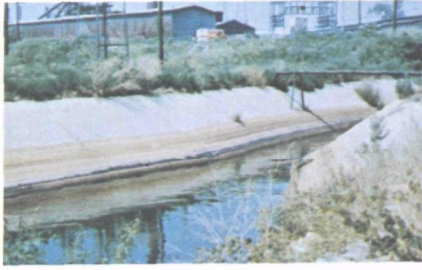
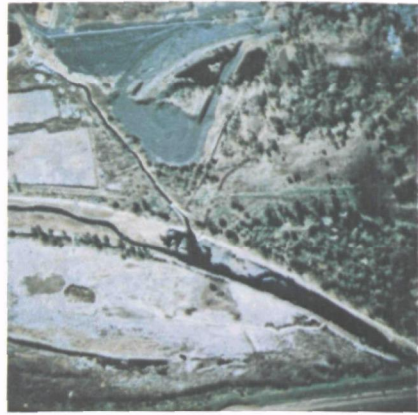
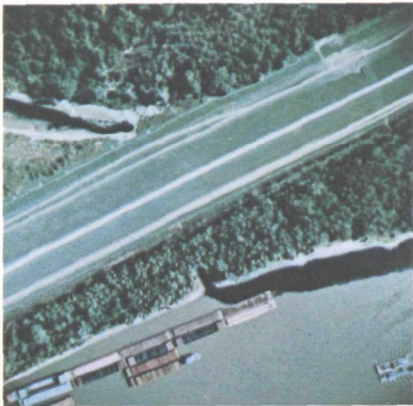
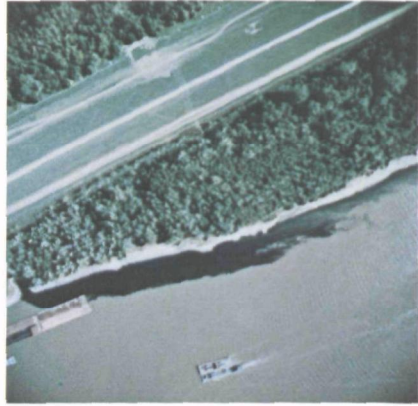
Figure 8 Steel mill and adjacent industrial waste drainage

before it reaches the river levee is shown in Fig. 8b. Figure 8c is an aerial color image of the effluent passing under the levee, and Fig. 8d shows the dissipation of the waste in the river.

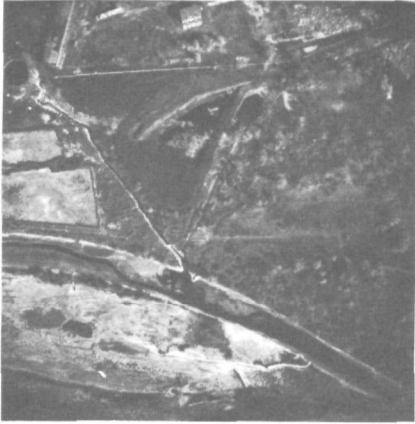
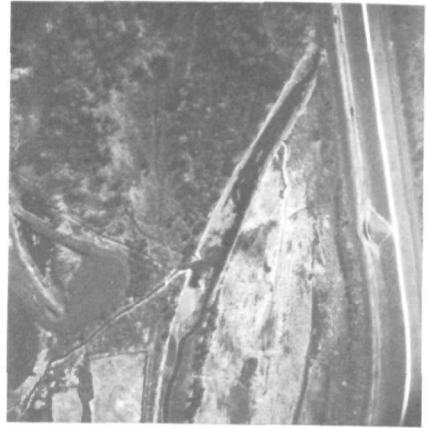
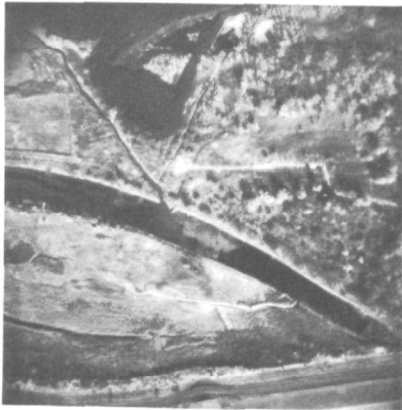
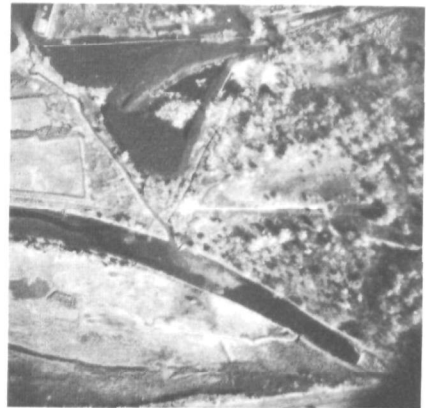
Figure 10 Steel mill and adjacent industrial waste drainage

spectral regions, results in reduced image waste background contrast but increases the detail. Film/filter combination 2424/99 gives better contrast of the drainage area to the background than film/filter combination 2403/99 because it records more near-infrared radiation reflected from the ground and vegetation. However, in the detection of oil in water, the near-infrared absorption of water reduces the oil water contrast.

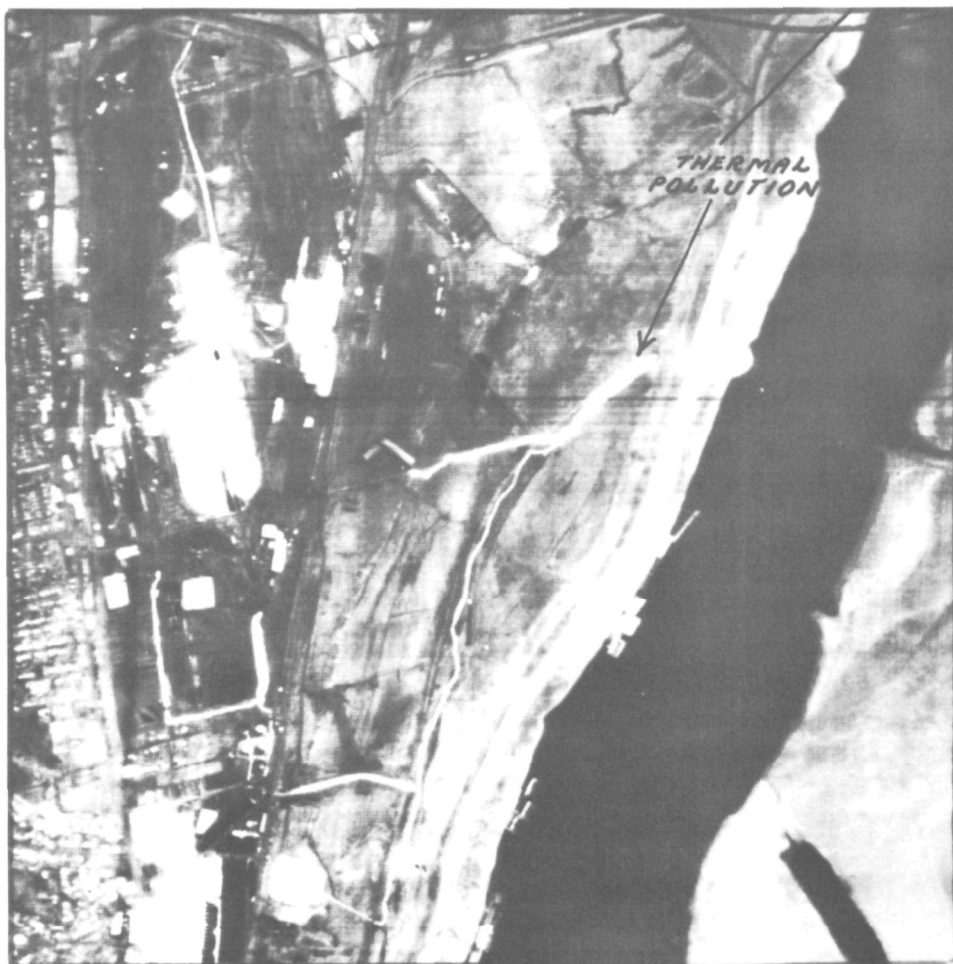
Figure 11 Thermal infrared image of steel mill and adjacent industrial waste drainage

Figure 11 is a thermal infrared image of the drainage pattern observed near the steel mill discussed above. The drainage creek is shown as a white area, indicating that its temperature is higher than the background. A temperature increase could be the result of the temperature at which the waste is discharged from the industrial area, or of the absorption and reradiation properties of the waste material. The value of thermal infrared imagery is the detection of pollutant materials warmer than their surroundings.

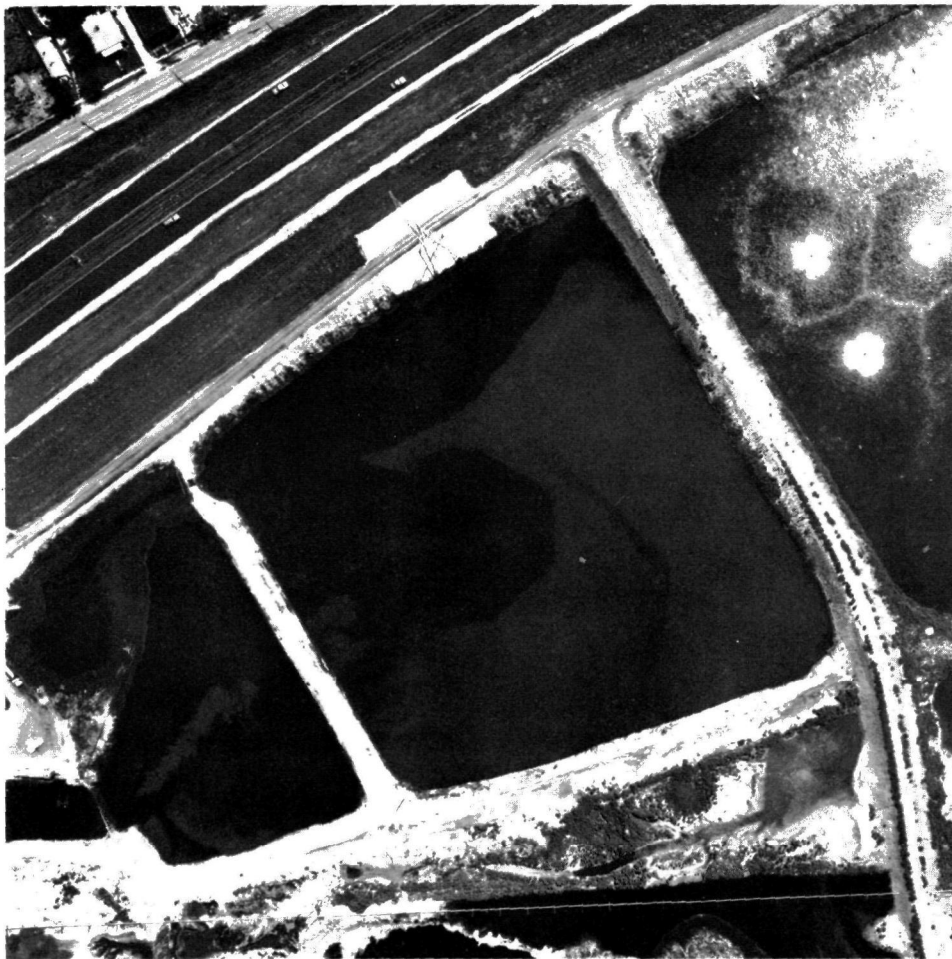
Figure 13 Baseline imagery of waste oxidation ponds

The oil detention pond area shown in Fig. 13 is part of a larger pond complex. The complete complex is on the river side of a levee. A flood control drain located north of these ponds reduces the potential threat of river contamination by these ponds during times of high water. The ponds themselves are enclosed by lesser dikes to ensure their separation. The dikes appear well maintained and have controlled flow from one pond to the next. The larger pond has an area of 6.8 acres but the depth is unknown.

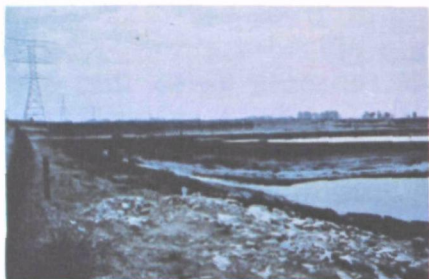
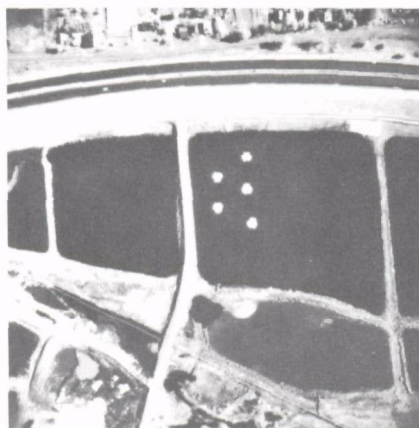
A ground truth photograph of the pond is shown in Fig. 14a. An aerial color photograph of this area covered during the multiband flights is shown in Fig. 14b. The five "starred" areas are the aerators. The oil waste initially pumped into the pond may be seen in the left-hand portion of the photograph labeled area A. The best film/filter combinations for identifying the oil in the ponds were found to be 2424/99, 2424/32, 2403/99, and 2403/35, as shown in Figs. 14c, 14d, 15a, and 15b, respectively. Similar results were obtained with filters 99 and 98 and with 32 and 35 with both film types 2403 and 2424. The maximum contrast of oil-water was obtained with film type 2403 because of the strong absorption of water in the near-infrared as recorded by film type 2424. Film type 2403 and filter 35 or 32 and 98 or 99 give the best oil-water contrast.

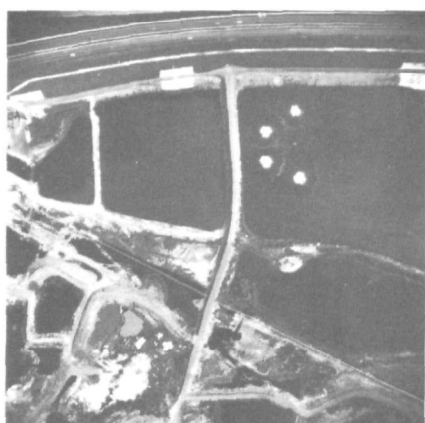
a) 2403/99

Figure 15 Waste oxidation ponds

The imagery of this pond recorded with film/filter combination 2403/18A is shown in Fig. 15c. Filter 18A transmits the ultraviolet radiation of the spectrum (300 to 400 nm). With this filter, some water penetration can be seen since flow patterns from one pond to the next could be seen. Since oil is strongly reflective in this spectral region, the observed striations are believed to be oil.

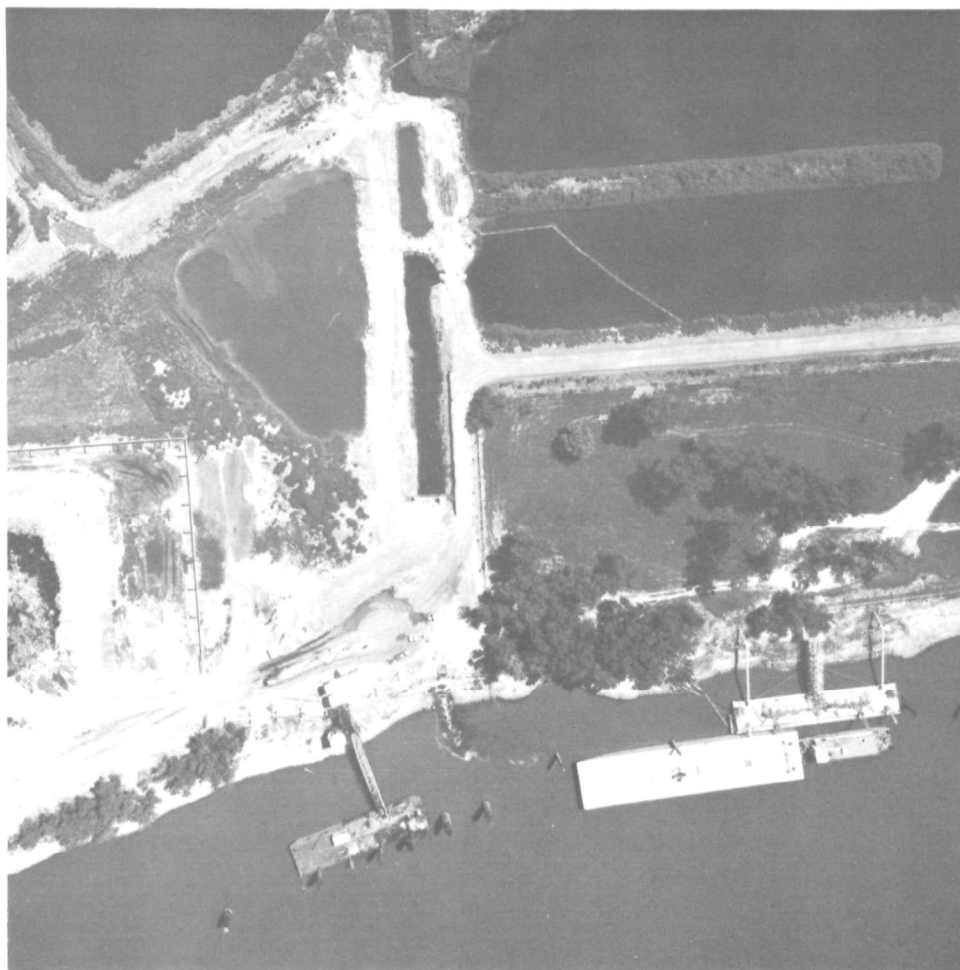
Figure 16 Baseline imagery of oil refinery effluent

The waste treatment ponds described in the last section eventually empty into the river and could represent a potential threat to the river. A baseline photograph of the effluent area is shown in Fig. 16. The drain, labeled A in the photograph, is approximately 28 ft wide and is controlled by a large gate valve. From this point it flows underground to the river. The river opening is approximately 15 ft wide and can be located by the plume of liquid being dumped into the river.

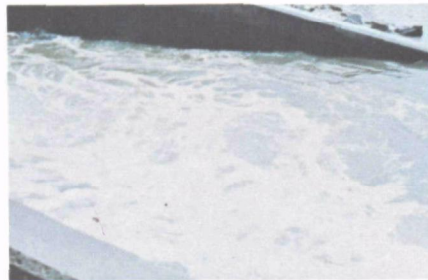
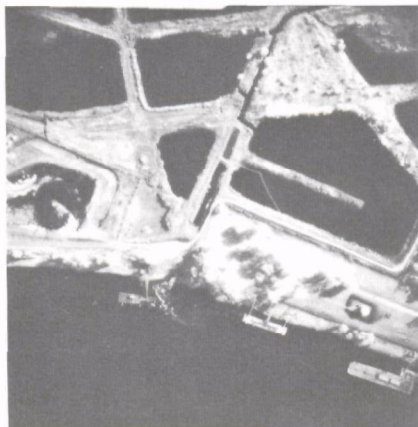
Figure 17 Oil refinery effluent

An aerial color photograph containing the oil refinery effluent (labeled A) is shown in Fig. 17a. A ground truth photograph of this effluent is shown in Fig. 17b. Ground truth teams reported no visible evidence of oil at this effluent. The white caps seen in both Figs. 17a and 17b are an unusual feature of this effluent which the oil industry has been unable to remove. Fish are known to gather at this effluent to feed.

Filters 18A, 47B, and 39 transmit blue and ultraviolet radiation which penetrates water surfaces. As pointed out in the last section, images recorded with these filters and both film types 2403 and 2424 revealed oil flow patterns in the lagoon. Figure 17c is the imagery of the oil pond effluent as recorded by film/filter combination 2424/47B. The 47B filter does allow some water penetration as the white foam can be seen dissipating in the river.

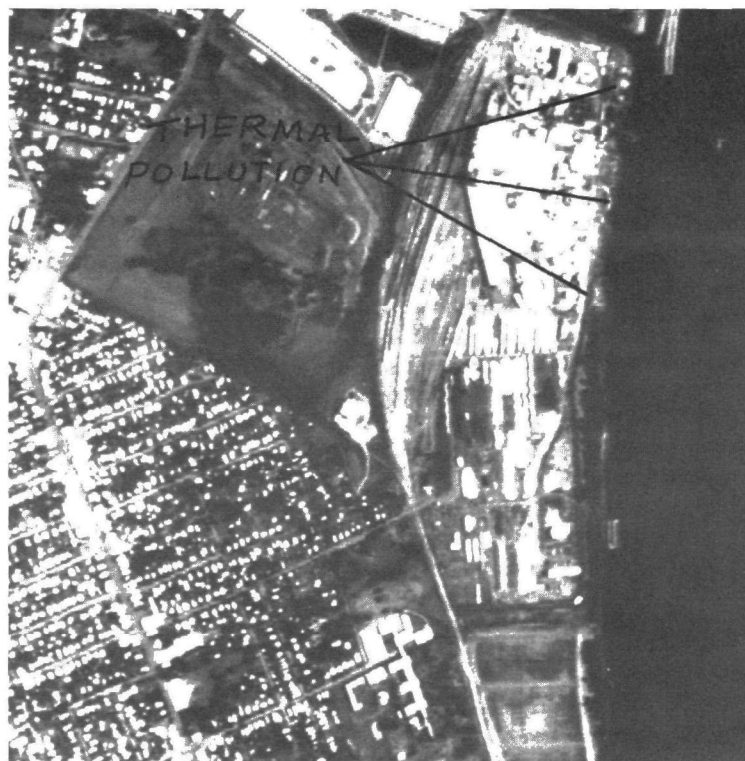
Figure 20 Thermal infrared image of titanium plant and effluents

Figure 20 is a thermal infrared image of the titanium plant and its effluents. Most of the plant processing areas appear very bright, indicating a temperature increase over the background. Some of the effluents also appear bright and represent a warm or hot effluent. From the ground truth missions, process cooling water is known to be emptied into the river and could constitute an infrared return. For this type of industry, the value of infrared photography over multiband or color photography is in identifying various processing facilities by their temperature signature and in identifying real thermal pollution threats to the inland waterway.

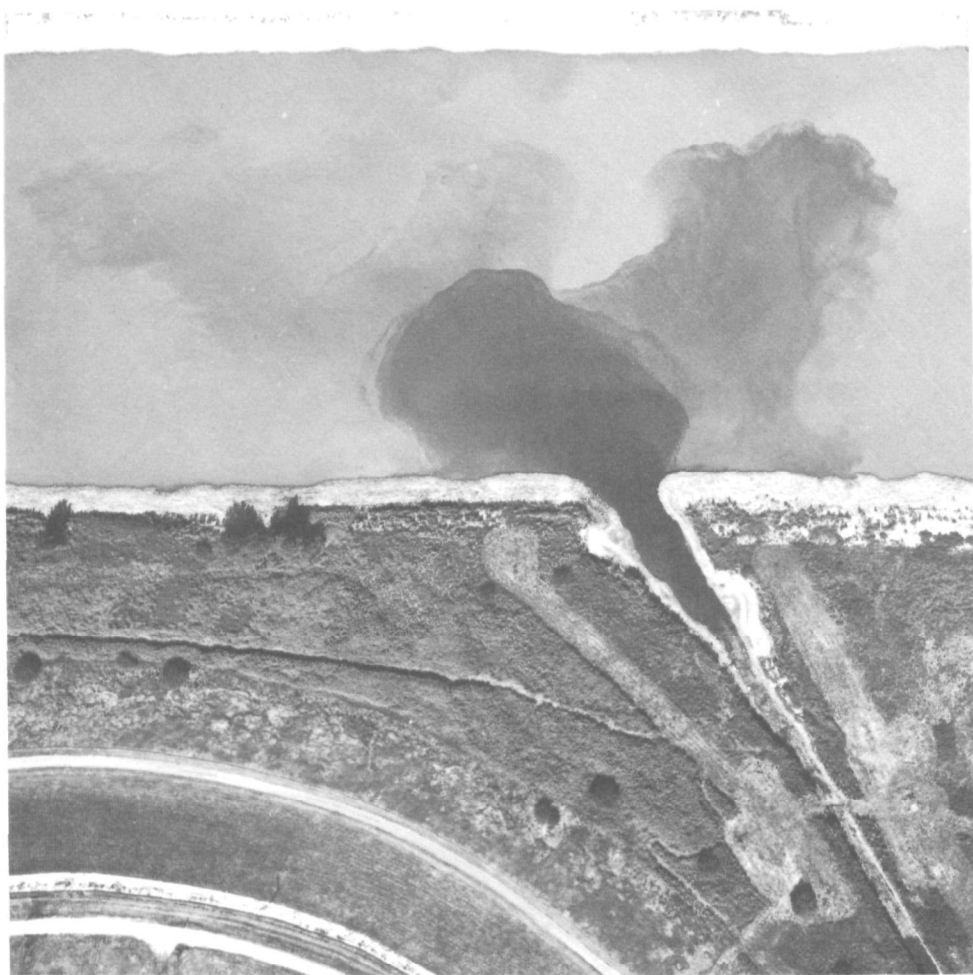
Figure 21 Baseline imagery of sewage plant effluent

The sewage discharge, confined between flood dikes to form a simple drainage pattern, is shown in Fig. 21. The drain is approximately 20 ft wide and dumps into a navigation canal 468 ft wide. The effluent from the sewage facility is very dark, indicating the presence of oil which could come from the various industries, including a steel mill, which drain directly into the sewage system. Figure 22 is an aerial color photograph of the sewage effluent. The best film/filter combination for detecting the effluent was found to be 2403/99, as shown in Fig. 22b. The use of this film/filter combination confirms the presence of a high percentage of oil. The film/filter combination suppresses the radiation reflected from oil and again emphasizes negative contrast enhancement. Figure 22c shows the imagery obtained with the film/filter combination 2424/99. The high absorption by water of near-infrared radiation reduces the sewage-water contrast drastically. When the imagery is compared with that obtained from the oil refinery, the observed contrast reduction is probably a result of near-infrared reflectance from materials

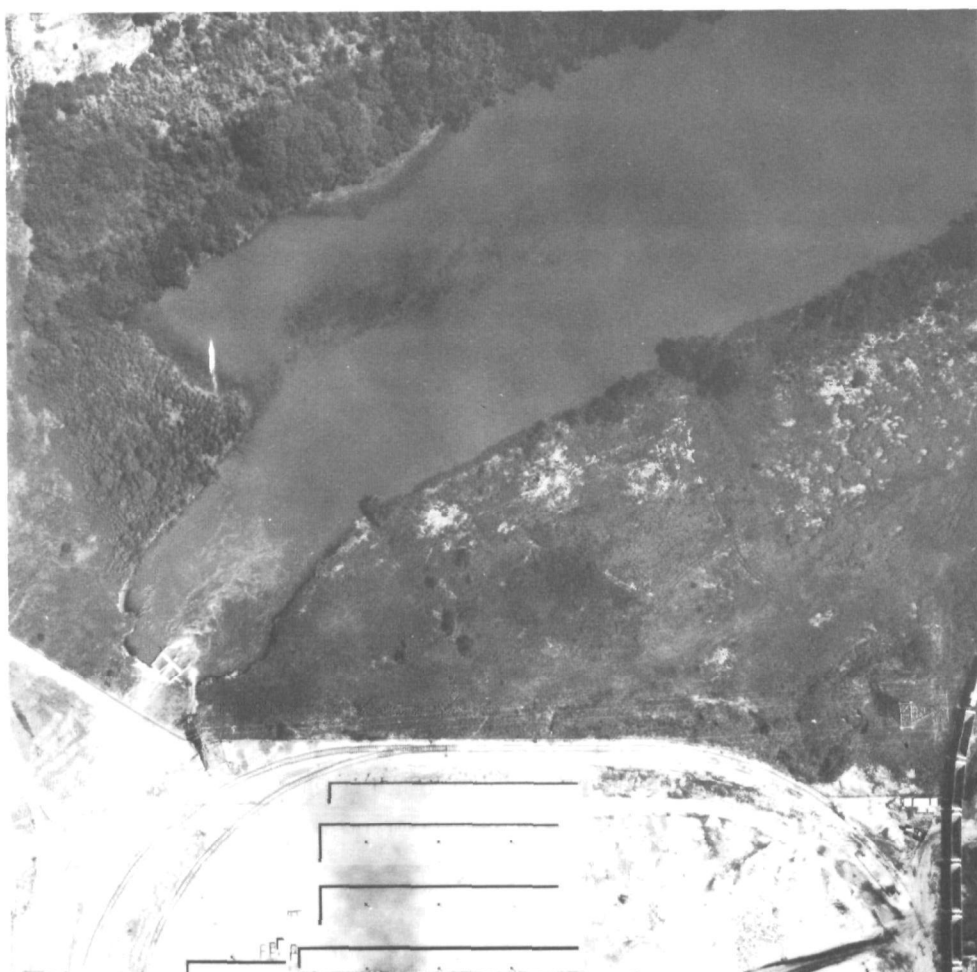
Figure 23 Baseline imagery of power plant effluent

The power plant pumps water from the river into the main plant to be used for cooling. The heated water plus the plant sewage constitute the power plant effluent. Hence the threat to the inland waterway is thermal pollution. The liquid discharge area of a power plant is shown in Fig. 23. The primary discharge is through two cement structures approximately 13 ft by 26 ft and equipped with gates. A secondary discharge is located to the lower right of the cement structures and comes from a cement pipe approximately 2 ft in diameter. The discharge contains raw sewage and drainage from within the plant itself.

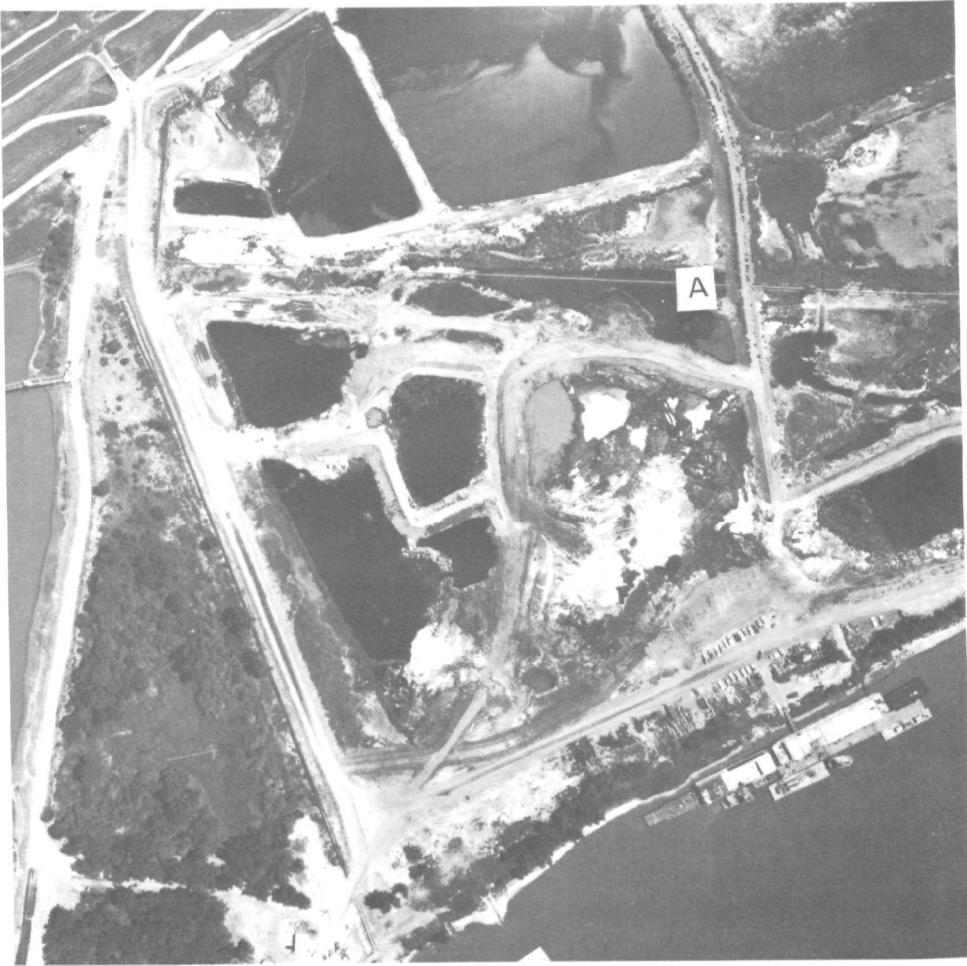
Figure 28 Baseline imagery of oil refinery waste area

The oil waste area labeled B in the aerial color photograph will now be discussed. On both film types 2424 and 2403, the imagery obtained with filters 35 and 99 have approximately the same contrast. This indicates that the ultraviolet, blue, and red radiation reflected from this area is negligible. Note, however, that the imagery of area B recorded on film type 2424 is lighter than that recorded on film type 2403. It can be concluded that area B reflects strongly in the near-infrared. Note that these spectral characteristics are different than those of area A. From these multiband photographs, the various waste materials can be separated and identified. From a ground truth mission it was learned that

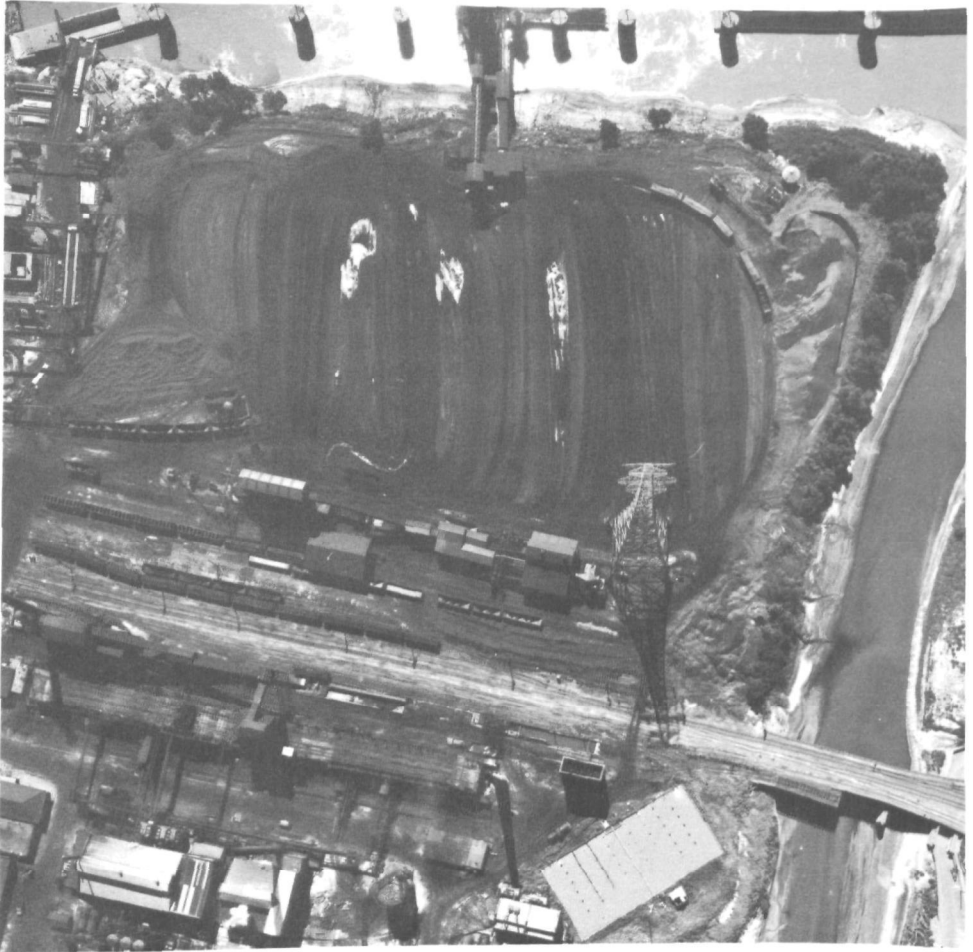
Figure 32 Baseline imagery of open storage of coal

The commercial coal storage yard shown in Fig. 32 is located at the intersection of two rivers. The coal pile is approximately 780 ft long and 535 ft wide and can be serviced by barge, rail, or truck. The storage is open without any protective dikes and apparently has no underground drainage system. A natural runoff pattern exists to the Mississippi River and to the river located at the right side of the photograph. Coal dust in suspension can be detected in the river downstream from the barge handling facility. Coal sediments can be seen in the creek just below the railroad bridge in the lower right of the photograph.

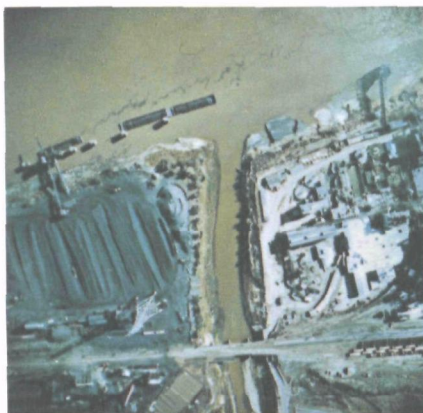
Figure 33 Coal storage and loading area

A color aerial photograph of the area is shown in Fig. 33. A close examination of the area with a 10X magnifier revealed coal dust drainage from the coal pile into the river. Likewise, coal spilled in the river during barge loading can also be seen. The multiband imagery was examined to see if contrast enhancement of coal and coal dust drainage was achieved with any film/filter combination. Some contrast enhancement was obtained with filters 99, 98, and 75 with both film types 2403 and 2424. The contrast enhancement was obtained by suppression of the reflected radiation from coal which occurs in the ultraviolet and blue portions of the spectrum. After a detailed analysis was made of the multiband imagery, it was concluded that more information was available in the color photography. Making the coal pile darker in the multiband imagery does not particularly aid the photointerpreter.

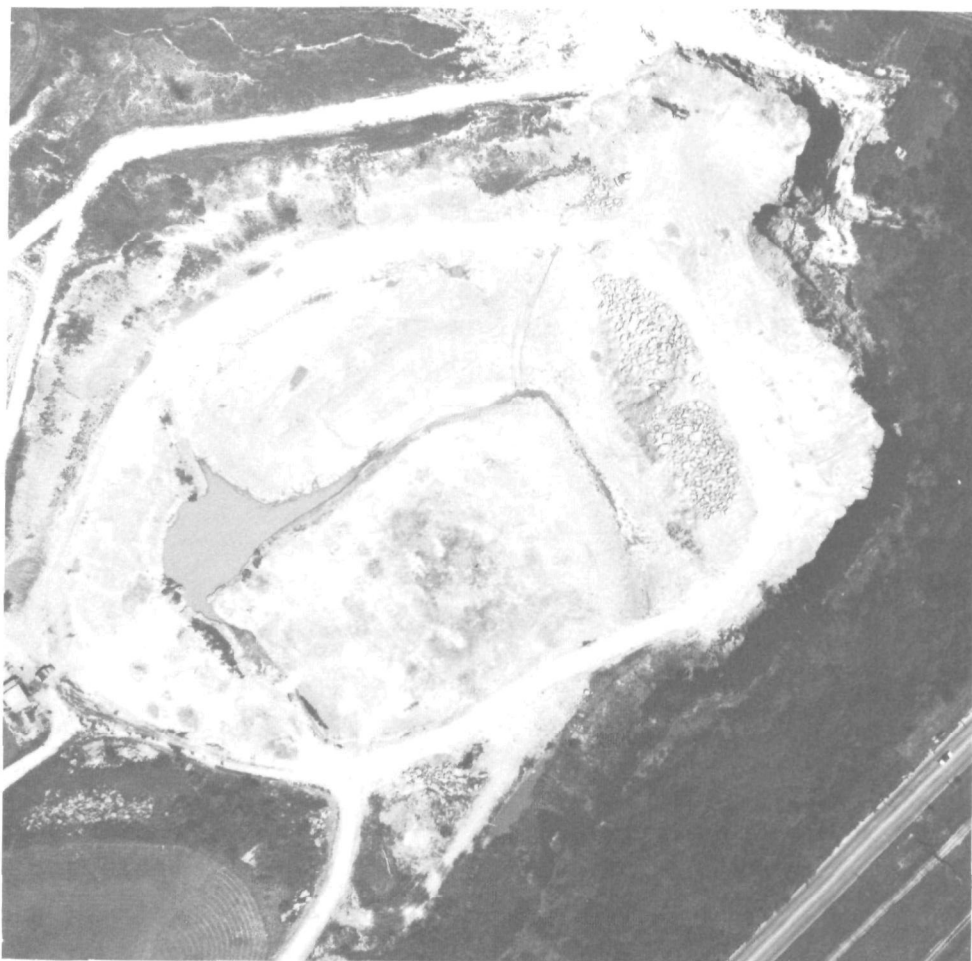
Figure 34 Baseline imagery of open shale quarry

The value of the multiband flights was in determining the best film/filter combination for detecting shale and limestone. The results can be used to locate and identify shale and limestone in other areas adjacent to inland waterways to determine if a potential threat to aquatic life exists.

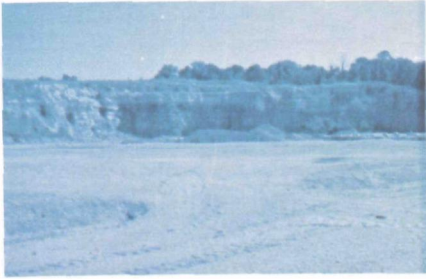
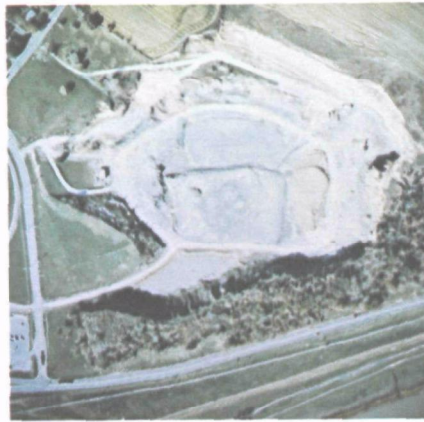
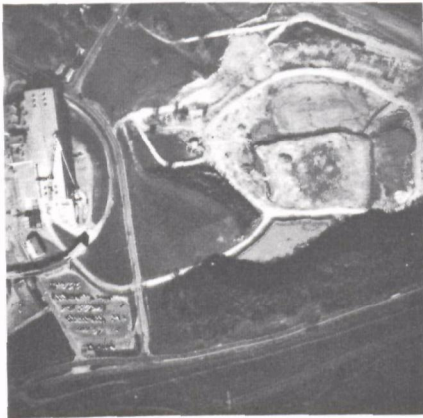
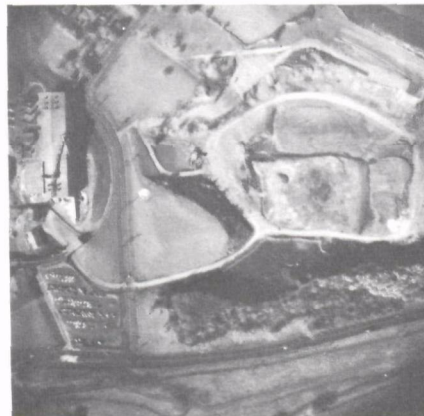
Figure 35 Shale quarry

A ground truth photograph and an aerial color photograph of the quarry are shown in Figs. 35a and 35b, respectively. From the photographs, the shale and limestone is observed to be grayish white. The multiband imagery analysis revealed the best film/filter combinations were 2403/99, 2403/98, 2403/75, 2424/99, 2424/98, and 2424/75. The imagery recorded on both film types 2403 and 2424 with filters 99, 98, and 75 appeared very similar. Figures 35c and 35d are the imagery of the shale and limestone

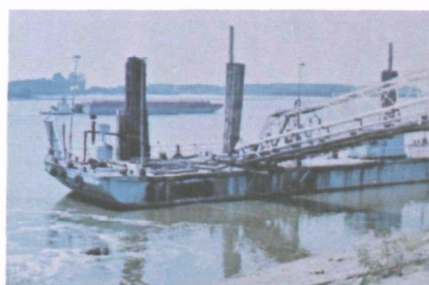
Figure 37 a) Baseline and b) ground truth imagery of barge loading area

The petroleum transfer point shown in the base and ground truth photographs of Figs. 37a and 37b, respectively, is very similar to the transfer area discussed above. The facility is connected to the main plant by five pipelines and has pumping and flow regulation equipment on site. Two revetted tanks on the shoreline were being improved at the time the baseline photography was taken. The actual loading is done from two floating docks moored to the shoreline and equipped with overhead pipelines. The danger of spill threat during the actual transfer operations also exists here. No spills are in evidence at the time of photography.

The value of multiband photography over areas containing pipelines over or adjacent to waterways is in detecting and identifying spills occurring from pipe leaks or during barge-loading operations. The two barge-loadings shown in Figs. 36 and 37 were covered during the multiband flights. During these flights, no pipe leaks or spills in the barge-loading operations were detected. Hence, experimental evidence was not available to assess the effectiveness of multiband imagery in this area. Samples of the multiband imagery of one of these barge-loading areas are shown in Fig. 29. Oil would be the most probable spill threat to occur in this area. From other sections of this report the best film/filter combinations for detecting this spill would be 2403/99, 2403/32, 2424/99, and 2424/32. Film type 2403 would be more effective over the harbor while film type 2424 would be better over land areas. This result is based on the near-infrared absorption of water that reduces the oil-water contrast on film type 2424 imagery and on the ground reflection of near-infrared radiation that enhances the oil-ground contrast in film type 2424 imagery.

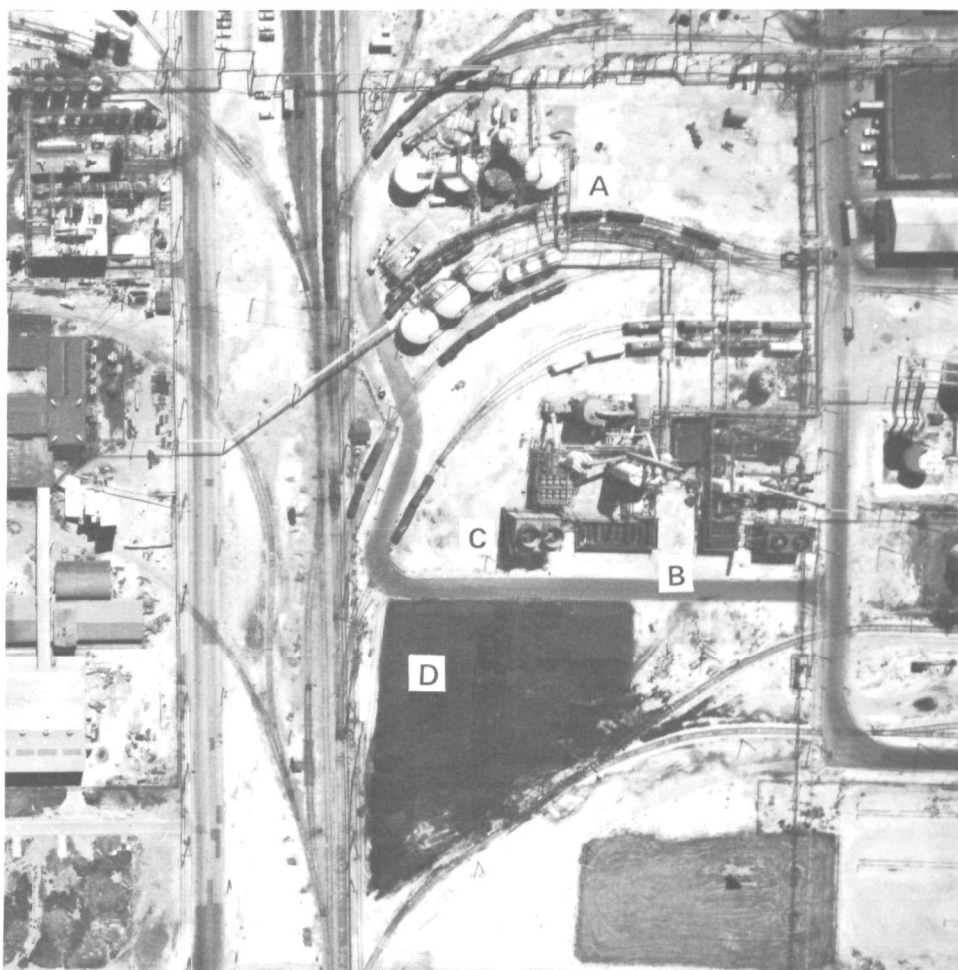
Figure 38 Baseline imagery of chemical plant acid loading area

Figure 38 is a portion of a chemical loading facility covered during the flights. While the area is behind the flood levee, the analysis made here demonstrates the technique that can be used in similar areas located on an inland waterway. Areas A, B, C, and D are a sulfuric acid loading area, a sulfuric acid contact plant, cooling towers, and a reserve coal pile, respectively. The chemical storage area has one railroad siding equipped to load nine railroad tank cars sequentially and one truck facility capable of handling two tank trucks simultaneously. There are six large storage tanks, four smaller tanks, and two more large storage tanks under construction. The large and small tanks have a diameter of approximately 35 ft and 15 ft, respectively, and are approximately 20 ft high. From the black-and-white imagery, there are no apparent spill threats in the area. The area is very flat and would not represent a potential threat even if it were directly adjacent to the river. A very indistinct mottled appearance on the ground is attributed to natural soil difference.

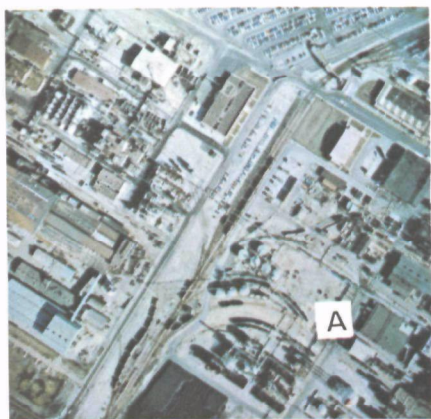
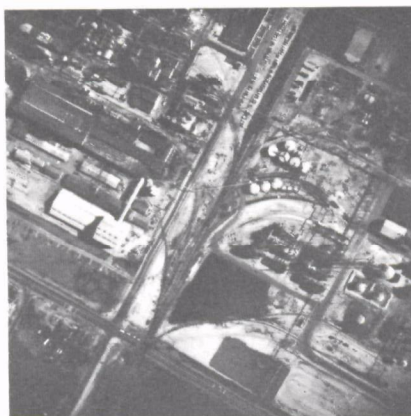
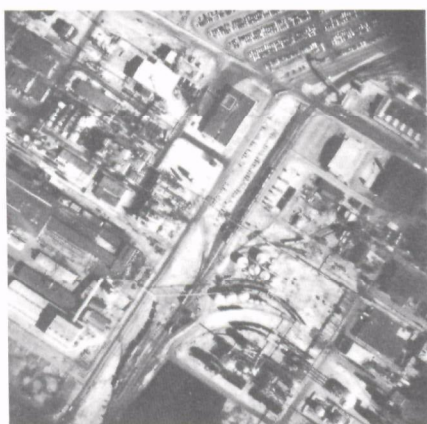
Figure 39 Sulfuric acid loading area

Generally, the number of spills detected in all the industrial loading areas was very small. One example of a possible spill in the chemical plant is labeled A in Fig. 39a. A ground truth team learned the yellow residue on the ground at the sulfuric acid loading area is a result of storage of bulk sulfur in past years. Multiband photography was evaluated to determine if any film/filter combination was effective in identifying the sulfur deposits. The results could be used in areas adjacent to waterways to identify an unknown deposit to determine if it represented a real or potential threat to the waterway. An examination of the multiband imagery revealed that film/filter combinations 2403/99 and 2424/99 gave the maximum contrast enhancement. These images are shown in Figs. 39b and 39c, respectively.

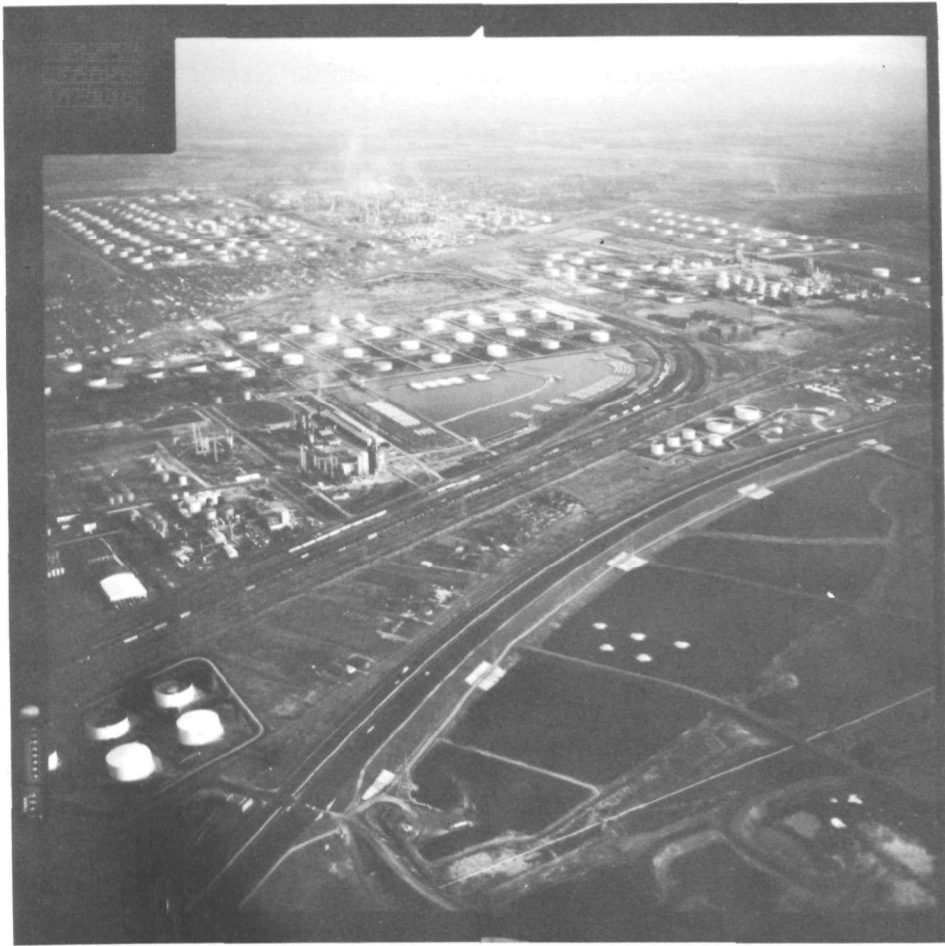
Figure 43 Oblique imagery of oil refinery

An oblique photograph of an oil refinery complex shown in Fig. 43 is typical of this type of imagery. North is to the left of the photograph. Detail is greatly degraded by ground haze in the upper 1/3 of the photograph. To the layman, it is superior to vertical imagery because the viewer has definite clues regarding relative object heights. To the photointerpreter, however, the scale changes throughout the photograph, making mensuration difficult. The same area of the photograph, where detail is discernible, could be covered by a vertical photograph from a higher altitude. The scale of such a photograph would be constant throughout and contain more reliable vertical information when viewed stereoscopically.

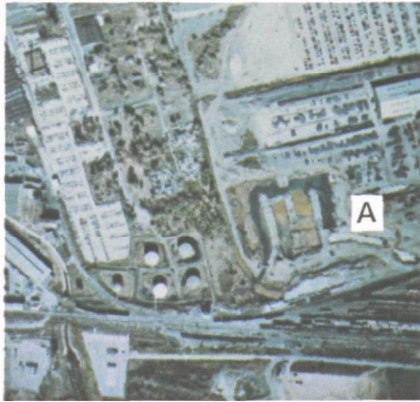
a) 2448/HF3

The steel mill waste lagoons shown in the color aerial photograph in Fig. 1a are spectrally characterized by a variety of colors. Before being treated with caustic soda, the lagoons are yellowish red in color. After treatment, the ponds acquired a rust-colored or a black appearance. The rust-colored area is iron or scale settlement. A ground truth team learned the black color is a residue resulting from the reaction of spent caustic soda with water. A photograph of a typical pond obtained during an initial ground truth mission is shown in Fig. 1b. Note the rust color appearance of the pond in the upper portion of the photograph while the pond to the right appears free of pollutants. The black and rust-colored appearance of the ponds settling area is contrasted with the untreated yellow portion of the lagoon labeled A.

The value of multiband photography is in the identification of the materials present in these lagoons. These results can be applied to areas located adjacent to inland waterways to identify unknown spills and thus located potential and real spill sources threatening inland waterways. The multiband flights revealed that the film/filter combinations 2403/99, 2403/65, 2403/32, 2424/99, and 2424/35 gave the best image contrast for this area. These film/filter combinations are shown in Figs. 1c and 1d and 2a, 2b, and 2c, respectively. Only small differences were found in the imagery recorded with film type 2403 and filters 99, 98 and 75. The same conclusion was derived for these filters coupled with film type 2424. Similarly, there were only slight differences in the imagery recorded with filters 32 and 35. As can be seen from Figs. 1 and 2, the oil water area imagery is slightly darker for the 99 filter coupled with both film types 2403 and 2424. The imagery recorded with film/filter combination 2424/35 gives better area definition than the 2424/99 imagery. This is indicative of a spectral return in the ultraviolet and blue portions of the spectrum. The imagery recorded with film/filter combination 2403/32 and 2403/65 even better defines this area because of the water-reflected visible radiation. The film/filter combination 2424/35 imagery shows strong water absorption in the near-infrared. Thus it is difficult to distinguish oil from the water.

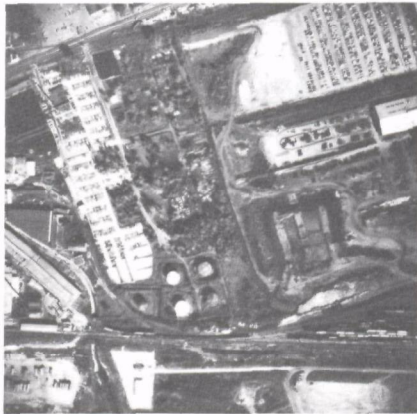
c) 2403/99

combinations 2403/99, 2424/99, and 2424/35, this area is dark in tonal quality, representing a complete contrast reversal. This area strongly reflects ultraviolet, blue, and green visible radiation and absorbs near-infrared radiation.

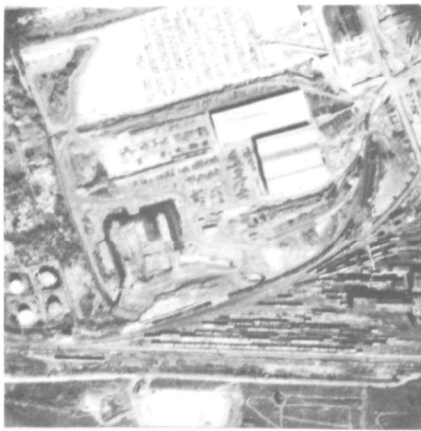
a) 2403/32

The rust-colored area shows small contrast variations in the imagery recorded on five film/filter combinations shown in Figs. 1 and 2. The imagery of this area obtained with film/filter combinations 2403/32 and 2424/35 is lighter than that obtained with filter 99 and film types 2403 and 2424. This is anticipated since filters 32 and 35 transmit the red portion of the spectrum. The imagery from film/filter combinations 2403/65 is darker in this area than that taken with film/filter combination 2403/32 because of blockage of the red spectral region. The imagery of this area taken with 2403/99 is lighter than that obtained

from 2403/65. This indicates some reflectance of this area in the 500 to 600 nm range. The imagery obtained with film types 2424/35 and 2424/99 is found to be darker than that obtained with 2403/32 and 2403/99, respectively. This indicates some near-infrared absorption by this area. A comparison of the imagery obtained with film/filter combinations 2424/35 and 2424/99 indicates that the red reflectance is greater than the near infrared absorption. Thus, the various film/filter combinations allow the spectral characteristics of the materials under investigation to be determined. One film/filter combination cannot be used effectively for detecting the three different areas defined in this lagoon. Color photography reveals the maximum amount of information.

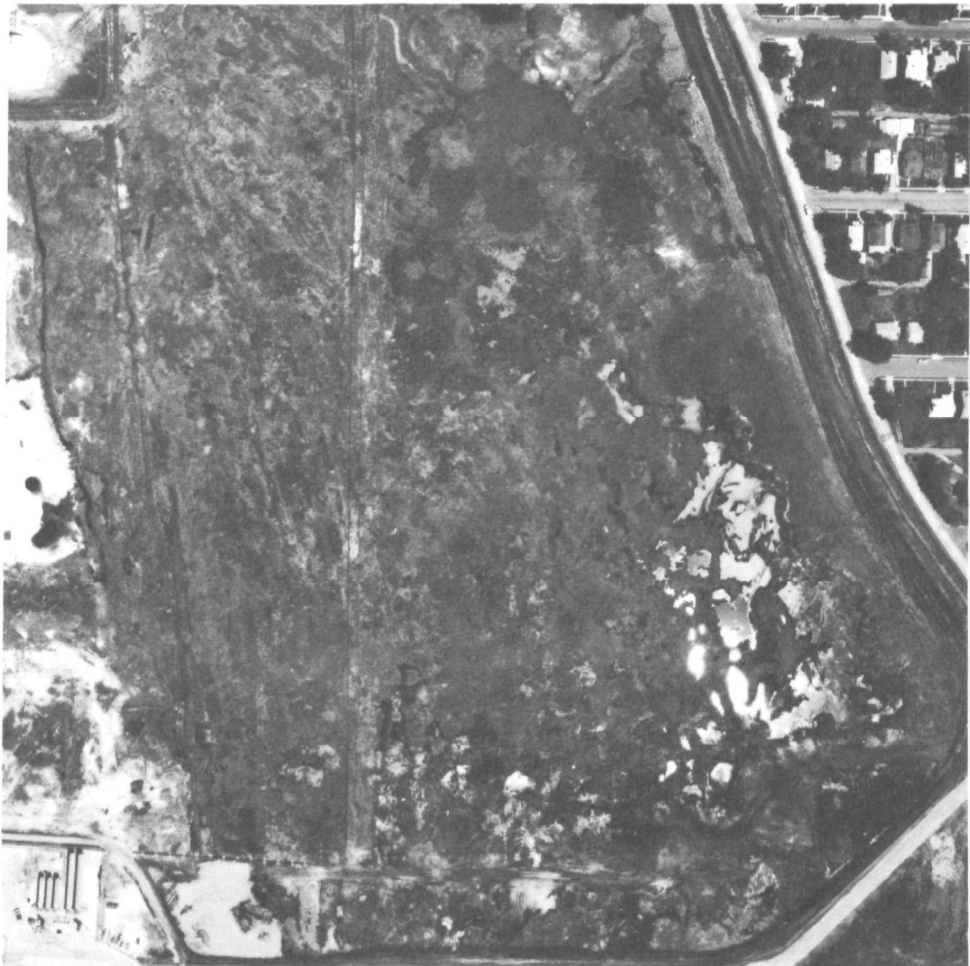
Figure 1 Baseline imagery of oil refinery waste dump

Another oil waste area of 63 acres was covered during this project and is shown in Fig. 1. It is located 7,000 ft from the river and does not represent a direct threat to the inland waterway. In addition, the area is located on a flood plain and no distinct drainage pattern is observed. The area is of interest for two reasons, First, it represents a waste area that differs distinctly from other oil waste areas already discussed. The oil waste in this area is located in small patches dispersed among small, stagnant water ponds, vegetation, filter cakes and emulsified oil waste, which accounts for the mottled appearance of the image shown in Fig. 1. Second, the results of the multiband image analysis can in similar areas located adjacent to inland waterways to identify unknown spills. Upon identification, the potential or real threat of the spill source to the inland waterway can be evaluated.
