EPA-R2-72-007

Aerial Surveillance Spill Prevention System

AERIAL SURVEILLANCE SPILL PREVENTION SYSTEM

Contract No. 68-01-0140
Project 15080 HOK

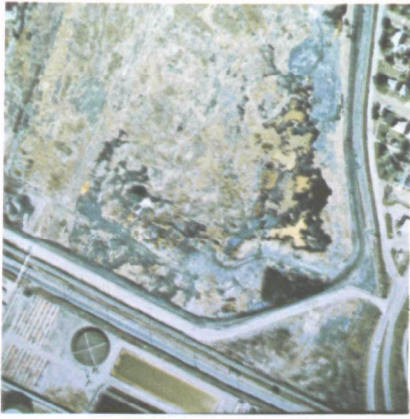
a) 2448/HF3

An aerial color photograph of the area obtained on the multiband flights is shown in Fig. 2a. An accompanying ground truth photograph of the oil lying on the ground is shown in Fig. 2b. The multiband imagery revealed the best film/filter combinations for contrast enhancement were 2403/32, 2403/99, 2424/32, and 2424/99. Images of the area using these film/filter combinations are shown in Figs. 2c, 2d, 2e and 2f, respectively. As concluded in the preceding section, color photography appears best in identifying the emulsified oil waste and filter cakes. The emphasis here is on separating the black oil waste from the background material. The imagery recorded with filter 99 for both film types 2424 and 2403 gives the maximum negative enhancement of the oil to the background when compared with the imagery recorded with filter 32. Filter 99's absorption of the ultraviolet, blue, and red radiation reflected by oil is responsible for this. When comparing film type 2424 and 2403 imagery, better oil background contrast with type 2424 is observed because of the near-infrared reflectance of the background. Because of the water near-infrared absorption, however, it is sometimes difficult to distinguish oil from water on film type 2424 imagery. Furthermore, the moisture content of various ground regions produces a variety of shades of gray on film type 2424, tending to distract the photointerpreter. On film type 2403 imagery, these shades of gray are subdued as the water ponds do not absorb as much visible radiation making it easier to detect oil from water. For these reasons, film/filter combinations 2403/99 and 2403/32 would be more effective than 2424/99 and 2424/32 in detecting oil waste in this particular type of area.
