Utilization of Fly Ash and Coal Mine Refuse as a Road Base Material

EPA-600/7-79-122
August 1979

UTILIZATION OF FLY ASH AND COAL MINE REFUSE
AS A ROAD BASE MATERIAL

Roger C. Wilmoth and Robert B. Scott
Resource Extraction and Handling Division
Industrial Environmental Research Laboratory
Cincinnati, Ohio 45268

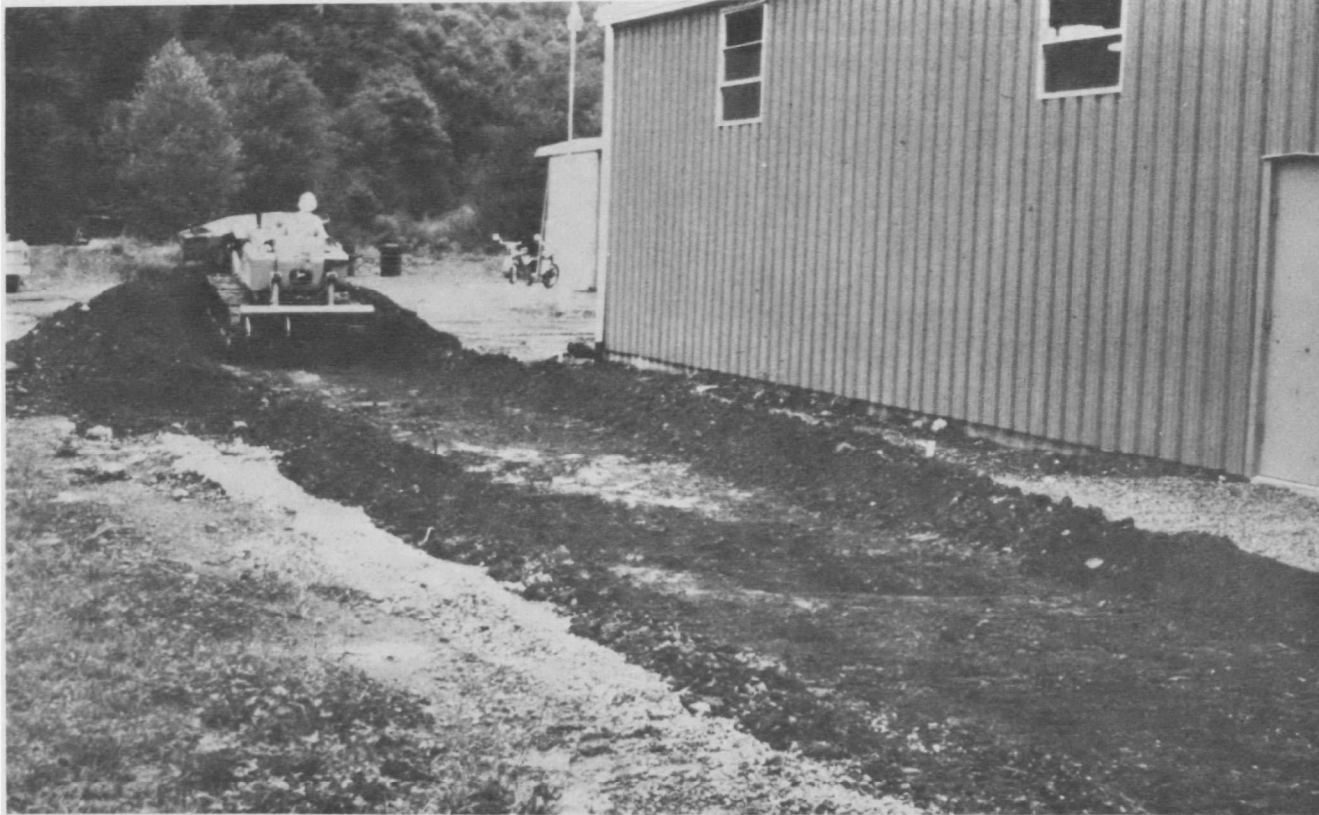
Figure 4. Excavation of existing ground to subgrade level (Area 2).

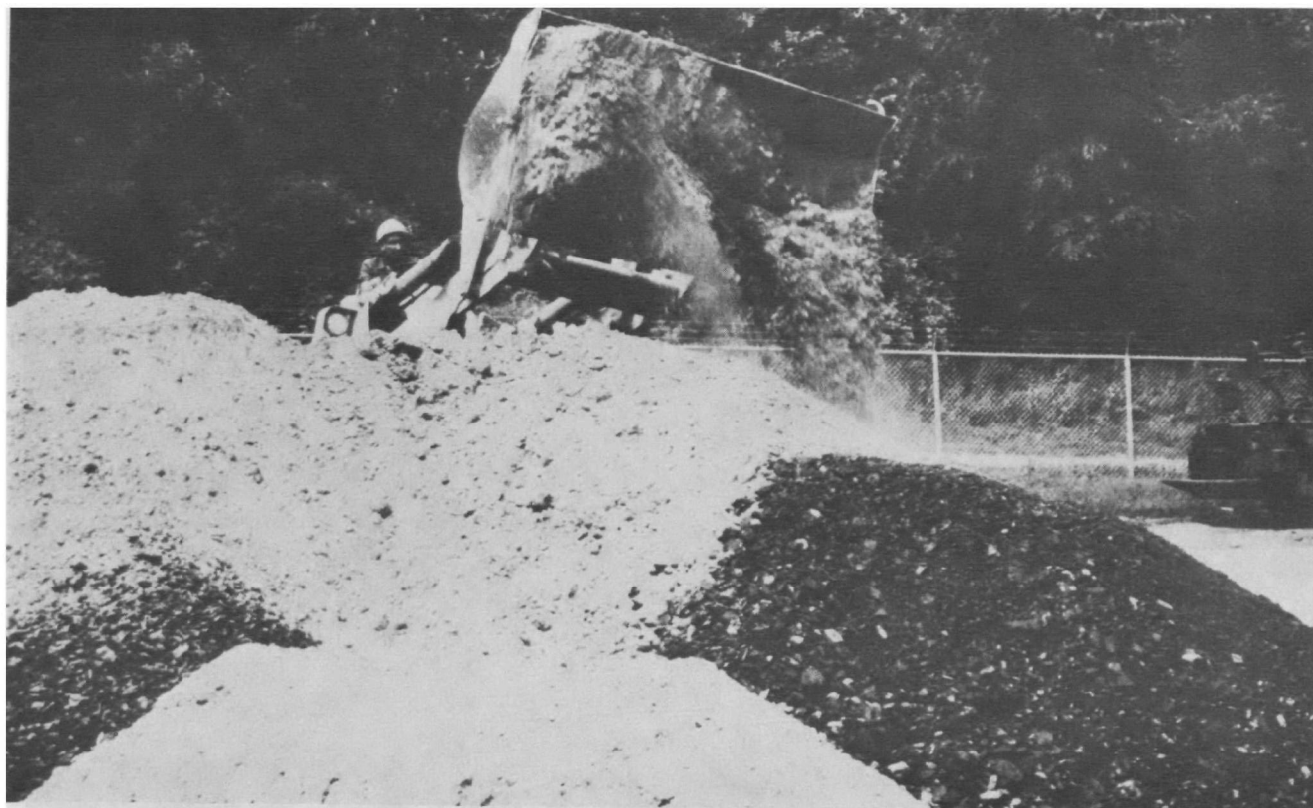
Figure 6. Mixing the refuse and fly ash with an endloader (Area 2).

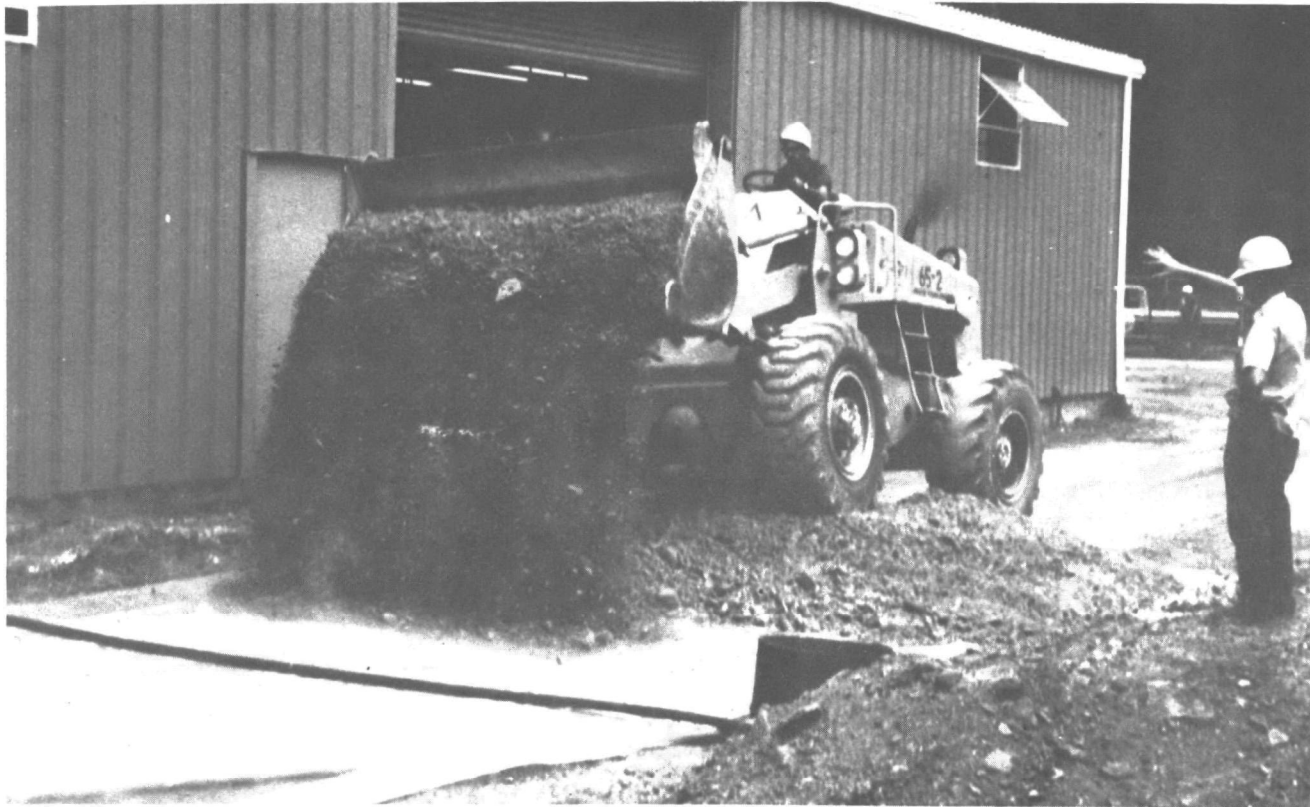
Figure 7. Placing the refuse-fly ash mixture base material (Area 2).

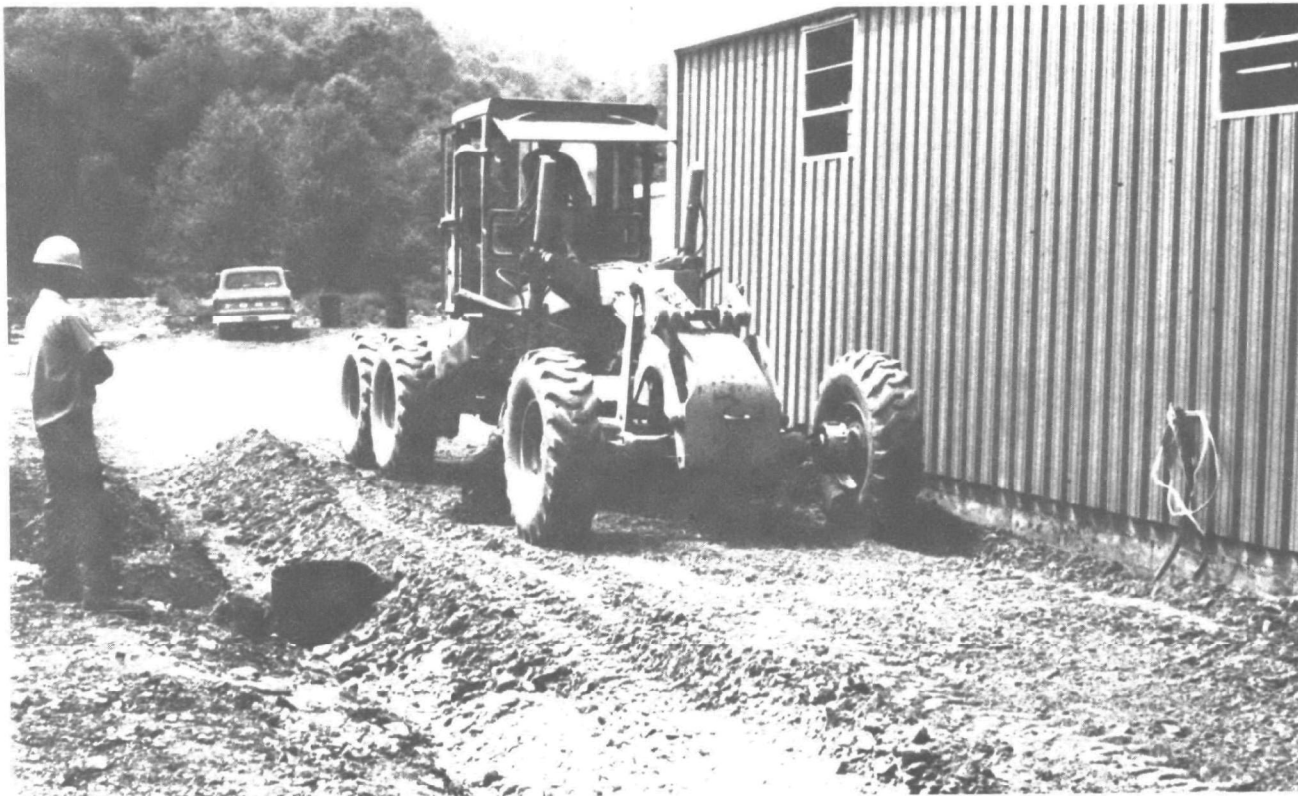
Figure 8. Grading the base material (Area 2).

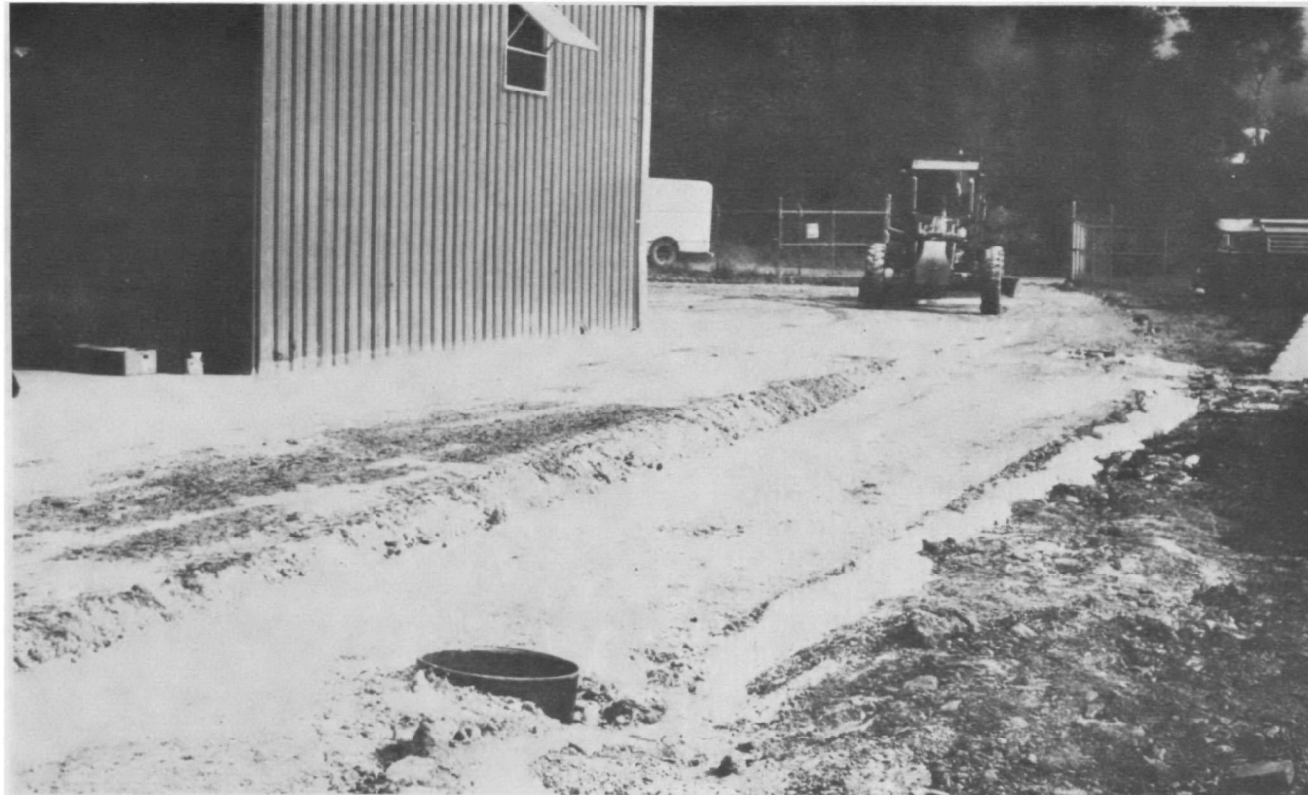
Figure 9. The prepared base material after lime was added to the top 6 in (15.2 cm) (Area 2).

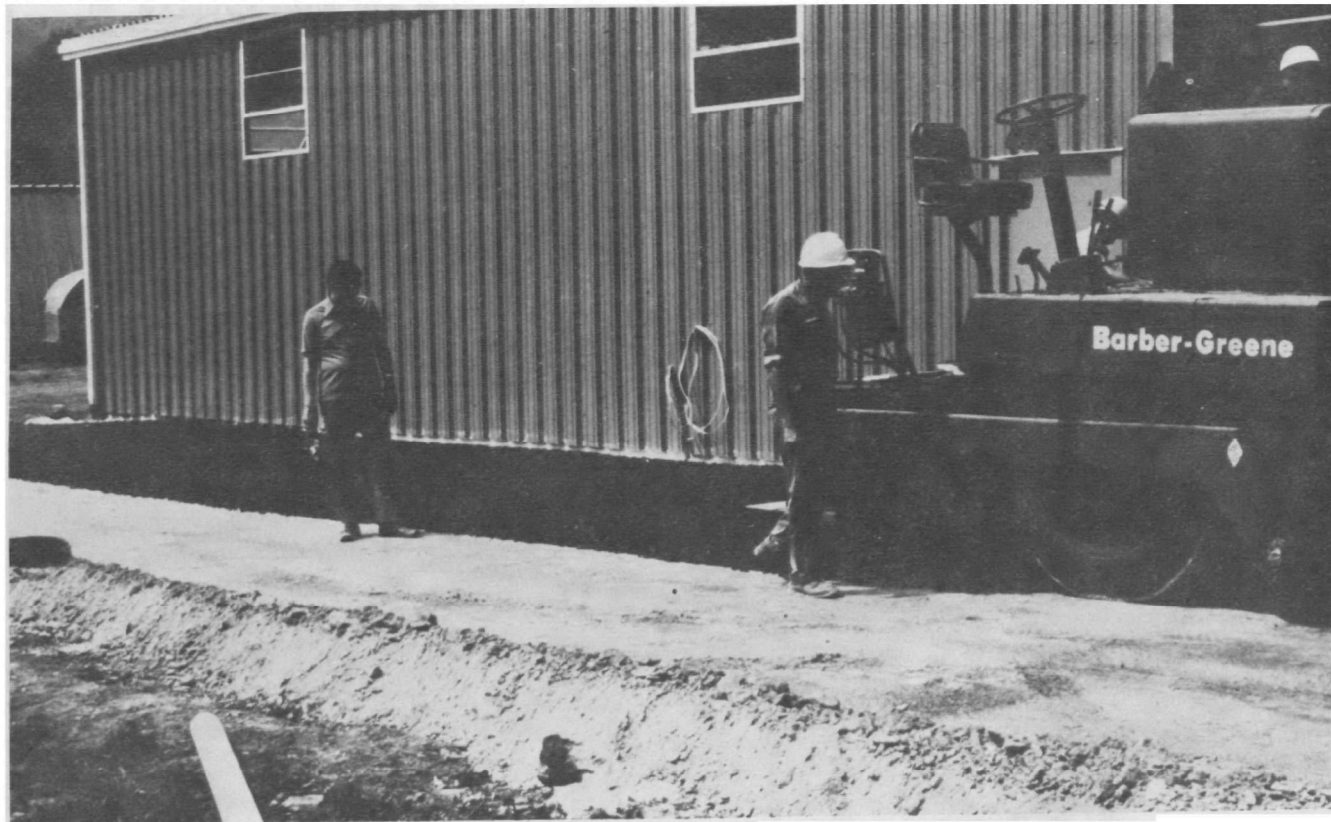
Figure 10. Placement of the base-course asphalt (Area 2).

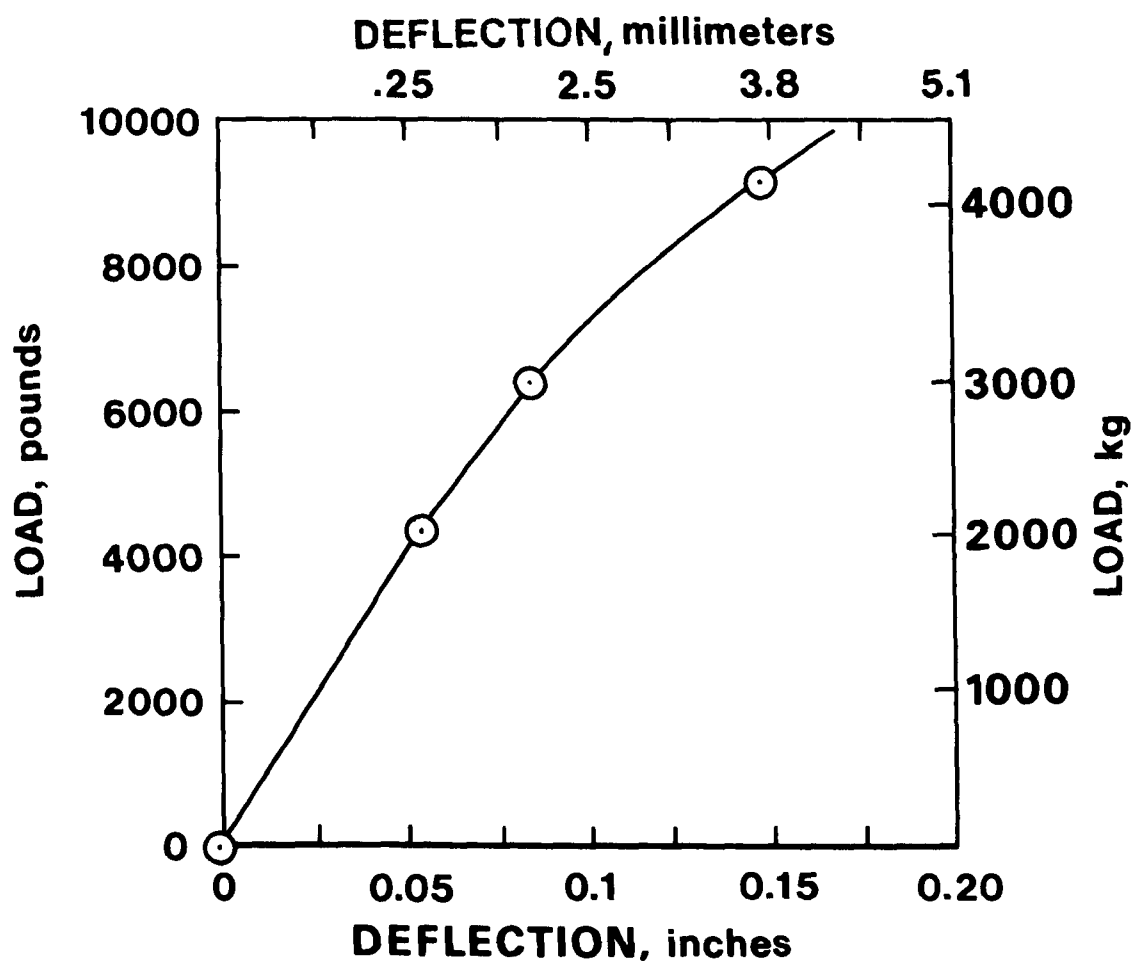
**FIGURE 16. Load deflection curve
for Area 1, top of base.**

The results of the plate bearing tests that were performed on the base and subbase sections are tabulated in Table 4. The plate bearing tests were performed according to ASTM Standard Method D-1195-64, Repetitive Static Plate Load Tests of Soils and Flexible Pavement Components, for Use in Evaluation and Design of Airport and Highway Pavements. The tests were run confined on plates of either 10-in (25.4-cm) or 12-in (30.5-cm) diameter, as noted in Table 4. Under test load, the coal mine refuse behaved essentially as a granular material. The deflections under applied loads became stabilized after only a few minutes, even at the higher loads. Complete rebound upon release of the applied loads was obtained in a few minutes. Load-deflection curves for Area 1 are shown in Figures 15 and 16. These are considered typical of the various results.

$$k = \frac{P}{\delta}$$

and δ is the deflection in inches. The bearing value, P , is the plate pressure required to give a deflection of 0.2 in (0.5 cm). The modulus of elasticity, E , is based on Boussinesq theory with a correction for the effect of the surcharge. (9) These data are indicative of a low-quality granular material suitable as a sub-base but of questionable value as a base course under asphaltic concrete."

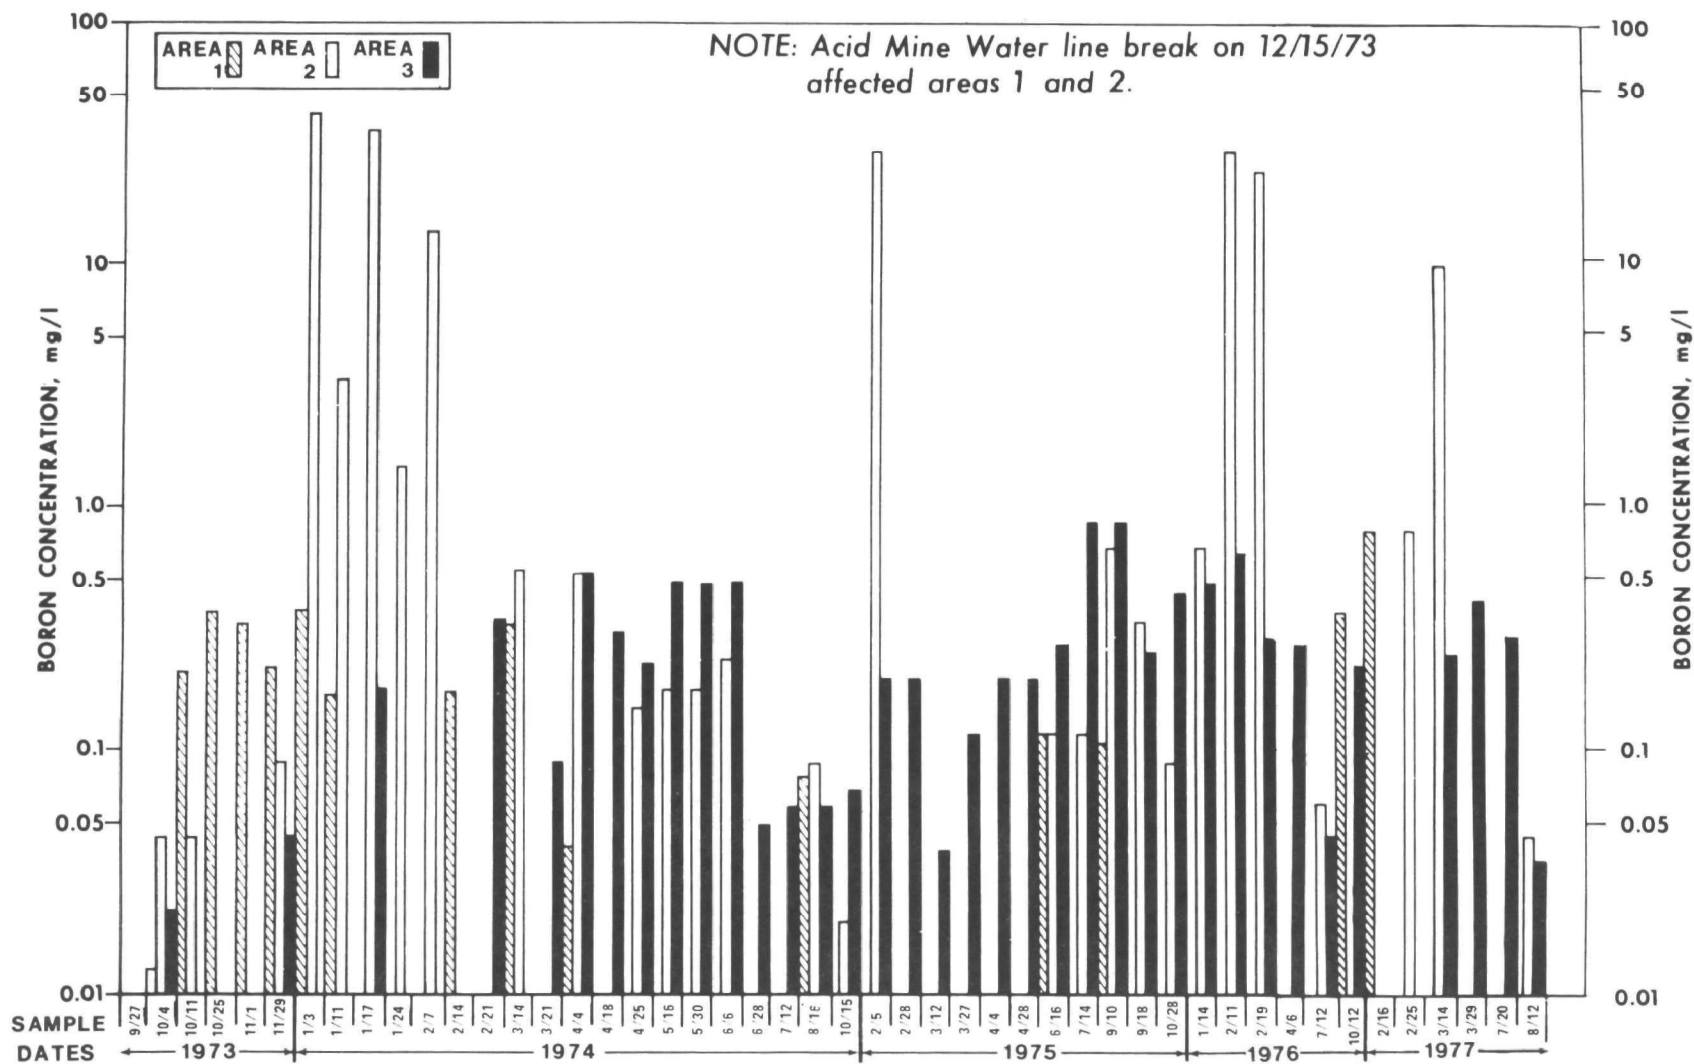
FIGURE 20. Comparison of boron concentration in the effluents from each test area.

The cause of the spike of boron concentrations ranging from 10 to 40 mg/l during successive winter months (1974-77) is not known. It has been reported (10) that a boron concentration above 4 mg/l in irrigation water was generally unsatisfactory for most crops. Experimental evidence concerning the toxicity of boron to livestock water demonstrated that an upper limit of 5.0 mg/l would be acceptable. The recommended maximum concentrations for semi-tolerant and tolerant plants are 1 and 2 mg/l. (10)

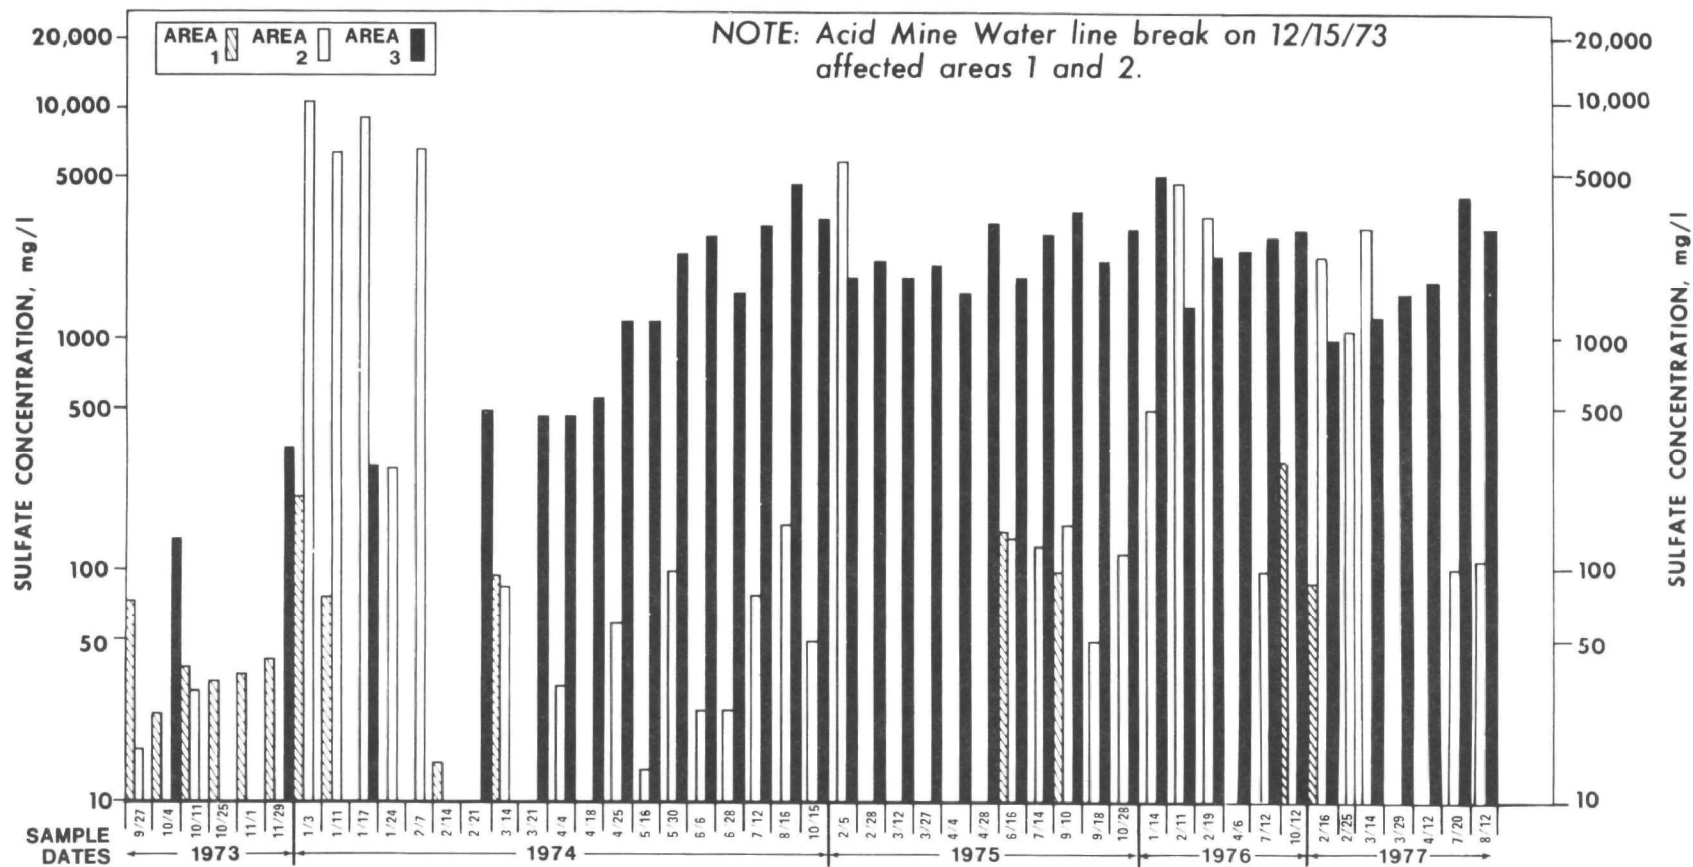
FIGURE 22. Comparison of sulfate concentrations in the effluents from each test area.

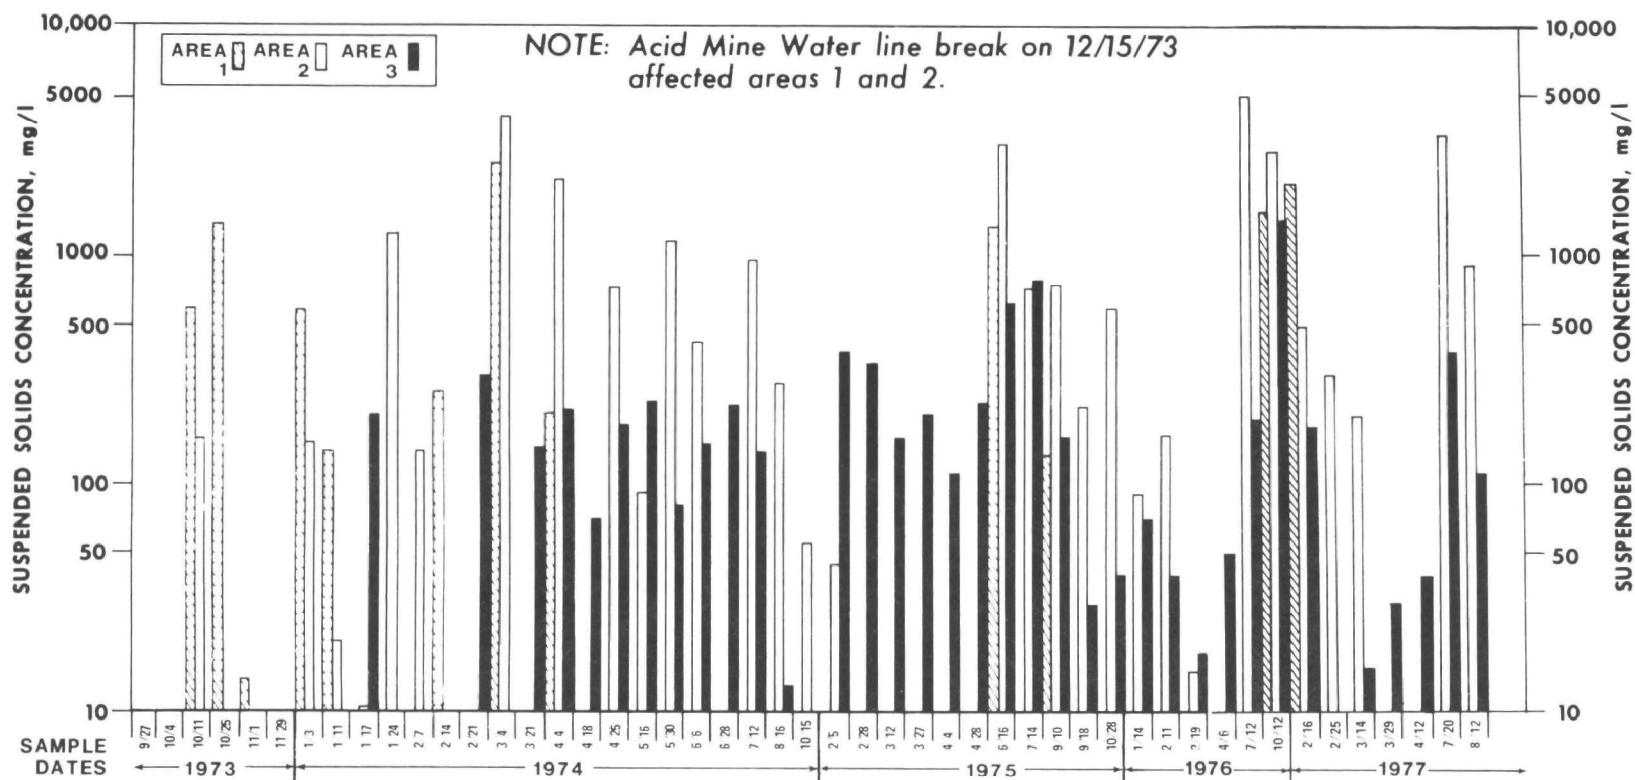
FIGURE 23. Comparison of suspended solids in the effluents from each test area.
