REMOTE SENSING STUDY
EASTERN FLORIDA COAST
DADE COUNTY, FLORIDA

NATIONAL FIELD INVESTIGATIONS CENTER-DENVER
DENVER, COLORADO
AND
REGION IV, ATLANTA, GEORGIA

AUGUST 1972

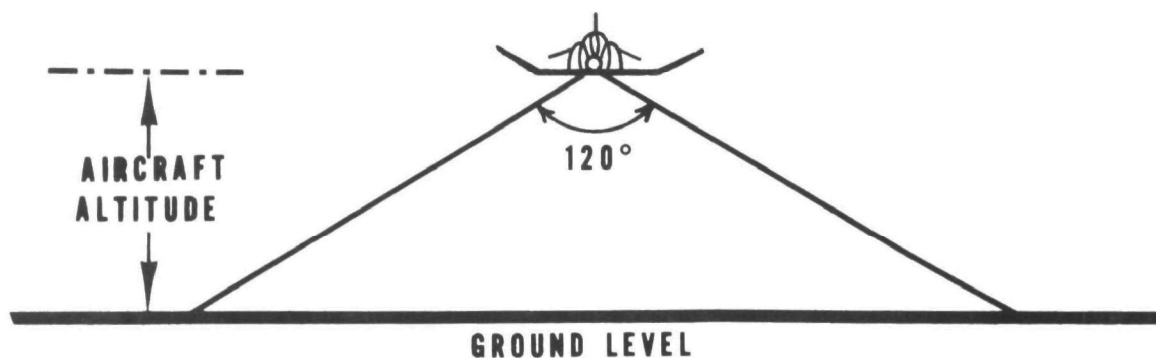
Figure 7B Field-of-View of the IRLS.

system to record on film the amount of infrared energy detected in the imaged area. The effective focal length of the AAS-18 is 1.15 inches and the field of view is 120° .

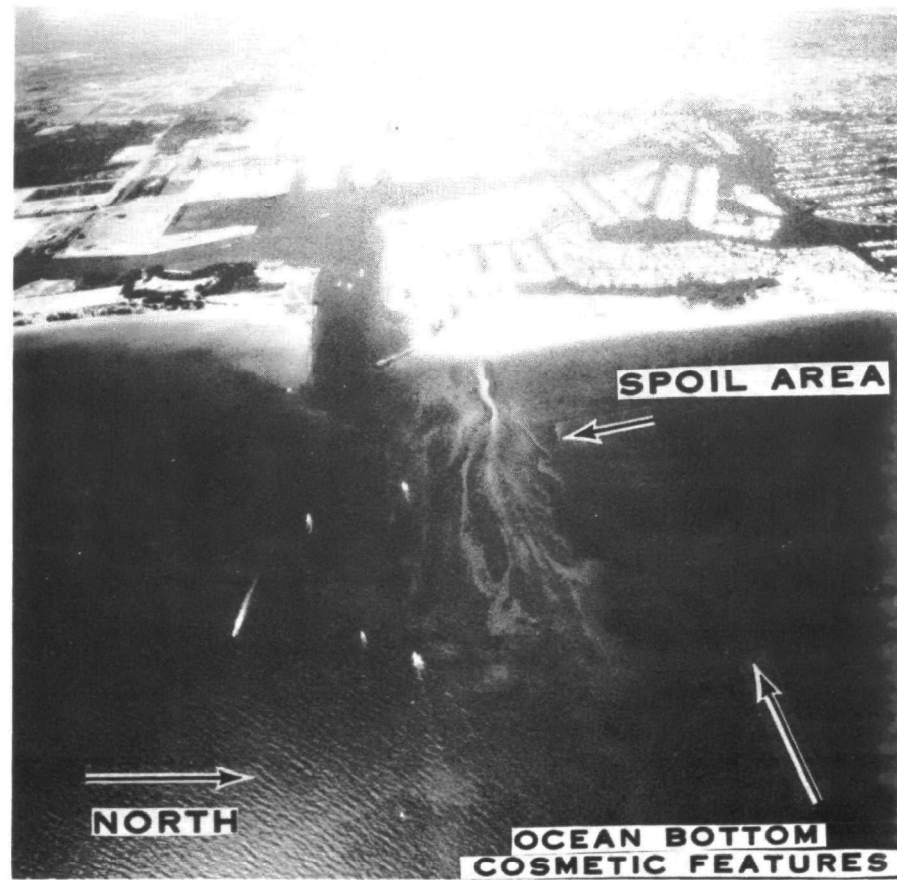
Figure 17 - Port Everglades

Definite features, such as coral reefs, sand, mud, rock, and aquatic growth on the bottom strata, could not be identified in the imagery. There were fairly well defined light/dark-toned areas seen in the imagery, but they could not be classified except as cosmetic features of the ocean bottom. These different toned areas are shown in Figure 24A through 24H, with the hatched markings depicting the dark tones. (An example of cosmetic features is shown in Figure 17).
