EPA-670/2-74-092
December 1974

CRANKCASE DRAINAGE FROM IN-SERVICE OUTBOARD MOTORS

Charles T. Hare
Karl J. Springer
Southwest Research Institute
Department of Emissions Research
San Antonio, Texas 78284

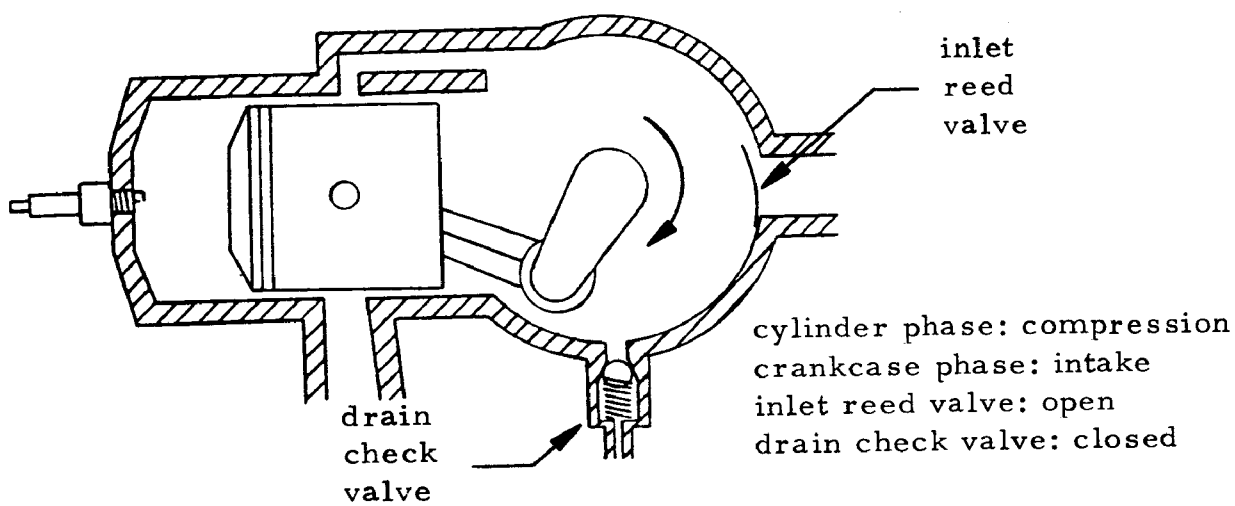
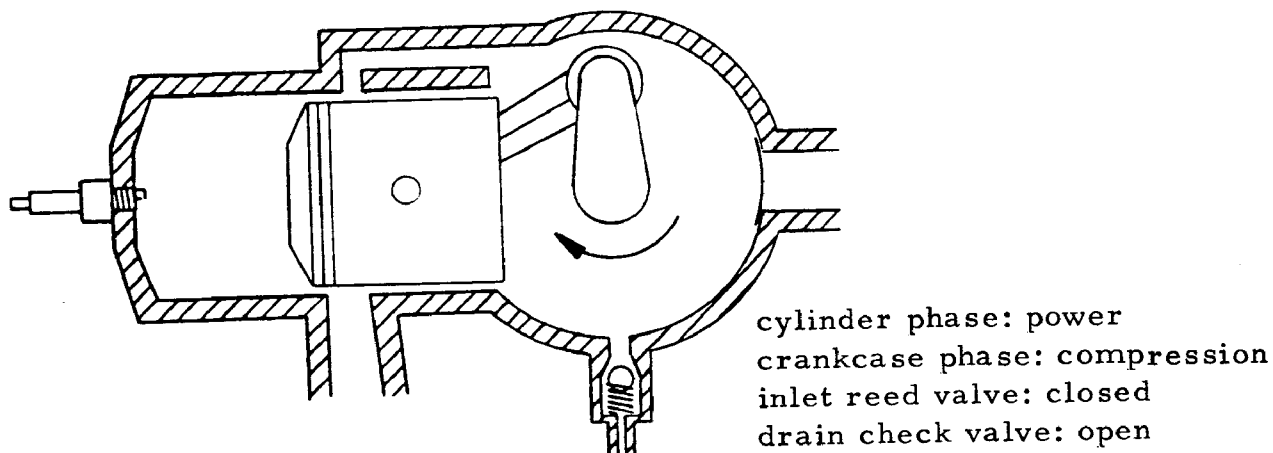
Figure 1. Simplified schematic section of a 2-stroke cycle gasoline engine

Figure 1 is a simplified schematic diagram of a 2-stroke gasoline engine (reed-valve type) which shows how the crankcase drainage systems of the older engines operate. Figure 1a shows the engine during the compression stroke, and at the same time the crankcase is in its intake phase, with the inlet reed valve open and the drain check valve closed. Figure 1b shows the engine during the power stroke, and the crankcase is in its compression phase, with the inlet reed valve closed and the drain check valve open. Since both the inlet reed valve and the drainage check valve are pressure-actuated, flow into and out of the crankcase depends on crankcase pressure. When crankcase pressure is low (during compression stroke), mixture is inducted into the crankcase and drainage can collect over the check valve. When crankcase pressure is high

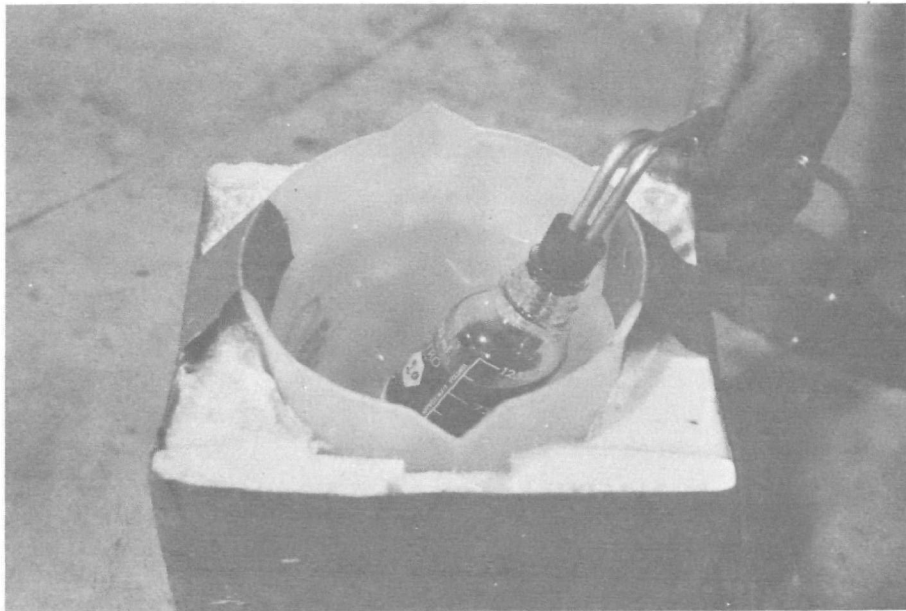
Figure 2. Insulated container for sample bottle and water bath used during tests

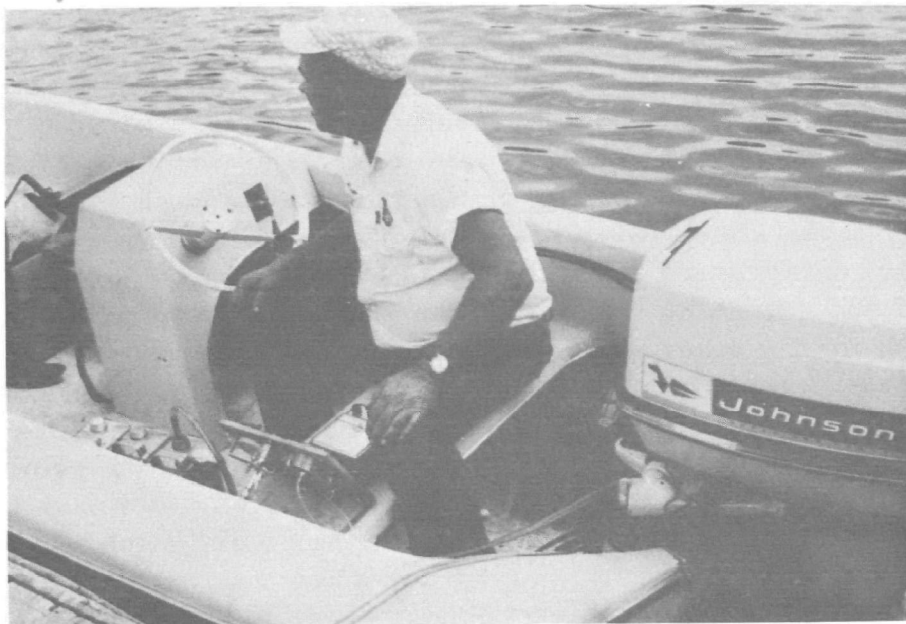
Figure 3. Engine undergoing drainage test, showing drainage tube, pre-weighed fuel cans, and tachometer (on seat)

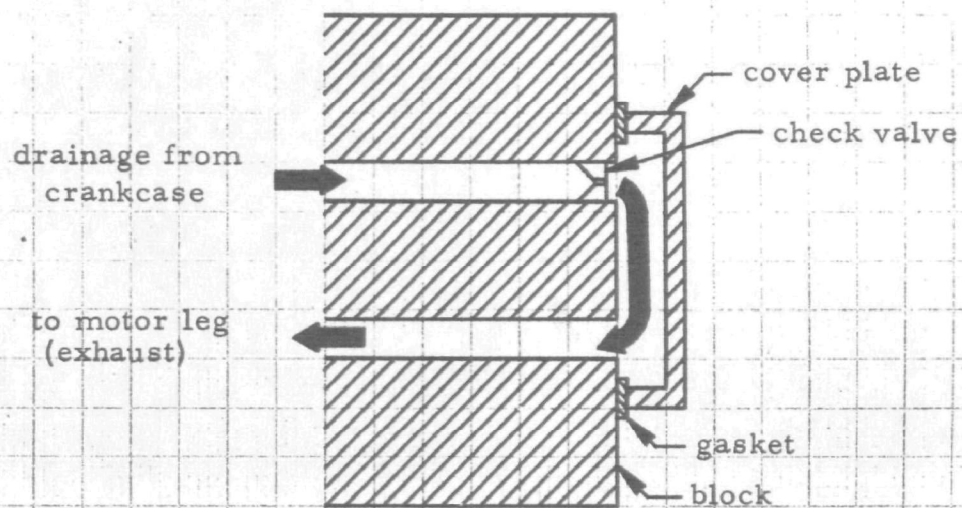
Figure 7a. Schematic section of typical drain system

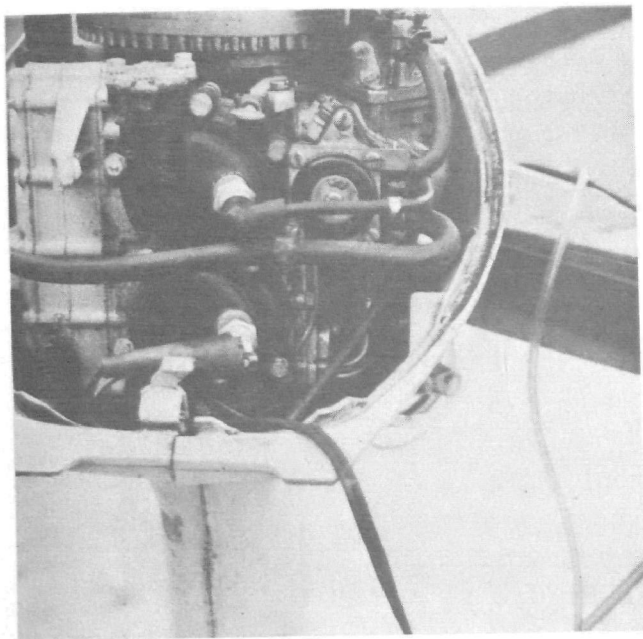
Figure 8. Installation of tachometer leads and special plate for re-routing of crankcase drainage, engine 1

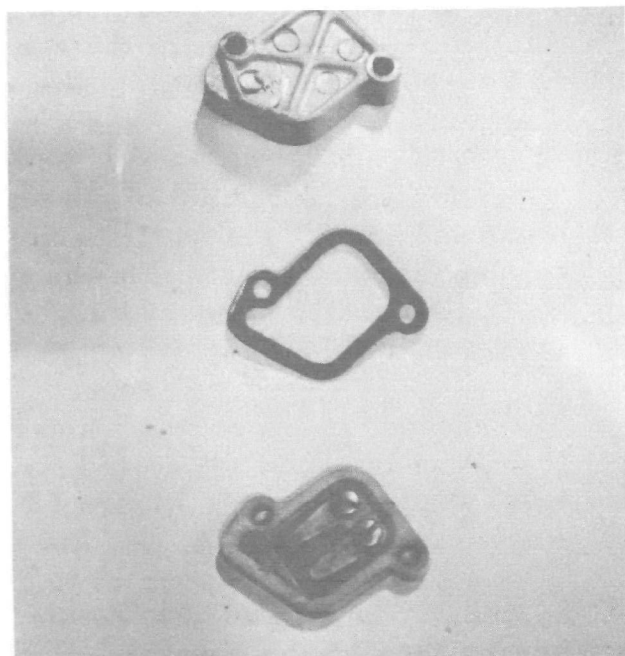
Figure 9. (Top to bottom) crankcase relief valve cover plate, gasket, and reed plate similar to those widely used on OMC engines

faces of the stock drainage reed plate and cover plate, and Figure 10 shows the inside faces of the same parts. The modified cover plate had a web added to separate the reed valves from the hole which leads down into the motor leg, and a modified gasket was made to seal this partition. In operation, both gaseous and liquid drainage components were routed out of the chamber covering the drainage reed valves to the sample bottle, and gaseous constituents were routed back to their normal outlet. This modified plate was used to collect drainage on Engines 1, 3, 8, 9, 12, 13, 21, 25, 28, 33, 34, and 35, which were OMC twins.

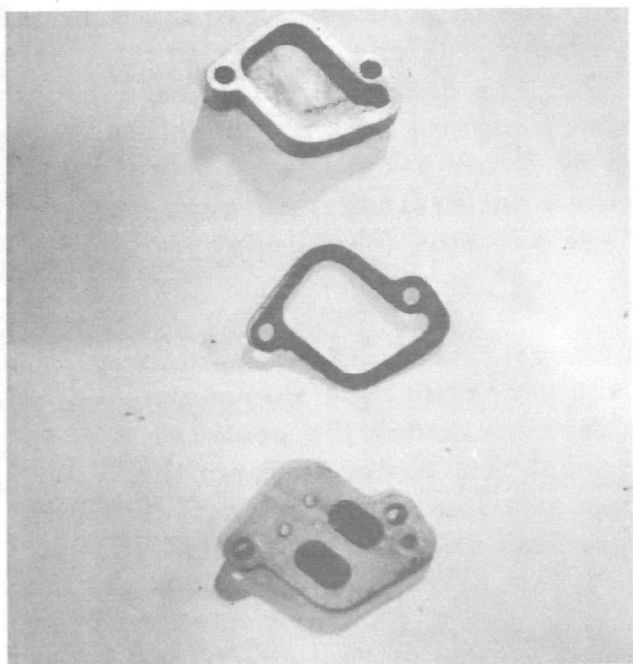
Figure 10. * Inside faces of same parts shown in Figure 9

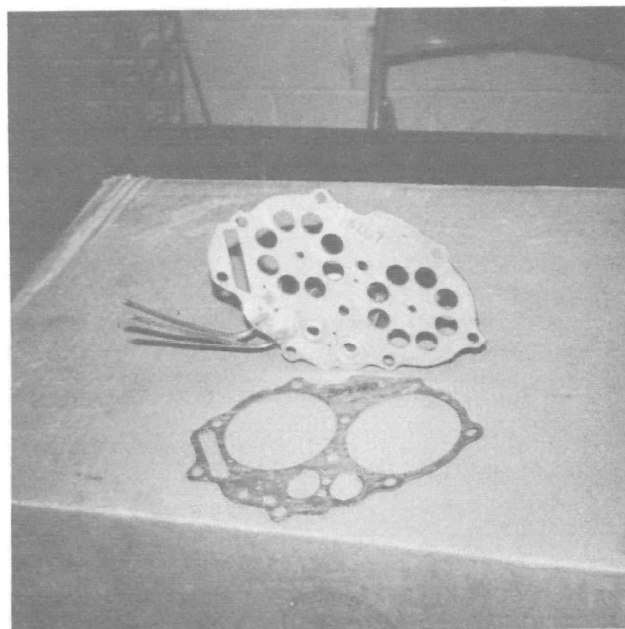
Figure 11. Modified reed plate used to extract drainage from OMC 15 hp and 18 hp motors (engines 2 and 5)

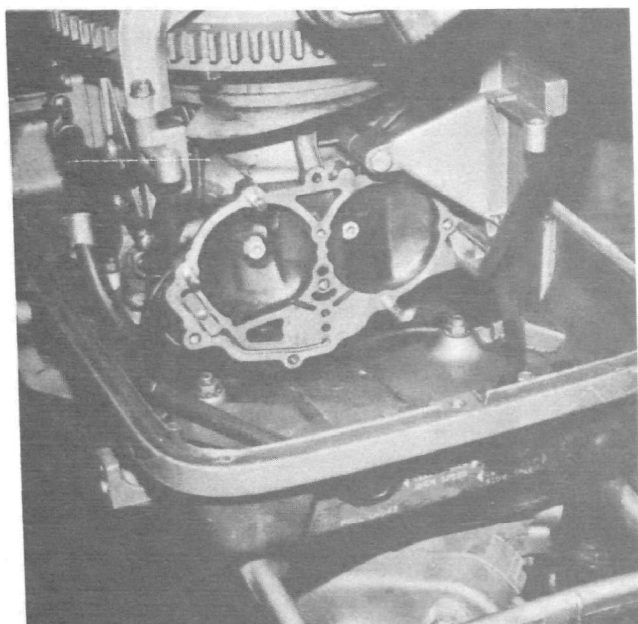
Figure 12. Front face of crankcase half, engine 2, showing normal crankcase drainage channel

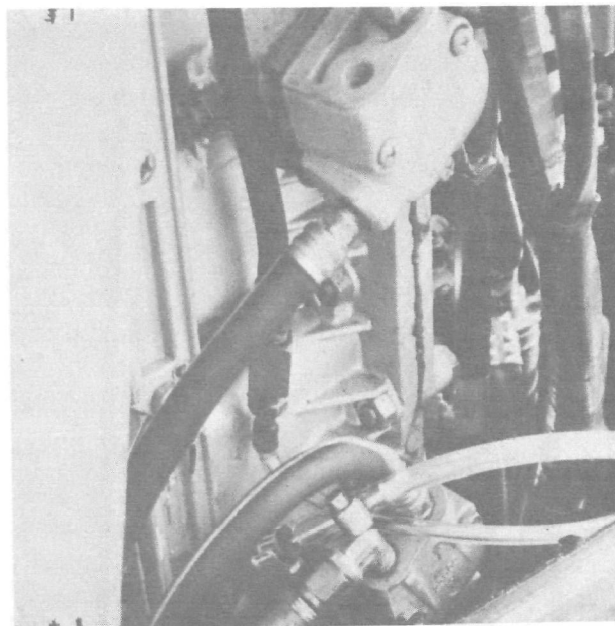
Figure 13. Drainage re-routing system typical of those used on 4- and 6-cylinder Mercury motors (engine 14 shown)

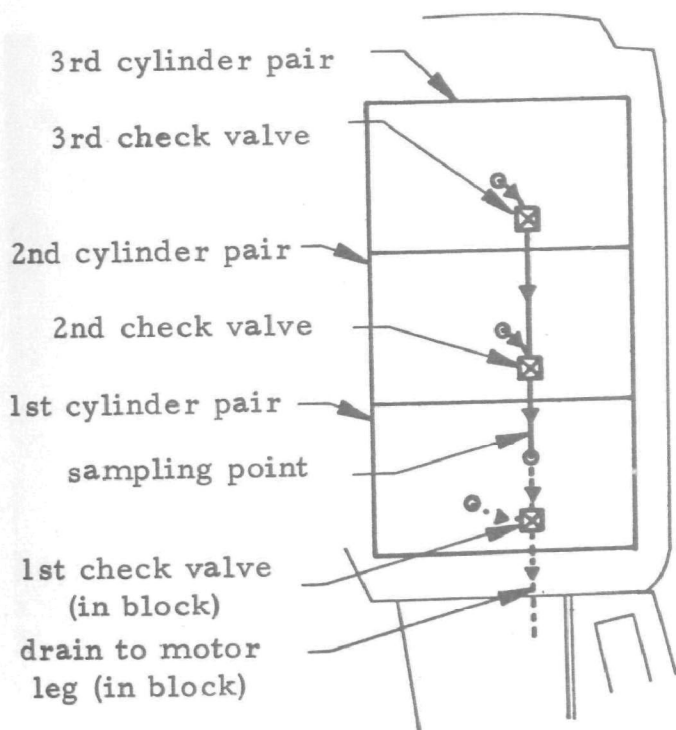
Figure 14. Schematic of drain system, Mercury 6-cylinder motor

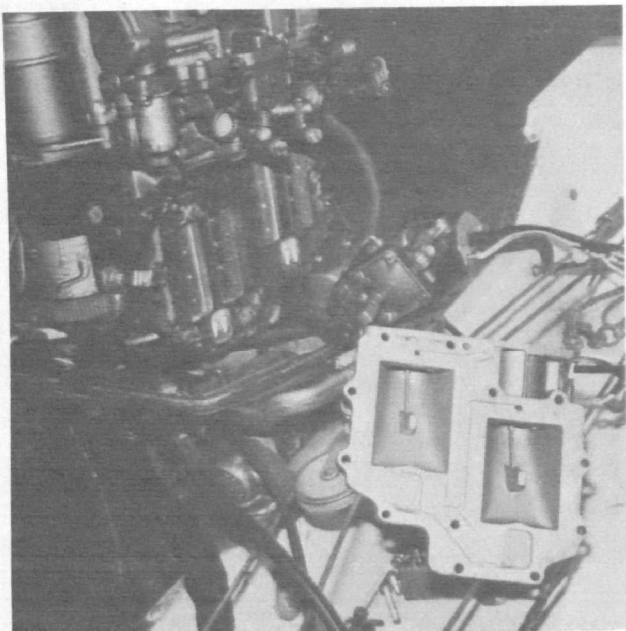
Figure 16. Engine 10 (OMC V-4) partially disassembled, showing drainage reed valves below ports in reed block (left) and stock inlet manifold (lower right)

The modification made to OMC V-4 engines, shown in Figures 16 through 19, involved changes to the inlet manifold. The stock manifold and the reed block are shown in Figure 16, while Figures 17 and 18 show two

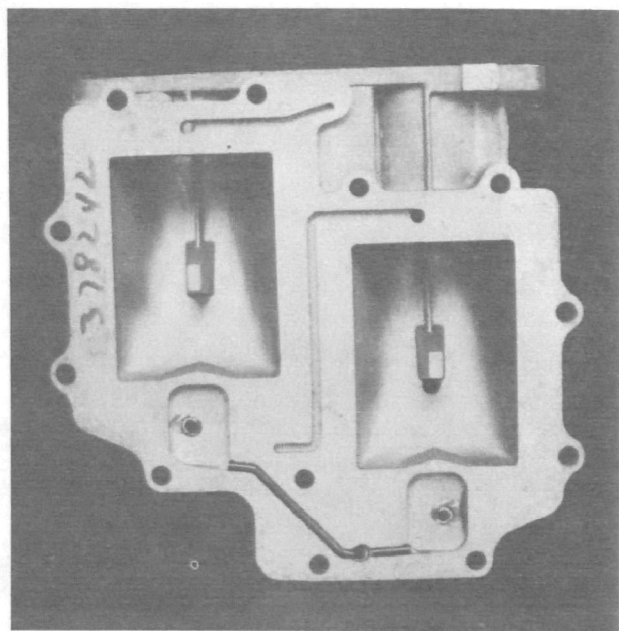
Figure 17. Modified OMC V-4 inlet manifold, showing blocked drain channel, two drain holes, and one return hole

views of the revised manifold. The principle used here was again the blocking of normal drain passages, diverting drainage into the sample collecting system and permitting gases to escape through the return line and into the motor leg. Figure 19 shows the installation of the modified part as well as drainage and return lines. The modified V-4 inlet manifold was used for tests on Engines 10, 15, 15a, 18, and 22.

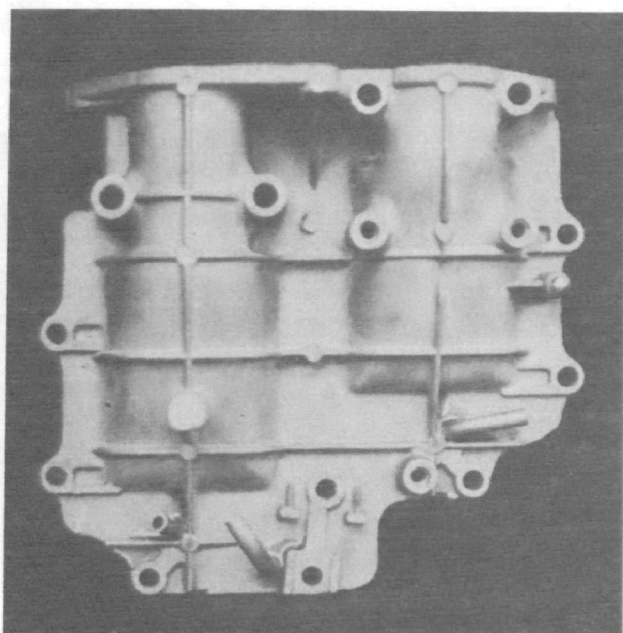
Figure 18. Outside of modified OMC V-4 inlet manifold, showing drain tubes (left and right), gas return tube (center), and blocked manifold pressure tap (appears white, left)

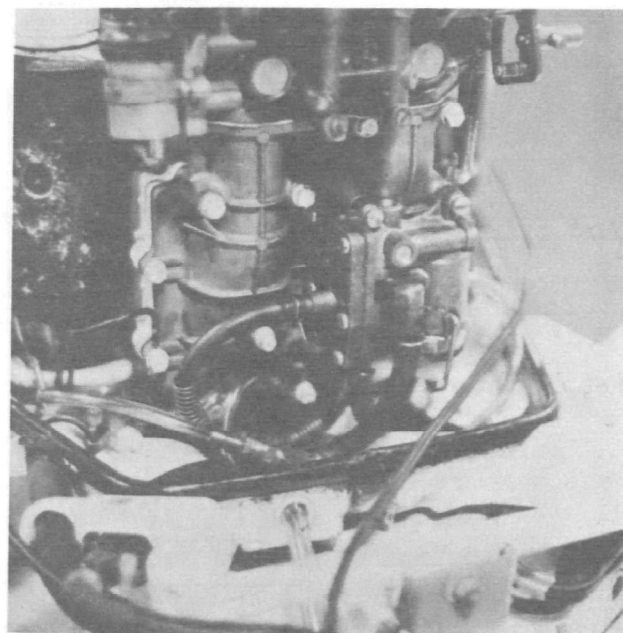
Figure 19. Modified inlet manifold installed on engine 10, showing routing of drain and return tubes (two drain tubes join at the tee just inside motor cover)

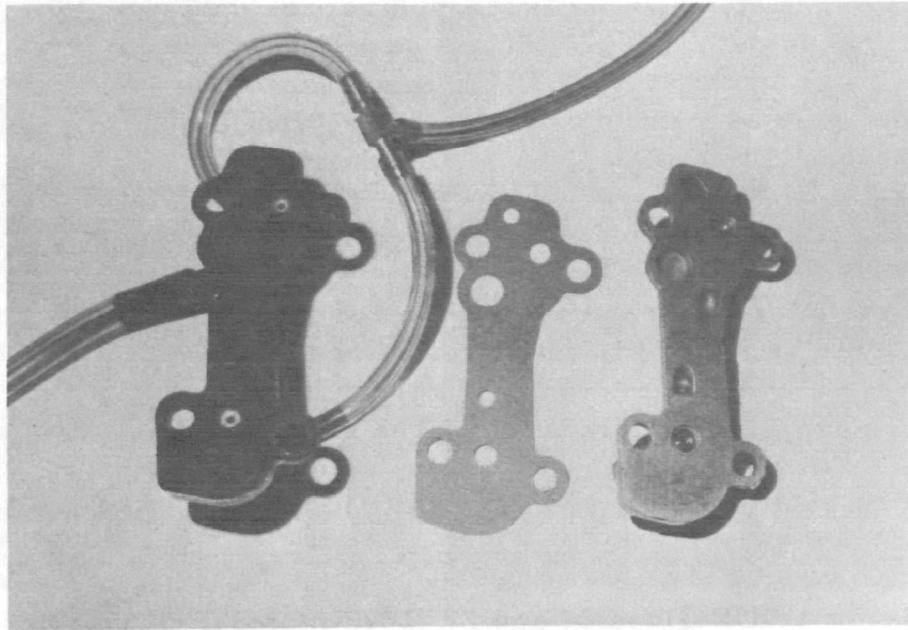
Figure 20. Modified and stock crankcase bleed valve plates for a 1970 Chrysler 5 hp outboard

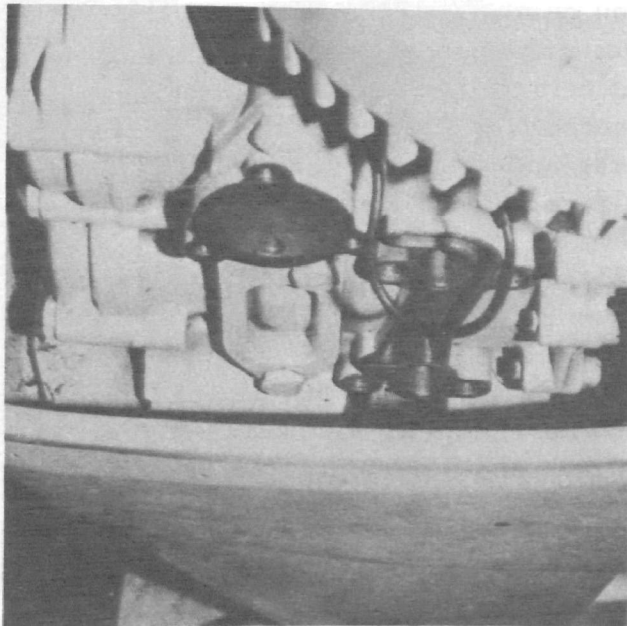
Figure 21. Mounting position for crankcase bleed valve plate on a Chrysler 5 hp outboard

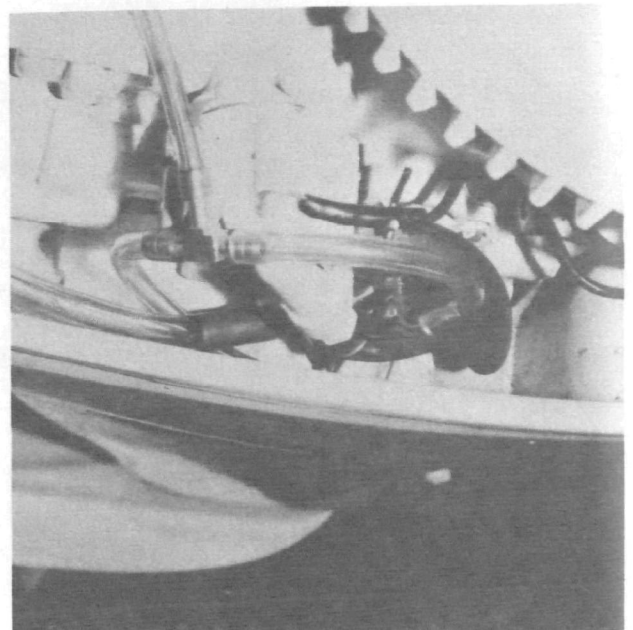
Figure 22. Modified crankcase bleed valve plate installed on a Chrysler 5 hp outboard

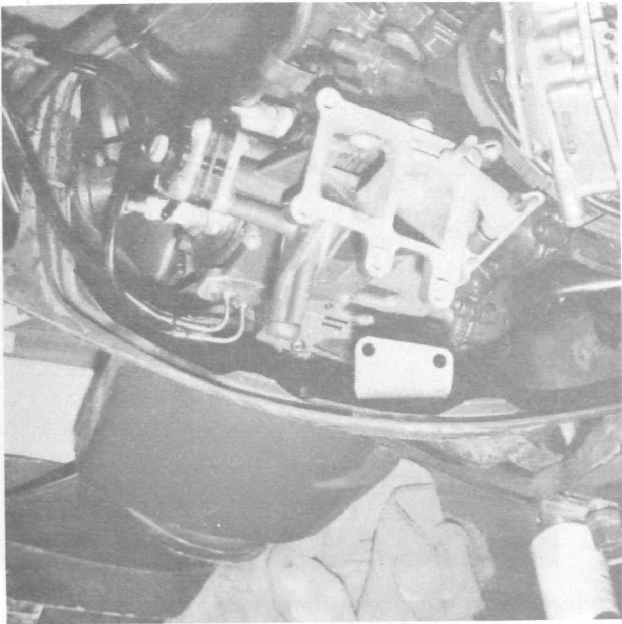
Figure 23. Modified inlet manifold moved back on engine 24 to show check valve and blocked passages

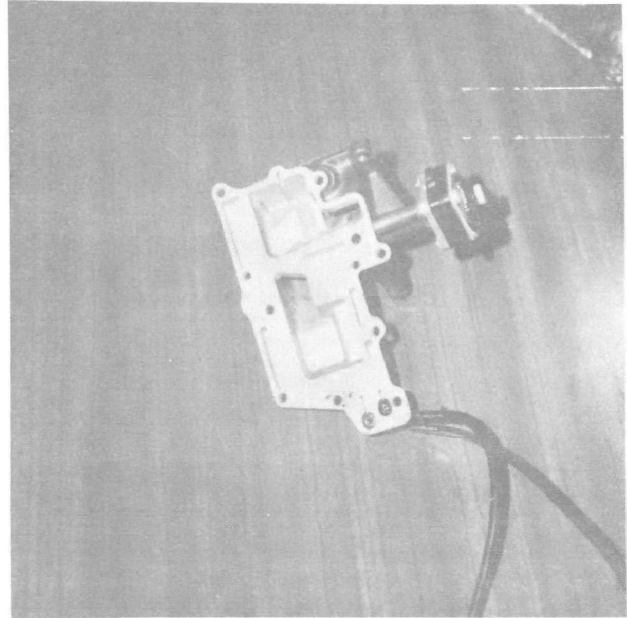
Figure 24. Modified inlet manifold used for tests on engines 24 and 27

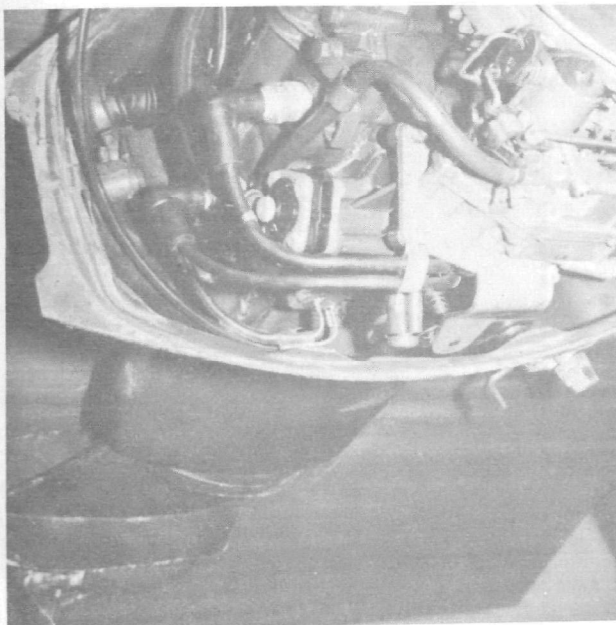
Figure 25. Modified inlet manifold installed on engine 24

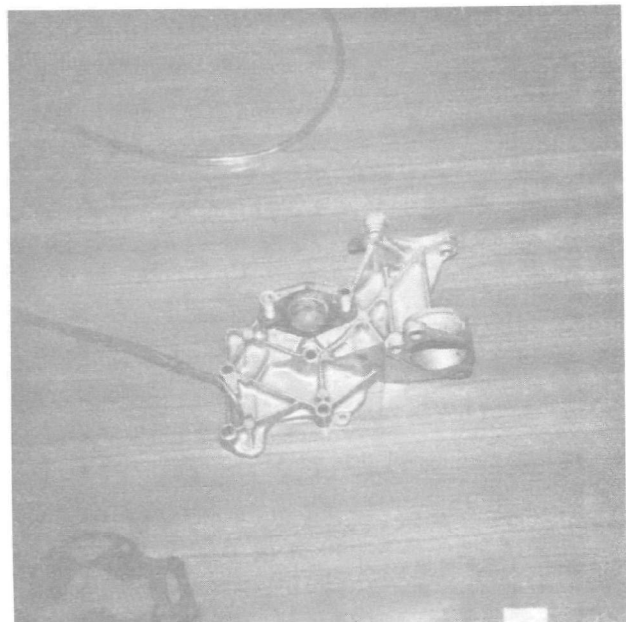
Figure 26. Modified inlet manifold used for tests on engine 26, outside view

The modification required for Engine 25, an OMC 6 hp model, again was in the inlet manifold as shown in Figures 26 through 28. Figure 26 shows the exterior of the manifold with the single drain tube, and Figure 27 shows the same part from the inside. Due to the proximity of the drainage reed valves to the internal (downstream) drain passage, it was impractical to use a gas return line on this engine; and gases (not liquid) were vented to the atmosphere from the sample bottle. Figure 28 shows the front face of the inlet reed plate of Engine 25, the surface on which the inlet manifold was mounted.

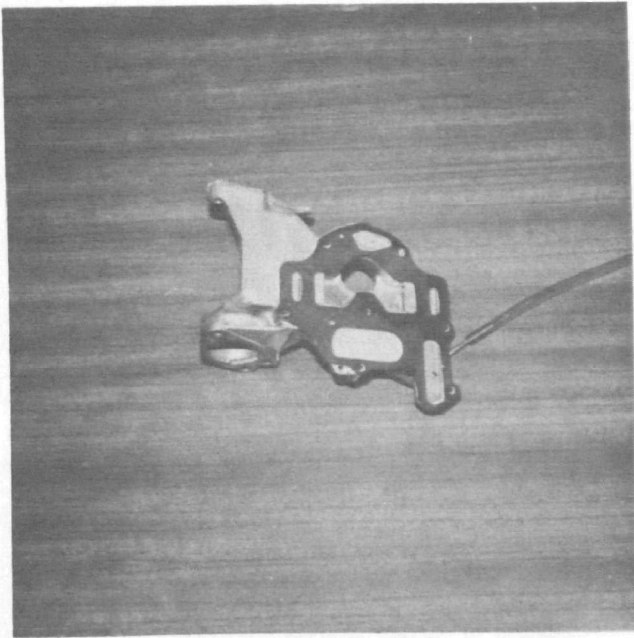
Figure 27. Modified inlet manifold used for tests on engine 26; inside view

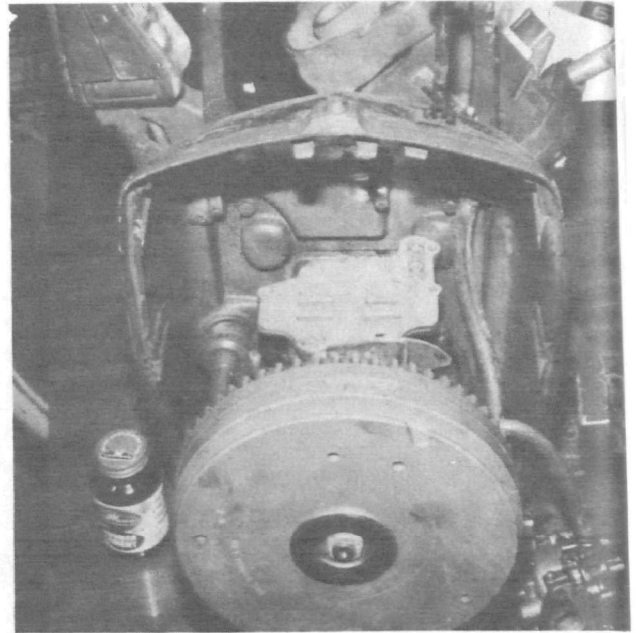
Figure 28. Front face of inlet reed plate, engine 26

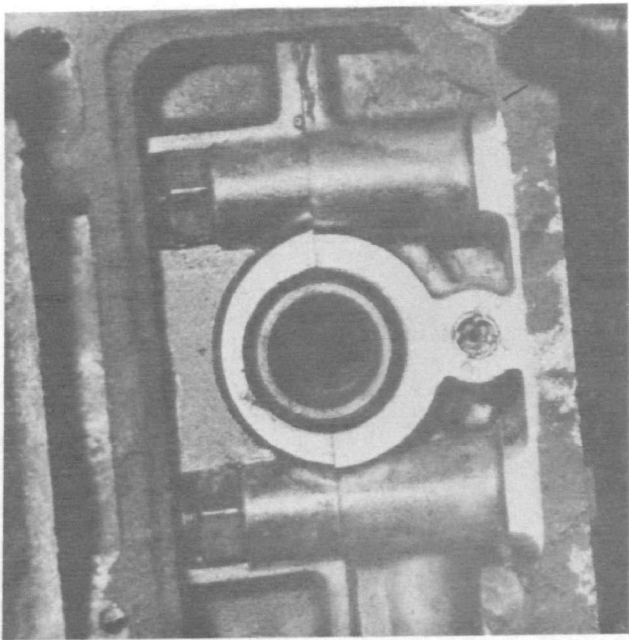
Figure 29. Bottom surface of power-head, engine 29, showing crankshaft and check valve

The last engine tested in 1972 was Number 29, a Mercury 6 hp unit; and it required more extensive disassembly before drainage could be measured than any other test engine. Figure 29 shows the bottom surface of

the powerhead, with the internally-splined crankshaft at center and the drain check valve right of center (forward of the crankshaft, as assembled). In normal operation, drainage simply dropped into a conical recess surrounding the upper end of the driveshaft and was free to mix with exhaust and cooling water below that point. The modification made is shown in Figure 30 and consisted of sealing (with epoxy) a small brass connector into the recess where the check valve was mounted. The small tube was then attached to the connector and routed out of the motor leg through a hole drilled for the purpose. No gas return line was employed on this engine. It should be noted that the modification described here, or some similar effort, would have been necessary for measurement of drainage from the lower pair of cylinders on all the other Mercury engines tested. Engine 29 was purchased by the contractor so the extensive work could be done, because it was not considered reasonable to ask private owners for permission to do such work on their engines.

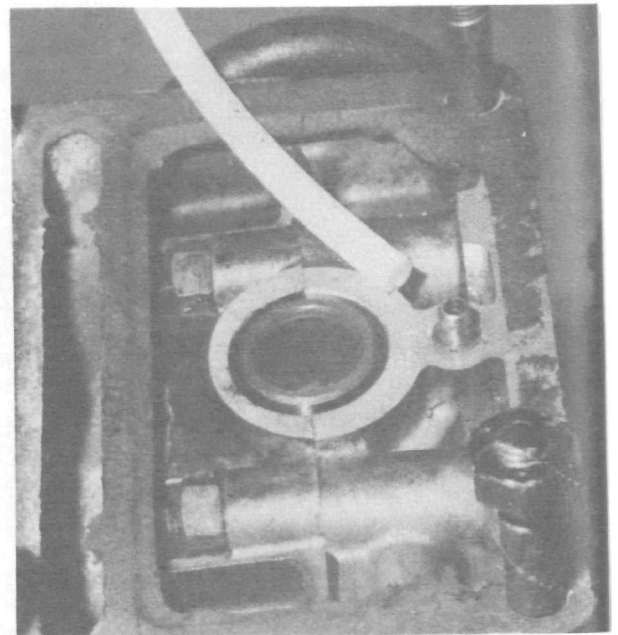
Figure 30. Connector added to check valve on engine 29 for acquisition of sample

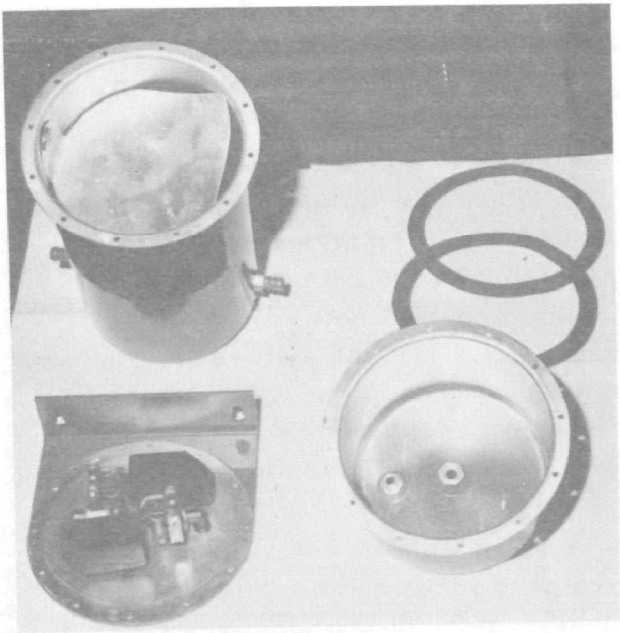
Figure 31. Crankcase drainage interception/recirculation device disassembled

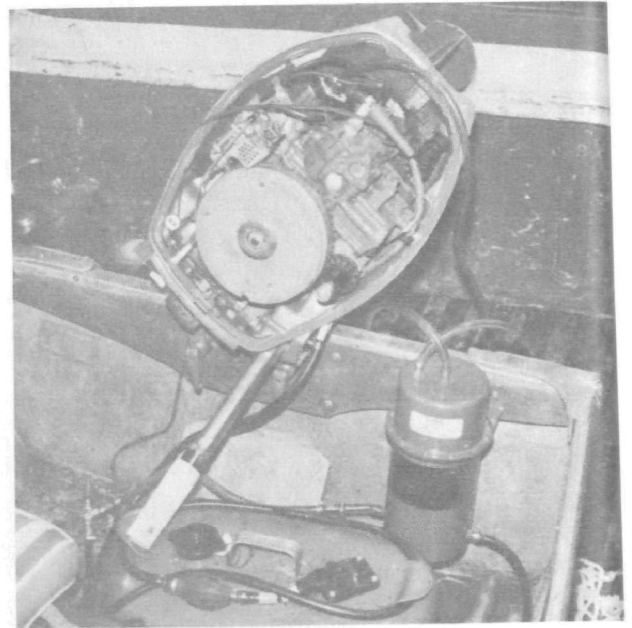
Figure 32. Crankcase drainage interception/recirculation device as installed on a small boat

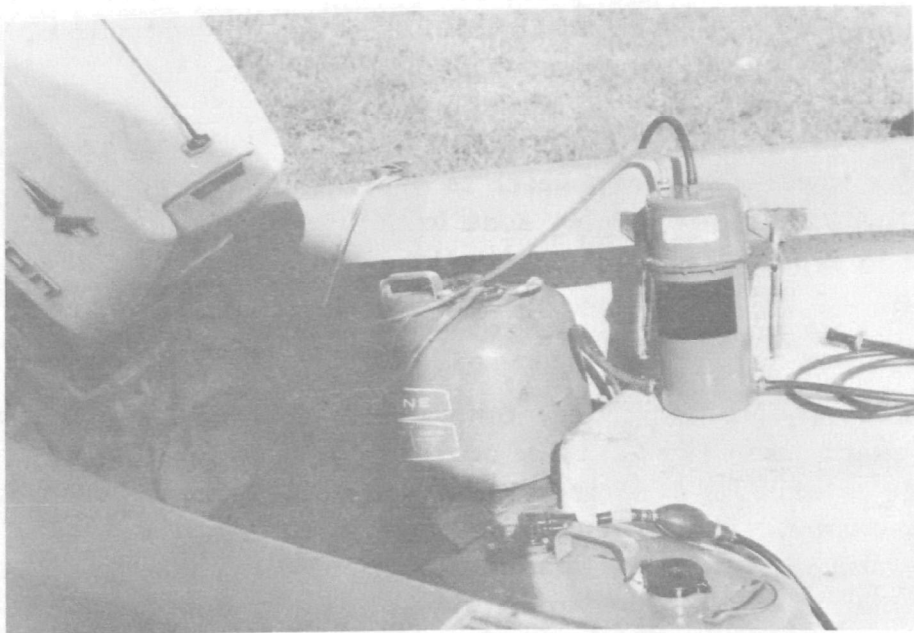
Figure 33. Crankcase drainage interception/recirculation device installed (temporarily) on a larger boat

In addition to the drainage measurements on the entire group of test engines, the contract included a cursory assessment of a commercially-available drainage interception and recirculation device. This assessment included brief studies of effectiveness and ease of installation, and some tests to determine influence on engine performance. The device is shown disassembled in Figure 31 and consists of the lower chamber (upper left in photo), dividing plate with float valves (lower left), and upper chamber (shown inverted at bottom right of photo). In operation, drainage entered the upper chamber through the off-center fitting, gases were vented to the atmosphere through the center fitting, and liquids accumulated over the dividing plate until one (or both) of the float valves opened. The lower chamber, which is essentially an expansion of the stock fuel line, acts as a mixing zone for the drainage and incoming fresh fuel. A typical permanent installation of this device is shown in Figure 32 with a 9.5 hp motor, and the temporary installation used for a 40 hp motor is shown in Figure 33.

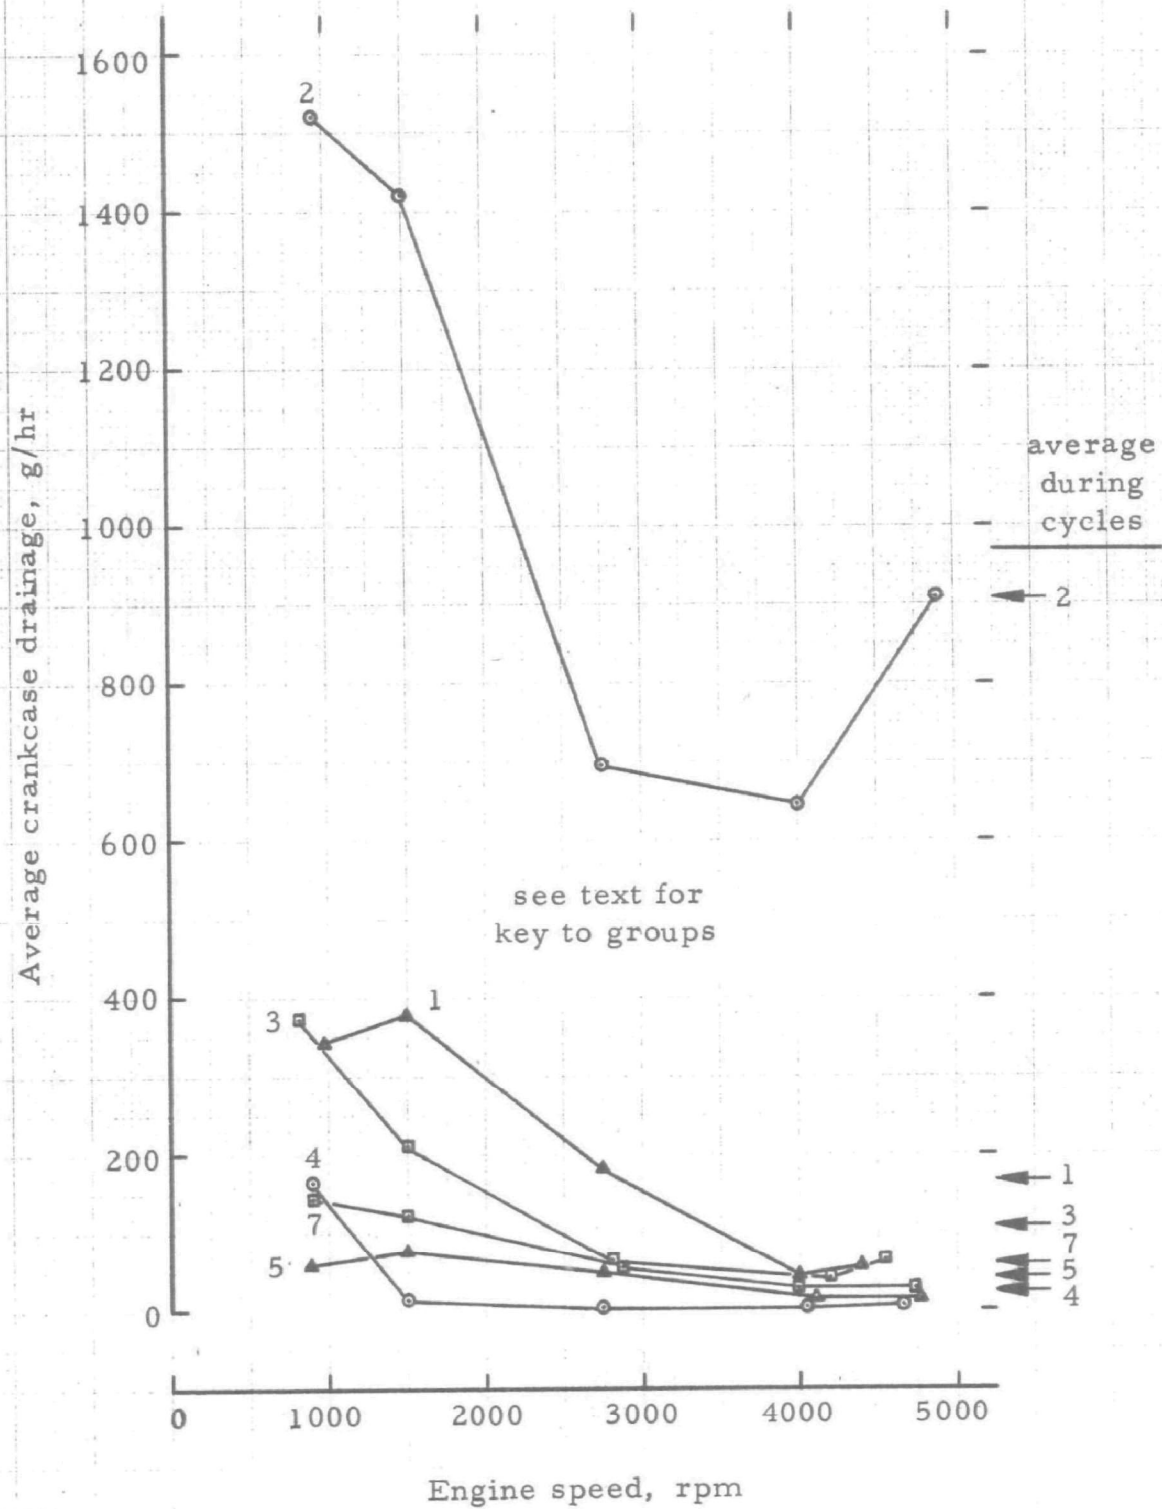
Figure 34. Average crankcase drainage (mass rates) for six engine groups, during cycles and as functions of engine speed

Figures 34 and 35 are presented to show data from Tables 8 and 9 graphically. Figure 34 shows average drainage rates from groups 1-5 and group 7 as recorded in Table 8, including drainage both as a function of crankshaft speed and during cycles. In terms of total drainage rates, group 2 (OMC V-4's) stands apart at the high end of the scale. Groups 1 and 3 (OMC 9.5 hp twins and OMC 30-40 hp twins) occupy the middle of the scale,

and the other groups (7, 4, 5) are fairly close at the low end. Drainage during cycles is indicated by the arrows at the right side of the graph.

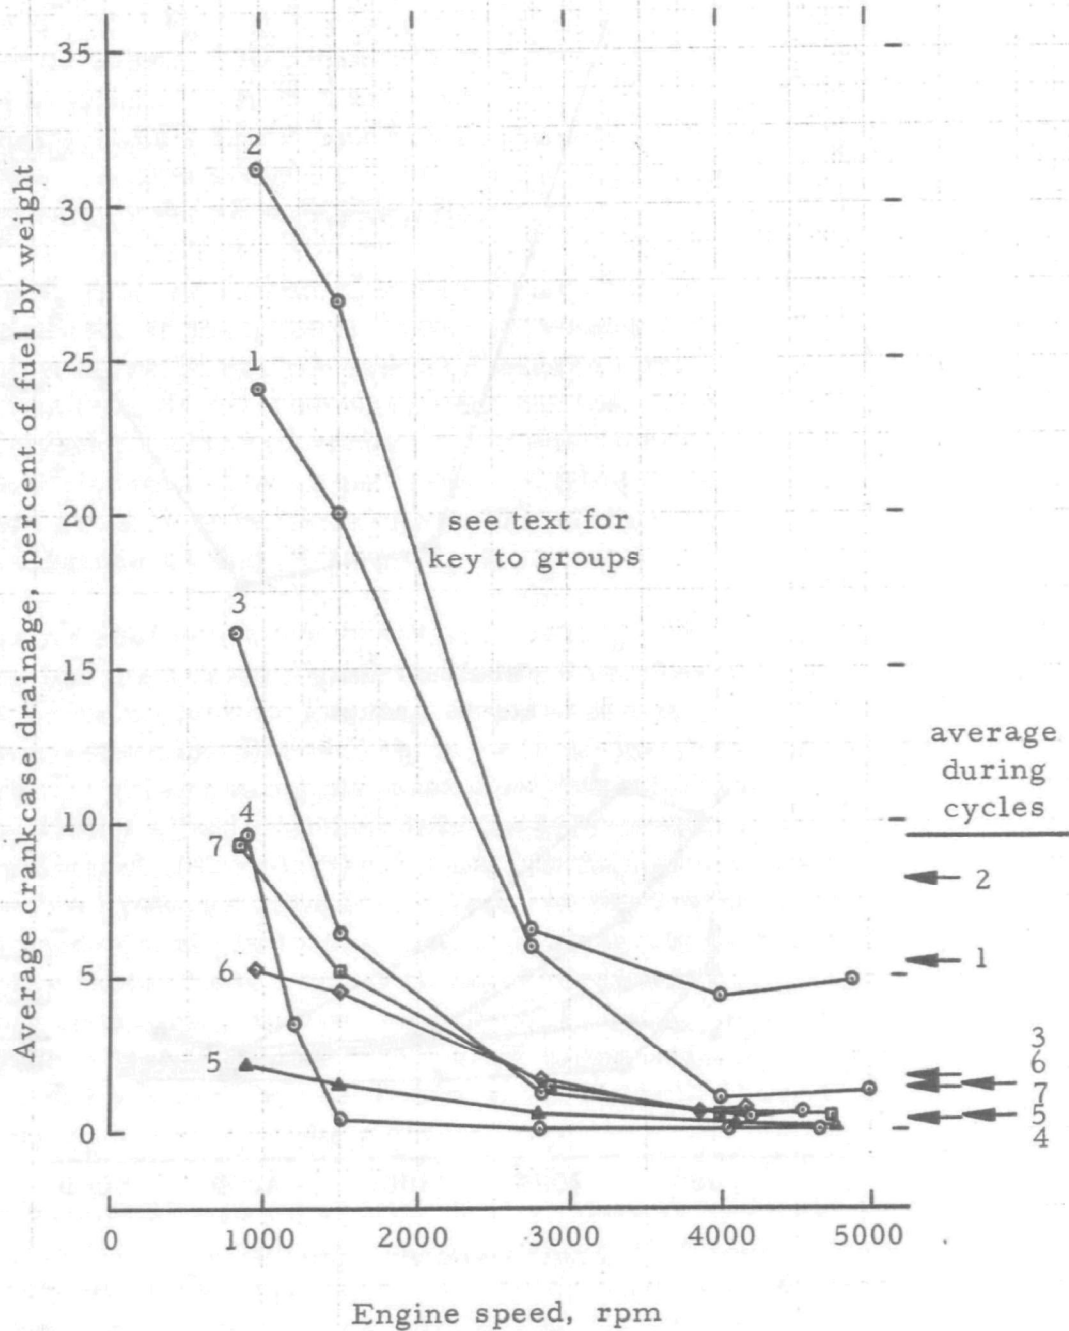
Figure 35. Average crankcase drainage (weight percent of fuel) for seven engine groups, during cycles and as functions of engine speed

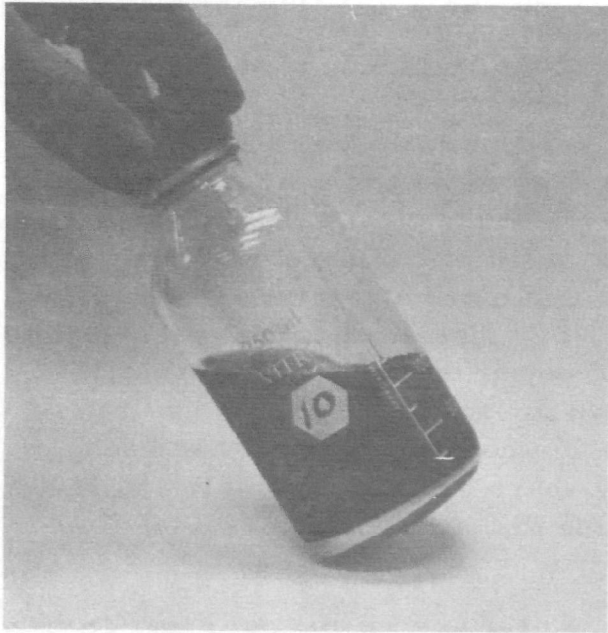
Figure 36. Typical sample from engine 9 showing water layer under drainage

Drainage emitted from three of the "defective" engines (Nos. 9, 25, and 29) did contain water, as documented by Figures 36 through 38. The water appeared to be physically mixed with drainage to some extent, and further "settling" of the two layers occurred when the samples stood for several days. Several methods were employed to separate the hydrocarbon and water phases, including decanting and absorbing the aqueous phase with a dessicant. The most successful technique was removal of the aqueous phase through a long hypodermic needle, permitting the remaining fuel-based material to be measured volumetrically and to be weighed in the normal manner. The white appearance of the water layer in Figures 36 through 38 was apparently due to partial mixing of water and hydrocarbon materials, causing a certain amount of emulsification. After an extended period without agitation, some clarity returned to the water phase, with more change being evident for those samples which contained more water than drainage.

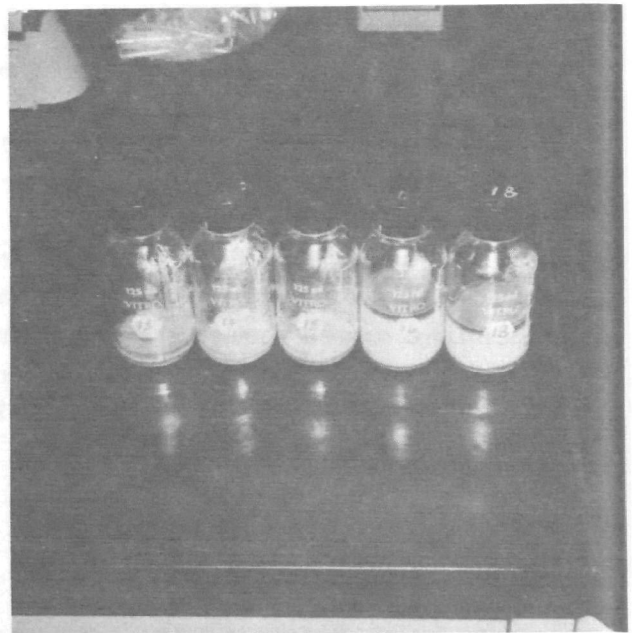
Figure 37. Drainage samples from motor no. 25 showing water layers under fuel-based material

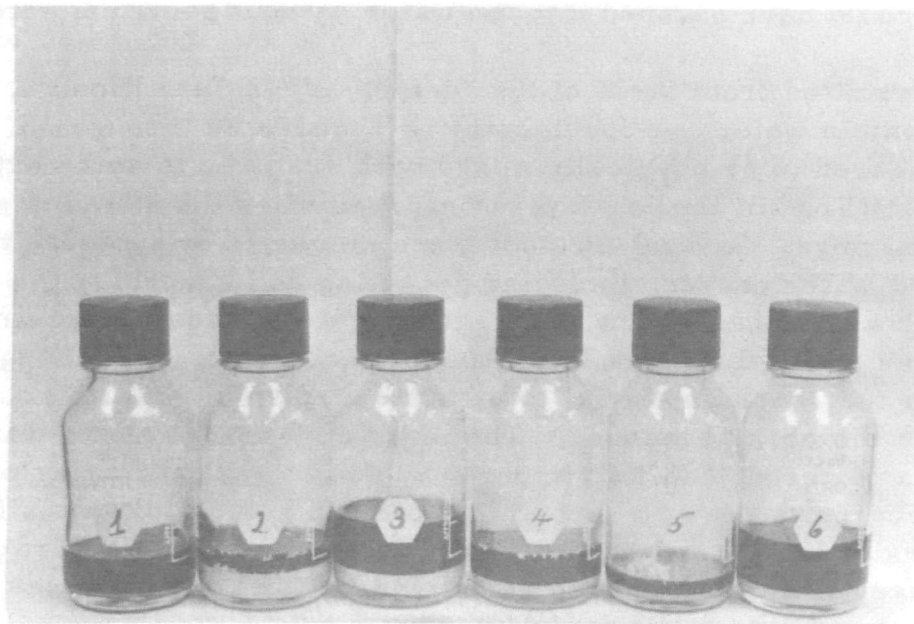
Figure 38. Drainage samples from engine 29 showing water layers under fuel-based material

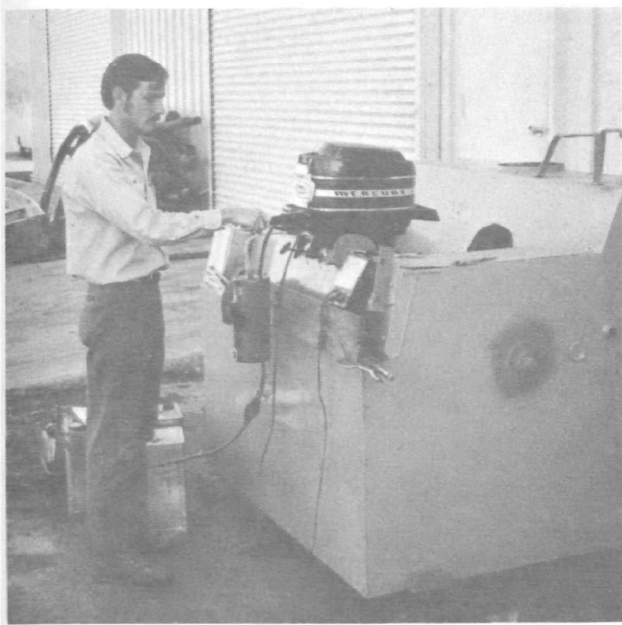
Figure 39. Stationary tank test of Mercury 6 hp motor with interception/recirculation device

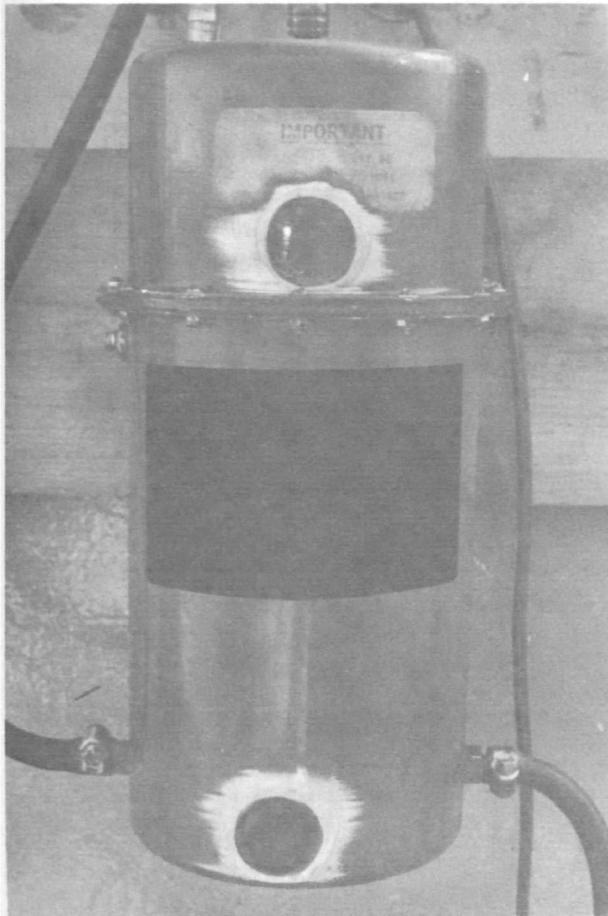
Figure 41. Device after about 1.5 hours of operation

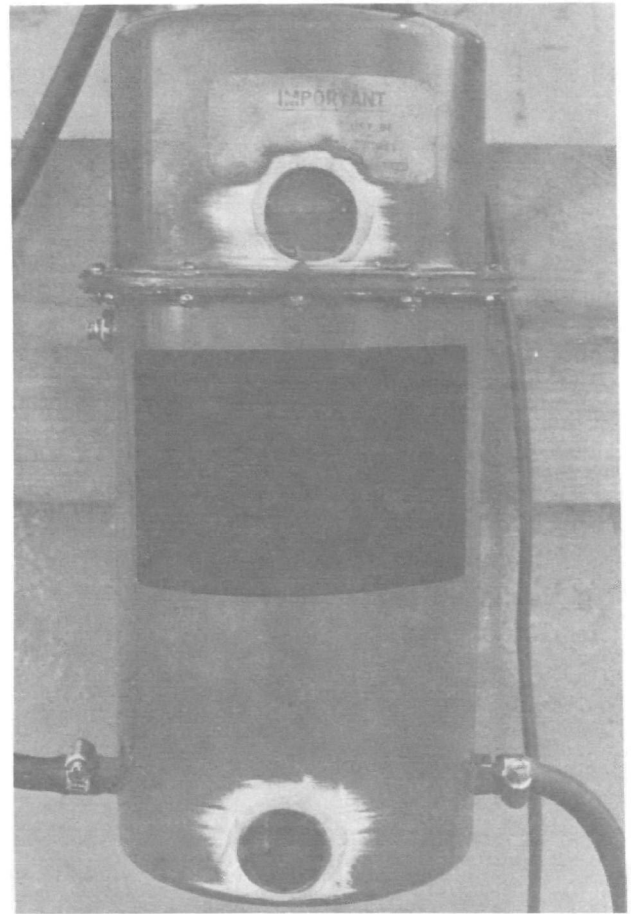
Figure 40. Drainage interception/recirculation device after about one hour of operation

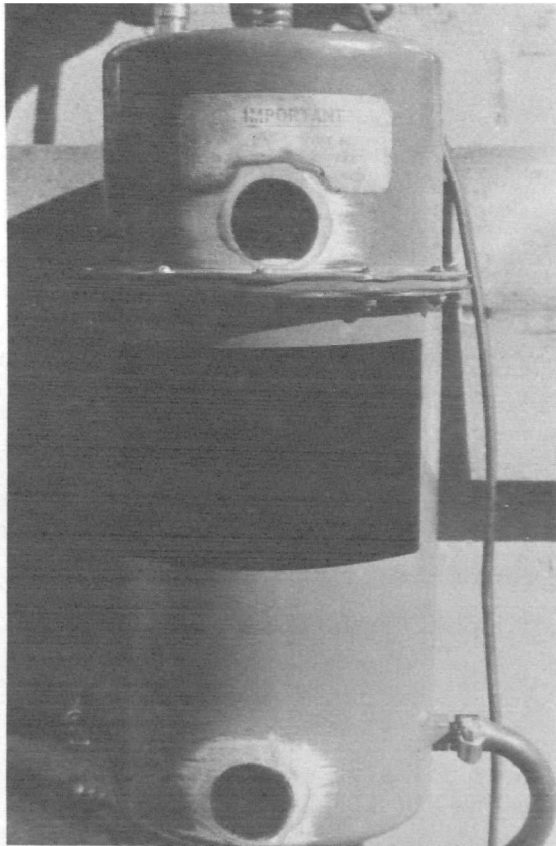
Figure 42. Drainage interception/ recirculation device after about five hours of operation on unit 29
