EPA-670/2-74-092
December 1974

CRANKCASE DRAINAGE FROM IN-SERVICE OUTBOARD MOTORS

Charles T. Hare
Karl J. Springer
Southwest Research Institute
Department of Emissions Research
San Antonio, Texas 78284

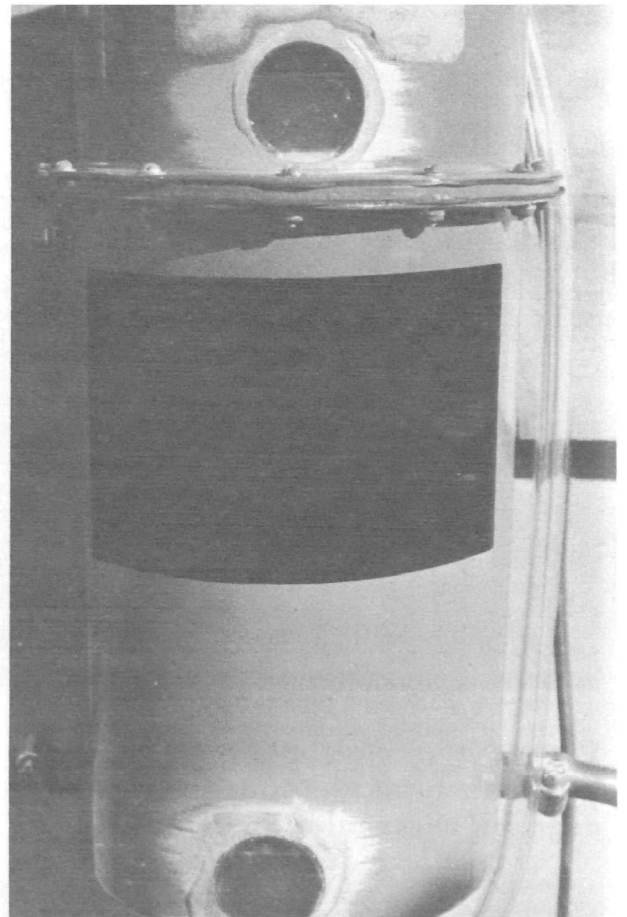
Figure 43. Device after five hours 43 minutes of operation (end of test) on engine 29

operation to the point at which sufficient water had built up in the lower chamber to stop the engine. Engine stoppage by choking the fuel system with water would have occurred much more rapidly for an engine which emitted more water, such as Engine 25 (see Figure 37). This engine stoppage is not necessarily a disadvantage of the device, because it would alert the motor owner that a problem existed, and he might be able to have his engine repaired before serious damage occurred (such as from storage of an engine over the winter with water in the crankcase). It was also observed that the water fractions of some drainage samples had a high viscosity, more or less in proportion to their degree of turbidity. Note in Figure 36, for instance, that the water fraction in the sample did not form a horizontal interface with the fuel-based material when the bottle was tilted. This particular property of the aqueous layer could cause the orifices of the float-controlled valves in the recirculating device to plug when water reached their level (in the top chamber), which would cause the top chamber to overflow through its vent tube and render the device ineffective.

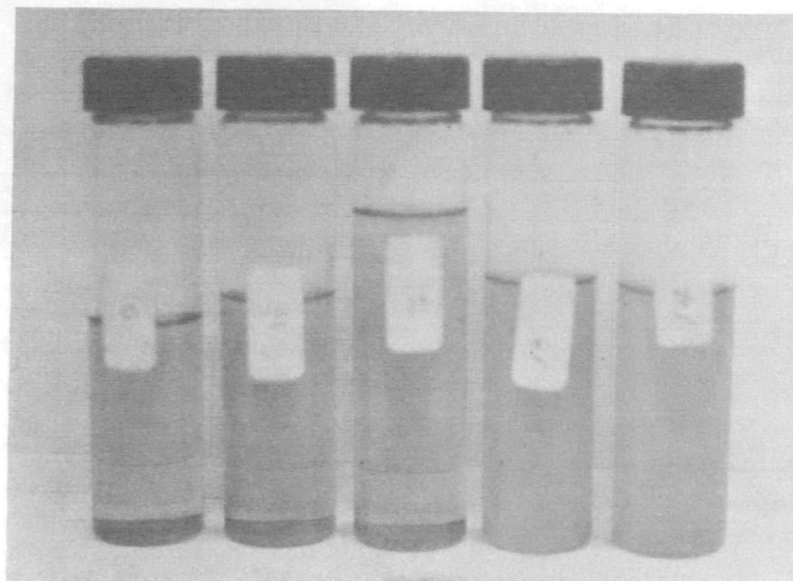
Figure 44. Fuel samples taken from line downstream of recirculation device for engine 29 (sampling times shown in Table 10)

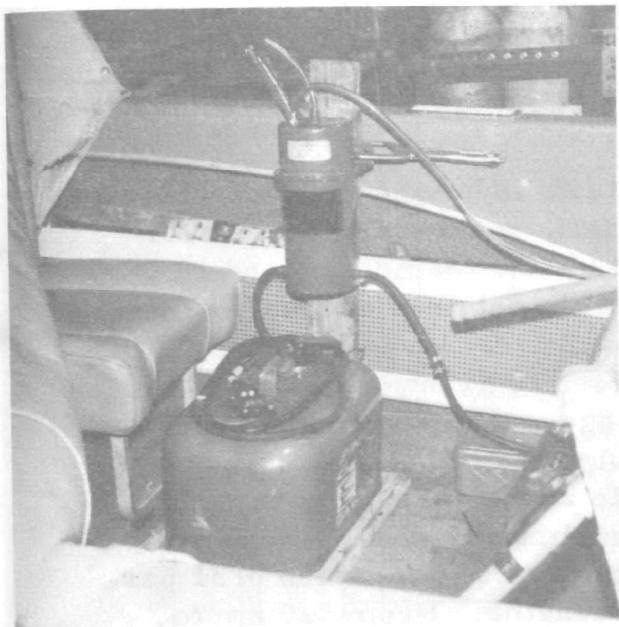
Figure 45. Installation of interception/recirculation device for operation of engine 18

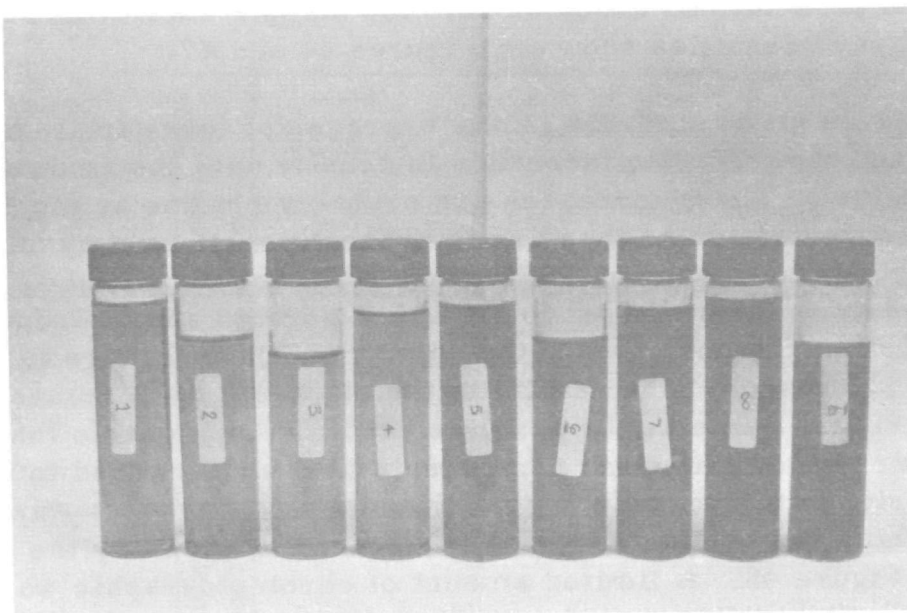
Figure 47. Fuel samples taken from line downstream of recirculating device for engine 18 (sampling times shown in Table 11)

for the last few samples. The base gasoline color was a light yellow-orange, and the OMC oil used was a dark blue-green. This photo is not a quantitative indicator of the difference between fresh fuel and fuel mixed with drainage, but it does help visualize the changes which occurred.

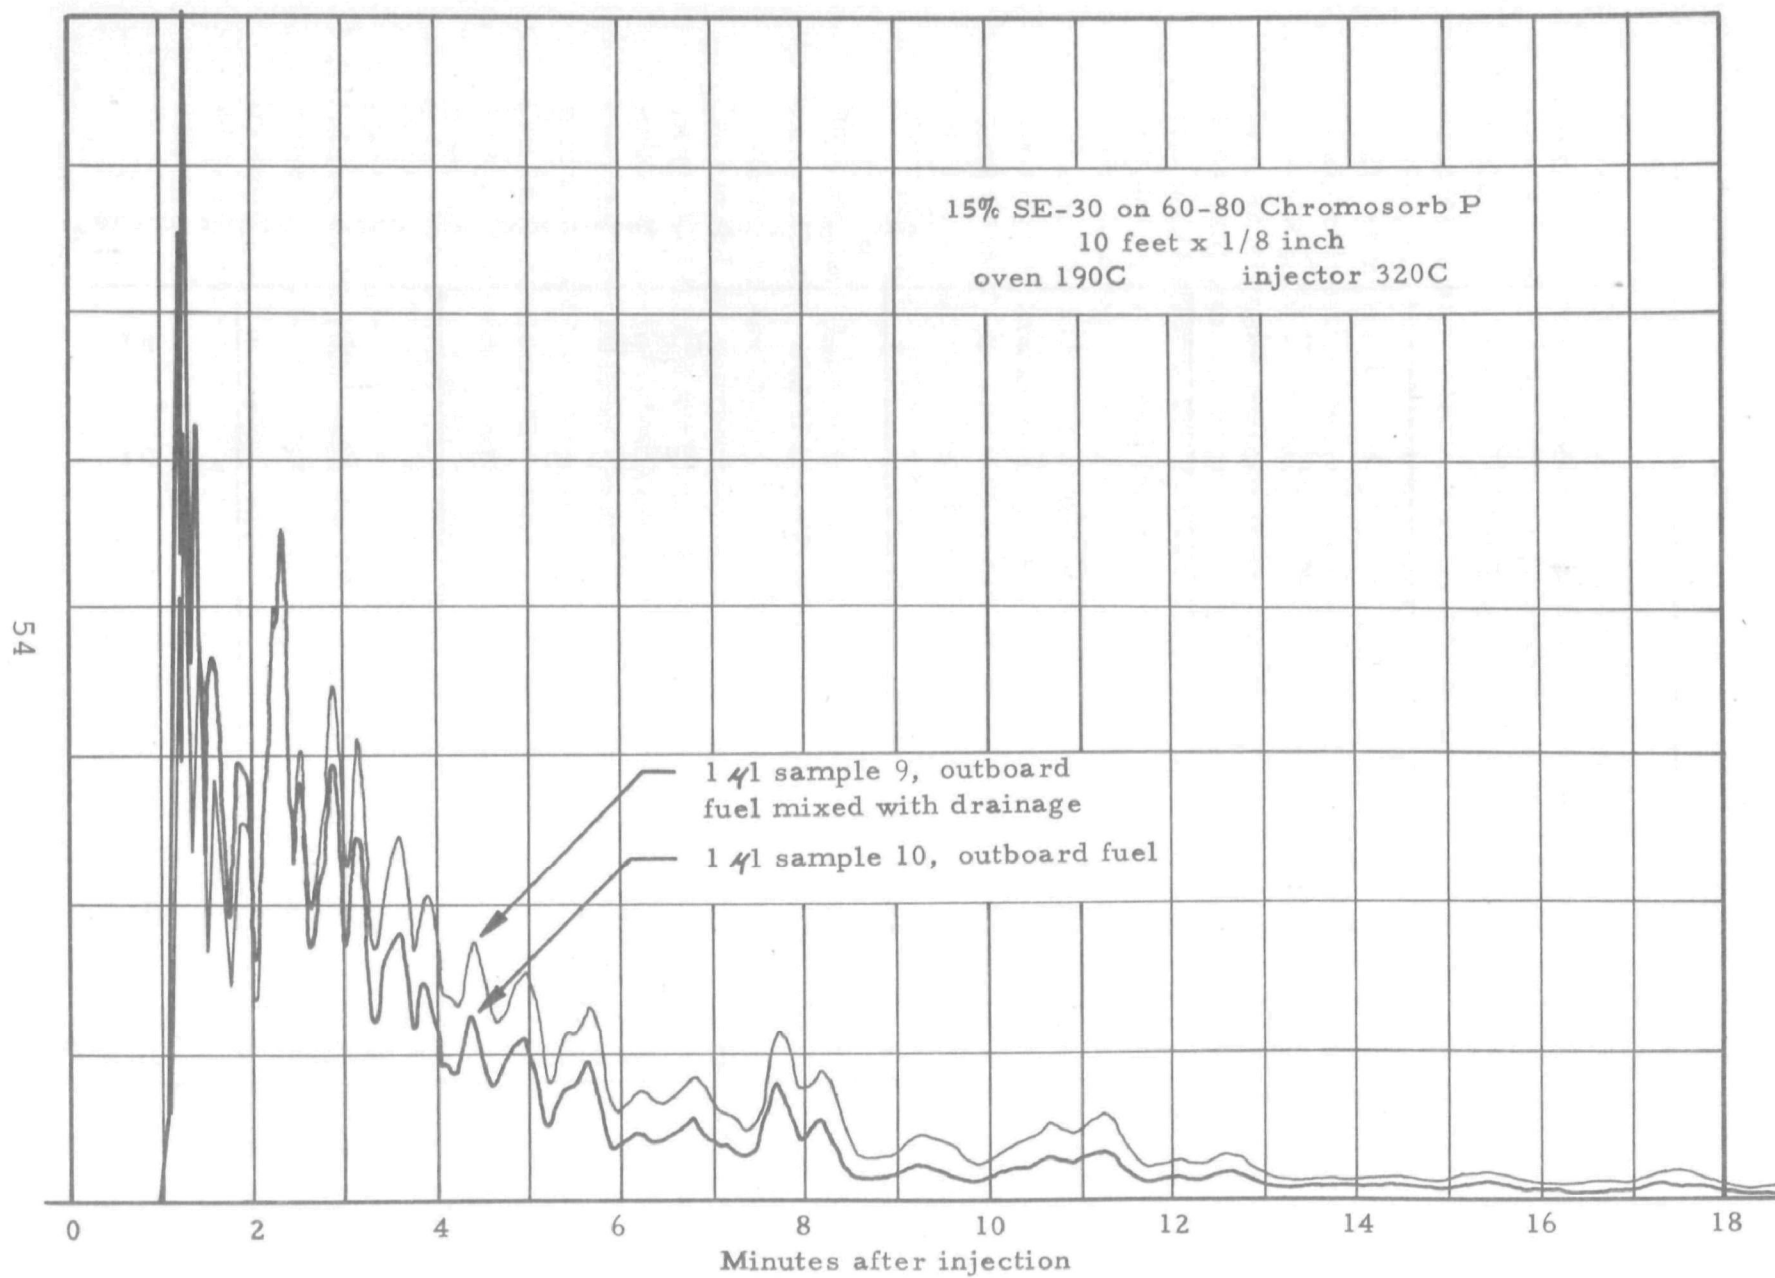
Figure 48. Chromatogram (tracing) of outboard fuel and fuel mixed with drainage
