INDUSTRIAL WASTES SURVEY  
MAPLEWOOD POULTRY  
POULTRY PROCESSING

BELFAST, MAINE

DECEMBER 1 AND 2, 1970

MAPLEWOOD POULTRY AND POULTRY PROCESSING  
BELFAST BAY, BELFAST, MAINE  
DECEMBER 1-2, 1970

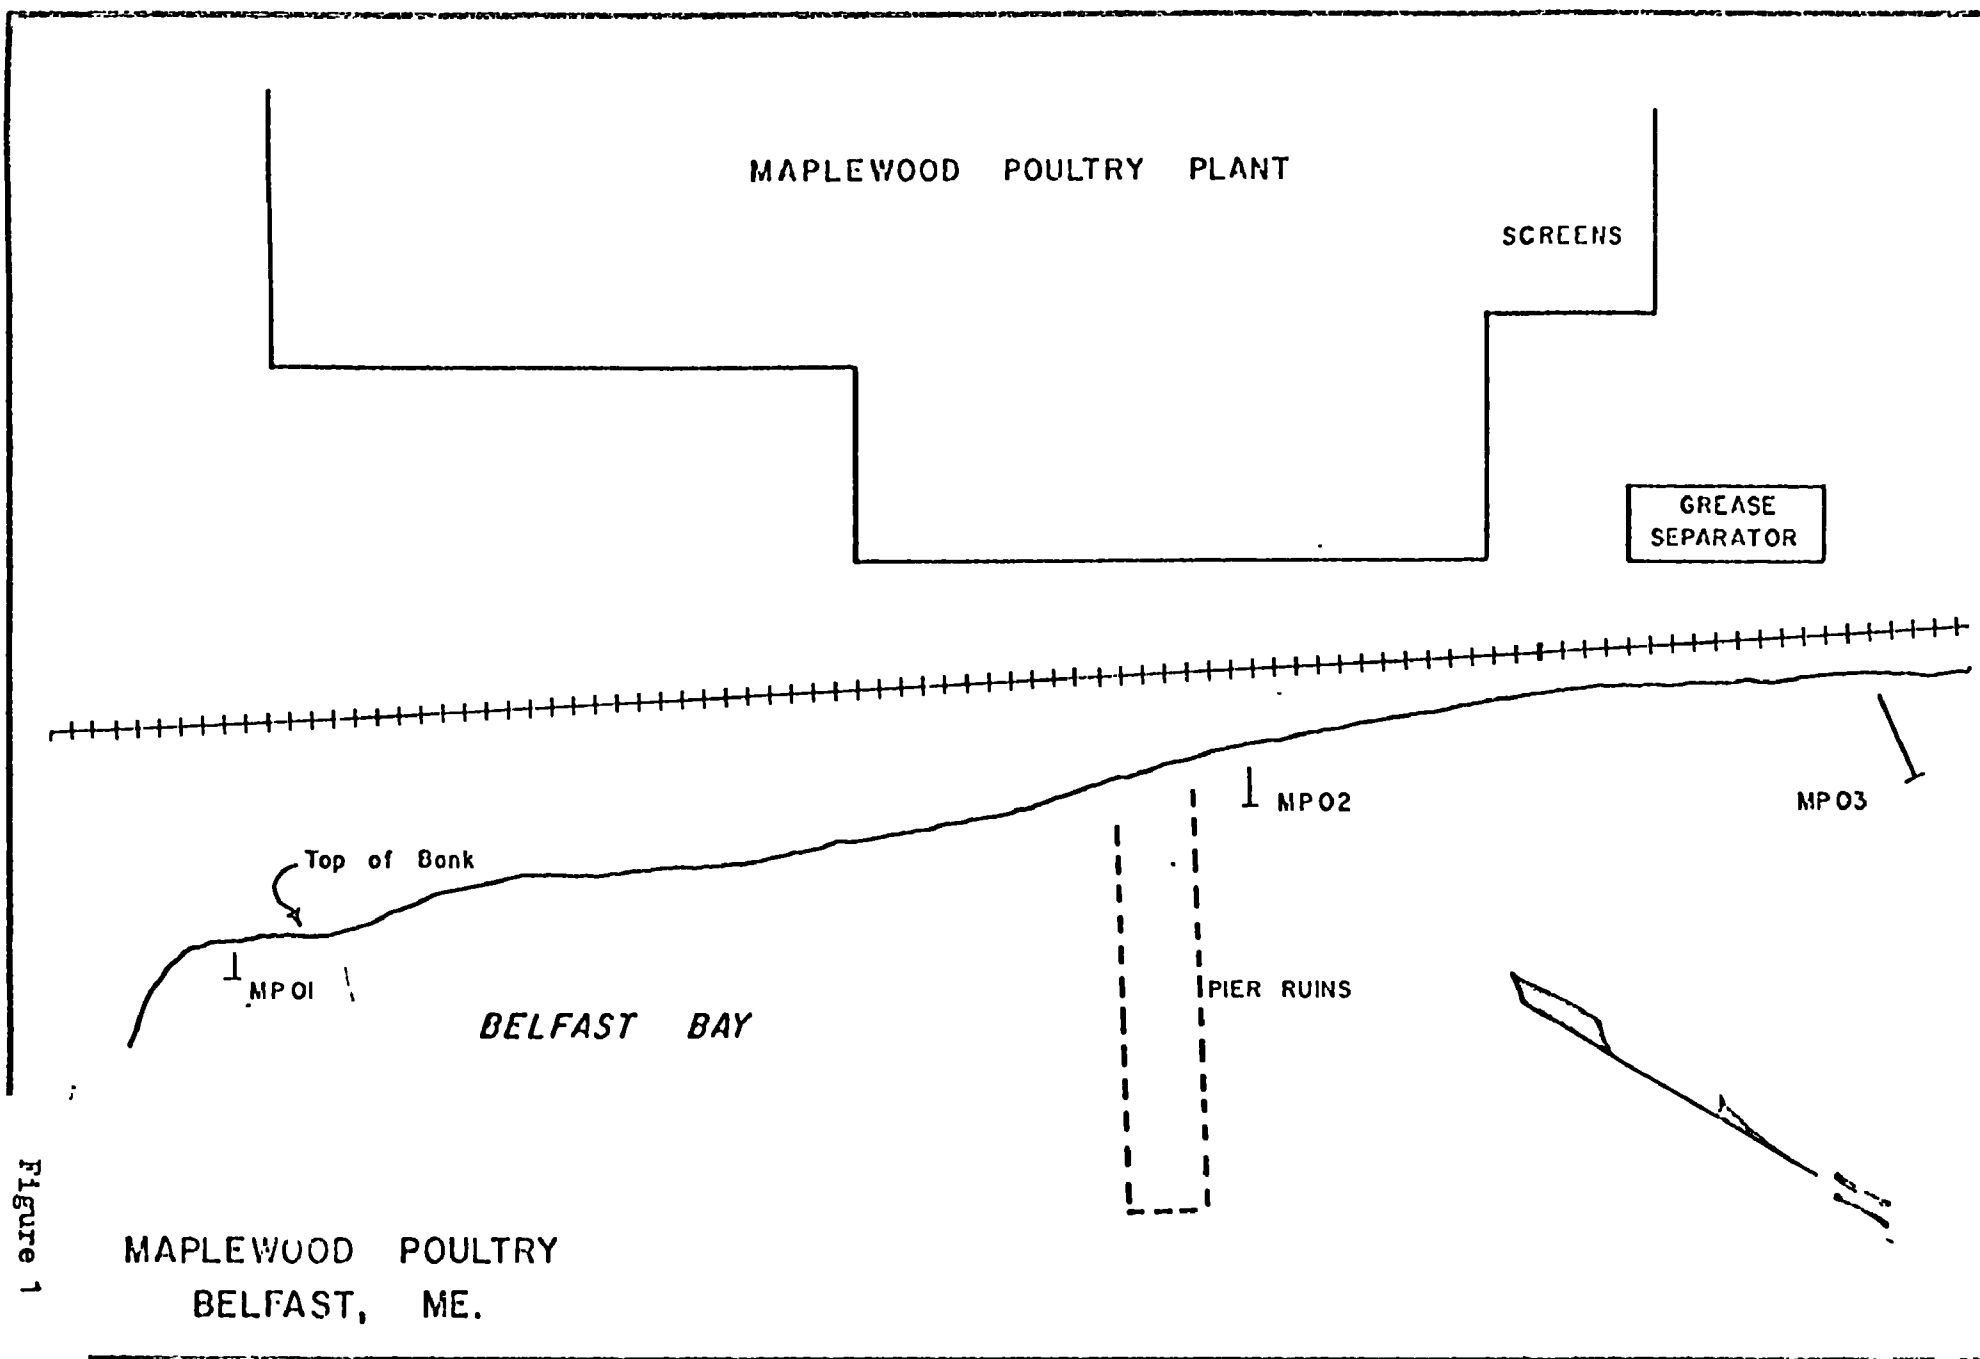
Figure 1

The southernmost outfall (Station MP-01) is a 24" concrete pipe which reportedly carries the waste from the picking room area where the birds are killed and plucked. The effluent was a reddish-yellow color and varied markedly in quantity of flow (Figure 1 and 3).

pipe reportedly carries the drainage from the preparing rooms. This had the smallest flow of the three outfalls (Figure 1 and 3).

The northernmost outfall (Station MP-03) is a 30" corrugated steel pipe which carries the waste from the eviscerating area. The waste is the largest of three effluents and is passed through screens and a grease separator before discharge (Figure 1 and 4).
