Laboratory Studies of Soil Bedding
Requirements for Flexible Membrane Liners

EPA-600/2-84-021

Geotechnical Laboratory

U. S. Army Engineer Waterways Experiment Station
Vicksburg, Mississippi 39180

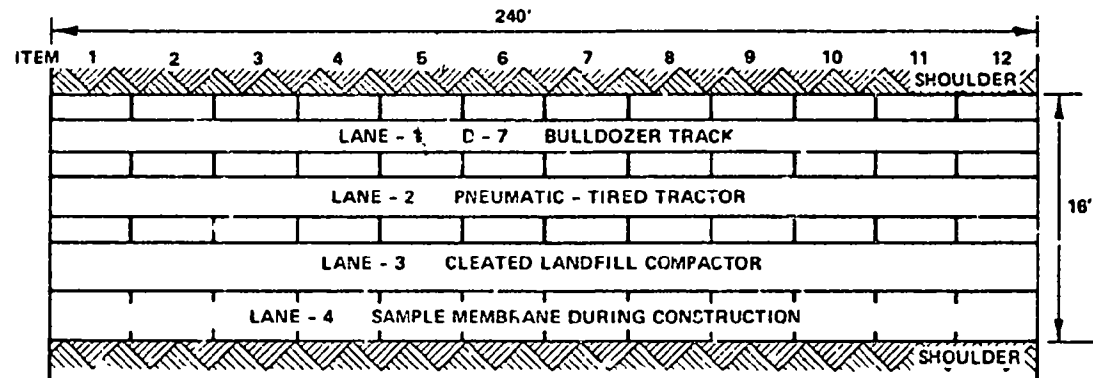
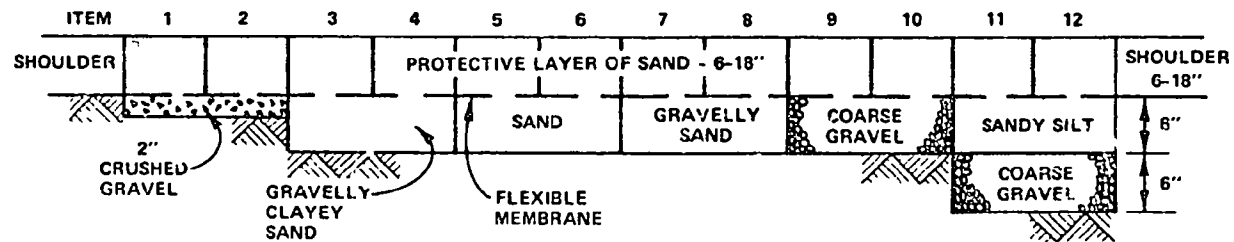
Figure 1. Plan and profile of test section.

PLAN

PROFILE

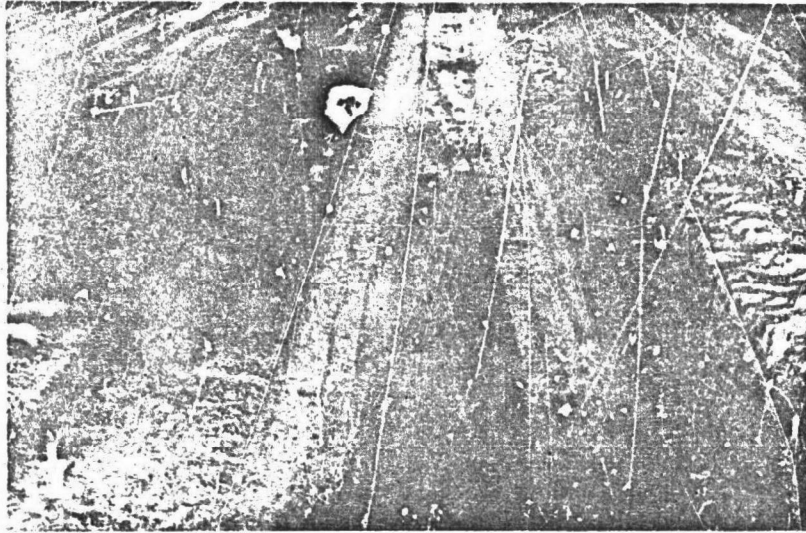
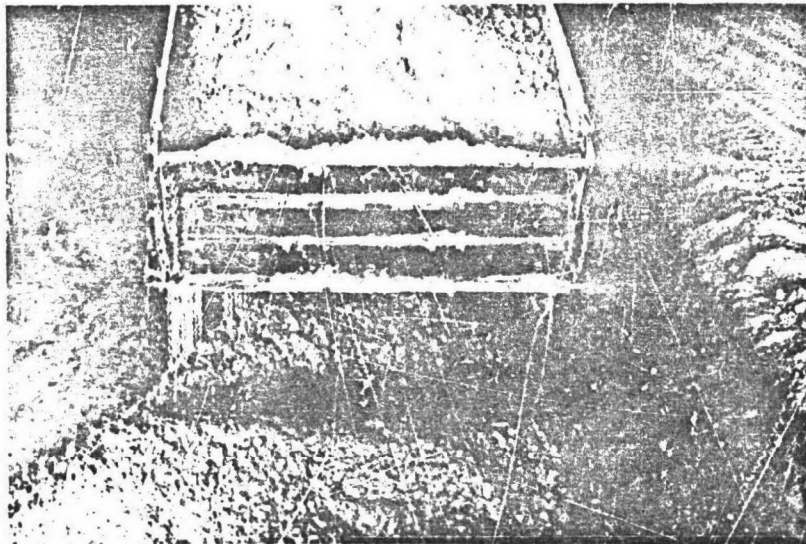
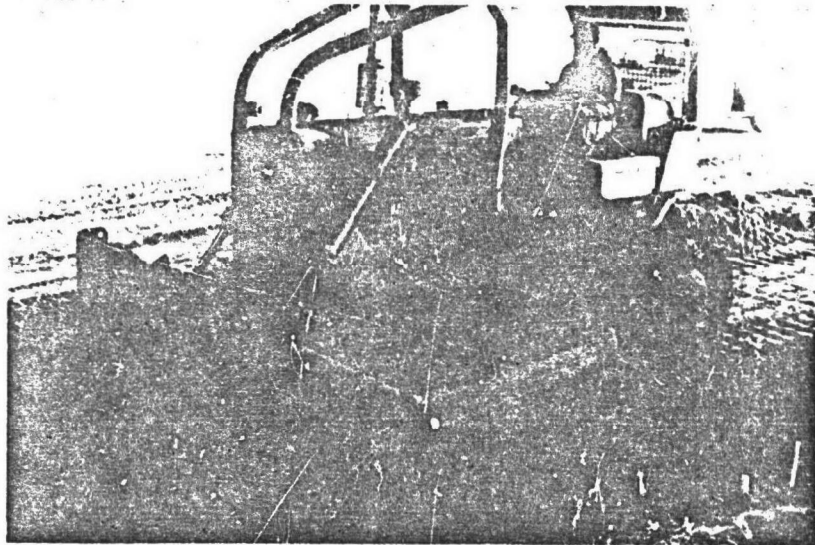
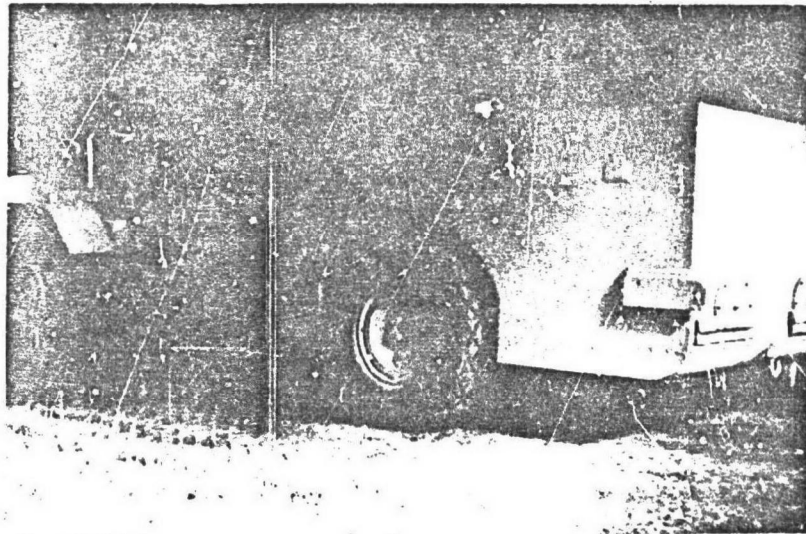
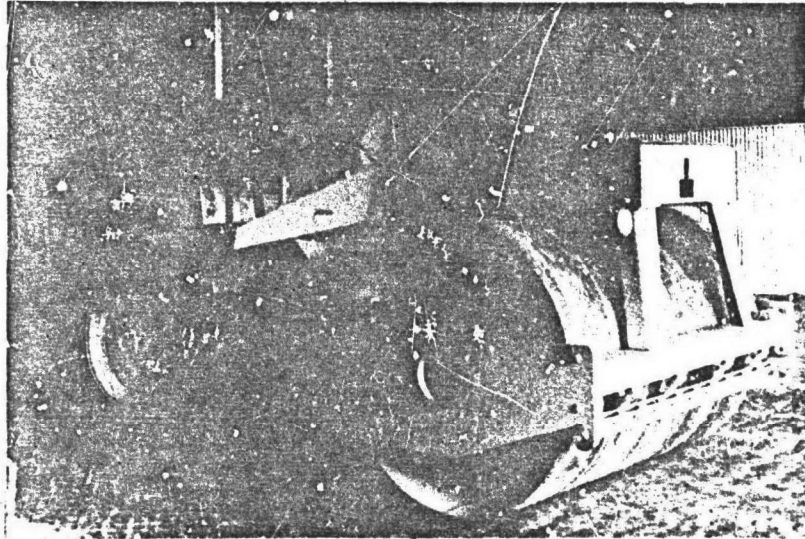
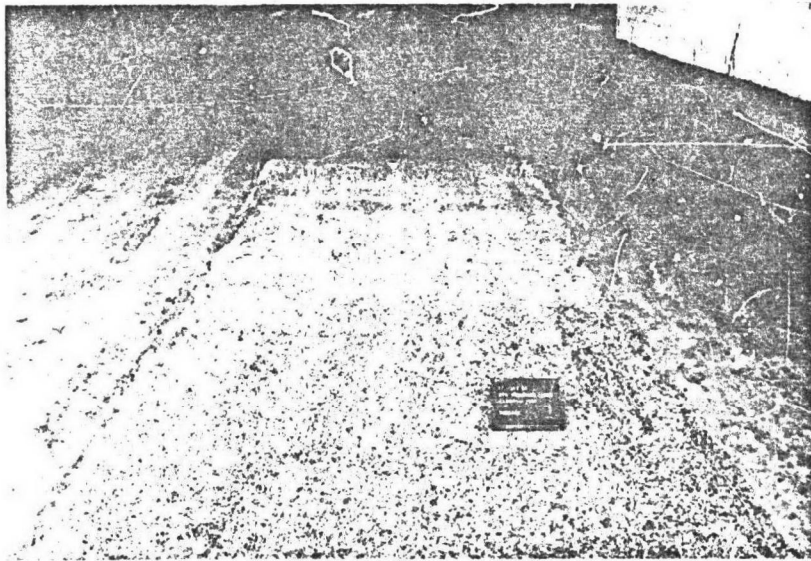
Figure 2. Construction of the test section.

a. Test section prior to placement of selected subgrades.

b. Subgrade being placed in Items 3 and 4.

c. Spreading subgrade material.

d. Pneumatic-tire roller used for compaction of subgrade.

e. Vibratory roller used for compaction of subgrade.

f. Overall view of test section with subgrades in place.

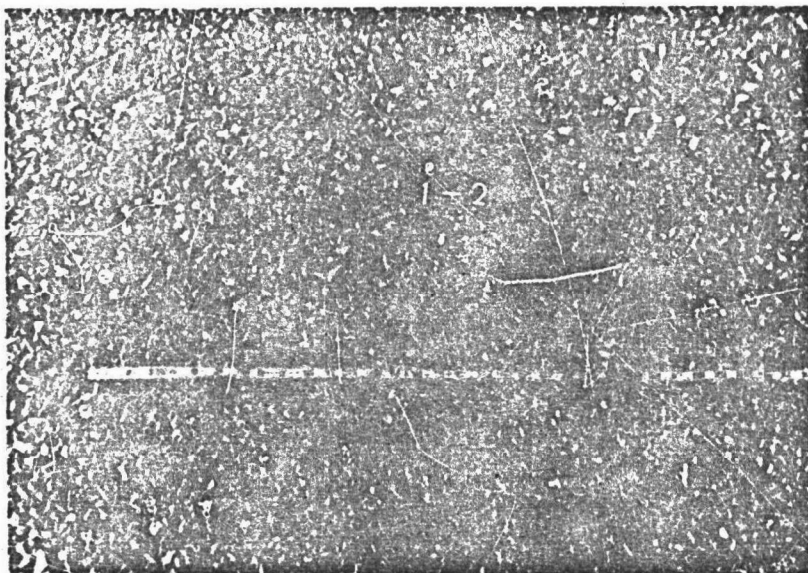
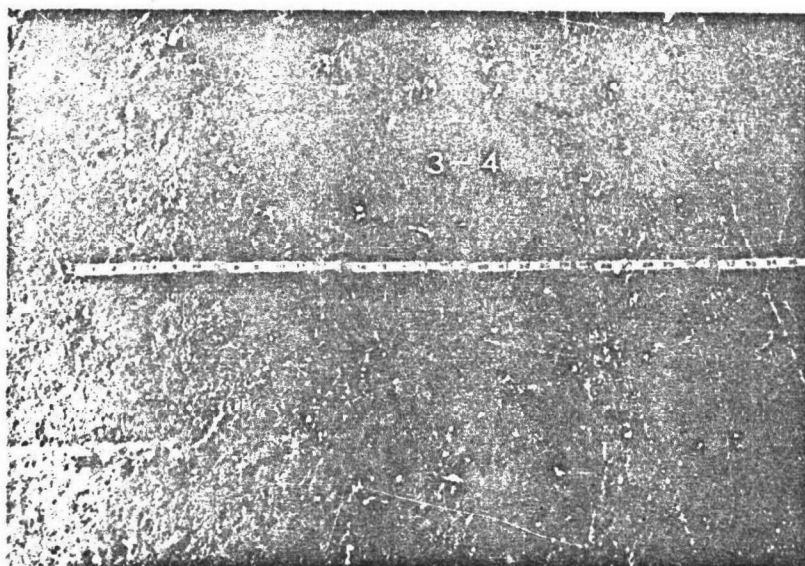
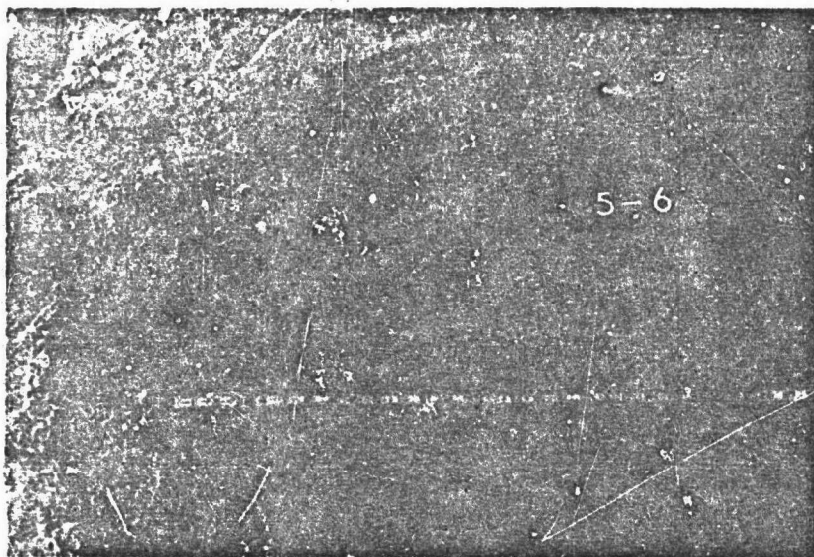
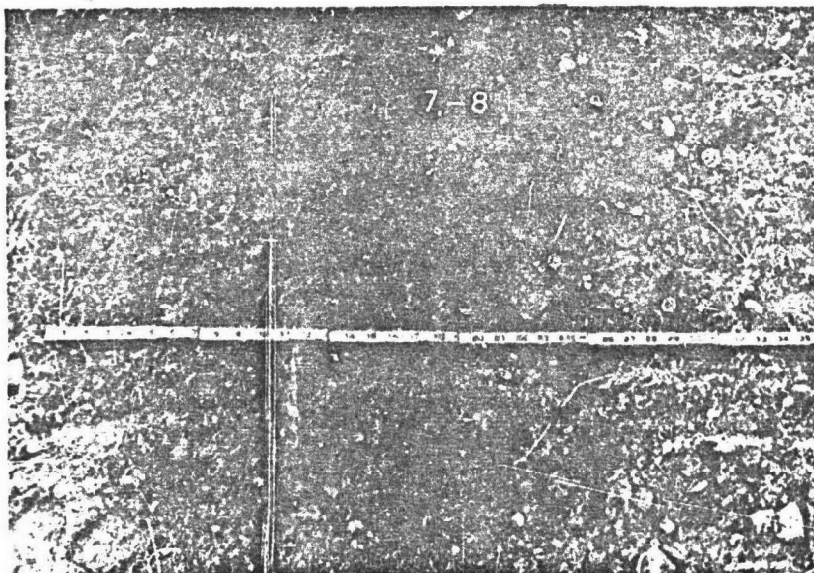
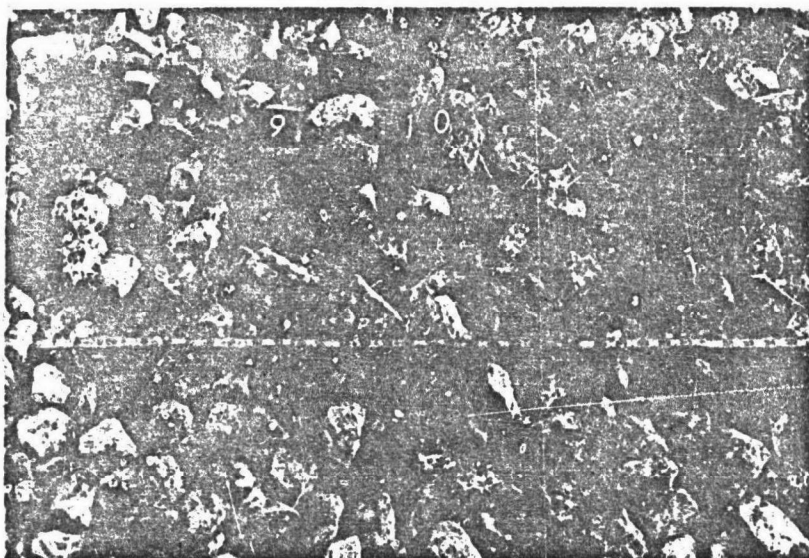
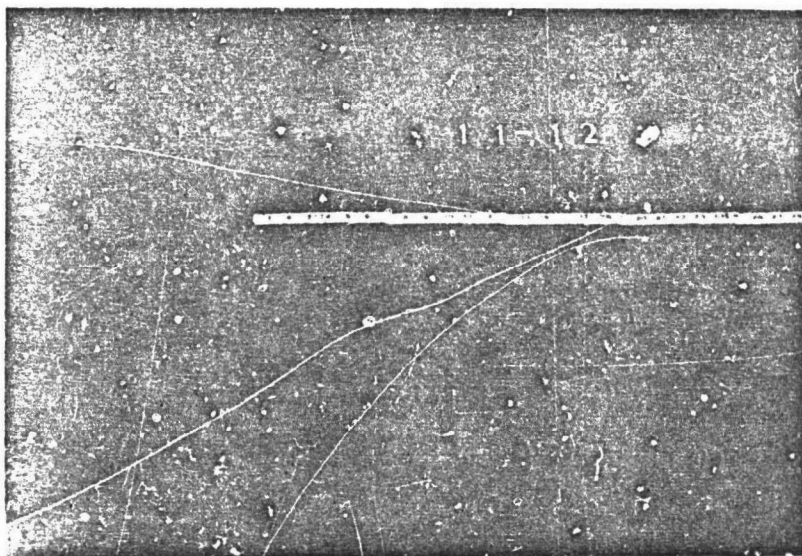
Figure 2. (Continued).

g. Close-up of material in Items 1-2.

h. Close-up of material in Items 3-4.

i. Close-up of material in Items 5-6.

j. Close-up of material in Items 7-8.

k. Close-up of material in Items 9-10.

L. Close-up of material in Items 11-12.

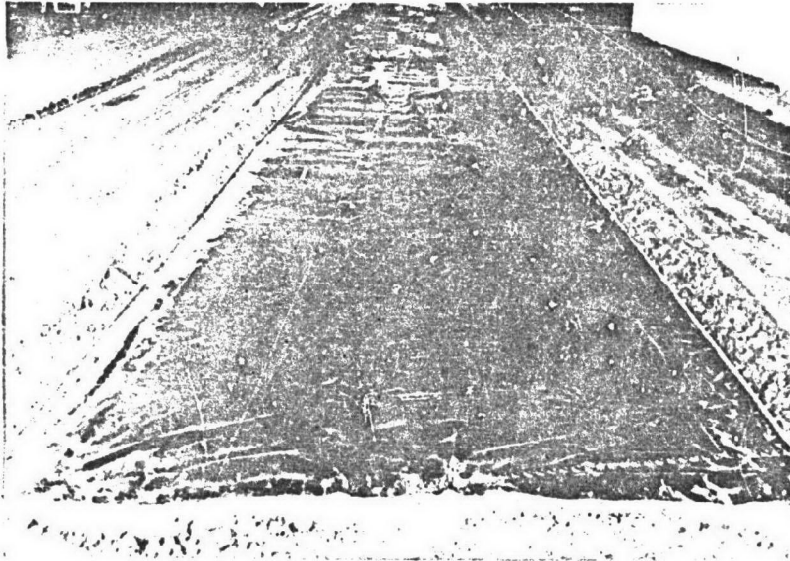
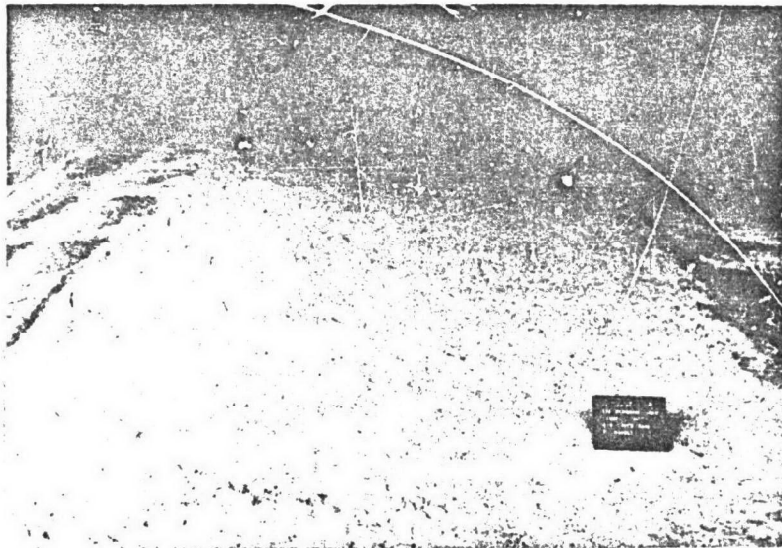
Figure 2. (Concluded).

m. Membranes in place; note 6-in. shoulders on both sides of test section.

n. Completed test section with 6 in. of protective sand.

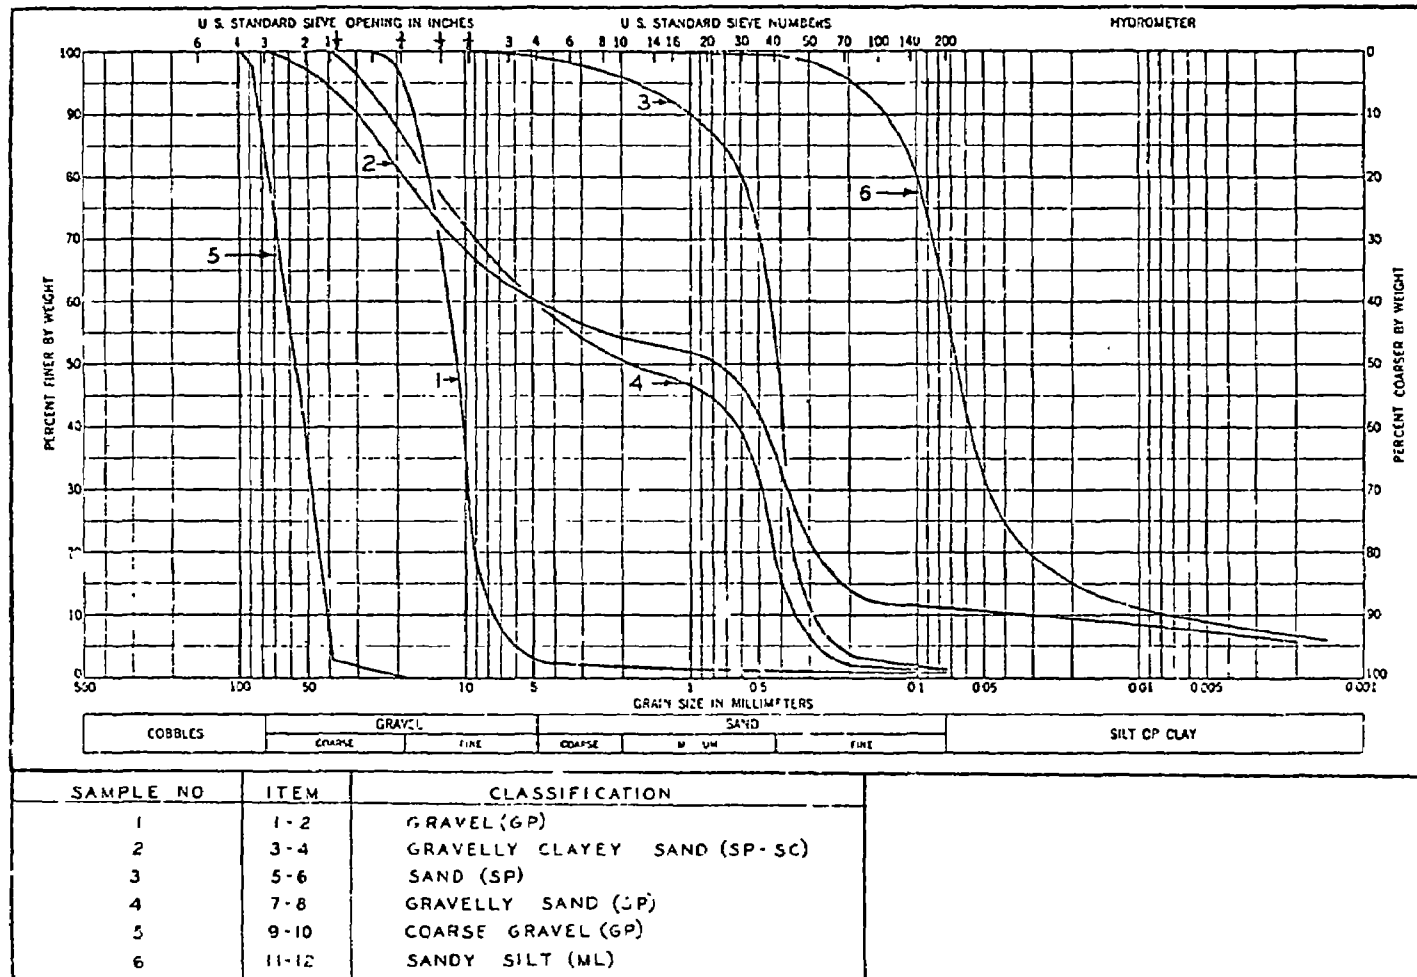
Figure 3. Gradation curves for selected subgrades.

It should be noted that the sand in items 5 and 6 was the same type of sand that was used for the protective cover layers. The sand was a local (Vicksburg, Mississippi) sand usually used as the fine aggregate in concrete. Gradation curves for the subgrade materials are shown in Figure 3.

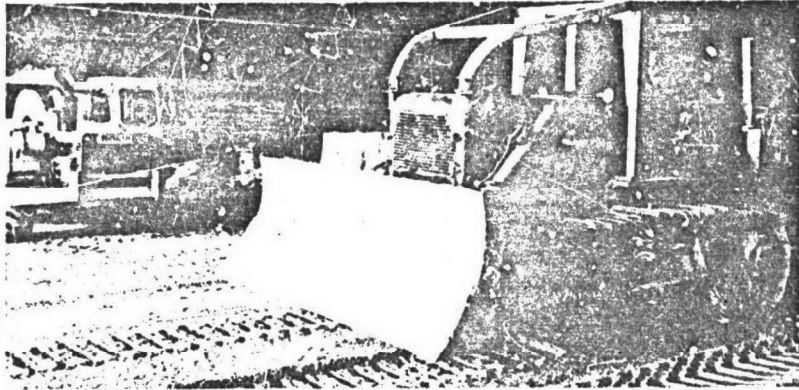
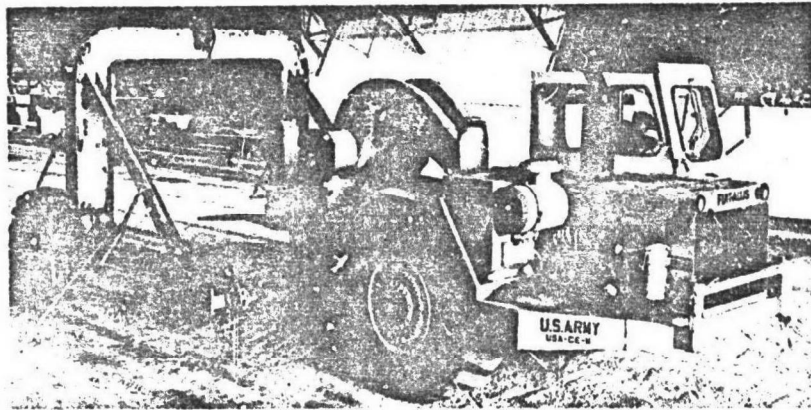
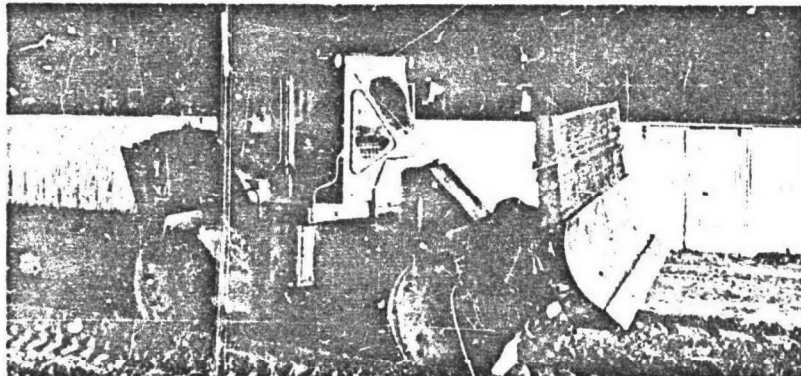
Figure 4. Vehicles used to traffic test sections.

a. D-7 Bulldozer.

b. Pneumatic-tired tractor.

c. Cleated landfill compactor.

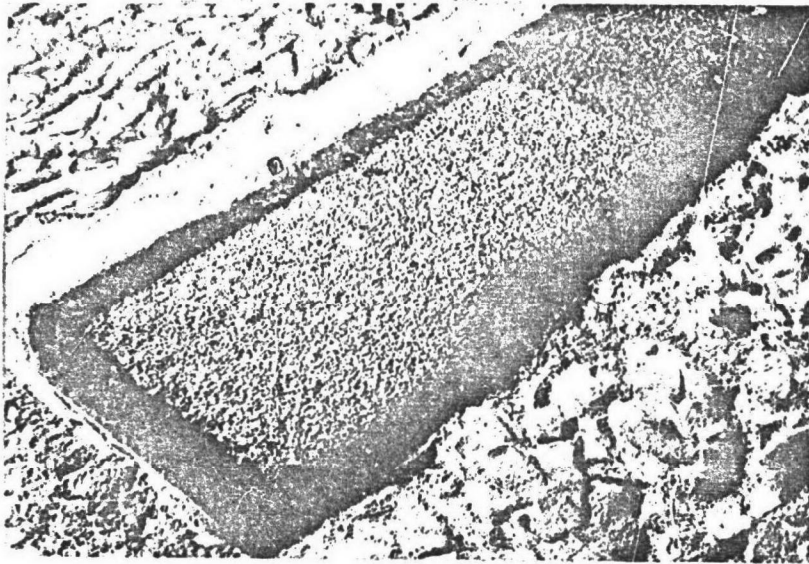
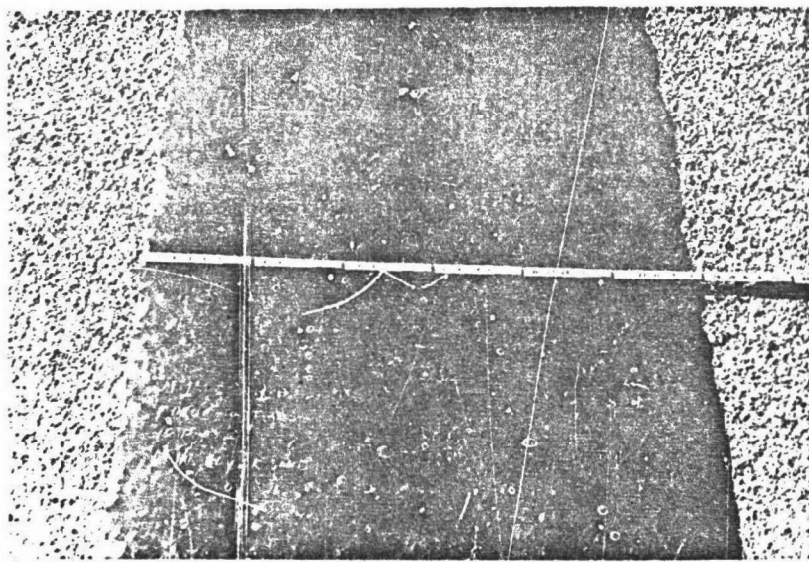
Figure 5. Excavated trench and membrane, test program 1.

a. Inspection trench after removal of membrane.

b. Holes in membrane after 10 passes of the
pneumatic-tired tractor.

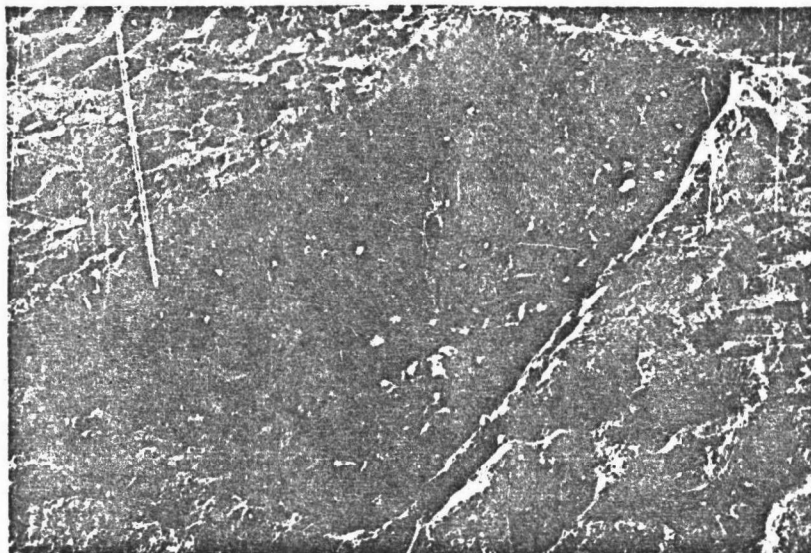
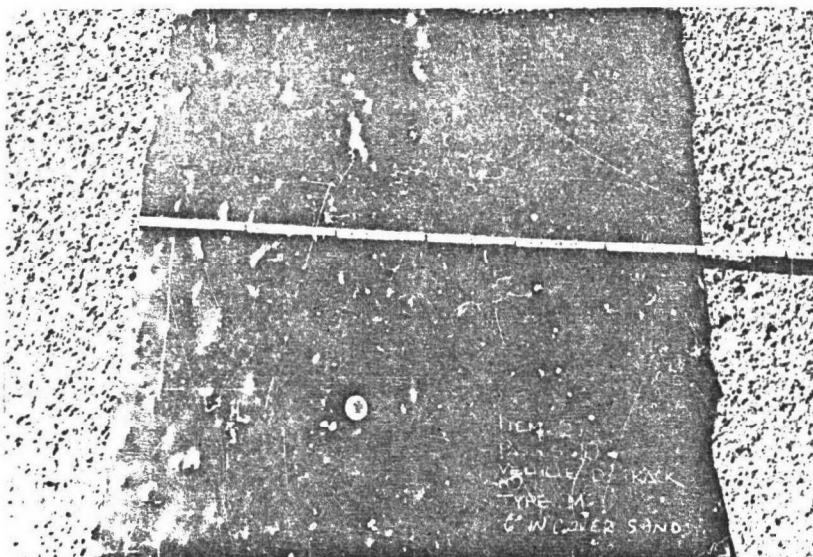
Figure 6. Inspection trench and membrane after traffic, test program 1.

a. Excavated trench in item 10, No. 1 and 2 designate track and tire traffic lanes.

b. Inspected membrane; note identification markings.

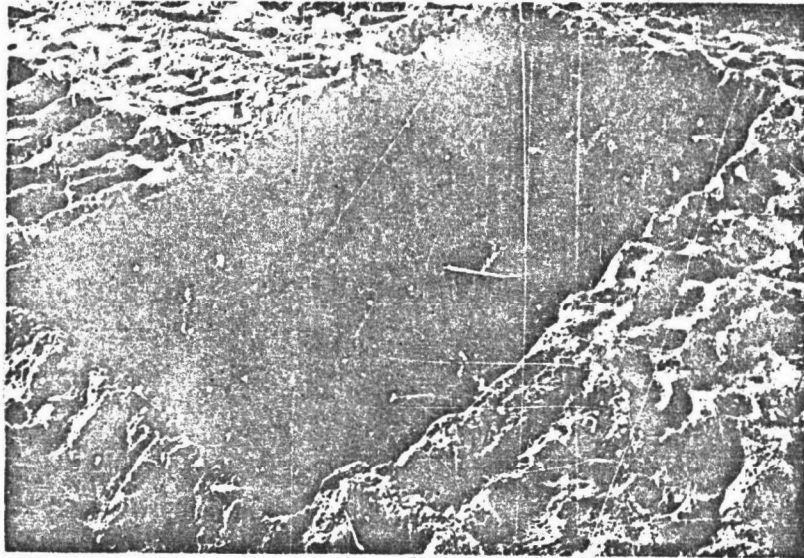
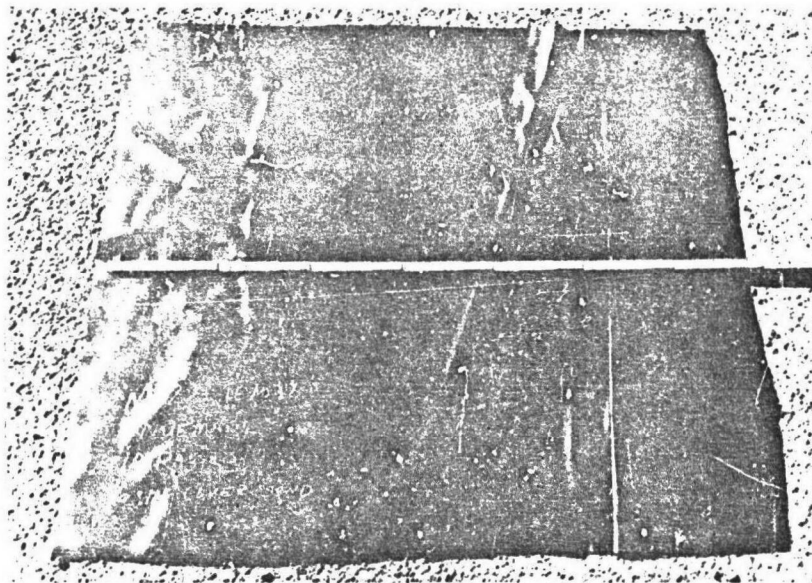
Figure 7. Trench and membrane from items 11 and 12, test program 1.

a. Trench in item 11 after 10 passes of traffic.

b. Membrane after 10 passes of pneumatic-tired tractor, no punctures.

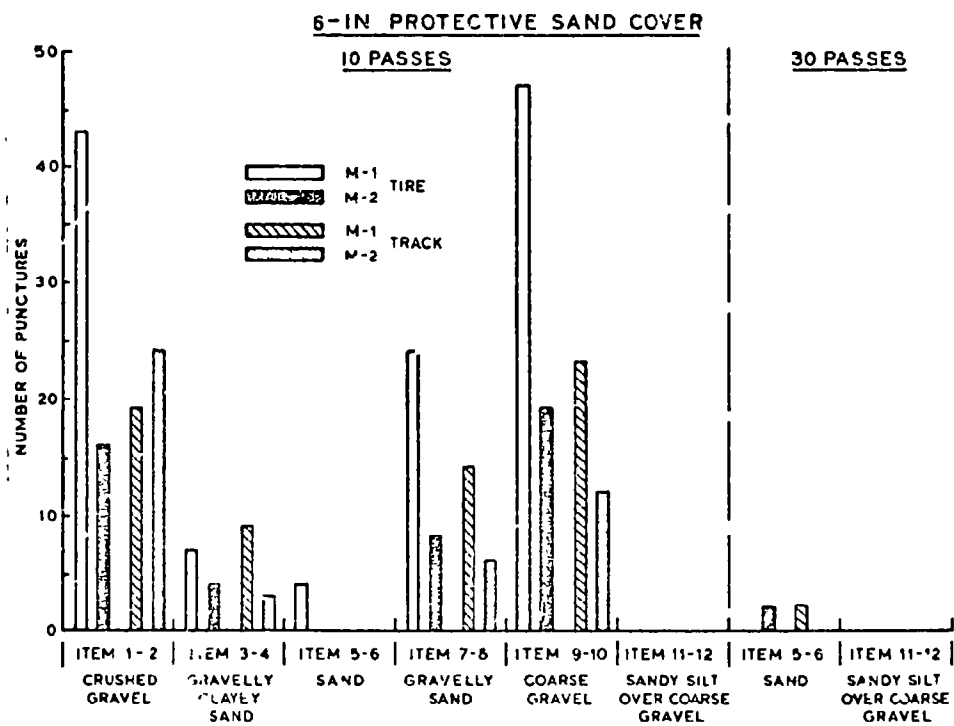
Figure 8. Results of test program 1.

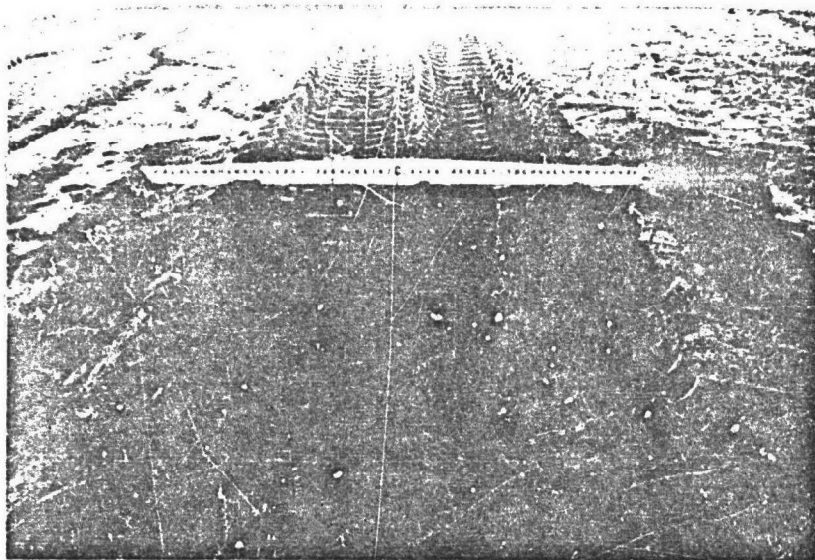
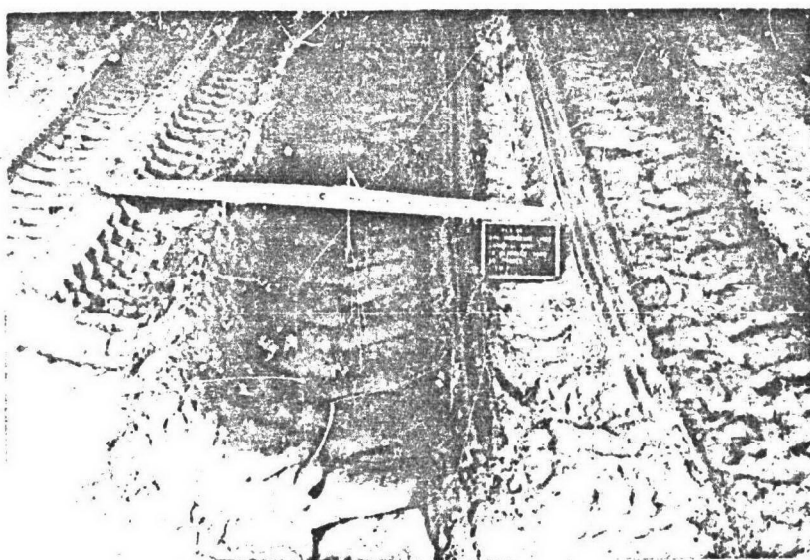
Figure 9. Rutting in 18-in. sand protective layer.

a. Lane 1 (track), lane 2 (tire) rutting
after 30 passes.

b. Rut pattern of cleated landfill compactor.

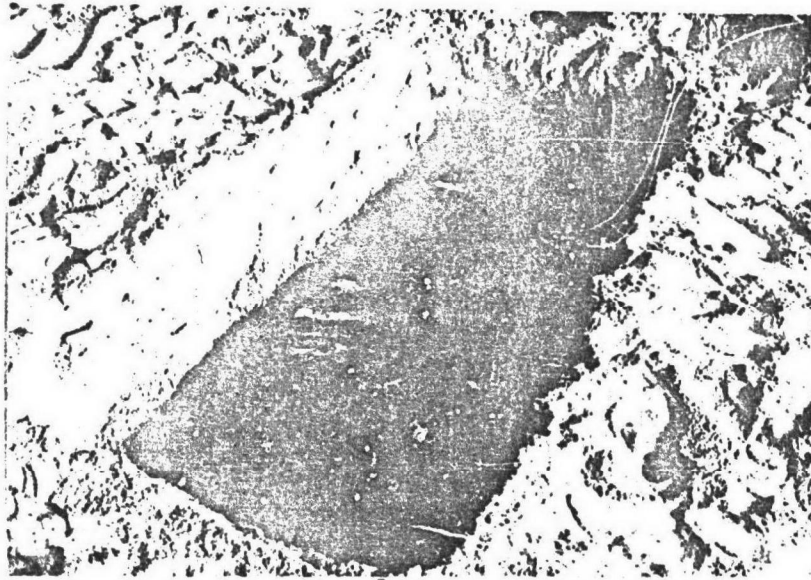
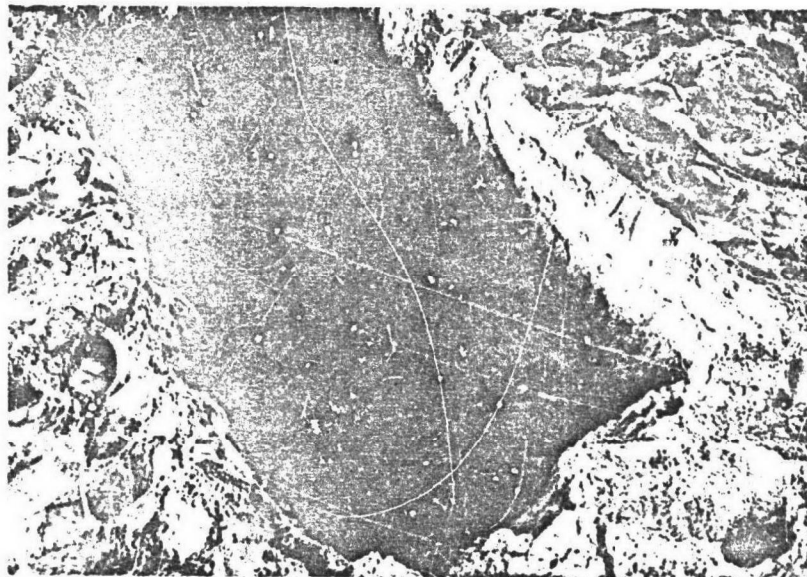
Figure 10. Membrane in trenches before removal and inspection, test program 2.

a. Membrane in item 3 after 10 passes.

b. Membrane in item 10 after 10 passes.

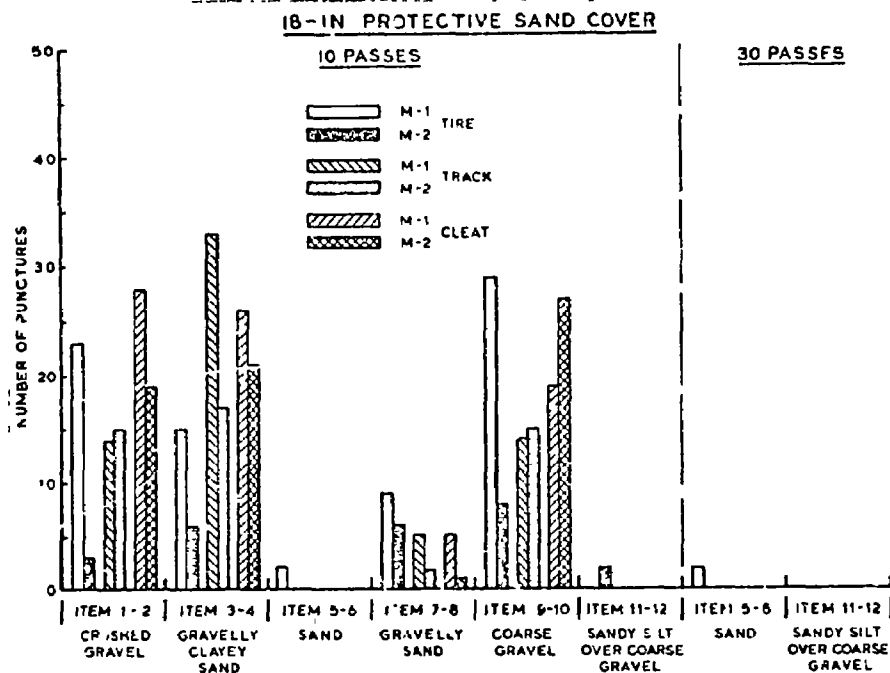
Figure 11. Results of test program 2.

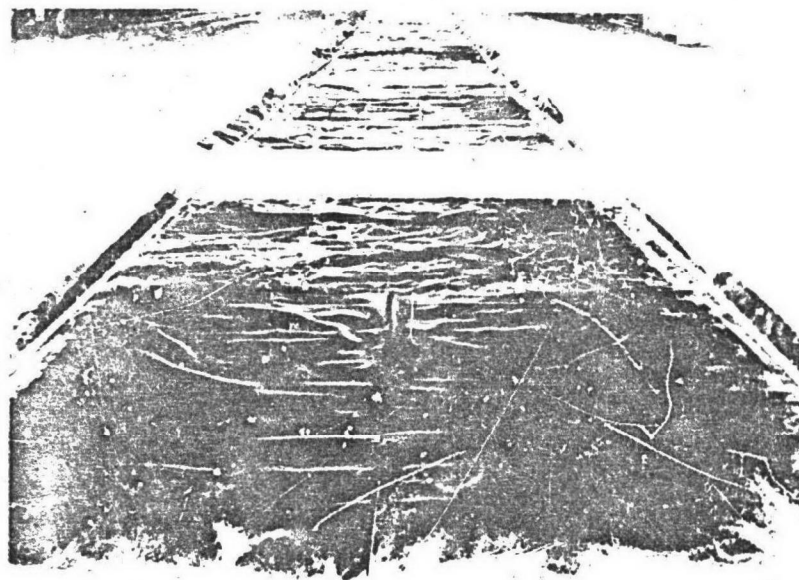
Figure 12. Fabric and four membranes tested
in test programs 3 and 4.

a. Nonwoven fabric placed on subgrade.

b. Four membranes in place; M3 is the gray membrane.

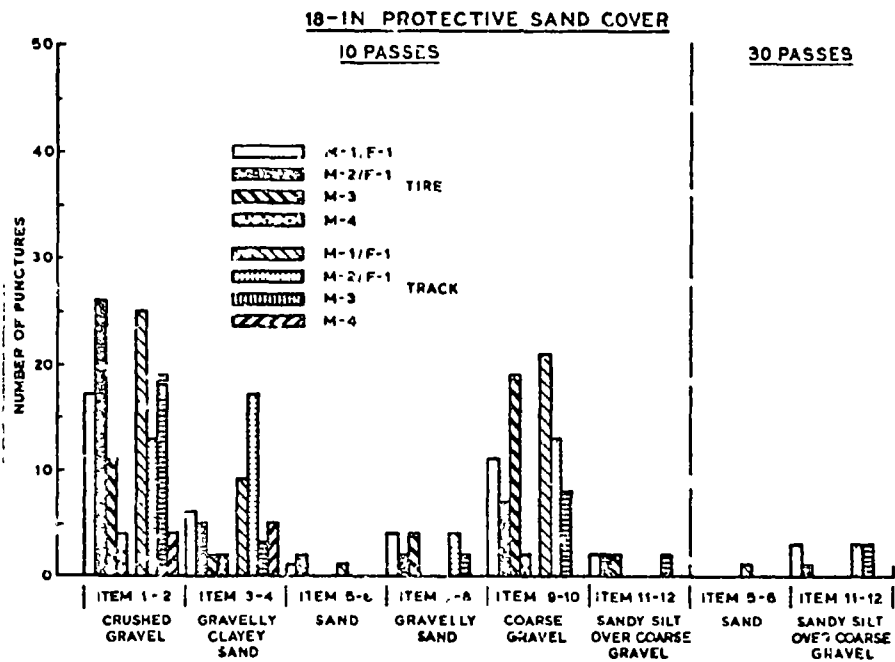
Figure 13. Results of test program 3.

20-ft-long items were subdivided into two 10-ft-long subitems which resulted in four separate test items in each of the six types of subgrade materials. The four test subitems per subgrade material were overlaid with membranes M1, M2, and M4, respectively. A nonwoven fabric material (F1), used as a separation barrier or a bedding material, was placed between the M1 and M2 membranes and the subgrade. Photographs showing both the fabric material and the four membranes in place in test program 3 are shown in Figure 12. Test results for test program 3 after trafficking both the D-7 bulldozer and the pneumatic-tired tractor are presented in Figure 13.

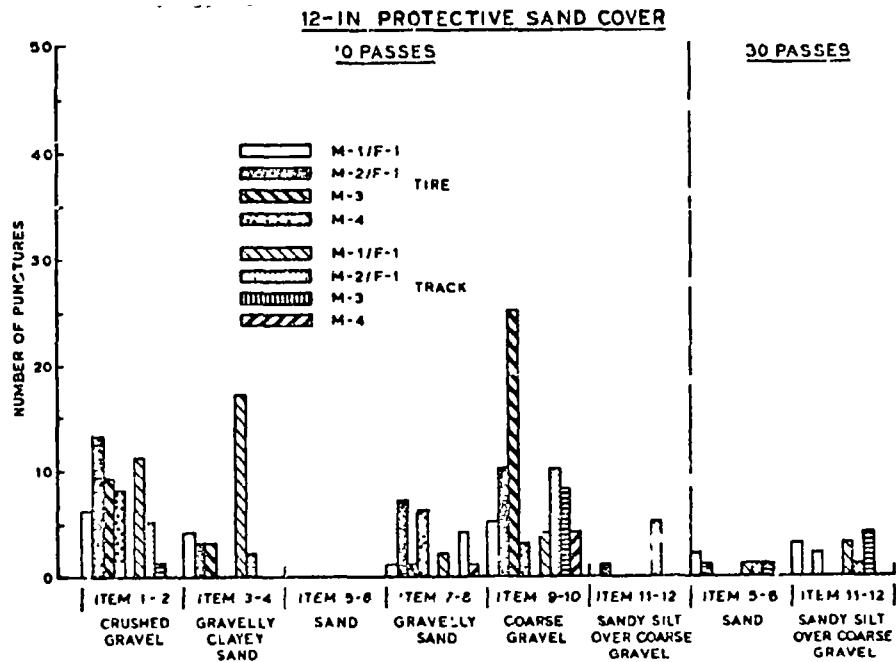
Figure 14. Results of test program 4.

After completion of test program 3, 6 in. of the protective sand layer and 6 in. of the shoulders were removed from the entire test section. With the protective layer of sand now 12 in. in thickness, another series of traffic tests was performed using the same two vehicles. During this test program, traffic was applied to the various test items by moving the test vehicles to lanes 3 and 4 of the test section. Results from this series of tests are shown in Figure 14.

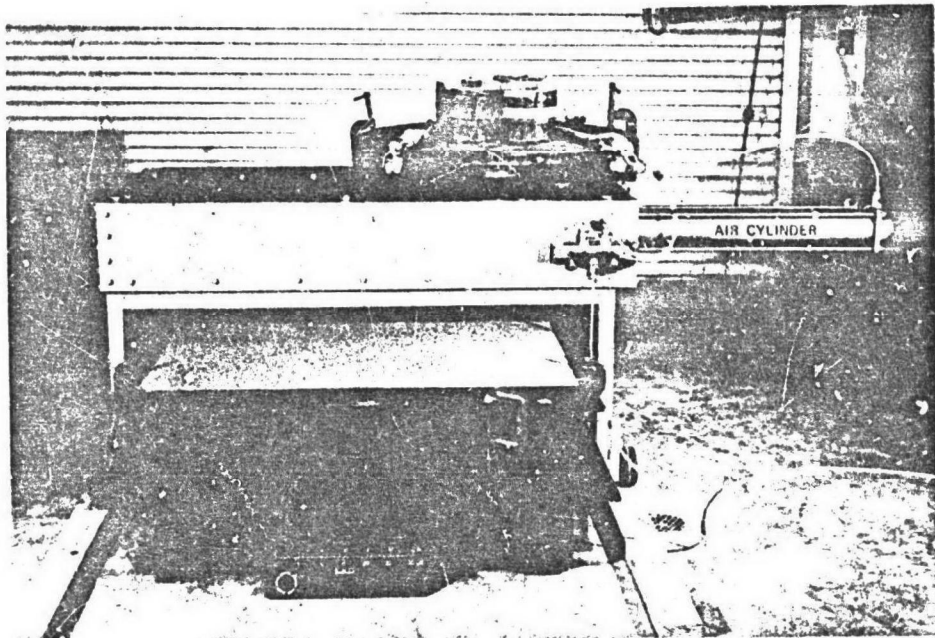
Figure 15. Model load cart and soil box.

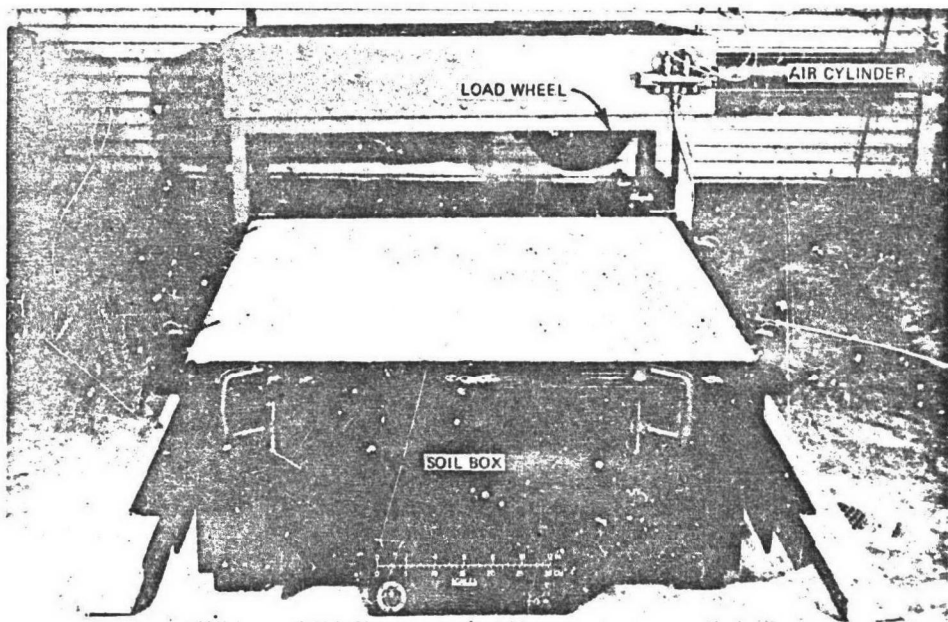
Figure 16. Lower portion of the load wheel in background, soil box in the foreground.

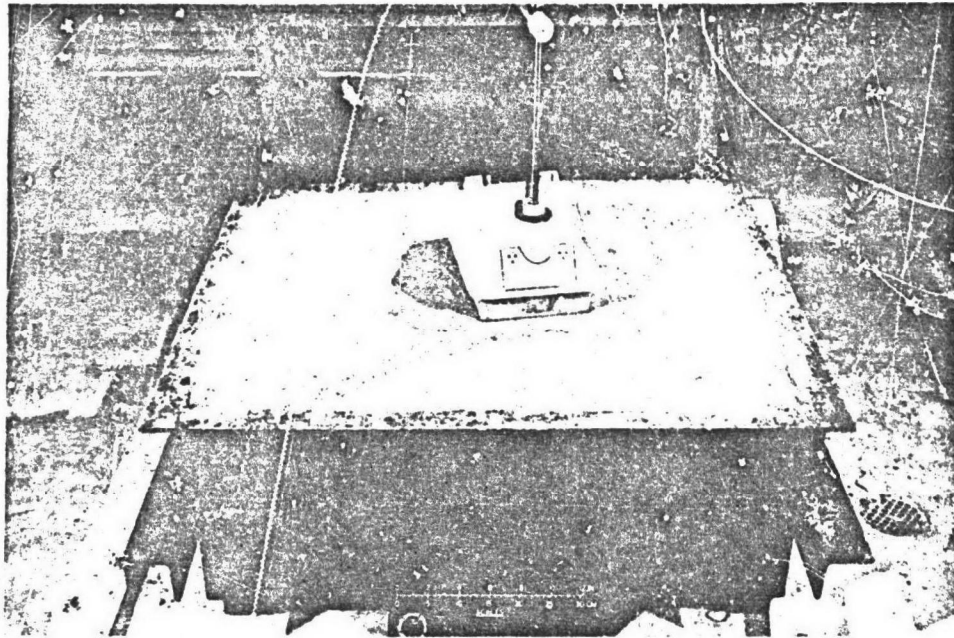
Figure 17. Troxler Nuclear Densitometer used to measure density and water content.

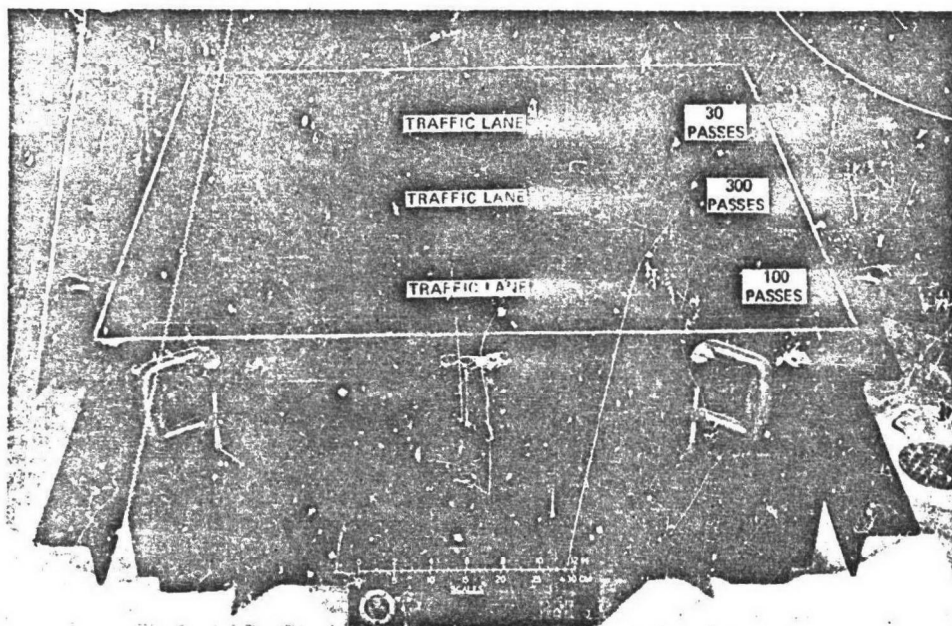
Figure 18. Membrane placed over compacted soil with collar for sand clamped in place and tracking lanes marked.

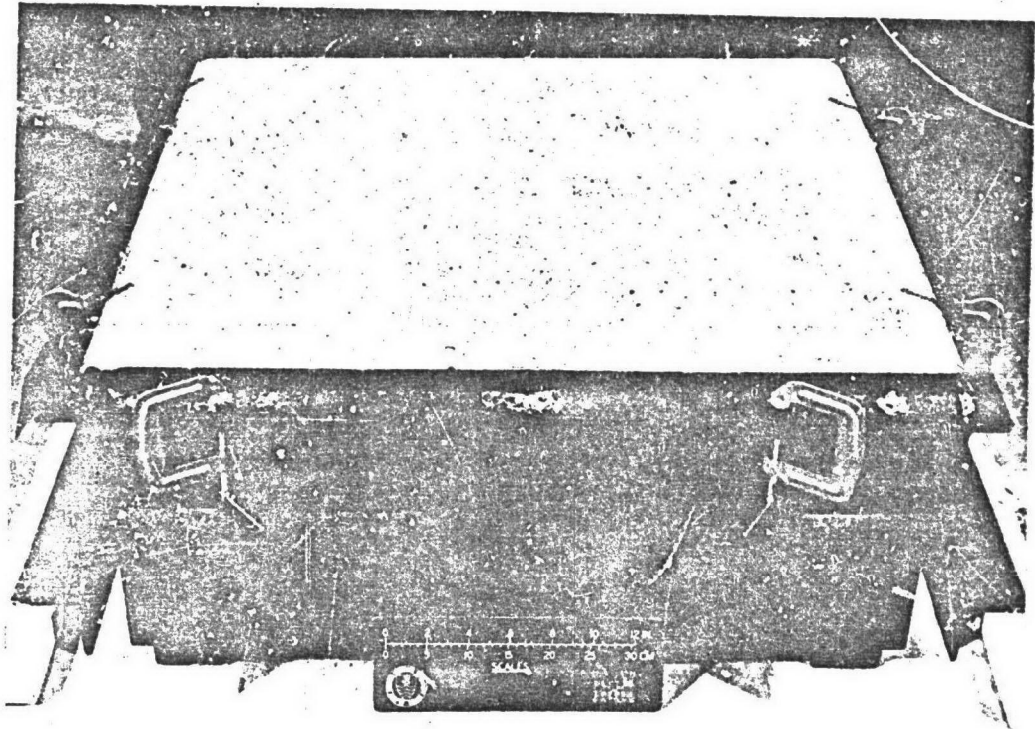
Figure 19. Soil box ready for traffic.

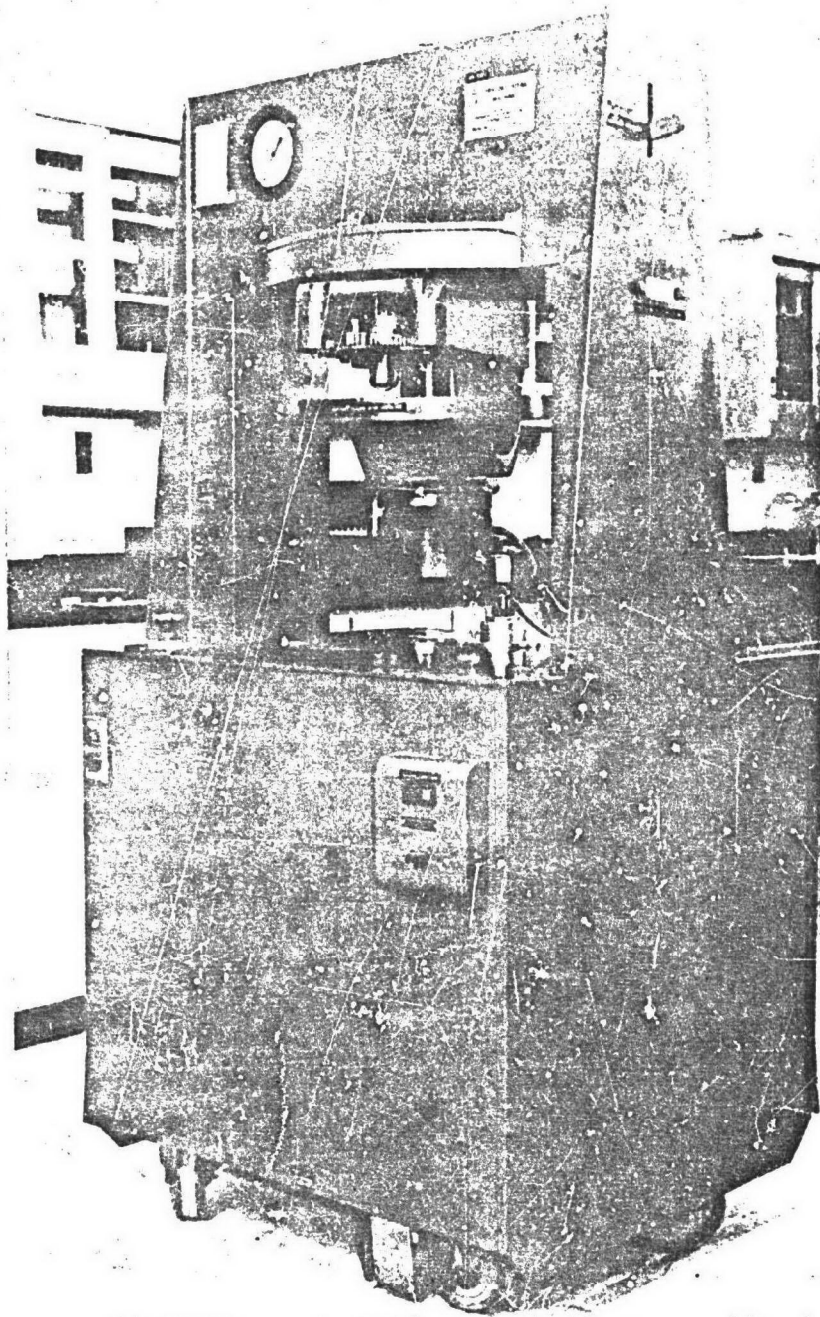
Figure 20. Gyratory compactor.

The gyratory shear test was conducted in the gyratory testing machine shown in Figure 20. Figure 21 gives a schematic drawing of the gyratory machine. In this test a vertical load is applied by a piston to a material sample contained in a tilted mold. By applying a rotating load to the mold, shear strain is induced through the sample. The combined action of the vertical stress and shear strain is similar to the kneading action of a
