Laboratory Studies of Soil Bedding
Requirements for Flexible Membrane Liners

EPA-600/2-84-021

Geotechnical Laboratory

U. S. Army Engineer Waterways Experiment Station
Vicksburg, Mississippi 39180

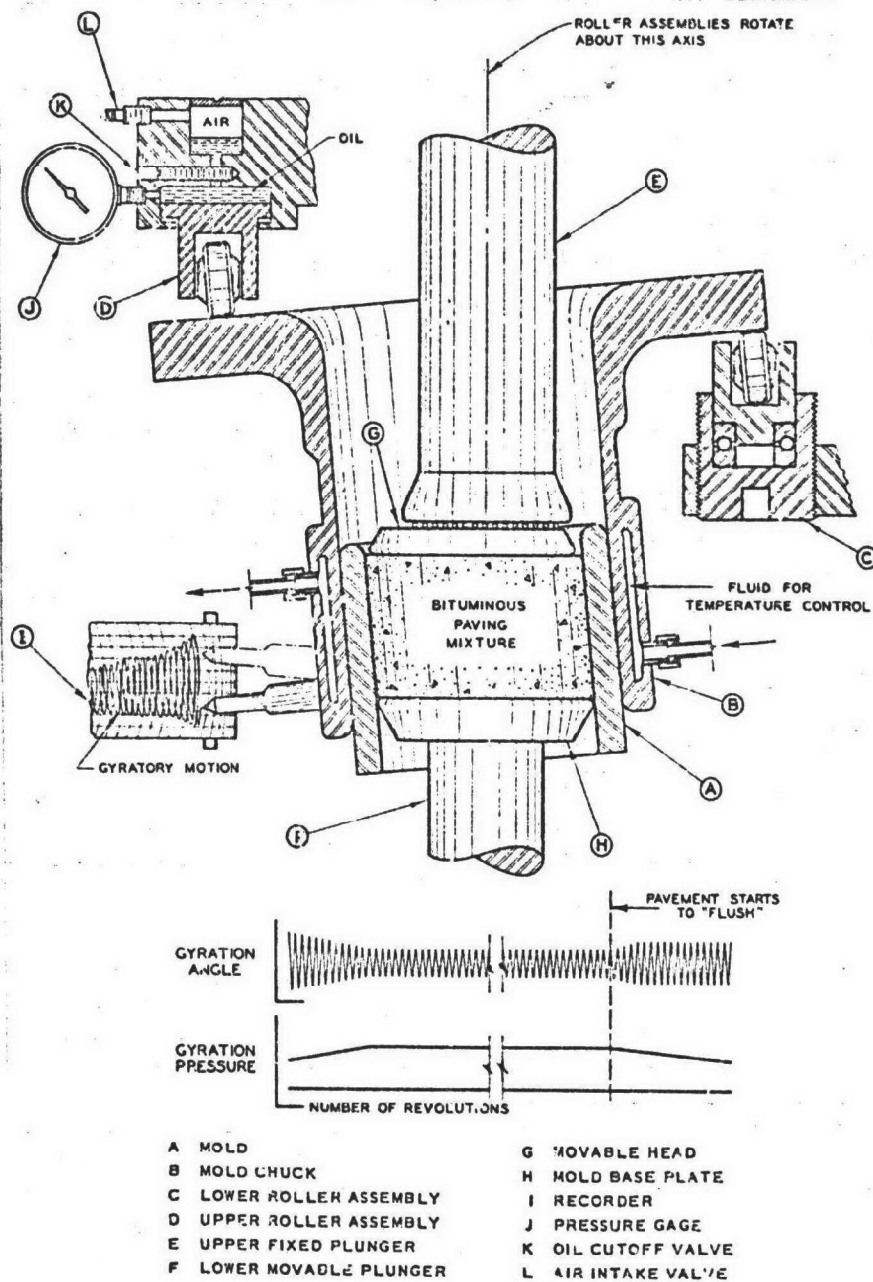
Figure 21. Schematic illustration of gyratory machine.

The gyratory shear test was conducted in the gyratory testing machine shown in Figure 20. Figure 21 gives a schematic drawing of the gyratory machine. In this test a vertical load is applied by a piston to a material sample contained in a tilted mold. By applying a rotating load to the mold, shear strain is induced through the sample. The combined action of the vertical stress and shear strain is similar to the kneading action of a

rolling tire load. During the test, the applied load (pressure), tilt or angle of gyration (usually 1 degree), and number of revolutions are controlled.

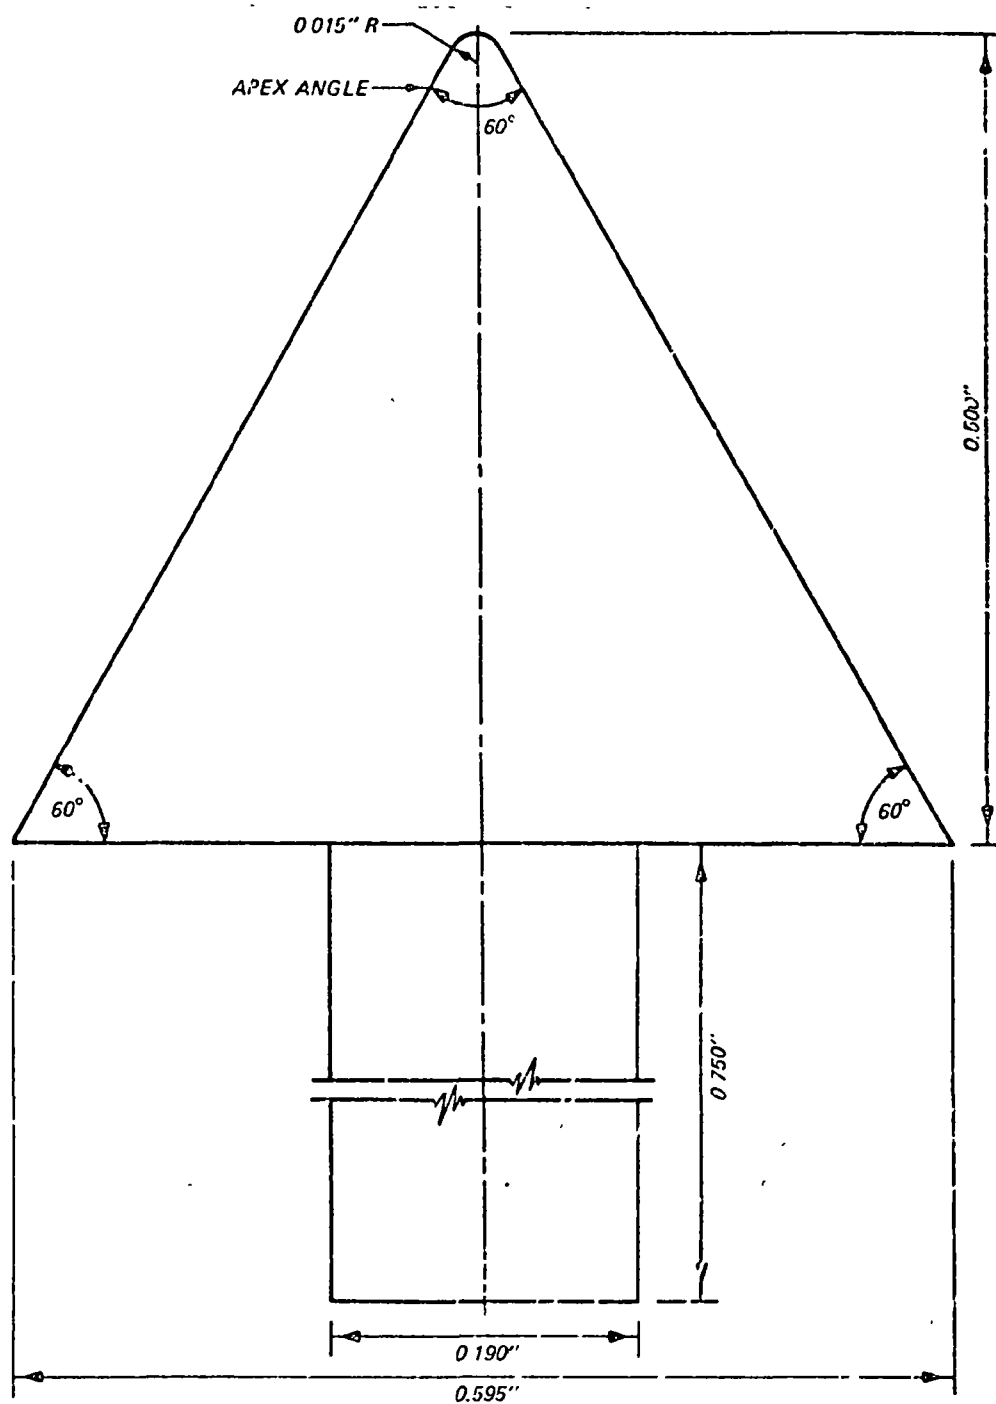
Figure 22. Dimensions of a typical barb.

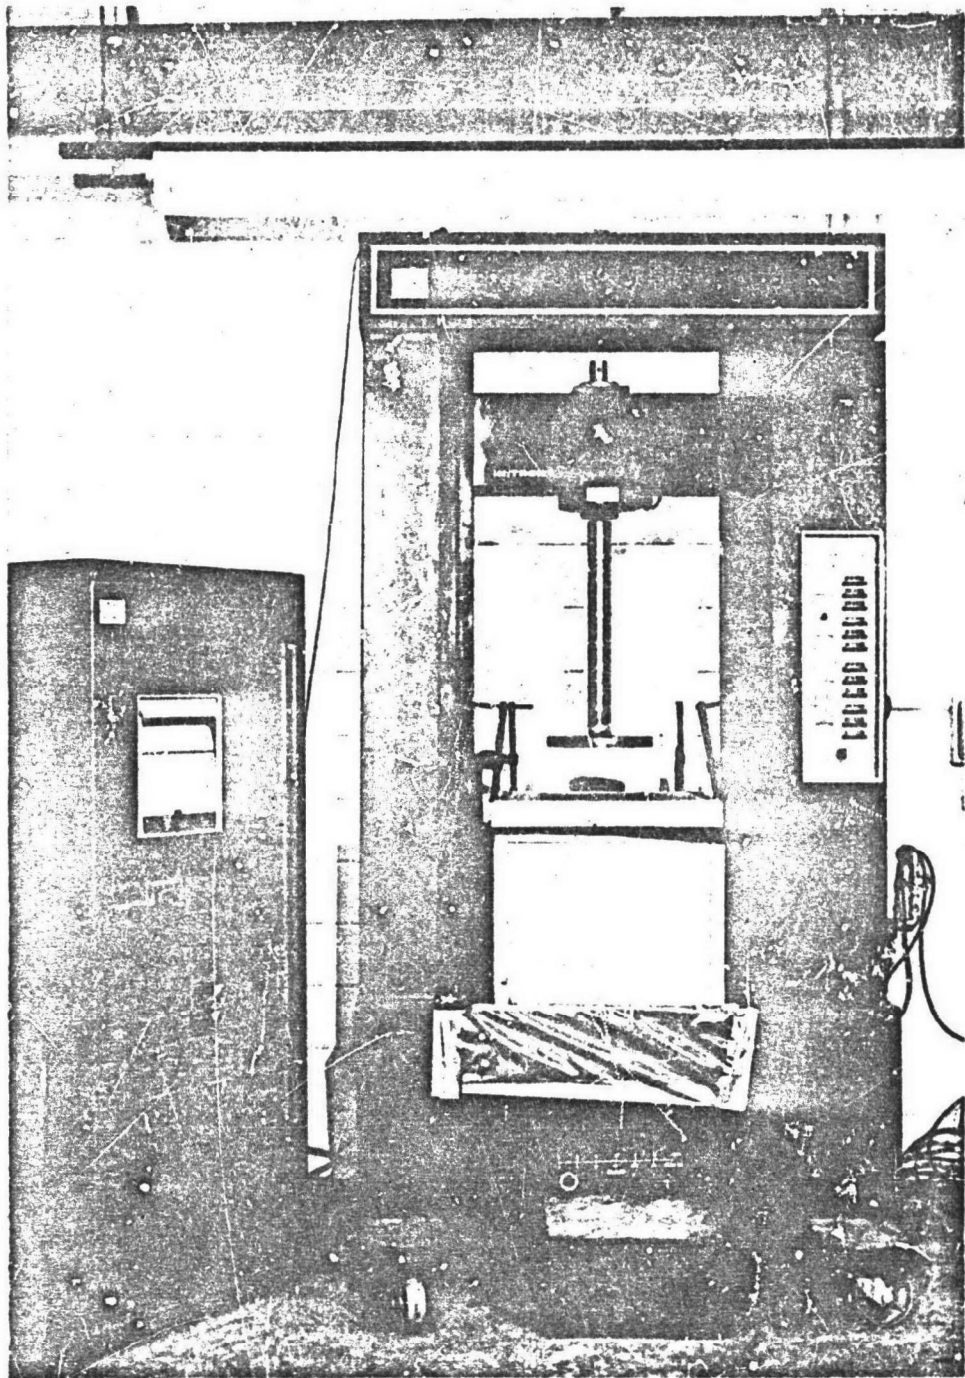
Figure 23. Instron machine, recorder, and soil membrane test setup.

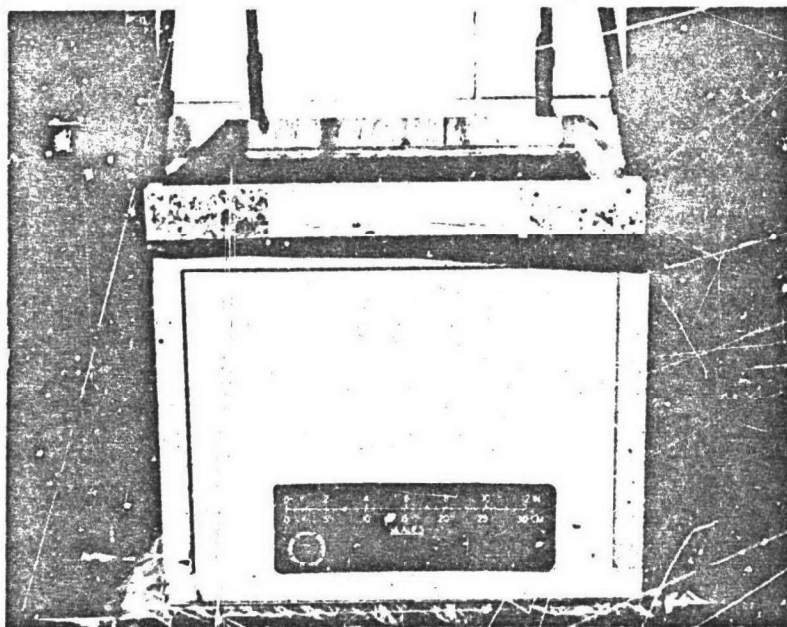
Figure 25. Membrane and 2-1/2-in.-deep collar clamped in position for sand cover.

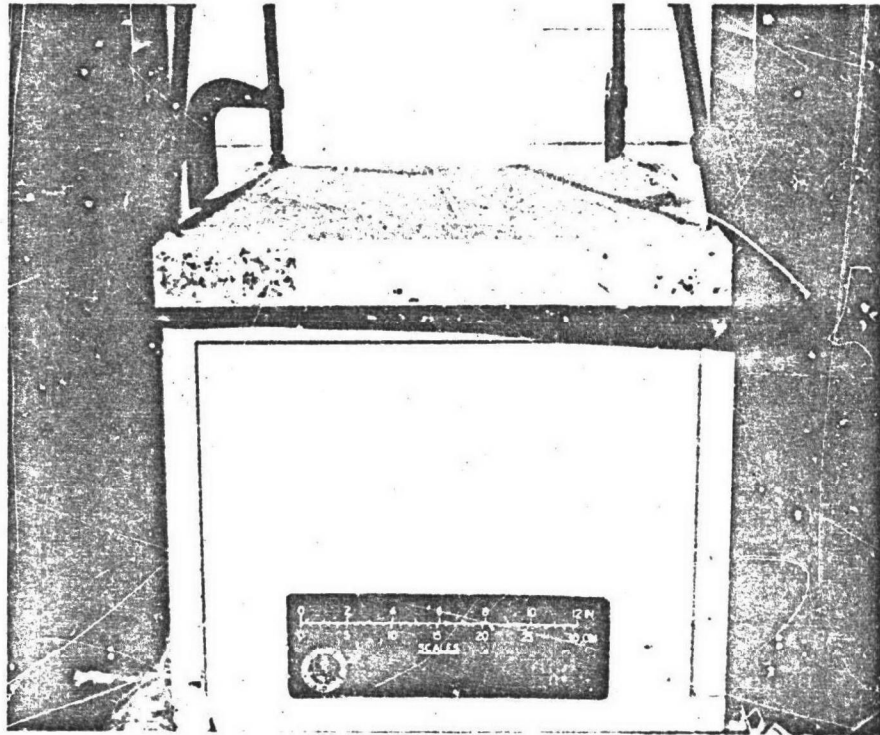
Figure 26. Cover sand compacted and leveled for test.

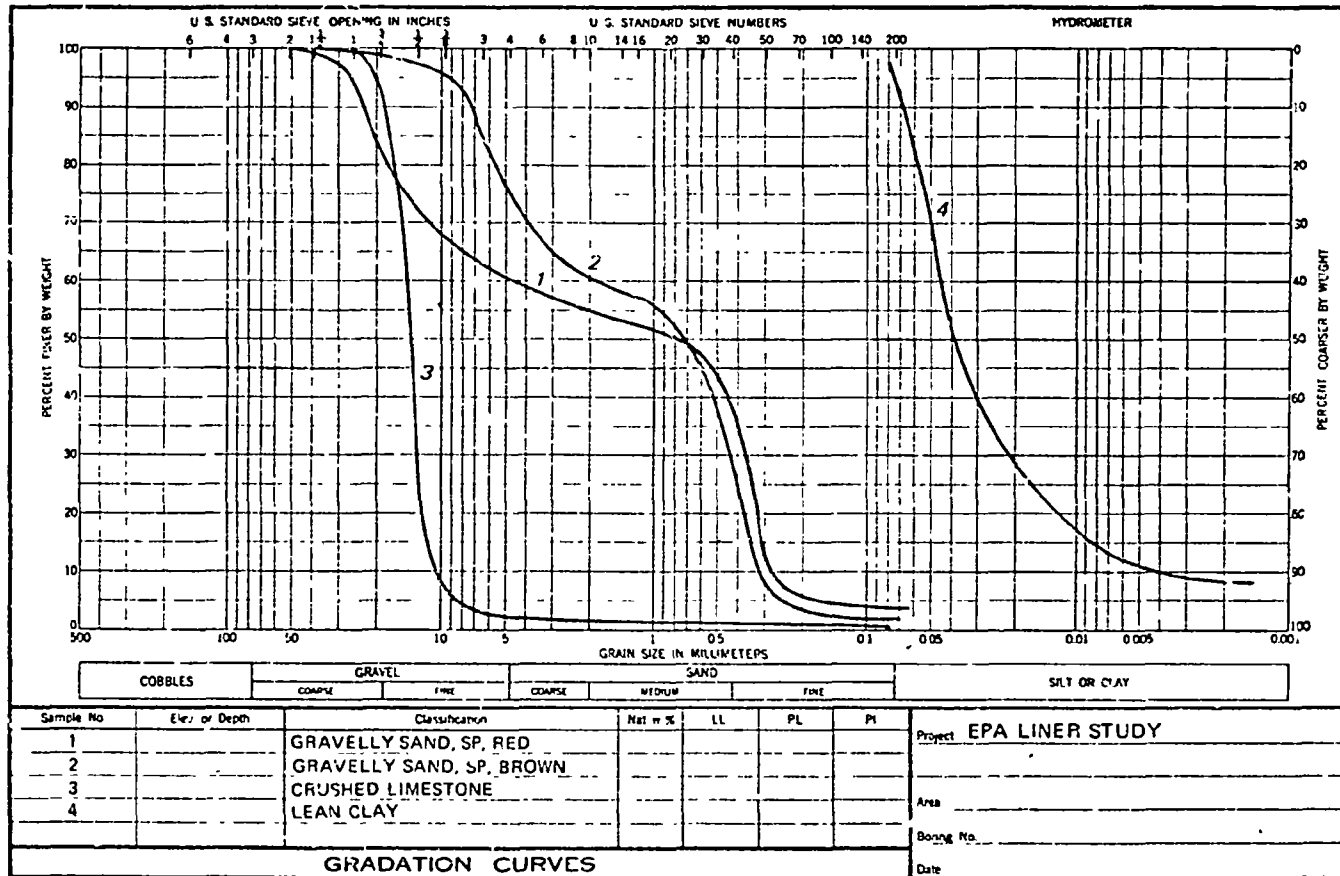
Figure 27. Classification and gradation of gravelly sand subgrade

The soils selected for use in testing the membrane liners were similar to those used in the initial full-scale tests. Two gravelly sands (SP) were used. One gravelly sand commonly found in concrete mixes was used as a cover material to protect the membrane liner during tests. This material was sieved and only that portion passing the 3/8-in. sieve was utilized for test purposes. The other gravelly sand was used as a subgrade material. The gradation curves for these soils are shown in Figure 27.

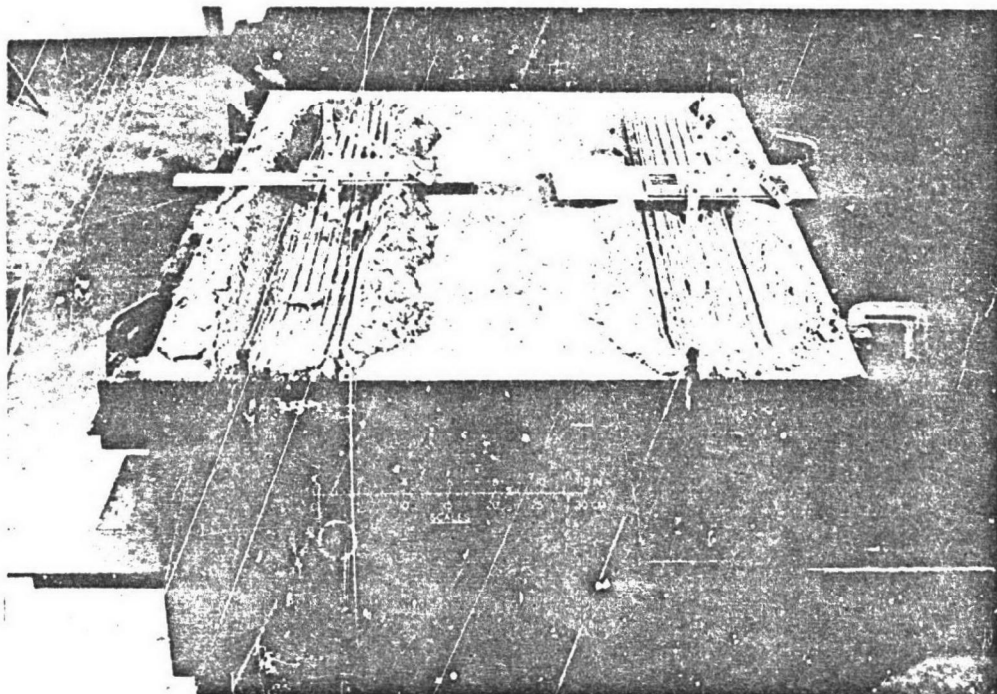
Figure 28. Typical ruts in sand cover at 10 and 2 passes.

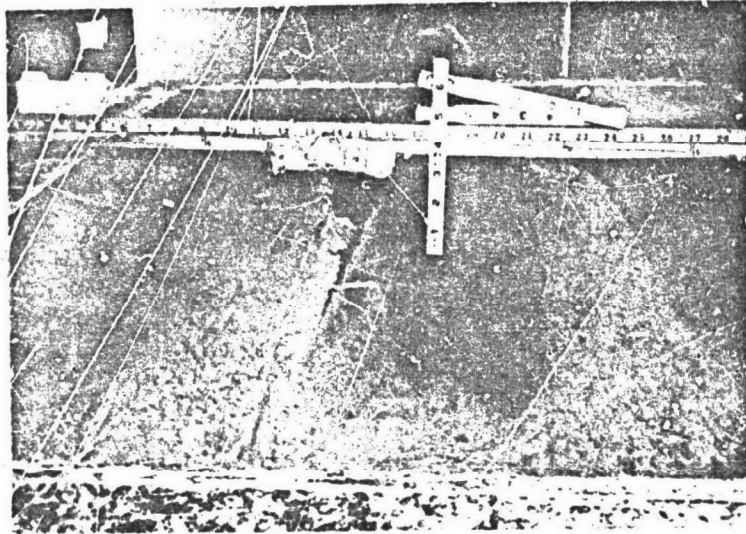
Figure 29. Rutting in clay used as bedding over subgrade.

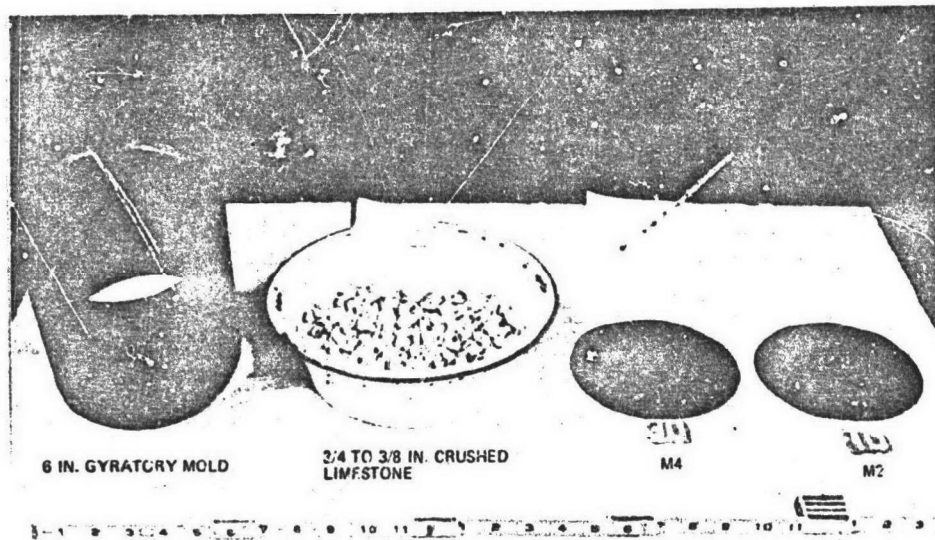
Figure 30. Six-inch gyratory mold, 3/4- to 3/8-in. crushed limestone, M4 after 30 revolutions (note scuff marks), and M2 with 20 punctures after 10 revolutions.

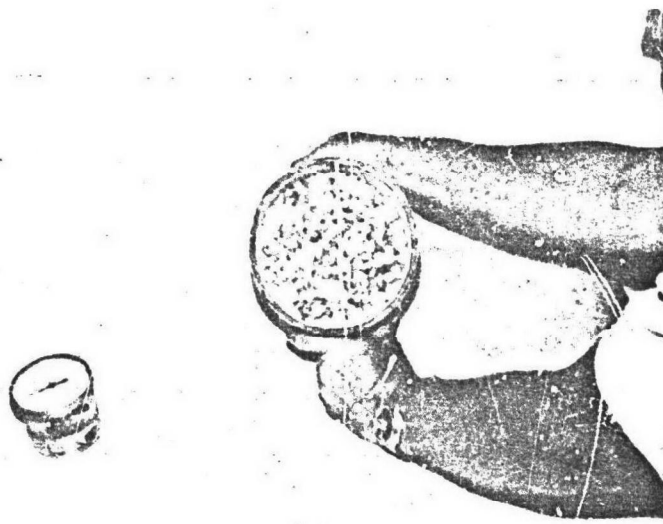
Figure 31. Interface of clay and limestone after 500 revolutions.

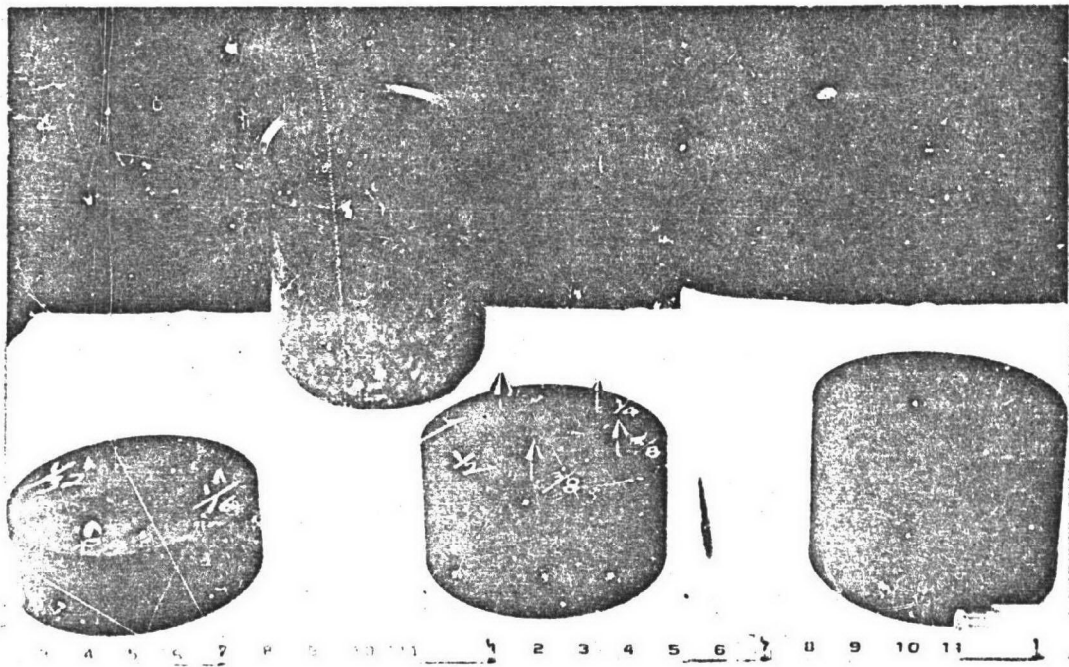
Figure 32. Steel mold, rubber subbase discs and barbs.

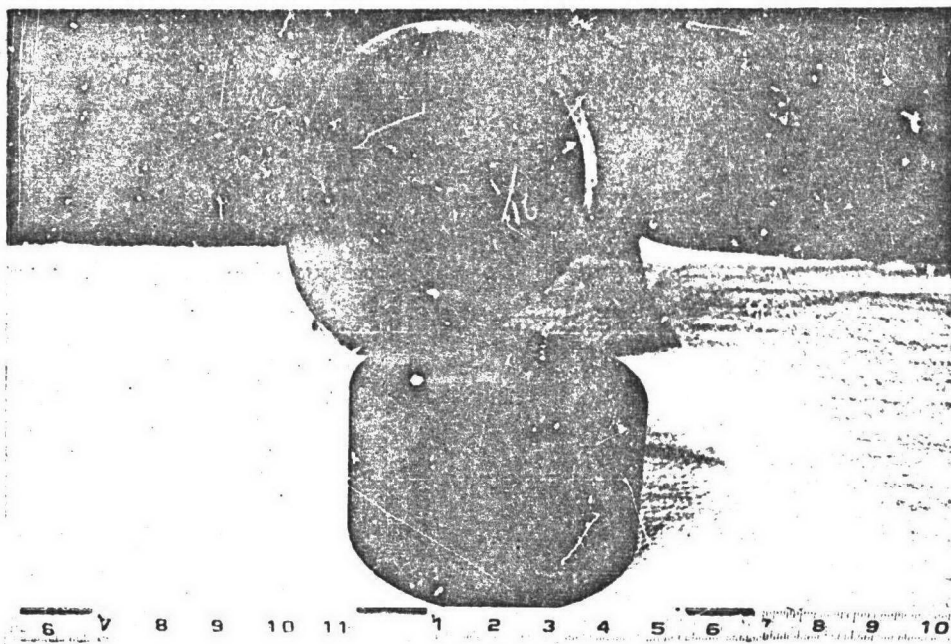
Figure 33. Two-inch-thick rubber subbase in mold with barbs,
4-in.-thick rubber subbase in foreground.

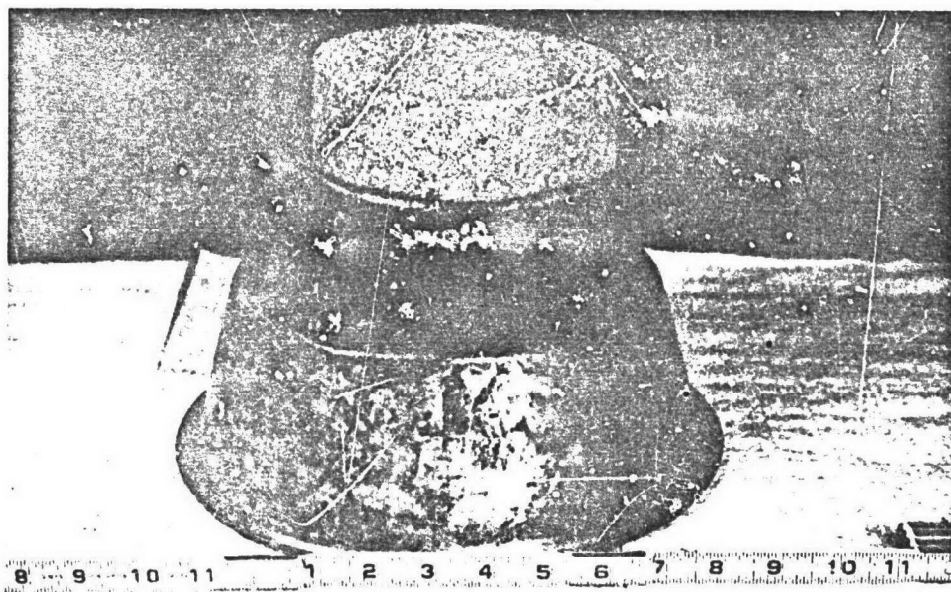
Figure 34. Typical test sample after 10 revolutions.

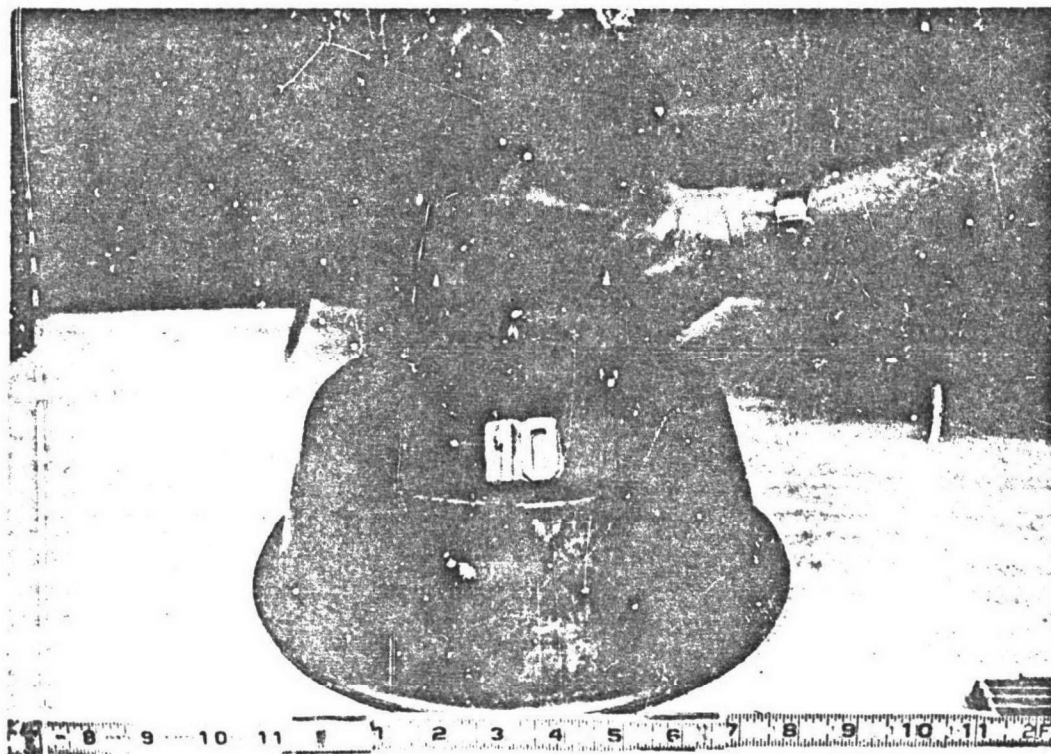
Figure 35. Indentations in membrane caused by the three barbs after 10 revolutions.

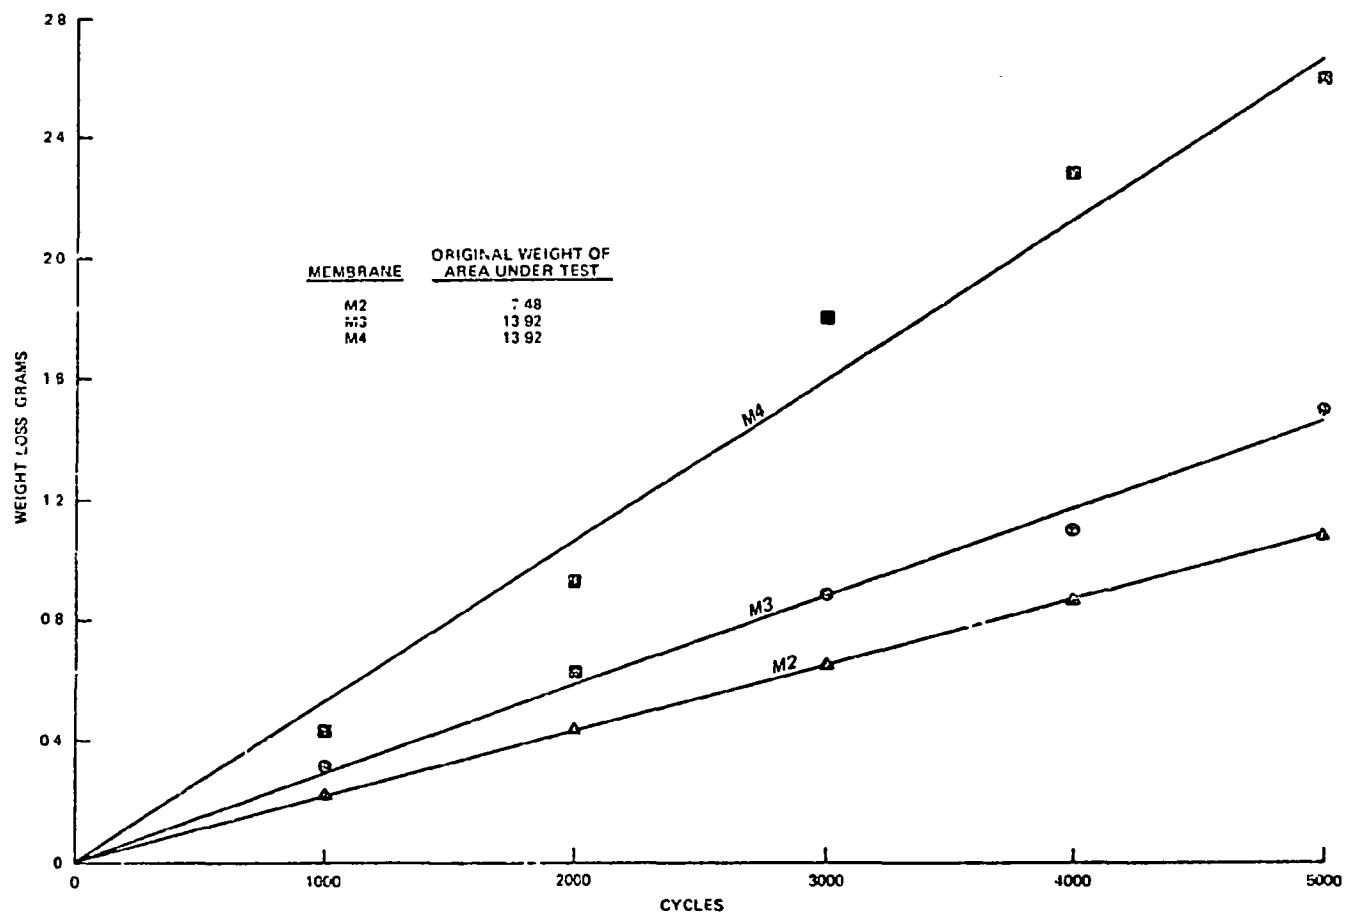
Figure 36. Weight loss versus abrasion cycles of membranes.
