AESTHETIC RESERVOIR COVERS

ENVIRONMENTAL PROTECTION AGENCY
WATER HYGIENE PROGRAM
REGION IX
SAN FRANCISCO, CALIFORNIA

-- 1971 --

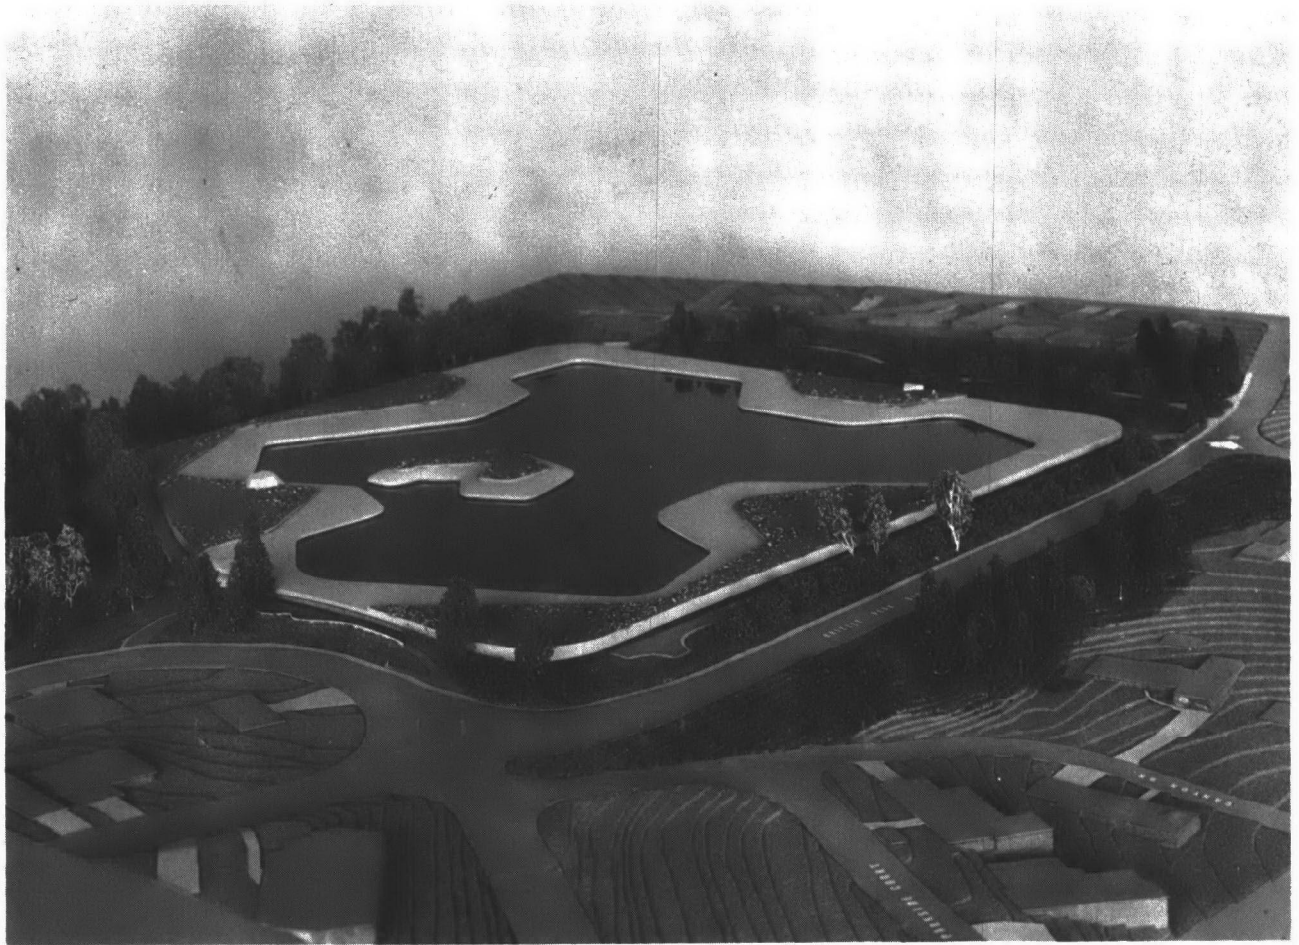
MODEL OF PROPOSED SUMMIT RESERVOIR COVER

Summit Reservoir (volume 40 million gallons) will be covered in the near future. The proposed appearance, as shown on the next page, incorporates the idea of a mirror (false lake) finish which has been successful in Cincinnati, Ohio (Eden Park Reservoir, shown on cover). This reservoir, because of its location and service area, cannot be taken completely out of service while a cover is being installed. Fortunately, it was originally constructed with a partition which creates two separate sections -- one section will be drained and covered while the other section continues to serve the pressure zone.

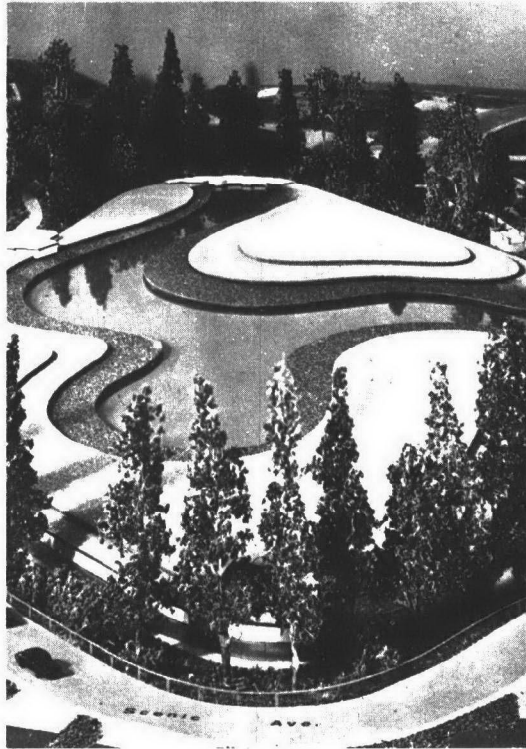
MODEL OF PIEDMONT RESERVOIR NO. 2

Piedmont Reservoir No. 2 (volume 23 million gallons) was originally an earthen reservoir. The "false lake" concept was incorporated into the design and the following two pages show subsequent stages of construction.

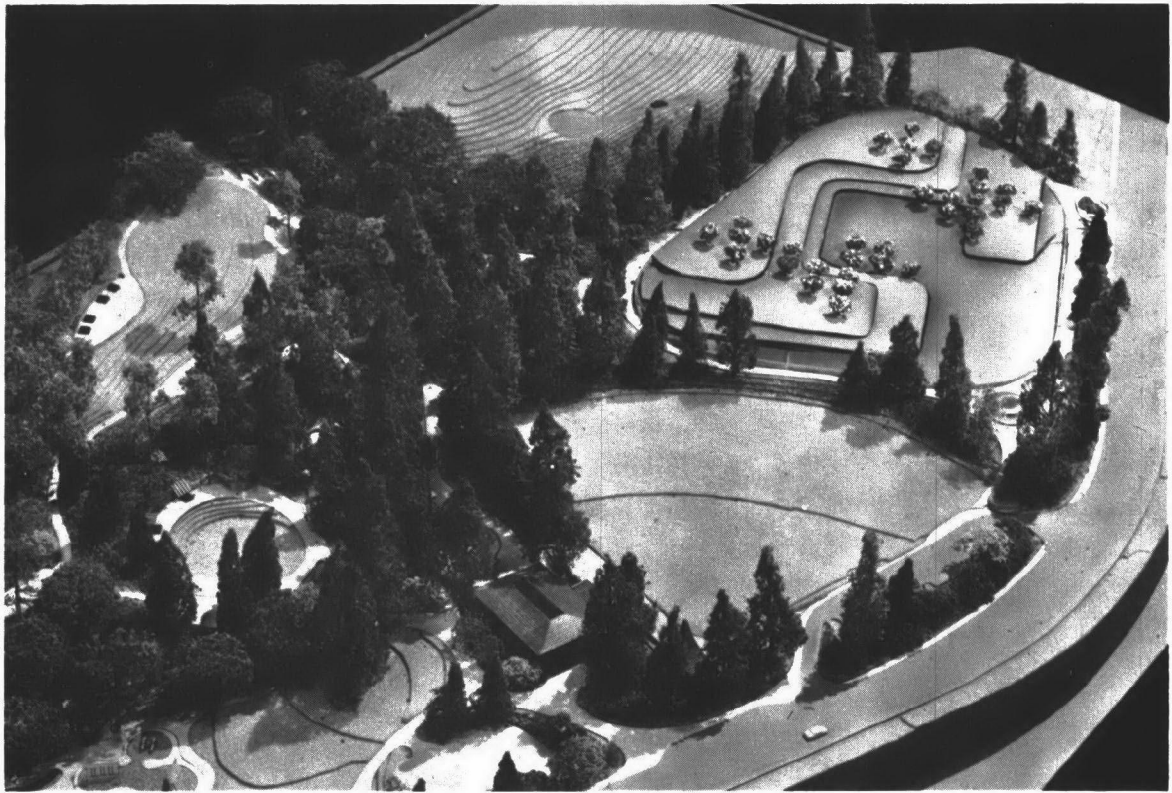
BERRYMAN RESERVOIR (volume 23 million gallons) is shown as the conceptual model (above) and "as built" (below). With the reservoir protected, the adjacent land area provides a recreational site for the neighborhood.
