AERIAL PHOTOGRAPHIC SITE ANALYSIS FORT WADSWORTH NAVAL STATION Staten Island, New York

EPA Region 2

TS-PIC-95076
August 1995

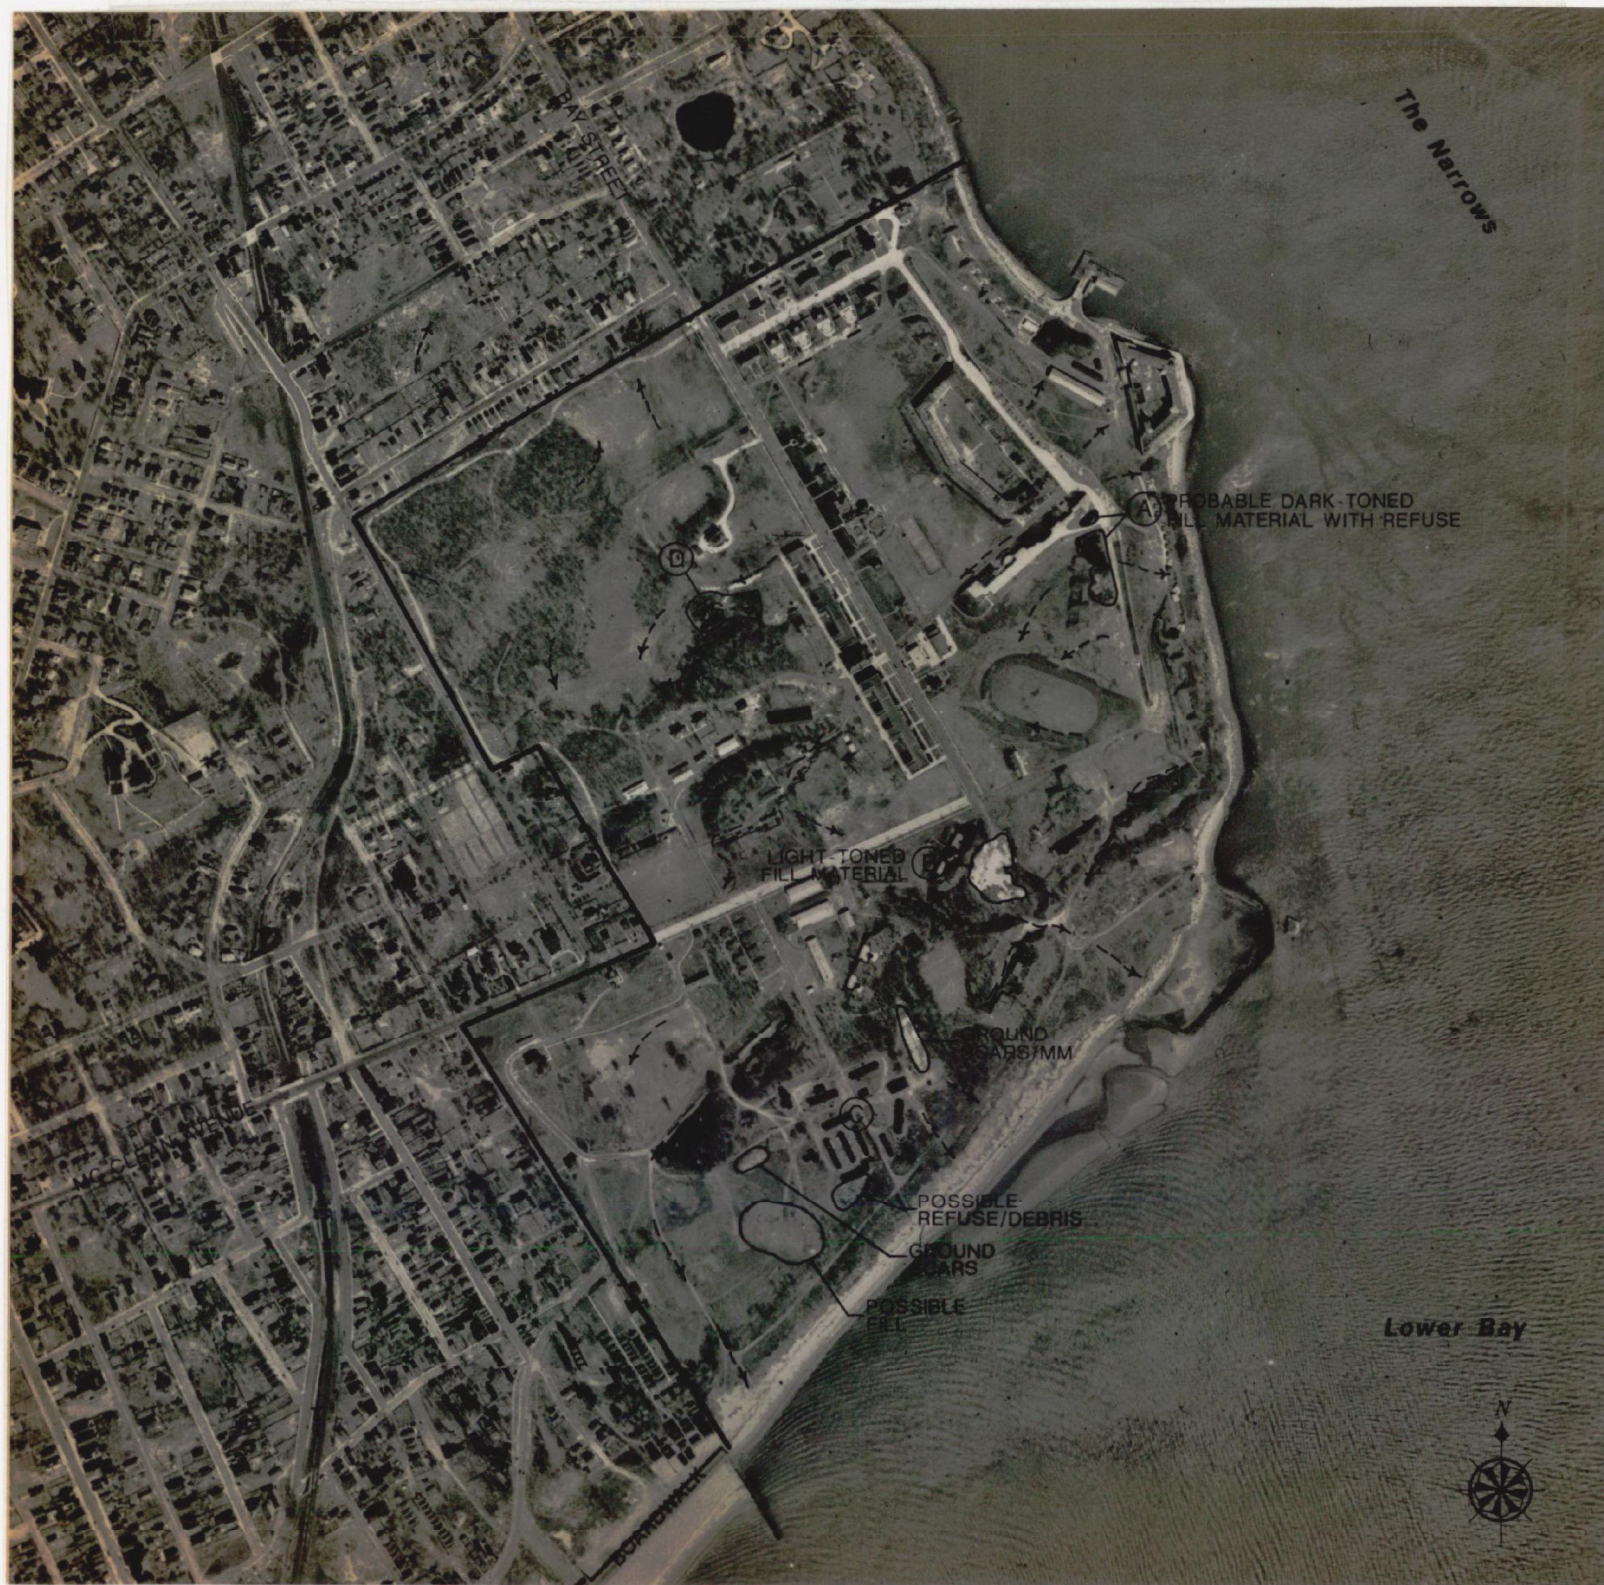
Figure 3. Fort Wadsworth Naval Station, April 6, 1940. Approximate scale 1:7920.

Probable dark-toned fill material has been deposited along with possible refuse and lighter-toned fill material near a road on the eastern side of the site (Annotation A). An access road leads into another area where light-toned fill material is being deposited (Annotation B).

Light-toned ground scars and probable medium-toned earthen mounded material (MM) can be seen near a multi-unit housing development (Annotation C) and may be related to their construction. On the other side of the development a ground scarred area and possible fill area can be seen. Also, refuse and or construction debris are visible south of one of the multi-unit houses.

Disturbed ground (DG) is seen in a slight ravine in the central portion of the site (Annotation D). The mottled appearance and presence of an access road may indicate disposal in this area.

Drainage arrow annotations are used to show the irregular drainage patterns within the study area caused by the ruins of the former earthen battleworks and gun mount fortifications built at this historic, coastal defensive, fort.

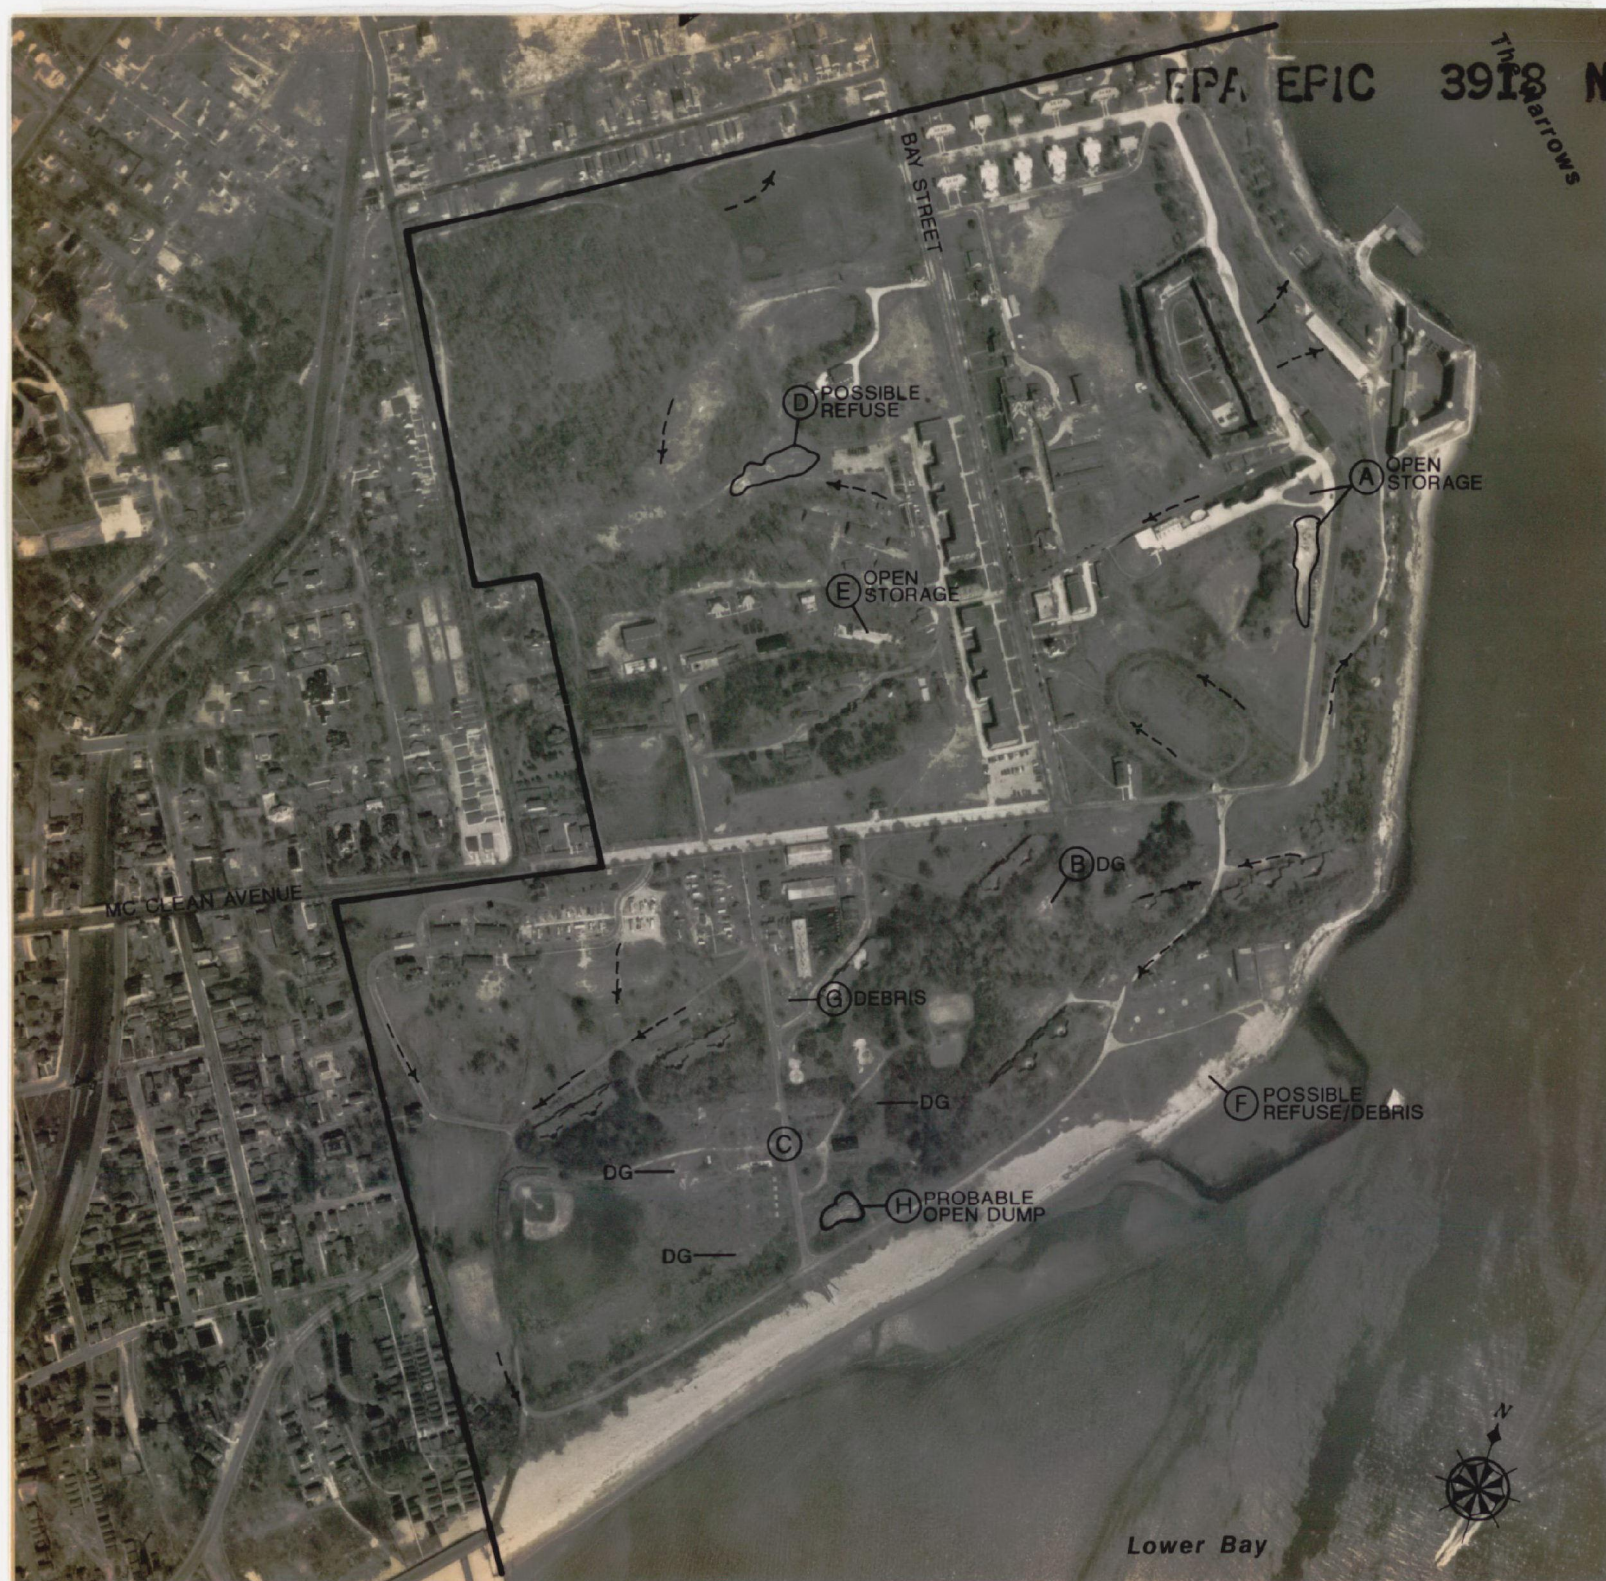
Figure 4. Fort Wadsworth Naval Station, April 20, 1951. Approximate scale 1:6000.

Open storage of mounded material, tanks and/or equipment has occurred at the location of the probable fill noted in the eastern portion of the site (Annotation A). A small amount of possible refuse is seen where disturbed ground was noted in 1940 (Annotation D). Open storage of containers and equipment on a former building site is also noted (Annotation E).

Other features visible include possible refuse/debris on the beach (Annotation F), a debris piled beside a large shed-type building (Annotation G), and a probable open dump site for fill material (Annotation H).

The multi-unit housing development site (Annotation C) has been dismantled. The sites around Annotations C and B, previously observed as piles of fill and/or debris on the 1940 photography, have since become overgrown with vegetation and are noted as disturbed ground.

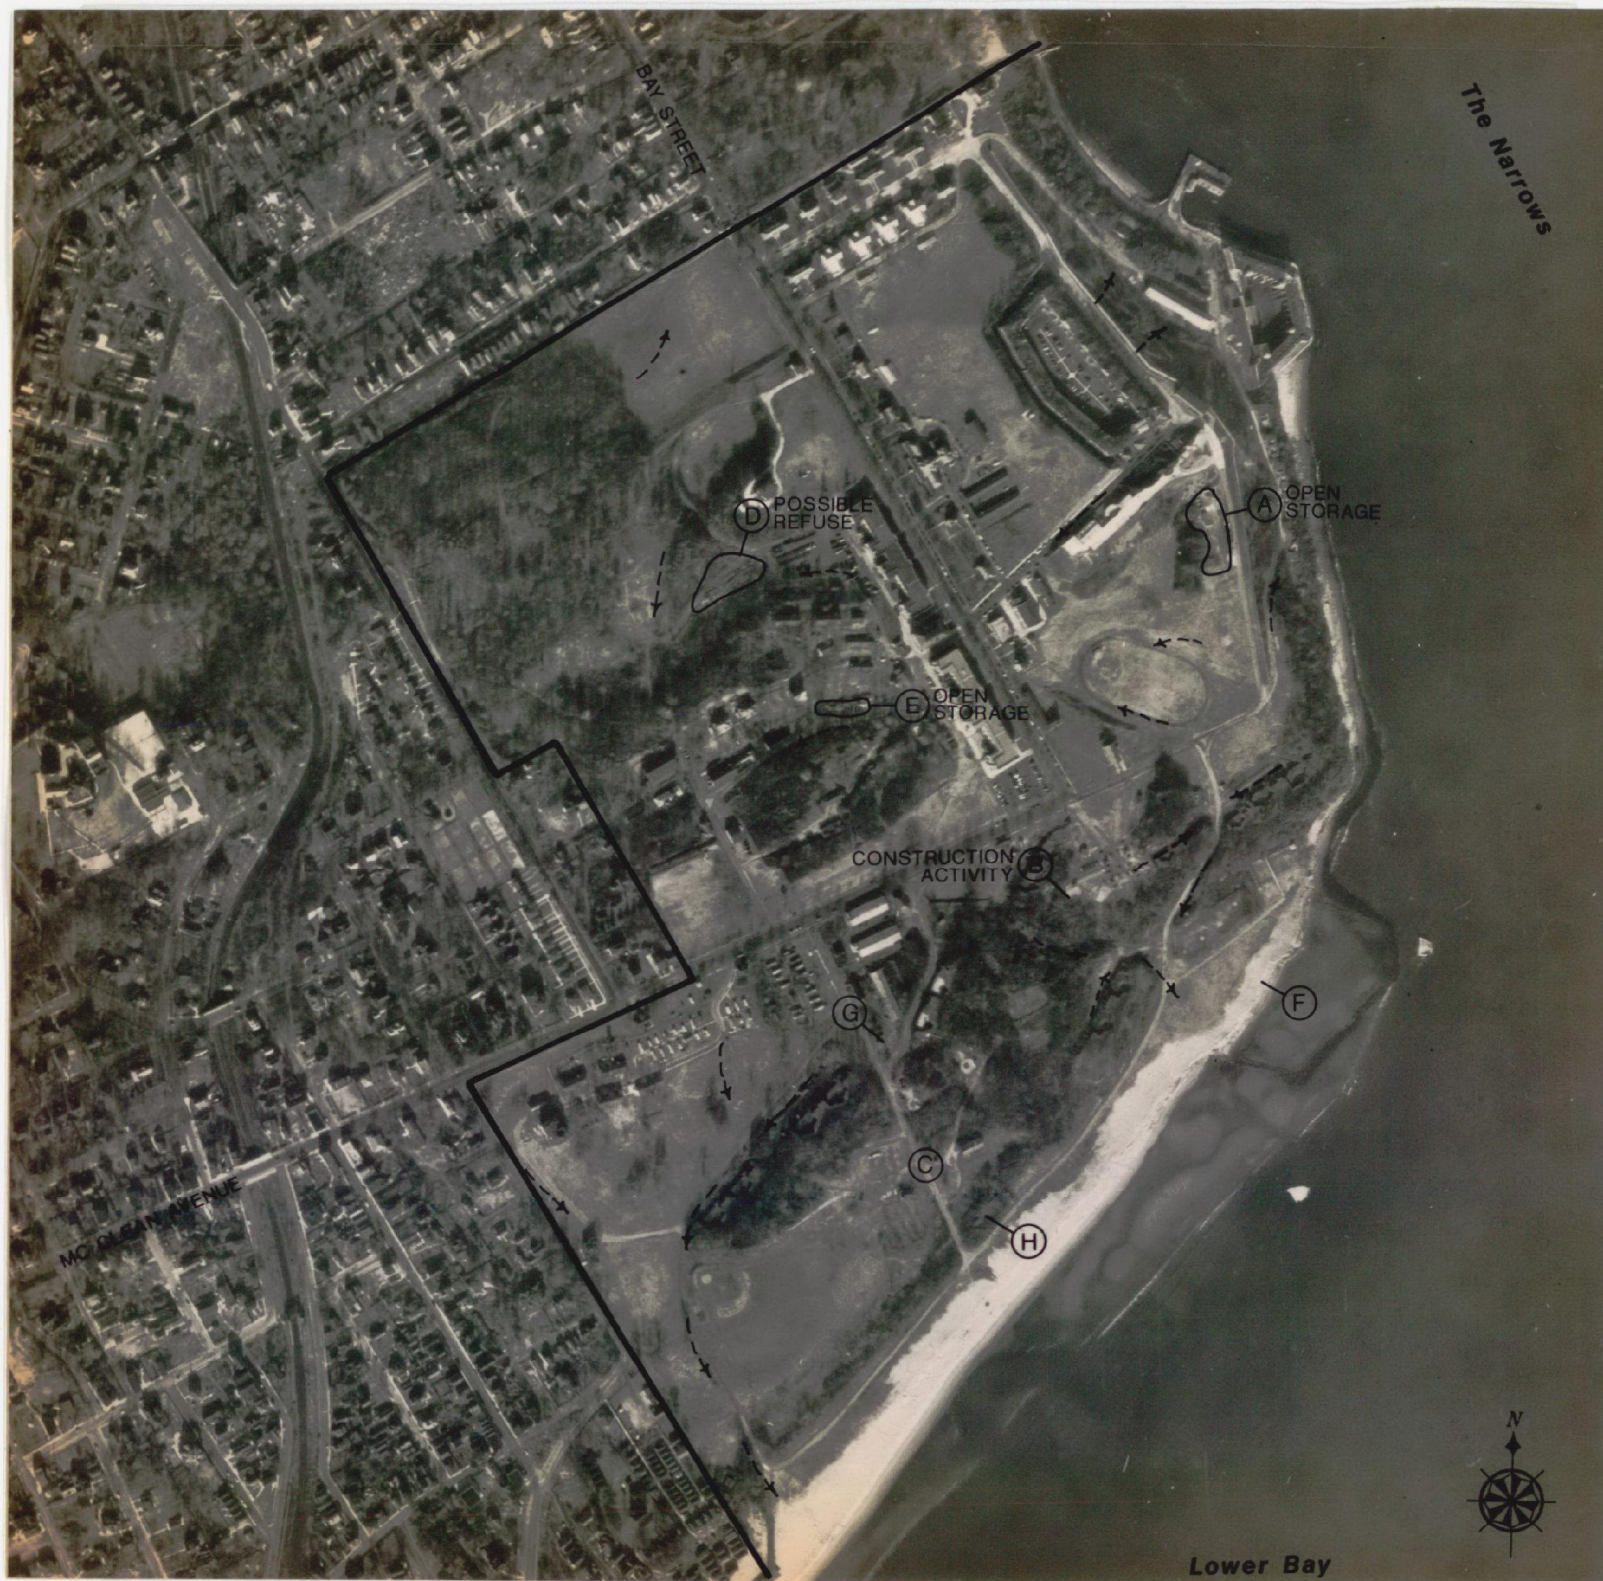
Figure 5. Fort Wadsworth Naval Station, January 4, 1954. Approximate scale 1:6720.

Open storage of mounded material, tanks and/or equipment has continued at the location of the probable fill noted in the eastern portion of the site (Annotation A). There has been new construction at the location of a previously reported disturbed ground (Annotation B).

The dump site for possible refuse appears to have expanded since 1951 (Annotation D). There is open storage of containers and equipment on a nearby former building site (Annotation E). There is no waste disposal activity noted at the former waste disposal, construction, or disturbed ground areas (Annotations C, F, G, and H).

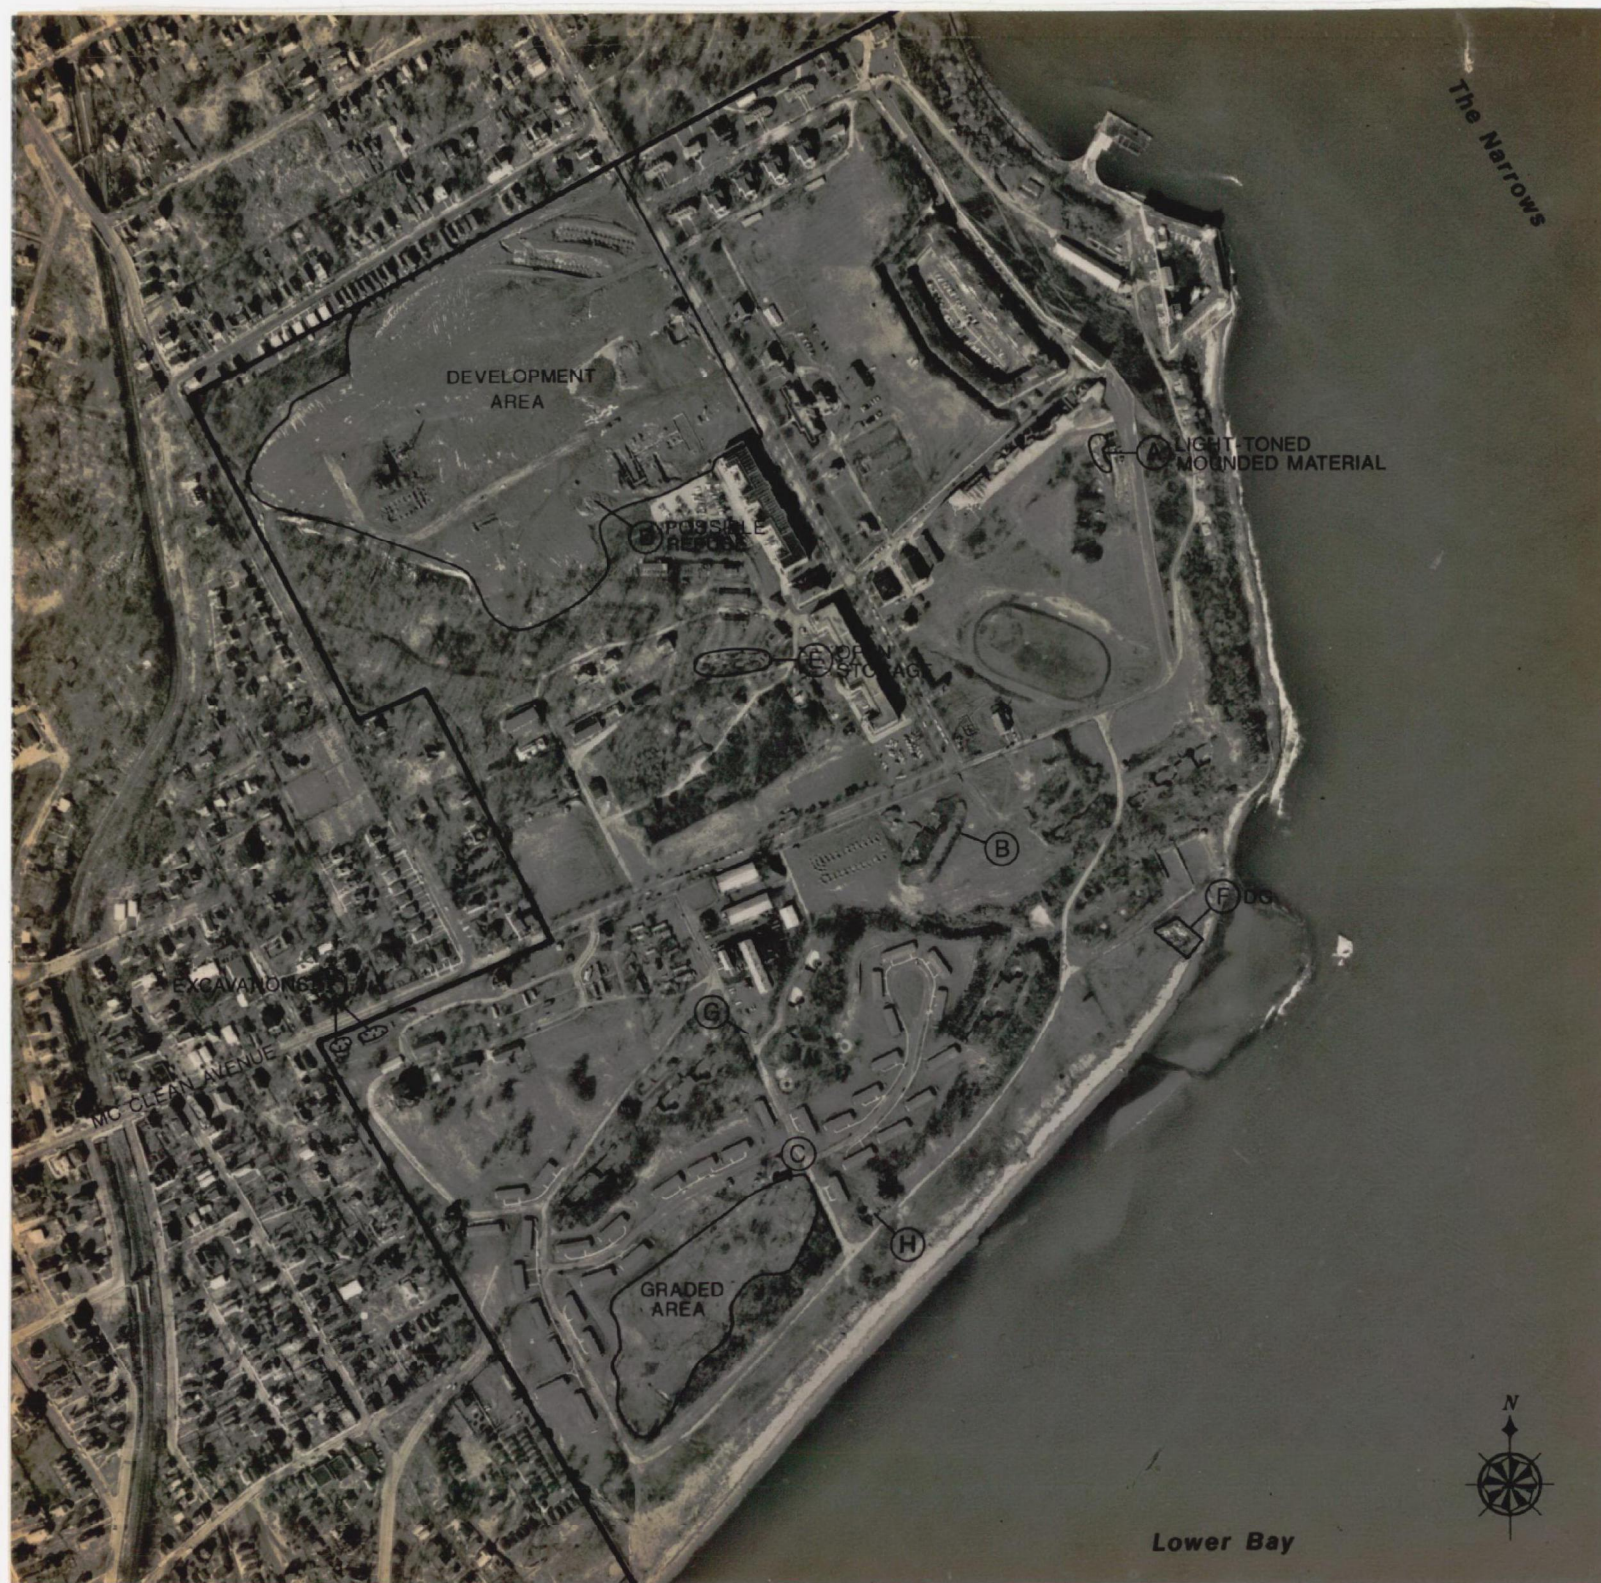
Figure 6. Fort Wadsworth Naval Station, February 17, 1960. Approximate scale 1:6200.

Since 1954, filling, grading, excavation and other features associated with site development are present in a northern portion of Fort Wadsworth labeled "Development Area". No features unique to waste disposal activity are noted. A small amount of light-toned mounded material is present on the former open storage area in the eastern portion of the fort, although most of this area is now used for parking (Annotation A). A graded area observed in the southern portion of the fort is probably related to the construction of additional residential dwellings (Annotation C).

The previously reported location for open storage of containers and equipment is still present (Annotation E). The previously reported area of possible refuse and/or debris in 1951, but reported as inactive in 1954, now appears to be fenced (Annotation F). Two excavations near the west perimeter of the fort are likely related to construction activity rather than waste disposal (Annotation I). There is no waste disposal activity noted at the former waste disposal, construction, or disturbed ground areas (Annotations B, C, G, and H).

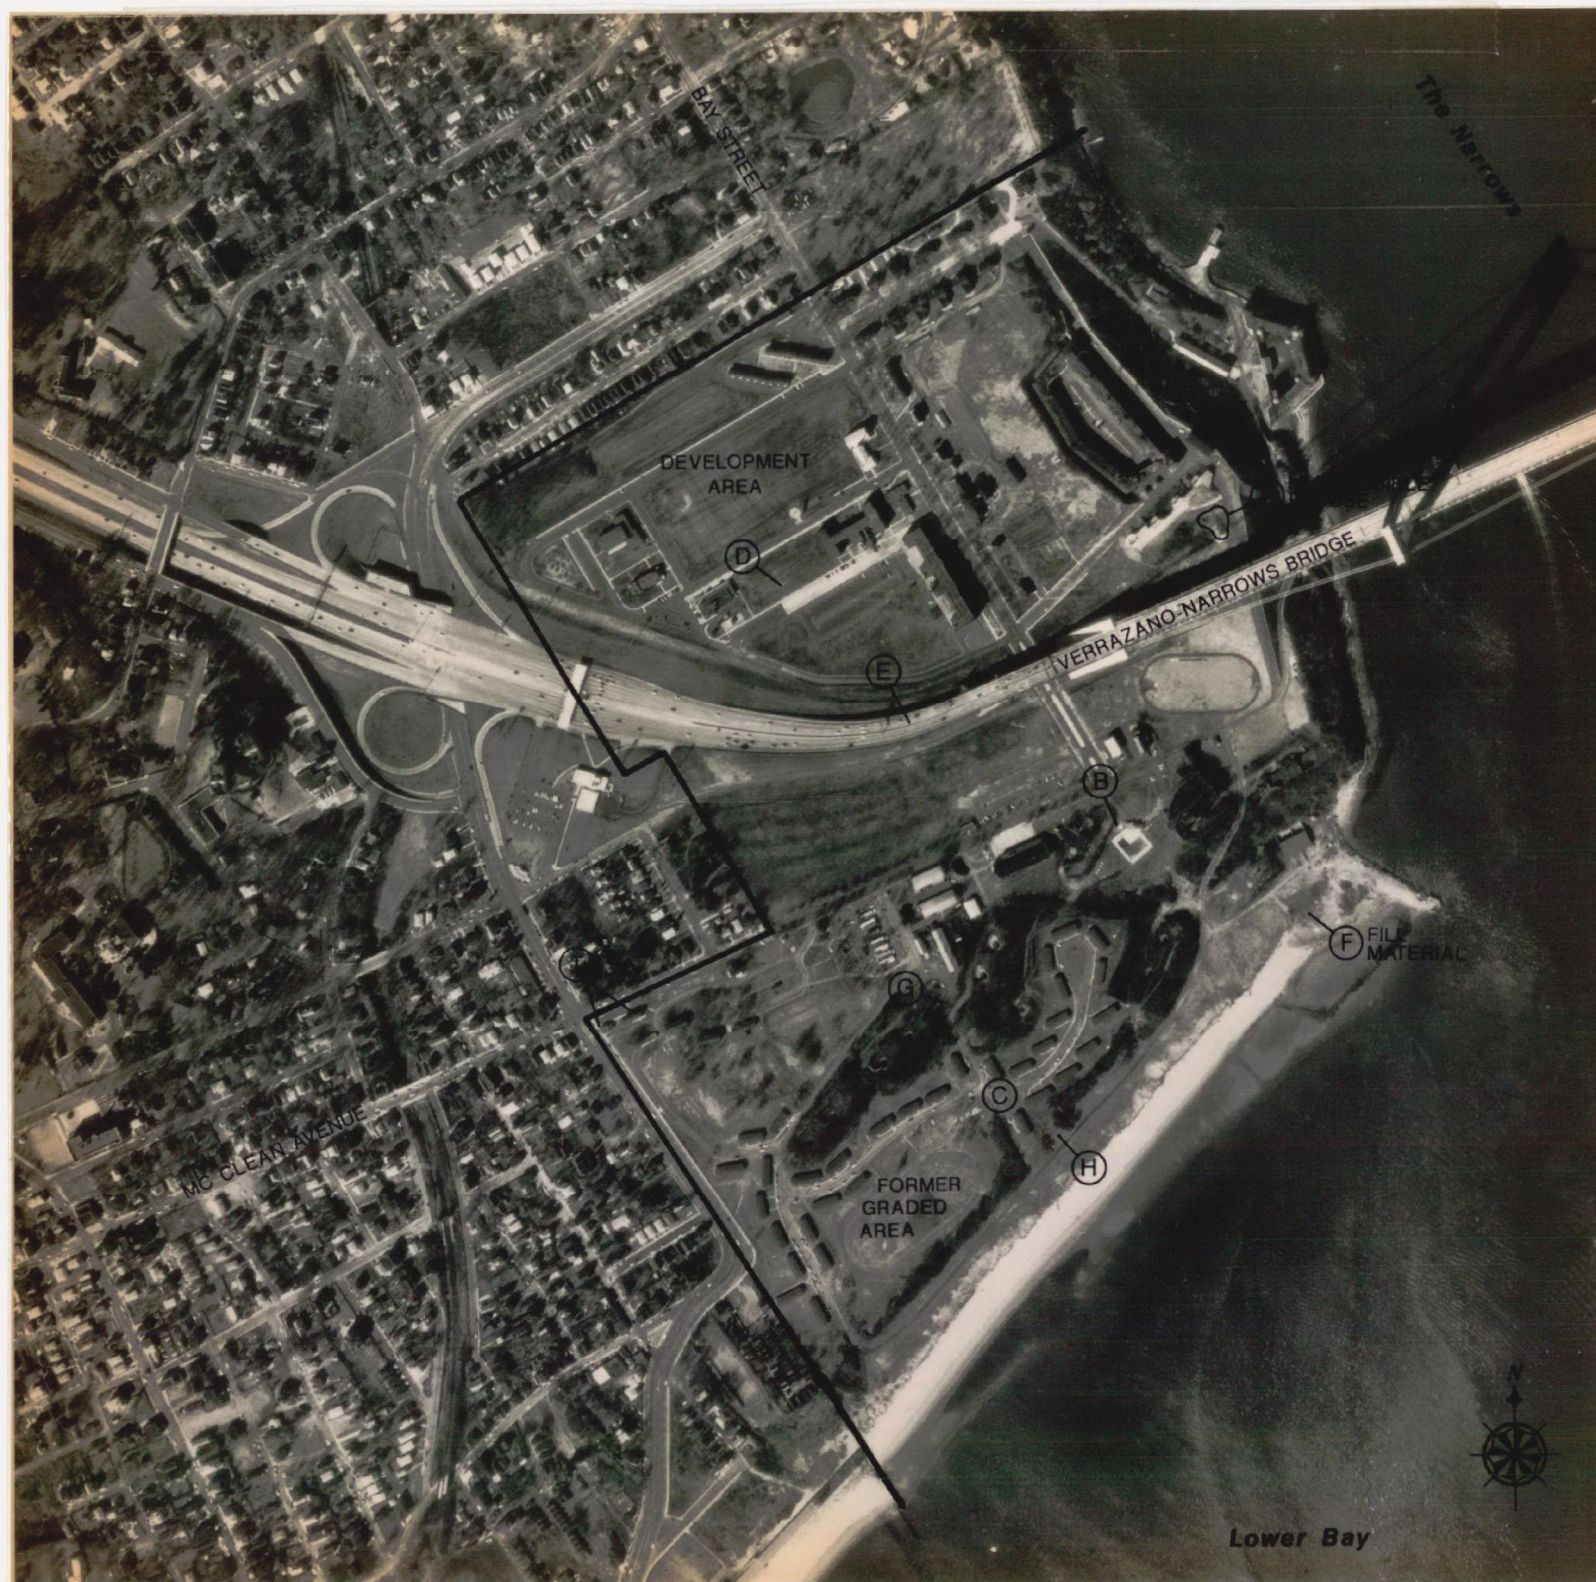
Figure 7. Fort Wadsworth Naval Station, February 22, 1966. Approximate scale 1:7200.

The 1966 aerial photography reveals the Verrazano-Narrows Bridge has been constructed across the central portion of the fort. The location labeled "Development Area" on the 1960 photograph has been converted to an open area with the addition of seven new buildings. A small area along the north side of the Verrazano-Narrows Bridge has mounds of material and possible refuse present (Annotation A). The disturbed ground noted on the beach in 1960 has become the site of beach replenishment/filling activity (Annotation F). The previously reported two excavations near the west perimeter of the fort are the locations of two recently constructed residences (Annotation I). There is no waste disposal activity noted at the former waste disposal, construction, or disturbed ground areas (Annotations B, C, D, E, G, H and I).

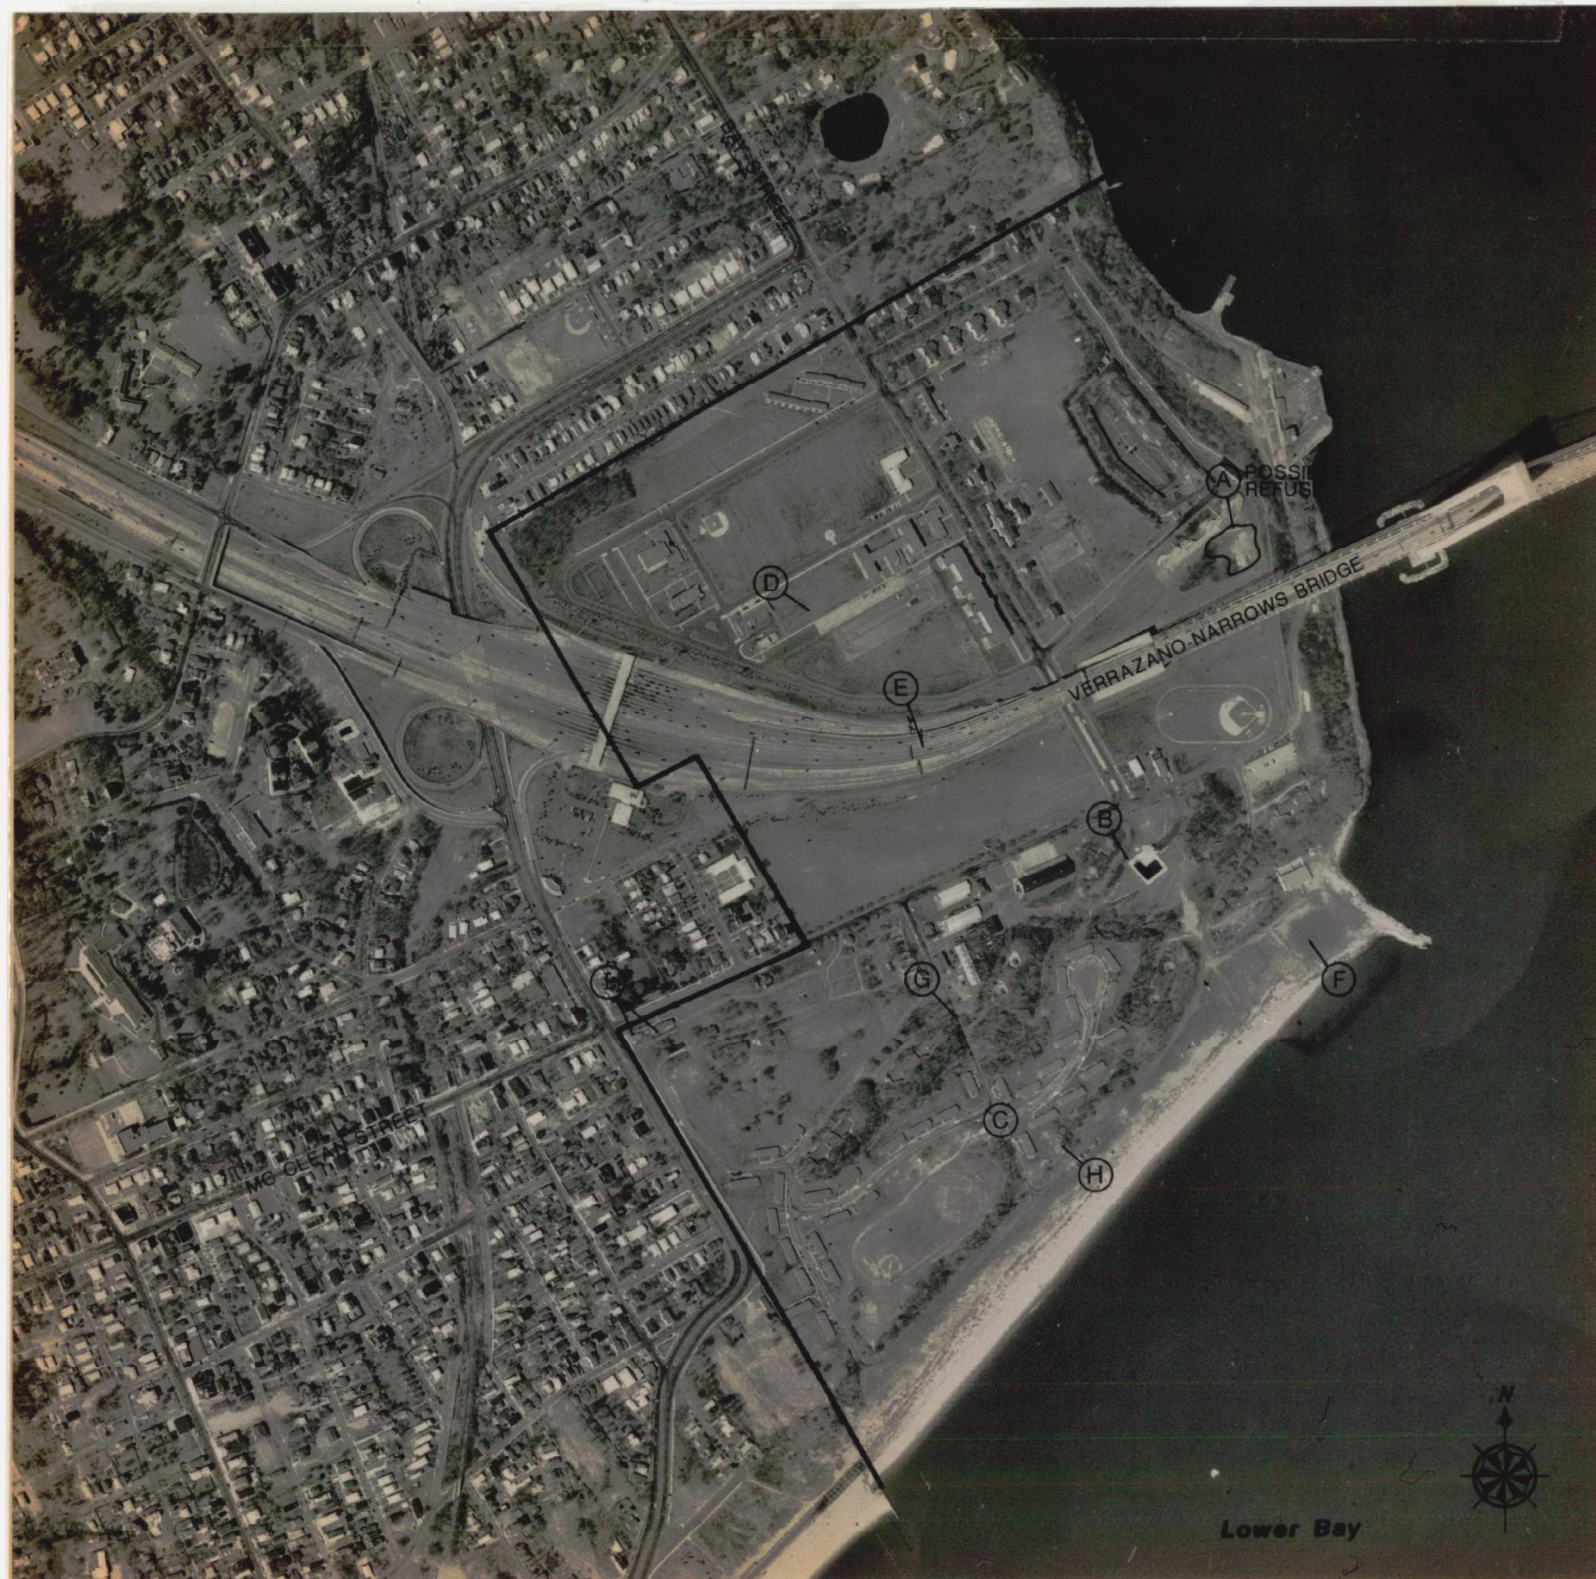
Figure 8. Fort Wadsworth Naval Station, April 12, 1970. Approximate scale 1:7920.

Since 1966 there has been no significant new construction at Fort Wadsworth except construction to enlarge the number of ramps providing access to the Verrazano-Narrows Bridge. A small area along the north side of the bridge has mounds of material and possible refuse present and appears to be used as a dumpster site (Annotation A). No other significant changes occur at Fort Wadsworth through 1993. There is no waste disposal activity noted at the former waste disposal, construction, or disturbed ground areas (Annotations B, C, D, E, F, G, H and I).
