# Demonstration of the AquaBlok<sup>®</sup> Sediment Capping Technology

## Innovative Technology Evaluation Report

**Final**

National Risk Management Research Laboratory  
Office of Research and Development  
U.S. Environmental Protection Agency  
Cincinnati, Ohio 45268

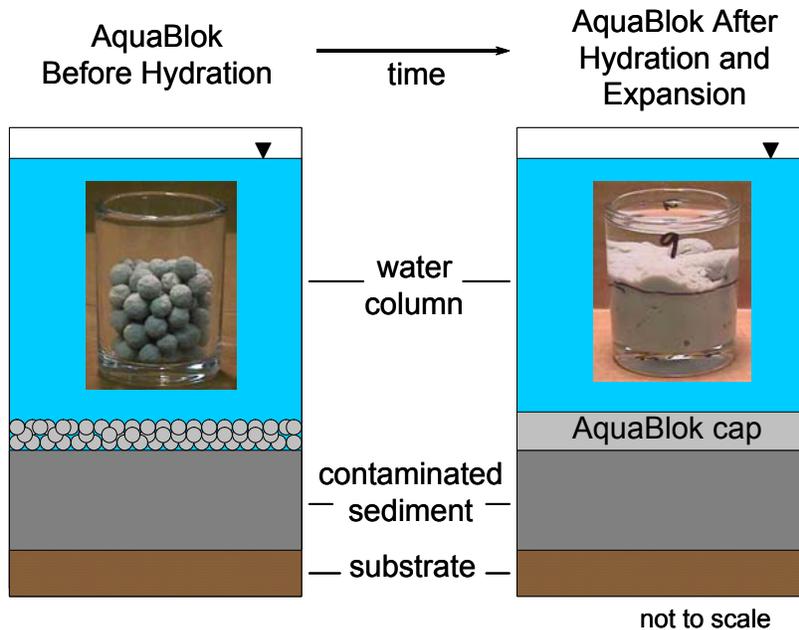
**Figure 1-1. Integrated Conceptual and Actual View of AquaBlok® Capping Material**  
(EPA Tech Trends, February 2000)

AquaBlok<sup>®</sup> can be manufactured in specific blends to accommodate specific cleanup objectives. It is generally packaged in large bags

but can be packaged loose in bulk containers. It can be transported by truck, rail, or barge, and can be directly deployed at cleanup sites from land using typical excavation equipment, from water using direct-application barges or barge cranes, or by air using helicopters. It can also be placed by hand if necessary. The material can be manufactured on site to meet a specific need or to achieve cost advantage (i.e., by using local sources of component materials). AquaBlok® can be placed, as with more traditional sediment capping materials, in one or more lifts to achieve a design cap thickness, and can be armored with other materials (e.g., sand, gravel, or stone) if necessary.

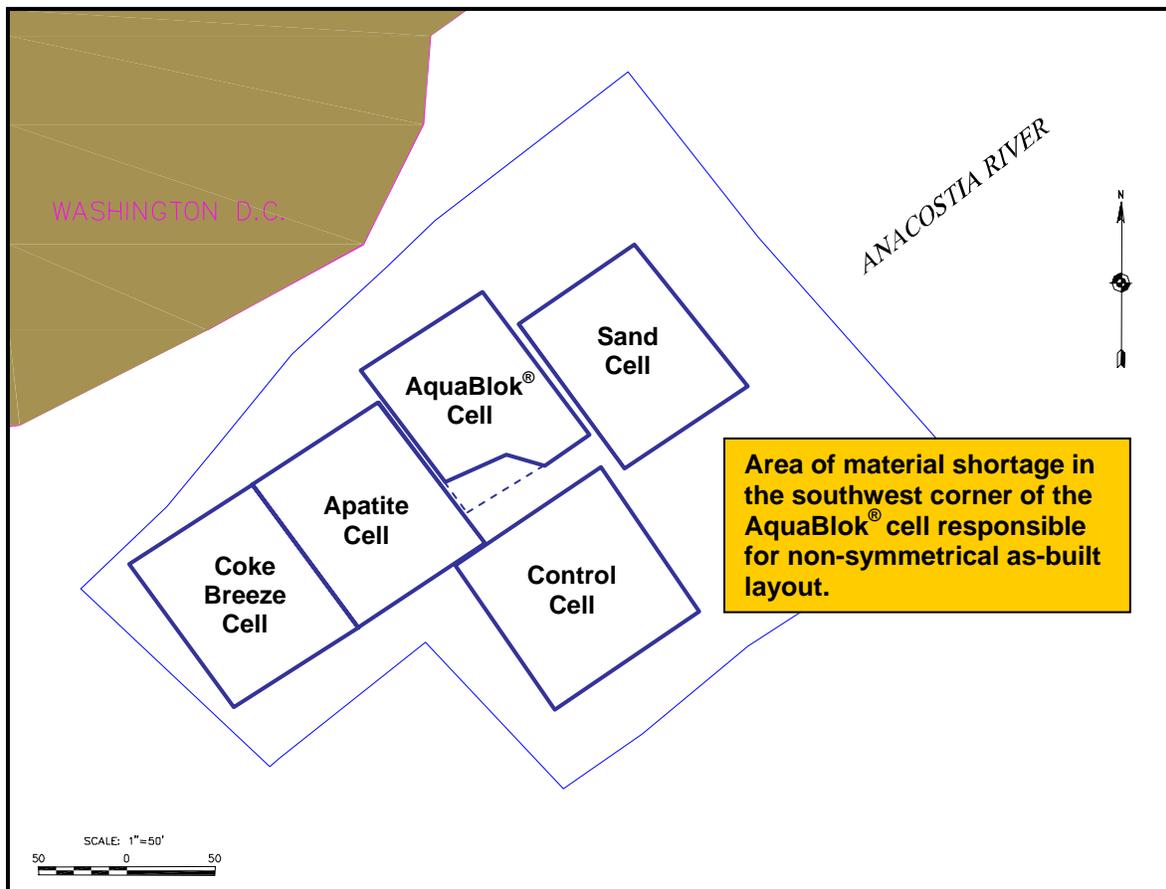
**Figure 3-4. AquaBlok® SITE Demonstration Area Capping Cell Layout**

Figure 3-4 shows the cap study design layout for the demonstration area, including all of the capping areas constructed and assessed during the AquaBlok® SITE demonstration and the HSRC innovative capping technology evaluation. As described in Section 3.1, the SITE demonstration focused on the performance of AquaBlok® while HSRC evaluated the effectiveness of apatite,

coke breeze, and AquaBlok® caps. However, for both studies, a traditional sand cap area was established to serve as a point of comparison between traditional and innovative technologies, and an uncapped control cell was established to provide a baseline for reference comparisons. These areas are also depicted on Figure 3-4.

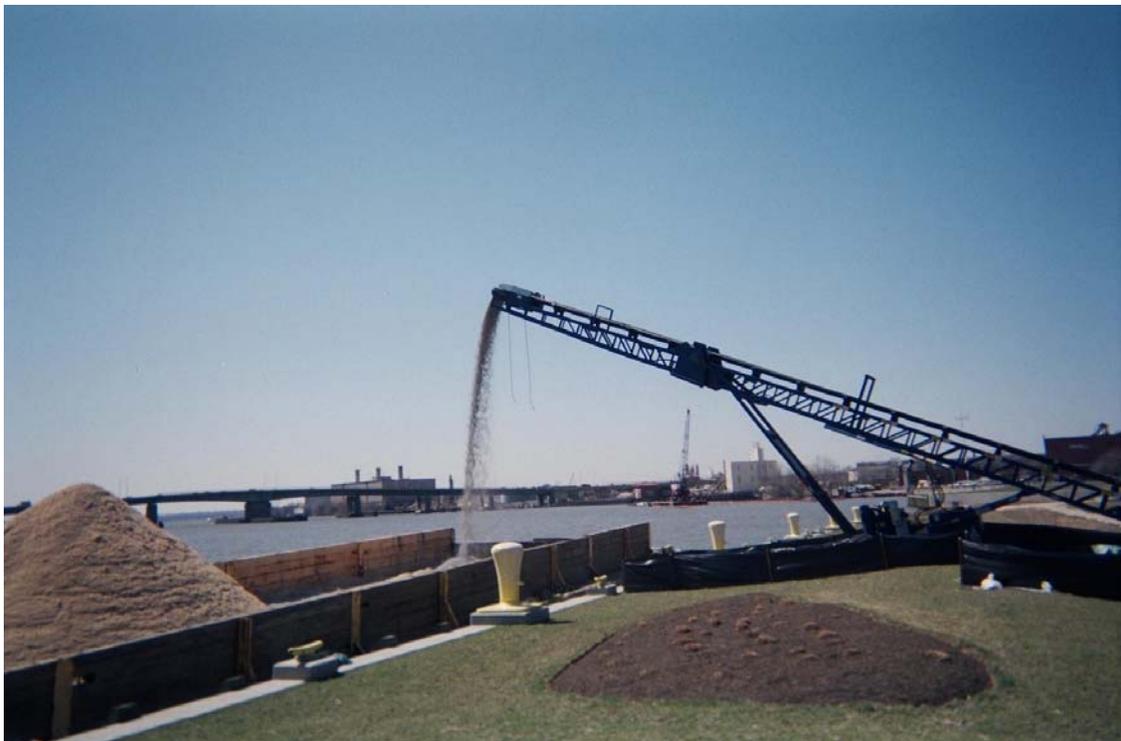
**Figure 3-7. Transferring Cap Material to Barge Using Conveyor**

nearshore loading area. A belt conveyor system was then used to transfer the materials from the nearshore material stockpile area to a material barge secured along the shoreline (see Figure 3-7). After loading, a tugboat was used to move the material barge beside a crane barge that was used to actually construct the caps (see Figure 3-8).

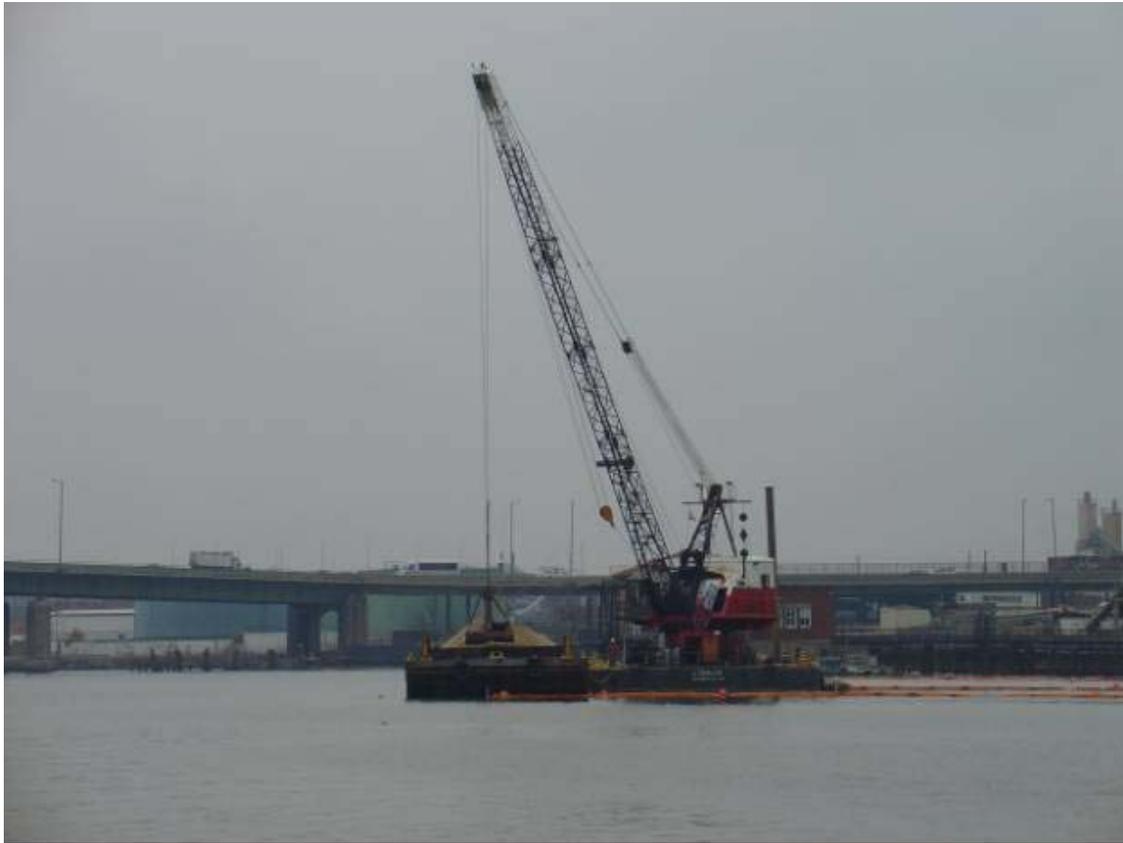
**Figure 3-8. Crane Barge Used to Place Caps in Demonstration Area**

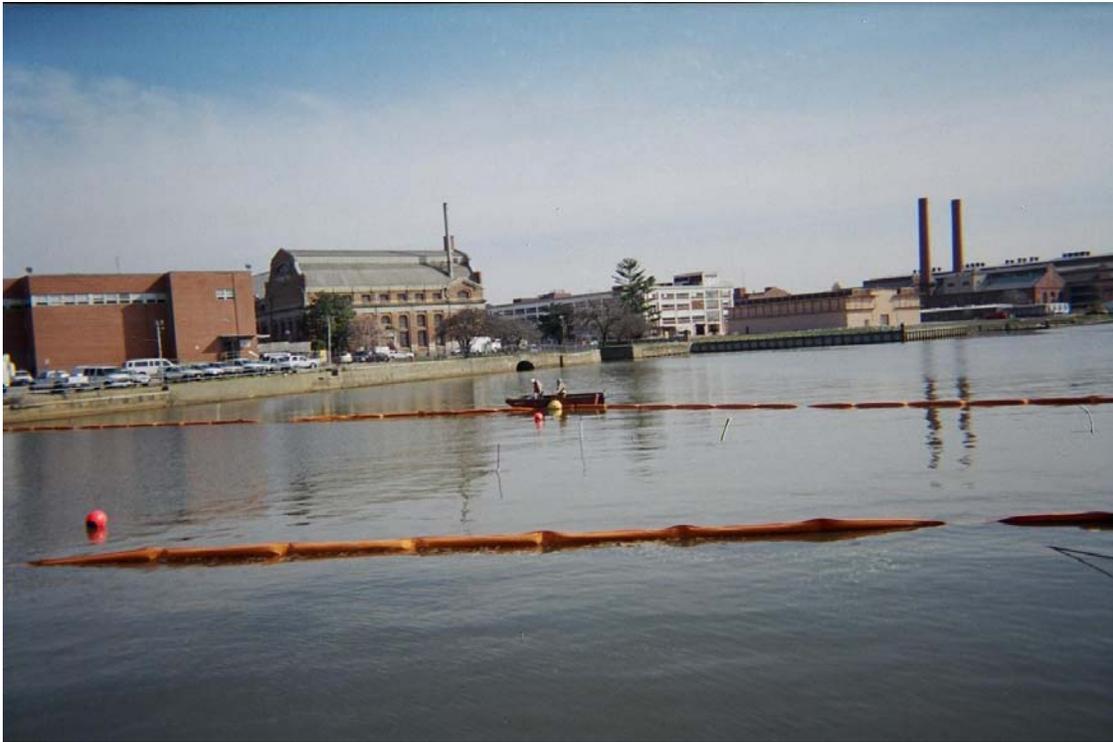
**Figure 3-9. Silt Curtains Deployed Around Demonstration Area Capping Cells**

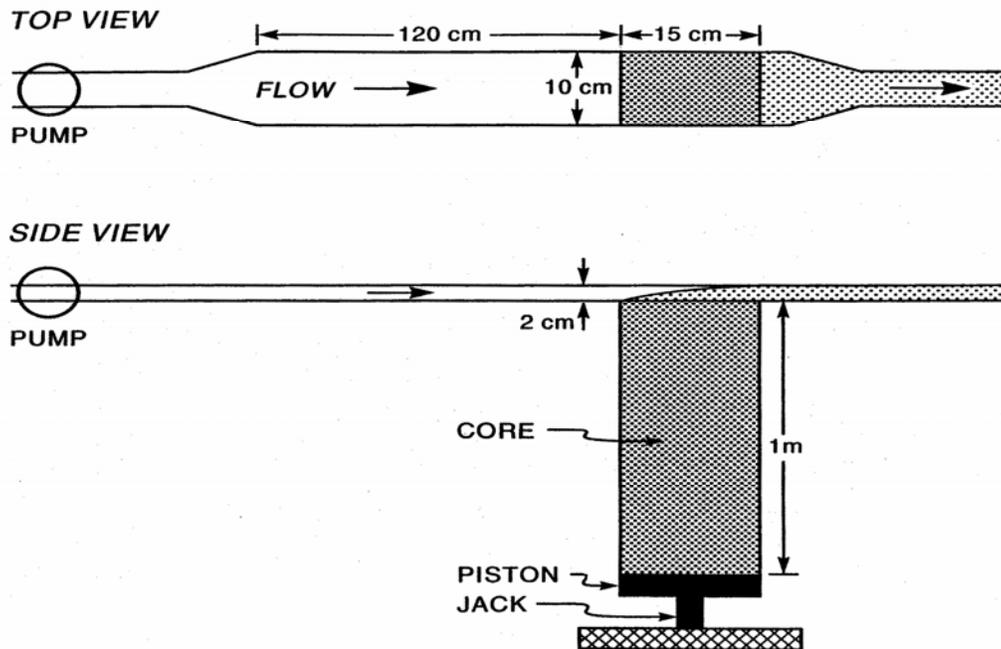
**Figure 3-10. Sedflume Schematic (from McNeil and Lick, 1996)**

section coring sleeve containing sediment is inserted. The main components of the flume are the coring sleeve, a test section where the coring sleeve is advanced, a water storage tank, a pump to force water through the system, an inlet for the introduction of uniform, fully-developed, turbulent flow, and a flow exit section. The Sedflume system, as with the coring sleeve, is generally constructed of a transparent material so that sediment-water interactions can be directly observed. Water is pumped from the water storage tank, through a pipe, and then through a flow converter into the rectangular duct shown on Figure 3-10.

Water is forced through the duct and the test section and over the surface of the test sediments. The shear produced by this flow causes the sediments to erode. As the sediments extruded from the core sleeve erode, the core is continually moved upward by the operator so that the sediment-water interface remains level with the bottom of the test and inlet sections (a few millimeters of the core does protrude above the section floor). The erosion rate is recorded as the degree of upward movement of the sediments in the coring tube over time.

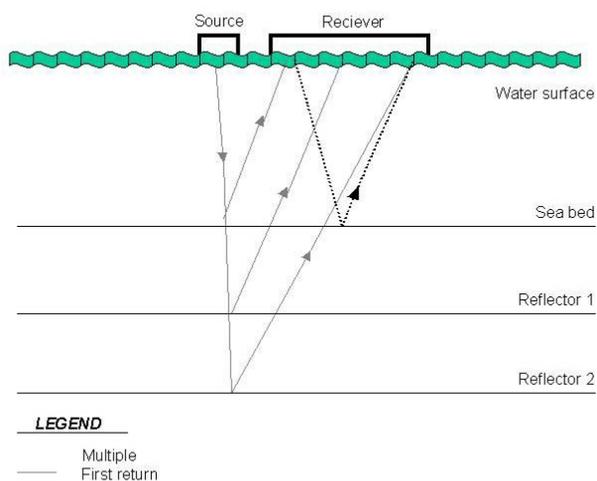
Sound produced at the source reflects off of the seabed surface, reflector 1, and reflector 2, which are areas of rapid density change. The receiver catches the reflected sound waves. A multiple sound wave is received at the same time as the reflector two sound wave, obscuring reflector 2 on the same seismic record.

**Figure 3-11. Principles of Acoustic Sub-Bottom Profiling**

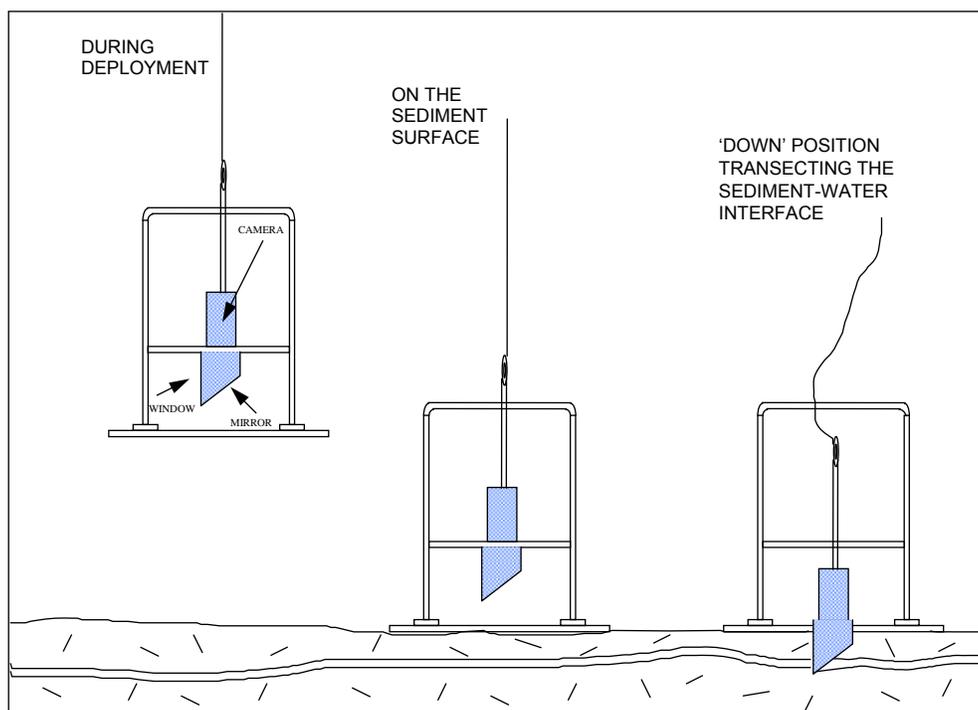
**Figure 3-12. Schematic of Sediment Profiling Camera**

The prism has an internal strobe mounted inside at the back of the wedge to provide illumination for the image. The prism chamber is filled with distilled water so the camera maintains an optically clear exposure path. The entire wedge assembly is mounted on a moveable carriage within a stainless steel or aluminum frame. The frame is lowered by a guide line to the seafloor mechanically from a surface vessel, and the tension on the wire keeps the prism in its “up” position. When the camera frame comes to rest on the sediment surface, the guide line goes slack (see Figure 3-12), and the camera prism descends into the sediment at a slow, controlled rate by the dampening action of a hydraulic piston to minimize disturbance at the sediment-water interface. On its descent, the prism trips a trigger that activates a time-delay circuit to allow the camera to reach maximum penetration into the seafloor before the picture is taken. Alternatively, the camera can be operated manually to take a series of images as the prism penetrates the sediment. The resulting images give the viewer the same perspective as looking through the side of an aquarium half-filled with sediment. The strobe can generally recharge in a matter of seconds.

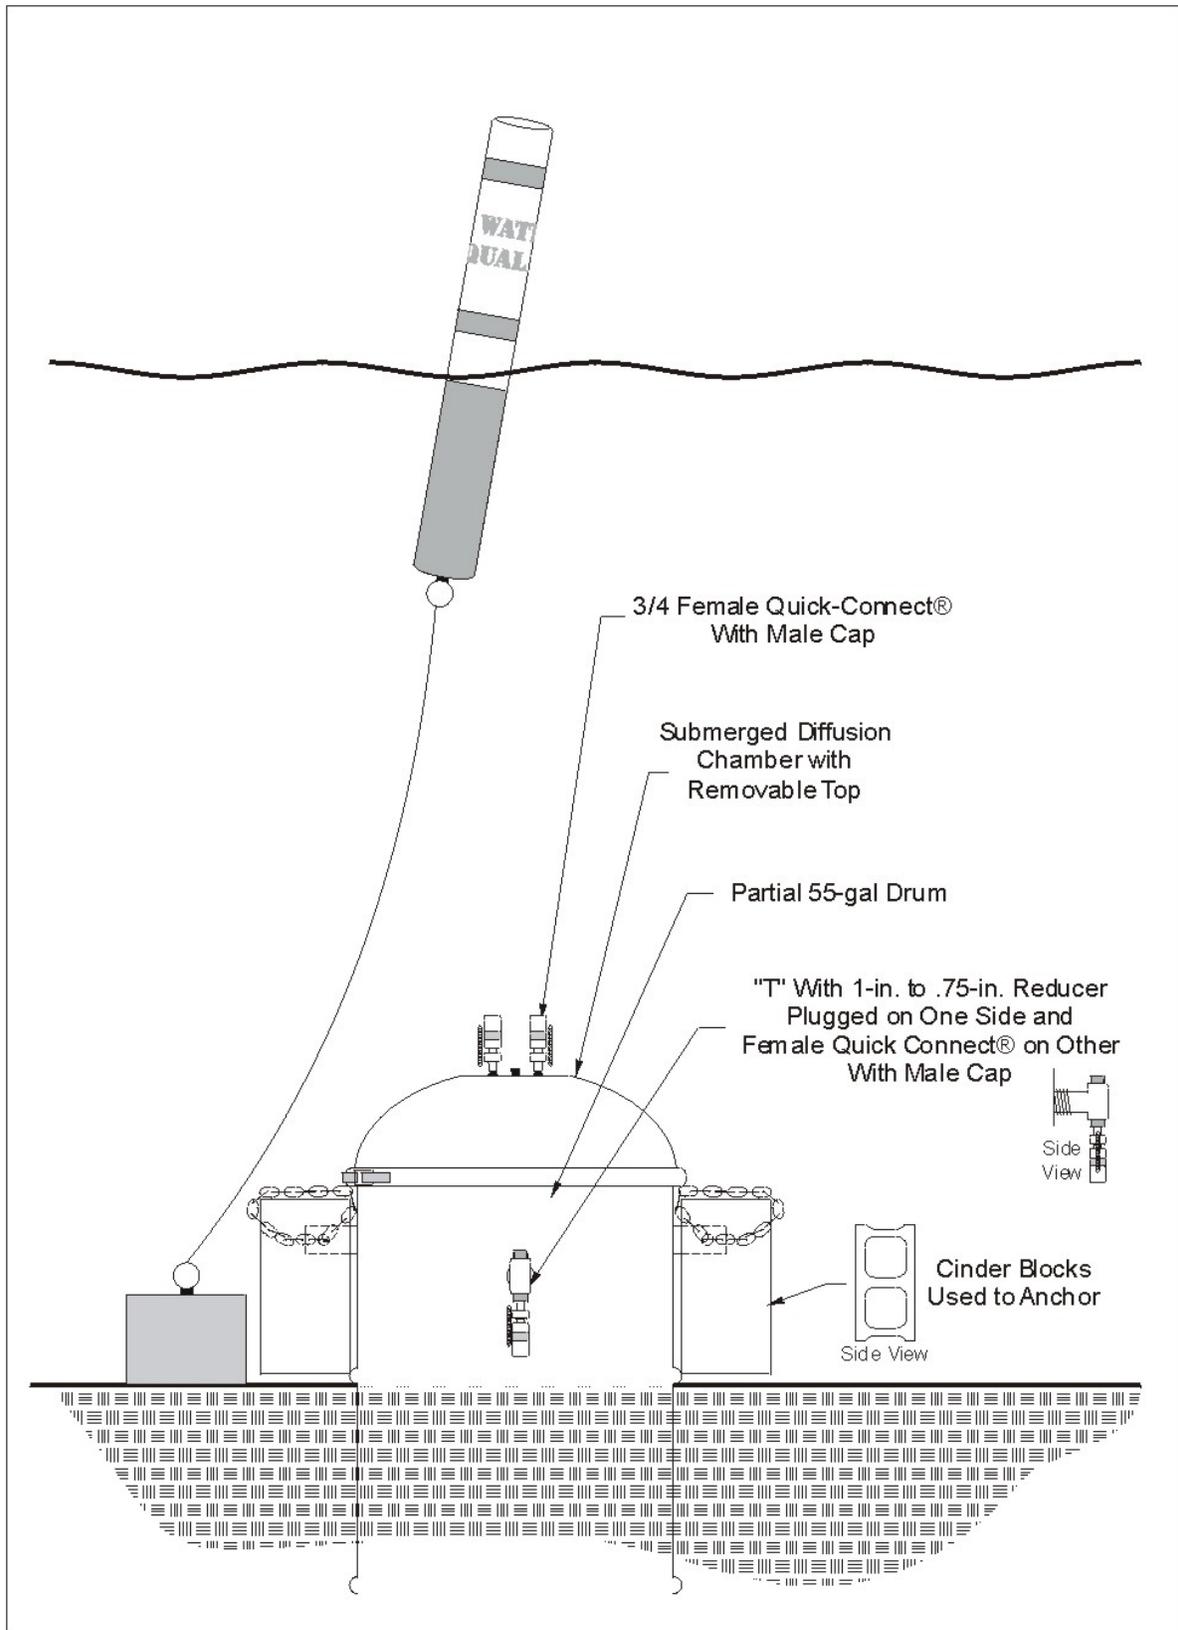
Figure 3-13. Schematic of Typical Submerged Gas Flux Chamber

Gas samples are obtained from a gas flux chamber using a dive team. Samples are usually collected using a gastight syringe equipped with a valved stainless steel male quick-connect fitting on an umbilical cord. The syringe is attached to the valved female, quick-connect fitting on the top of the “dome” lid of the chamber via the umbilical.

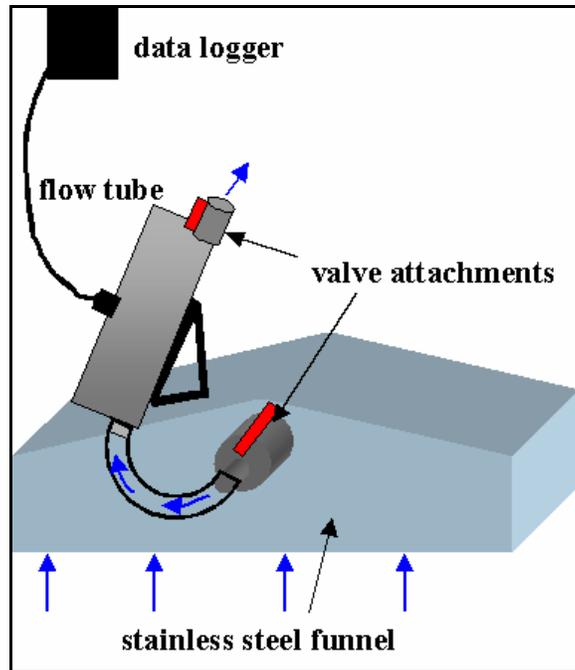
Figure 3-14. Schematic of Ultrasonic Seepage Meter (not to scale)

Using seepage meters, vertical advective flux is captured by a steel collection chamber with a square cross-section that is inserted into the sediment surface, generally by a dive team (see Figure 3-14). The captured aqueous discharge is directed via a length of tubing through an ultrasonic flow tube adapted for use in submarine environments. The flow tube is angled to allow trapped gases to escape. The ultrasonic device houses two piezoelectric transducers at either end of the flow tube that continually emit ultrasonic bursts (~400 bursts per second at an appropriate frequency) from one end of the meter to the other. The piezoelectric transducers continuously measure the travel times of the ultrasonic waves as water enters the flow tube and passes through the ultrasonic beam path (see Figure 3-15). The ultrasonic signal that travels with the direction of flow has a shorter travel time than the signal traveling against the direction of flow. The directional perturbation in travel time is directly proportional to the velocity of flow in the tube, and both forward and reverse fluid flows can be measured in real time. The ultrasonic measurement device is generally connected to a battery-powered data logger that records both incremental and cumulative discharge simultaneously. For field deployment, the data logger and a back-up battery are usually

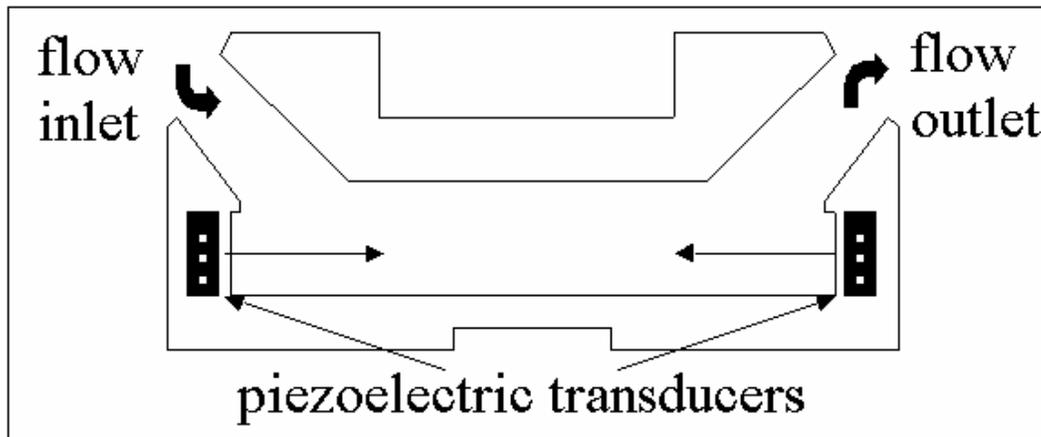
Figure 3-15. Conceptual Cross-Section of Ultrasonic Seepage Meter Flow Tube (from Paulsen et al., 2001)

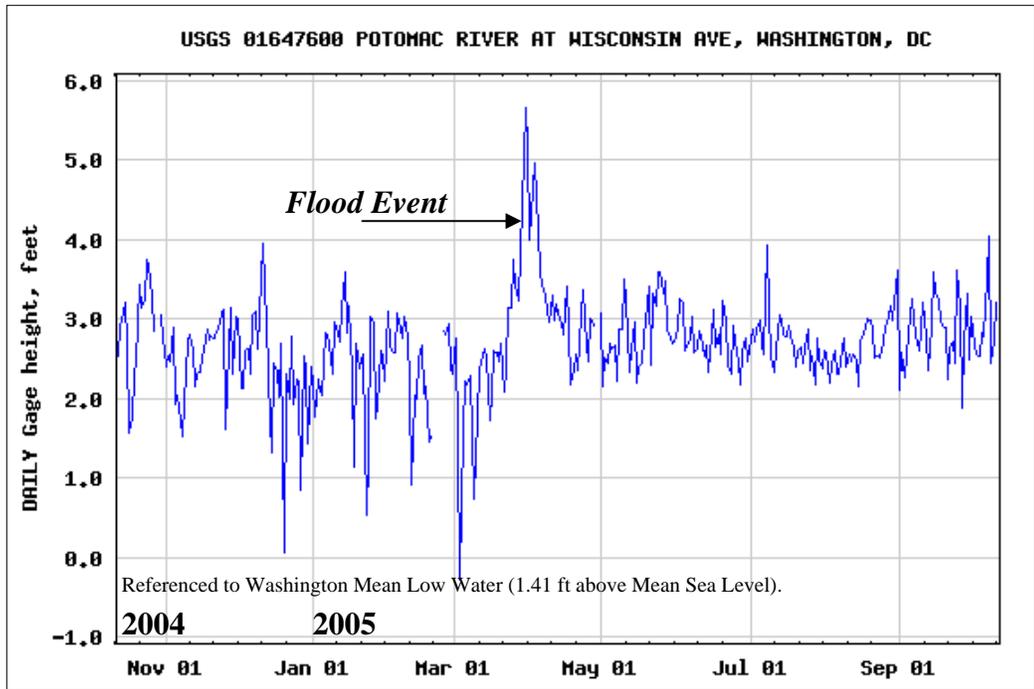
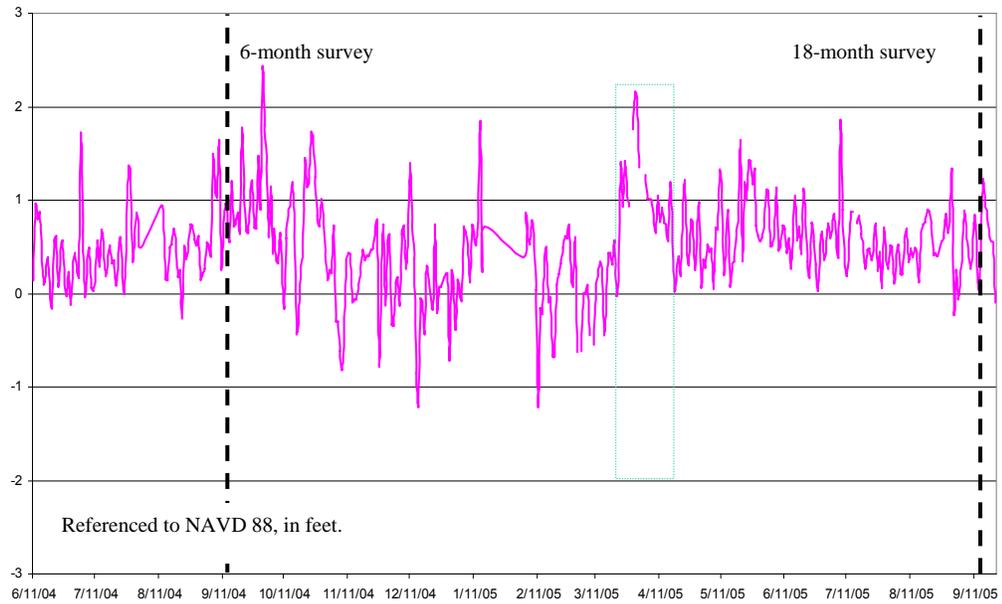
**Figure 3-21. Potomac River (top) and Anacostia River (bottom) River Flows During Demonstration (flood event in top panel is highlighted in green in lower panel; from United States Geologic Survey [USGS], 2006)**

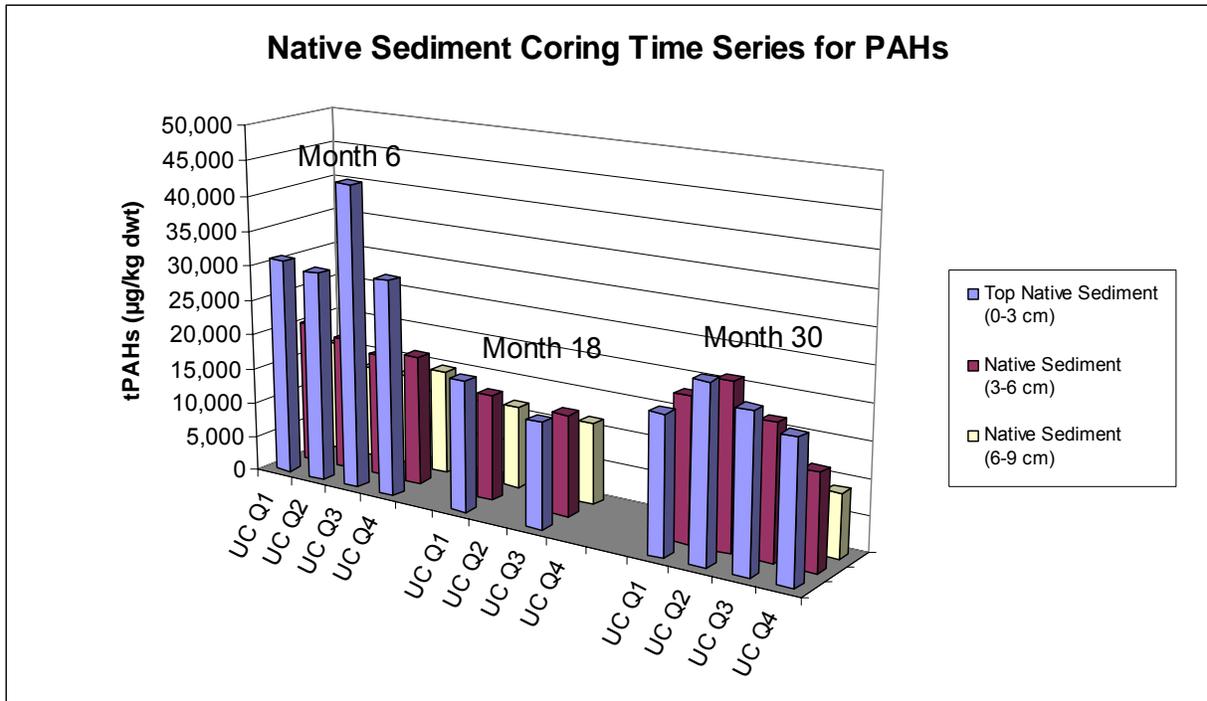
**Figure 3-23. Total PAHs in Control Cell Cores**

As demonstrated on Figure 3-23, total PAH concentrations in the surficial native sediments in the control cell during the six-month and 30-month post-capping coring events were generally between 20,000 and 40,000 µg/kg and declined to some extent with depth. Total surficial PAH concentrations during the 18-month post-capping coring effort were comparatively lower, which may have been an artifact of increased deposition of relatively disproportionately inorganic new sediment during this timeframe (see Sections 3.3.1.1.3 and 3.3.1.2.3). Alternatively, the variability in surficial total PAH concentrations could be related to simple laboratory analytical variability and/or the varying

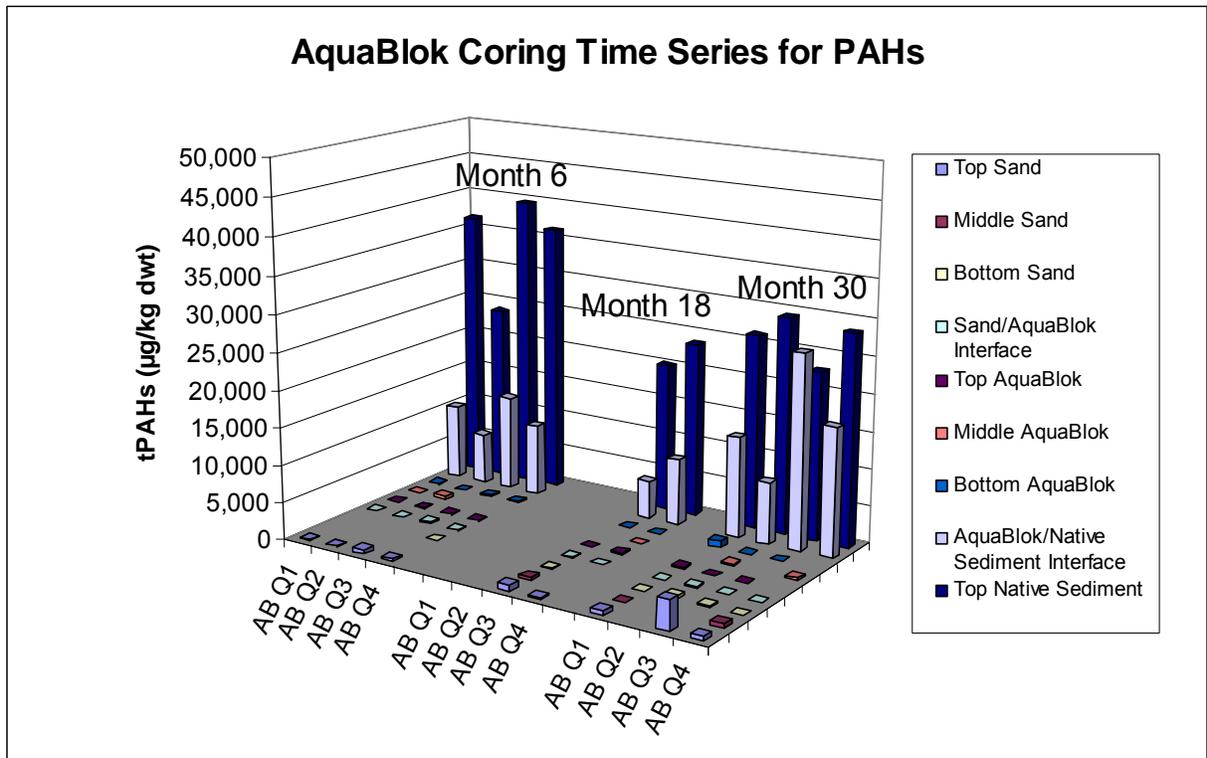
**Figure 3-24. Total PAHs in AquaBlok® Cell Cores**

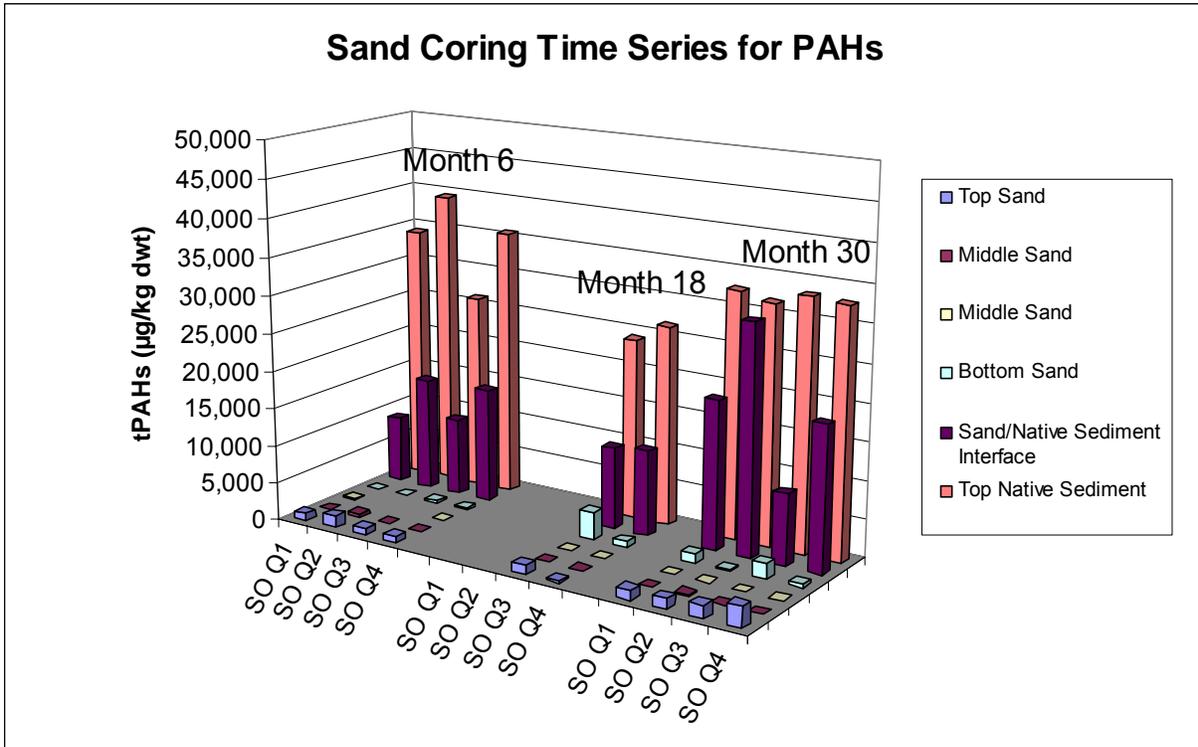
Figure 3-25. Total PAHs in Sand Cell Cores

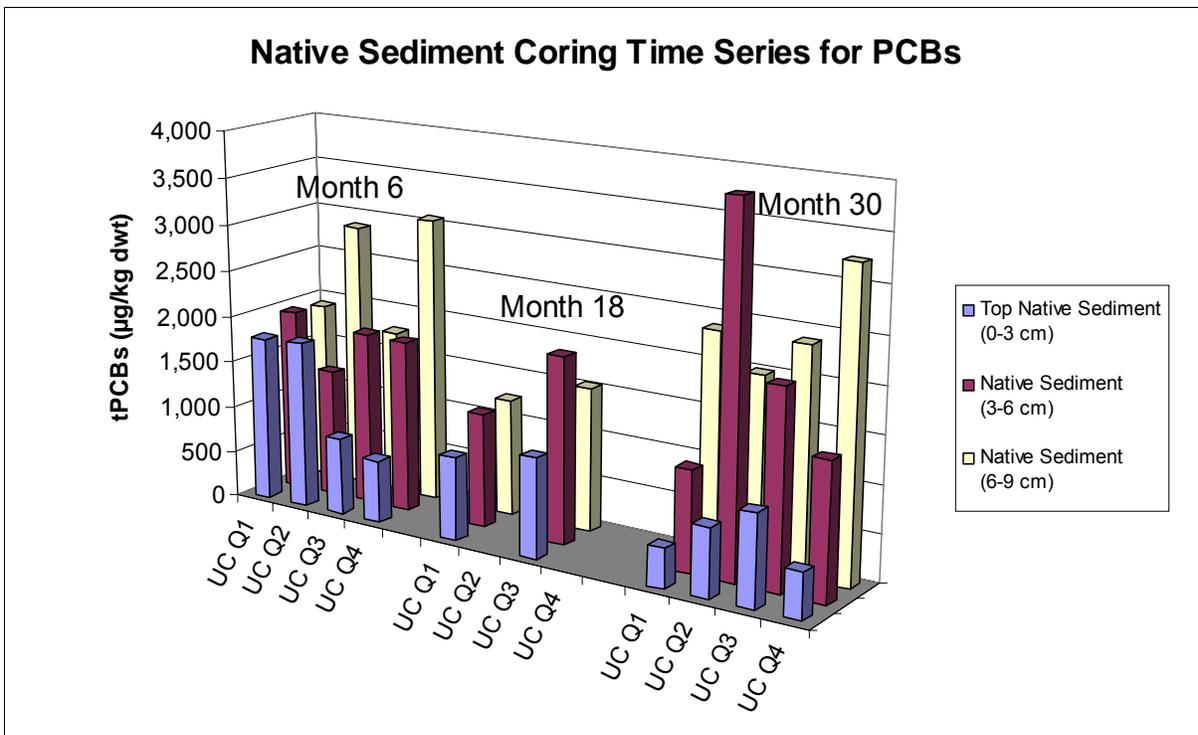
Figure 3-26. Total PCBs in Control Cell Cores

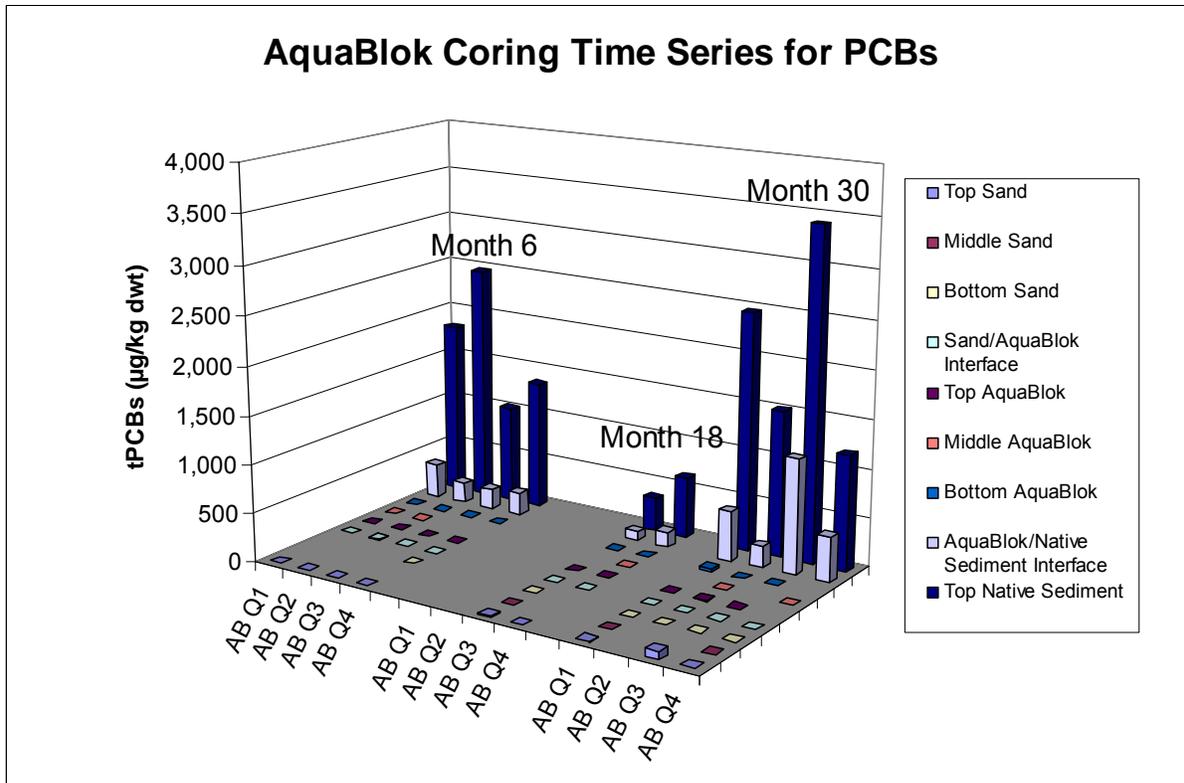
Figure 3-27. Total PCBs in AquaBlok® Cell Cores

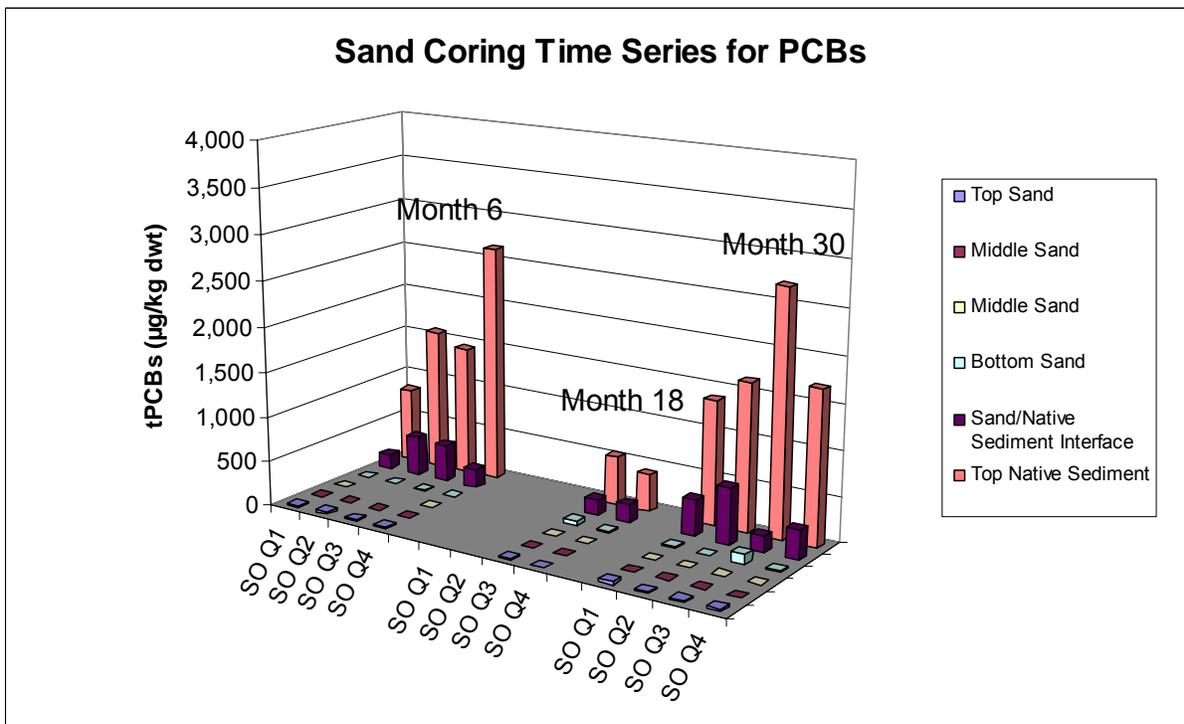
Figure 3-28. Total PCBs in Sand Cell Cores

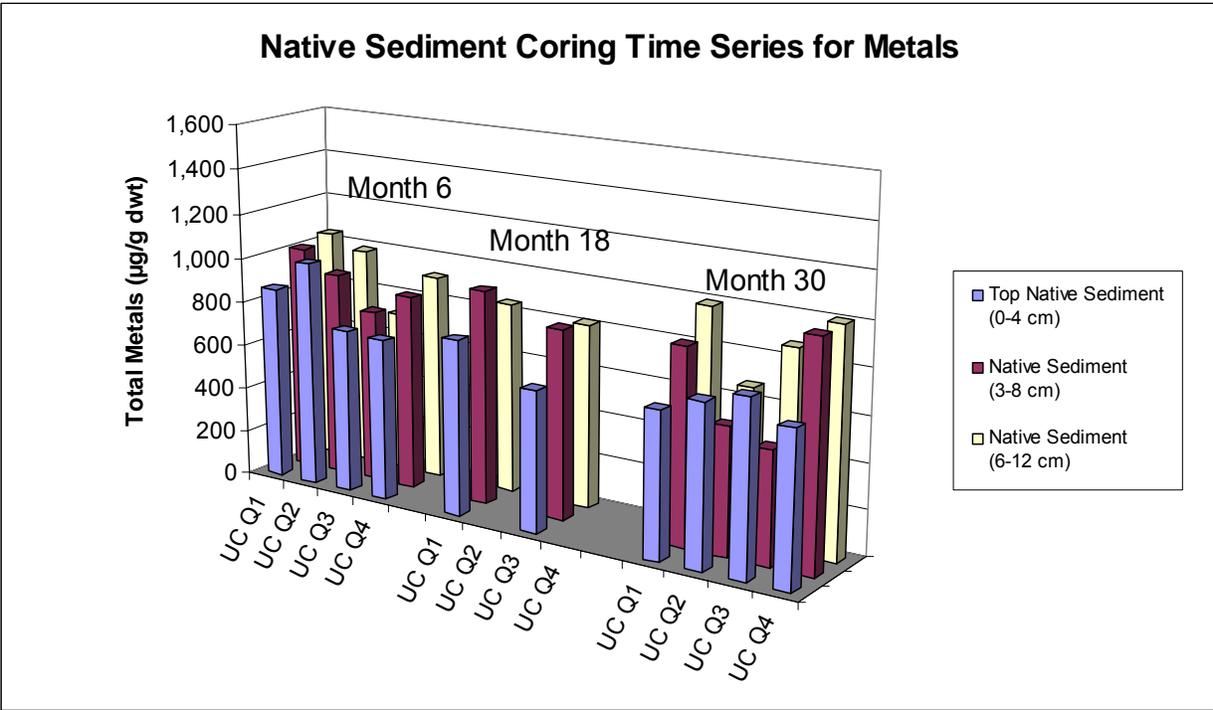
**Figure 3-29. Total Metals in Control Cell Cores**

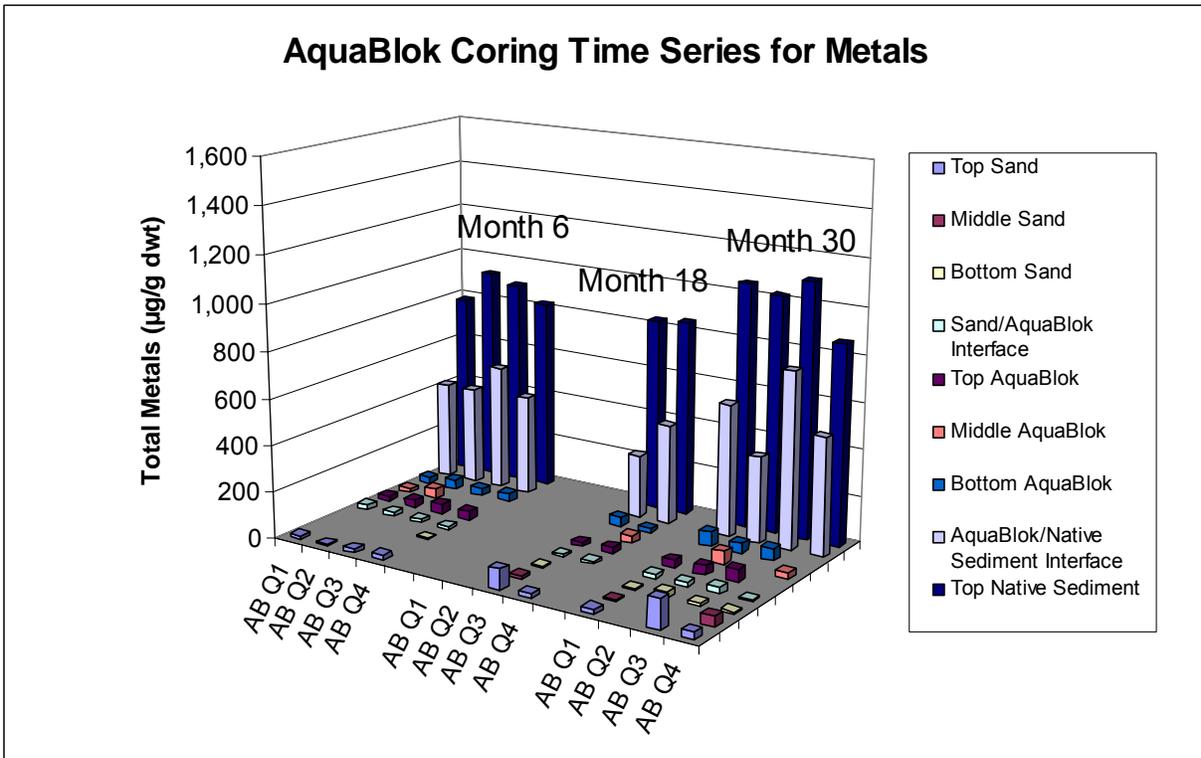
**Figure 3-30. Total Metals in AquaBlok® Cell Cores**

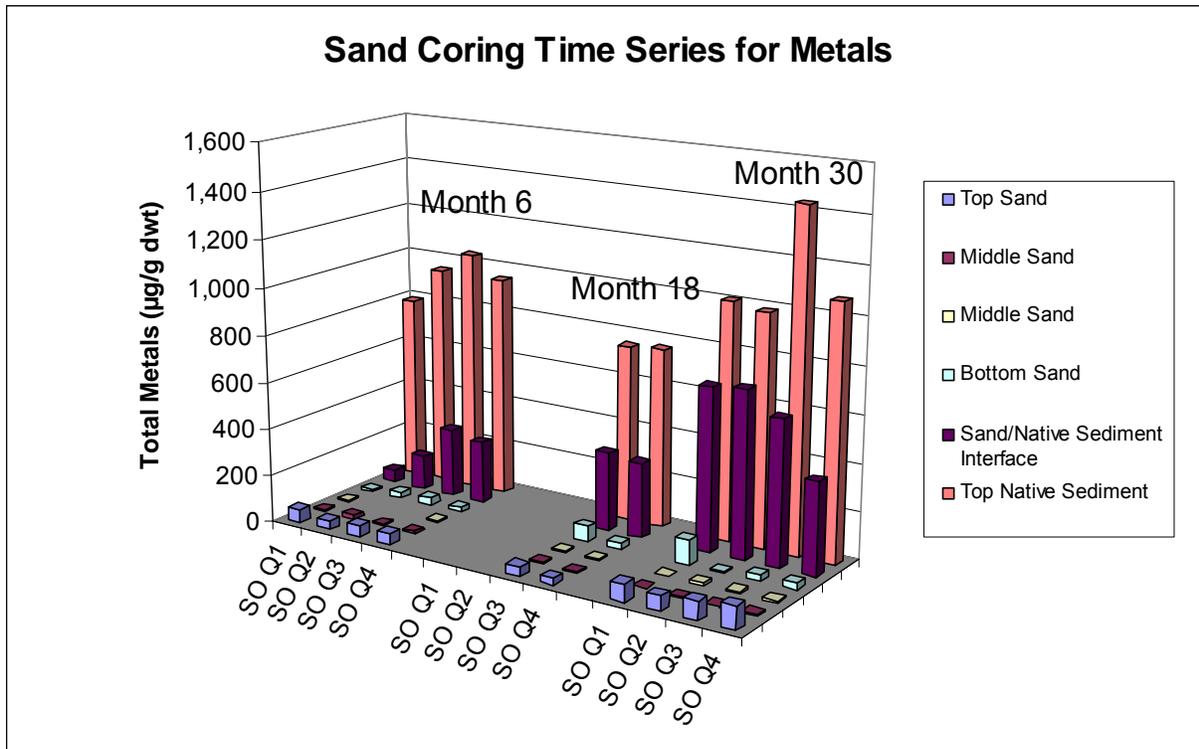
**Figure 3-31. Total Metals in Sand Cell Cores**

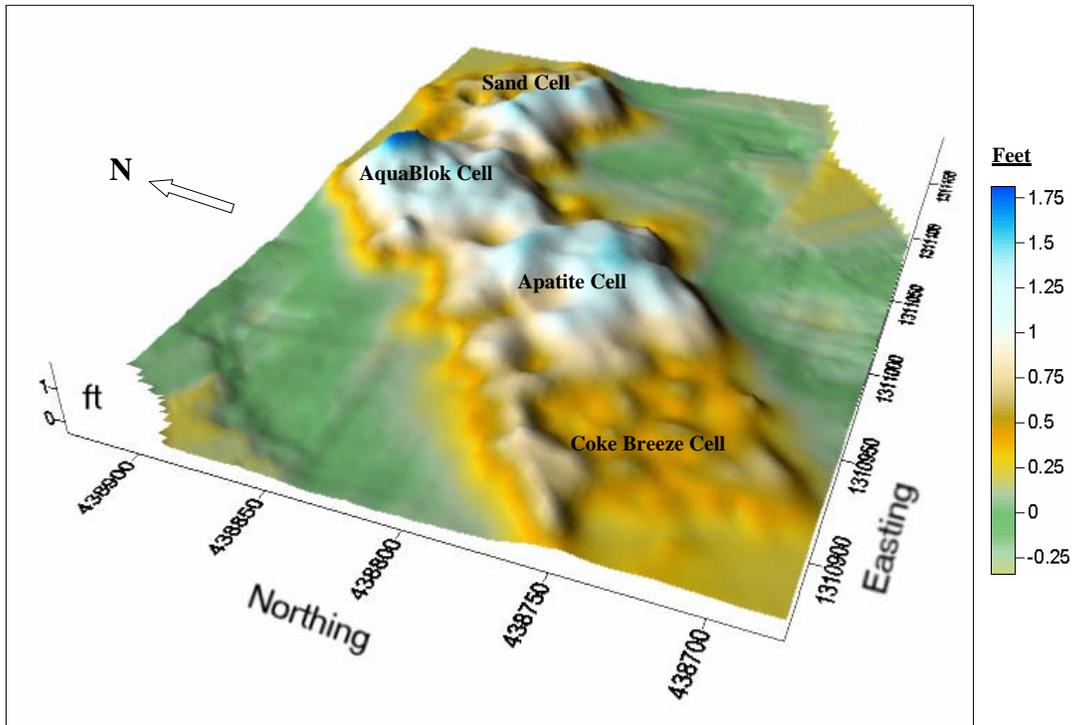
Figure 3-33. One-Month Post-Capping Bathymetric Cap Thickness Map

and the shortage of material to cap the southwestern cell corner (see Section 3.1.1 and Figure 3-4). These results also generally corroborate that design cap thicknesses were achieved. Figure 3-33 shows the three-

Overall, the bathymetric data generated during the SITE demonstration indicate that the AquaBlok® cap and the sand cap are highly stable in the demonstration area. However, these data do not directly describe the AquaBlok® material itself as the sand surface layer installed over the AquaBlok® was itself highly stable. Therefore, the AquaBlok® was not directly exposed to flow at the sediment/water interface. In addition, the traditional sand cap was similarly stable as compared to the sand covering the AquaBlok® material, meaning that a comparative evaluation of stability between sand and AquaBlok® is not possible on the basis of bathymetric data alone. Moreover, even with high flow conditions linked to significant storm events documented in the flow record for the Anacostia River, the sand covering the AquaBlok® cap and the traditional sand cap remained relatively unchanged throughout the SITE demonstration. This interpretation is, however, complicated by the inherently limited resolution of the data collection tools and the fact that the demonstration area is in a characteristically depositional environment and may not itself have been exposed to any significant degree to the increased energy of high flow events. Nevertheless, given that the AquaBlok® cap design for the SITE demonstration is relatively standard, the bathymetric data collected support that this approach yields a stable cap.

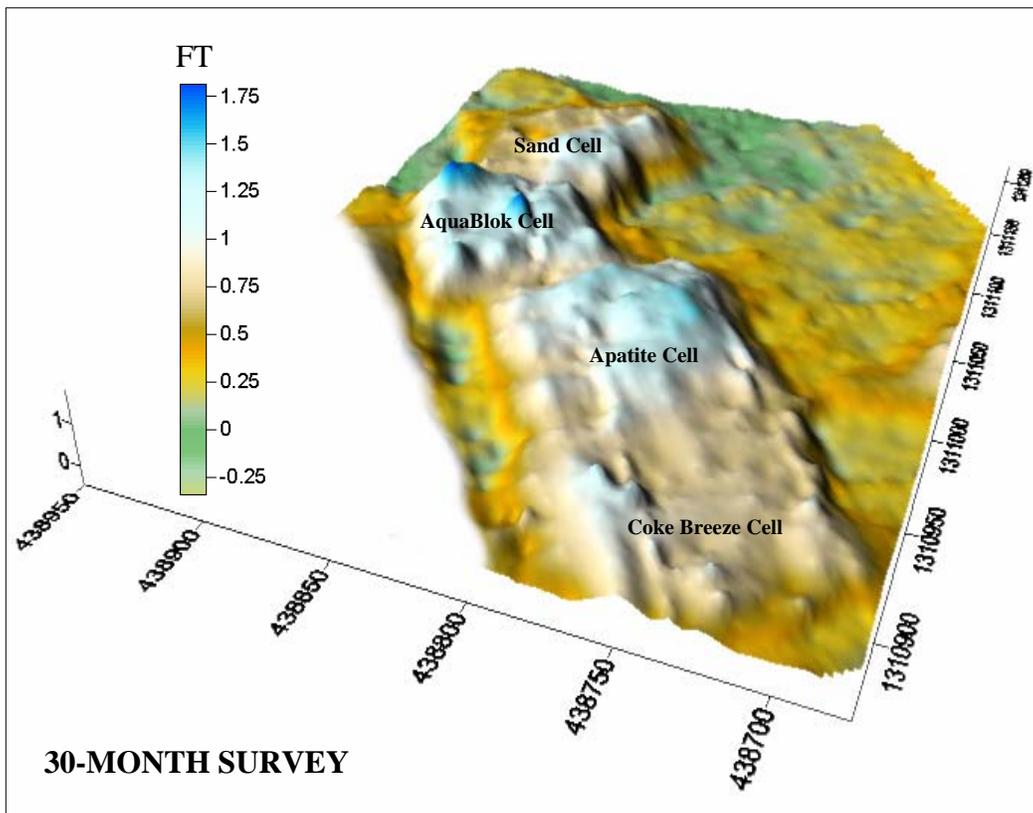
Figure 3-34. 30-Month Post-Capping Bathymetric Cap Thickness Map
