# Demonstration of the AquaBlok<sup>®</sup> Sediment Capping Technology

## Innovative Technology Evaluation Report

**Final**

National Risk Management Research Laboratory  
Office of Research and Development  
U.S. Environmental Protection Agency  
Cincinnati, Ohio 45268

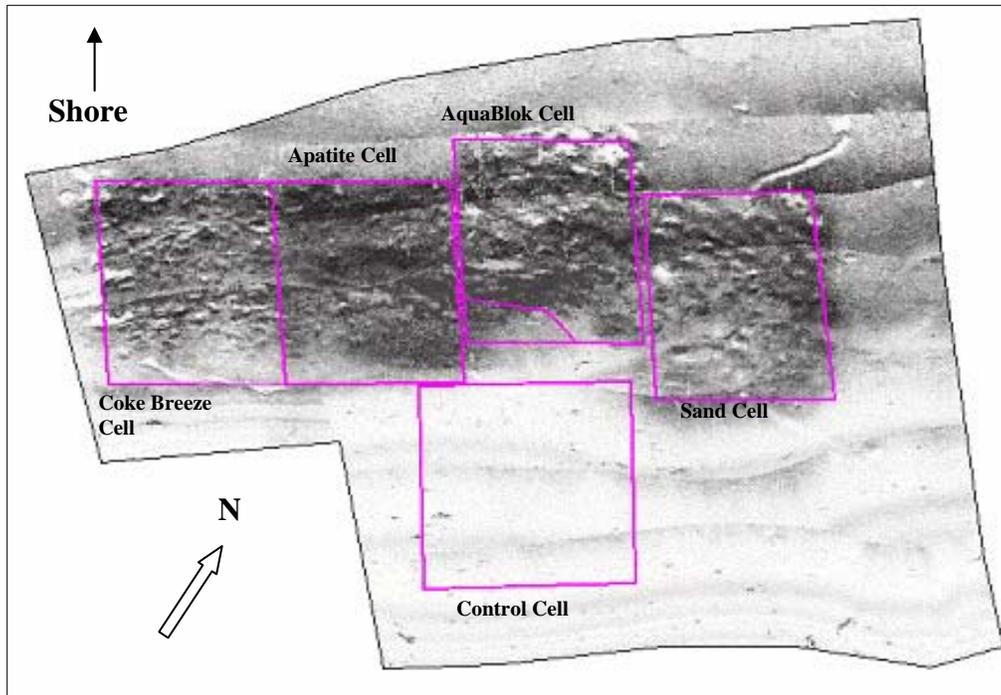
Figure 3-35. One-Month Post-Capping Side-Scan Sonar Map

Overall, the results of the side-scan sonar surveying conducted during the SITE demonstration program corroborate the results of the bathymetric surveying summarized in Section

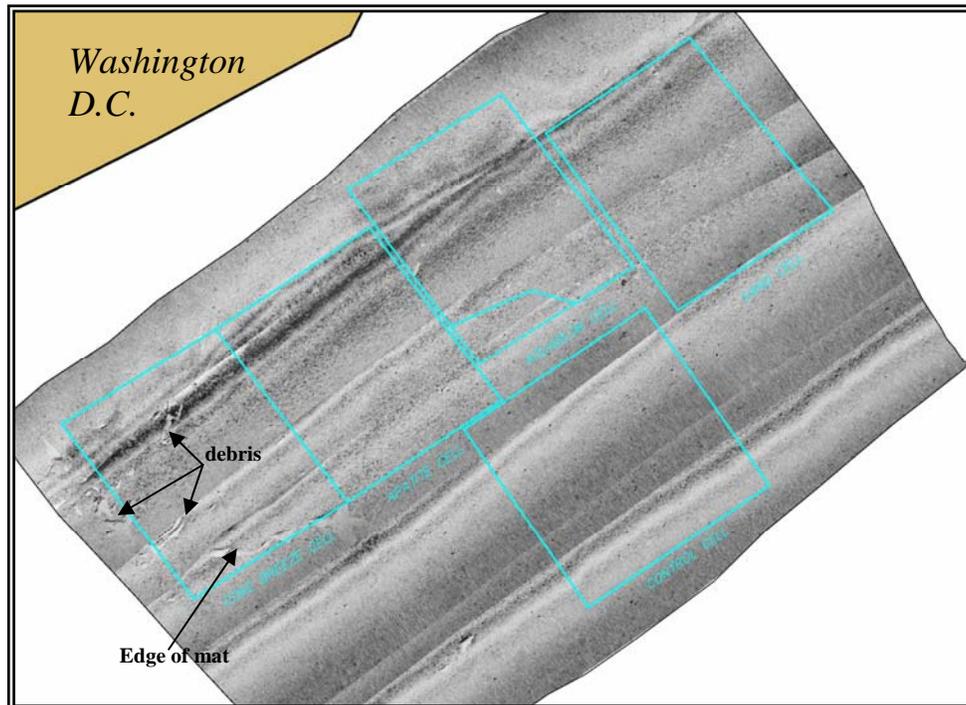
Figure 3-36. 30-Month Post-Capping Side-Scan Sonar Map

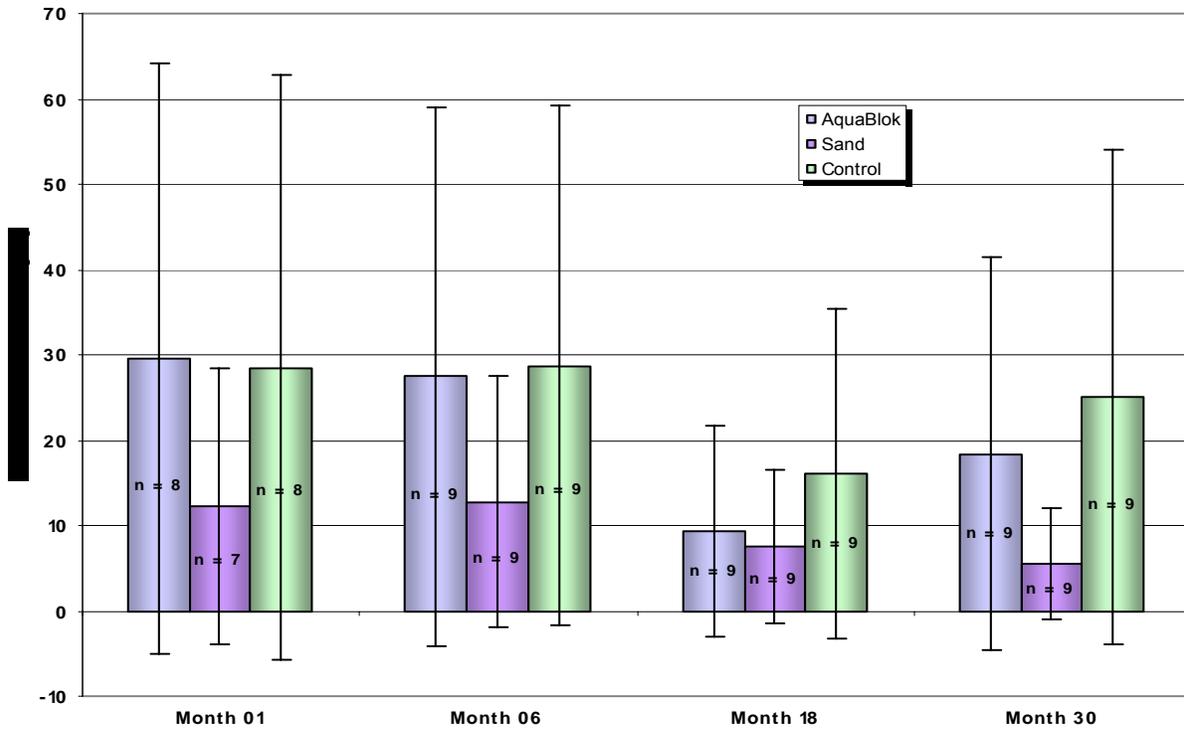
**Figure 3-38. Video SPI Camera Penetration Trend (columns represent the mean, n is the population size, and error bars represent 95% upper and lower confidence intervals around the mean)**

As indicated in Figure 3-38, depths of camera penetration were generally greatest in the control cell, and generally greater in the AquaBlok® cell compared to the sand cell. While it is intuitive that camera penetration depth would be greatest in the uncapped control cell, the reason for greater penetration rates in the AquaBlok® cell (which was covered with sand) relative to the sand cell is not readily explained. Overall penetration depths in the AquaBlok®, sand, and control cells generally declined throughout the course of the SPI surveys (see Figure 3-38), potentially indicative of grain sorting and “cementation” that would tend to inhibit physical penetration. Variations in penetration could also potentially be an artifact of even minor variations in the SPI equipment and/or equipment operation (e.g., specific manual efforts or camera weighting). The presence of and frequency of observation of biogenic and purely physical features in the surface and subsurface sediments throughout the demonstration area were generally highly consistent between the multiple SPI surveys. Such features were dominated by gas voids, but there were a limited number of biogenic structures (e.g., infauna tubes) also observed in the various surveys. There were no readily apparent differences in the presence of or frequency of observation of these features

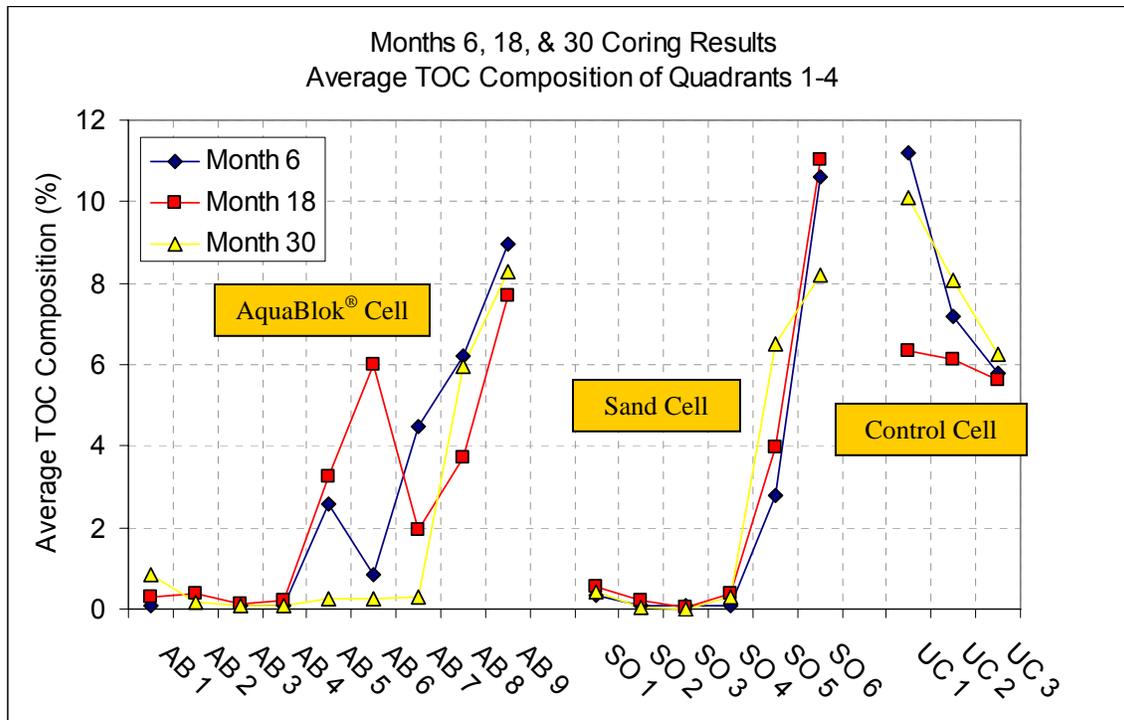
**Figure 3-40. Average TOC Concentration in Demonstration Area During SITE Demonstration (x-axis represents vertical core profile from shallowest at left to deepest at right)**

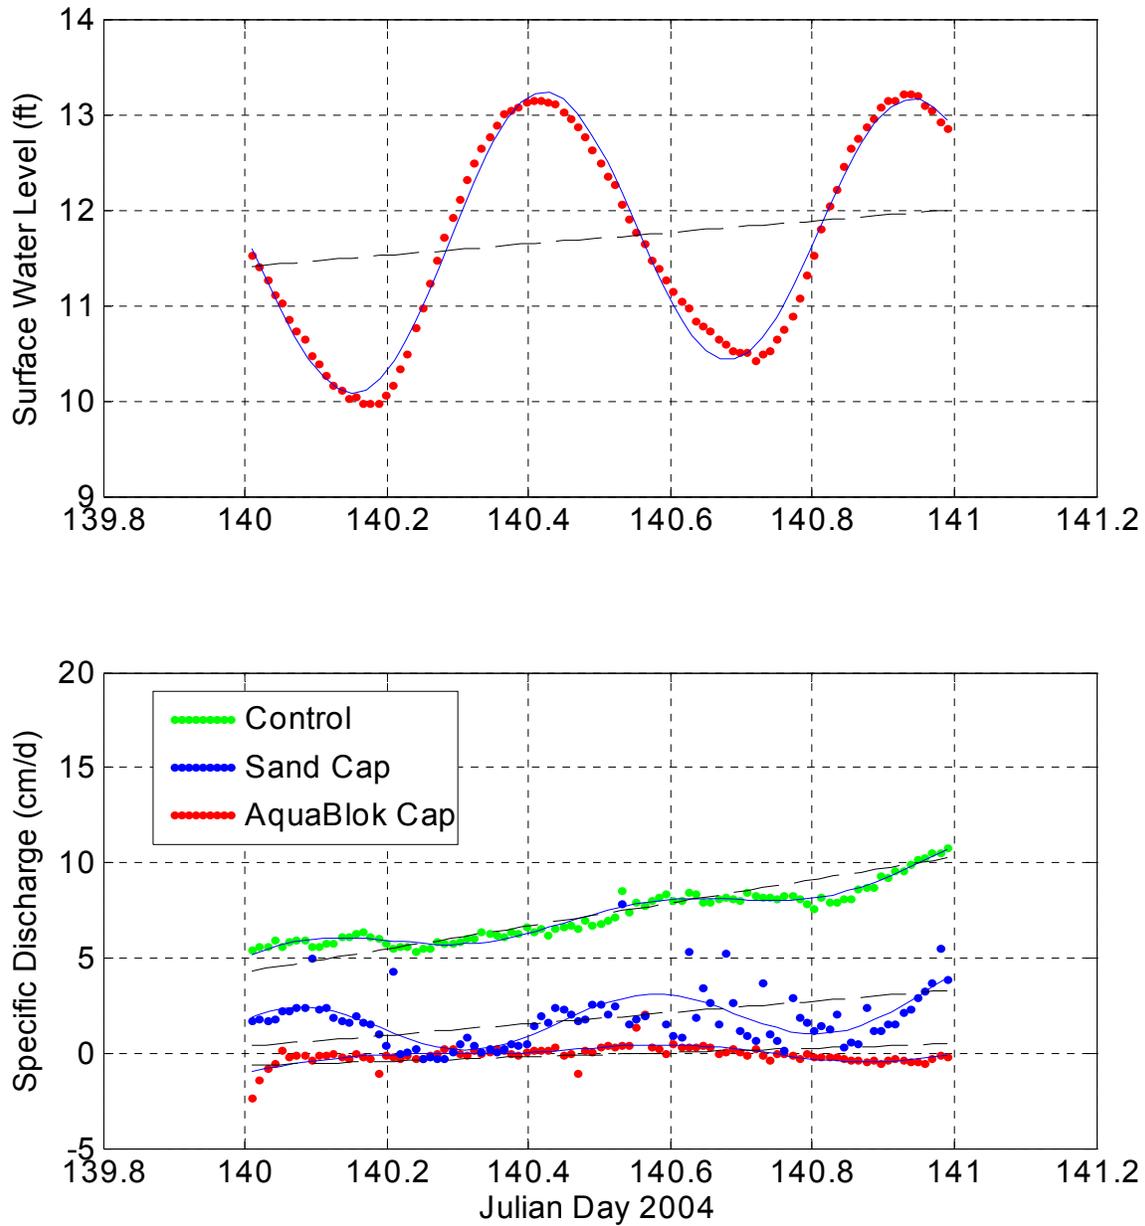
**Figure 3-42. Specific Discharge Rates in Demonstration Area During One-Month Post-Capping Survey (top panel is tidal phase, lower panel shows discharge as points, harmonic fit as solid curve, and trend as dashed line)**

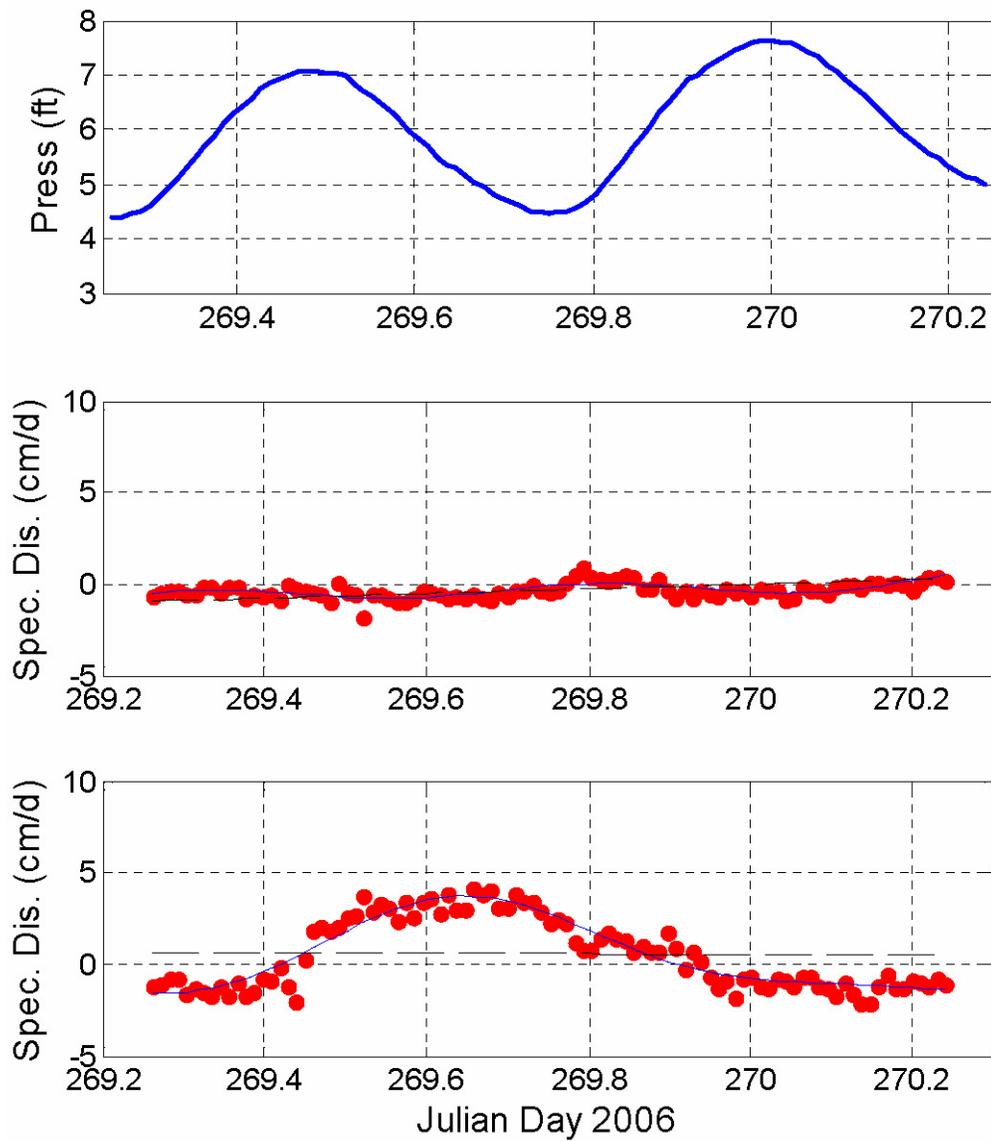
**Figure 3-43. Specific Discharge Rates in AquaBlok® Cell During 30-Month Post-Capping Survey (top panel is tidal phase, middle panel is station AQB1, lower panel is station AQB2; discharge shown as points, harmonic fit as solid curves, and trend as dashed lines; note station AQB2 is provided only as reference as station appeared compromised)**

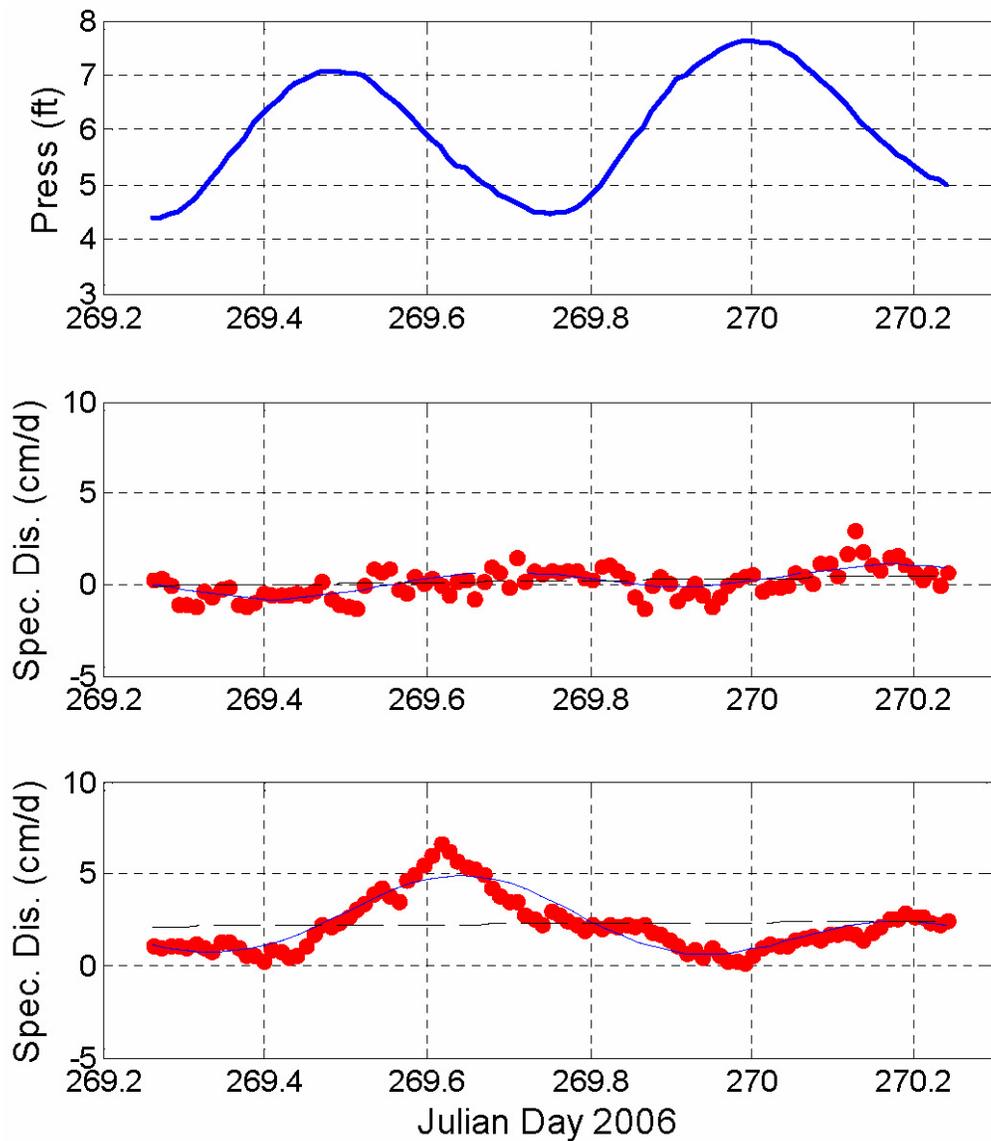
**Figure 3-44. Specific Discharge Rates in Sand Cell During 30-Month Post-Capping Survey (top panel is tidal phase, middle panel is station SC1, lower panel is station SC2; discharge shown as points, harmonic fit as solid curves, and trend as dashed lines)**

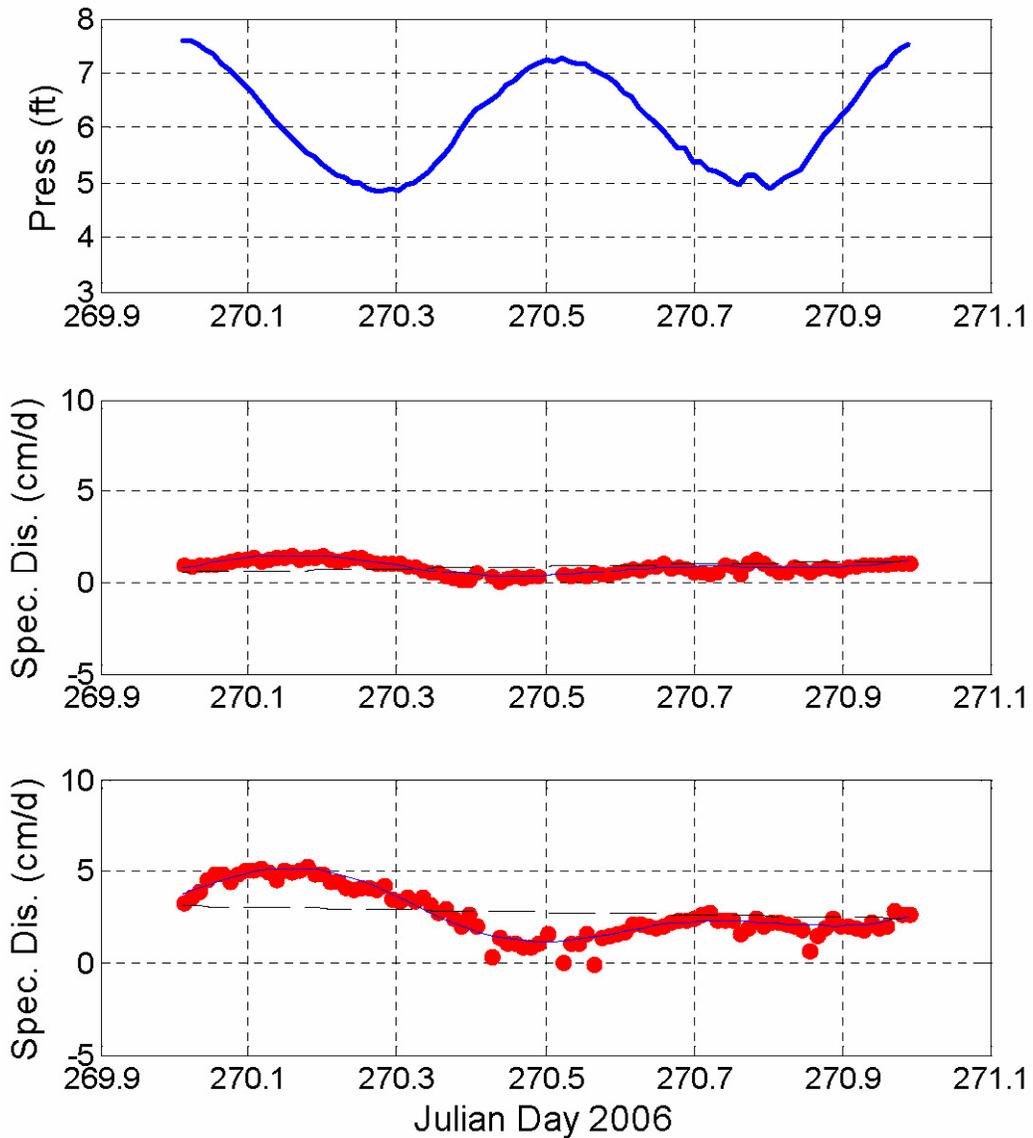
**Figure 3-45. Specific Discharge Rates in Control Cell During 30-Month Post-Capping Survey (top panel is tidal phase, middle panel is station CS1, lower panel is station CS2; discharge shown as points, harmonic fit as solid curves, and trend as dashed lines)**

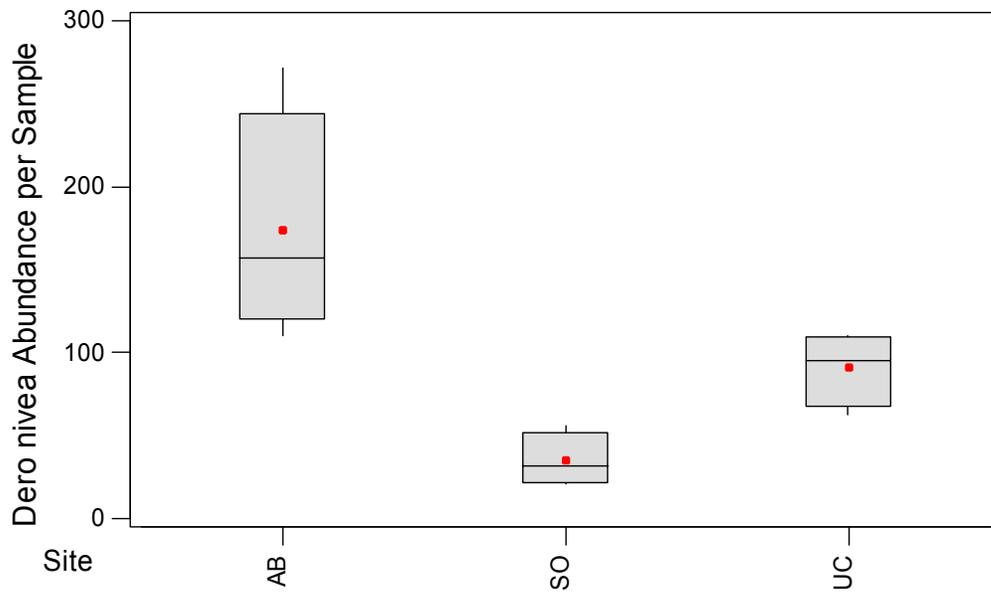
**Figure 3-47. Abundance of *Dero nivea* in AquaBlok (AB), Sand (SO), and Control (UC) Cells (red dot represents the mean and horizontal line represents the median)**

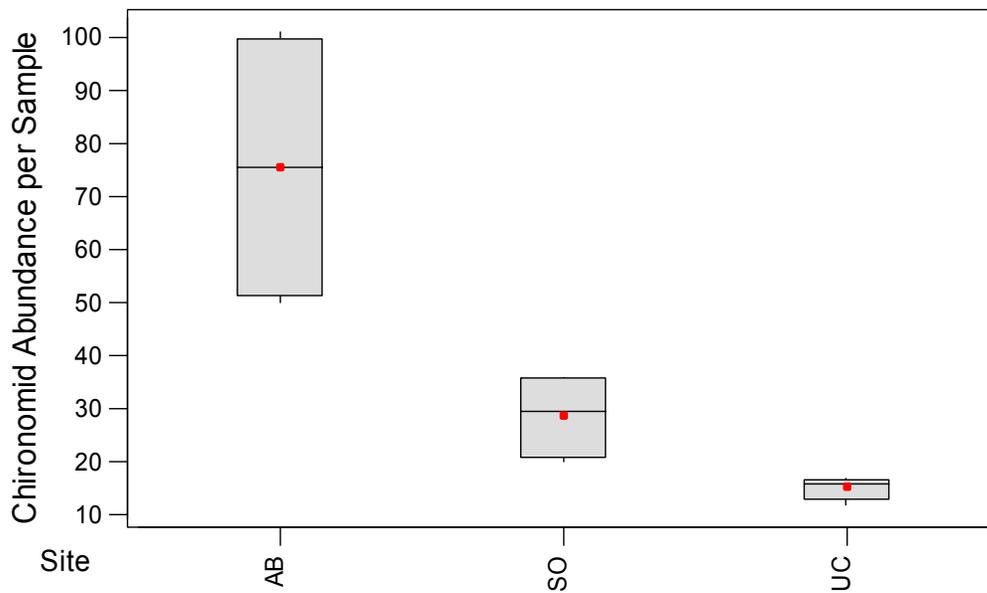
**Figure 3-48. Abundance of Chironomid Larvae in AquaBlok (AB), Sand (SO), and Control (UC) Cells (red dot represents the mean and horizontal line represents the median)**

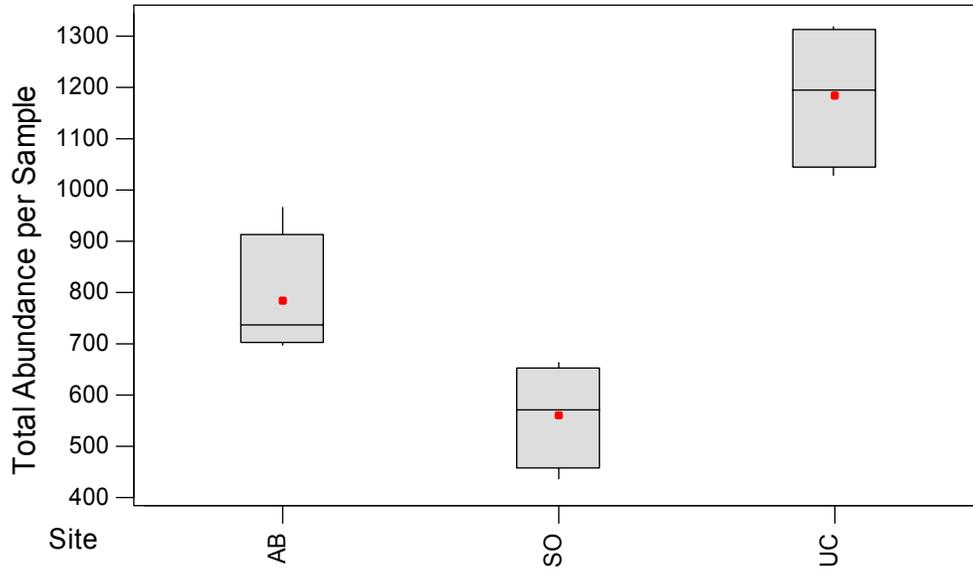
**Figure 3-49. Total Benthos Abundance in AquaBlok (AB), Sand (SO), and Control (UC) Cells (red dot represents the mean and horizontal line represents the median)**

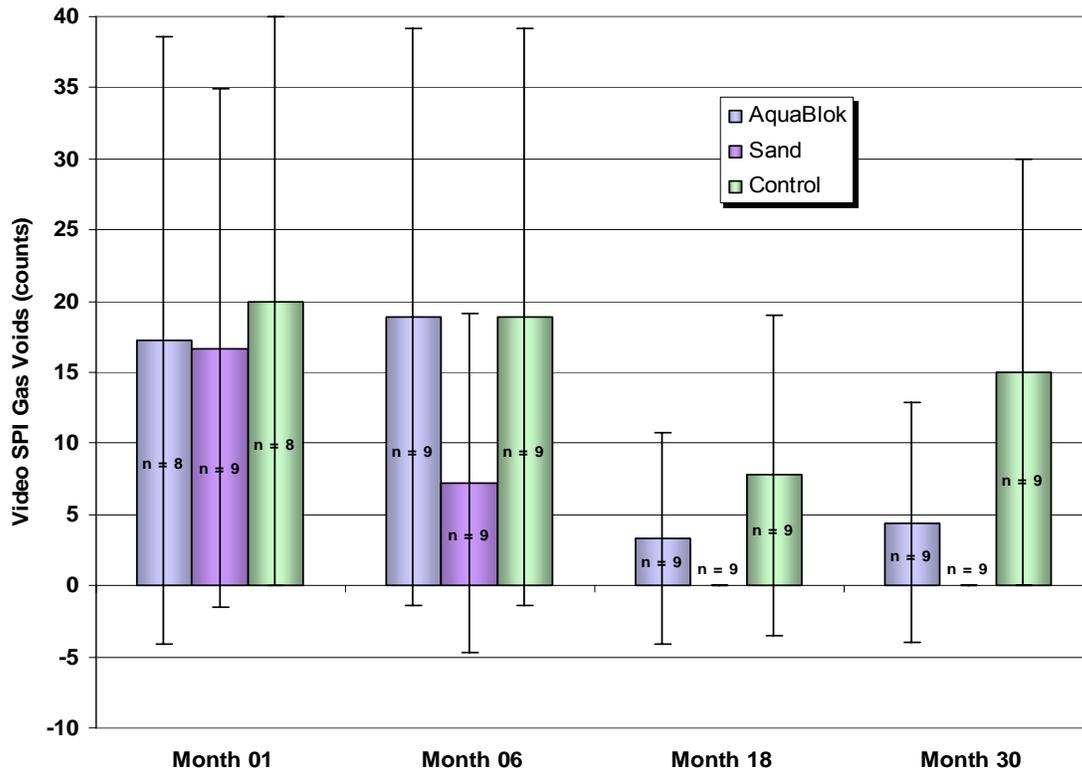
**Figure 3-50. Gas Void Occurrence Trend in Video SPI (columns represent the mean, n is the population size, and error bars represent 95% upper and lower confidence intervals around the mean)**
