**ADVANCED TECHNOLOGY
FOR
RADIUM REMOVAL
FROM
DRINKING WATER:**

THE FLATONIA WATER TREATMENT PROJECT

**Final Report for
U.S. Environmental Protection Agency
Contract No. 68-01-3985**

**Division of Occupational Health
and Radiation Control
Texas Department of Health
Austin, Texas**

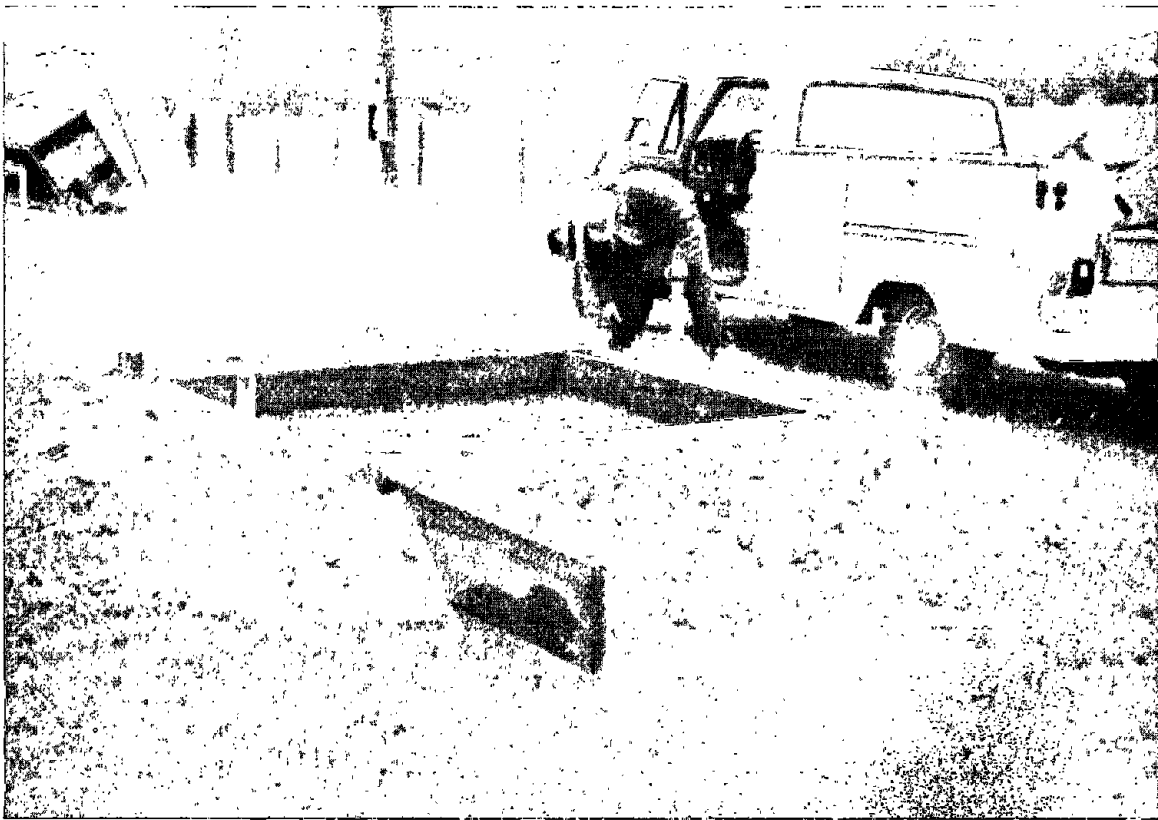
Figure 7. The finished form.

The foundation (6' x 6' x 9") was constructed in December 1977 of reinforced concrete (Figures 6 and 7). This proved to be larger than strictly necessary but provided a comfortable work area.

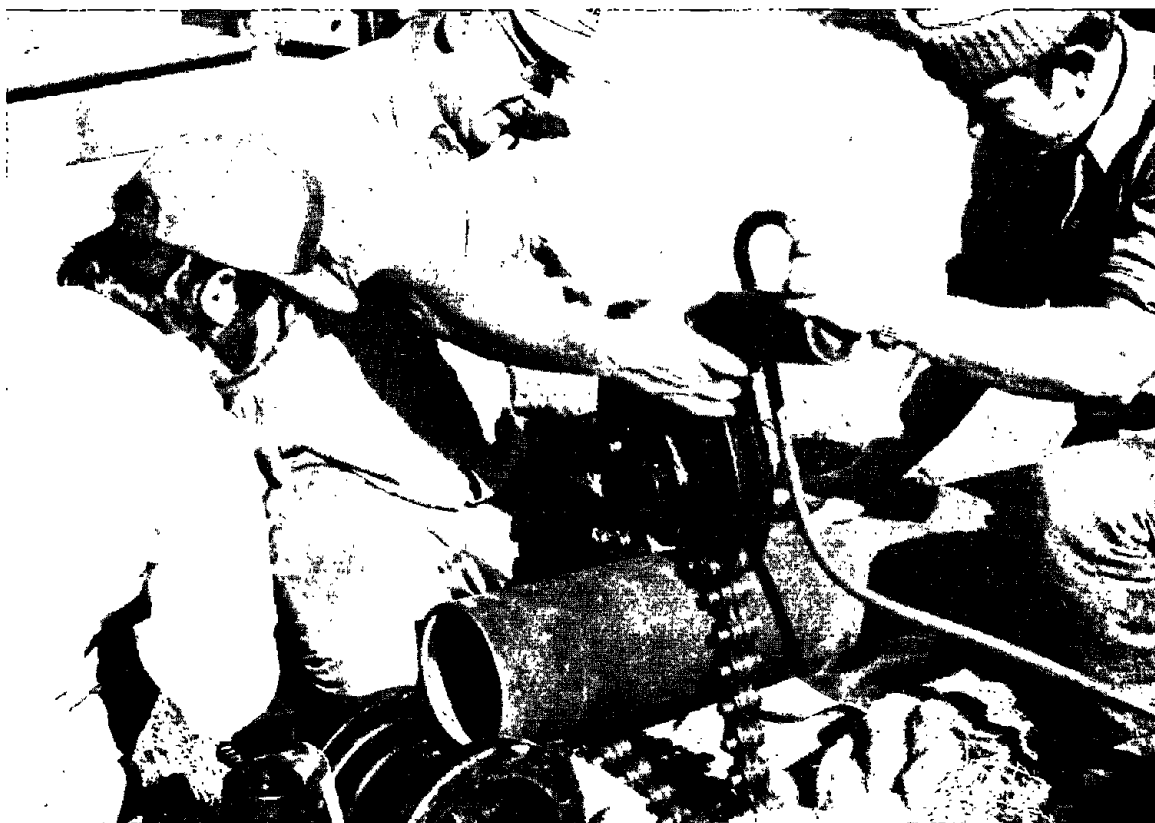
Figure 8. Problems were encountered in cutting pipe supplied under contract. The supplied pipe was not cast iron but a more durable and stronger, mild steel. The hydraulic pipe cutter operates only on brittle pipe.

After the filter housing arrived, the plumbing was connected. Difficulty in cutting cast iron pipe was encountered. Since the mechanical joint pipe fittings required nipples between adjacent fittings, small pieces of the pipe were needed. A hydraulic pipe cutter (Figure 8) was used, but failed to cut the pipe. The pipe, instead of fracturing like case iron does, merely deformed under the pressure. The pipe was supposed to have been cast iron but a well-intentioned contractor had substituted a stronger, less brittle pipe.

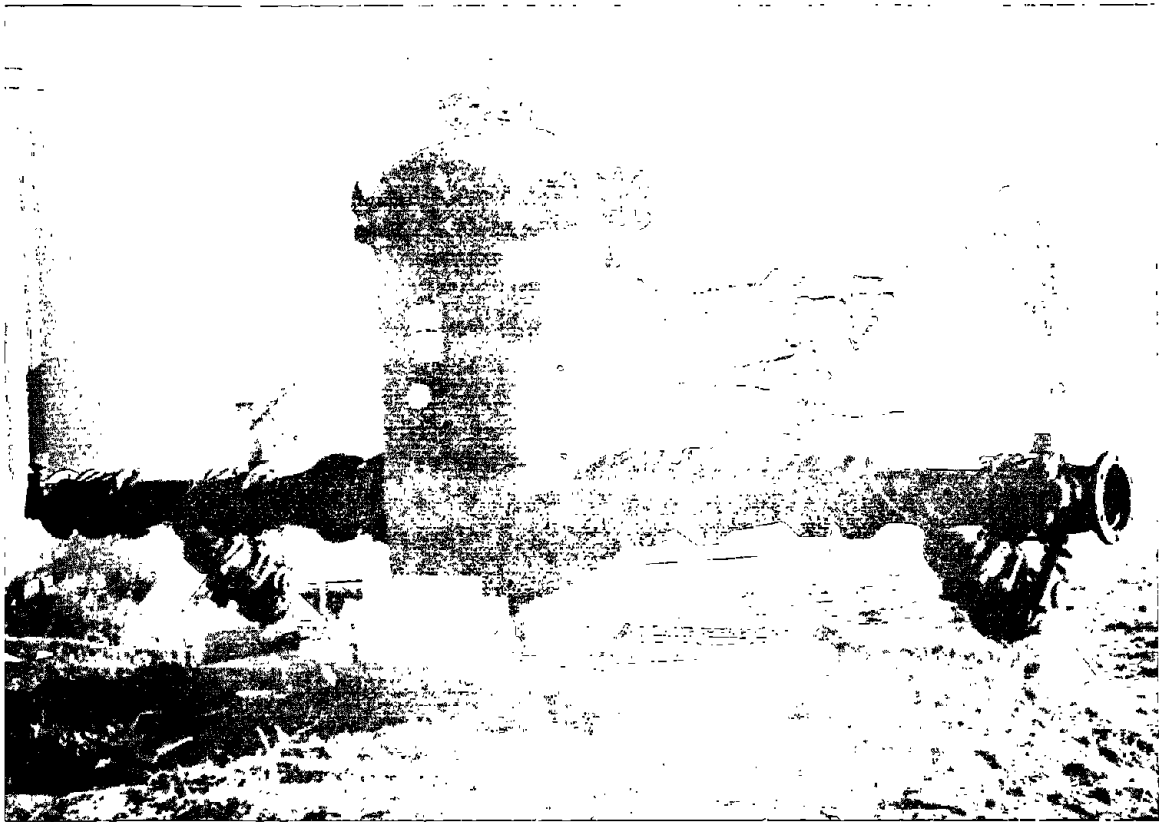
Figure 14. The assembled filter mechanism at the early testing stage.

and testing was begun (Figure 14).

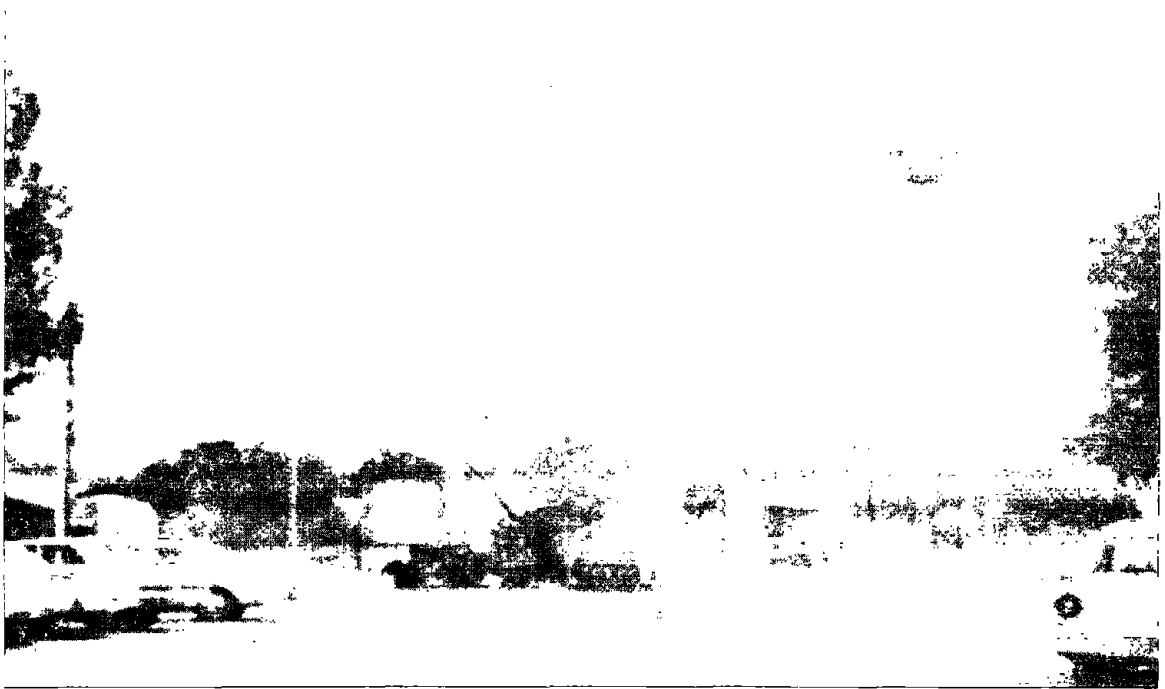
Figure 18. The City Warehouse is shown to the left of the base of the elevated water storage tank. It is the location of the filter preparation area.

The second filter housing is to be installed at the downtown water plant (Figure 17). The city warehouse just to the west of this plant is shown in Figure 18. It is in this building that our filter preparation area is housed.
