# **Analysis and Evaluation of a Radioactive Waste Package Retrieved from the Atlantic 2800 Meter Disposal Site**

P. COLOMBO, R.M. NEILSON, JR. AND M.W. KENDIG  
NUCLEAR WASTE MANAGEMENT RESEARCH GROUP  
DEPARTMENT OF NUCLEAR ENERGY  
BROOKHAVEN NATIONAL LABORATORY  
ASSOCIATED UNIVERSITIES, INC.  
UPTON, NEW YORK 11973

SEPTEMBER 1979

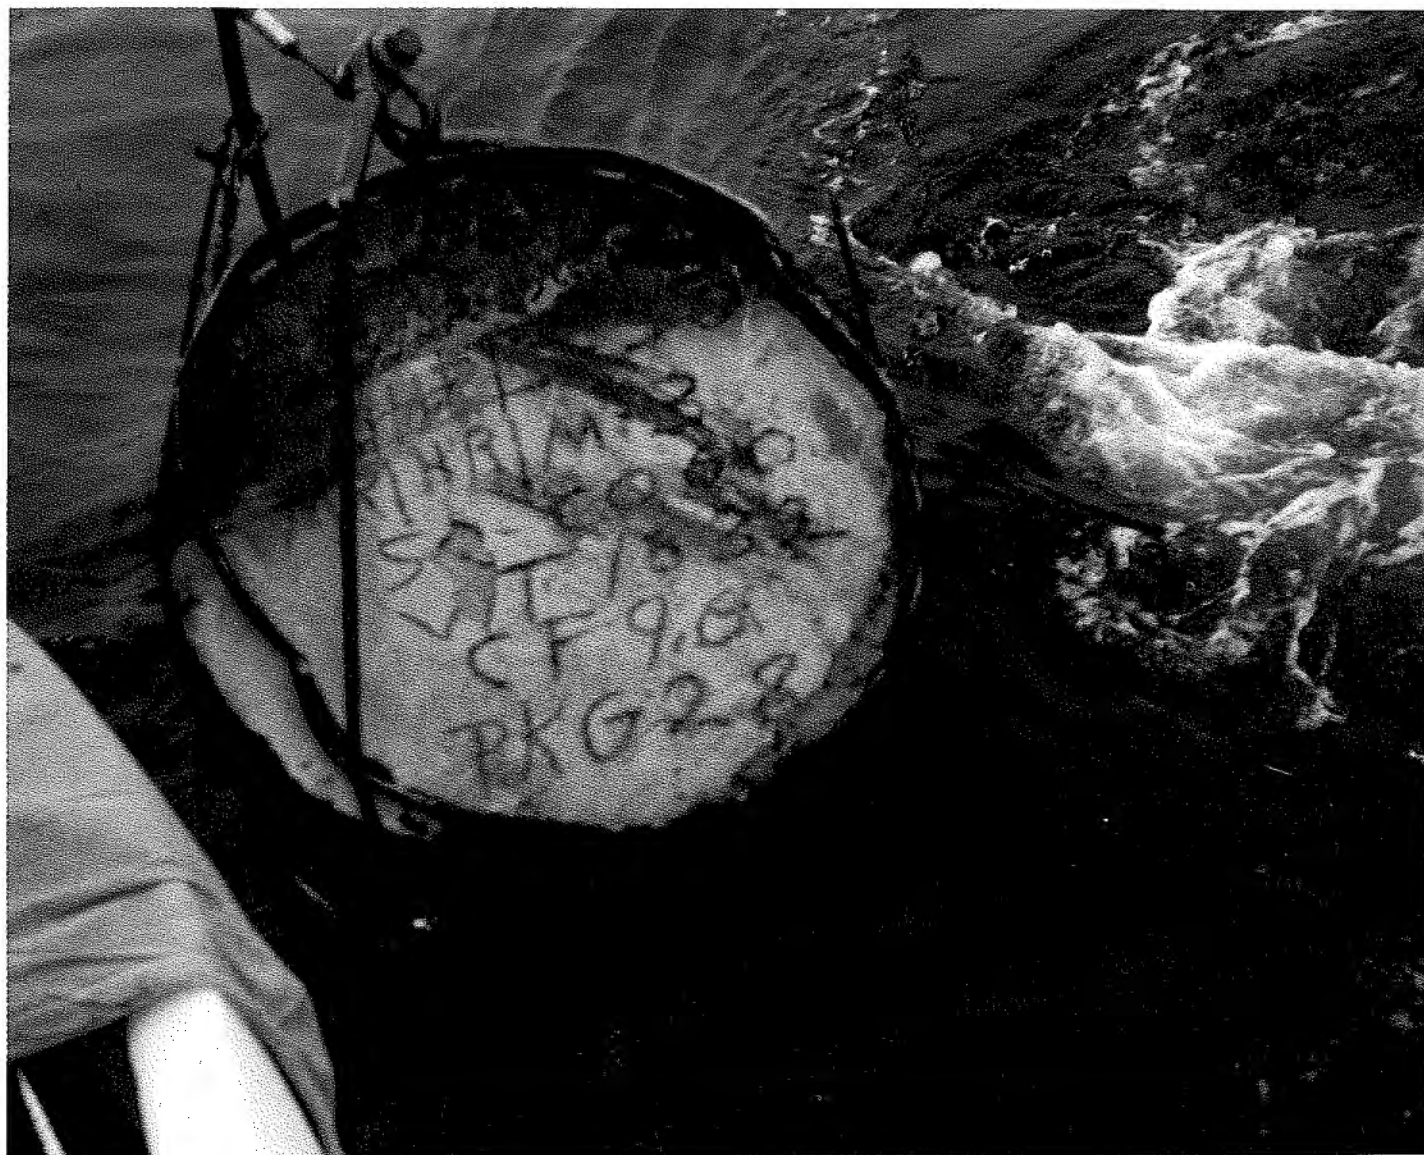
Figure 3(a). Open End of Radioactive Waste Package Immediately after Surfacing from the Atlantic 2800 m Disposal Site.

The retrieval procedure started aboard the Cape Henlopen at 0200 on July 31st with the recovery of the two 48-inch floats. At 0800 the waste package surfaced and the radiation level was monitored before being lifted aboard, as shown in Figures 3(a) and 3(b). Once aboard it was carefully documented photographically, sampled for corrosion products and biological growth, and finally sealed in a shipping container, which was flushed with dry argon. The elapsed time from the moment the waste package broke the surface until it was sealed in the shipping container was two hours.

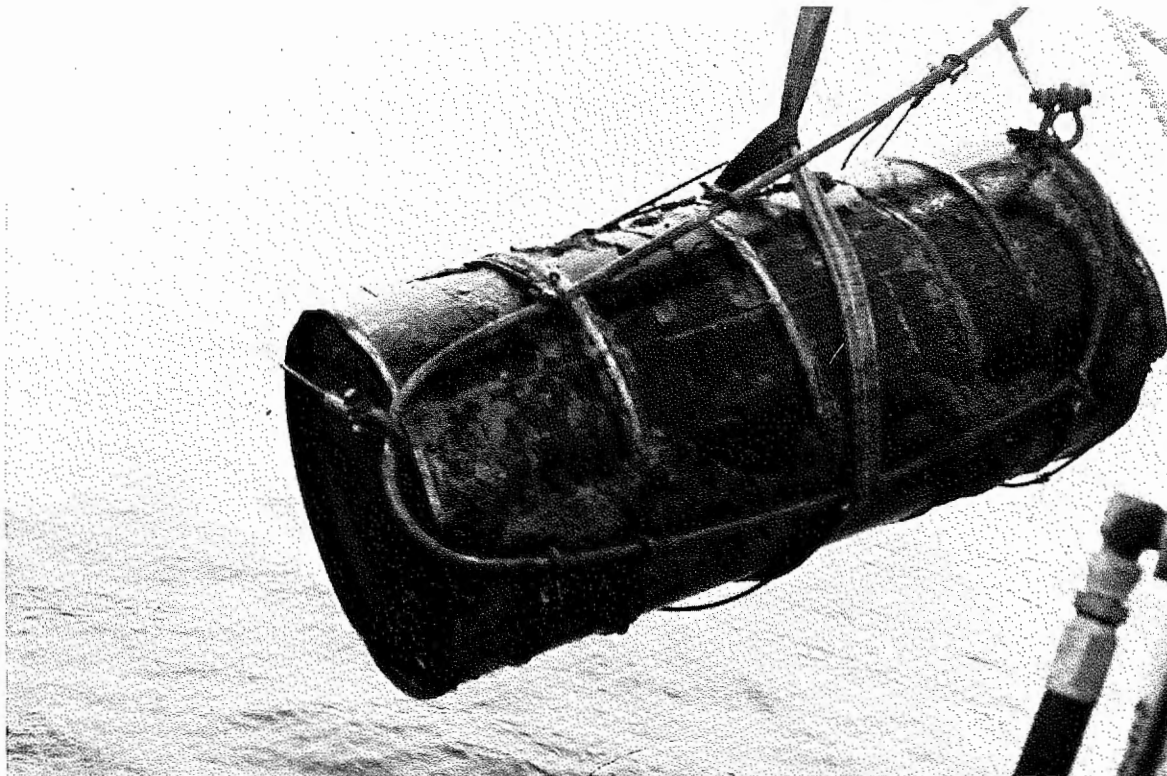
Figure 3(b). Side View of Radioactive Waste Package Prior to Being Brought Aboard.

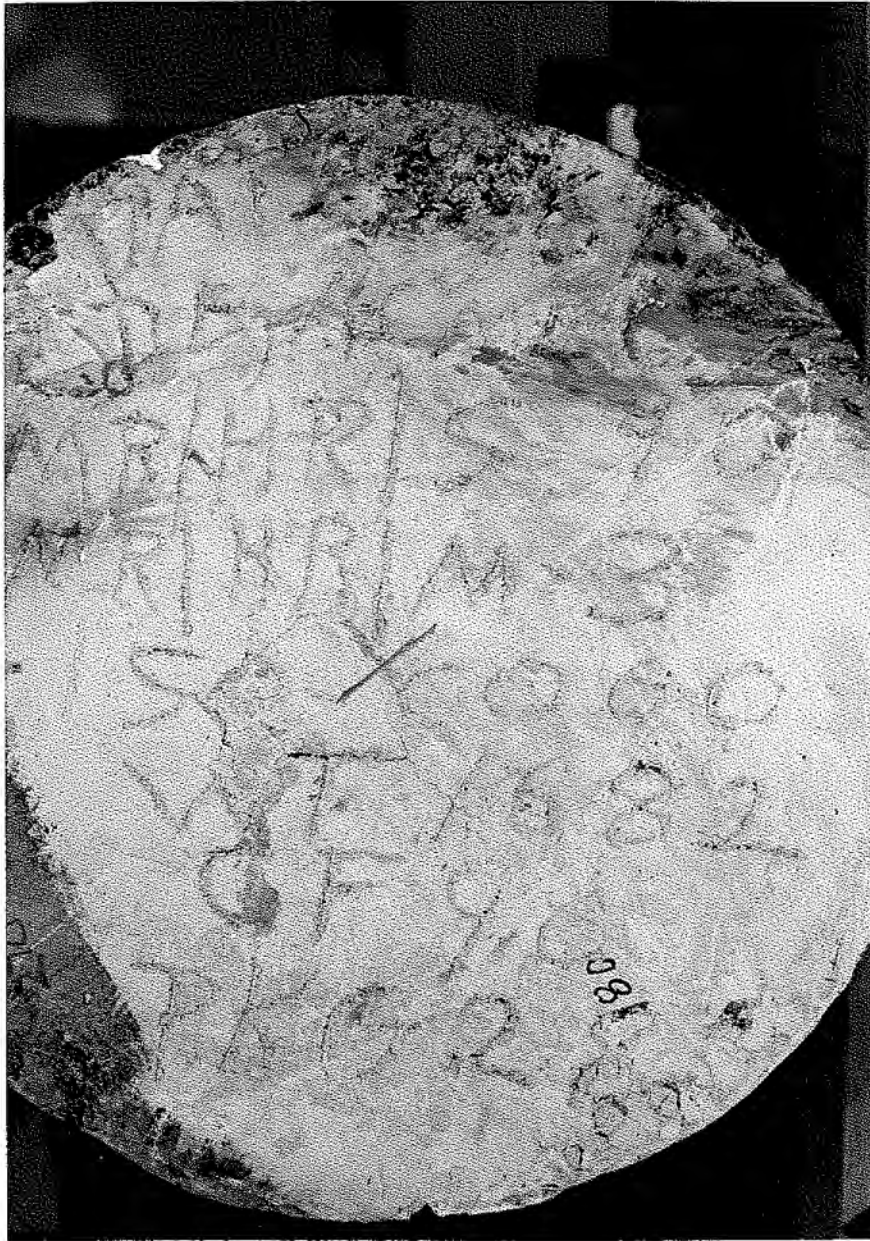
Figure 5. Surface Markings on the Exposed Concrete Face of the Waste Package.

The retrieved waste package\* comprised an eighty gallon mild steel drum filled with cement concrete. The waste form was 50.1 inches (127 cm) in length with a diameter of 22.9 inches (58.3 cm). According to identification markings stamped into the lower drum head, the 55 gallon drum was made from 18 gauge (nominal 0.0476 inch thickness) steel and was manufactured in June 1959. The drum did not have a lid and that portion of the exposed drum lip which was not in intimate contact with the concrete was almost completely separated from the drum body by corrosion. Markings scratched into the exposed top surface of the concrete are shown in Figure 5. These markings indicate that the Army Chemical Corps was the source of this waste package which had a radiation dose level of 40 and 3 mr/hr at the surface and at one meter, respectively, at the time of disposal. The surface dose rate measured after recovery ranged from 0.1 to 4.0 mr/hr with the highest reading at the open end portion of the drum buried in the sediment. Background levels were measured at a distance of one meter. The drum was designated package 28, dated 1961, and weighed 1682 pounds at the time of disposal. The markings also seem to indicate that the package contains cobalt-60.

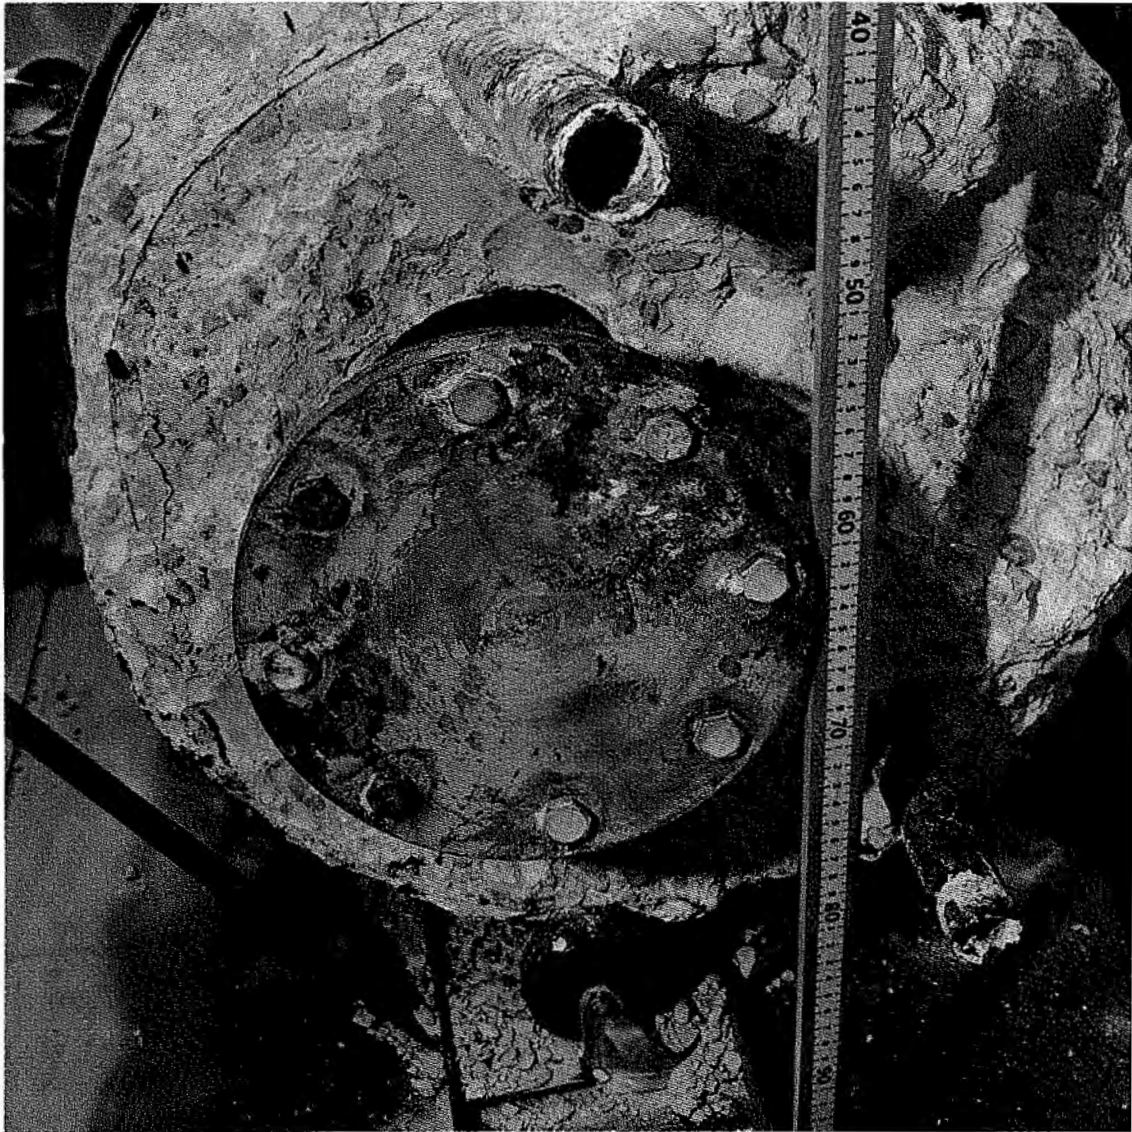
Figure 21. View of the Exposed Flange End of the Inner Container. Note the Gap between the Container and the Concrete Formed by Implosion of the Inner Container Wall during Descent.

of the waste form. The upper flange is observed in Figure 21 at a different angle showing the indentation which runs the length of the inner container on the side which imploded. The concrete debris after removal of the inner container are shown in Figure 22. The lower end of the steel pipe in the upper portion of this photograph was cut off during concrete removal. Figure 23 is a photograph of the inner steel vessel after removal from the waste form. This vessel had a mass of 96 lbs (43.5 kg) with a length of 39 inches (99 cm), and a body diameter of 6.5 inches (16.5 cm). The 0° marking on the edge of the flange corresponds to the 0° longitudinal axis of the concrete waste form. Note the implosion of the inner container along the 0° axis which occurred during or after descent to the sea floor. Figure 24 shows the inner container from the 180° orientation. The flange was removed from this container in an enclosed area using non-sparking tools because of the possibility of hydrogen pressurization due to radiolysis. No pressurization of the container was noted. Three wound filter assemblies were contained within as shown in Figures 25 and 26. Metal samples cut from this vessel for corrosion studies indicated a container wall thickness of 0.25 inches (0.64 cm). In addition, the vessel contained 1.74 liters of liquid which was collected for subsequent analysis. The cation constituents of this liquid were determined using a Perkin Elmer model 360 atomic absorption spectrophotometer. Sulfate content was measured with a Technicon Autoanalyzer II. This composition is compared in Table 2 to the composition of bottom seawater obtained in the vicinity of the retrieved waste package. These analyses indicate that the liquid in the inner steel vessel had significantly lower sodium, magnesium, and sulfate contents than the bottom seawater and that these constituents were not present in the same ratios. As such, it was determined that the liquid in the inner seal container was not seawater.

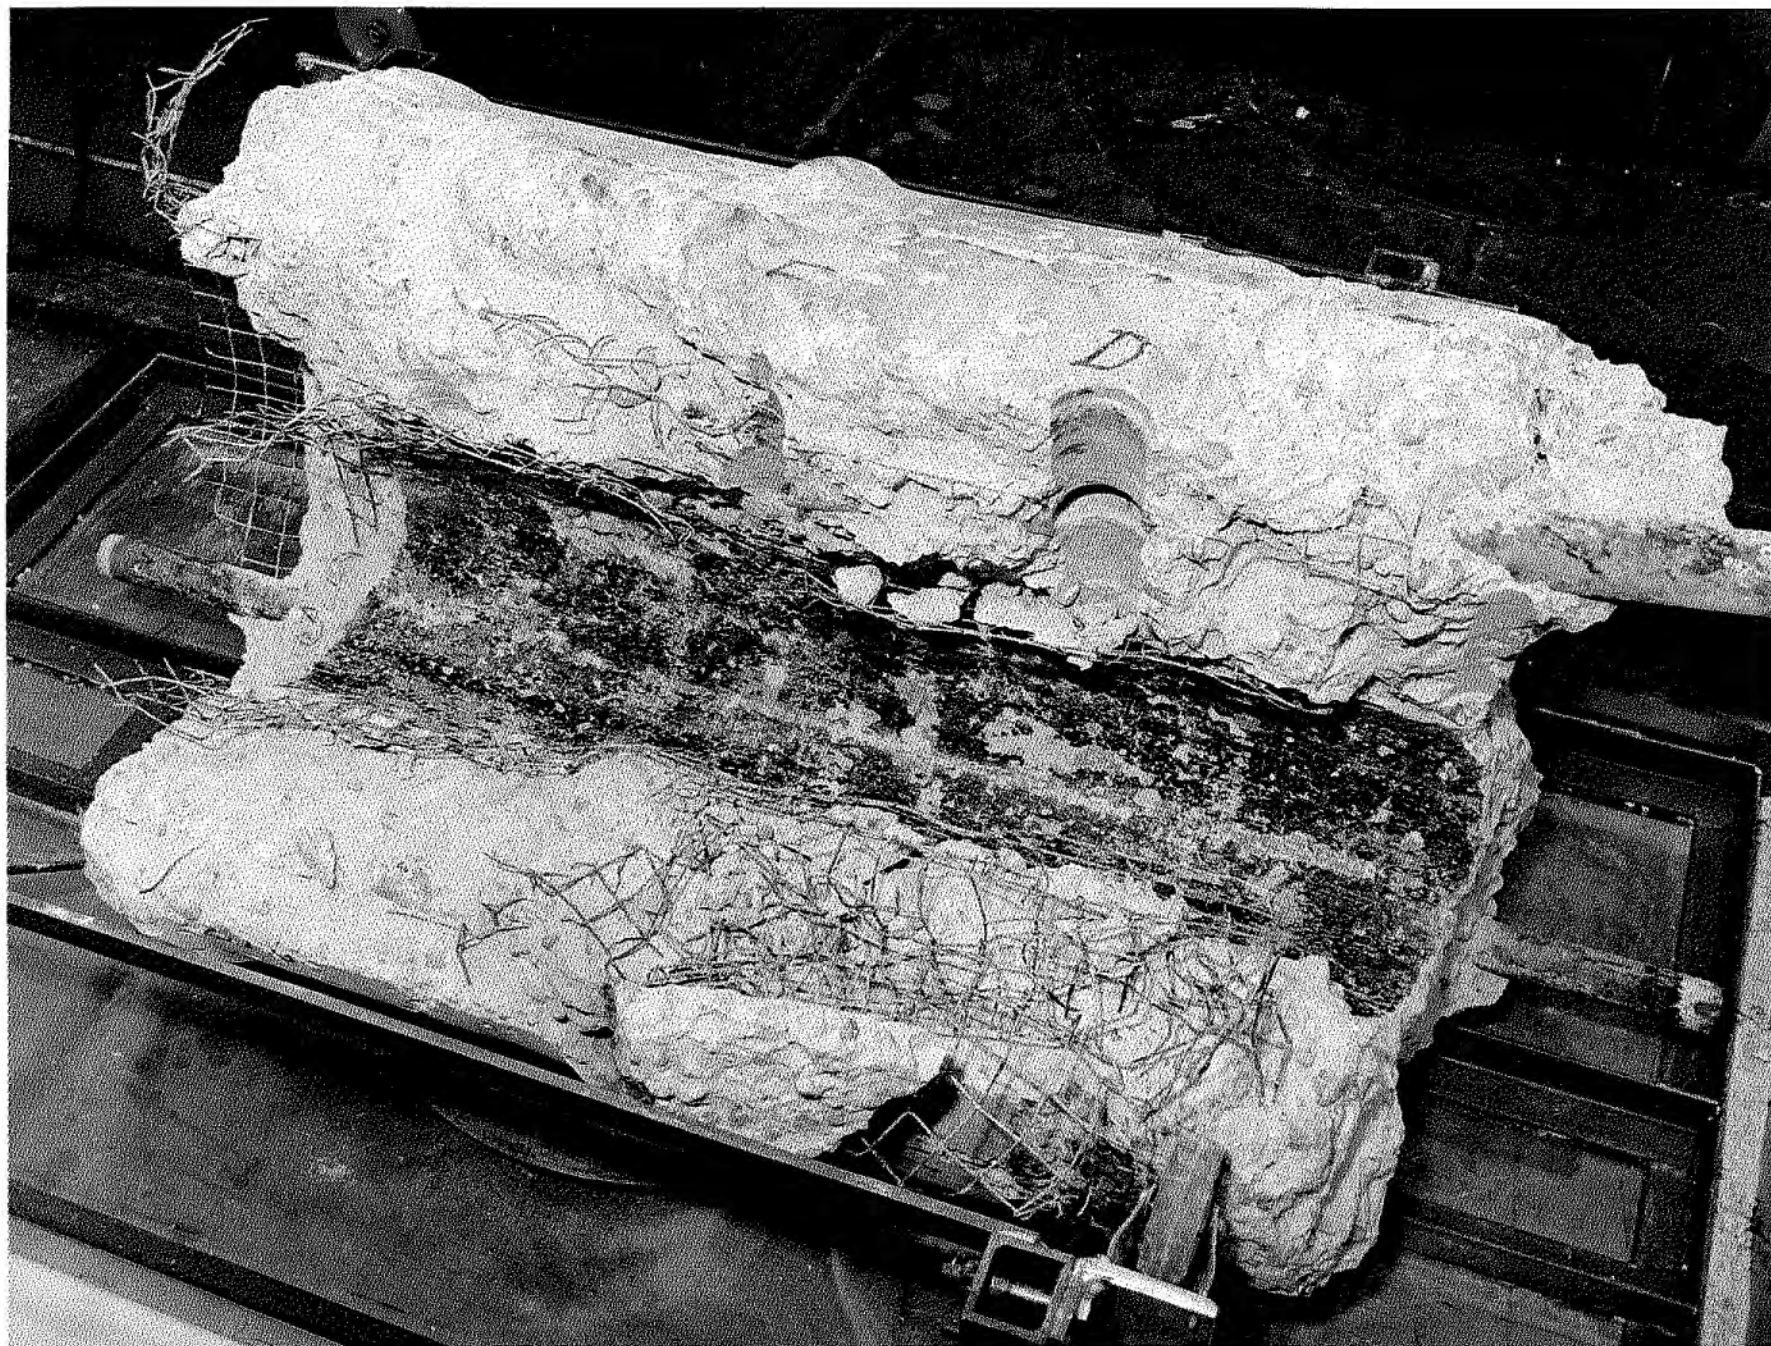
Figure 22. Concrete Waste Form after Removal of the Inner Container.

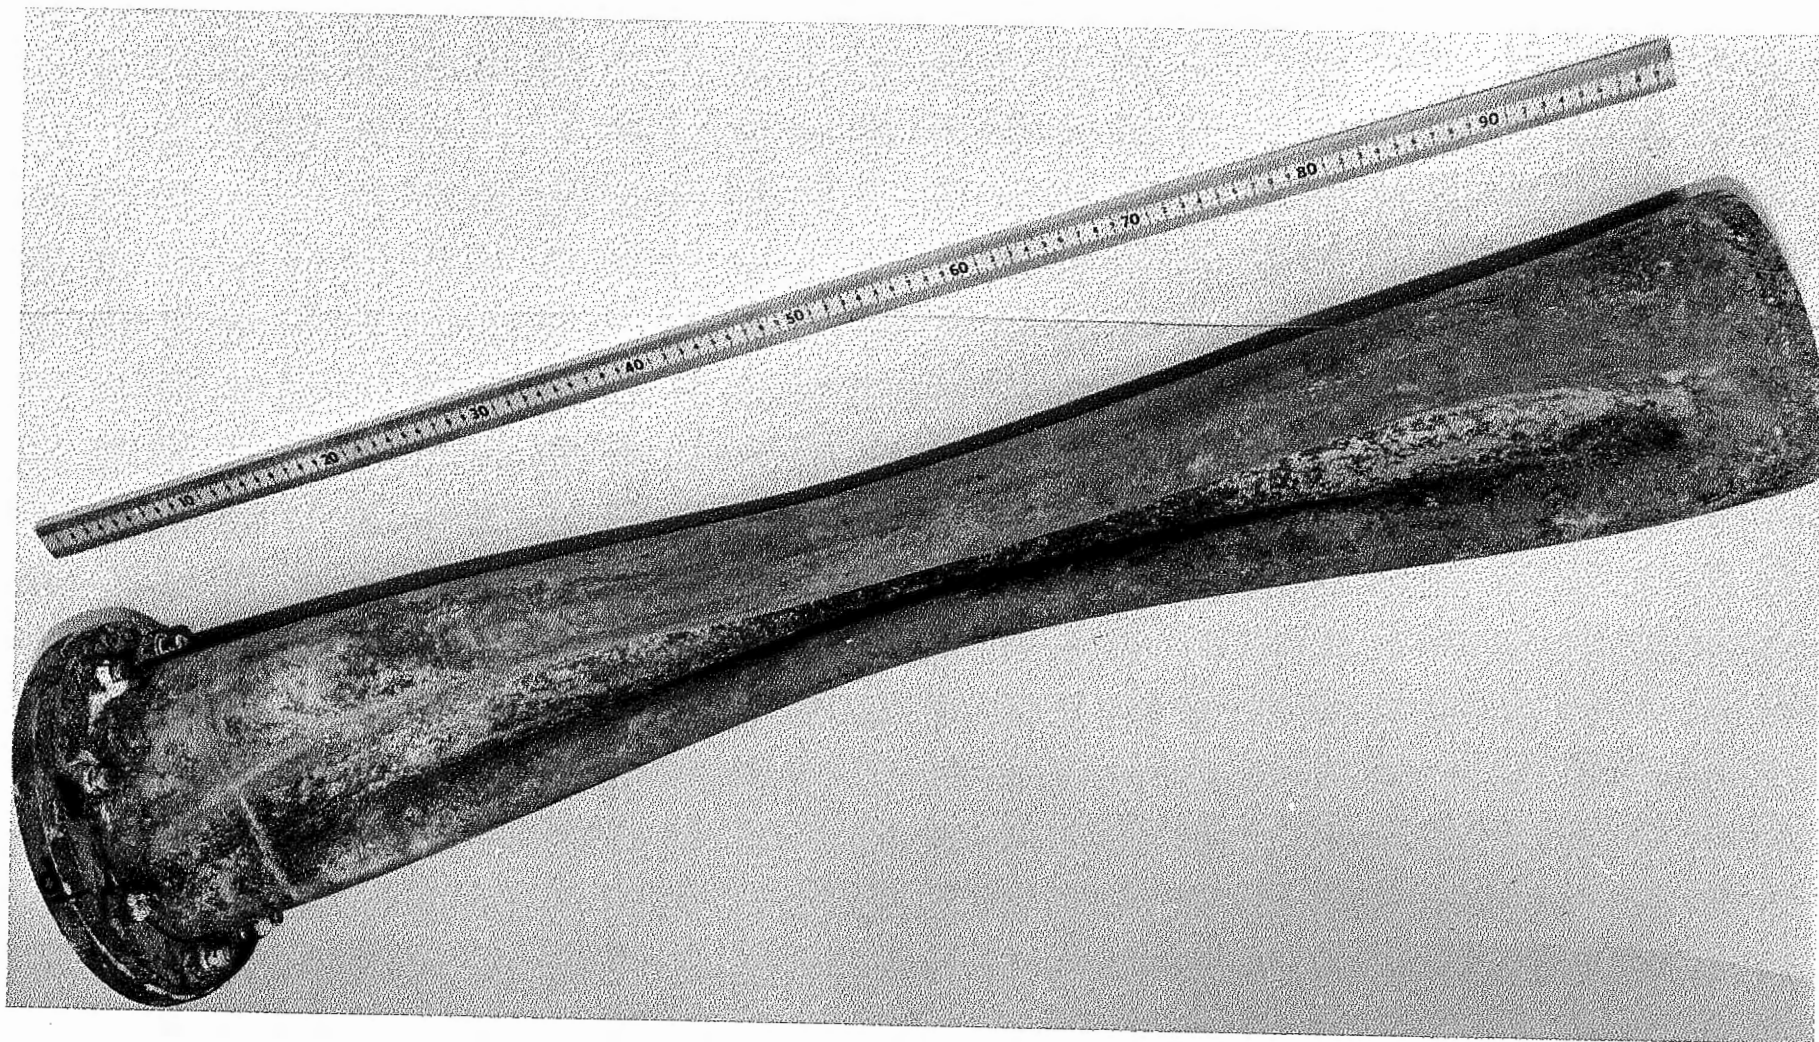
Figure 23. Inner Steel Vessel after Removal from the Waste Form. Note Implosion of the Container Walls along the 0° Longitudinal Axis.

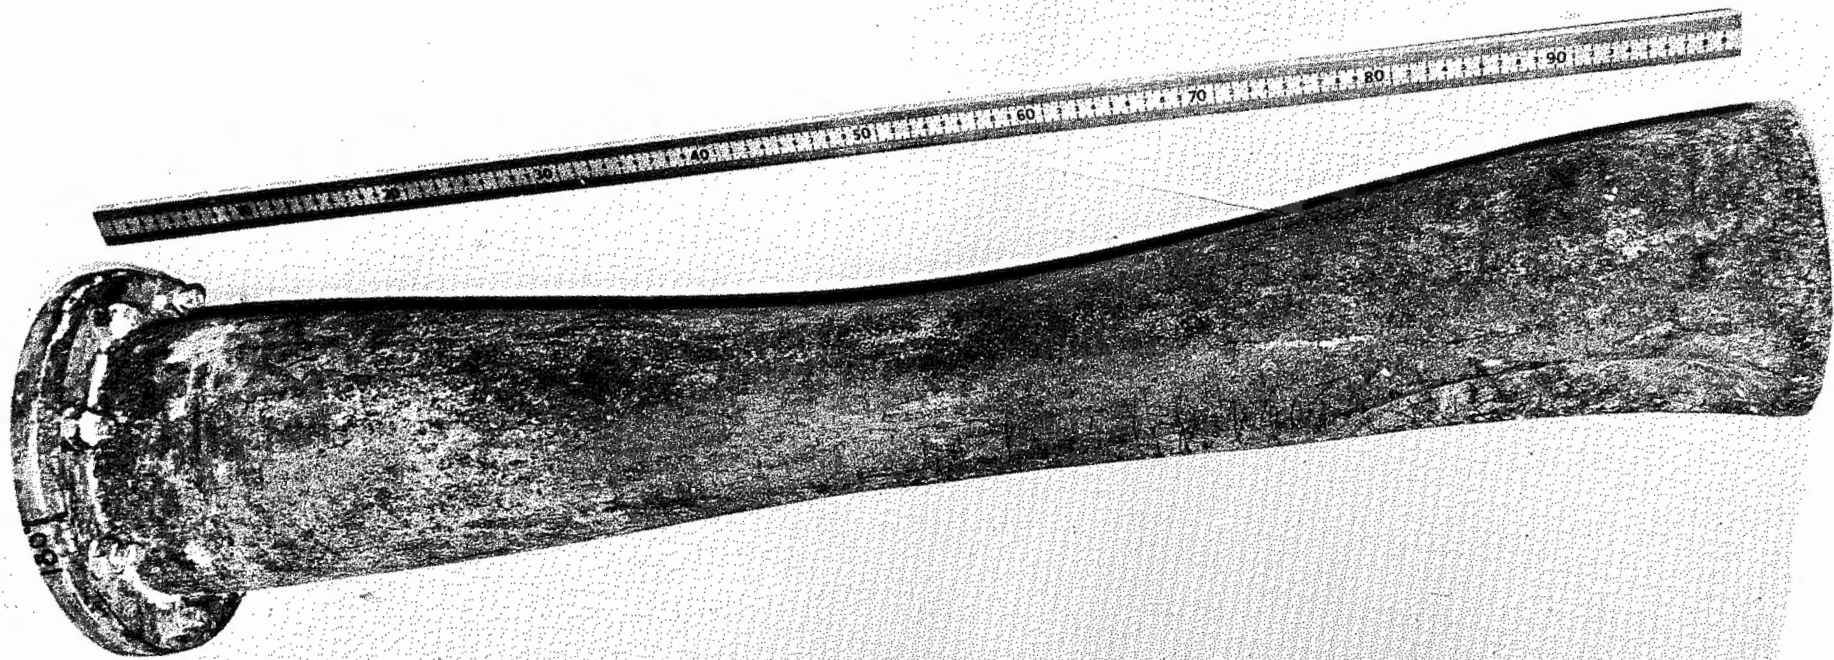
Figure 24. Inner Steel Vessel Viewed along the  $180^{\circ}$  Longitudinal Axis.

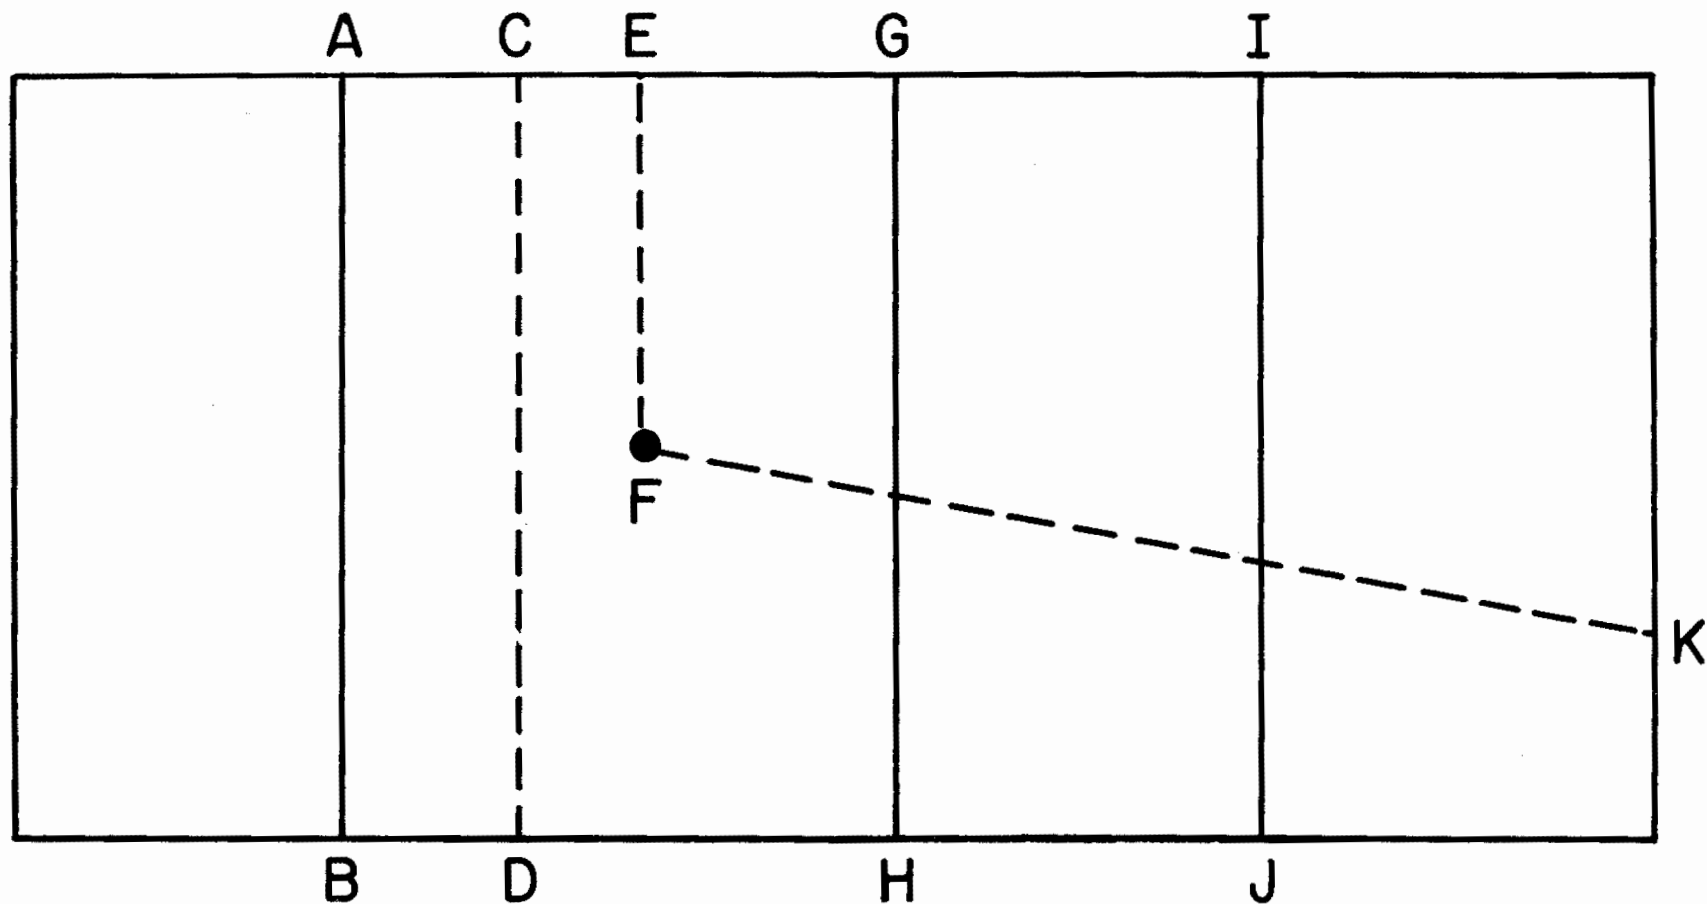
## CONTAINER SCHEMATIC

Figure 39. A Schematic illustrating Specific Features of the Container as Seen in Figure 38.

The waste package was first removed for inspection from its storage and transfer container on September 14, 1976. For the prior forty-five days since retrieval, the waste package was stored in a dry argon atmosphere. (A dry argon storage atmosphere was also utilized for subsequent intervals between sampling for corrosion studies.) A photographic survey of the waste container outer surface was performed at this time. The photographs included alphabetic labels whose coordinates were recorded, in terms of  $x$ ,  $r$ , and  $\theta$ . The coordinates ( $x$ ,  $r$  and  $\theta$ ) have as their ordinate a point defined by the intersection of the cylindrical axis and the plane of the rim at the concrete-exposed end of the container. The coordinate,  $x$ , is the distance parallel to the cylindrical axis running into the container. Looking at the concrete end,  $\theta$ , is defined as degrees of clockwise rotation about the cylindrical axis. This coordinate system is shown schematically in Figure 18. A map of the container surface is illustrated in Figure 37. In this figure, the container is shown rolled out into a plane after cutting along the  $180^\circ$  longitudinal axis. Figure 38 is a photograph of the waste package while Figure 39 is a schematic illustrating specific features of the waste container. The sediment line lies along FK in Figure 39. The container was constructed from two cylindrical carbon steel drums welded at  $x = 15\text{-}1/2"$ , the weld line being along CD. The container has three chimes, AB, GH, and IJ.

In contrast to the upper portion of the container, the mid-section exhibits relatively little general attack. The mid-section is that region bounded by CD and IJ as labelled in Figure 39. Much of an original surface coating on this portion has remained. In this area, however, severe local attack has occurred. As seen in Figure 42, the attack in this region is characterized by local pitting within the coated region, and general attack adjacent to the chimes. Figure 43 illustrates the attack specific to the neighborhood of the chimes. In fact, complete perforation was observed in some areas adjacent to the chimes, where corrosion product had deposited.

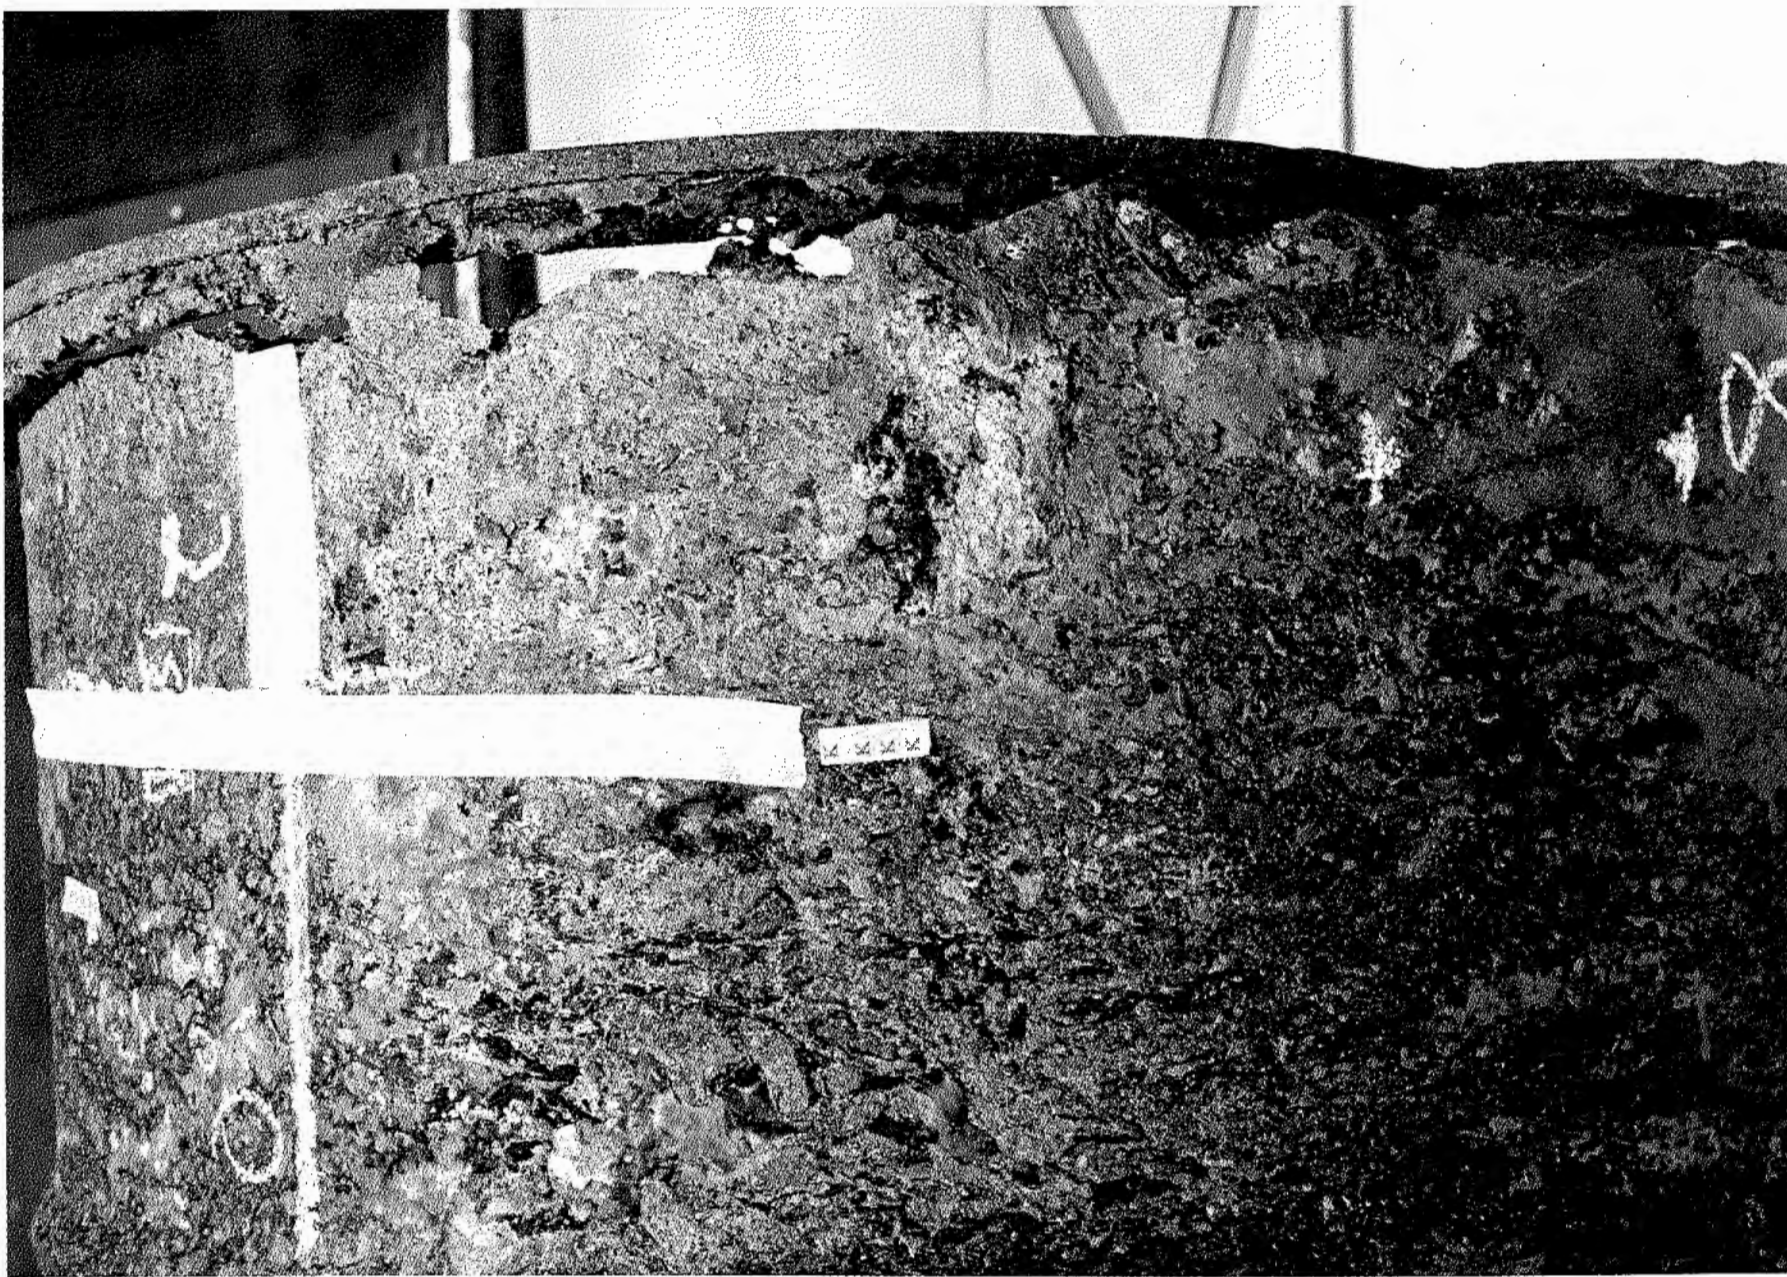
The upper portion of the container, between  $x = 0$  and  $x = 17\text{-}1/3"$  (EF) appears, from visual examination, to be attacked more severely than the remaining portion of the container. At the time of examination, much of this upper region contained loosely adhering material covering a dark red to black

scale directly adhering to the metal. Figures 40 and 41 show the severe attack as it appears on this upper portion of the container. The sediment side of this upper container region appears in Figure 40. Here much of the loosely adherent material is absent, thereby exposing the red-black substrate scale. On the sea-facing side of the container, Figure 41, more of the loose material had remained upon the surface. As shown in Figures 3(a) and 38, the rim located on this portion of the container is nearly severed as a result of the adjacent corrosive attack.

Figure 40. An Exterior View of the Upper Portion of the Container - Sediment Facing Side.

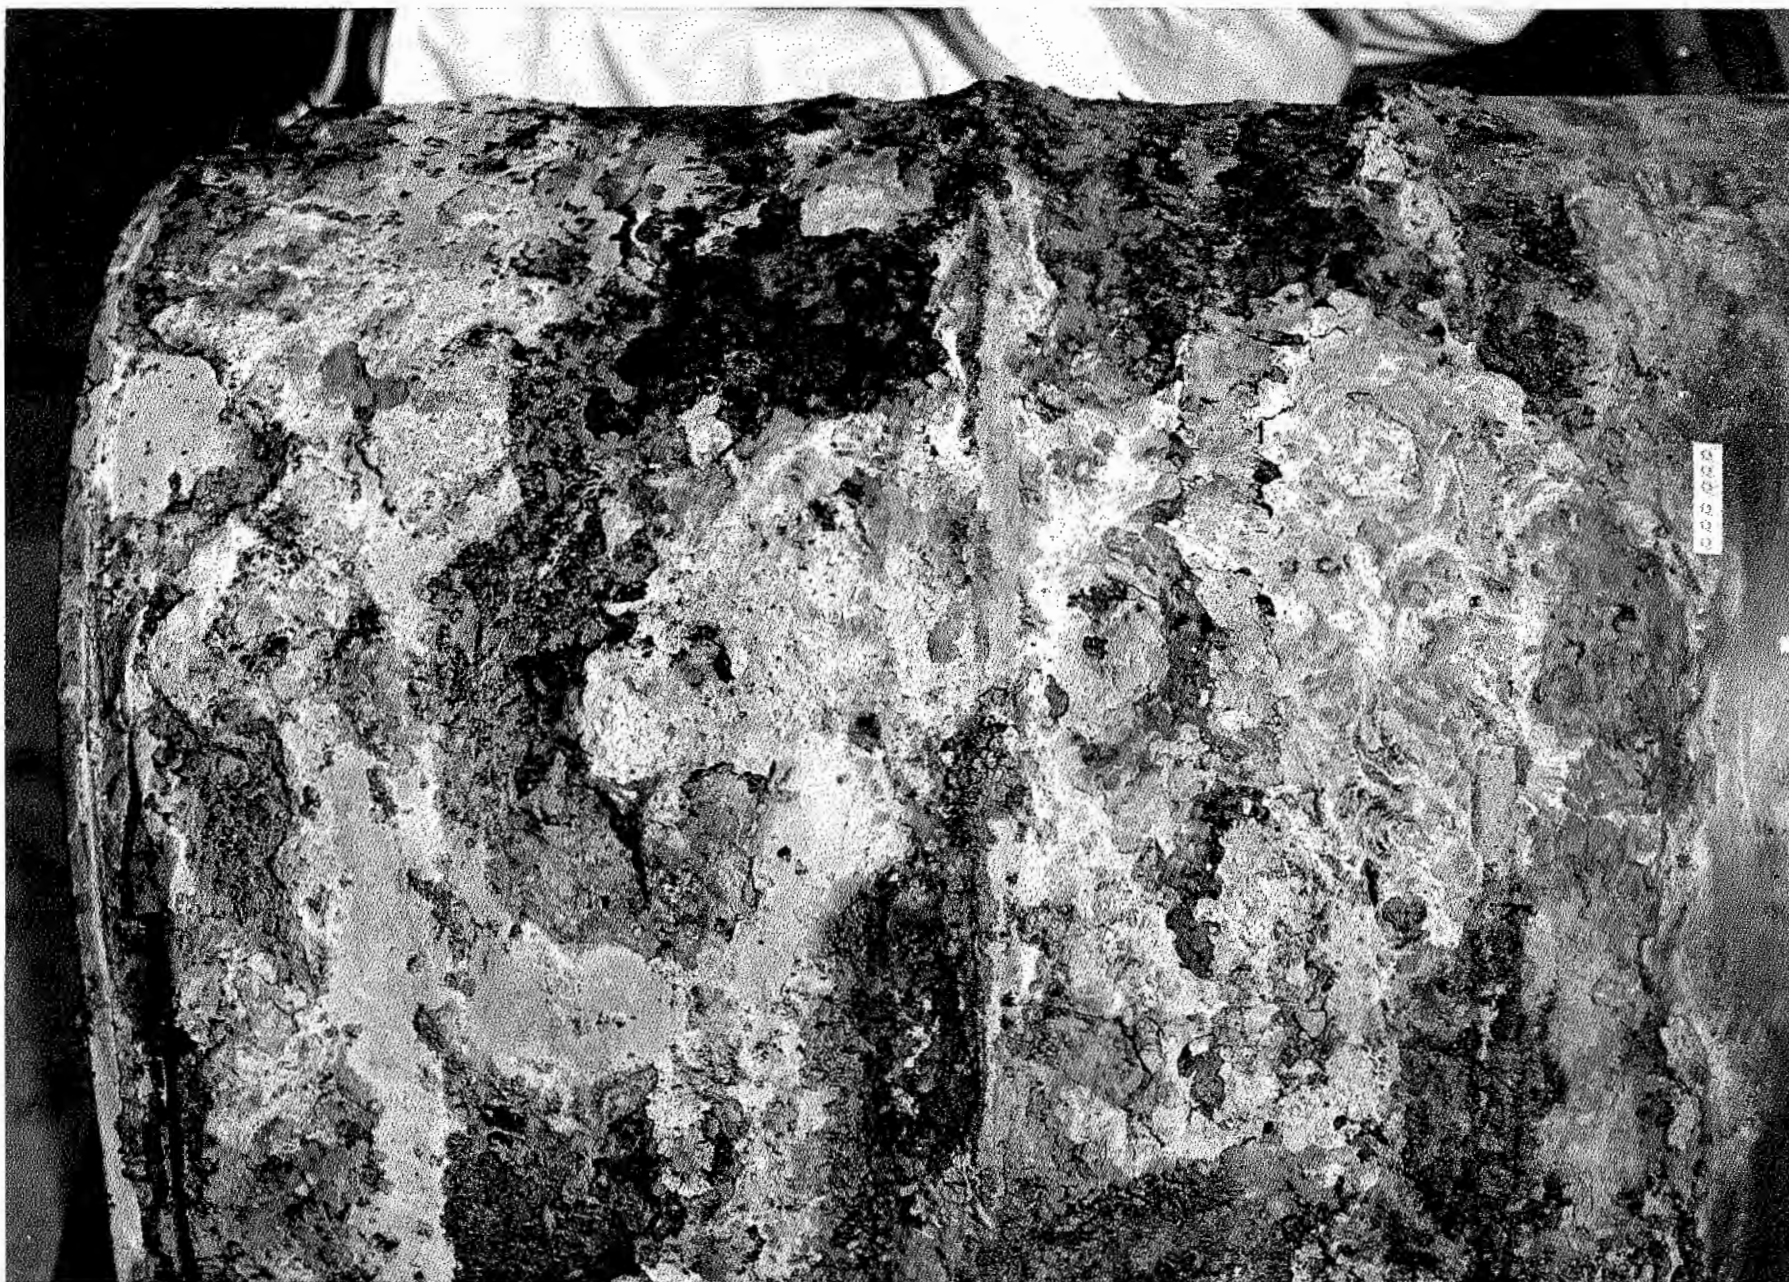
Figure 41. An Exterior View of the Upper Portion of the Container - Sea Facing Side.

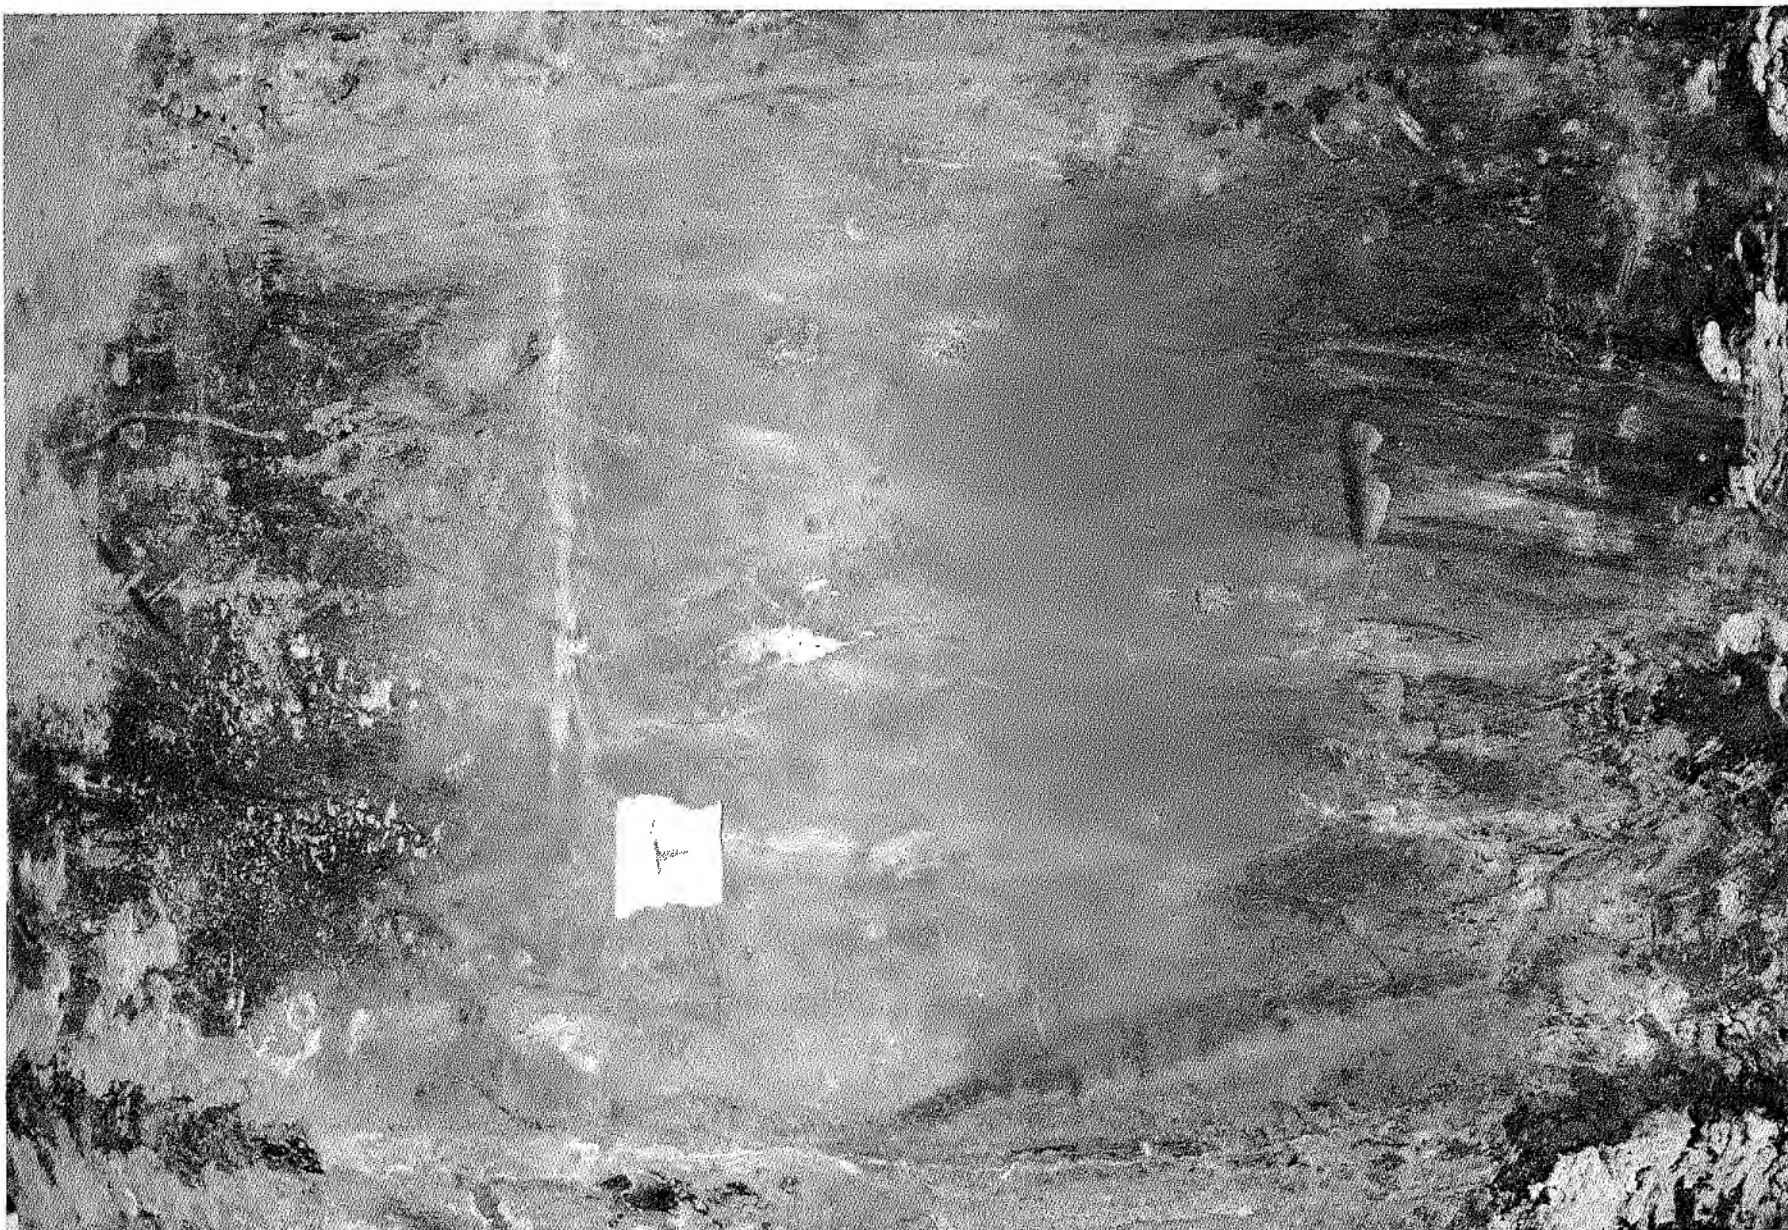
Figure 42. An Exterior View of the Mid-Section of the Container.

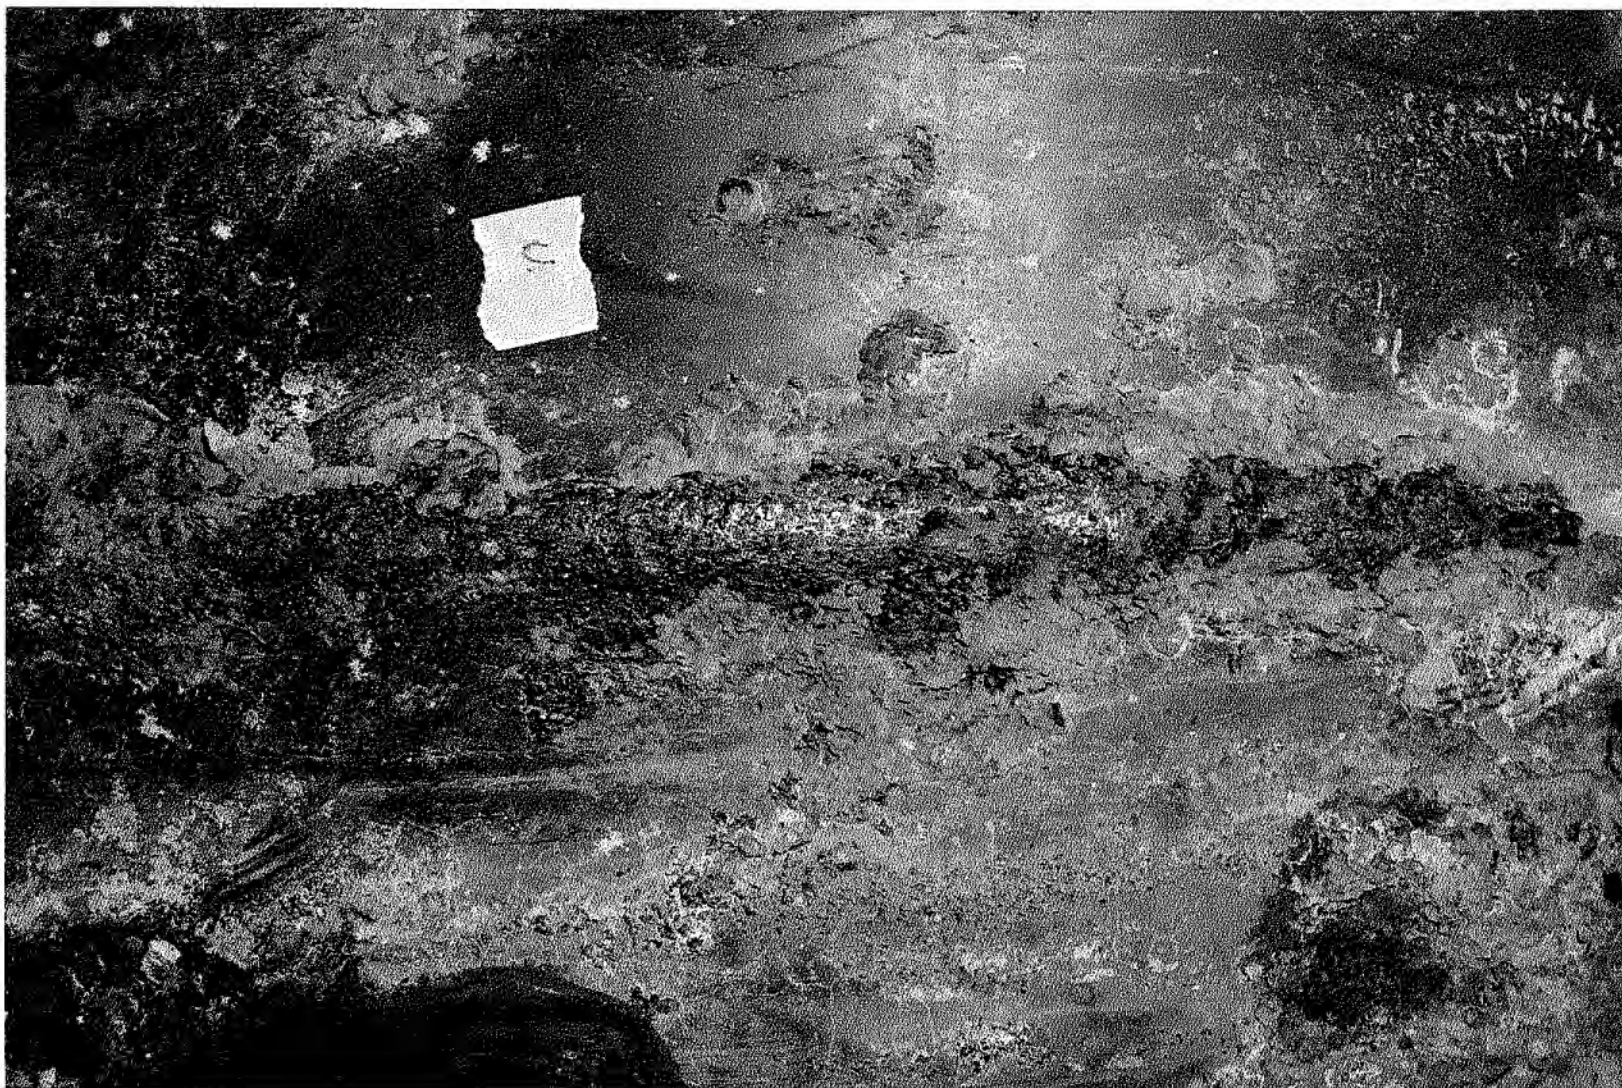
Figure 43. An Exterior View of General Attack Adjacent to a Chime within the Mid-Section.
