# **Analysis and Evaluation of a Radioactive Waste Package Retrieved from the Atlantic 2800 Meter Disposal Site**

P. COLOMBO, R.M. NEILSON, JR. AND M.W. KENDIG  
NUCLEAR WASTE MANAGEMENT RESEARCH GROUP  
DEPARTMENT OF NUCLEAR ENERGY  
BROOKHAVEN NATIONAL LABORATORY  
ASSOCIATED UNIVERSITIES, INC.  
UPTON, NEW YORK 11973

SEPTEMBER 1979

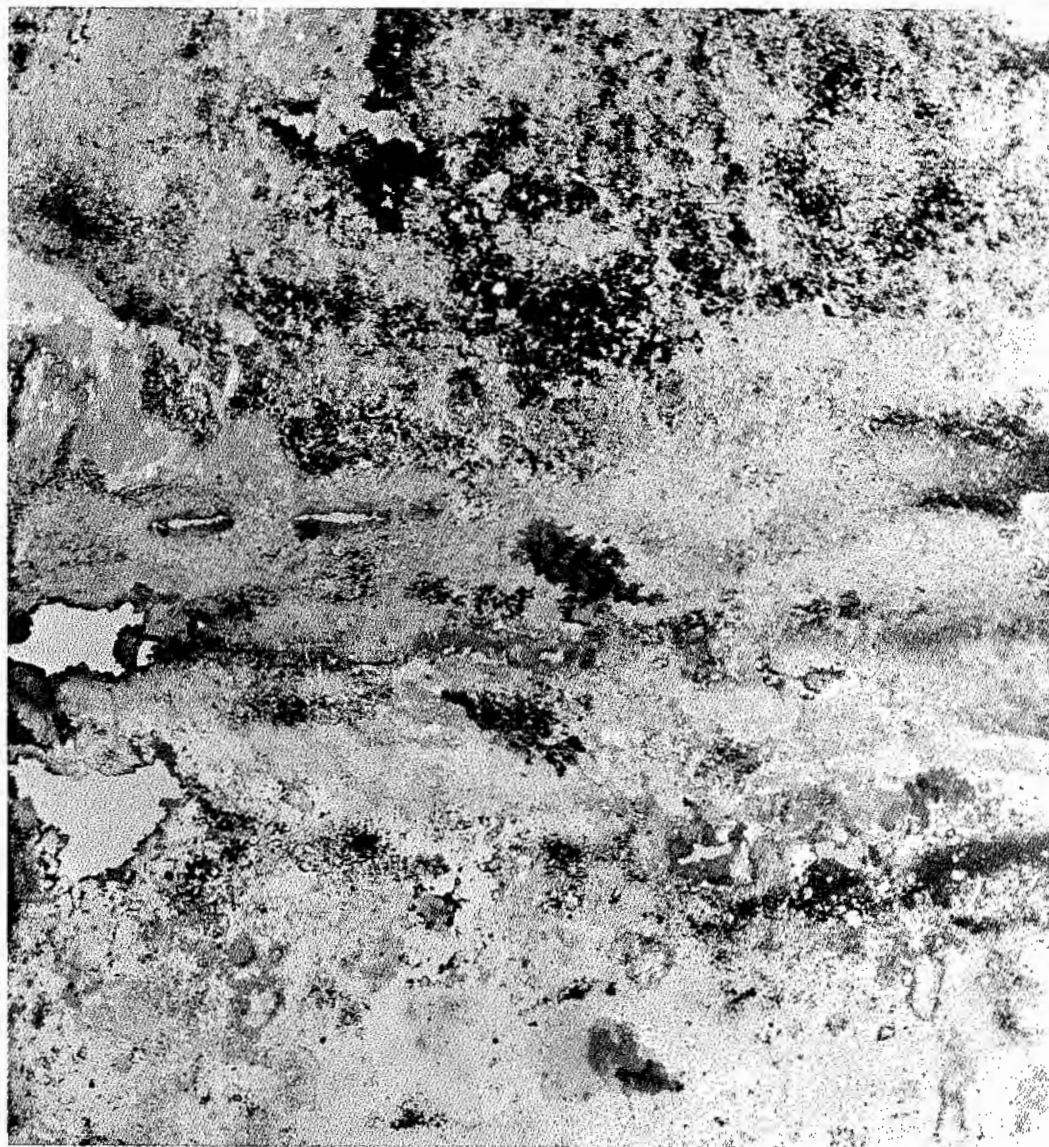
Further examination of the corrosion adjacent to the chimes, observed when the container was cut open and the inner surface viewed, indicated points of perforation. Some of these points are specific to the region immediately adjacent to the chimes, as viewed from the interior of the container. Figure 44 shows this chime specific attack perforating the sediment-facing side of the container, while Figure 45 shows a similar attack located on the sea-side of the container.

Figure 44. Sediment Side Perforation Adjacent to a Chime as Viewed from the Inside of the Carbon Steel Sheath.

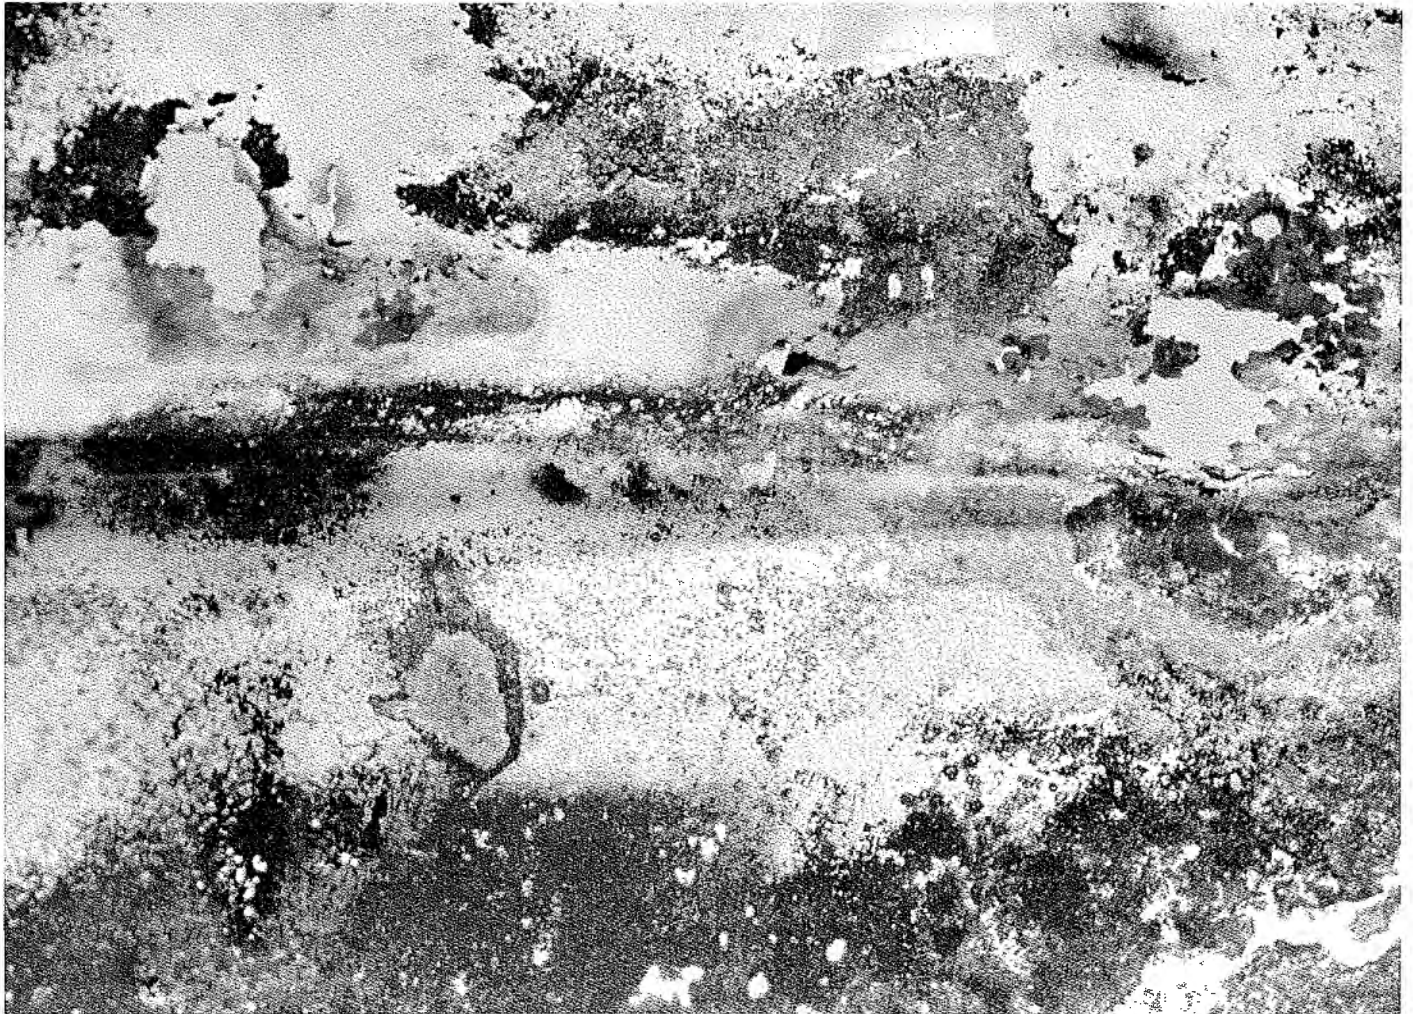
Figure 45. Sea Side Perforation Adjacent to a Chime as Viewed from the Inside of the Carbon Steel Sheath.

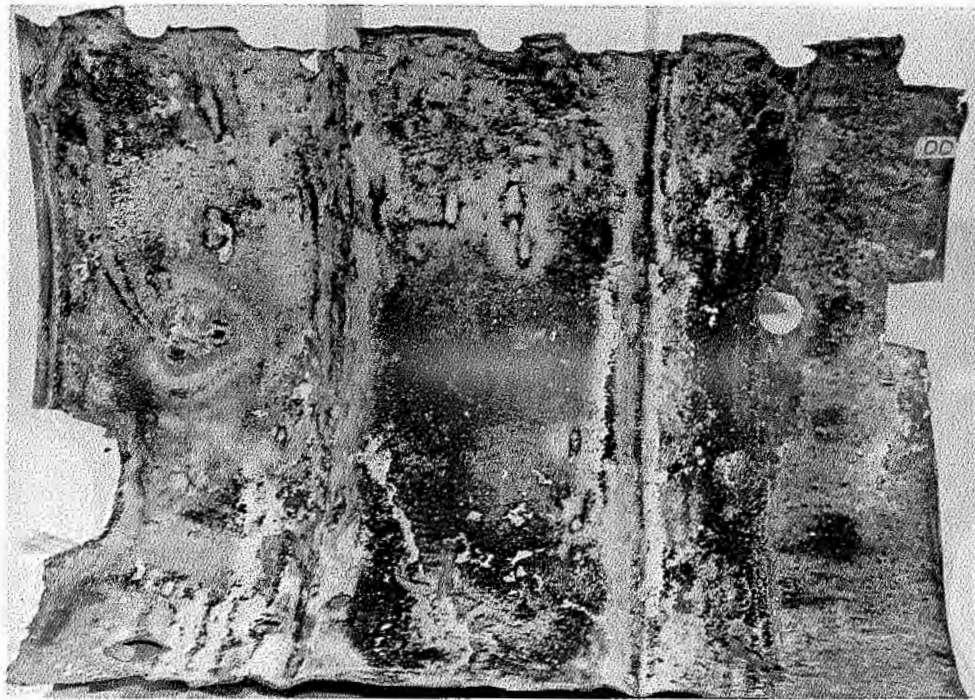
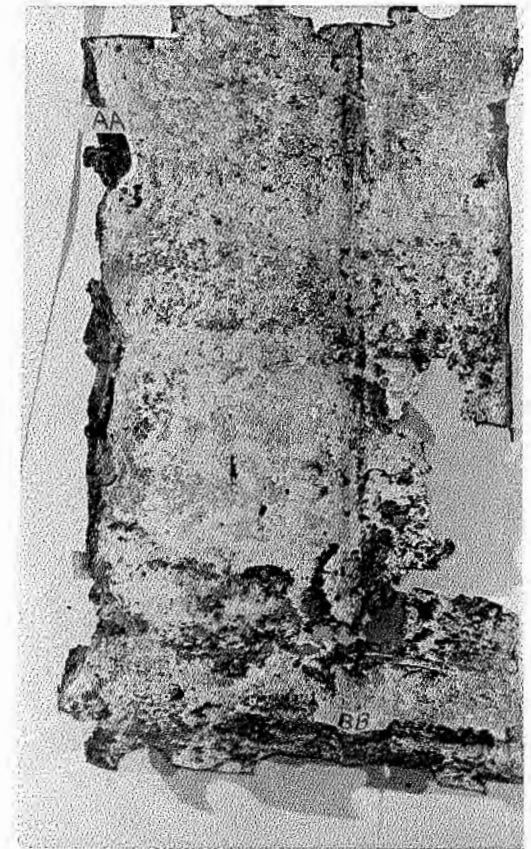
Figure 46 shows the entire inner surface of the carbon steel sheath. The upper portion in Figure 46 has retained much concrete which adheres to a rough red scale on the container. The lower portion of the container contains less adhering concrete. The metal interior surface in this region is black and appears to be smooth. The relative adherence of the concrete to these two portions of the container sheath correlates with the increased spalling of the waste form where it contacted these regions. Figure 47 shows the concrete waste form denuded of the carbon steel sheath. Clearly, the

Figure 46. The Interior Surface of the Carbon Steel Sheath.

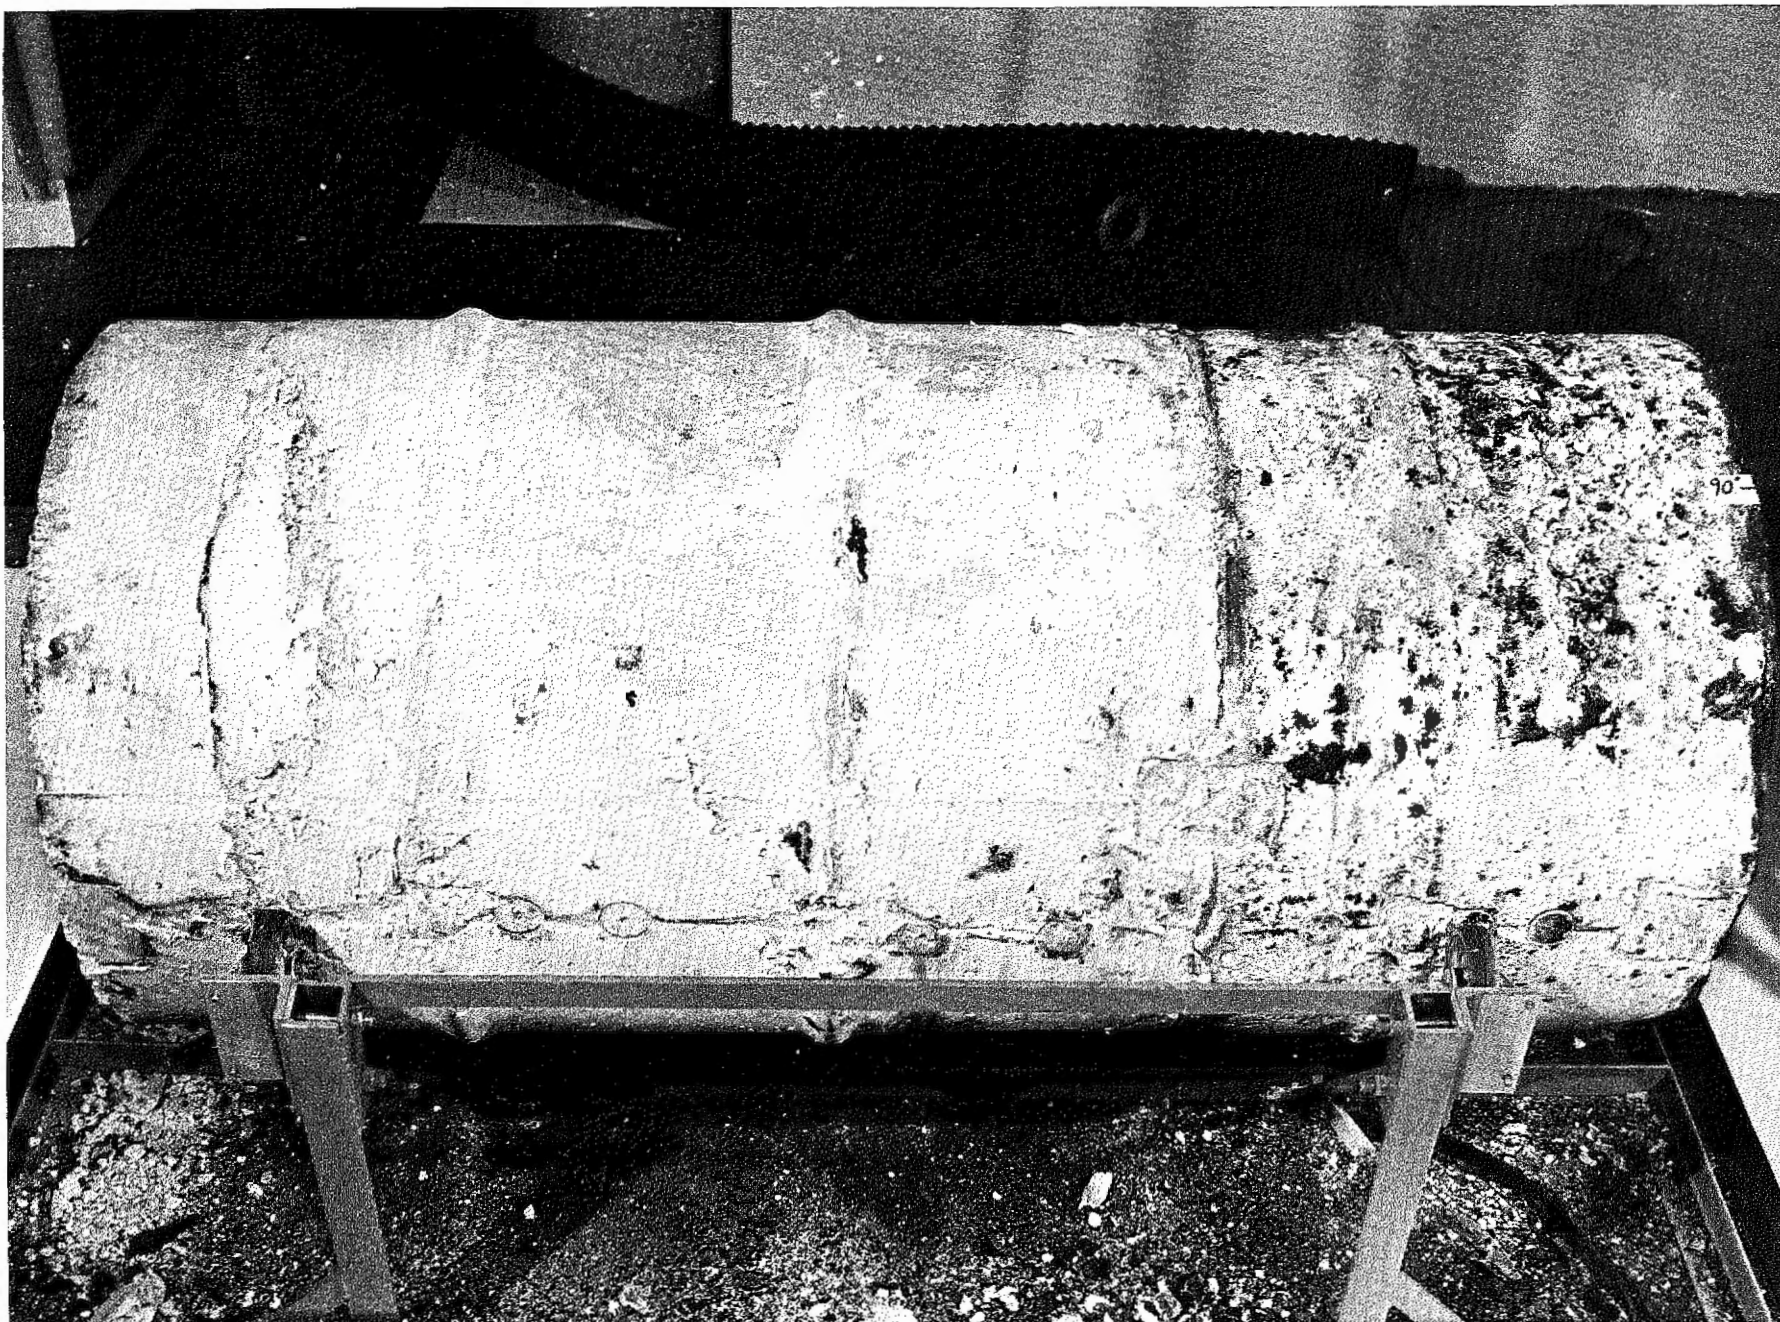
region contacting the upper portion of the sheath (and closer to the end exposed to the sea-water) is more severely degraded.

Figure 47. The Concrete Waste Form. The Upper Portion of the Form is to the Right in the Photograph.

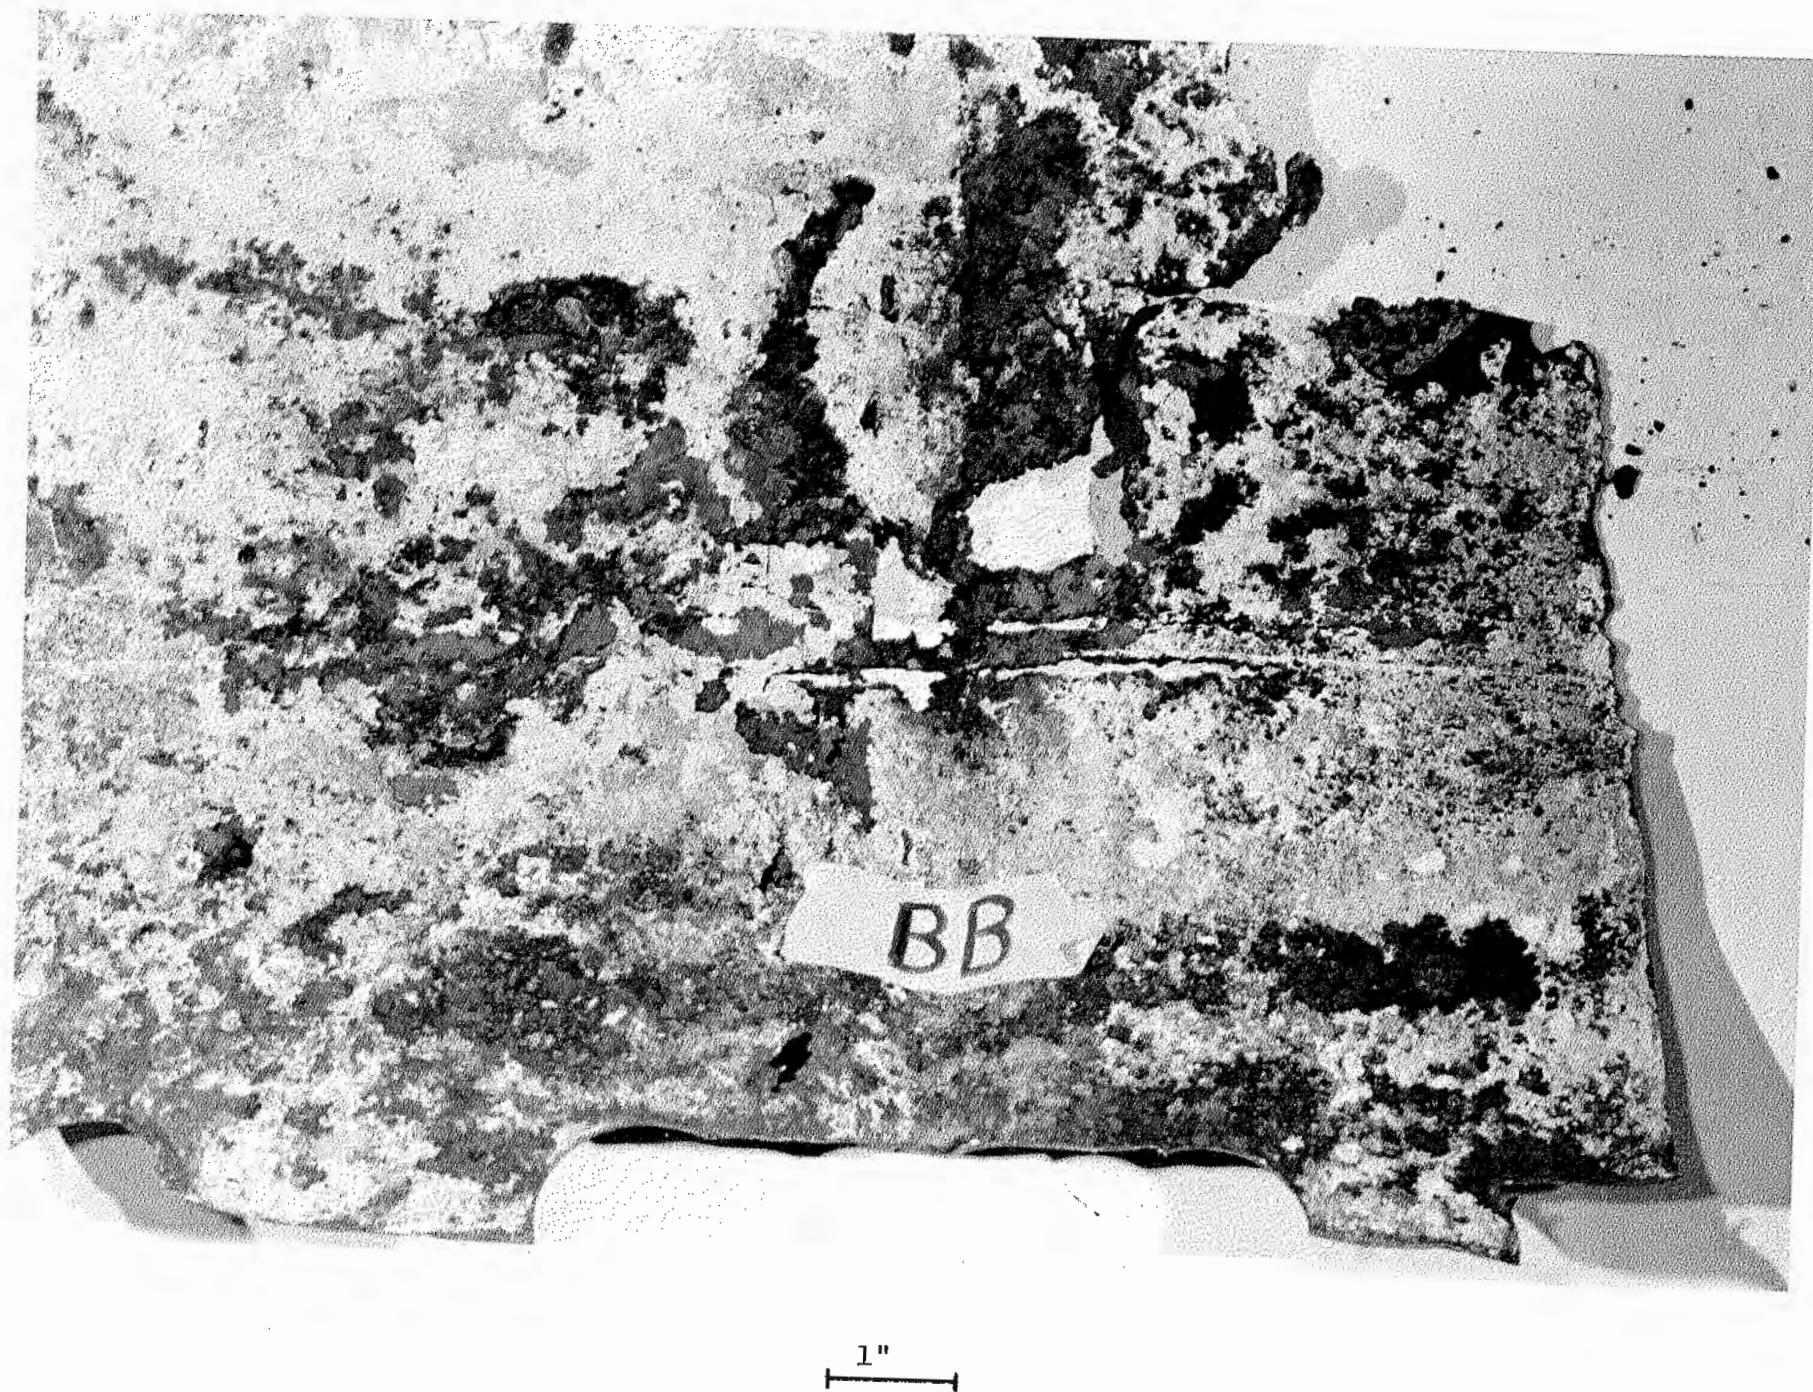
Some further observations can be made from the inside view of the sheath. Figure 48 shows attack which has perforated a region adjacent to a longitudinal weld in the upper portion of the container. Similarly, though not severely enough to produce perforation, the corrosion has also selectively attacked the region adjacent to the longitudinal weld in the lower container, Figure 49.

Figure 48. Attack Adjacent to the Weld in the Upper Container.

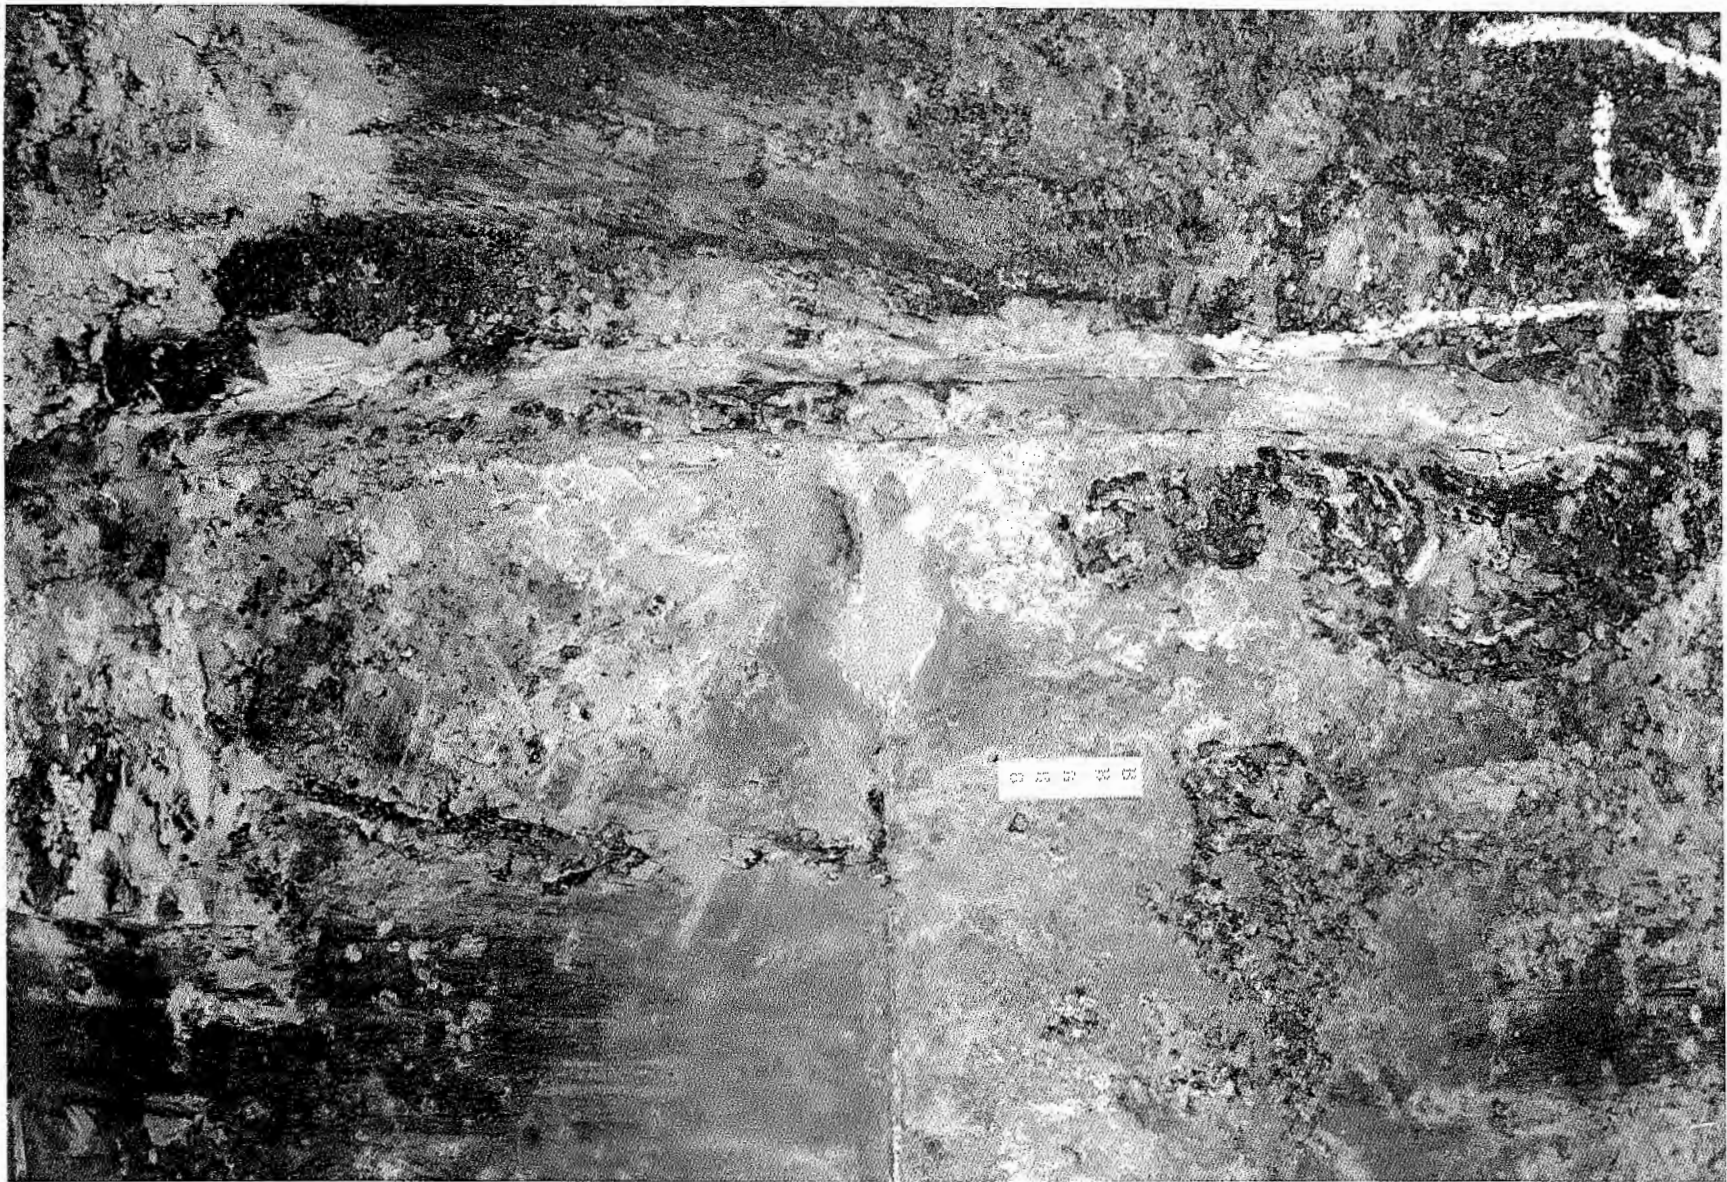
Figure 49. Attack Adjacent to the Weld in the Lower Container.

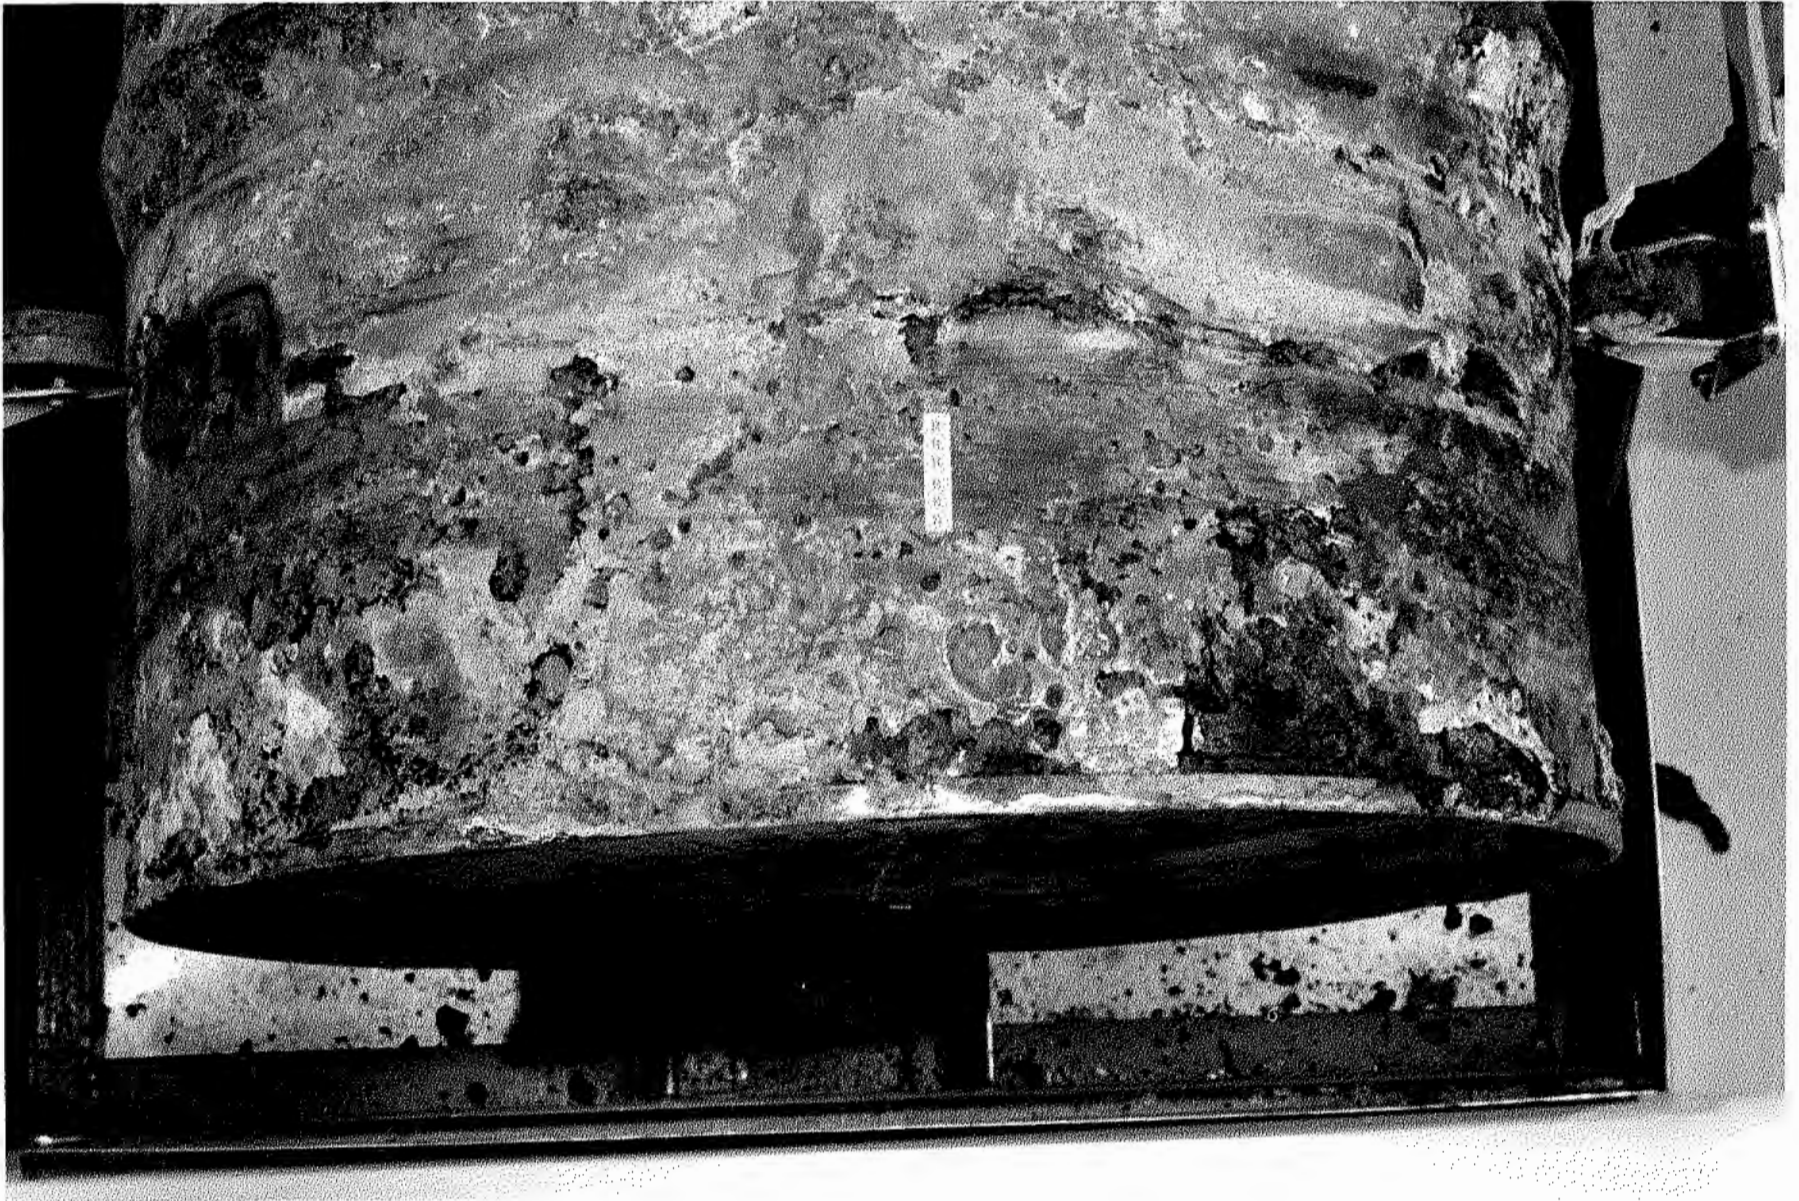
At the lower portion of the cylinder, corrosion has produced more extensive and typically deeper pits than those formed within the midsection. This is shown in Figure 50.

Figure 50. Macroscopic Pits Covering the Carbon S End of the Container.

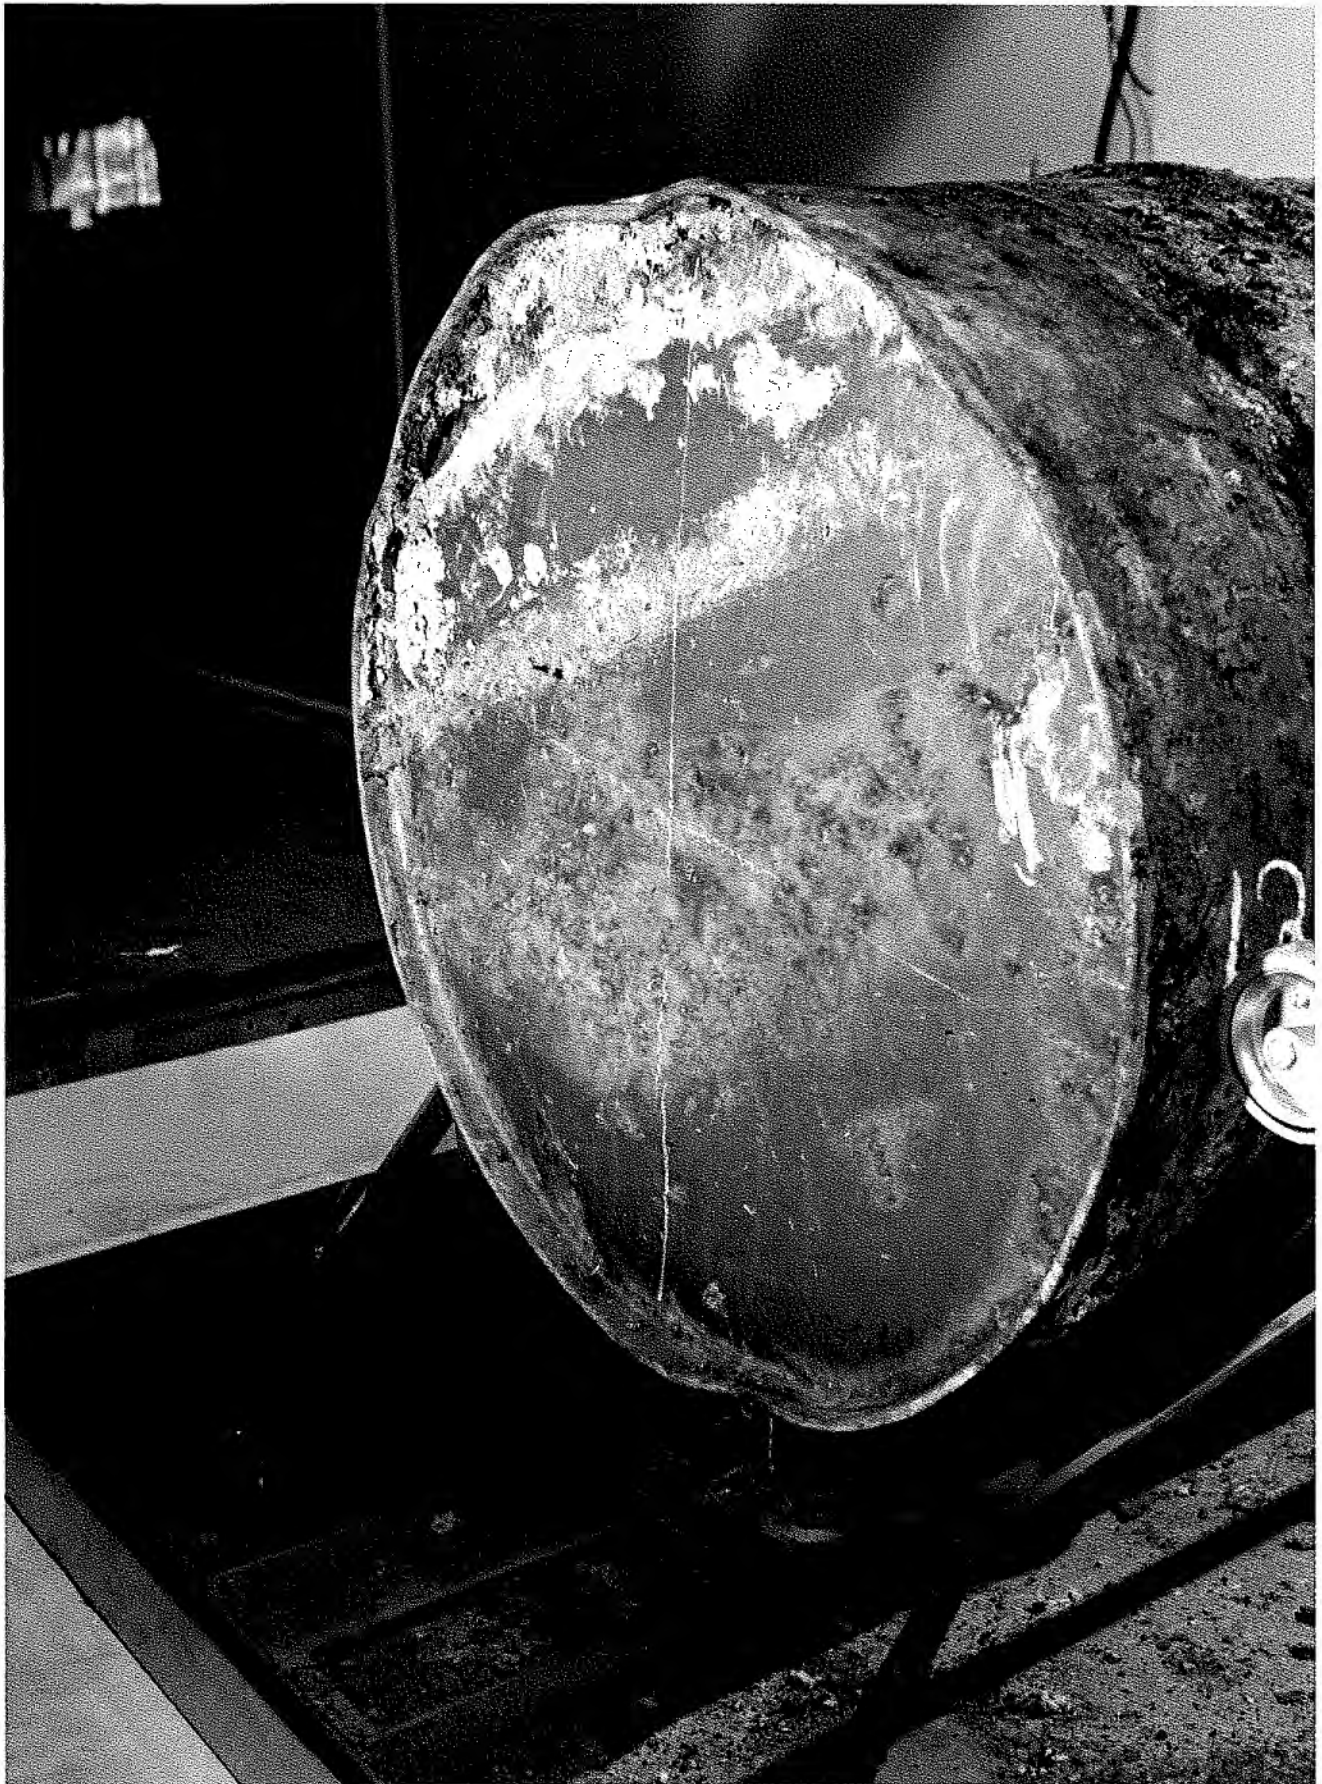
The metal cap on the lower end of the container is shown in Figures 51 and 52. Although there is little attack on this surface of the container, specific pitting has occurred on the rim and in the center. An interesting instance of coated steel corrosion, namely "filiform" corrosion is observed in this section, shown in Figure 52. This is a form of under coating tunneling attack which forms thread-like traces under the coating. Its active corrosion cell maintains dissolution within the dark head, producing ferrous ions and ferrous hydroxide, while the tail contains the oxidized ferric ion and hydrous ferric oxides and hydroxides.<sup>(6)</sup>

Figure 51. The Metal End of the Container.

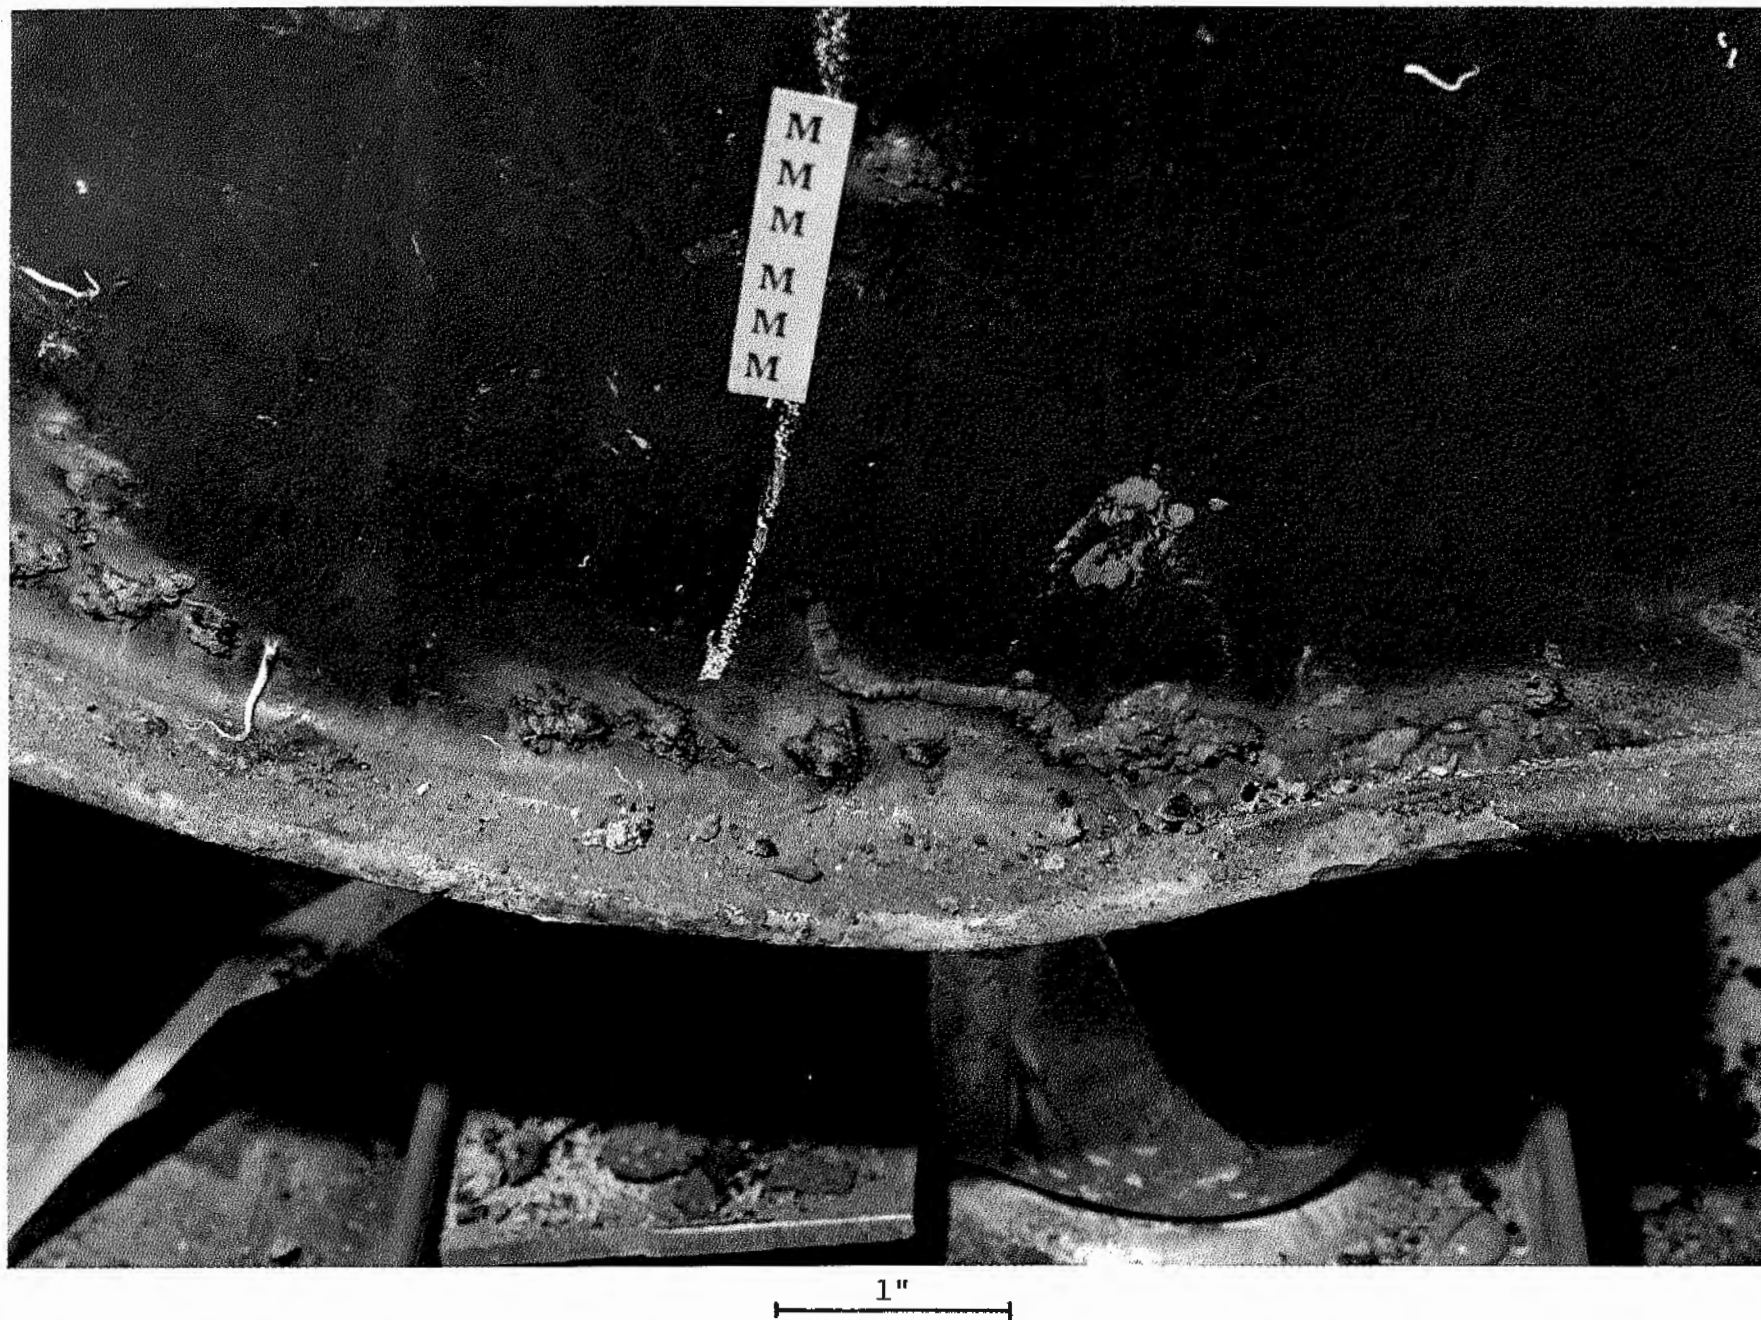
Figure 52. An Example of Filiform Corrosion.

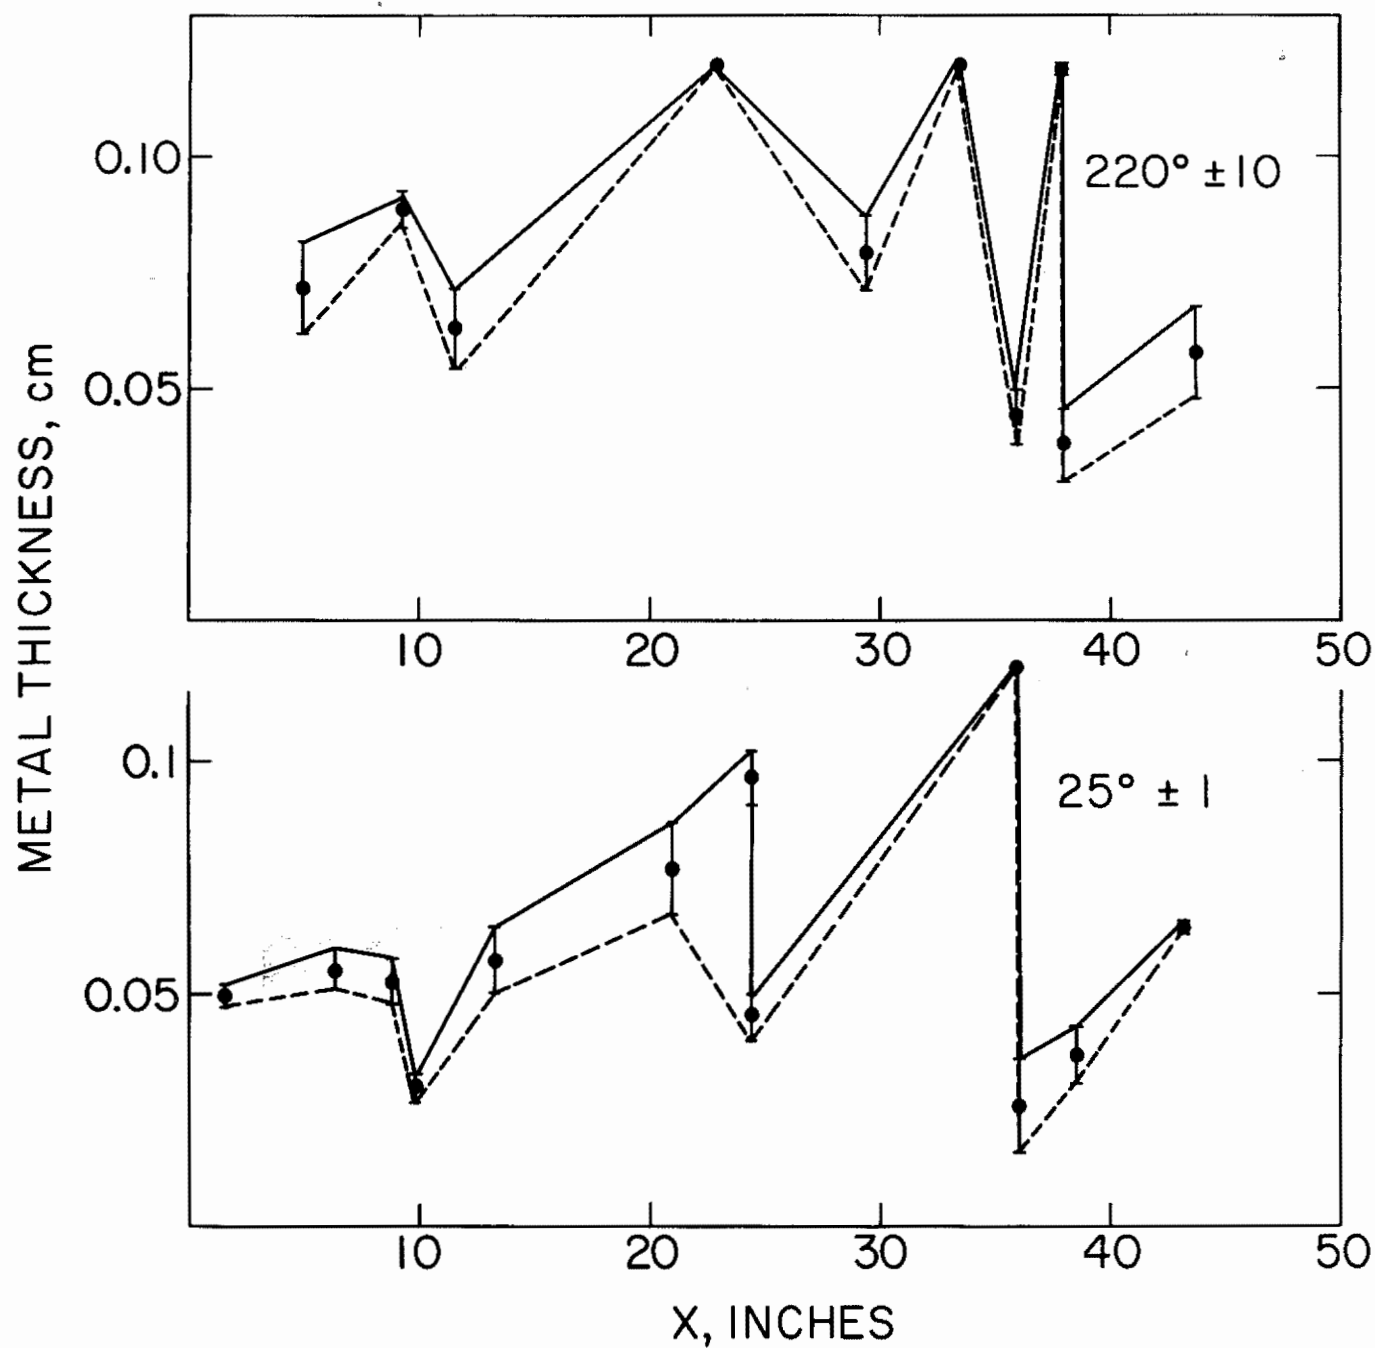
Metal thickness as a function of position on the container is presented in Figure 53. The error bars show the magnitude of the standard deviation of this measurement. Their magnitude is a measure of the surface roughness at the observed 50x magnification used in the microscopic measurement. Approximately 0.1" of cross-section length was sampled for each point in Figure 53. Figure 53a illustrates the dimension for the sea-side of the container at  $220^\circ$ , while Figure 53b presents similar data for the sediment-side of the container at  $25^\circ$ . The unattacked thickness of the container was determined from analyses of the metal in the rim folds at both ends to be 0.047 in (0.12 cm) for the upper container, and 0.039 in (0.10 cm) for the lower. The  $x = 0$  end of the container, i.e., the upper container shows significantly more general attack than that shown by the lower container. However, the lower container shows more severe local attack, even though there are several points between  $x = 20$  and  $x = 50$  where there is no measured dimension loss. Comparing now the thinning data for the sea-side to that for the sediment side, there is a small but significant difference in the thinning, the sediment side exhibiting more attack.

Figure 53. The Sheath Thickness vs. Container Position.

Since the corrosion rate of carbon steel in sea water is essentially constant,<sup>(7)</sup> an average corrosion rate for the material in this container may be estimated and compared to rates obtained under defined conditions. An observed rate is defined as  $(d_0 - d)/t$  where  $d_0$  is the initial dimension of the cross section of the container and  $d$  is the observed dimension at the time of the container recovery, 15 years,  $(t)$ , after being placed in the marine environment. Since there are points on the container where attack has completely penetrated the 0.039 in (0.1 cm) sheath, a lower limit for local corrosion can be placed at 0.0026 in/yr (0.067 mm/yr), while the average rates for the general attack on the upper container are  $0.0013 \pm 0.0002$  and  $0.0019 \pm 0.0002$  in/yr ( $0.032 \pm .006$  and  $0.049 \pm .006$  mm/yr) for the respective sea facing and sediment facing sides. As can be seen in Table 7, these values range somewhat under those observed for carbon steel in surface water. The corrosion rate for carbon steel in deep water at a site off the coast of California has been observed to be linear in oxygen concentration, following the equation:

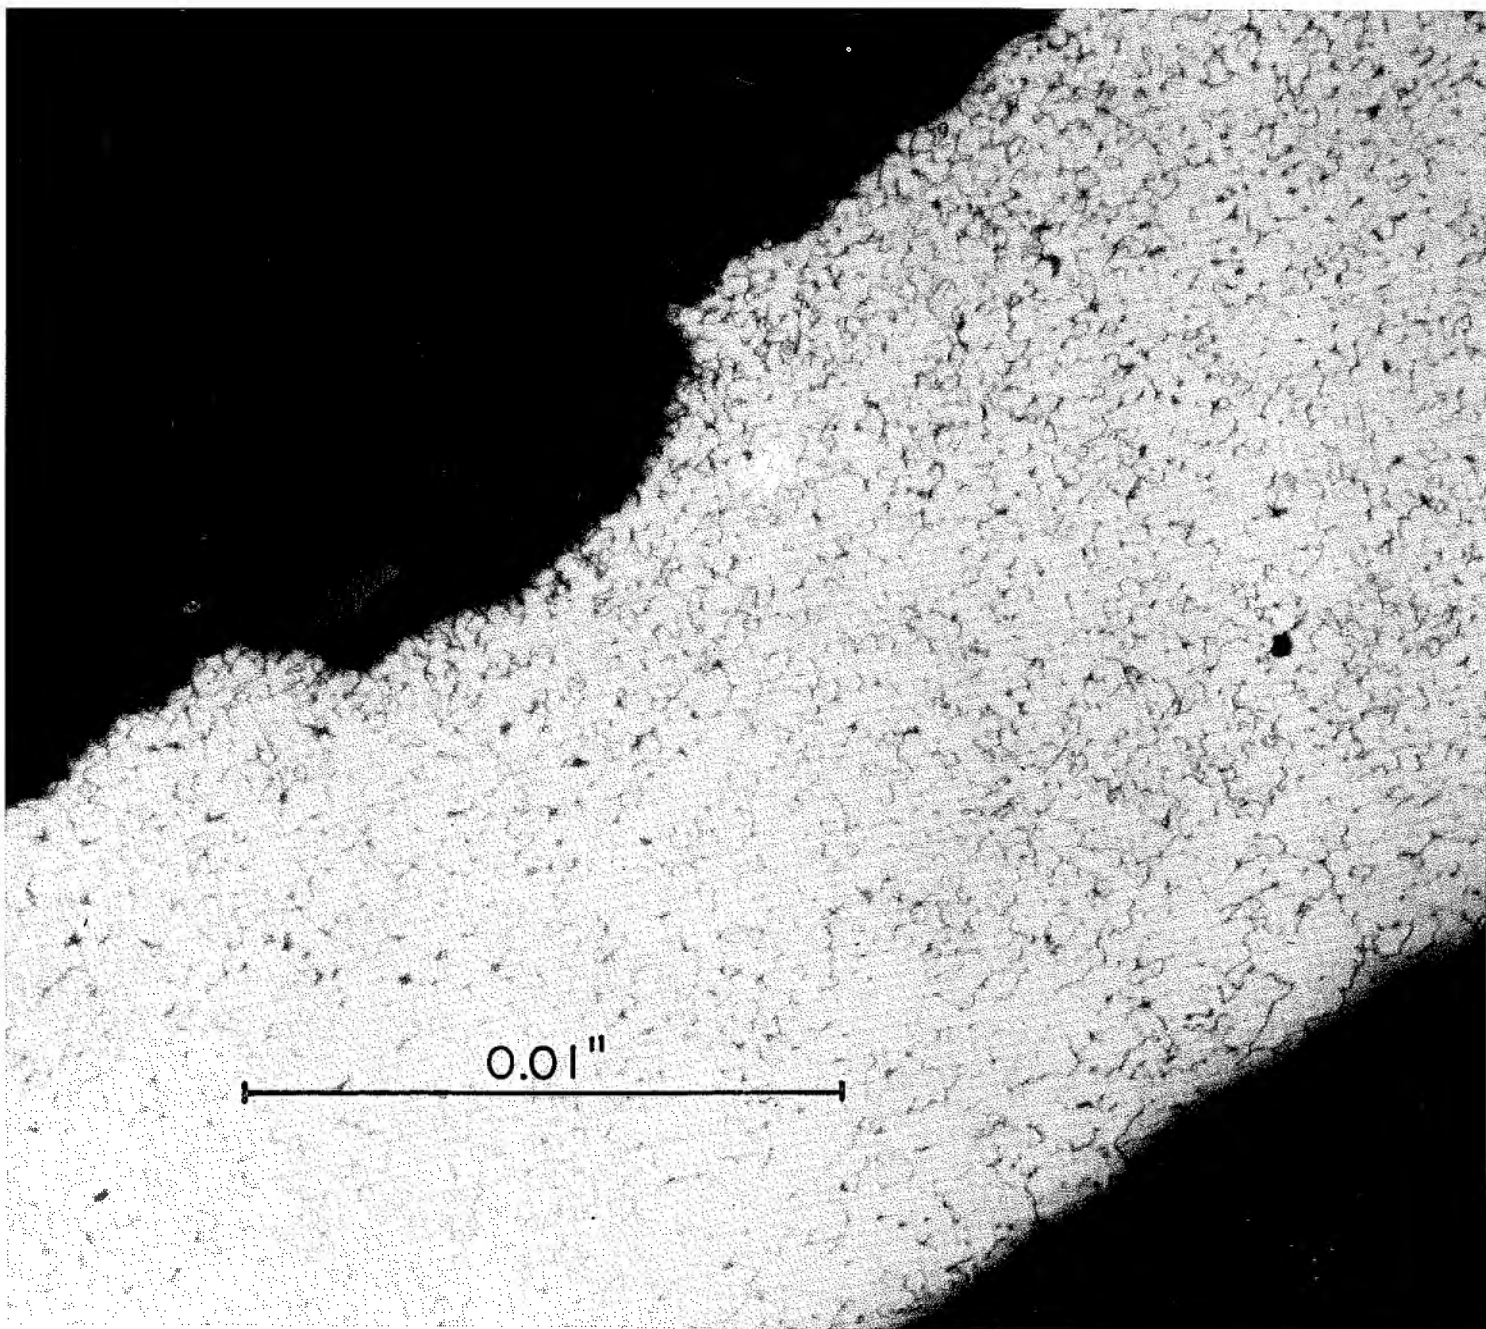
The chimes within the lower portion of the container, although exhibiting enhanced attack, show no apparent microstructural features which differ from the rest of the lower container. As can be seen in Figure 57, the attack at the chime surface appears more or less general, but with some shallow pitting.

Figure 57. Attack at a Chime.
