# **Analysis and Evaluation of a Radioactive Waste Package Retrieved from the Atlantic 2800 Meter Disposal Site**

P. COLOMBO, R.M. NEILSON, JR. AND M.W. KENDIG  
NUCLEAR WASTE MANAGEMENT RESEARCH GROUP  
DEPARTMENT OF NUCLEAR ENERGY  
BROOKHAVEN NATIONAL LABORATORY  
ASSOCIATED UNIVERSITIES, INC.  
UPTON, NEW YORK 11973

SEPTEMBER 1979

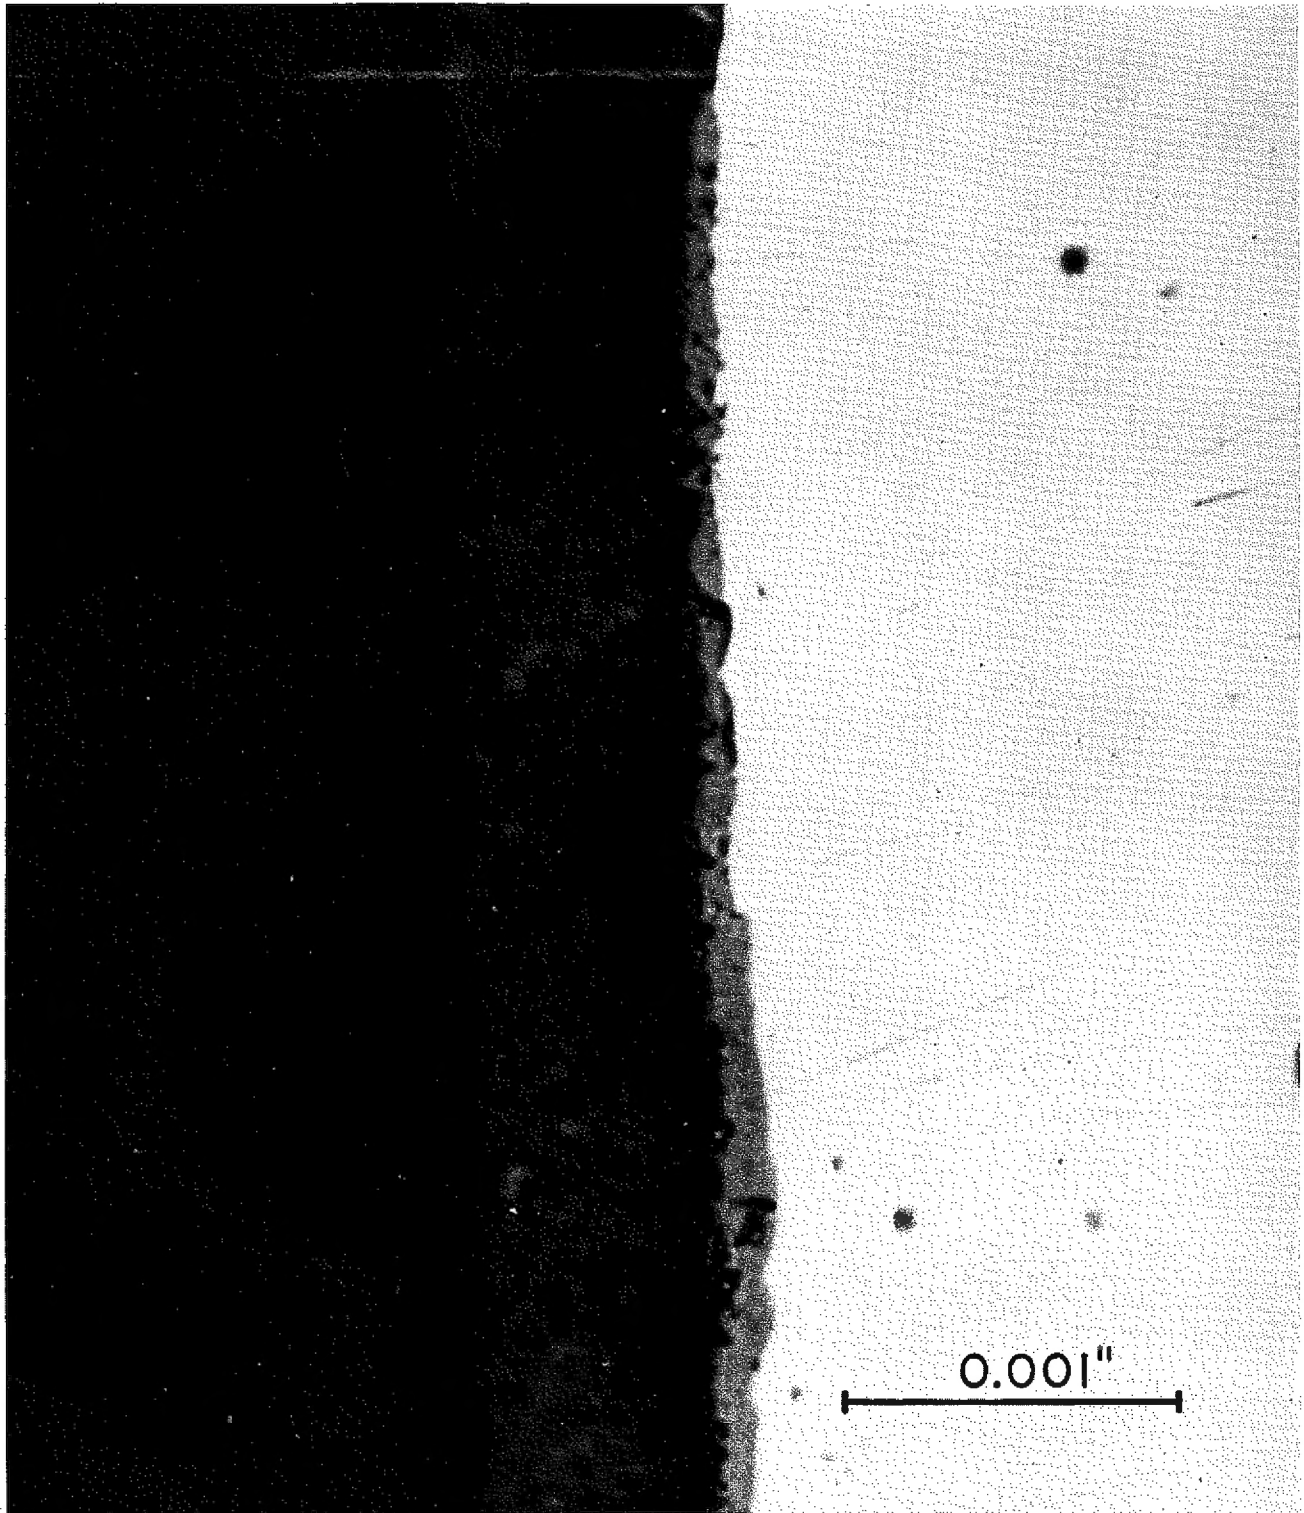
The coating surface consists of a 55  $\mu\text{m}$  lamina over a 3-5  $\mu\text{m}$  interfacial scale lying on the metal substrate. Figure 58 shows a photograph of the coating, scale, and metal. Non-dispersive x-ray fluorescence analysis of the interfacial region shows the coating to contain Ti, Cr, Zn, and Si, while the only element apparent within the scale interface is iron. Carefully removing a portion of the coating by abrasion reveals a black surface similar to the  $\text{Fe}_3\text{O}_4$  observed upon the inside of the carbon steel sheath. It can be concluded that this scale interface is not the conceivable result of a zinc phosphate or chromate conversion coating, but is, in fact, a  $\text{Fe}_3\text{O}_4$  scale.

Figure 58. The Coated Interface.

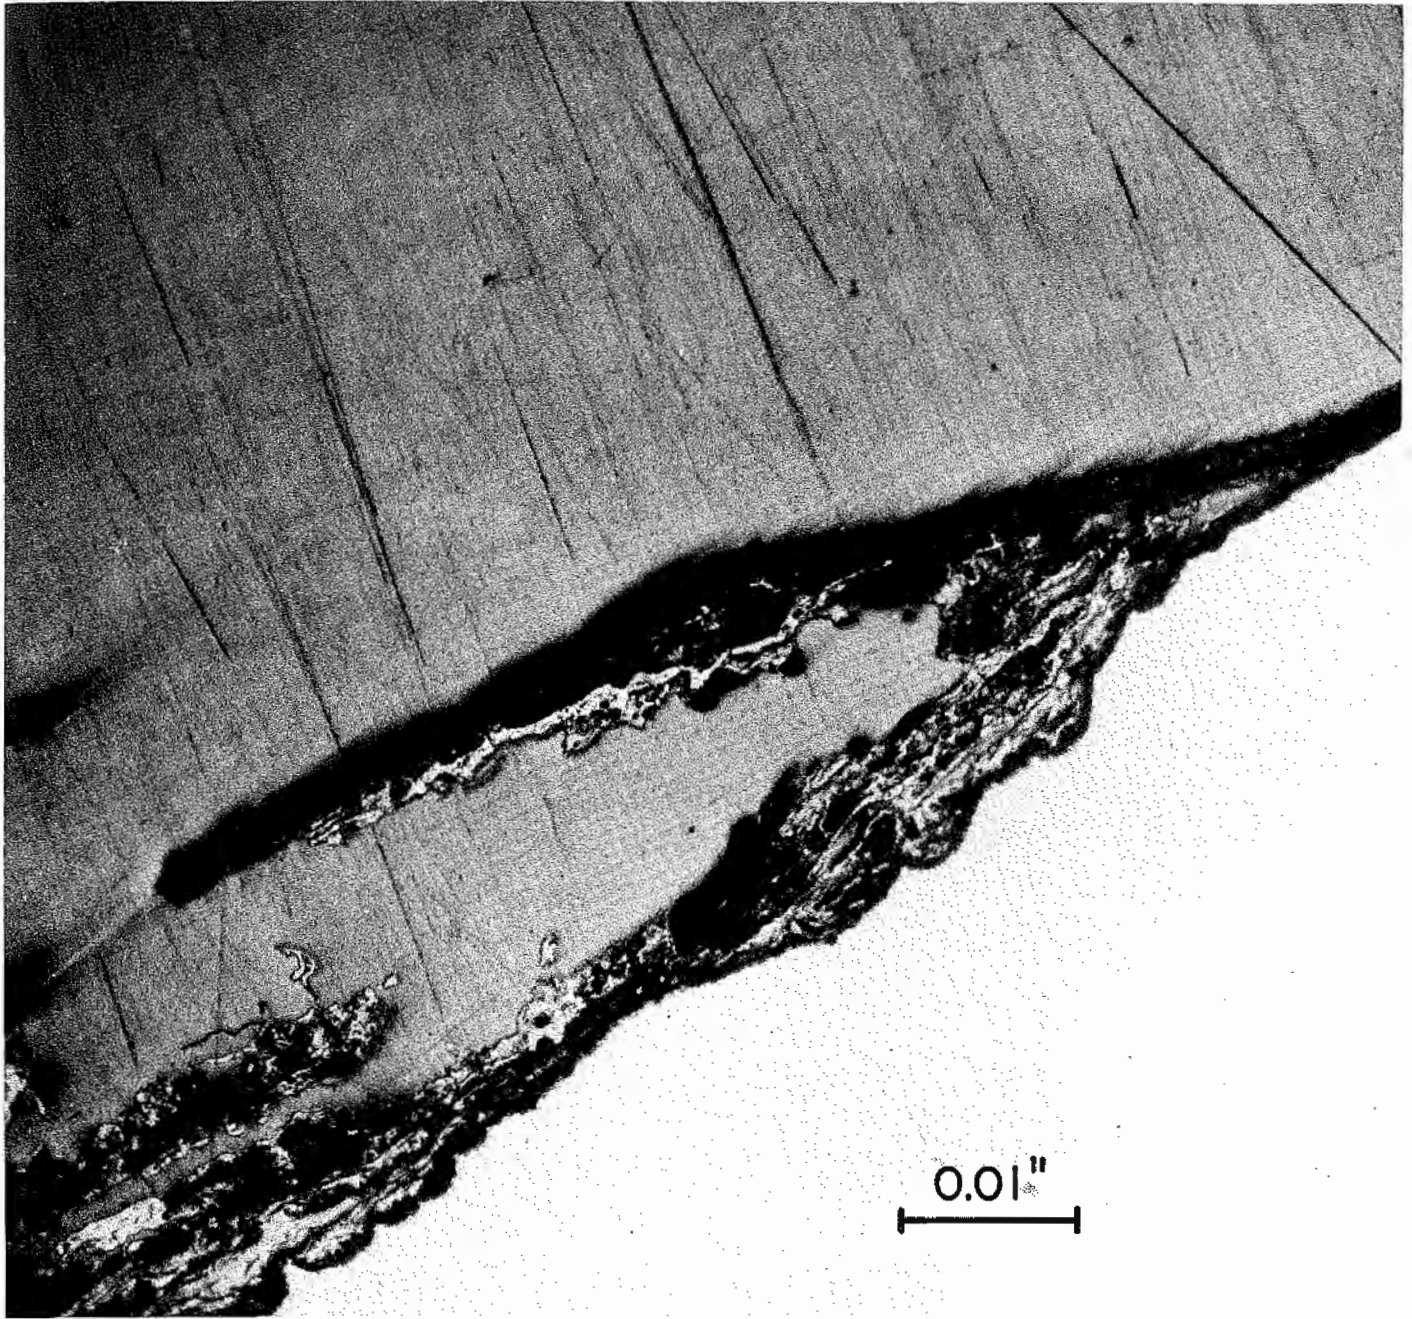
Figure 59 shows the cross section of a typical pit formed under the coating within the midsection. The microphotograph was made so as to highlight the coating and corrosion product. The coating and the interfacial

scale is elevated above the pitted region. Remaining within the pitted region is a corrosion product which appears to be wedged under the edge of the delaminating coating. The delamination structure is better illustrated in the scanning electron micrograph appearing in Figure 60. Pictured here is the coating at the top of the photograph. Failure took place to the left, where the interfacial oxide and coating had lifted.

Figure 59. A Pit Formed Within the Coated Region of the Mid-Section of the Container.

The significant point concerning this interface rests in the observation that in the neighborhood of a pit the adhesion of the coating system to the substrate fails at the interface of the scale to the metal, rather than that of the coating to the scale. This is illustrated in Figure 61. Here adhesion of the oxide to the coating remains while the oxide has lifted from the metal substrate.

Although lifting of the coating and scale appears to be influenced by the wedge of corrosion product formed within the crevice under the coating, disbonding of the metal/oxide interface appears even at a distance away from the actual lifting of the coating. This suggests an electrochemical mechanism in addition to a purely mechanically enhanced disbonding.

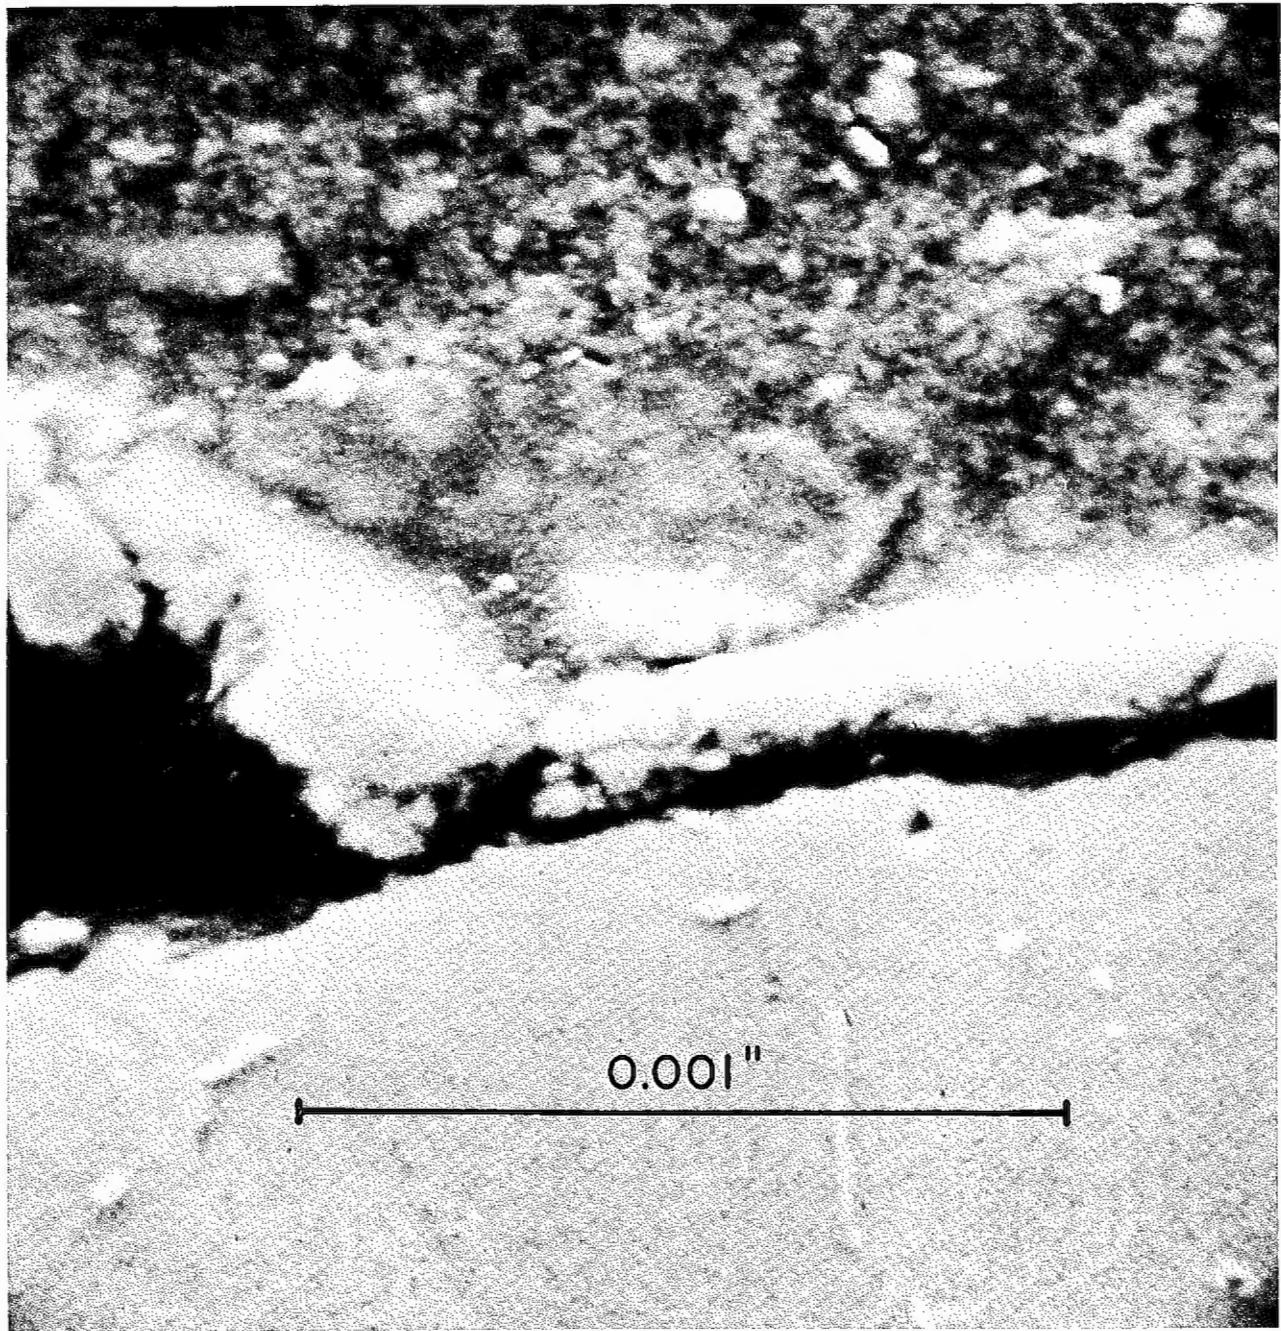
Figure 60. Scanning Electron Micrograph of  
the Disbonding of the Interfacial  
Oxide.
