L.U.S.T.LINE

A Report On Federal & State Programs To Control Leaking Underground Storage Tanks

Tanks in the Wake...

A Postmortem of Katrina, Rita, Wilma

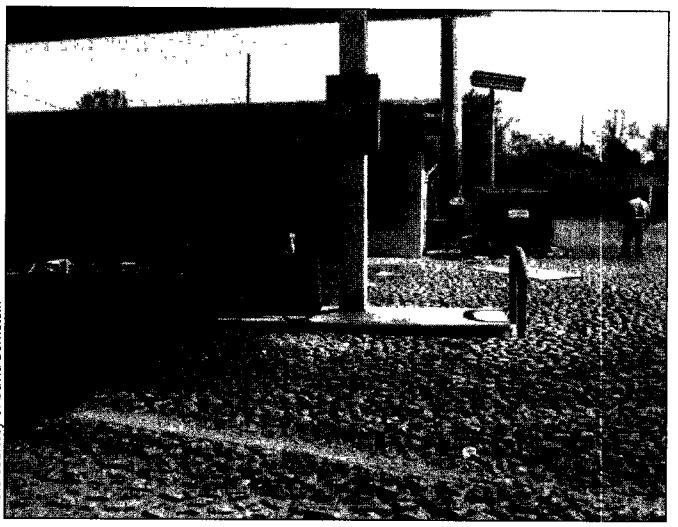
Mud, mud everywhere, and not a sump...

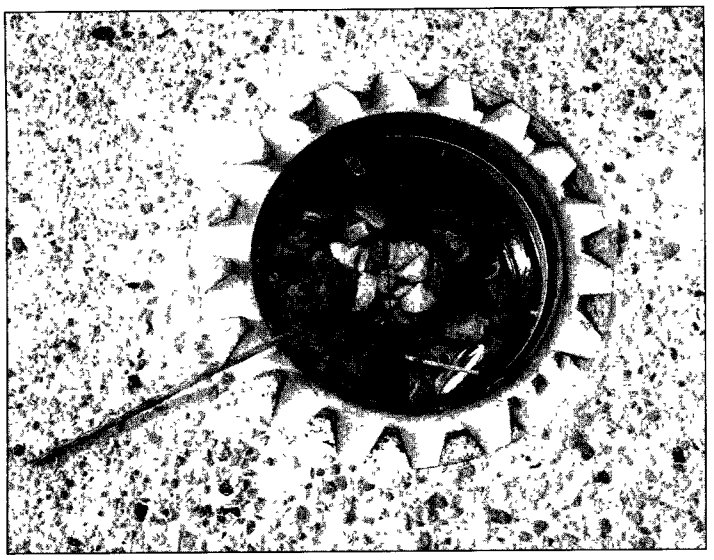
Cap gone from tank fill allowing four-inch riser to become filled with sand and debris during storm surge. This tank was found to be completely full of water with nine inches of sand/debris in the bottom.

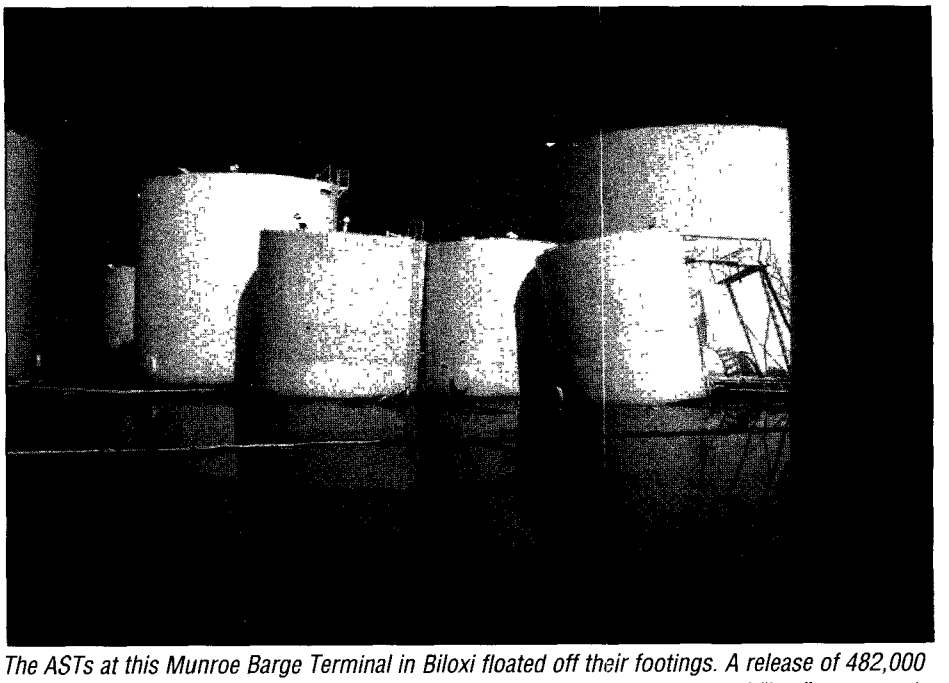
The ASTs at this Munroe Barge Terminal in Biloxi floated off their footings. A release of 482,000 gallons of fuel occurred, but no evidence of this fuel was ever seen (presumed "lost" out to sea). The three tanks that floated up against the larger tanks are 75,000-gallon gasoline tanks.

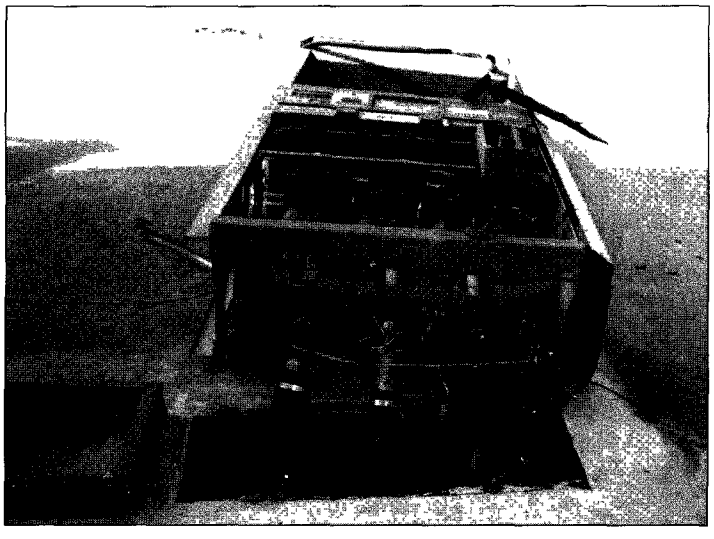
FIGURE 1. *This trio of shear valves did not function as designed. The valve body did not separate at the shear joint because the valves, along with their anchoring bar, were pulled up and out of the dispenser island.*

K. A shear valve is designed to operate when shear forces (forces acting perpendicular to the axis of the valve) affect the top part of the valve above the shear joint relative to the bottom part of the valve below the shear joint. (See Figure 2.) Shear forces are the kinds of forces involved when a vehicle rams into a dispenser. The wind and maybe water forces that tipped over these dispensers caused more of a tensional (stretching) force to be exerted on the shear valves as the dispenser cabinets tipped over. As a result, rather than the shear joints separating, they held and the piping was uprooted from the ground.

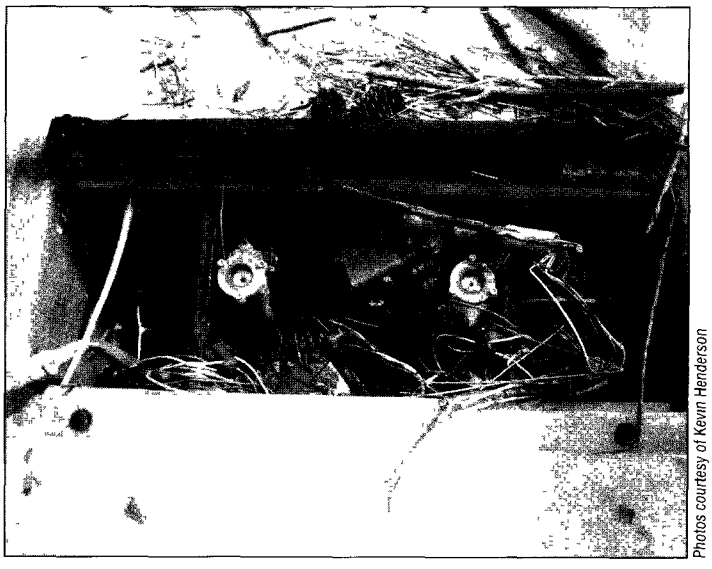
K. By and large they were solidly anchored, but again, they were anchored to resist shear forces. The tensional forces they experienced caused some of them to slide up and out of the clamps that were supposed to hold them in place. In some cases, the steel anchor bar to which the shear valves were attached failed to hold and was torn out of the dispenser island. (See Figure 1.) This is what generally occurred when multiple shear valves were attached to a single anchor bar that ran the length of the dispenser island opening. In cases where there were single shear valves anchored to individual anchor bars running across the short axis of the dispenser island opening, the anchoring mechanism seemed to hold better. (See Figure 2.)

FIGURE 2. *This pair of shear valves functioned as designed. The valve mechanisms closed completely and the bottom part of the valves remains solidly anchored to the dispenser island The top part of the valves, along with the entire dispenser, has been blown away.*

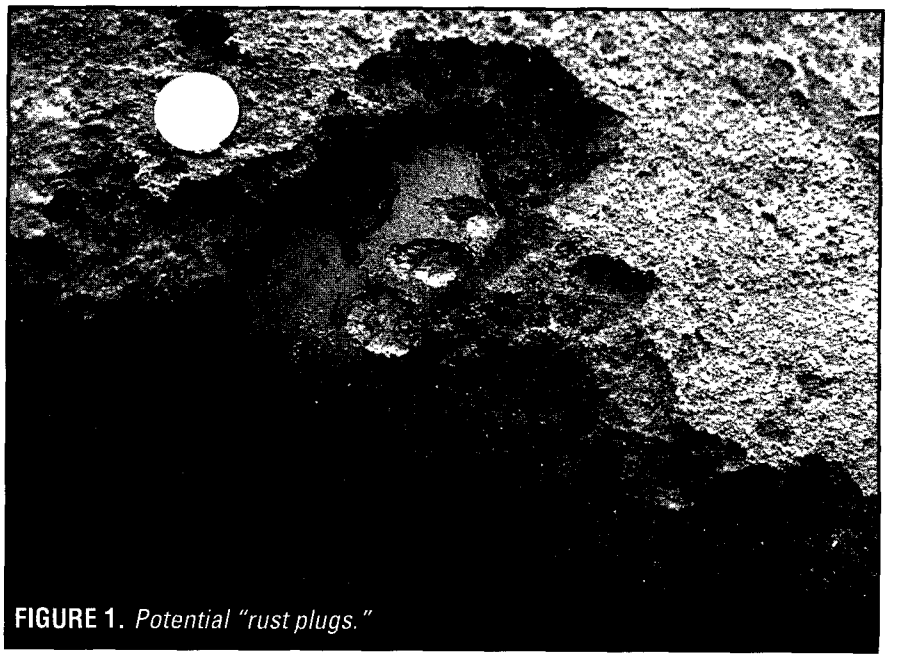
FIGURE 1. *Potential "rust plugs."*

FIGURE 2. *Internal corrosion so severe the tank could not be repaired for lining. The assessment of this tank predicted uniform corrosion.*

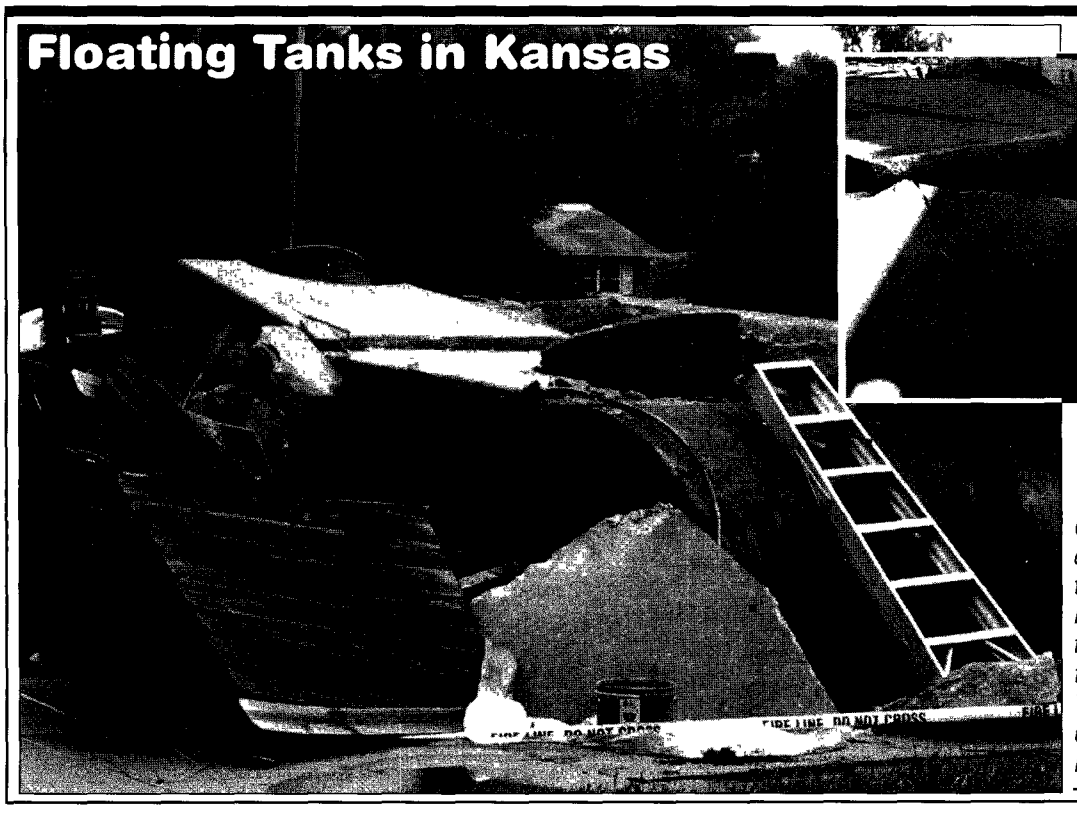
On September 22, heavy rains caused three of the four gasoline tanks at Phillips 66/Miller Mart in Lawrence, Kansas to float out of their subterranean home, smashing through the concrete pavement. The tanks were not anchored and contained little fuel, which would have served as ballast.
