EPA 560-5-84-006
October 1984

ASBESTOS IN BUILDINGS

NATIONAL SURVEY OF ASBESTOS-CONTAINING FRIABLE MATERIALS

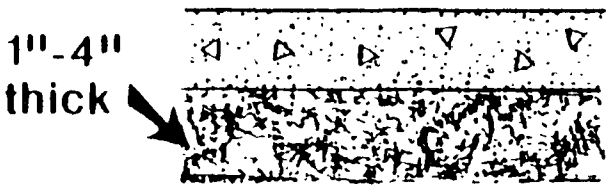
FIBROUS

1. Highly Friable
2. Very soft
3. Fluffy & Spongy
4. Loosely bonded together
5. Composed almost entirely of fibers
6. Cotton candy/Spanish Moss appearance
7. Usually contains more than 10% asbestos
