EPA 550-R-98-001
March 1998
www.epa.gov

EPA CHEMICAL ACCIDENT INVESTIGATION REPORT

Pennzoil Product Company Refinery Rouseville, Pennsylvania

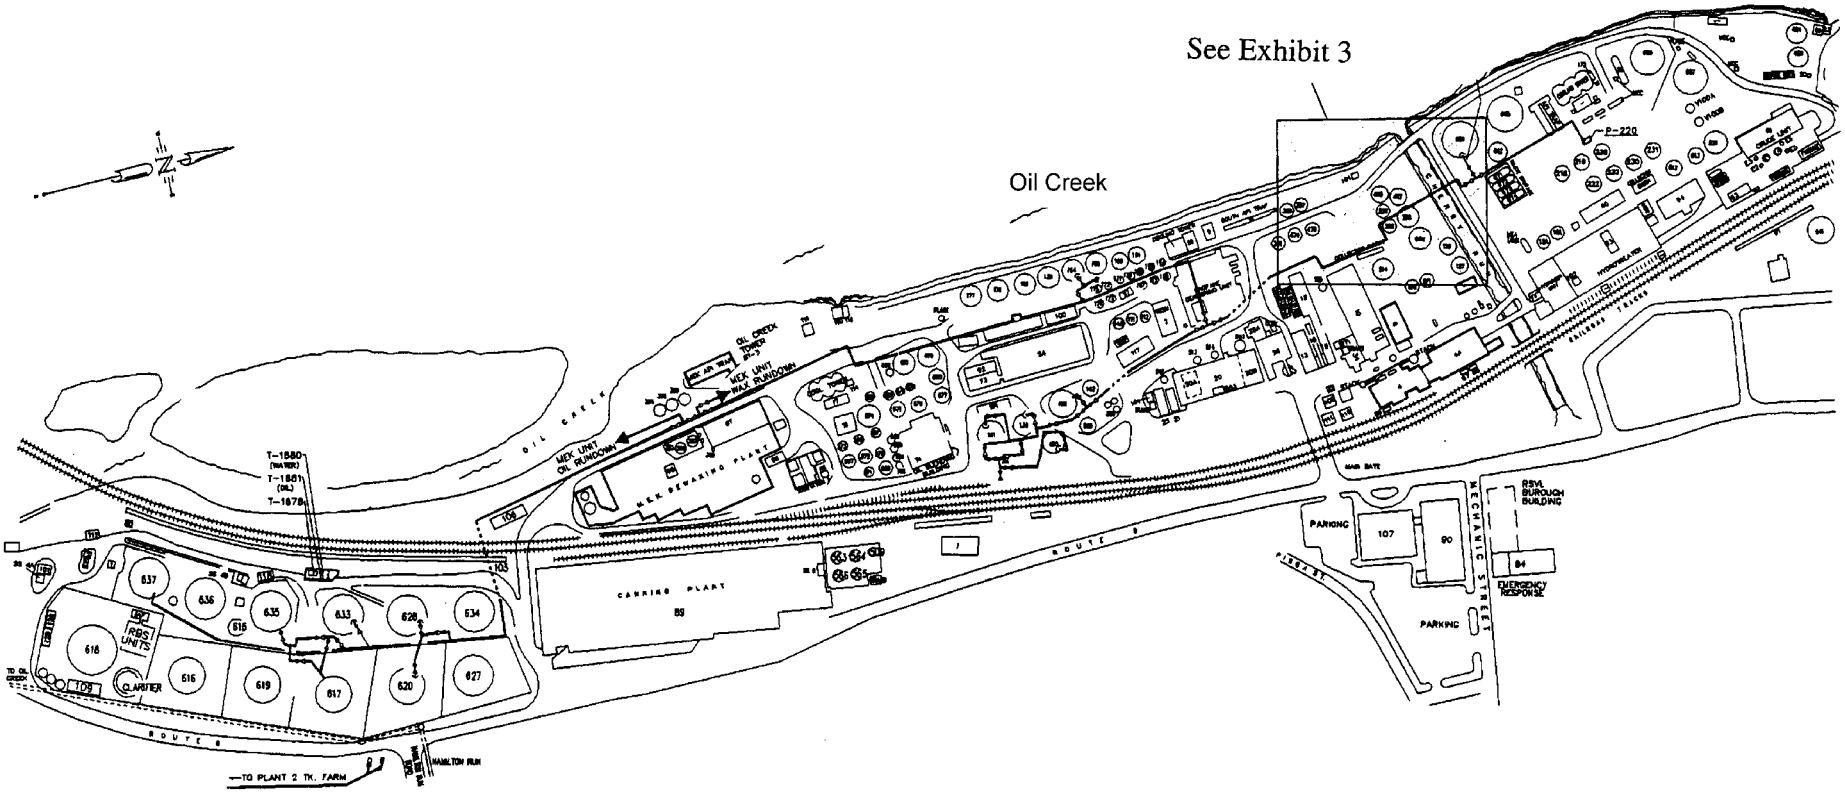
Exhibit 2
Rouseville Refinery Site Map

Notes
Curved lines indicate trajectory of tanks 487 and 488
Tanks 487 and 488: Oil and water mixture
Tank 208: Naptha; burned in place
Tank 662: Empty, being cleaned
Tanks 232, 233: No. 6 fuel oil (thick, heavy oil)

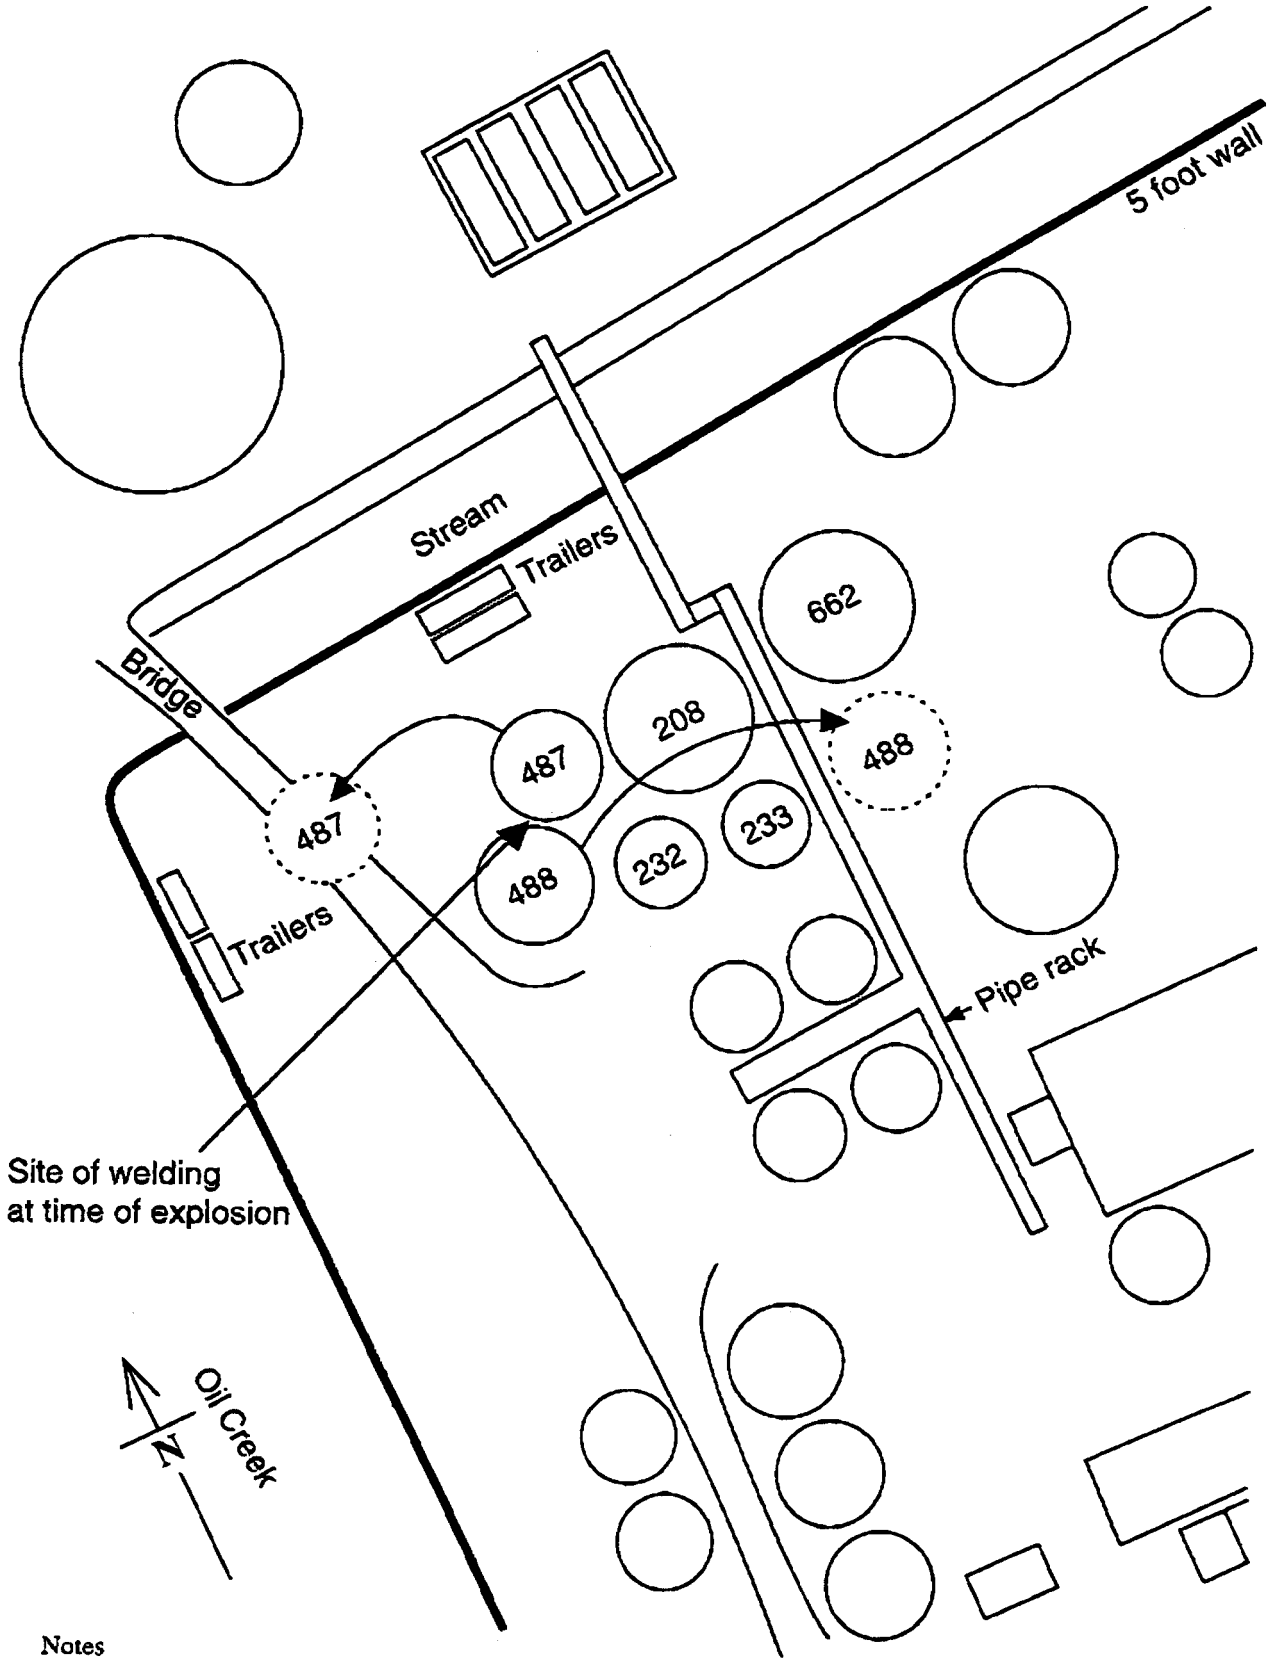
Exhibit 3
Area of Explosion and Fire at Pennzoil Refinery

As a result of the explosions, each tank failed catastrophically at the bottom seam where the vertical sidewall of the tank was connected to the bottom horizontal floor plate, lifting the tanks up in opposite directions. Tank 487 lifted off its base and landed about 20 feet to the west. Tank 488 landed about 50 feet to the east after clearing a storage tank and a pipe rack. The burning contents of the tanks, released when the tanks failed, created a wave of burning hydrocarbon that engulfed the entire area.

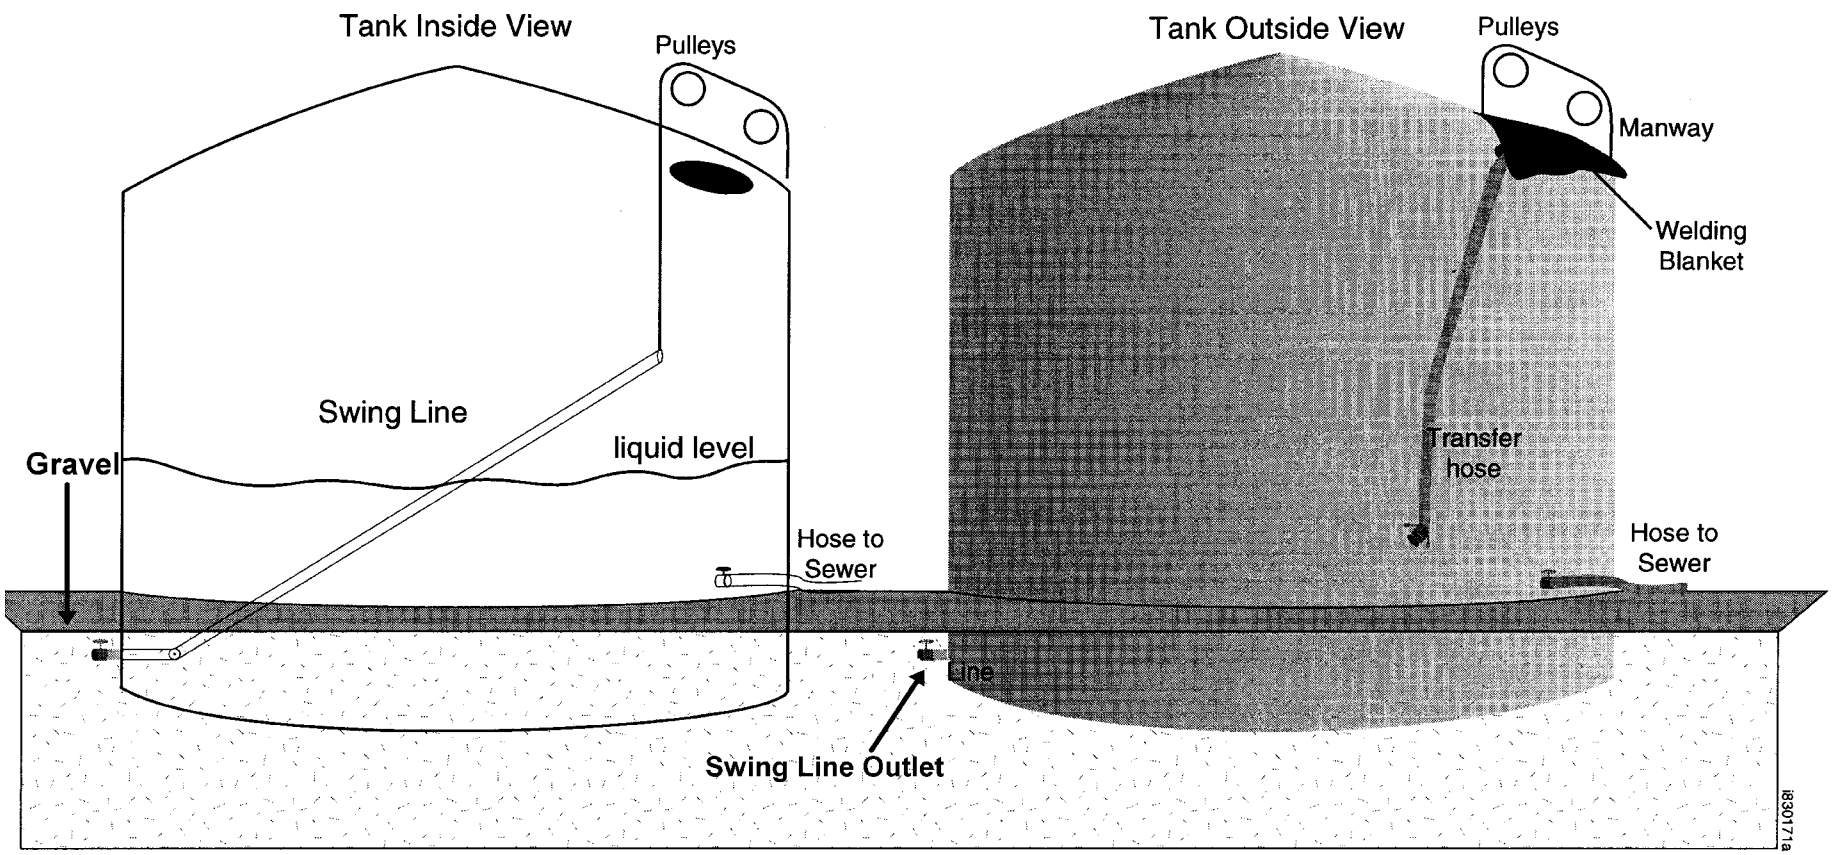
Exhibit 4
Inside and Outside Views of Tank 487

Vapor Escaping from Holes in Tank. After the explosion and fire, investigators discovered some holes up to a quarter inch in diameter, presumed to be from corrosion, near the top of the tank. If these holes were present before the explosion, they could have provided a route for vapor release and flame front flashback (see Exhibit 7). However, ignition sources would need to be very close to ignite the small amount of diluted vapor expected from this

- The bottoms of the tanks at the shell wall seam may have been weakened through corrosion. The tanks generally contained water at the bottom. Gravel was also built up around the bottoms and sides of the tanks, which may have allowed moisture to collect on the outside, on the bottom and tank wall edge, leading to corrosion and weakening of the bottom seam at the shell wall. (Evidence of this gravel can be seen in Exhibit 5-B, which shows the indentations left in the ground by tanks 487 and 488.)

2. Tanks 487 and 488 failed along their bottom seams, releasing their entire contents. There was evidence of corrosion along the bottom seam. The roofs of these tanks had been replaced since initial construction but the CAIT has no other information about whether these tanks were properly inspected or maintained on a routine basis.

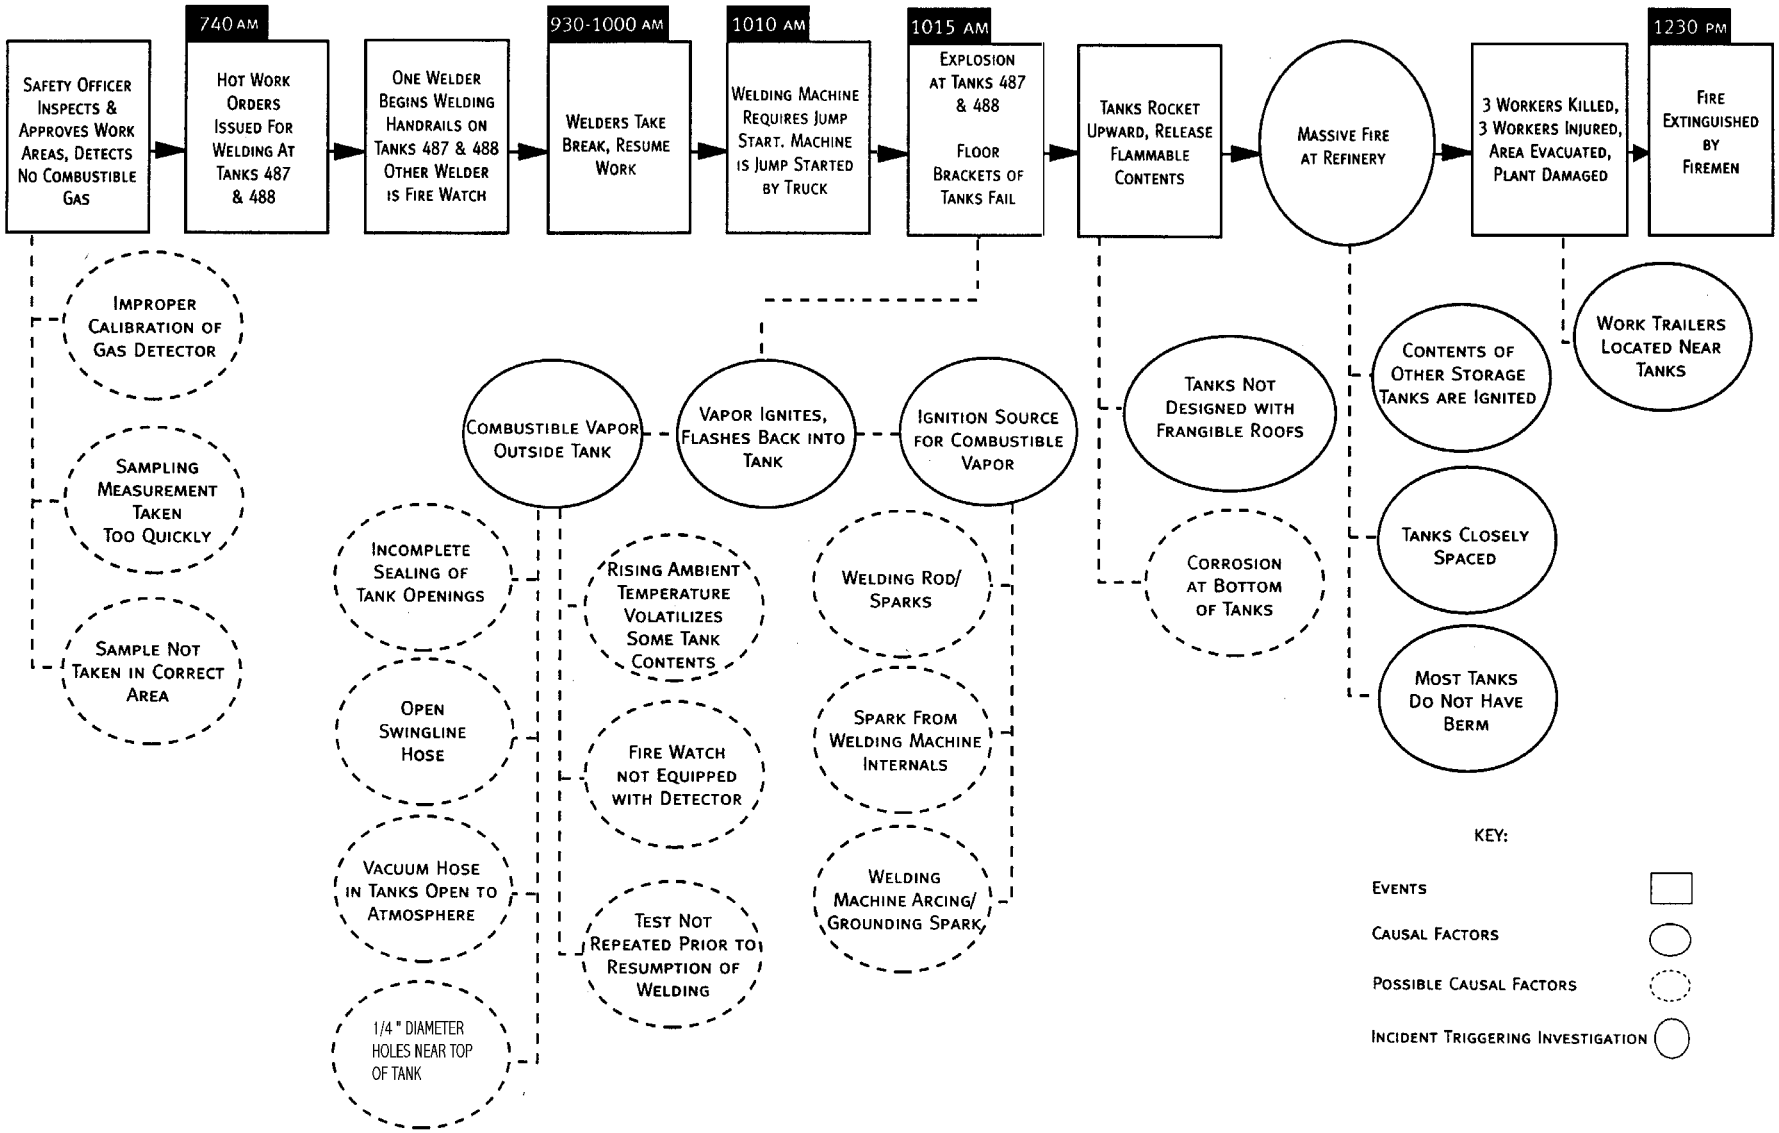
Exhibit 6
Event and Causal Factors Diagram
October 16, 1995 Explosion of Tanks 487 & 488 at Pennzoil Refinery - Rouseville, PA

- Following ignition of vapors, the storage tanks failed along their bottom seam and lifted off their base, releasing their contents.

- Once released, the burning liquid flowed without restriction to other areas nearby involving trailers, storage tanks and other equipment in the fire; and

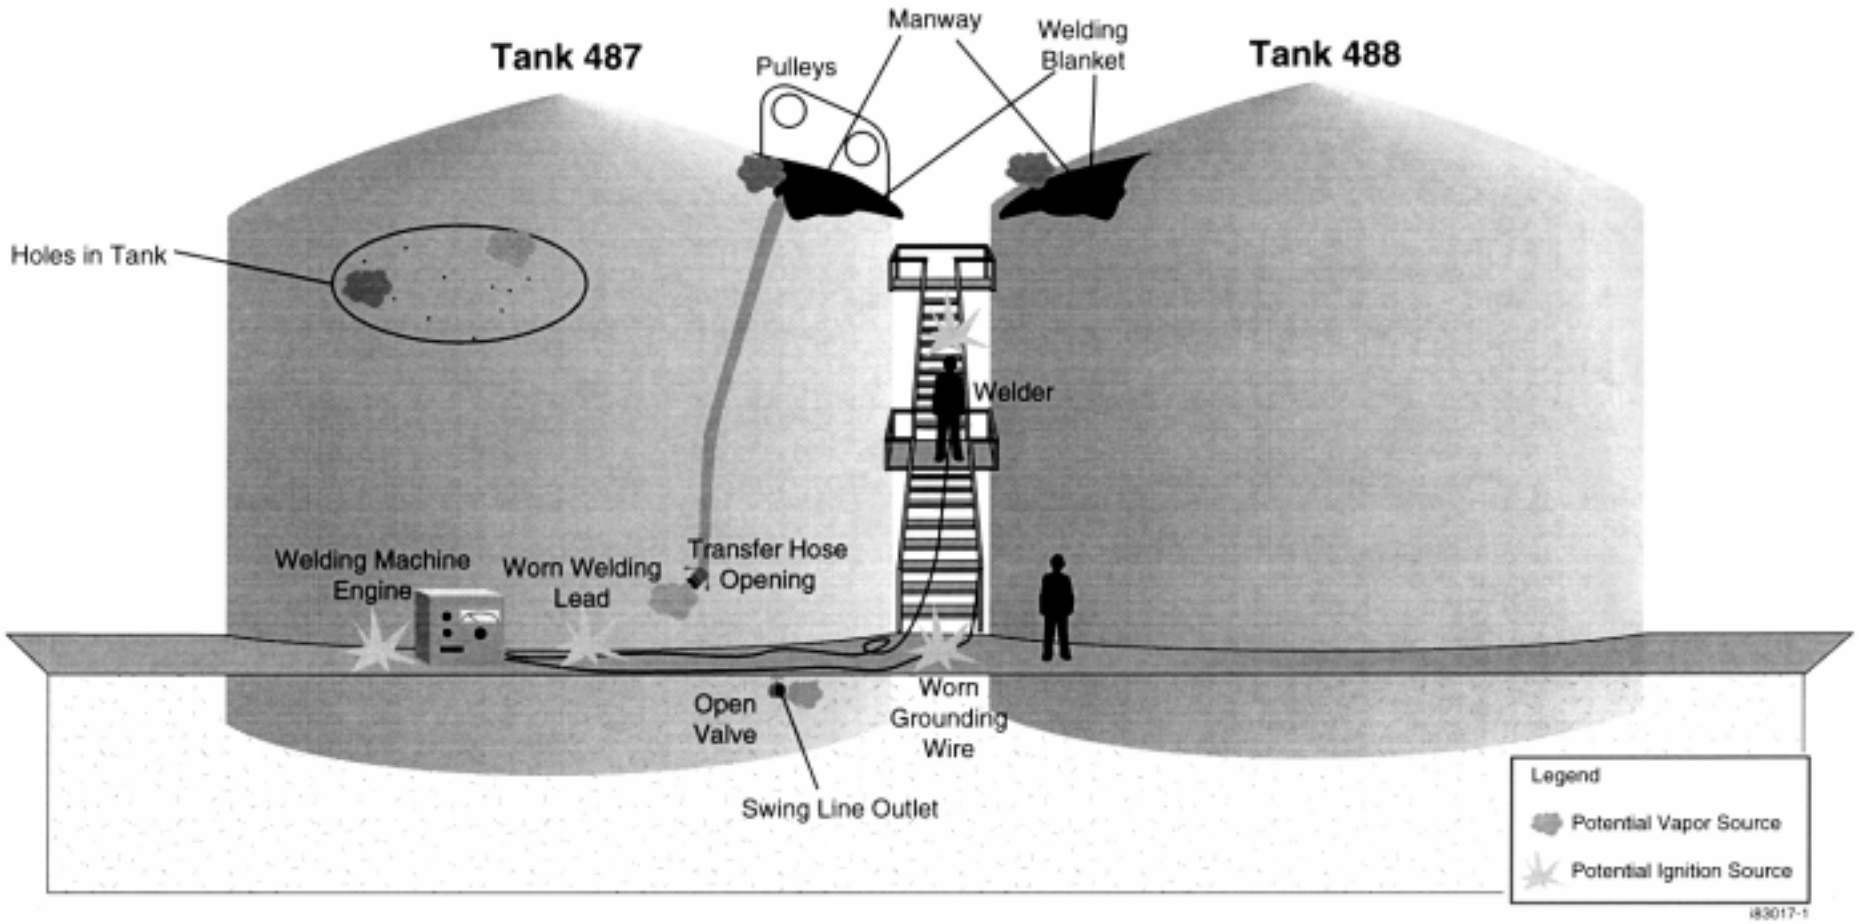
Exhibit 7
Pennzoil Tank Explosion:
Potential Vapor and Ignition Sources at Tanks 487 & 488

Vapor Escaping from Open Manway. Placement of a hose for discharge of liquids from vacuum trucks through the open manway into tank 487 prevented the manway cover from completely sealing the opening. Although a welding blanket was draped over this opening, vapor could have escaped into the surrounding area because the blankets are not designed to provide a vapor-tight seal. This potential vapor source is shown in Exhibit 7. The escape of vapor could have been aggravated by ambient conditions, since the outdoor temperature rose from early to mid-morning. The effect of ambient conditions is discussed in more detail under Section 4.3 below.

Vapor Escaping from Swingline. The swingline could have provided a route for vapor release (see Exhibit 7). The swingline portion inside the tank was raised above the liquid level in the tank vapor space. Investigators found after the accident that the outside valve near the base of the tank connected to the swingline inside the tank was open. As above, as the tank warmed, if sufficient driving force was present, undiluted heavier-than-air flammable vapors could have been pushed out through the swingline and open valve. If there was little or no wind, these dense vapors could have collected at grade level near ignition sources (see below). After ignition, the flame front could have flashed back through the swingline, igniting vapors in the tank. However, the end fitting on the swingline valve outside the tank was buried under the soil. Further, inspection of the inside of the swingline, after the accident, revealed no evidence of burn or scorch marks.

- The welding rod or sparks from hot slag or spatter possibly could have caused ignition of vapors present, if welding had been started (see Exhibit 7 for employee accounts of the position of the welder). During welding, flux coating the welding rod burns off. The welding rod being used by the welder was found after the accident and inspection revealed that flux on the tip was not burned off; however, there could have been an instantaneous arc, which could have caused ignition, but could have been of such short duration that the flux was not burned off. Or, the welding gun may have been dropped or kicked against the stairway causing an arc. However no evidence was discovered (e.g. arc marks) to support this scenario. Flammable and combustible materials are often ignited during hot work; generally, the material ignited is in the equipment being worked on. It is relatively rare for hot work to ignite a vapor cloud (Lees, 1996).

Pennzoil and other industries should review their hot work permitting processes and procedures and consider development of a management system or other mechanisms to ensure that all vapor and ignition sources are identified and controlled immediately prior to the start of hot work. For example, an equipment schematic and checklist could serve as a reminder or tool for ensuring that all potential vapor sources (manways, drains, valves) and ignition sources (electrical classifications, spark arrestors, grounds) are isolated or in proper working condition. Facilities should review past hot work incidents, conduct periodic audits or inspections of ongoing hot work, and develop a means to continuously improve or correct possible vapor or ignition source gaps in permitting procedures or processes. In addition, companies need to ensure that welding equipment is properly grounded and provide assurance that electrical current cannot find its way to equipment containing flammable materials.
