ORP/LV-78-4
July 1978

MISCELLANEOUS DATA AND INFORMATION COLLECTED DURING RADIATION SURVEYS AT THE FORMER MONUMENT URANIUM MILL SITE (1974-1975)

Joseph M. Hans, Jr.
Daphne Prochaska
Gregory G. Eadie

July 1978

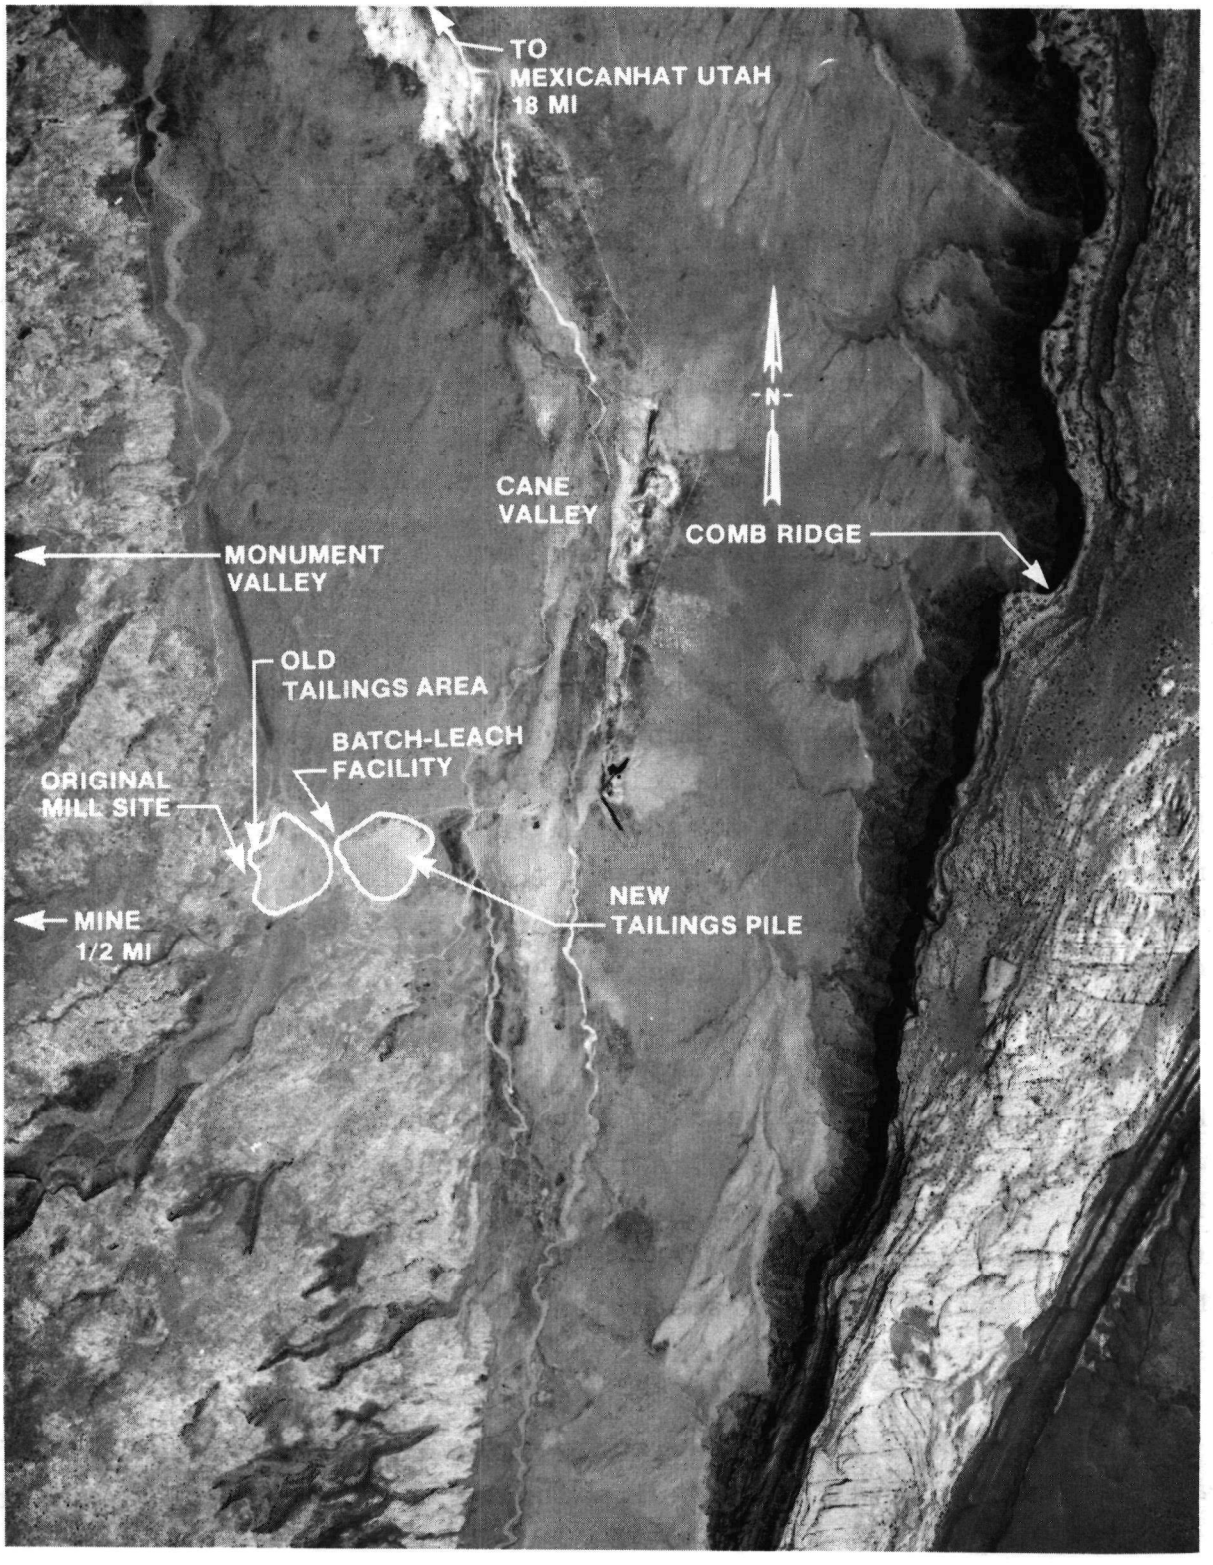
Figure 1. Aerial photograph of former Monument Uranium Mill site area

There are two tailings areas on the site, the old tailings area and the new tailings pile, which are approximately 500 feet apart. The old tailings area contains the residue of the original heap leach processed tailings and consists of approximately 165,000 tons (15 percent of the total) at an average depth of two to three feet. Most of the original sand tailings from the old tailings area were reprocessed and discharged into the larger, new tailings pile. The new tailings pile contains approximately 935,000 tons (85 percent of the total) and is the result of the

concentrator process. This pile covers 20 acres, is cone-shaped, and stands 55 feet high (FBDU, 1977).
