REGIONAL TEMPERATURE REPORTING NETWORK

1968 FIELD RECONNAISSANCE SURVEY

FEDERAL WATER POLLUTION CONTROL ADMINISTRATION
NORTHWEST REGION
PORTLAND, OREGON

Working Paper No. 62

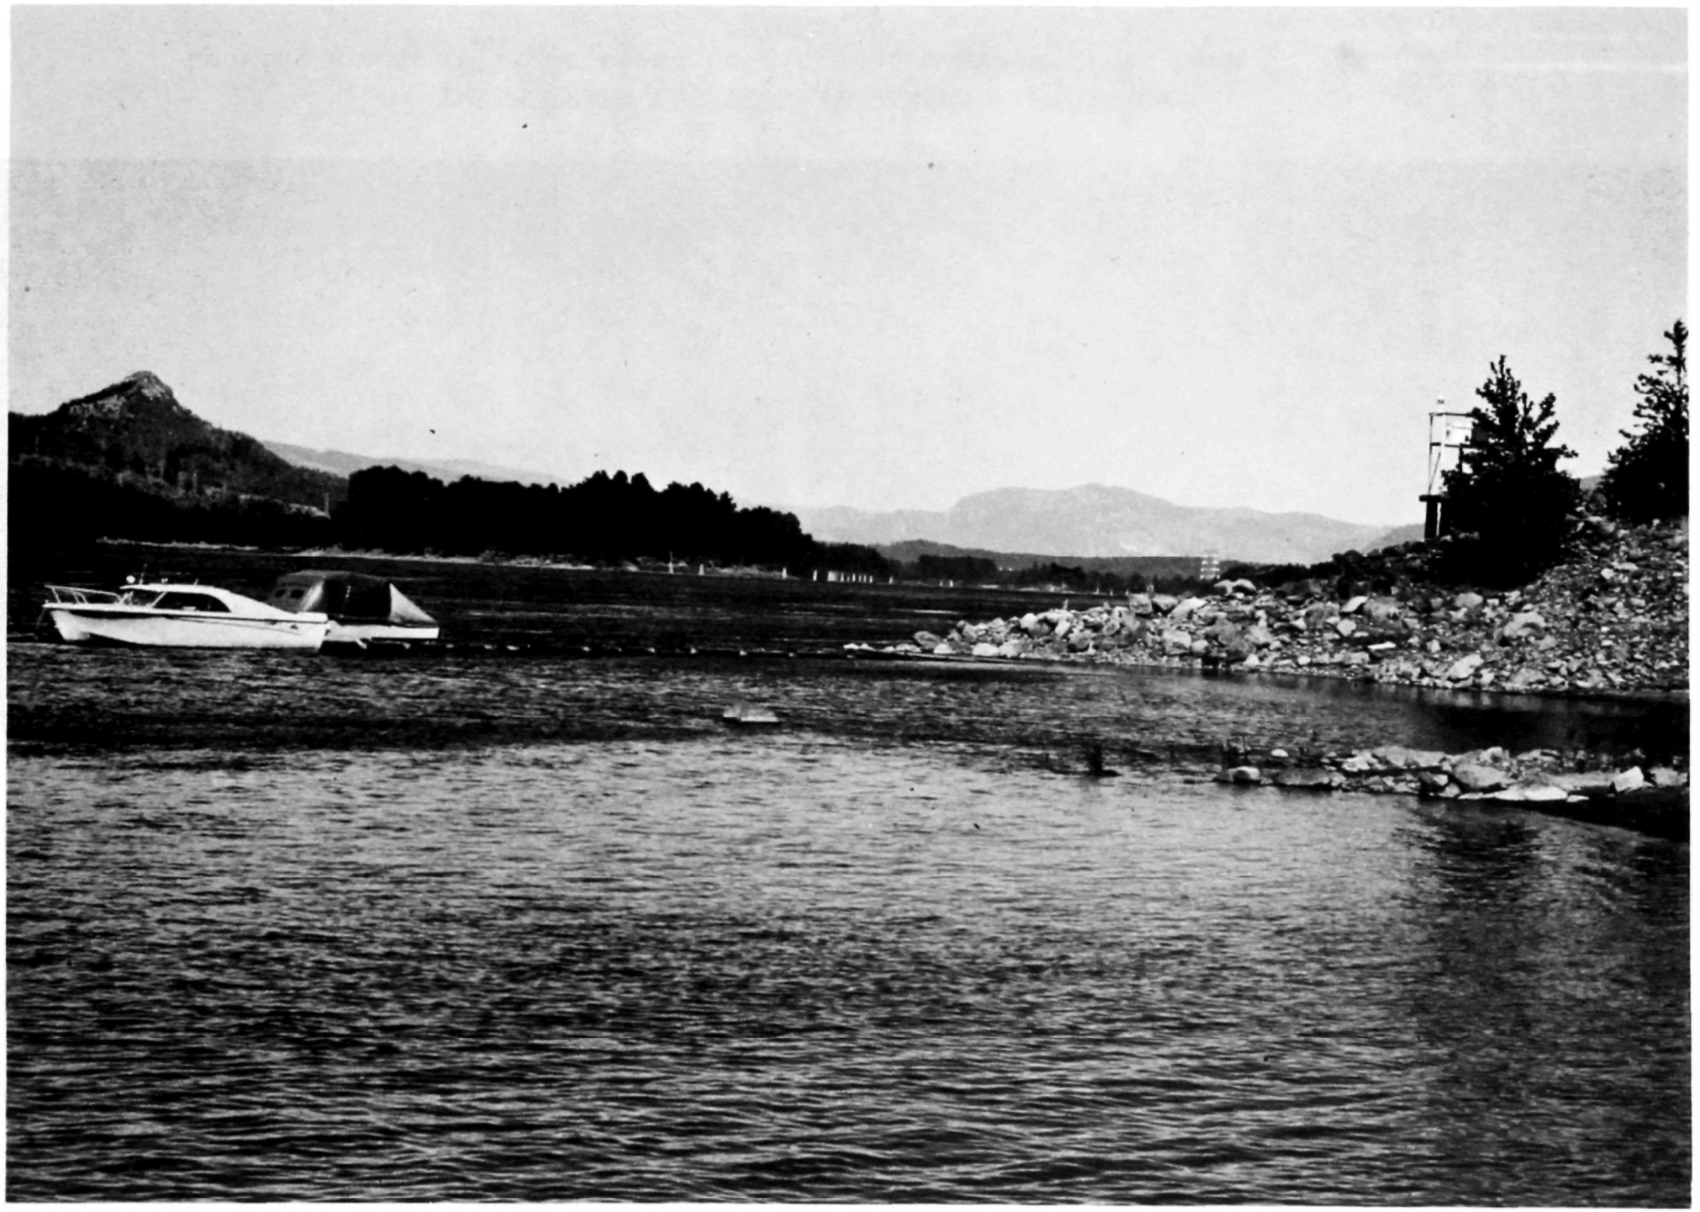
Continuous Columbia River water temperature readings are presently being recorded near Warrendale, Oregon, approximately five and one-half miles below Bonneville Dam. The Foxboro thermograph located there was installed by Battelle Northwest under contract to Portland General Electric Company. The Columbia River at this point is completely mixed so that the recorded temperature is representative of the river cross-section. Figure 3 shows the thermograph location on the left bank channel light stand. Figure 4 shows the thermograph (dark box) attached to the light stand. There has been no vandalism at this station in the past.

This location and instrument should be incorporated into the RTRN.

COLUMBIA RIVER AT WARRENDALE OREGON
Looking upstream Note: Thermograph box on right side of photograph
FIGURE 3

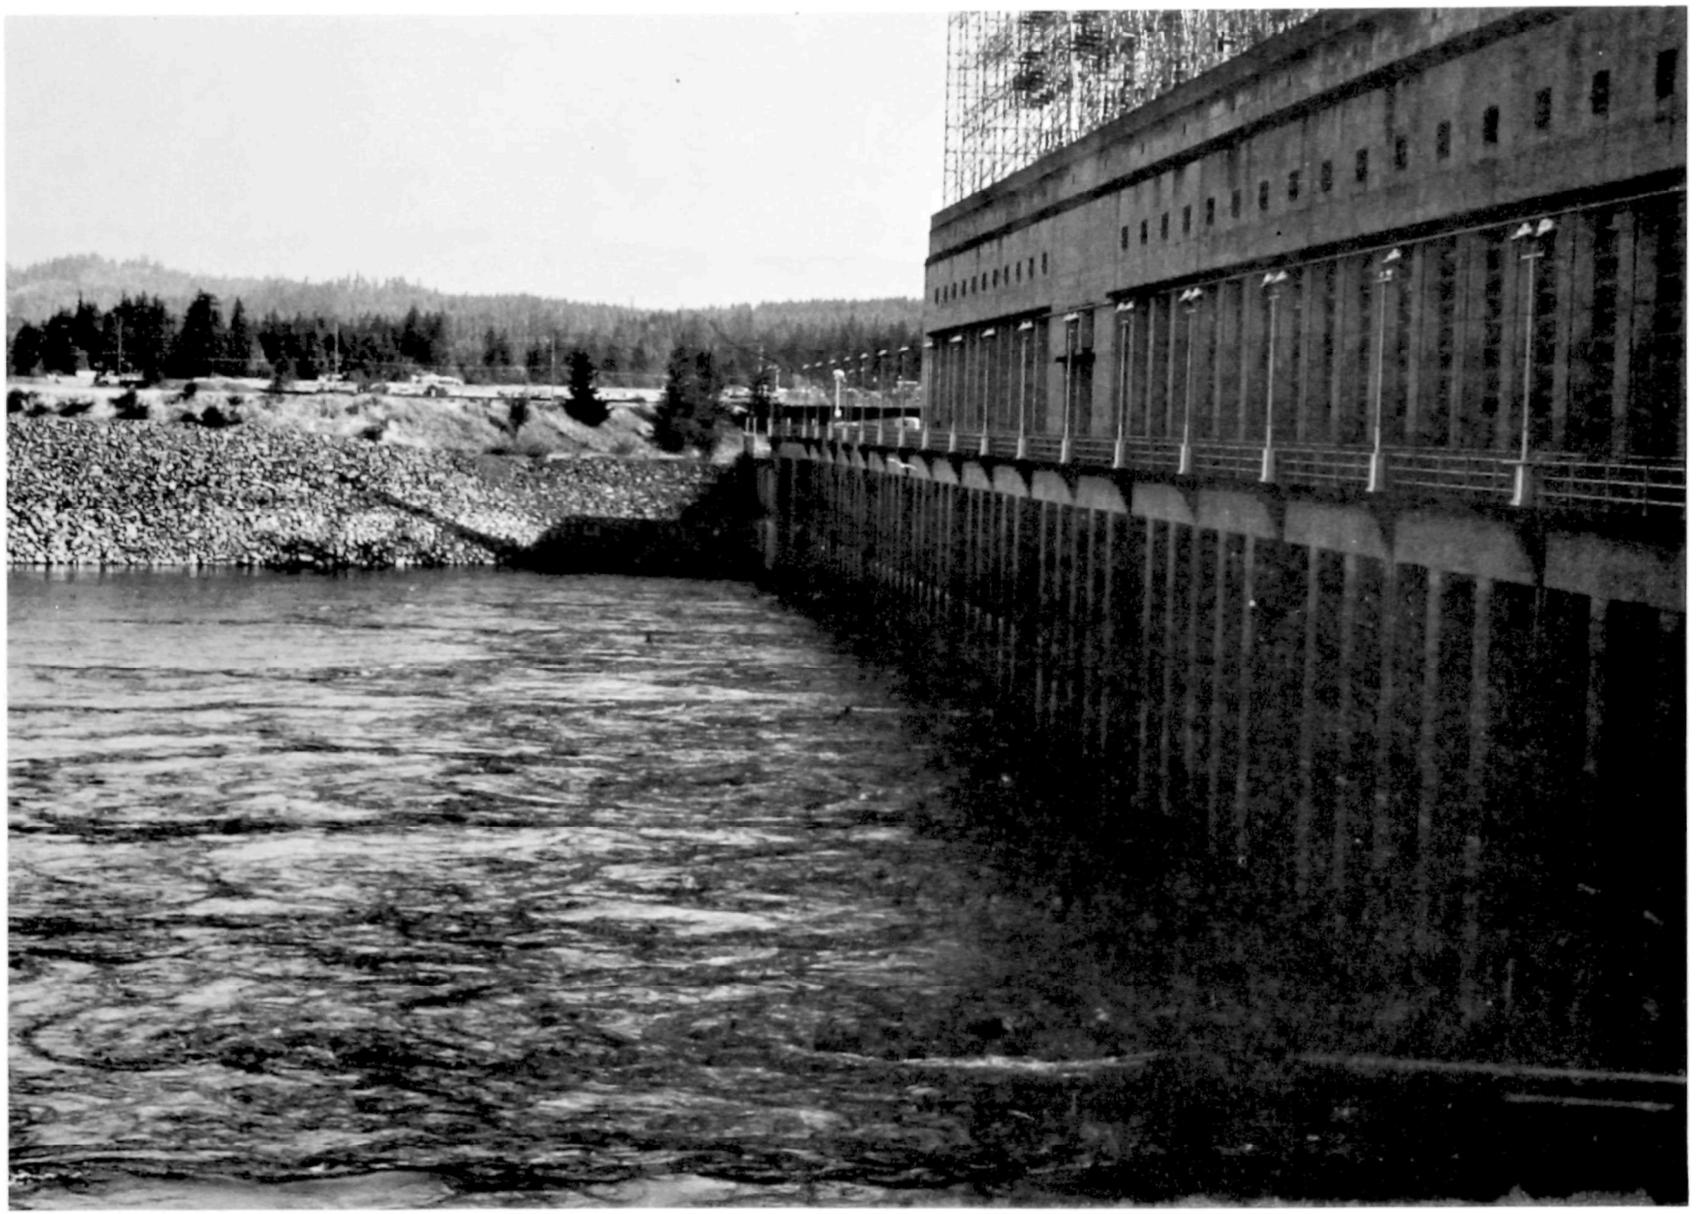
Bonneville Dam was considered as a possible thermograph location but was later eliminated in favor of the Warrendale site. The tailrace discharge at Bonneville Dam is completely mixed and would therefore give a representative temperature of flow releases. FIGURE 5 shows the tailrace condition below Bonneville powerhouse. A continuous recording instrument, if needed, should be located at the north end of the tailrace shown in FIGURE 5, because of a historical debris problem in the center and south portions of the tailrace. Vandalism at this project site is considered minor.

In past years, temperatures have been read and reported by project personnel from thermometers attached to the turbine cooling water lines but, with recent reductions in manpower, these temperatures are no longer taken.

Since the Warrendale (Site No.8) thermograph is operating satisfactorily, the Warrendale records can be used to represent the temperature condition below Bonneville Dam. The Bonneville Dam location would be an alternate site.

BONNEVILLE DAM
Looking north at right tailrace embankment (Q=80,000 cfs)
FIGURE 5

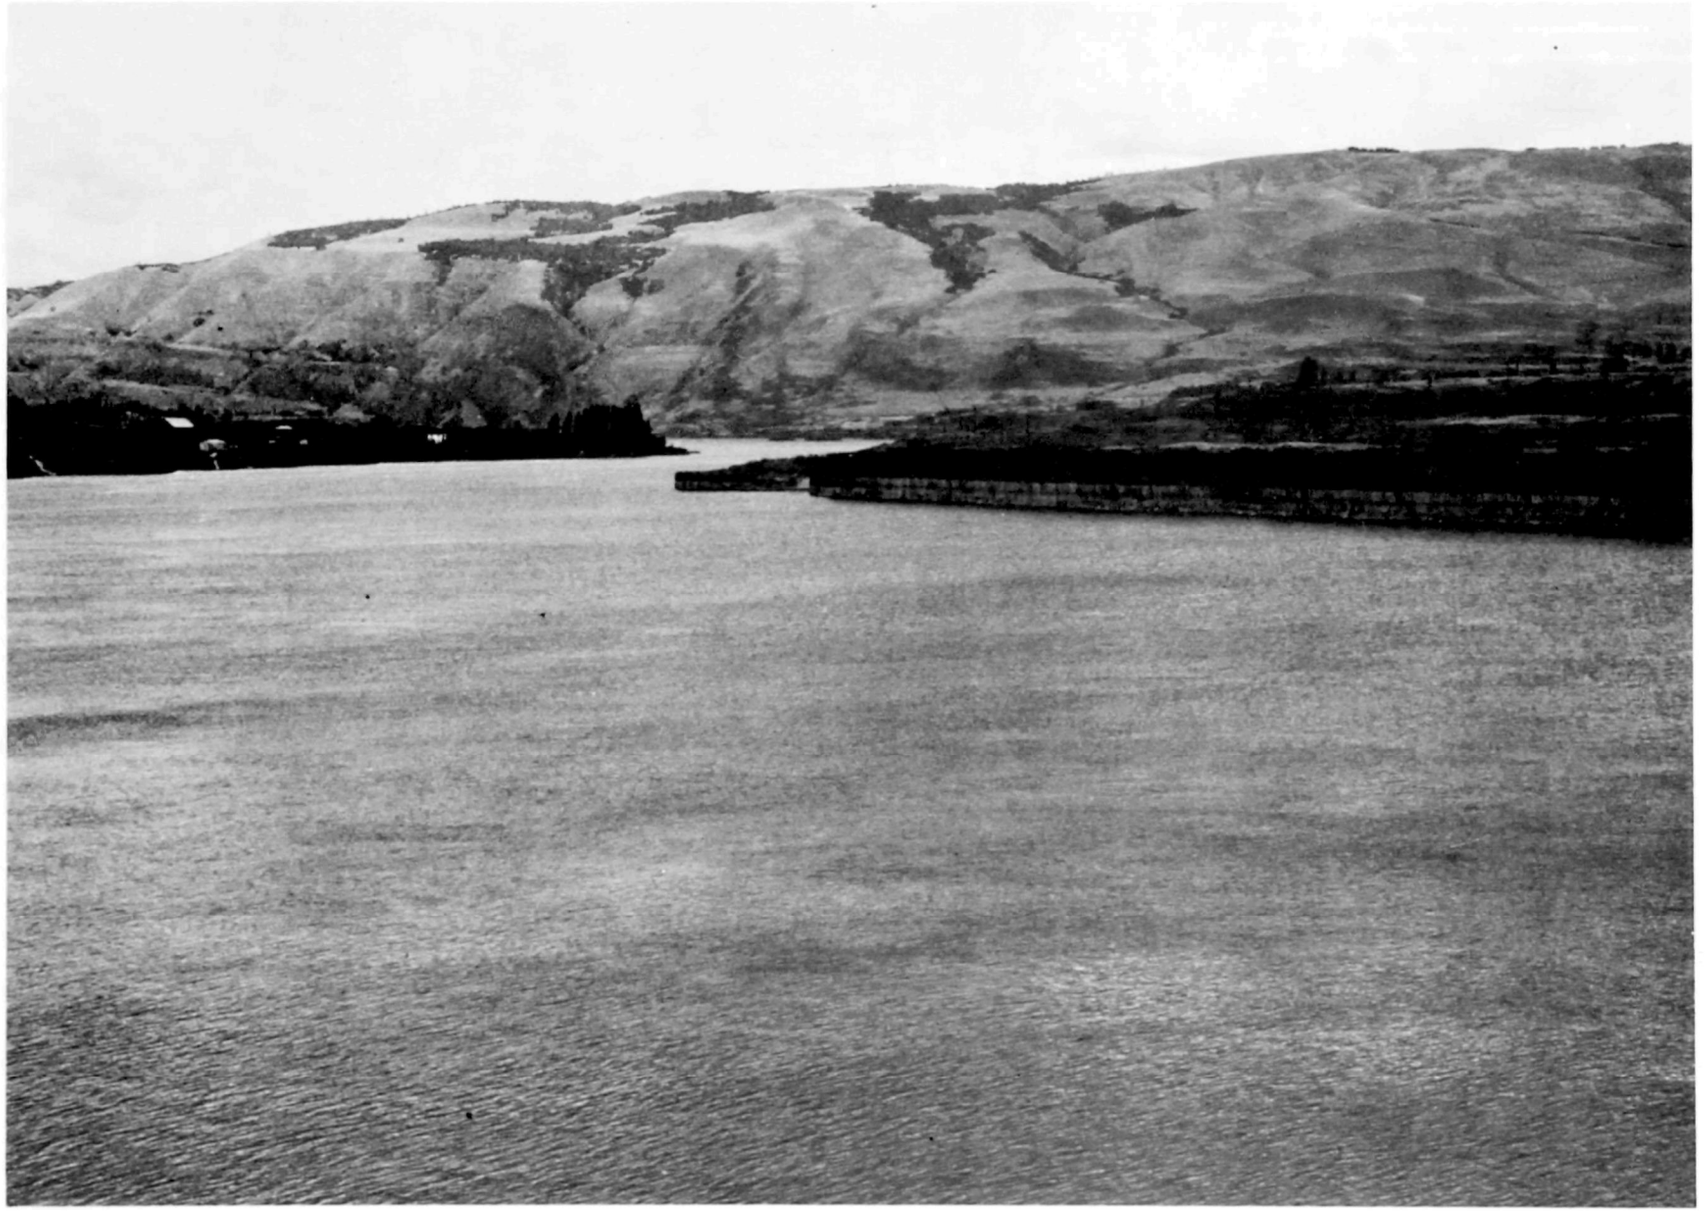
Figure 6 shows a view of the Dalles Dam upstream of the northeast corner of the dock and the picture in Figure 7 was taken looking downstream from the same location.

COLUMBIA RIVER AT THE DALLES PORT COMMISSION DOCK
Looking downstream and across the river from N.E. corner of the old dock
FIGURE 7

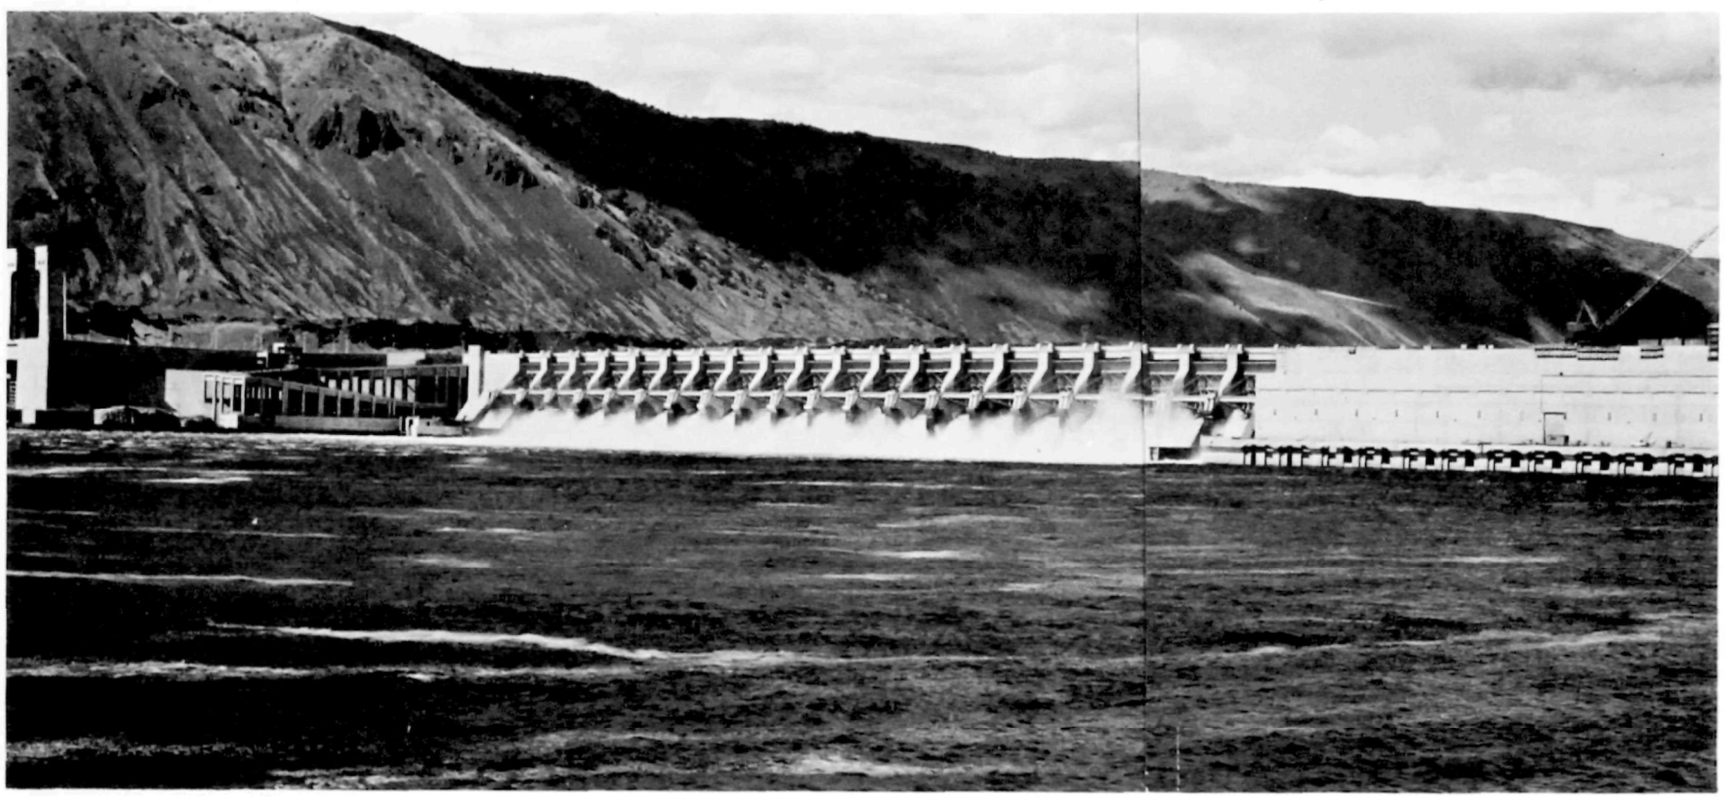
Battelle Northwest under contract to AEC has installed a Foxboro thermograph at tne Interstate Toll Bridge (RM 208) approximately 7½ miles below John Day Dam. The river at the bridge is completely mixed and should remain so after the flow is routed through the turbines. It is concluded that this thermograph should be incorporated into the network and its records be considered nearly representative of the dam discharge temperature. Figure 9 shows the Columbia River downstream of the bend shown in the photograph.

Vandalism should be minor at the bridge location since the toll bridge is tended at all times.

JOHN DAY DAM
Looking upstream at dam tailrace (Q-100,000 cfs)
FIGURE 8

COLUMBIA RIVER BELOW JOHN DAY DAM
Looking downstream from dam (Interstate bridge just downstream of bend of river)
FIGURE 9

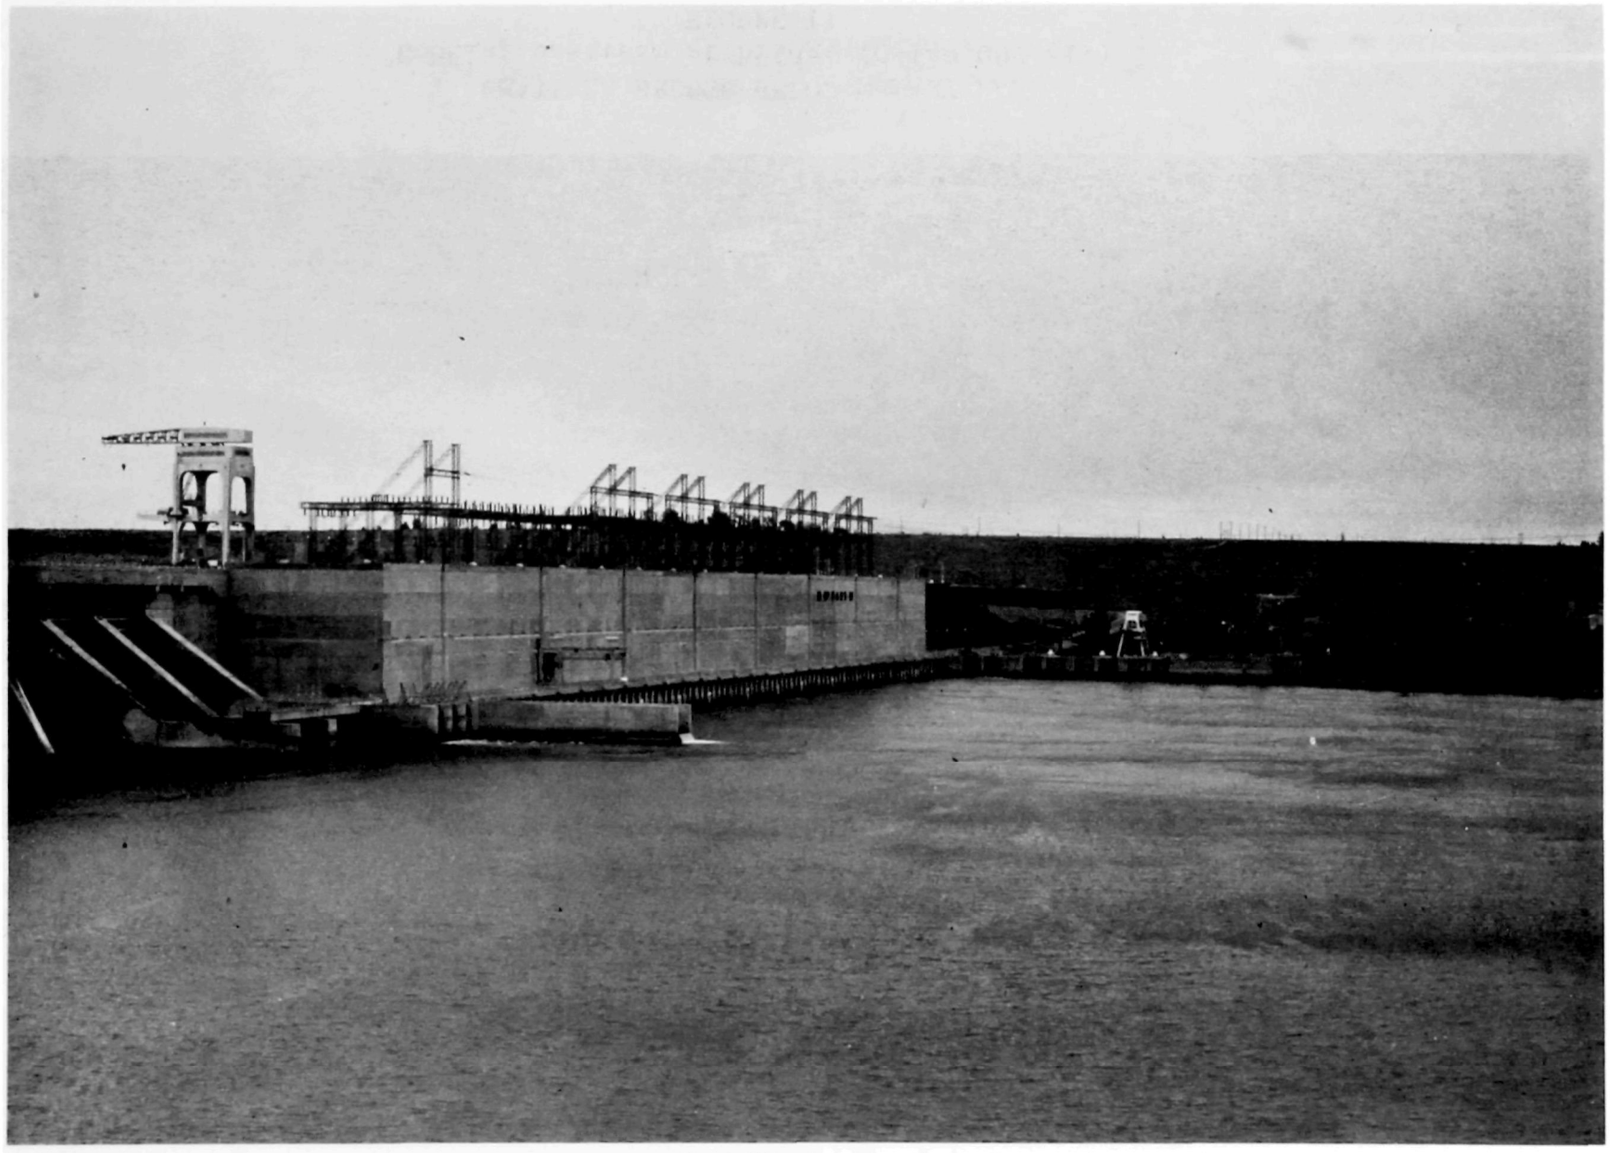
Sites at both McNary Dam (Figure 10) and the Umatilla toll bridge (Figure 11) downstream of the dam were investigated. A Foxboro thermograph was installed at the bridge by Battelle Northwest under contract with AEC and is currently providing river temperature data . The Umatilla Toll Bridge is tended at all times which would provide some protection against vandalism. The dam location is protected from vandalism and the tailrace is completely mixed although the thermistor could be damaged by debris in the tailrace during spilling operations.

The McNary project has the thermometers connected to the turbine cooling water lines which are not adequate for the network system, as discussed earlier, due to the need for a continuous, accurate record.

McNARY DAM
Looking south at trailrace area toward Oregon shore (Q=140,000 cfs)
FIGURE 10

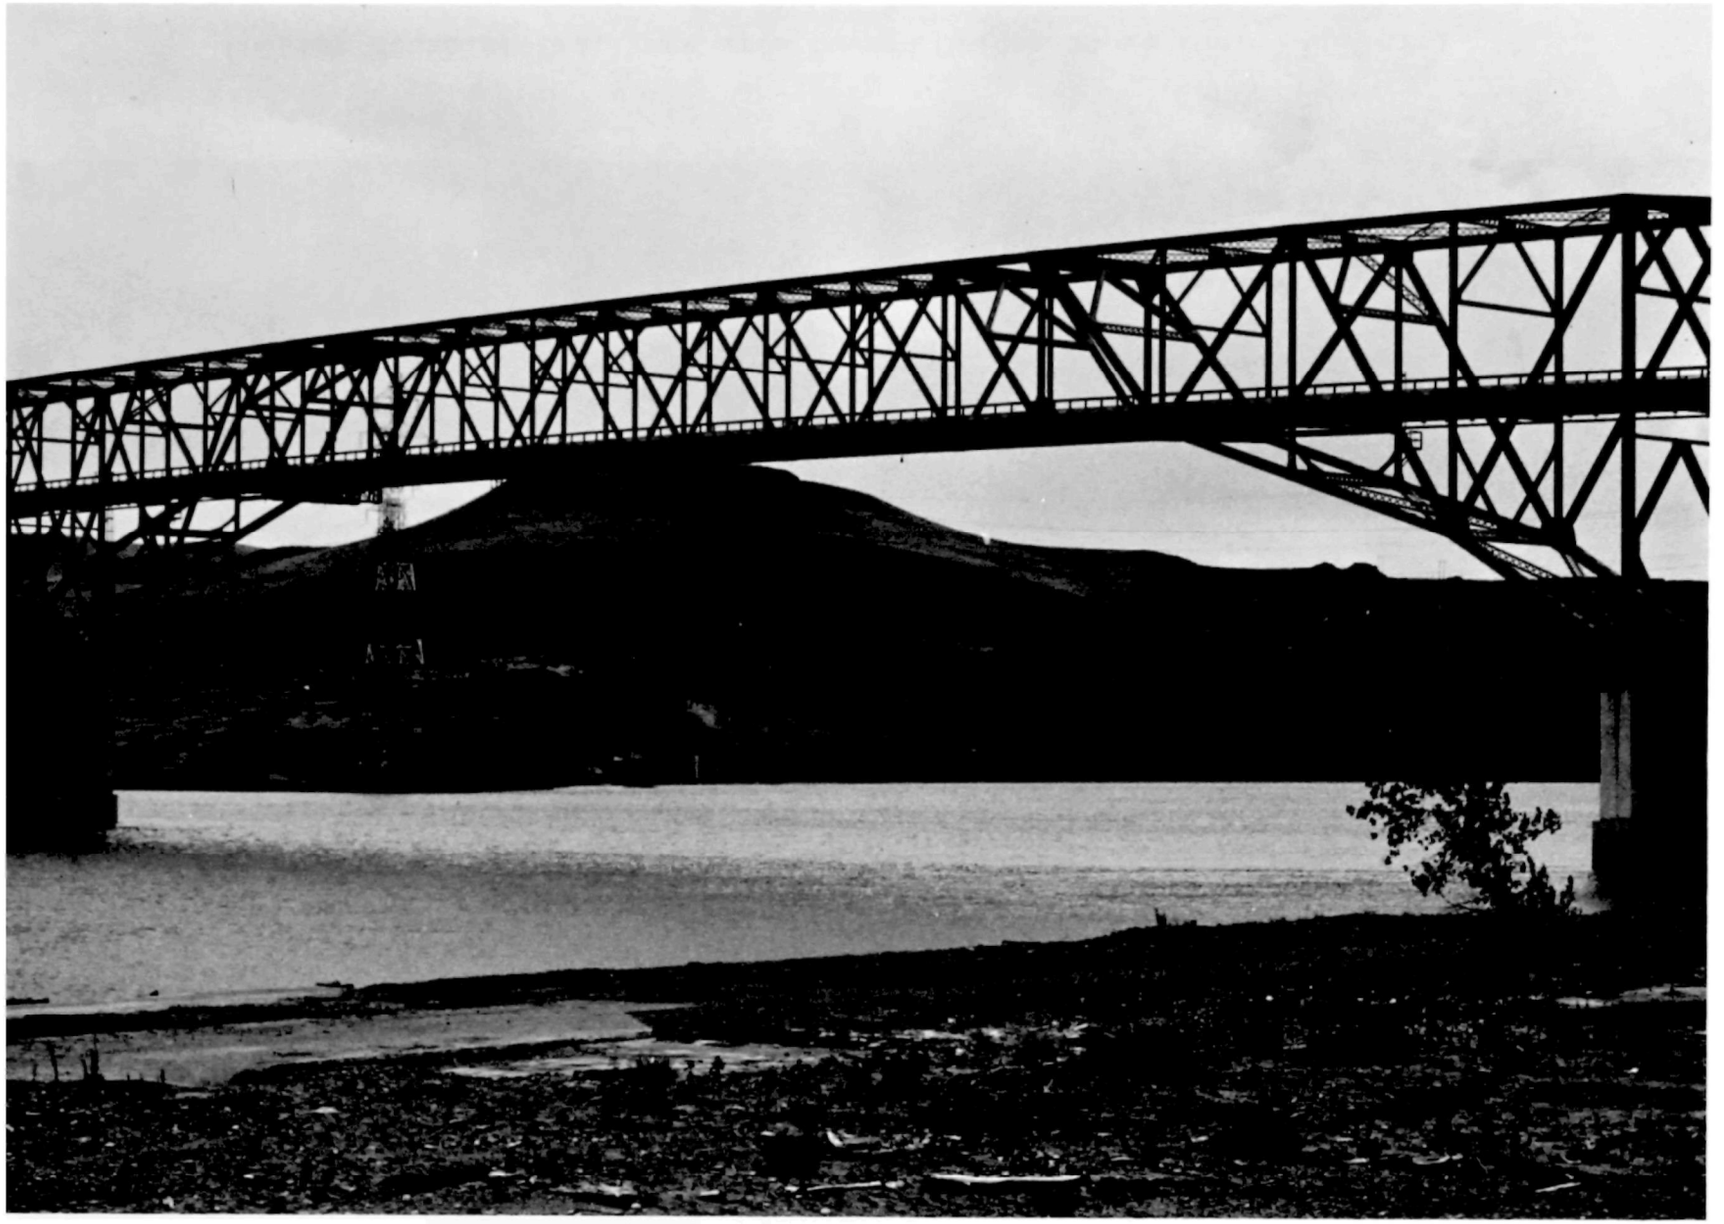
The existing thermograph at the Umatilla Bridge location (RM 209.5) is adequate for the RTRN system and should be included into it. The decision for the bridge location is also based on (1)the debris problem at the dam and (2) the possibility of a lateral stratification in McNary forebay which could produce an unequal temperature distribution in the tailrace.

UMATILLA BRIDGE BELOW McNARY DAM
Looking upstream at bridge (Q=140,000 cfs)
FIGURE 11

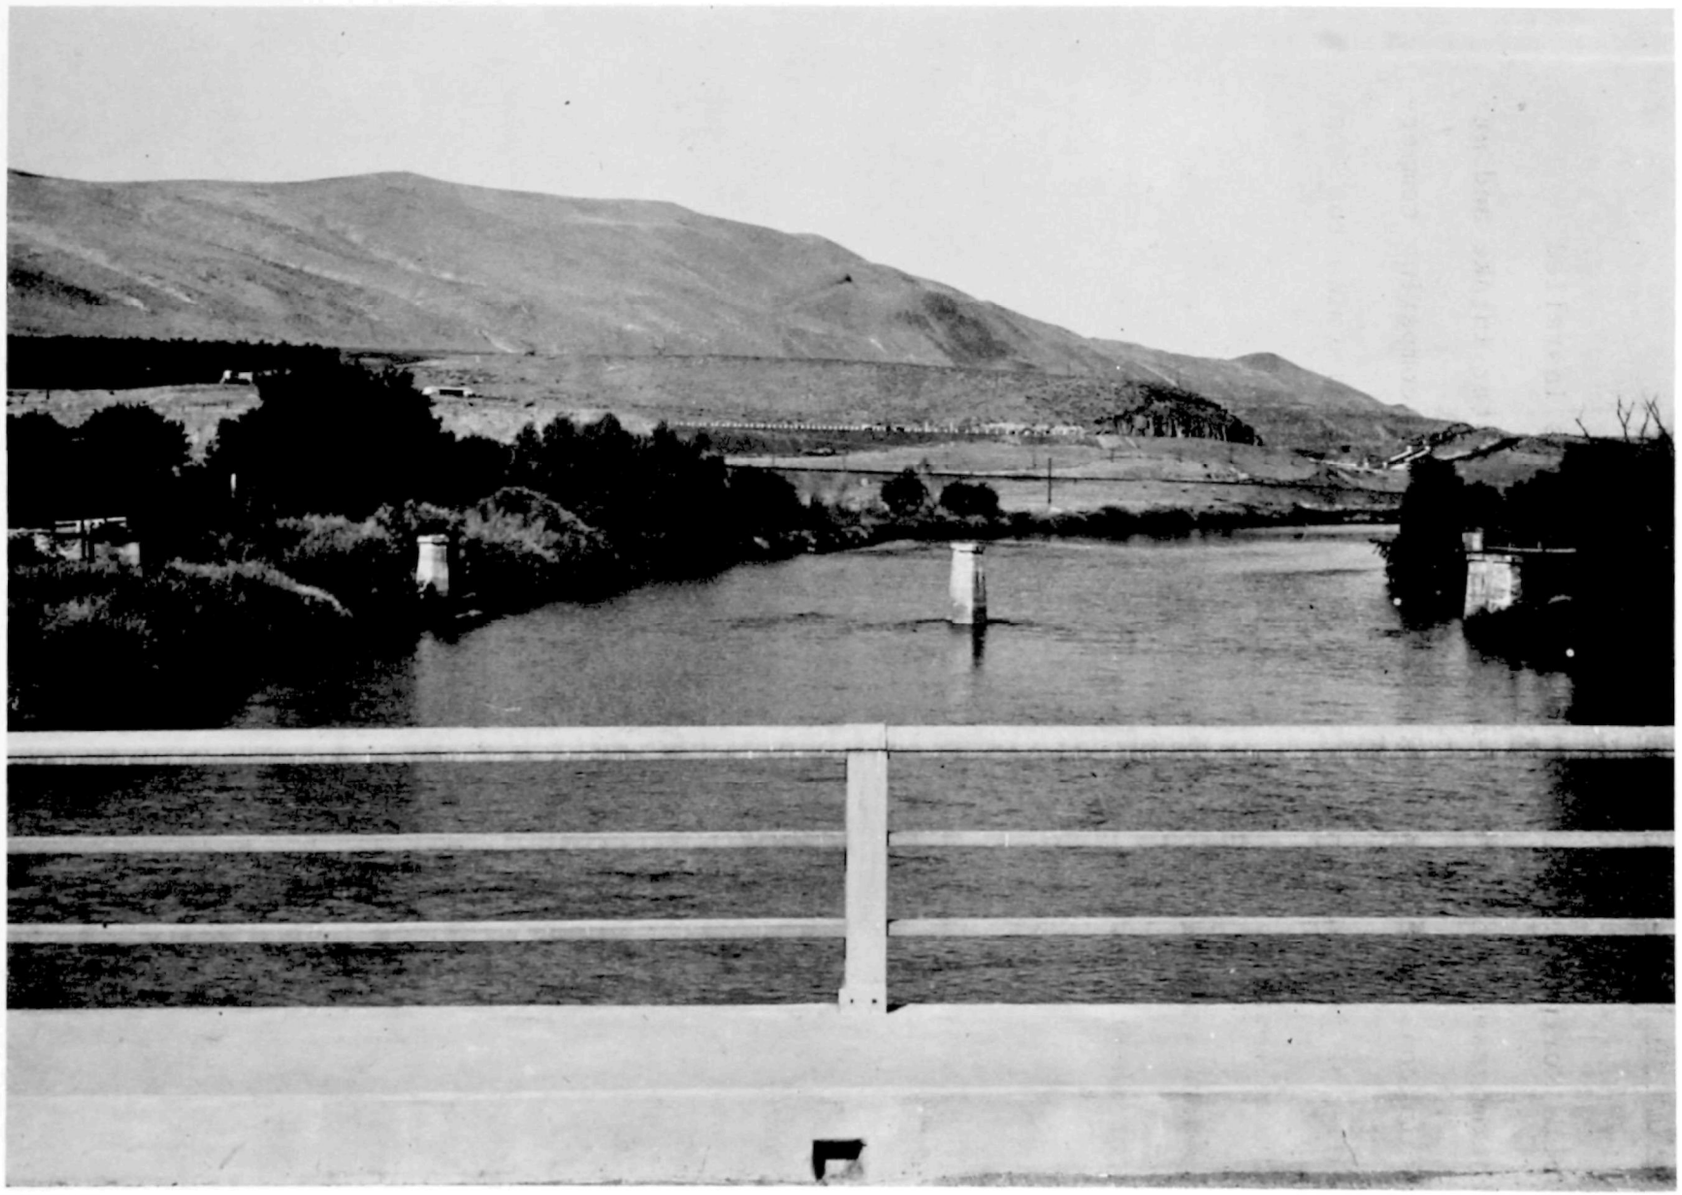
It has been suggested by scientists from Battelle Northwest that a location at the highway bridge at West Richland would yield a well mixed temperature condition, unaffected by the Columbia River backwater. Conclusions regarding a station on this river cannot be reached until the West Richland site can be investigated.

KIONA BRIDGE OVER THE YAKIMA RIVER
Looking upstream at the Kiona gauging station on the right side of the photograph
FIGURE 14

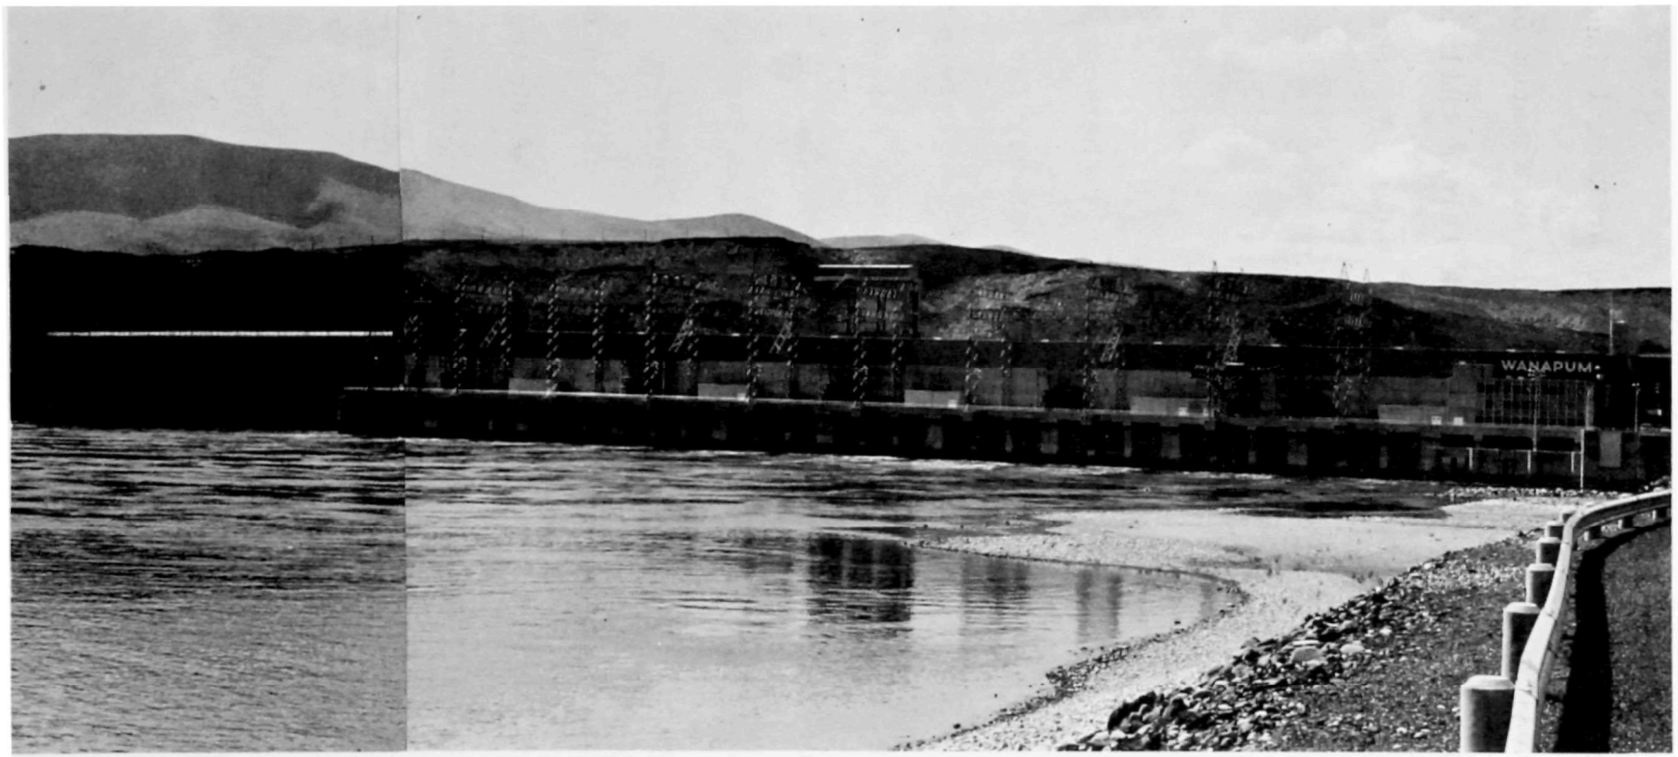
Wanapum Dam has a Leeds Northrup thermograph which records the temperature of water flowing through each turbine, using a temperature sensor in each scroll case. Field verification surveys will be required to determine whether this instrument should be included in the network. The tailrace is completely mixed so that thermograph measurements will be representative of the discharge conditions. A recorder can be placed on the tailrace deck (see FIGURE 15). Comparison of temperature data from the tailrace and scroll cases will determine whether the scroll case thermographs are adequate for the RTRN system. If so, the tailrace thermograph can be removed in favor of the project recorder.

WANAPUM DAM
Looking upstream at powerhouse and tailrace (Q 147,000 cfs)
FIGURE 15

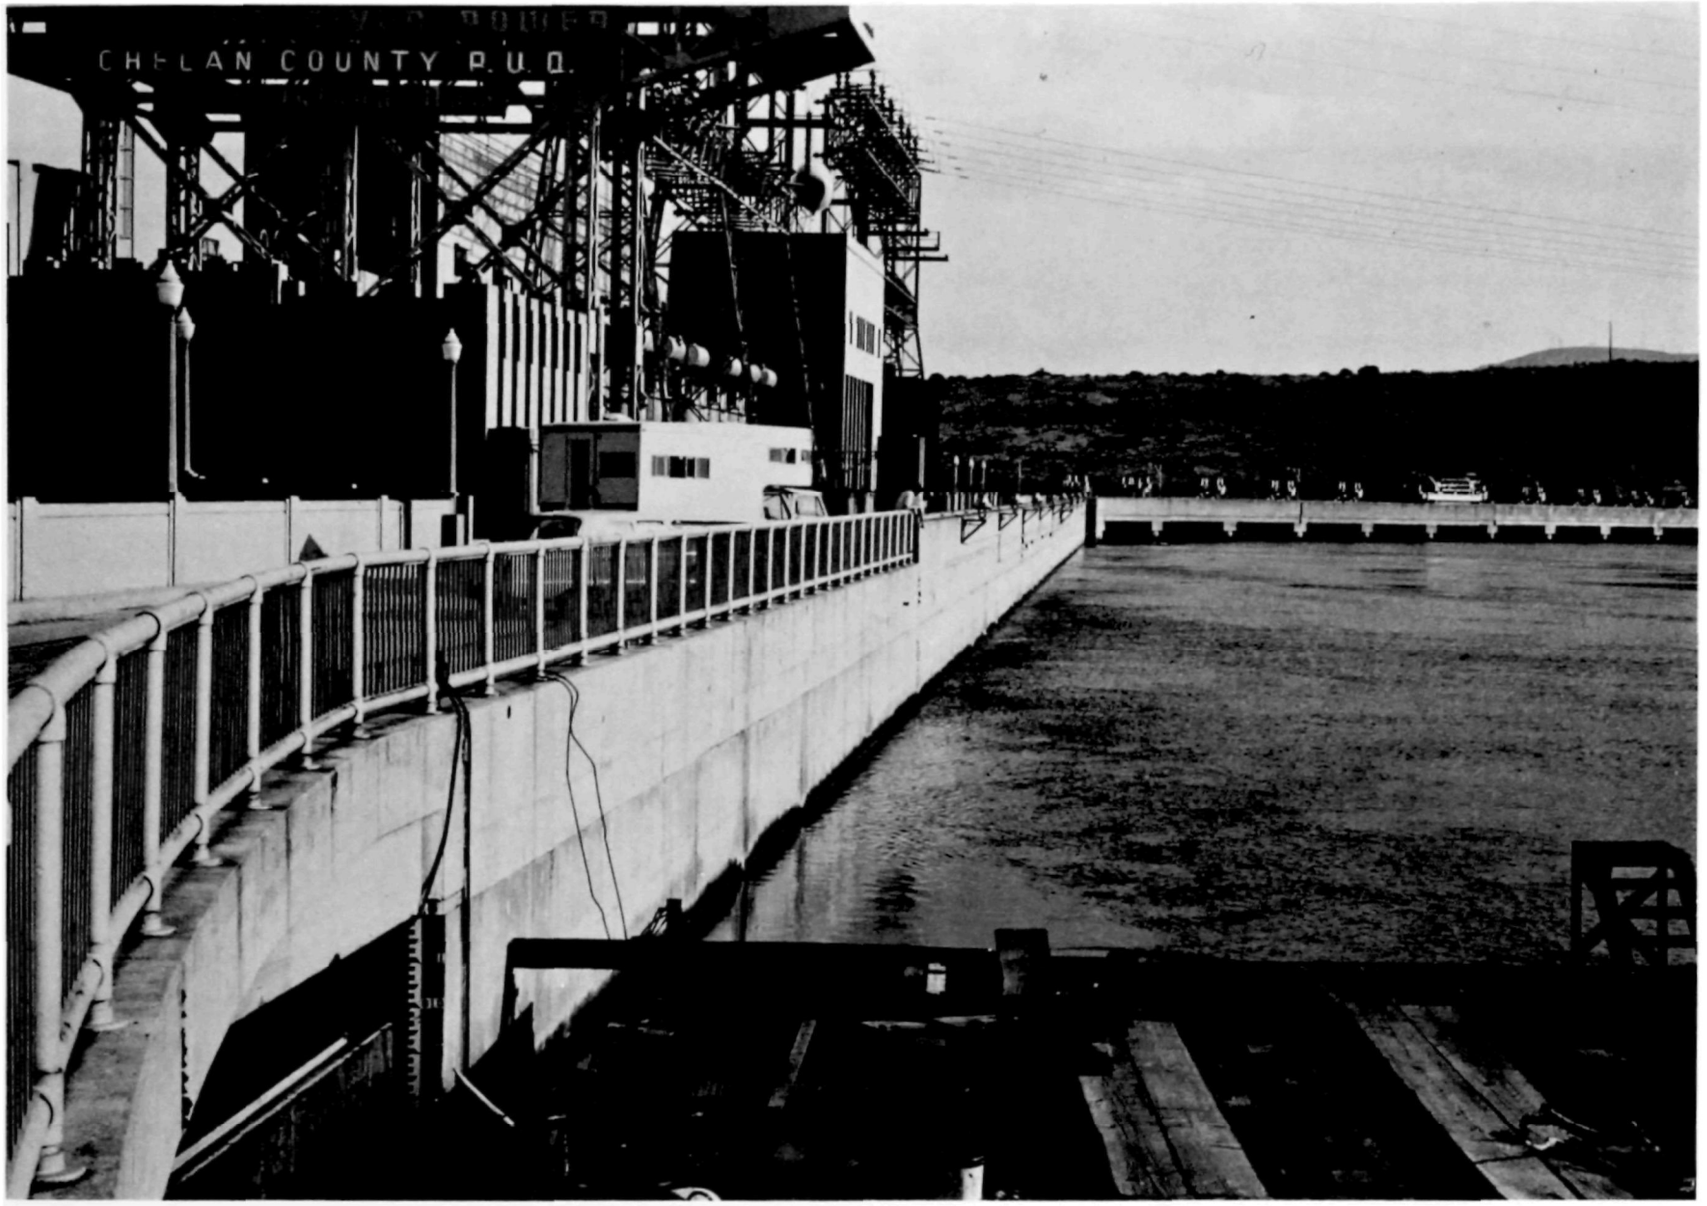
ROCK ISLAND DAM
Looking west across forebay of Dam (current toward opposite shore-Q=100,000 cfs)
FIGURE 17

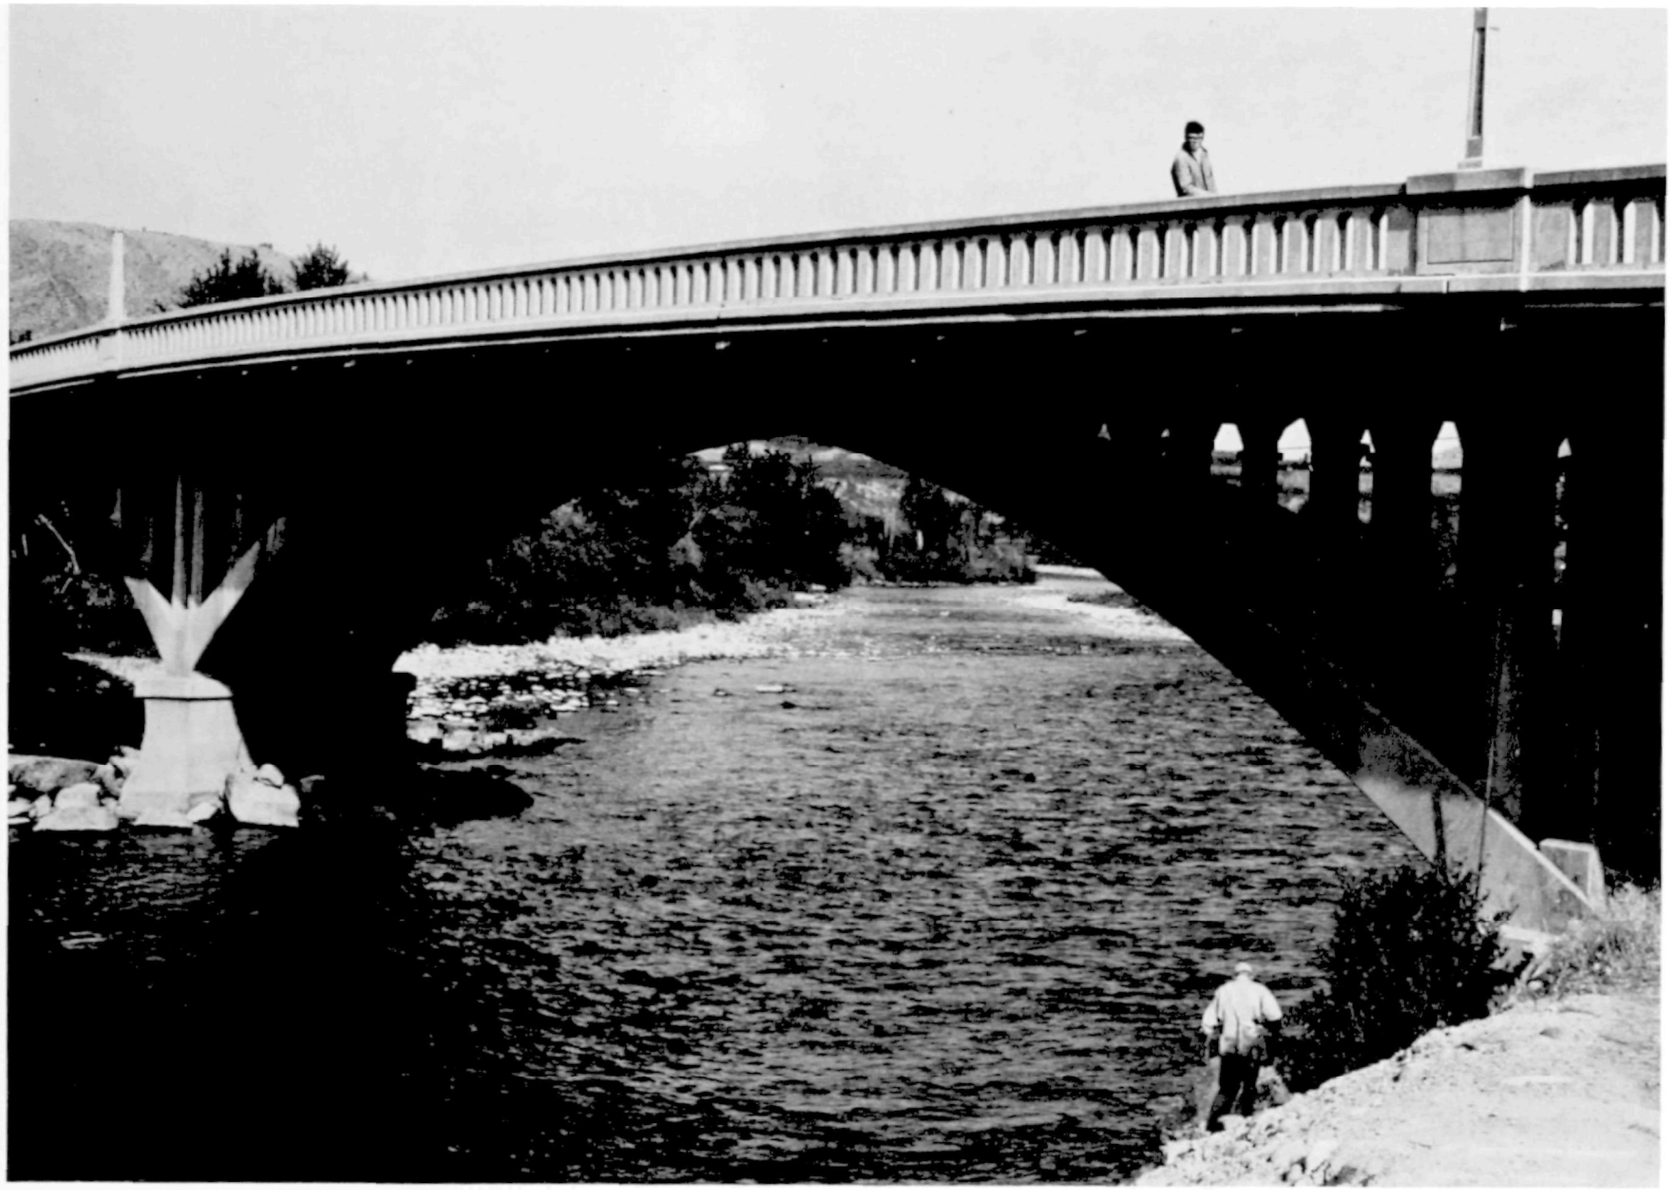
The Wenatchee River was selected as one of the streams requiring temperature monitoring in the initial stage of the program. FIGURE 18 shows the bridge over the Wenatchee River at Monitor, Washington, which is a potential thermograph site for this important Columbia River tributary. This location is far enough upstream to be out of the Columbia River backwater effect and temperature cross-sections which were taken on August 22, 1968, showed the river to be well mixed and fairly cold (13.25 ^{o}C). A thermograph located at this site will have to be heavily protected against potential vandalism.

BRIDGE OVER THE WENATCHEE RIVER AT MONITOR, WASHINGTON
FIGURE 18

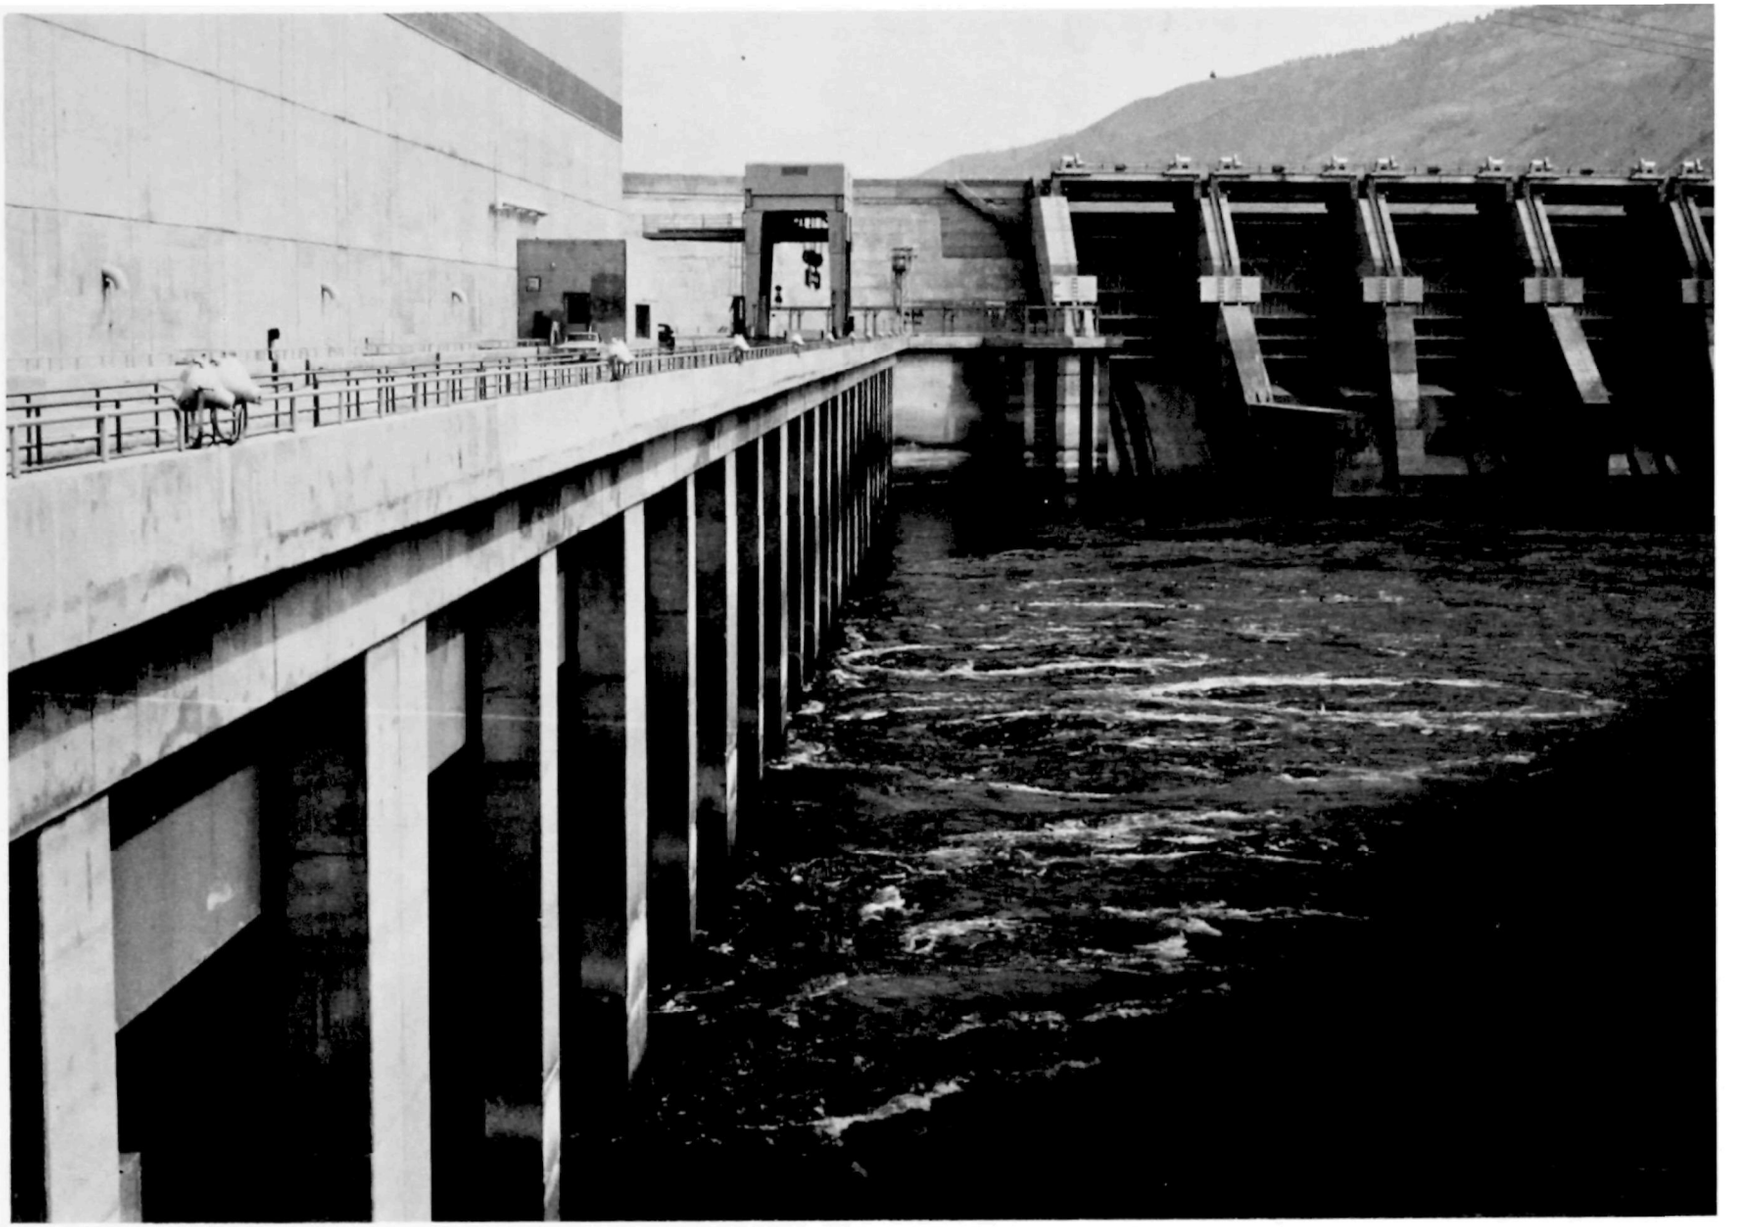
The tailrace of Rocky Reach Dam is considered a good location for monitoring discharge temperature. The tailrace shown on FIGURE 19 is completely mixed and FIGURE 20 shows the turbulent conditions downstream of the dam.

ROCKY REACH DAM
View of Tailrace (Q=96,000 cfs)
FIGURE 19

A continuous recording thermograph should be placed in the tailrace and these records used instead of the existing information obtained from the other devices. The thermograph will not interfere with project operation on the tailrace deck. The thermometer, even though accurate, cannot be incorporated into the RTRN due to the need for accurate continuous records.
