REGIONAL TEMPERATURE REPORTING NETWORK

1968 FIELD RECONNAISSANCE SURVEY

FEDERAL WATER POLLUTION CONTROL ADMINISTRATION
NORTHWEST REGION
PORTLAND, OREGON

Working Paper No. 62

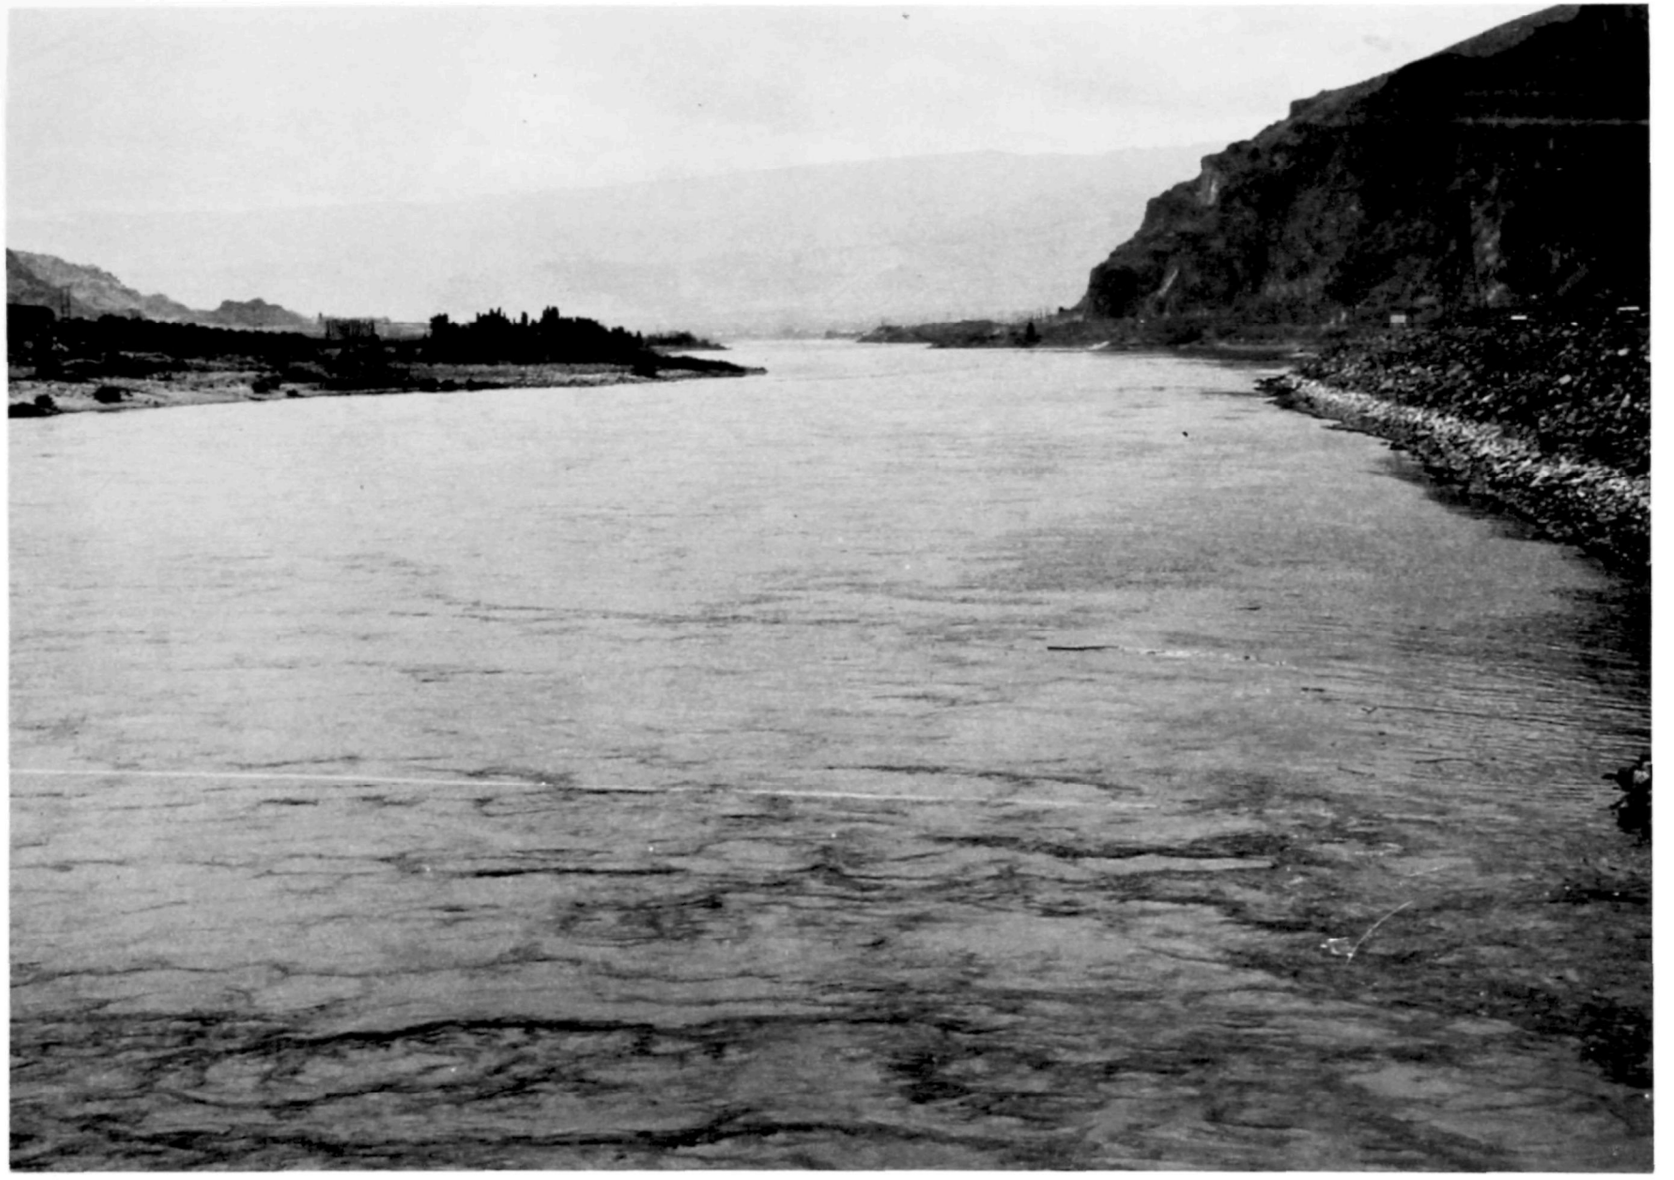
The tailrace of Rocky Reach Dam is considered a good location for monitoring discharge temperature. The tailrace shown on FIGURE 19 is completely mixed and FIGURE 20 shows the turbulent conditions downstream of the dam.

ROCKY REACH DAM
Looking downstream from powerhouse deck (Q=96,000 cfs)
FIGURE 20

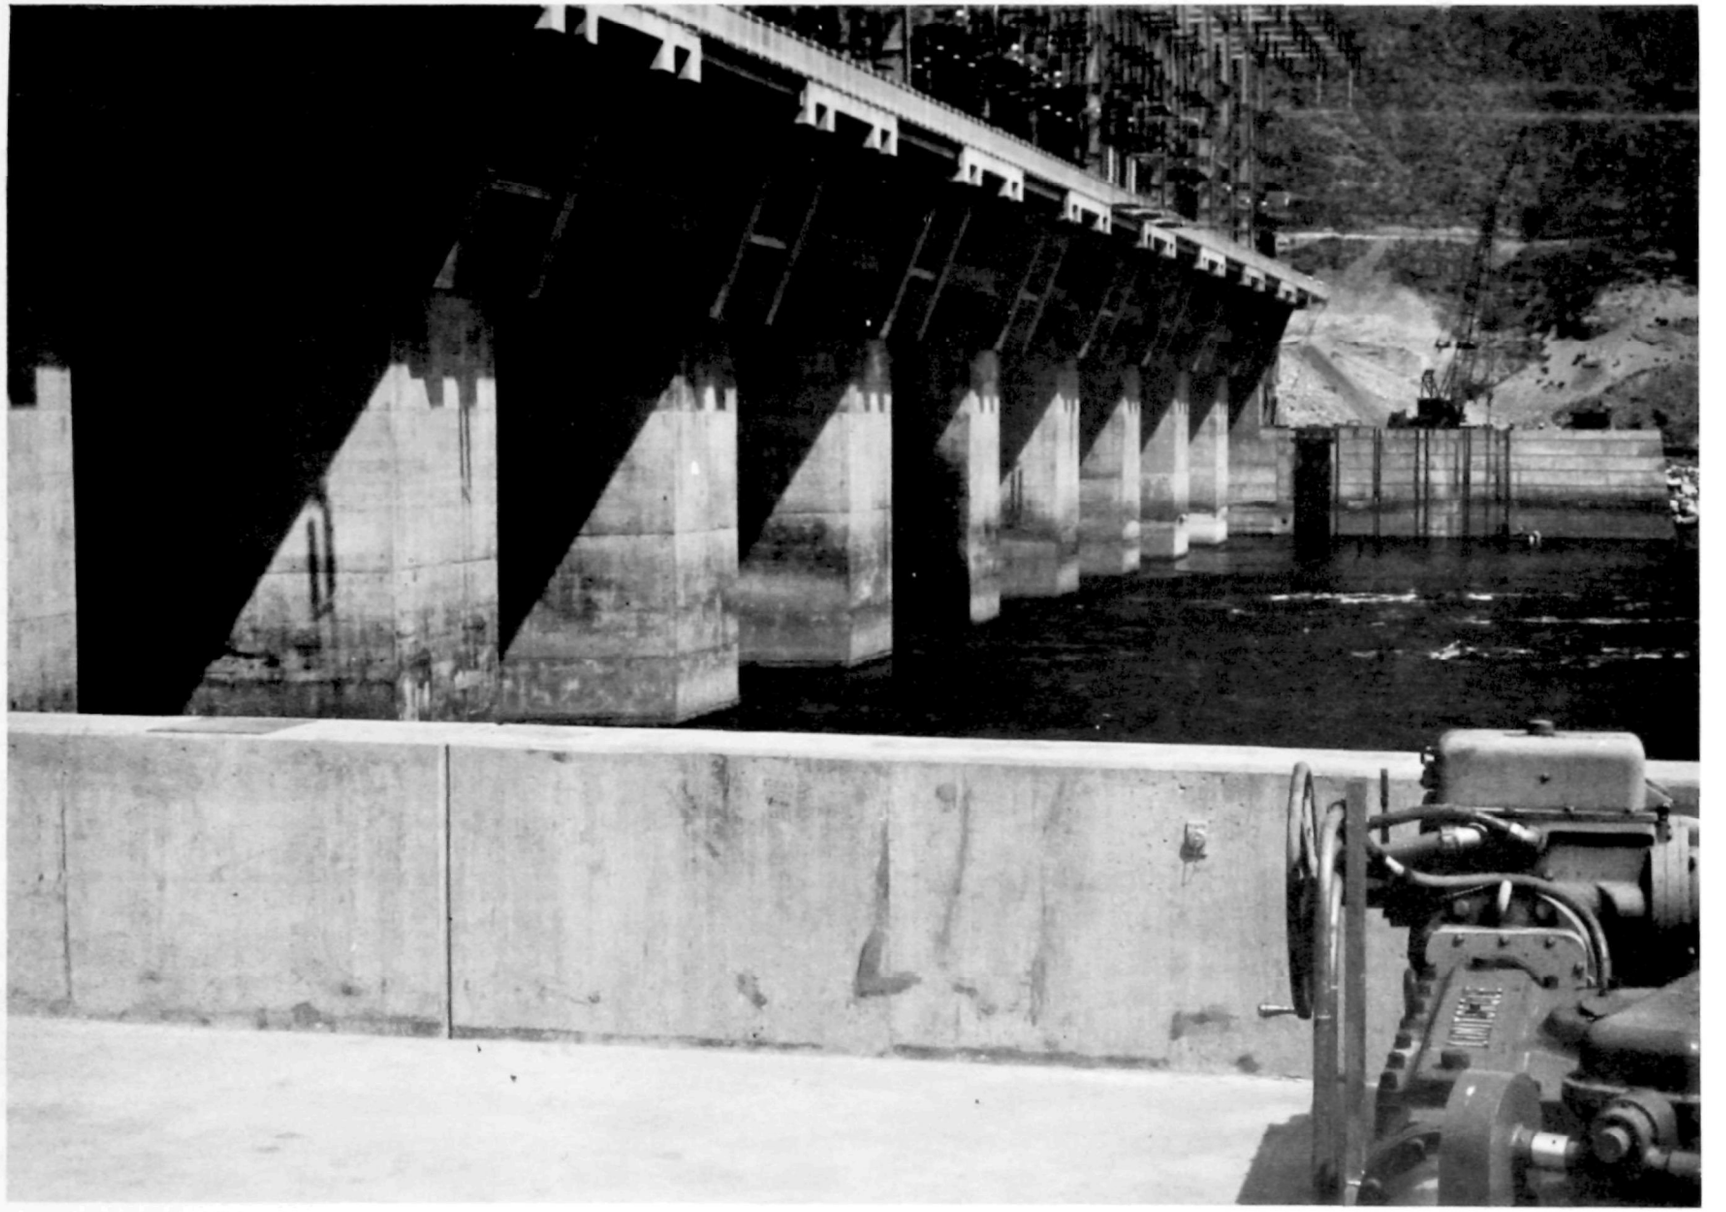
Wells Dam was still under construction when field reconnaissance survey personnel visited the site. The project manager suggested that the lower tailrace deck on the right bank of the river (shown on FIGURE 21) would be the most acceptable location for the thermograph. Temperature spot checks taken in the tailrace indicate that it is completely mixed; therefore, a thermograph placed at this location would yield representative temperatures. It is suggested that thermistor leads be placed through a pipe connected to the side of the tailrace wall because of the turbulent conditions caused by spillway flows (spillway and turbines are alternately spaced along axis of dam). FIGURE 22 shows the river downstream of dam.

WELLS DAM
Looking at tailrace and right bank tailrace wall
FIGURE 21

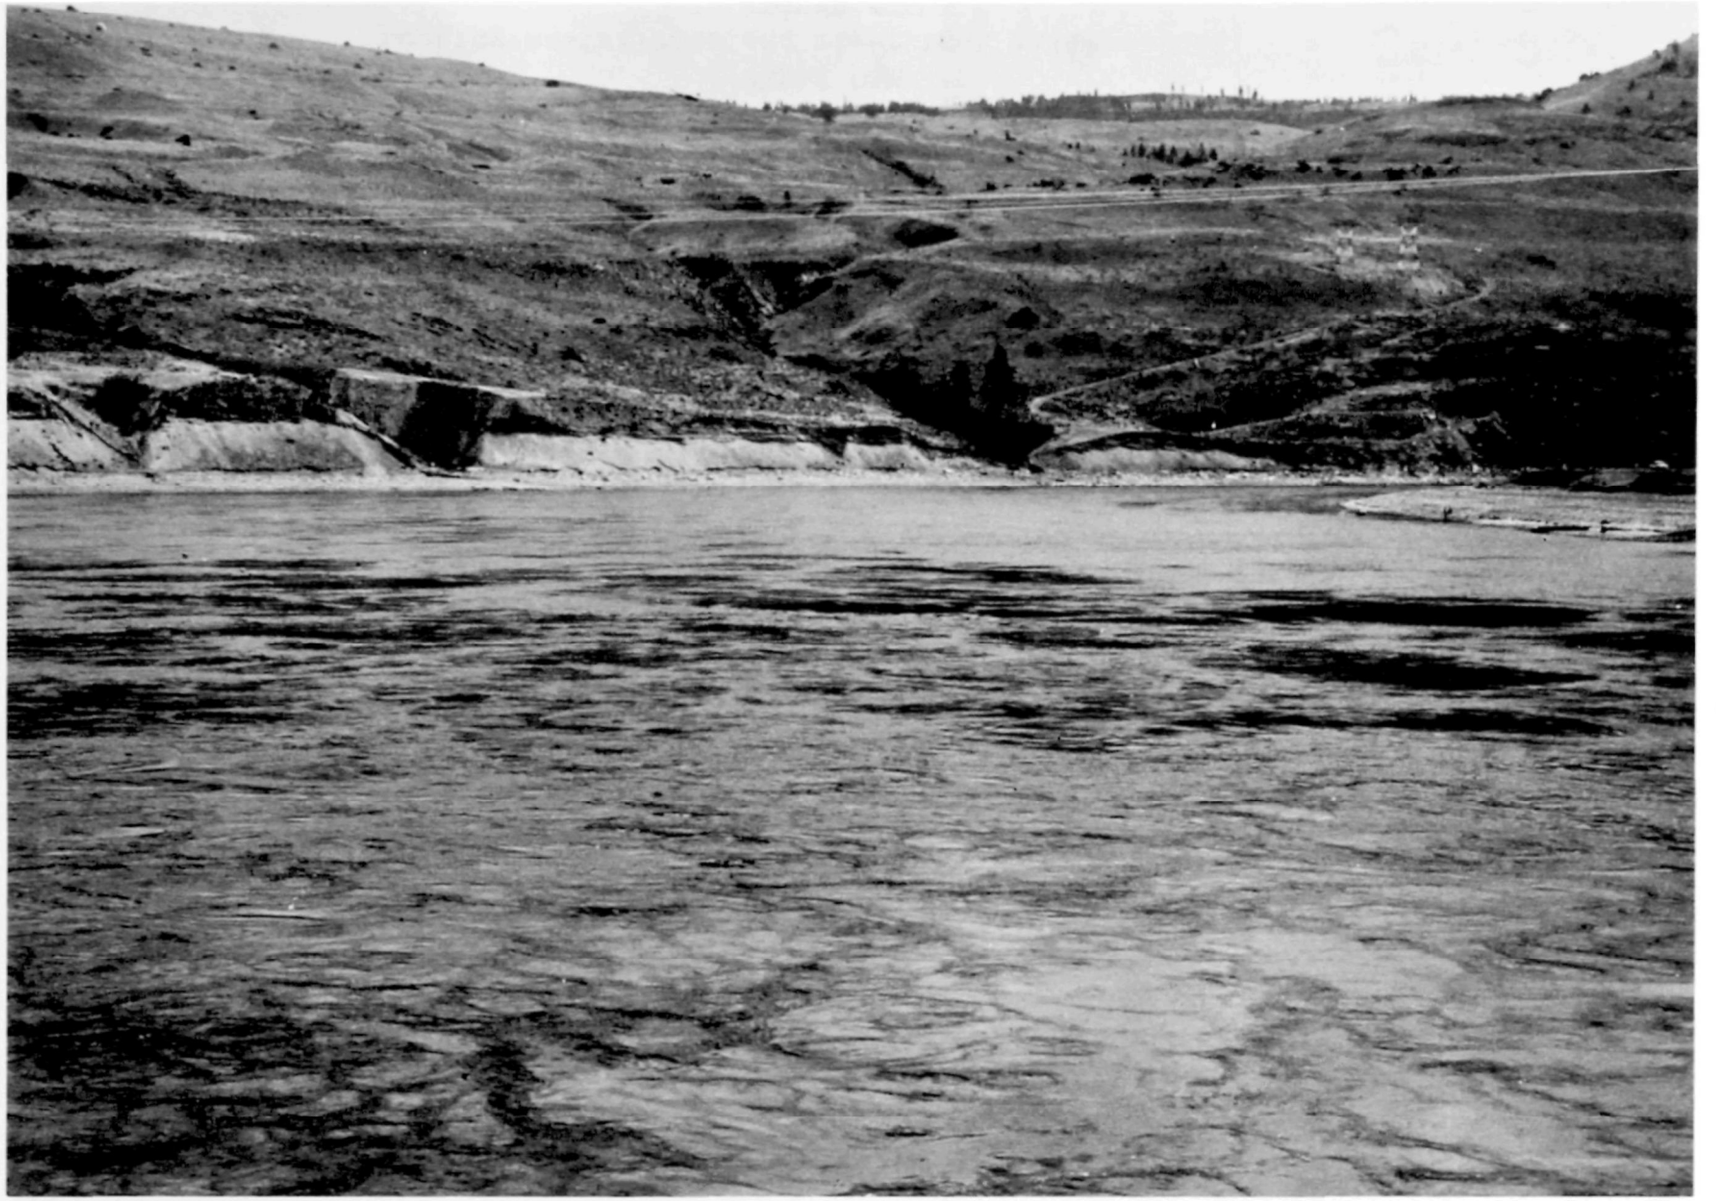
WELLS DAM
Looking downstream from tailrace deck
FIGURE 22

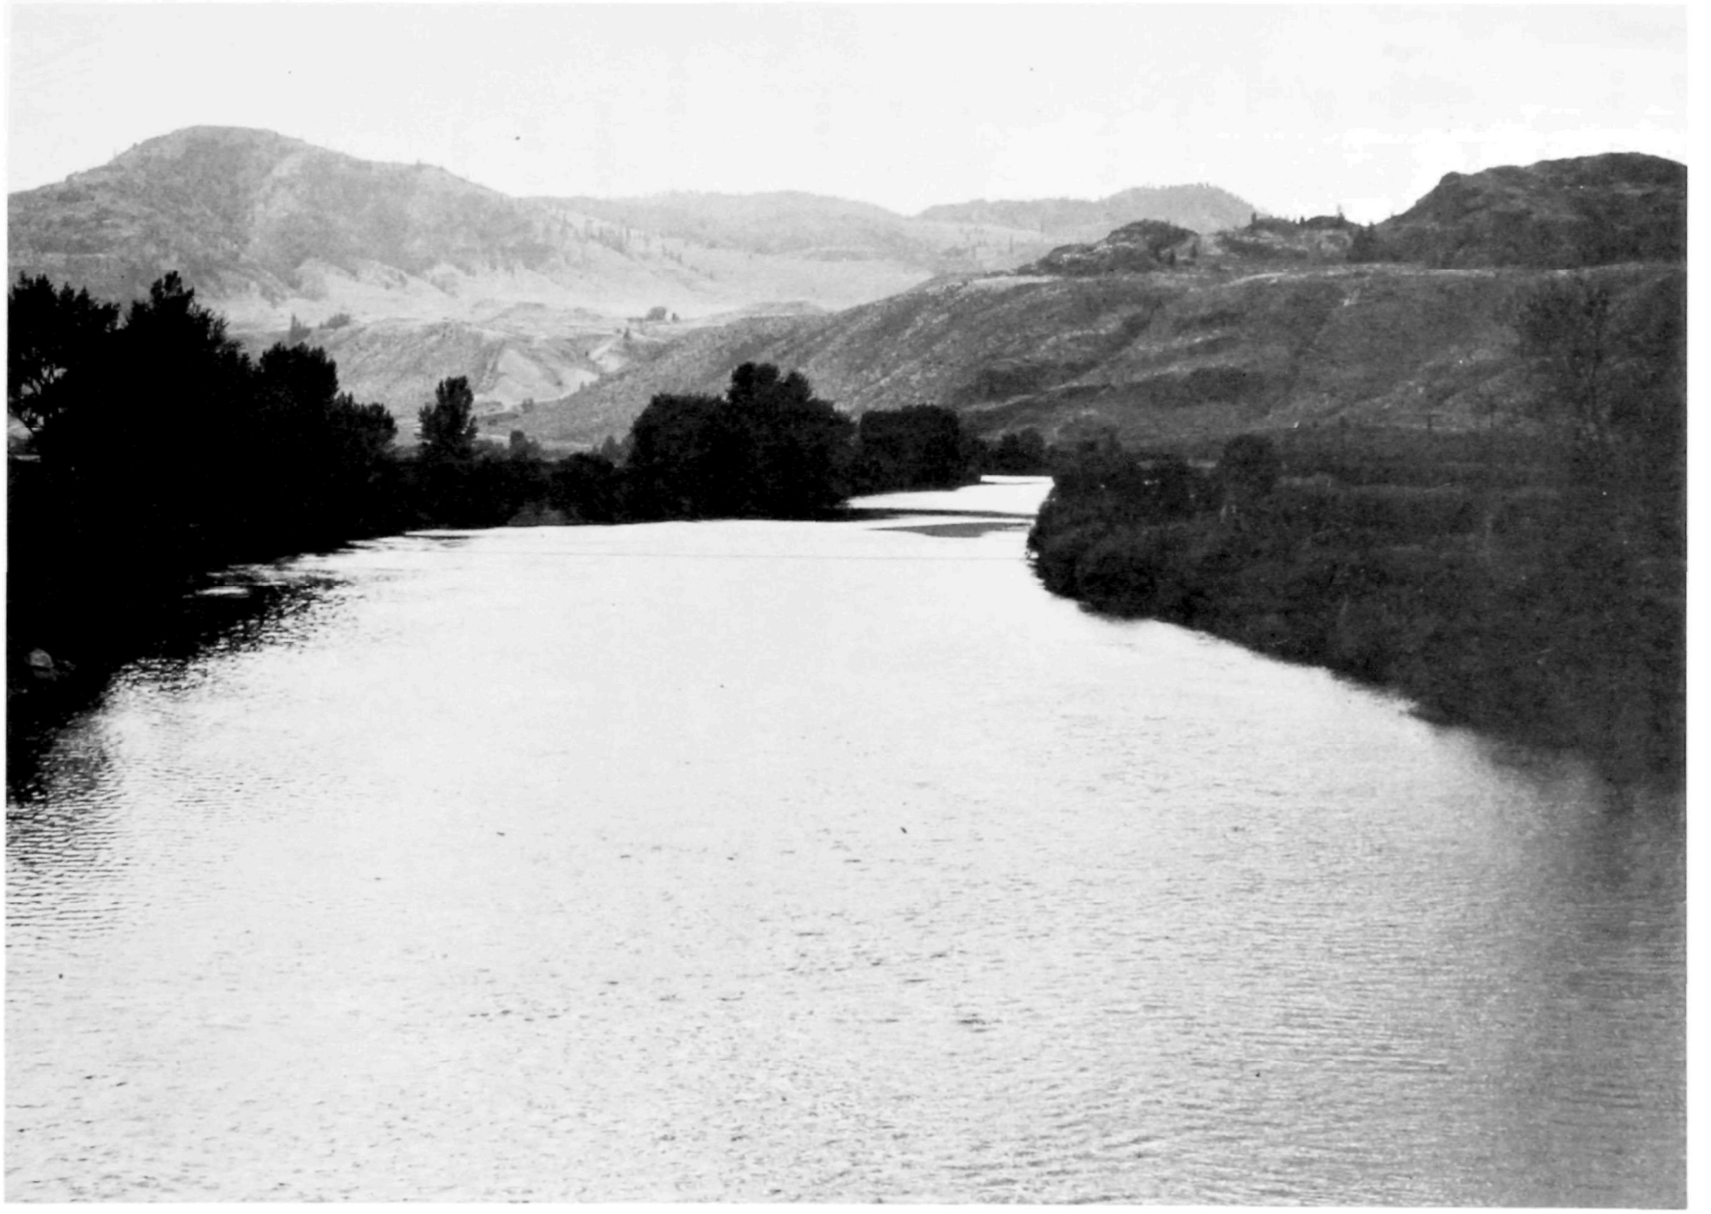
Further investigations will be necessary before a site on the Okanogan River can be recommended.

OKANOGAN RIVER NEAR MALOTT, WASHINGTON
Looking downstream from bridge
FIGURE 24

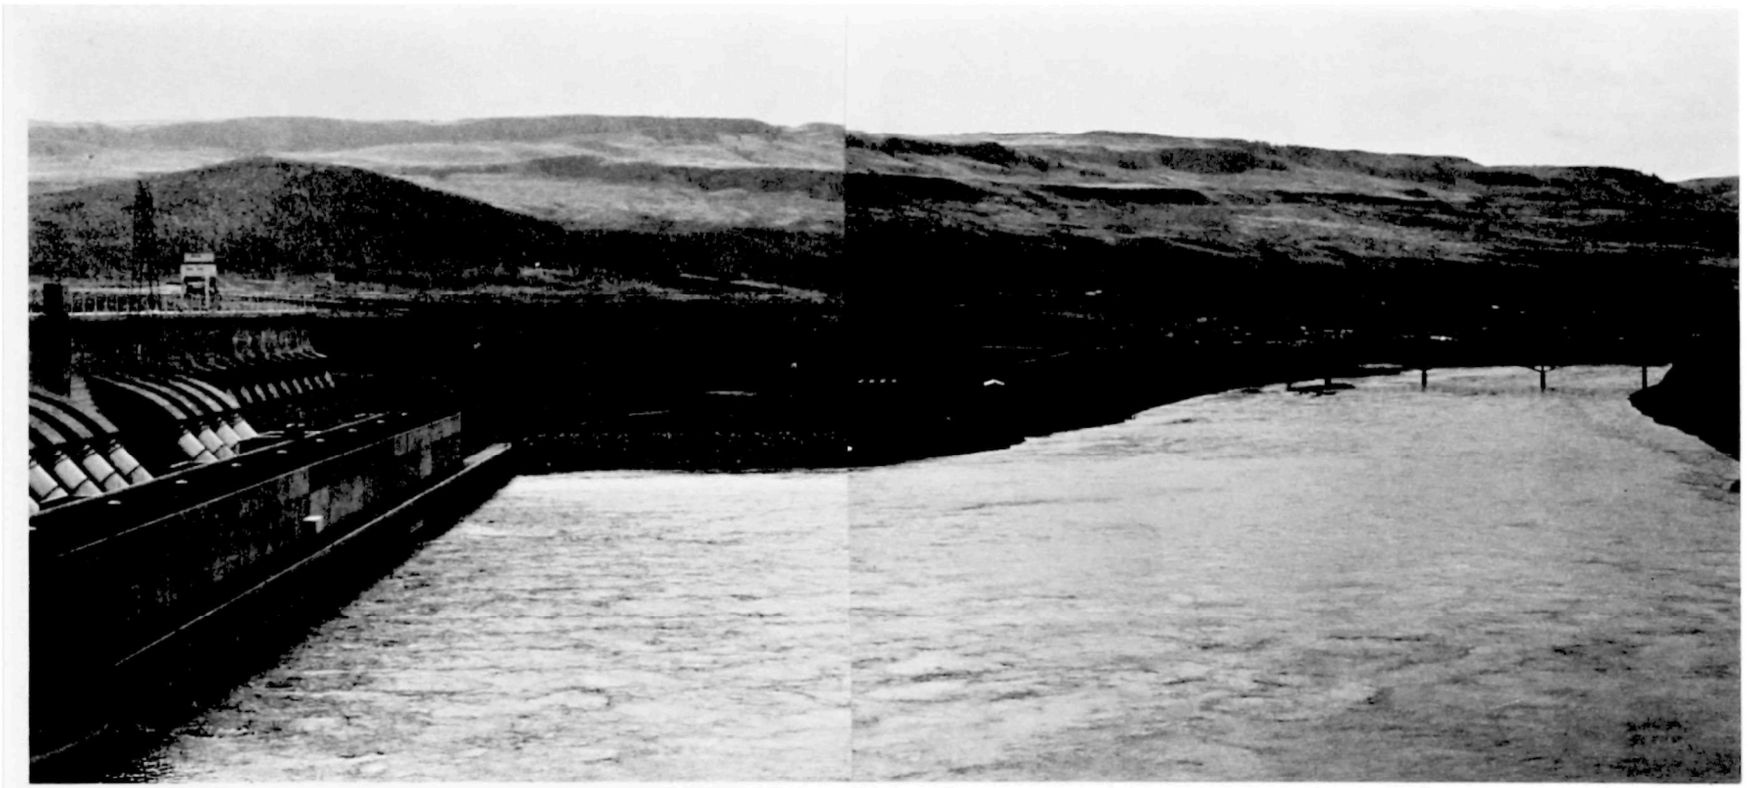
Temperature measurements are presently being read from a thermometer installed in the turbine cooling water lines. Since project personnel are depended upon to read temperatures, continuous records cannot be obtained. Therefore, a thermograph at the tailrace location appears to be preferable.

COLUMBIA RIVER BELOW CHIEF JOSEPH DAM
Looking at the dam tailrace and the downstream bridge (Q=102,000 cfs)
FIGURE 25

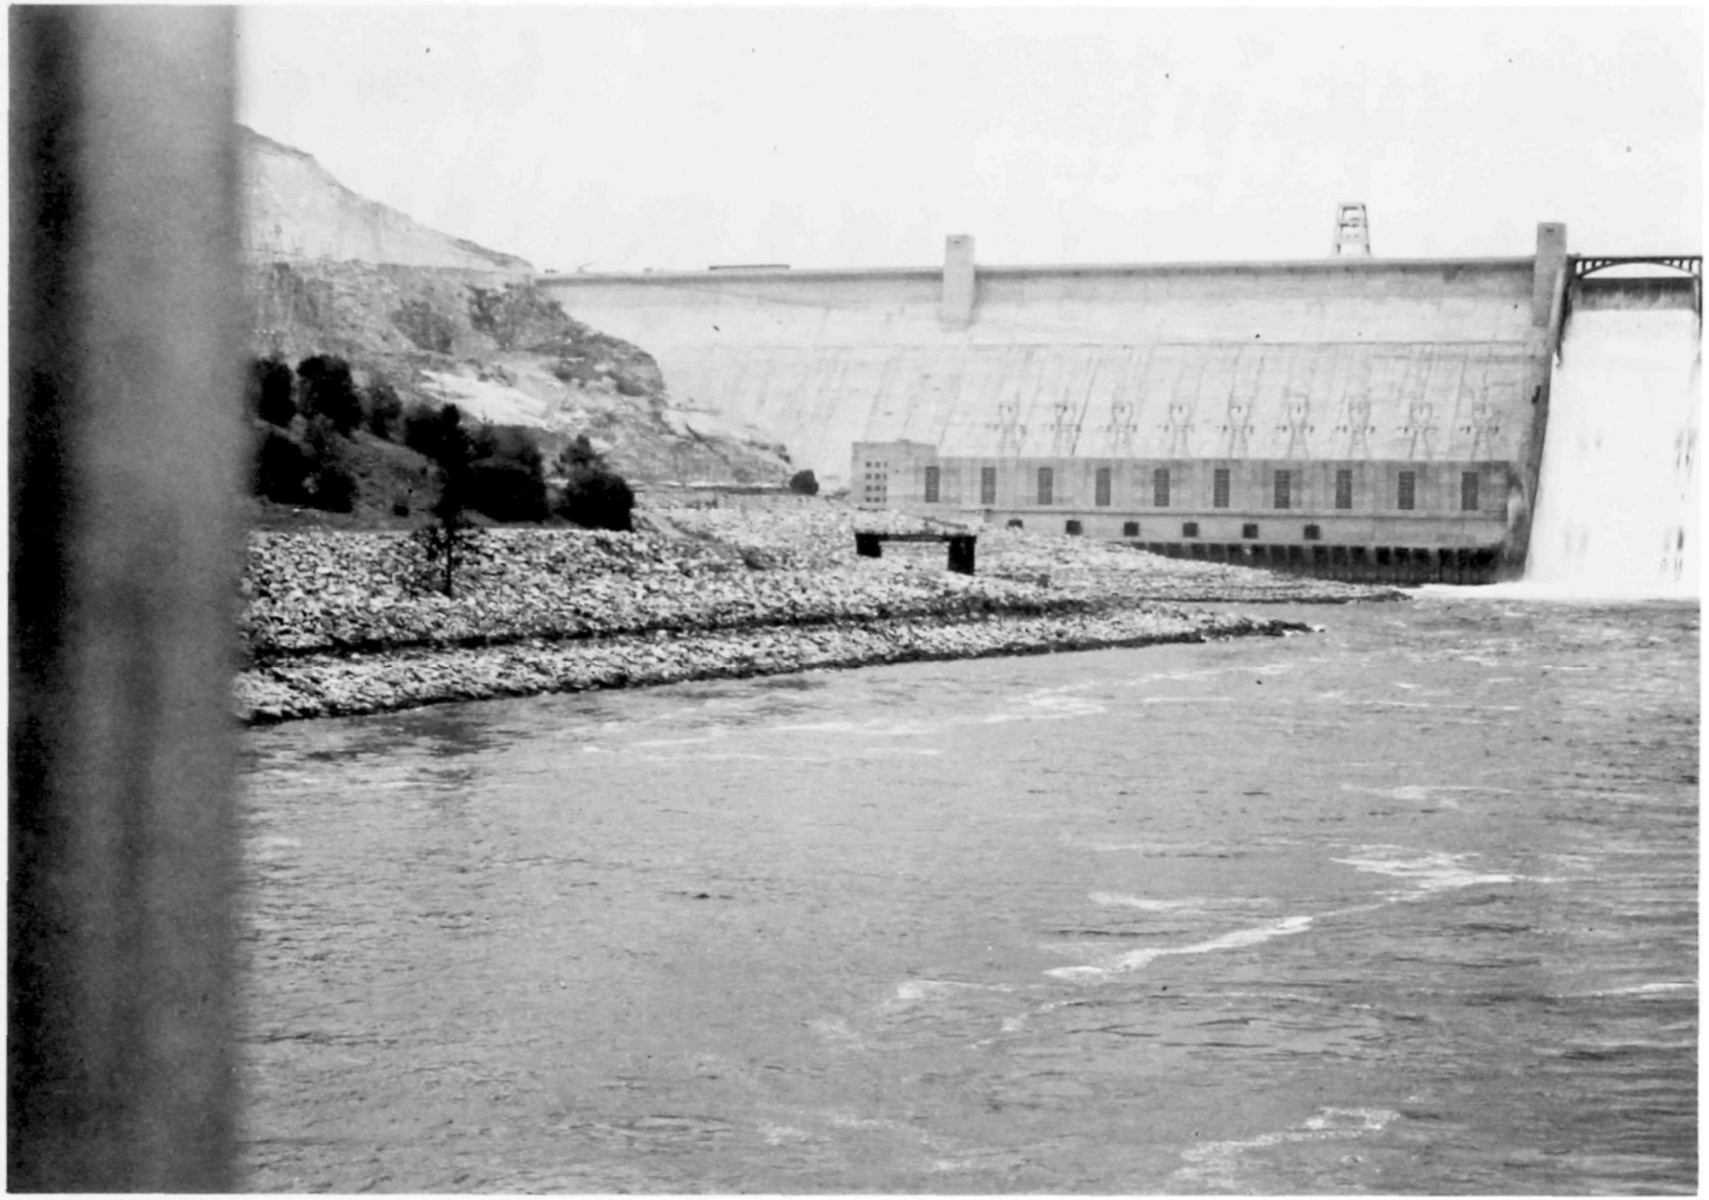
GRAND COULEE DAM
Looking upstream from bridge at right bank of dam (Q=99,000 cfs)
(Note: third powerhouse will be constructed in this area)
FIGURE 27

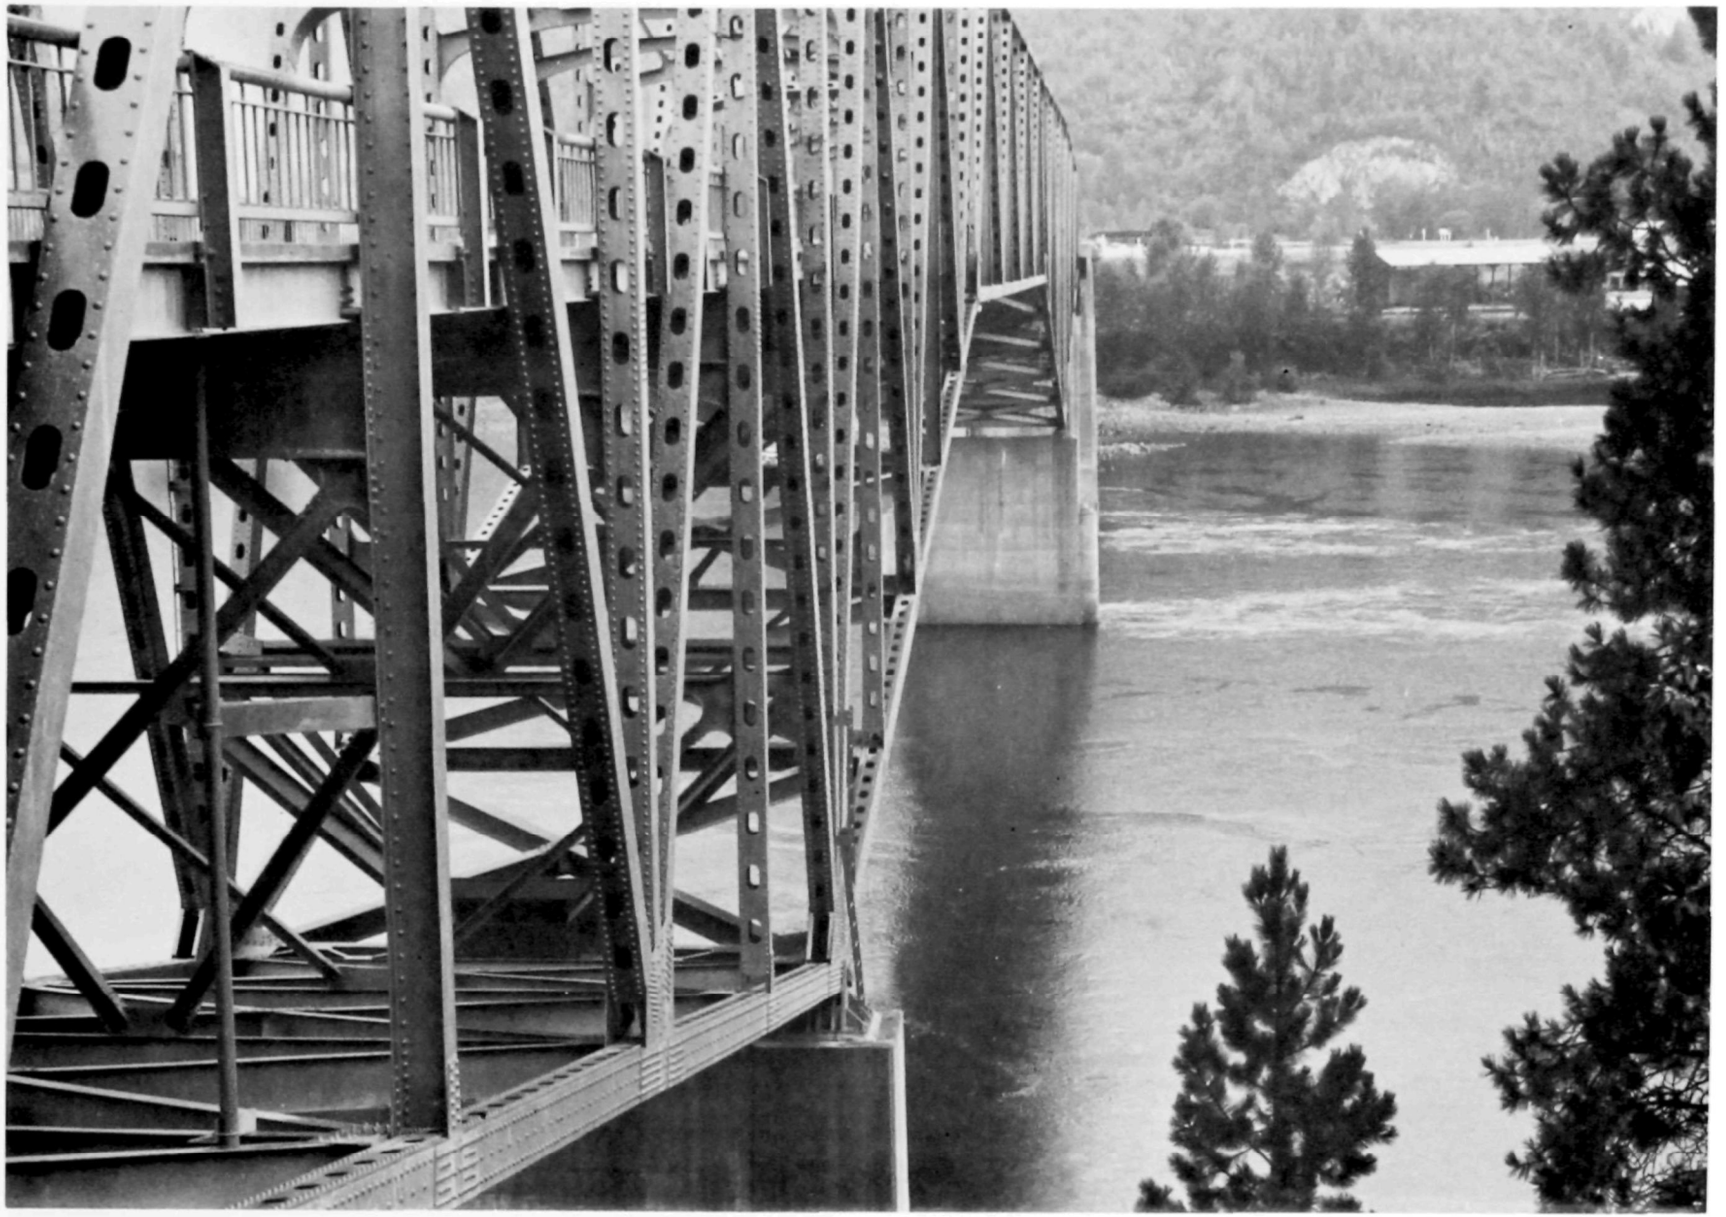
The bridge crossing the Columbia River at Northport, Washington (FIGURE 33) is a good location for a continuous recording thermograph. There is a moderate current past this location as can be seen from FIGURE 34 in contrast to the ponded river condition at Kettle Falls. Battelle Northwest under contract to AEC has installed a Foxboro thermograph on this bridge (see FIGURE 35) which should be satisfactory for the temperature reporting network. Temperature cross-sections taken on August 23, 1968, during the reconnaissance field trip indicated a well mixed river condition. Comparison of results from the two existing thermographs showed that temperatures at Kettle Falls were considerably greater than at Northport.

BRIDGE OVER COLUMBIA RIVER AT NORTH PORT, WASHINGTON
Looking toward left bank of river
FIGURE 33

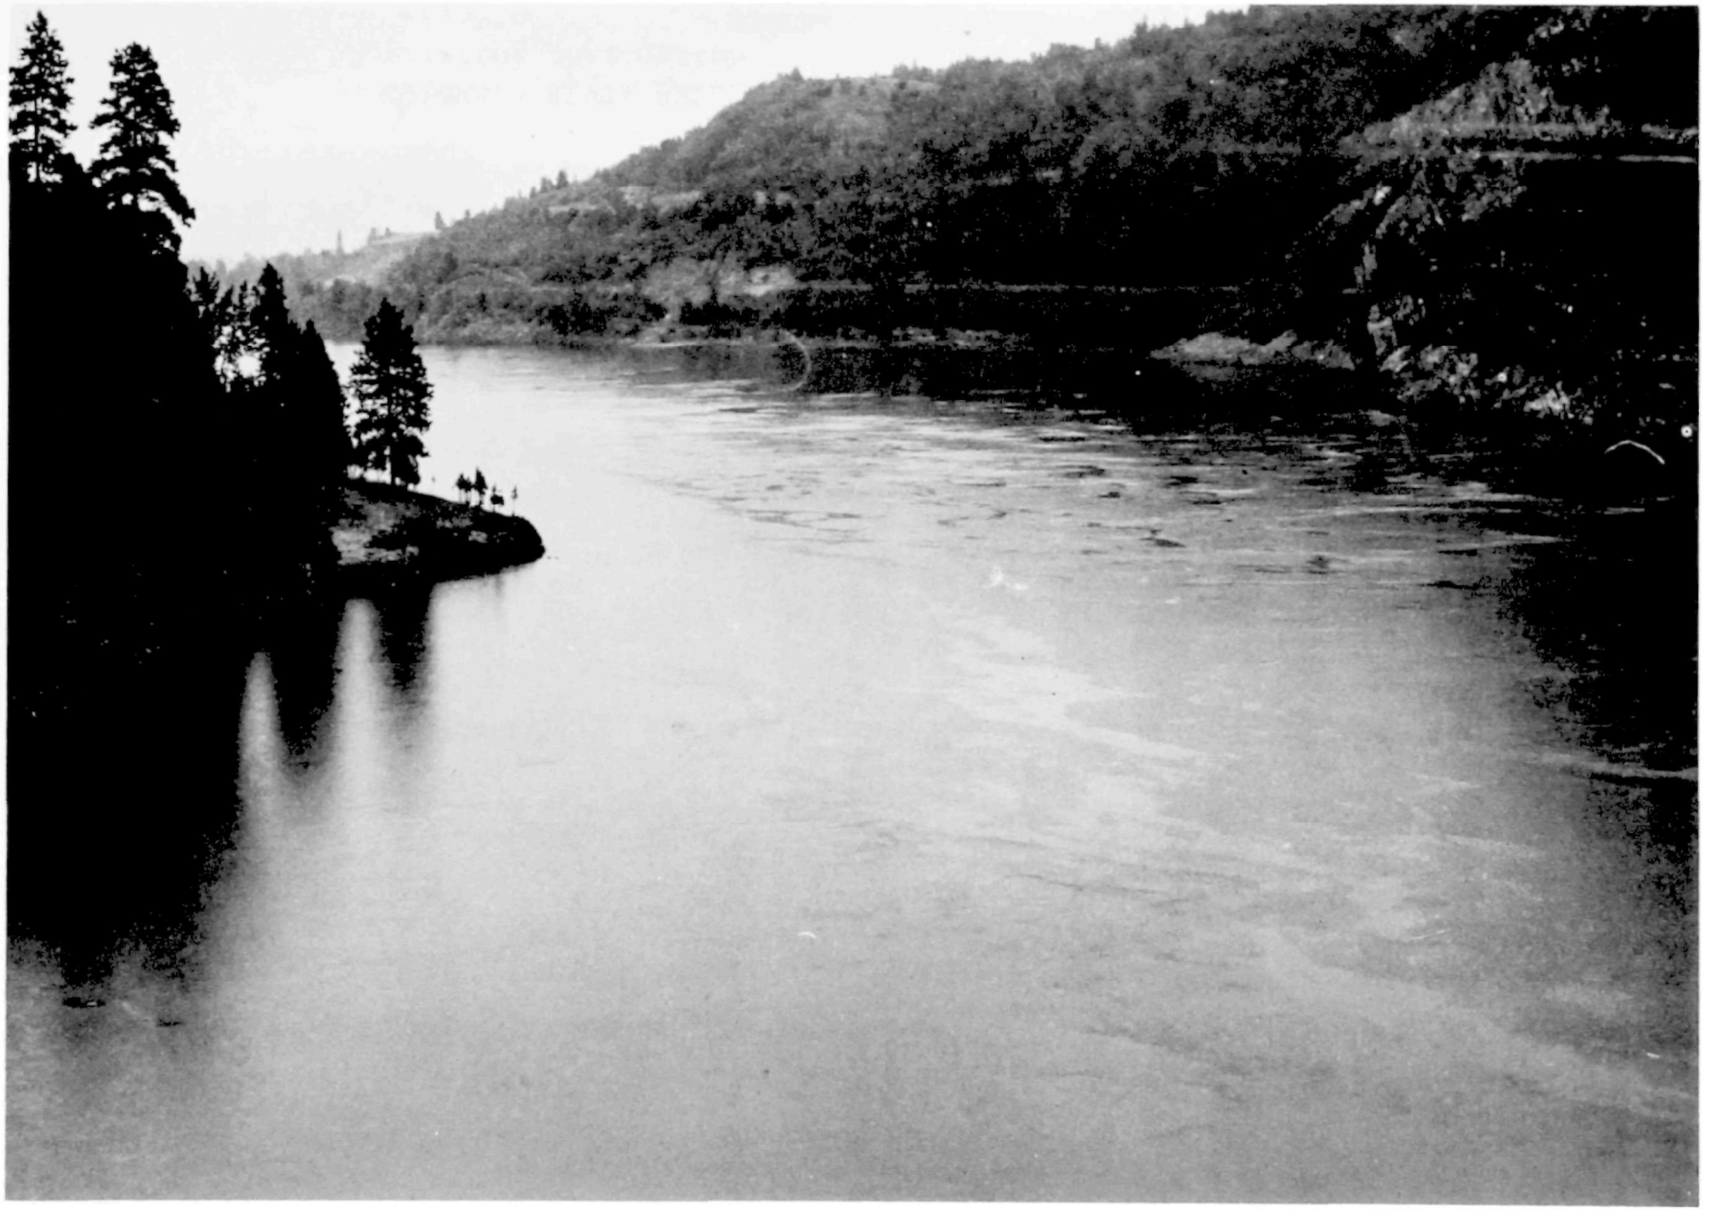
COLUMBIA RIVER AT NORTH PORT, WASHINGTON
Looking upstream (North)
FIGURE 34

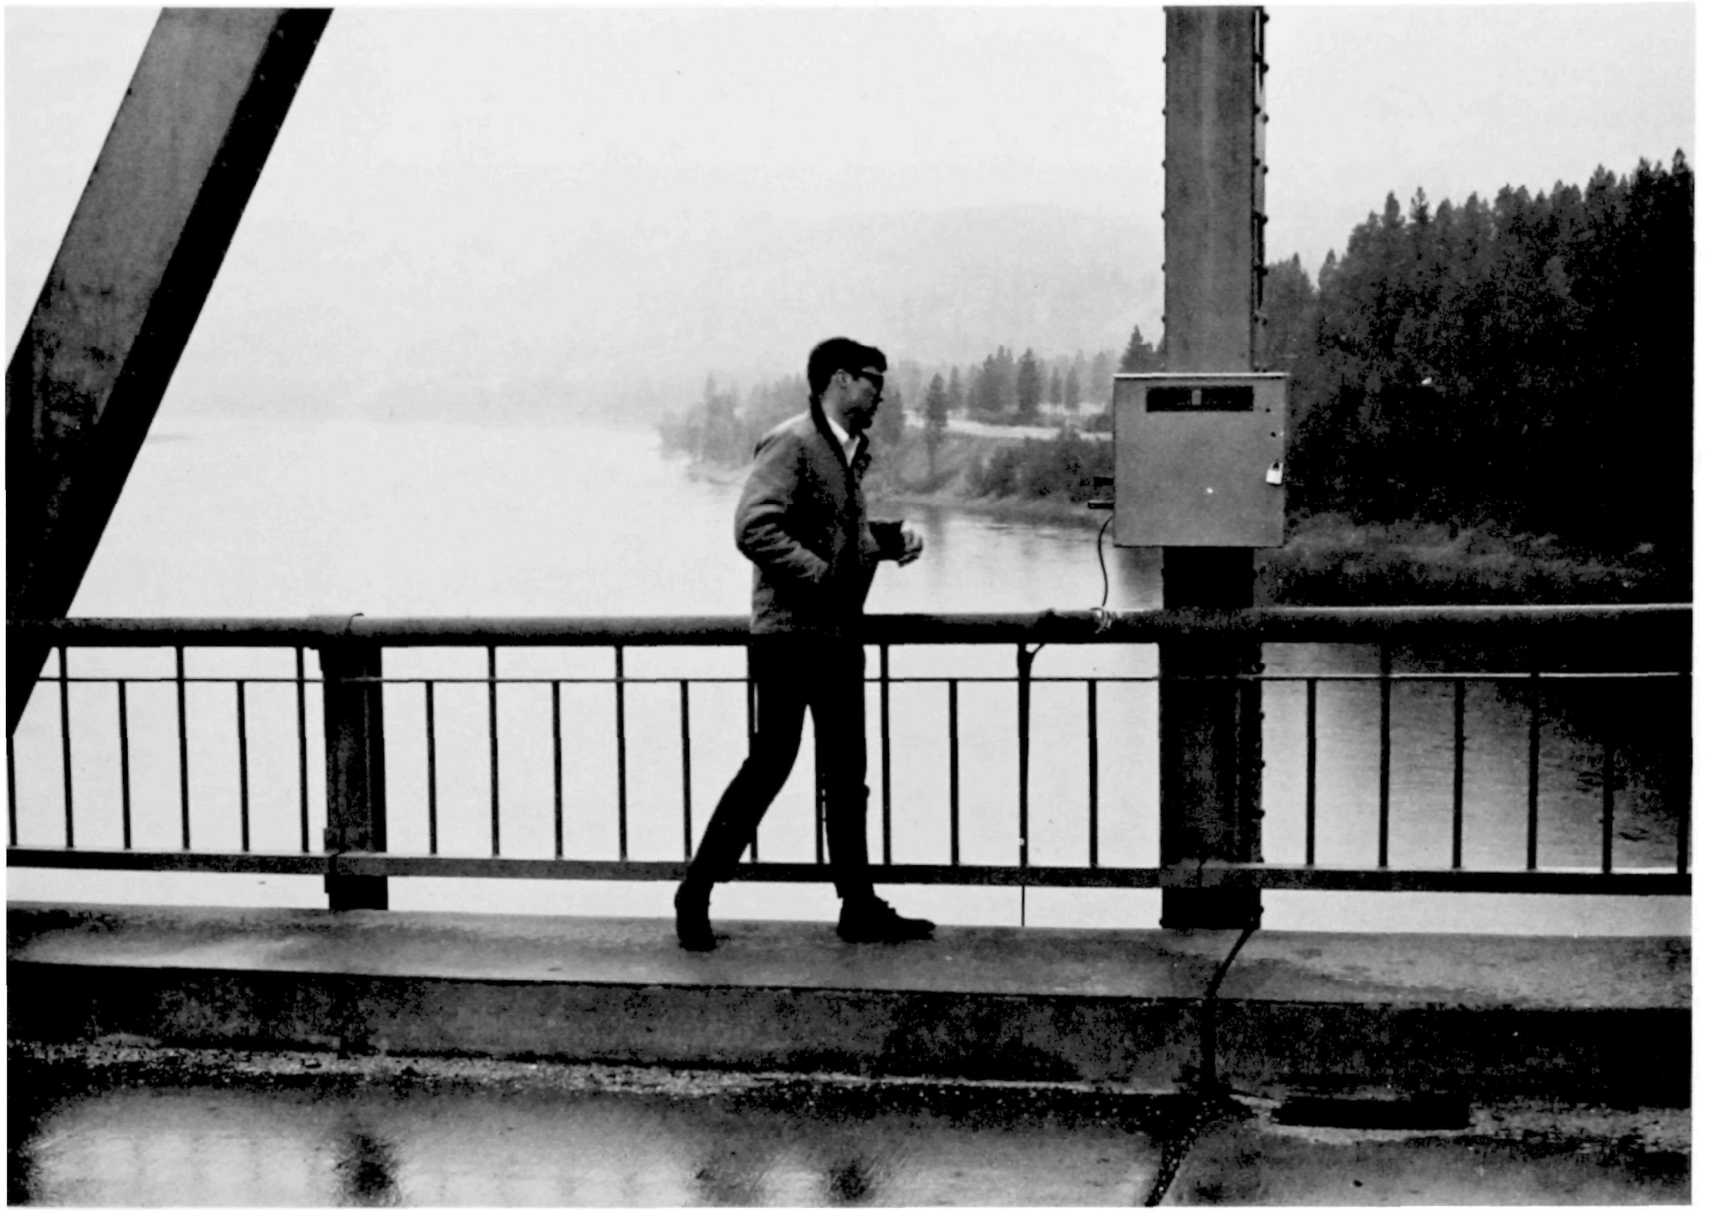
COLUMBIA RIVER BRIDGE AT NORTH PORT, WASHINGTON
View of existing thermograph housing at downstream side of bridge
FIGURE 35

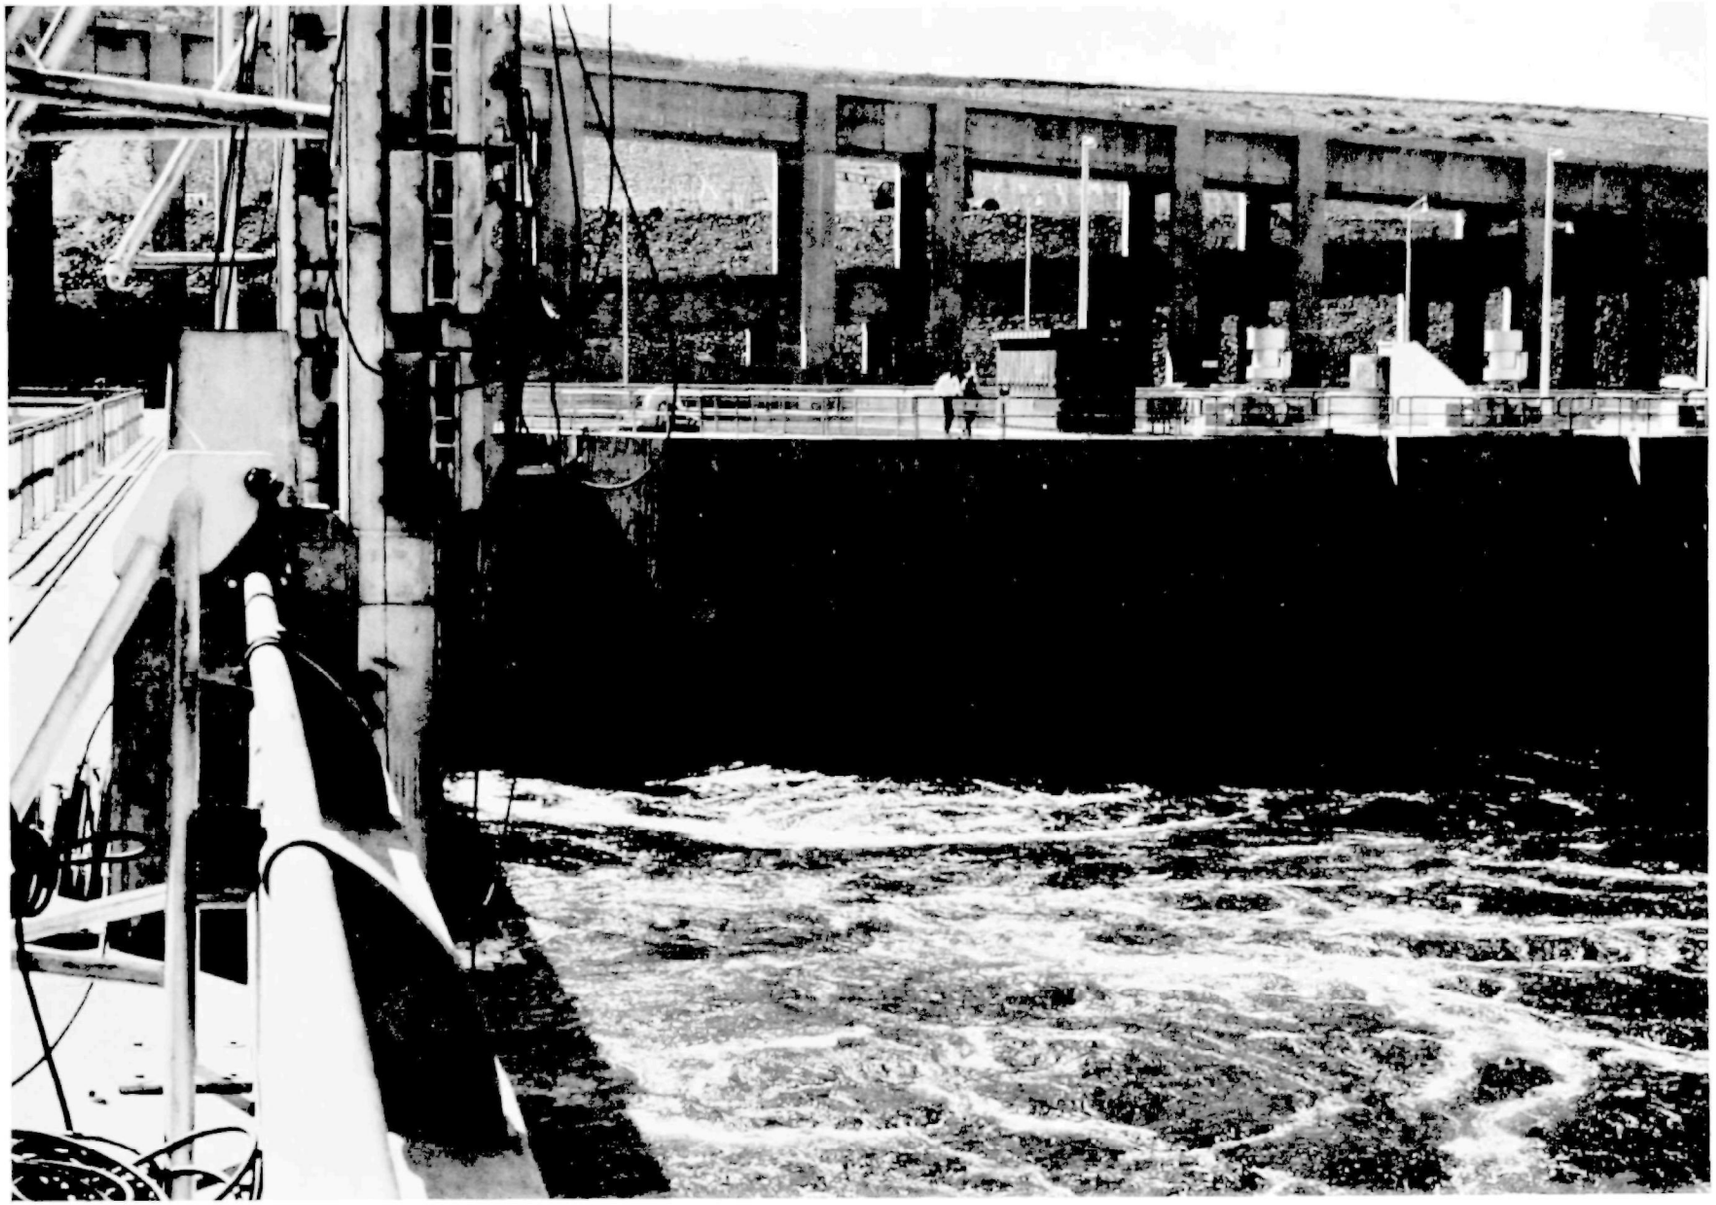
The tailrace of Ice Harbor Dam apprears to be an ideal location for a thermograph because of the completely mixed discharge from the dam. Stratified river conditions were documented further downstream during the reconnaissance survey. This stratification was caused by warmer Snake River water overriding the colder backwater from McNary pool.

FIGURE 36 shows a probable location for the continuous recording thermograph which is on the left side of the tailrace, approximately where the men shown in the photograph are standing. FIGURE 37 shows the turbulent river condition downstream of the potential thermograph location.

Temperature readings are presently being taken from a thermometer attached to the turbine cooling water lines. These records are not adequate for incorporation into the RTRN as discussed in earlier paragraphs.

ICE HARBOR DAM - SNAKE RIVER
Looking at tailrace and left wall downstream of powerhouse (Q=37,000 cfs)
FIGURE 36

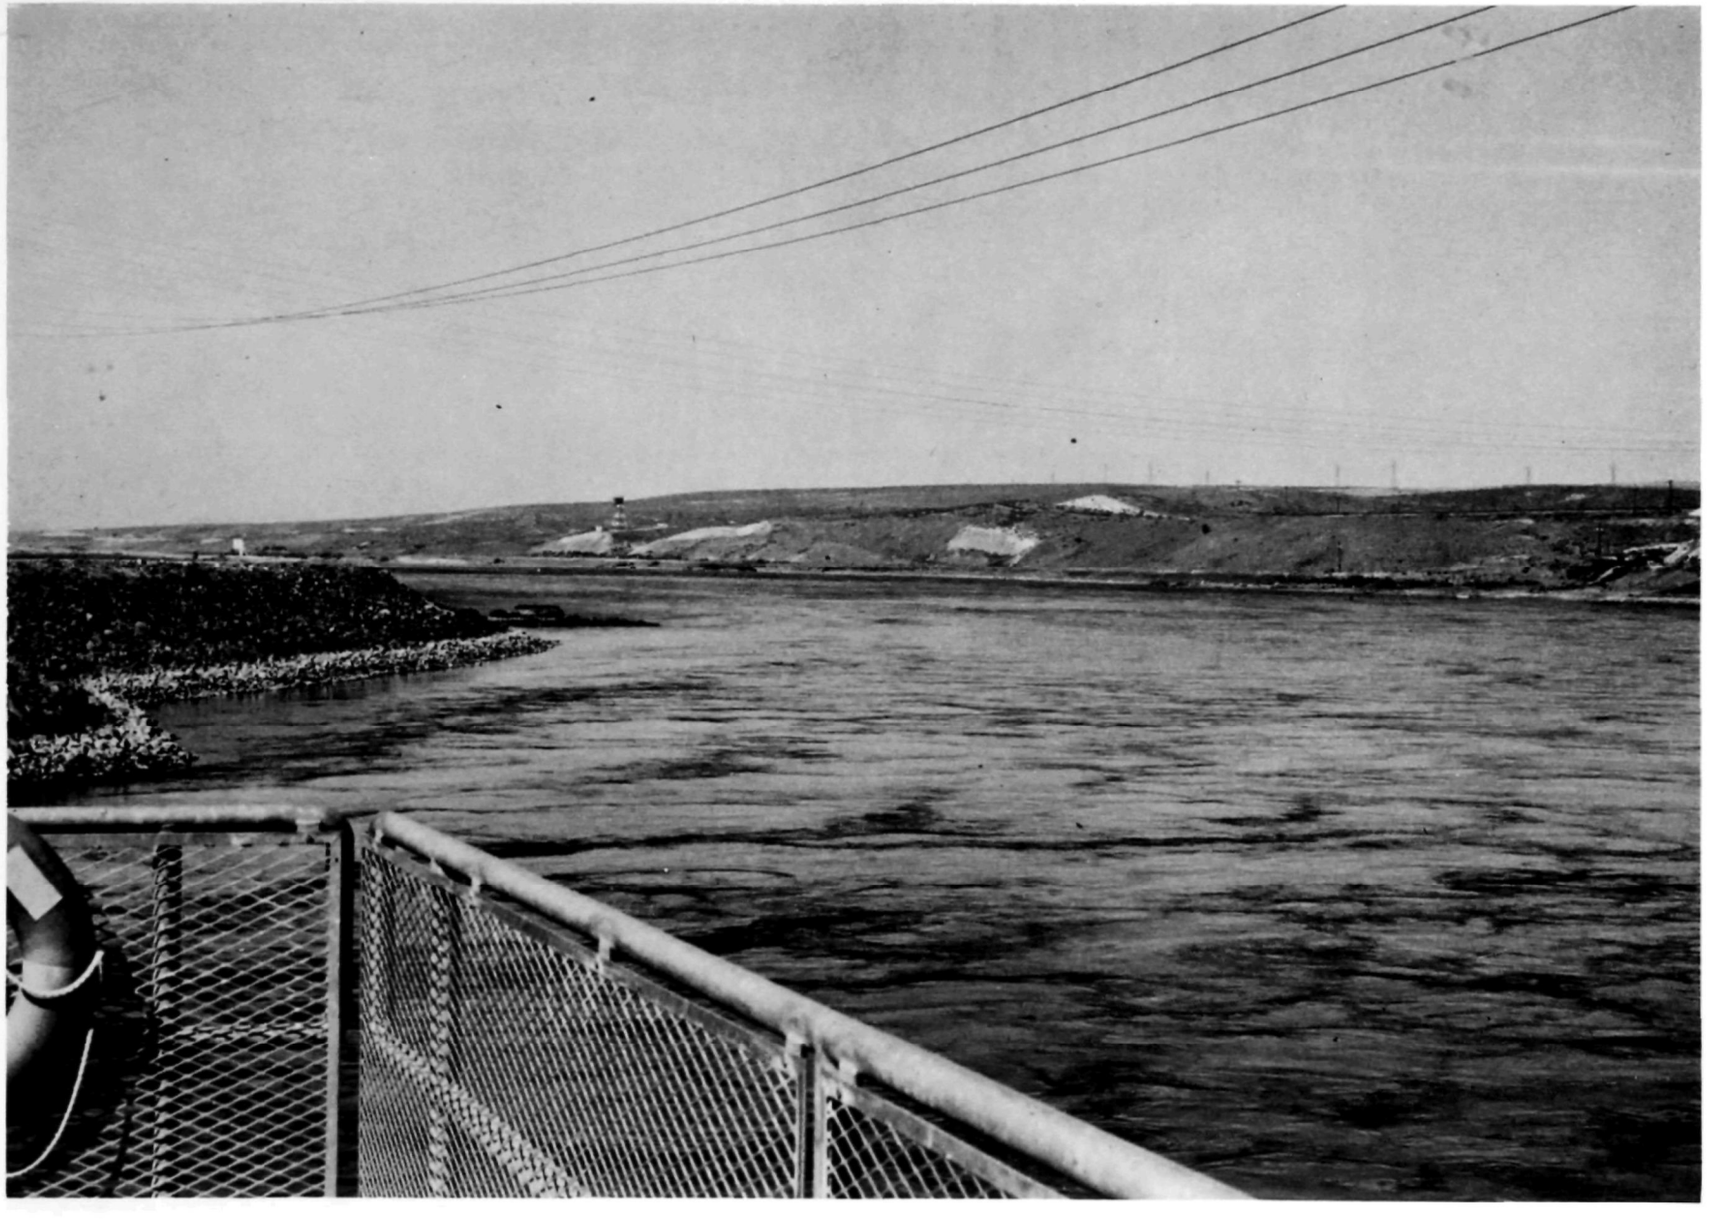
SNAKE RIVER DOWNSTREAM OF ICE HARBOR DAM
Looking at turbulent tailrace from left side of Dam (Q=37,000 cfs)
FIGURE 37
