REGIONAL TEMPERATURE REPORTING NETWORK

1968 FIELD RECONNAISSANCE SURVEY

FEDERAL WATER POLLUTION CONTROL ADMINISTRATION
NORTHWEST REGION
PORTLAND, OREGON

Working Paper No. 62

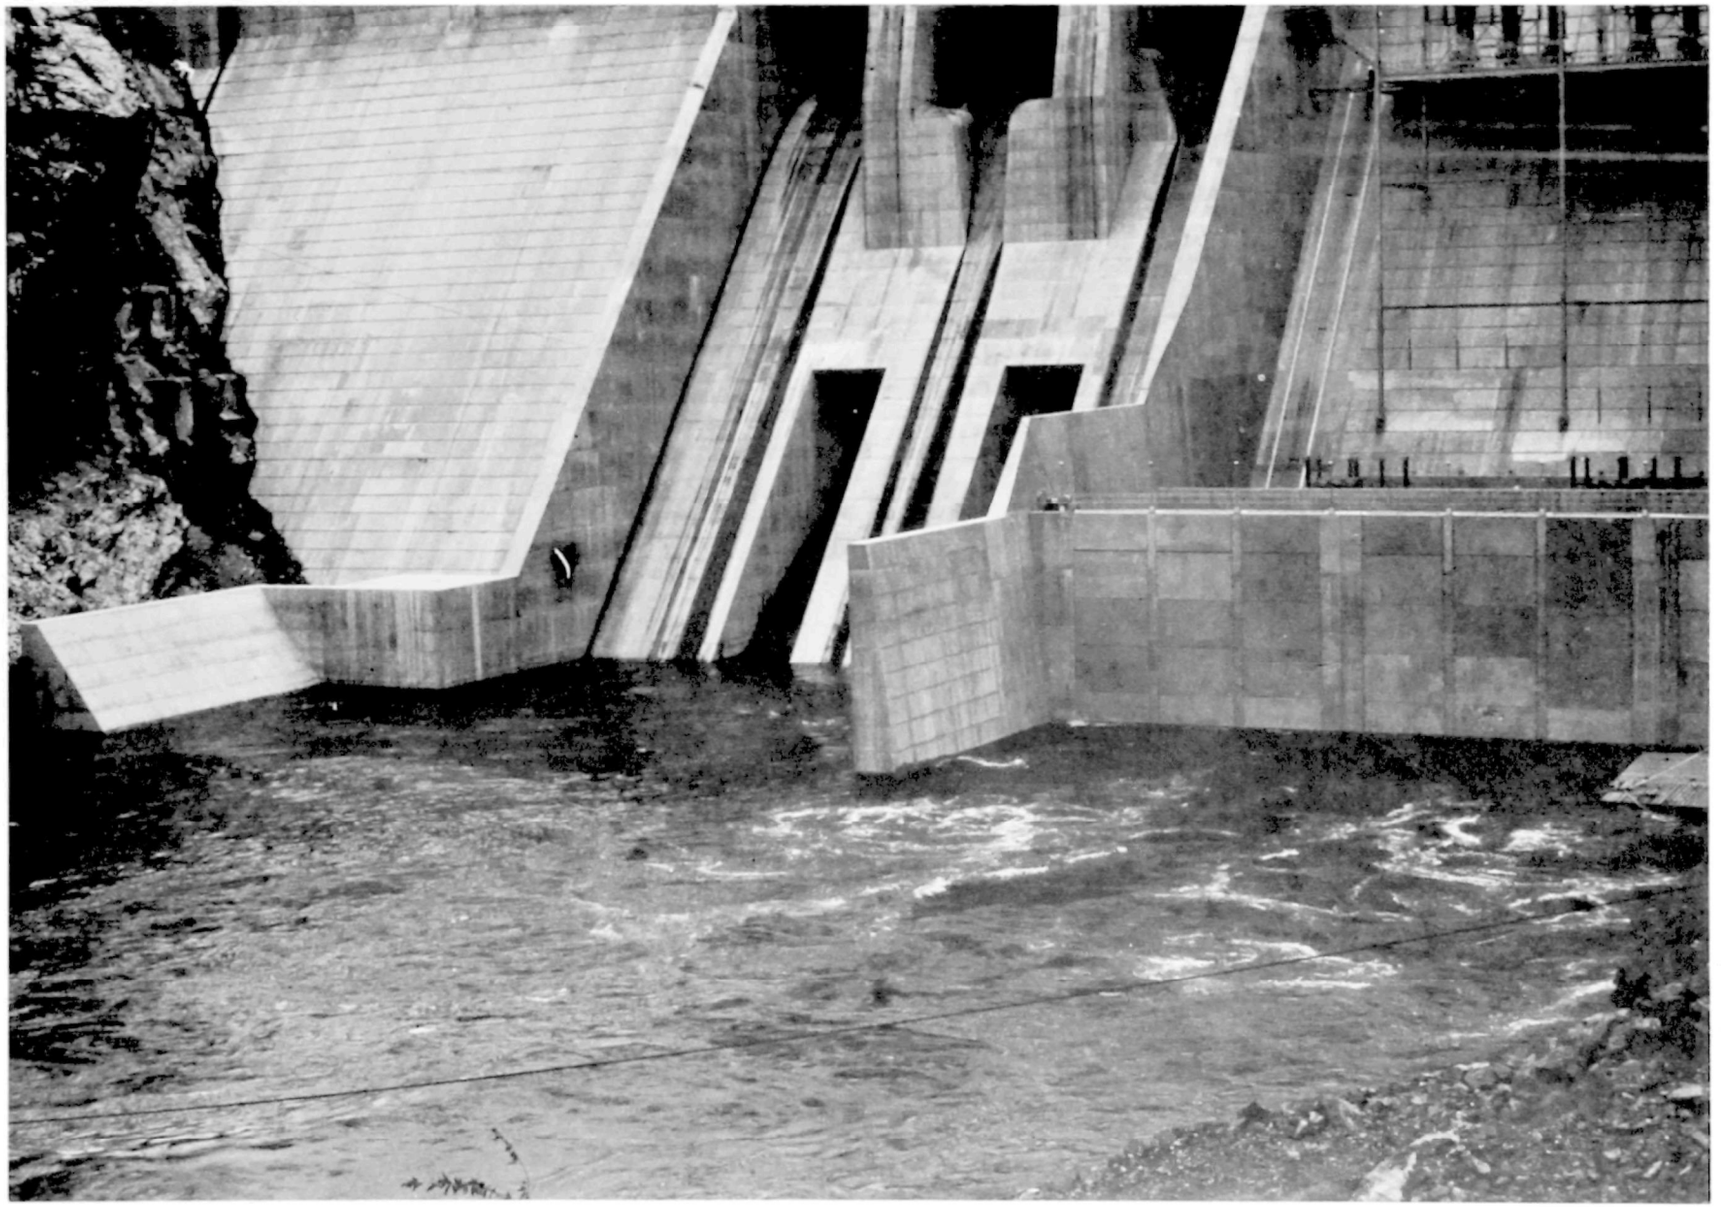
HELLS CANYON DAM
Looking upstream at downstream face of Dam
FIGURE 42

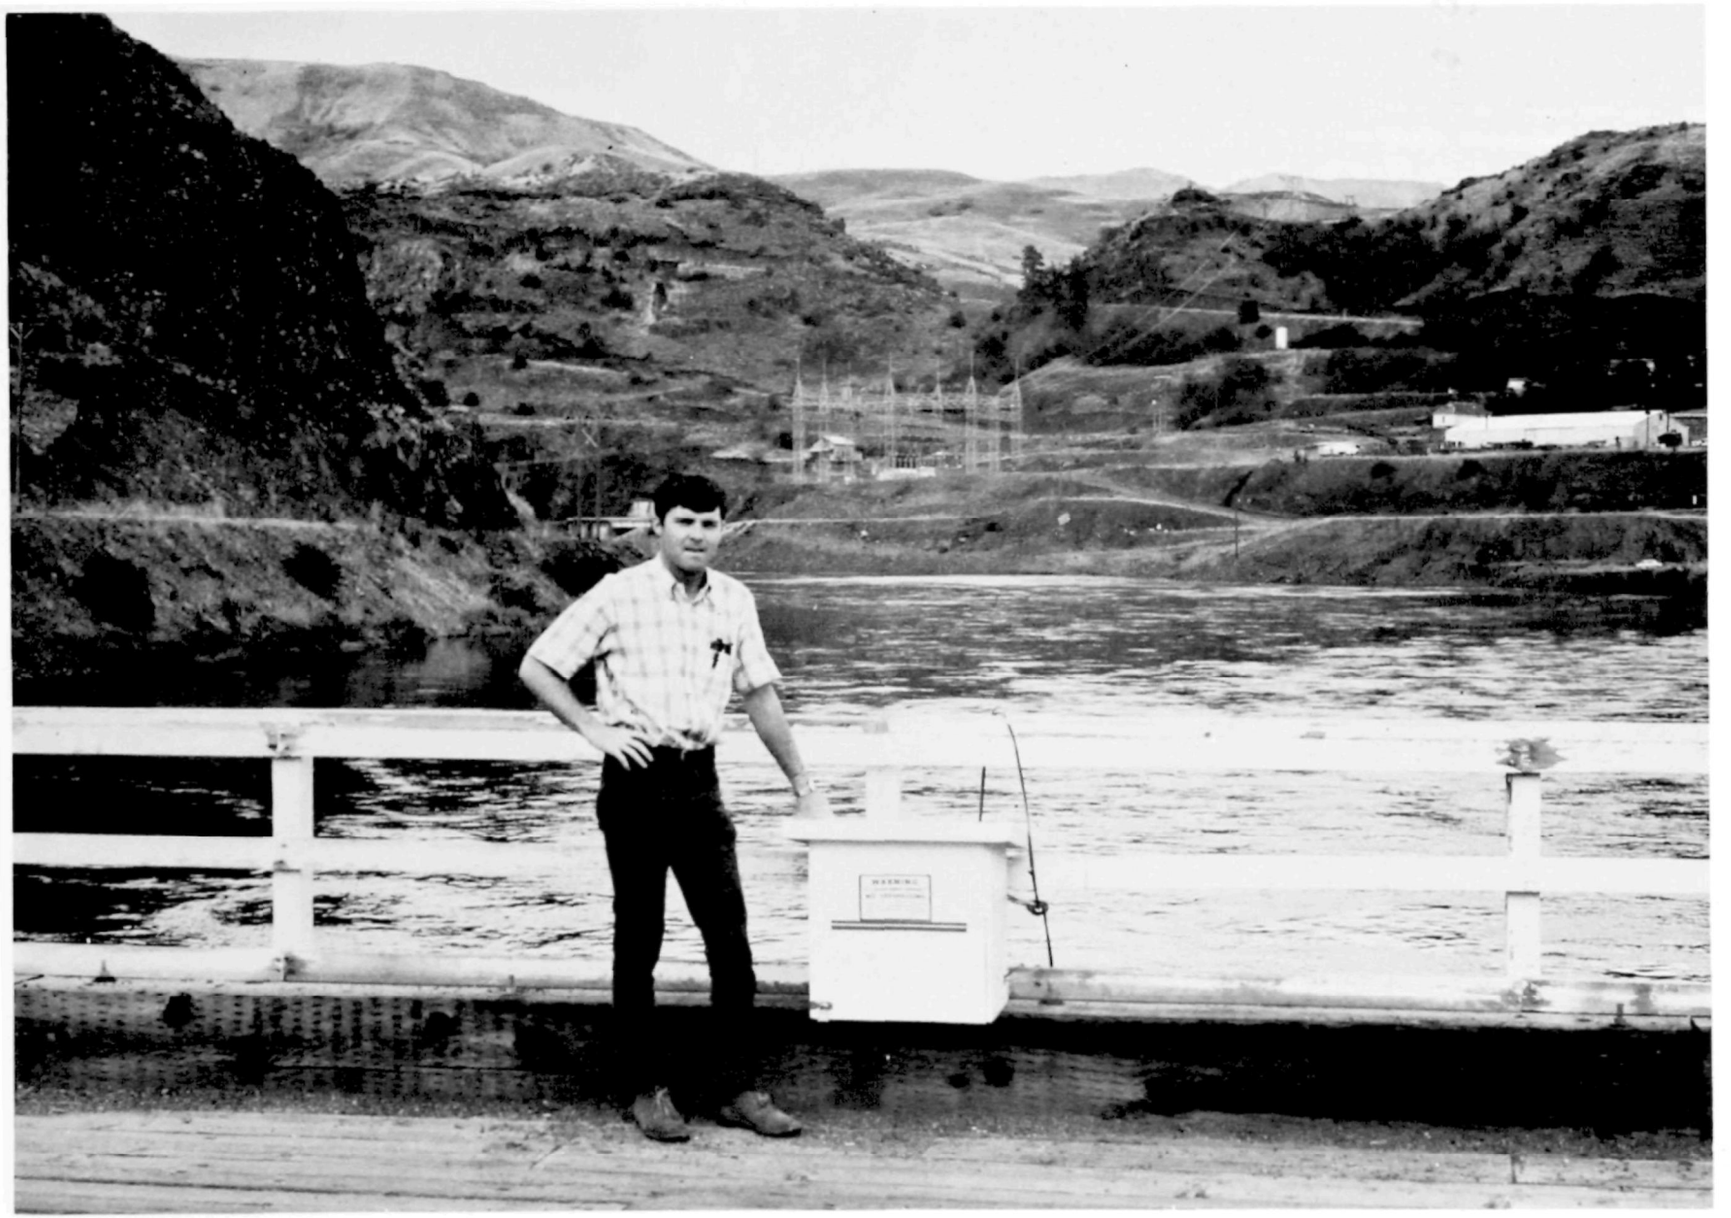
FIGURE 43 is a view of the existing FWPCA water quality instrument housing attached to the bridge just downstream of Oxbow Dam (barely visible in background). The bridge offers a practical location for a continuous recording thermograph due to the well mixed river condition at this point and easy site access. Vandalism is not considered to be a problem here because of its proximity to the dam. This water quality station has also been removed.

BRIDGE LOCATION ON THE SNAKE RIVER BELOW OXBOX DAM
Oxbow dam is just upstream around bend in the river
FIGURE 43

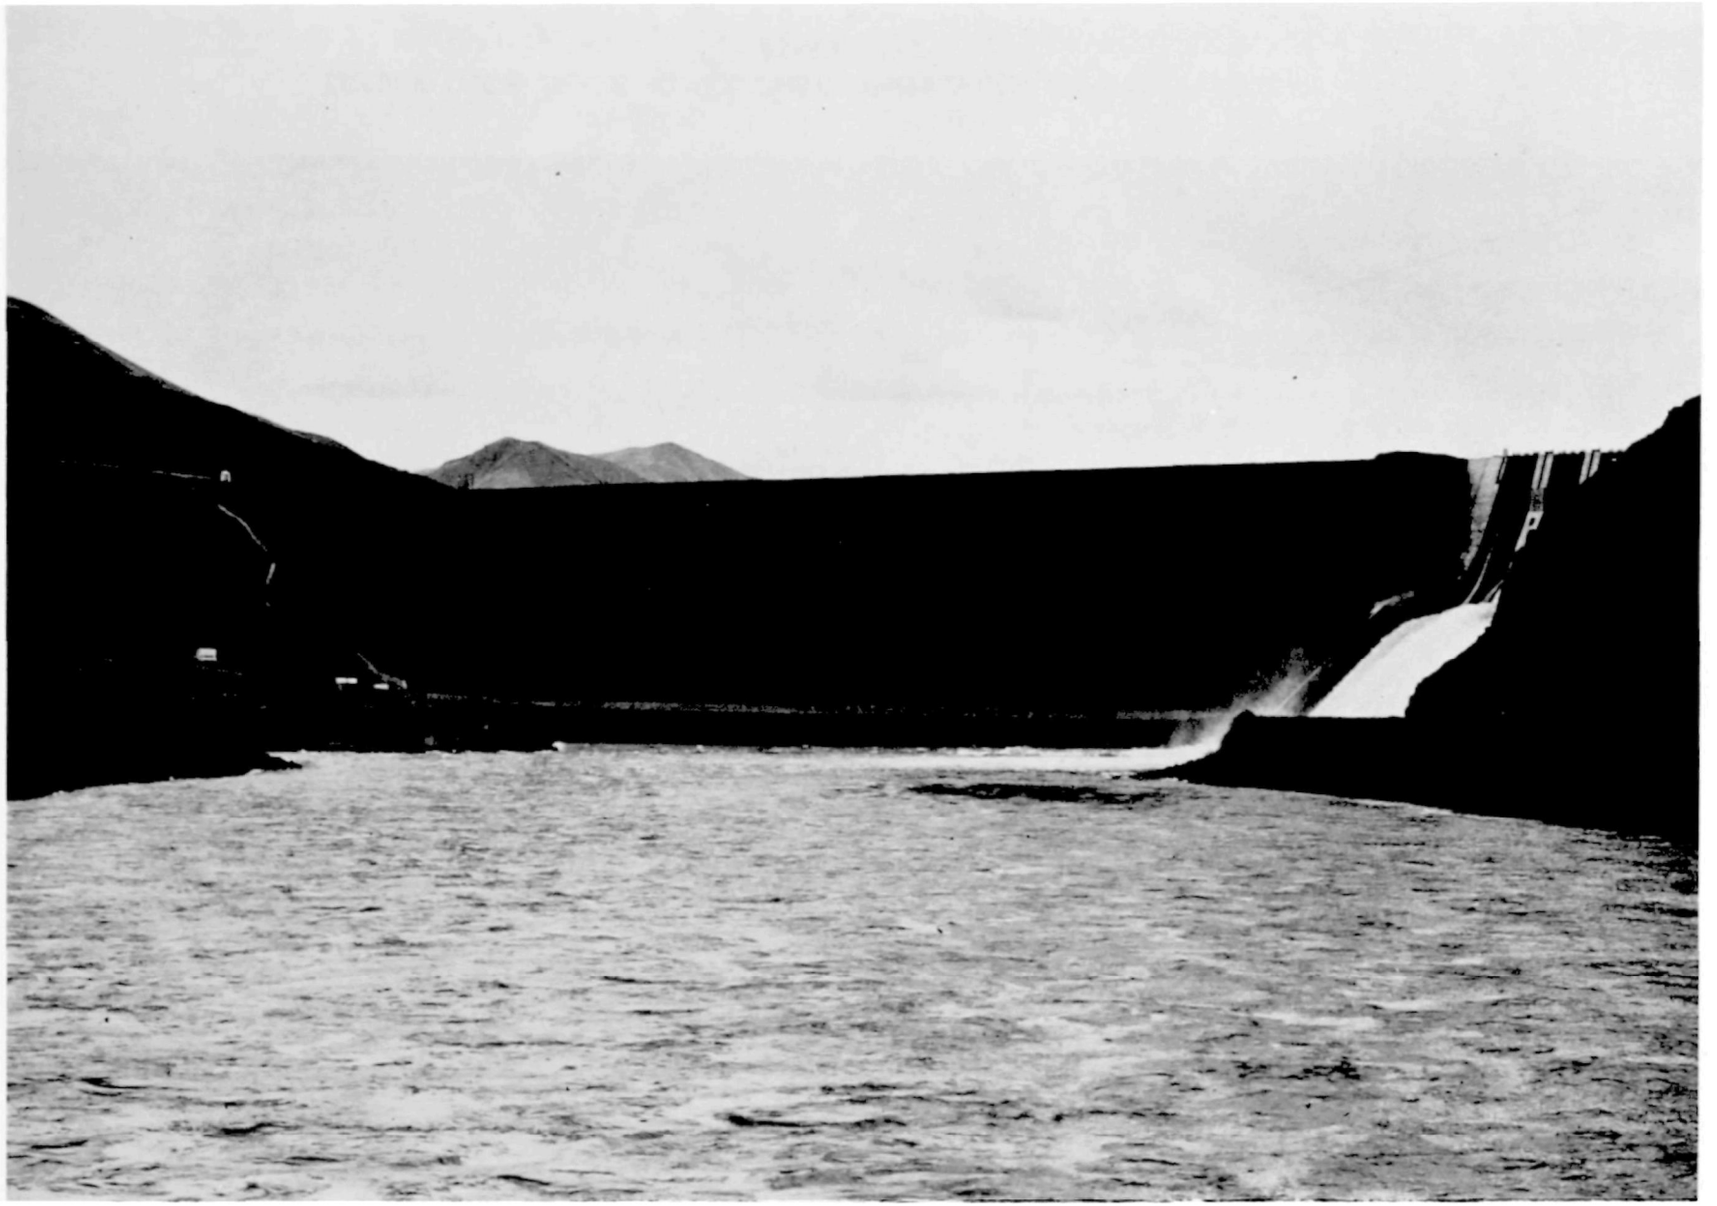
BROWNLEE DAM
Looking at downstream face of Dam from bridge below Dam
FIGURE 45

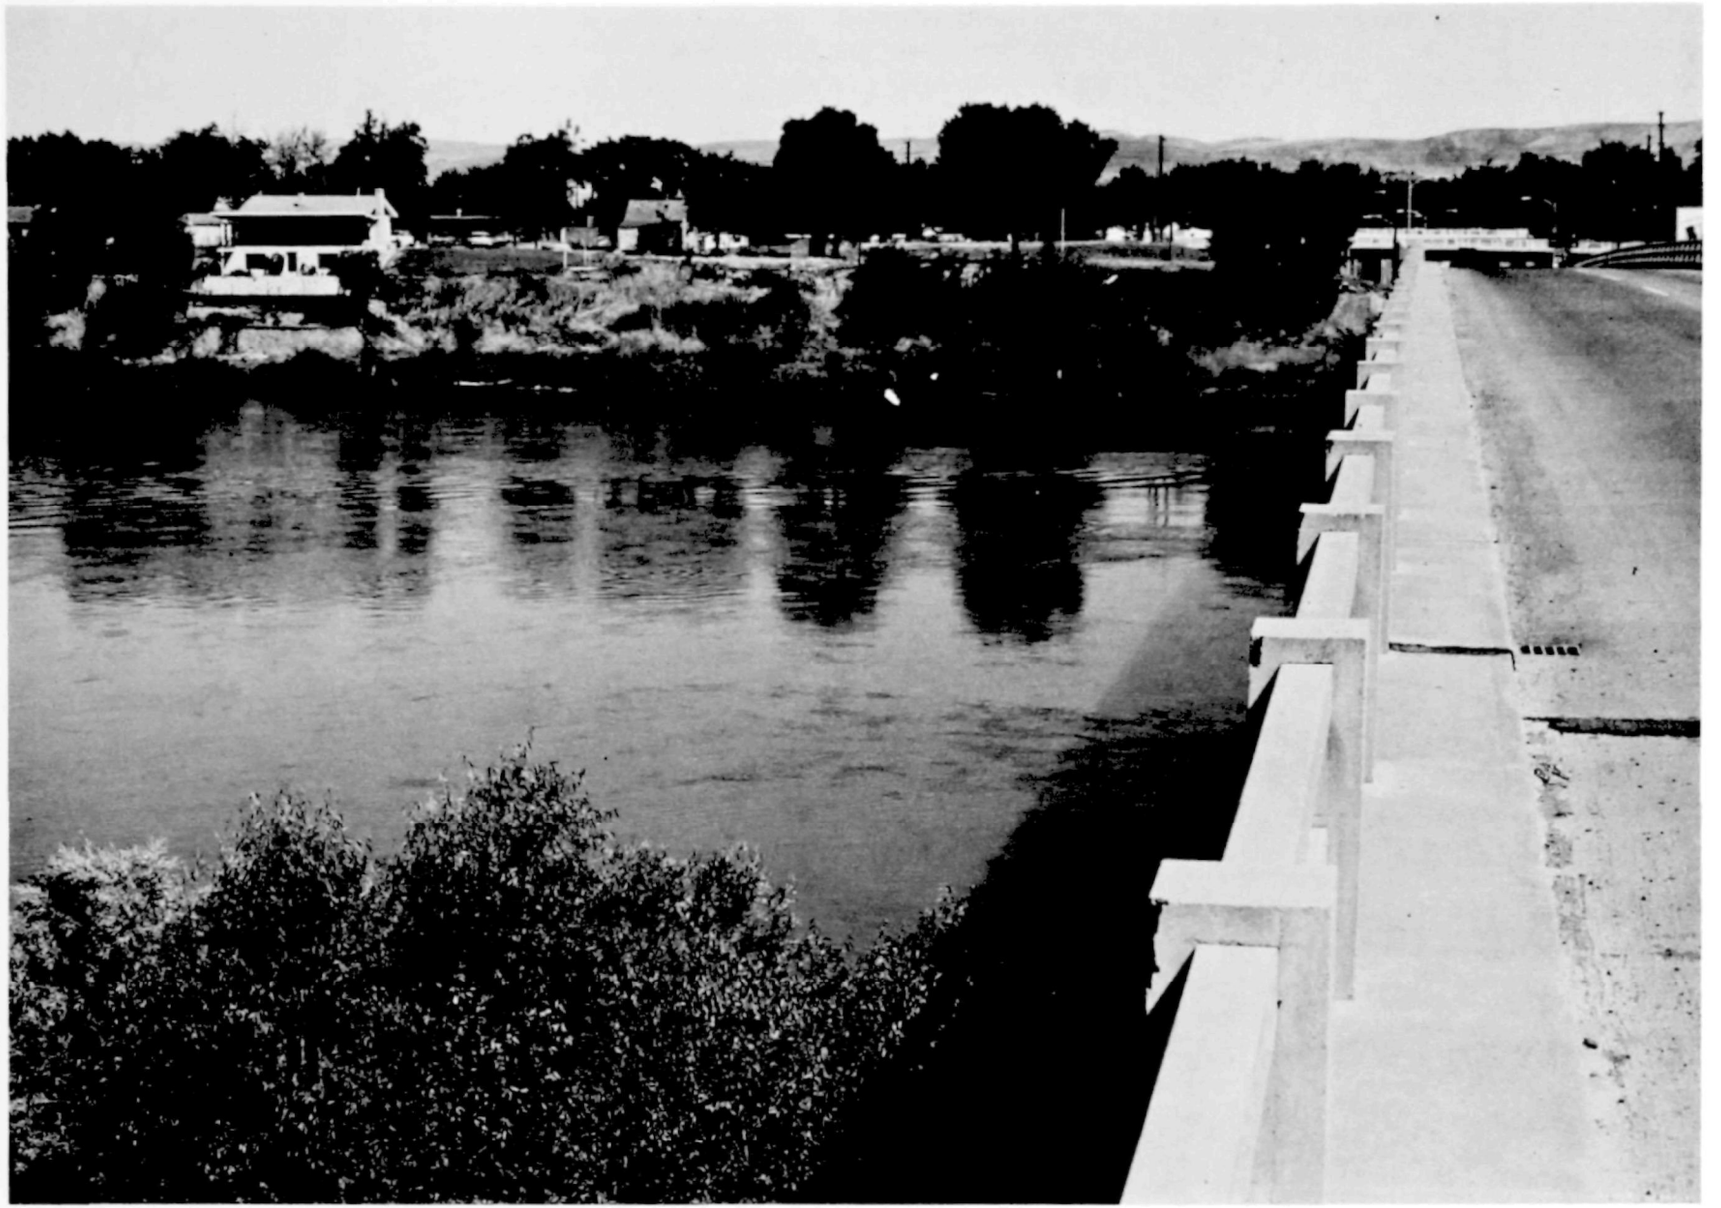
A possible thermograph location at Weiser, Idaho is approximately 0.5 miles downstream of the mouth of the Weiser River and is shown in FIGURE 46. The thermograph can be attached to the highway 30N bridge at Weiser, Idaho. Temperature cross-sections will be needed at this site before the thermograph is installed. Vandalism should not be much of a problem due to the heavy traffic over this main bridge.

SNAKE RIVER AT WEISER, IDAHO
Looking toward Idaho shore from Oregon shore at downstream side of Highway 30N bridge
FIGURE 46

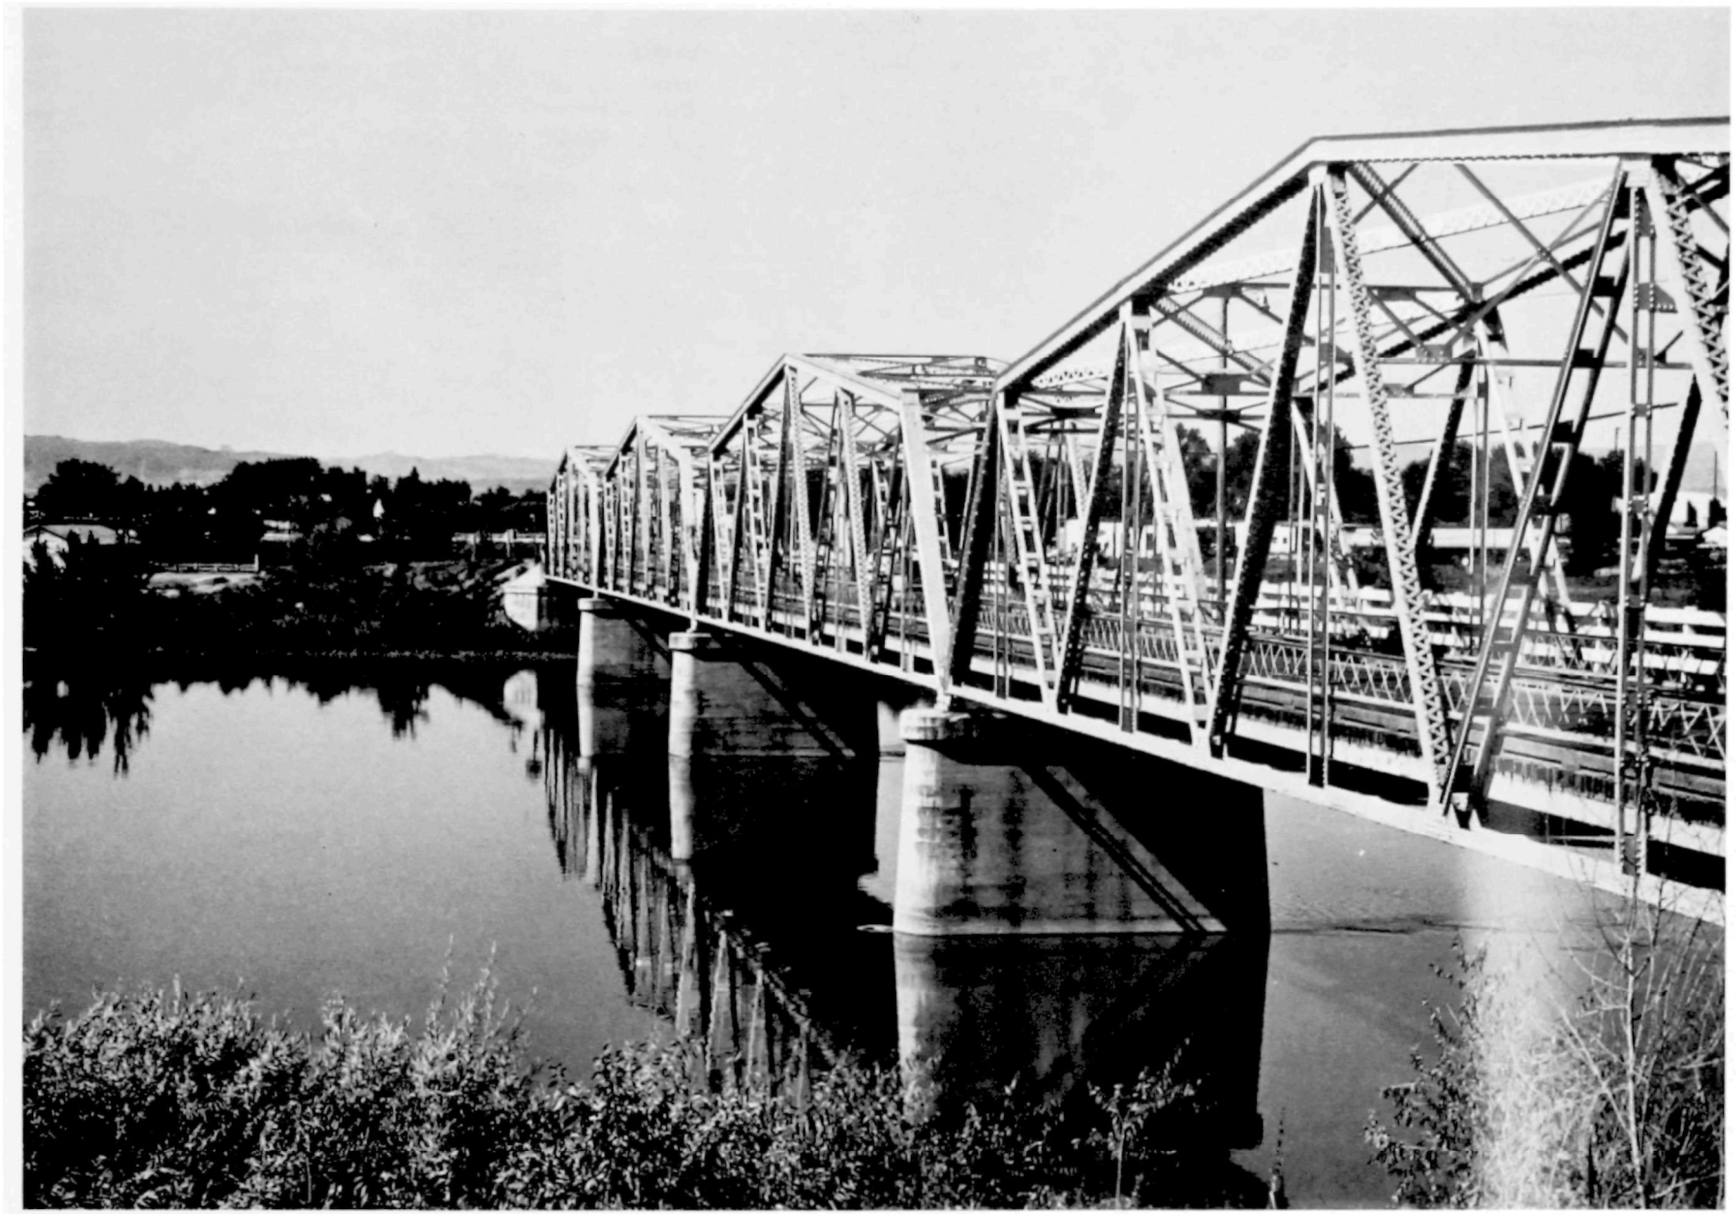
A thermograph site is needed on the Oregon-Idaho border of the Snake River to monitor temperature changes for "Water Quality Standards" purposes. Highway 19 bridge at Homedale, Idaho, shown on FIGURE 47, was investigated as a location for a continuous recording thermograph. Temperature cross-sections will have to be taken here prior to the installation of the recording instrument for insurance of a well mixed condition. Ample instrument protection against vandalism should be provided at this site.

SNAKE RIVER AT HOMEDALE, IDAHO
Looking across the Snake River toward left bank upstream of highway No. 19 bridge
FIGURE 47

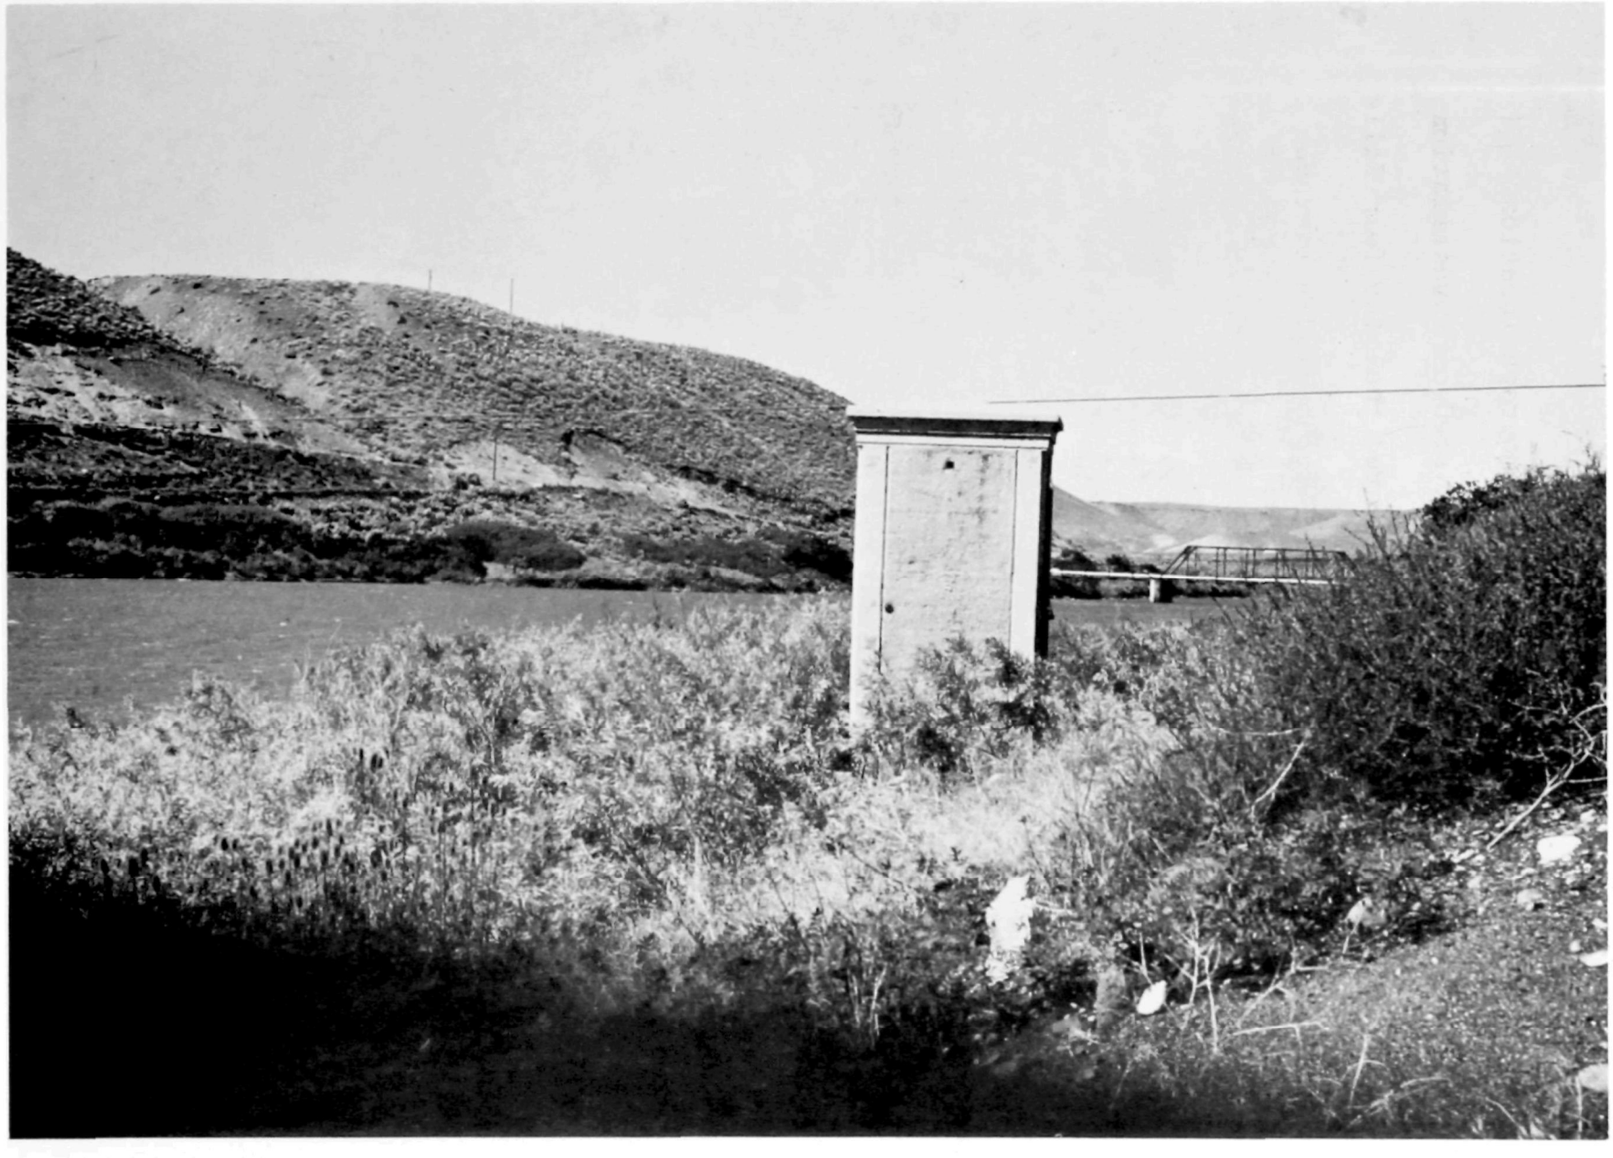
U.S.G.S. GAUGING STATION ON SNAKE RIVER AT KING HILL, IDAHO
Looking upstream at bridge with gauging station in foreground
FIGURE 49

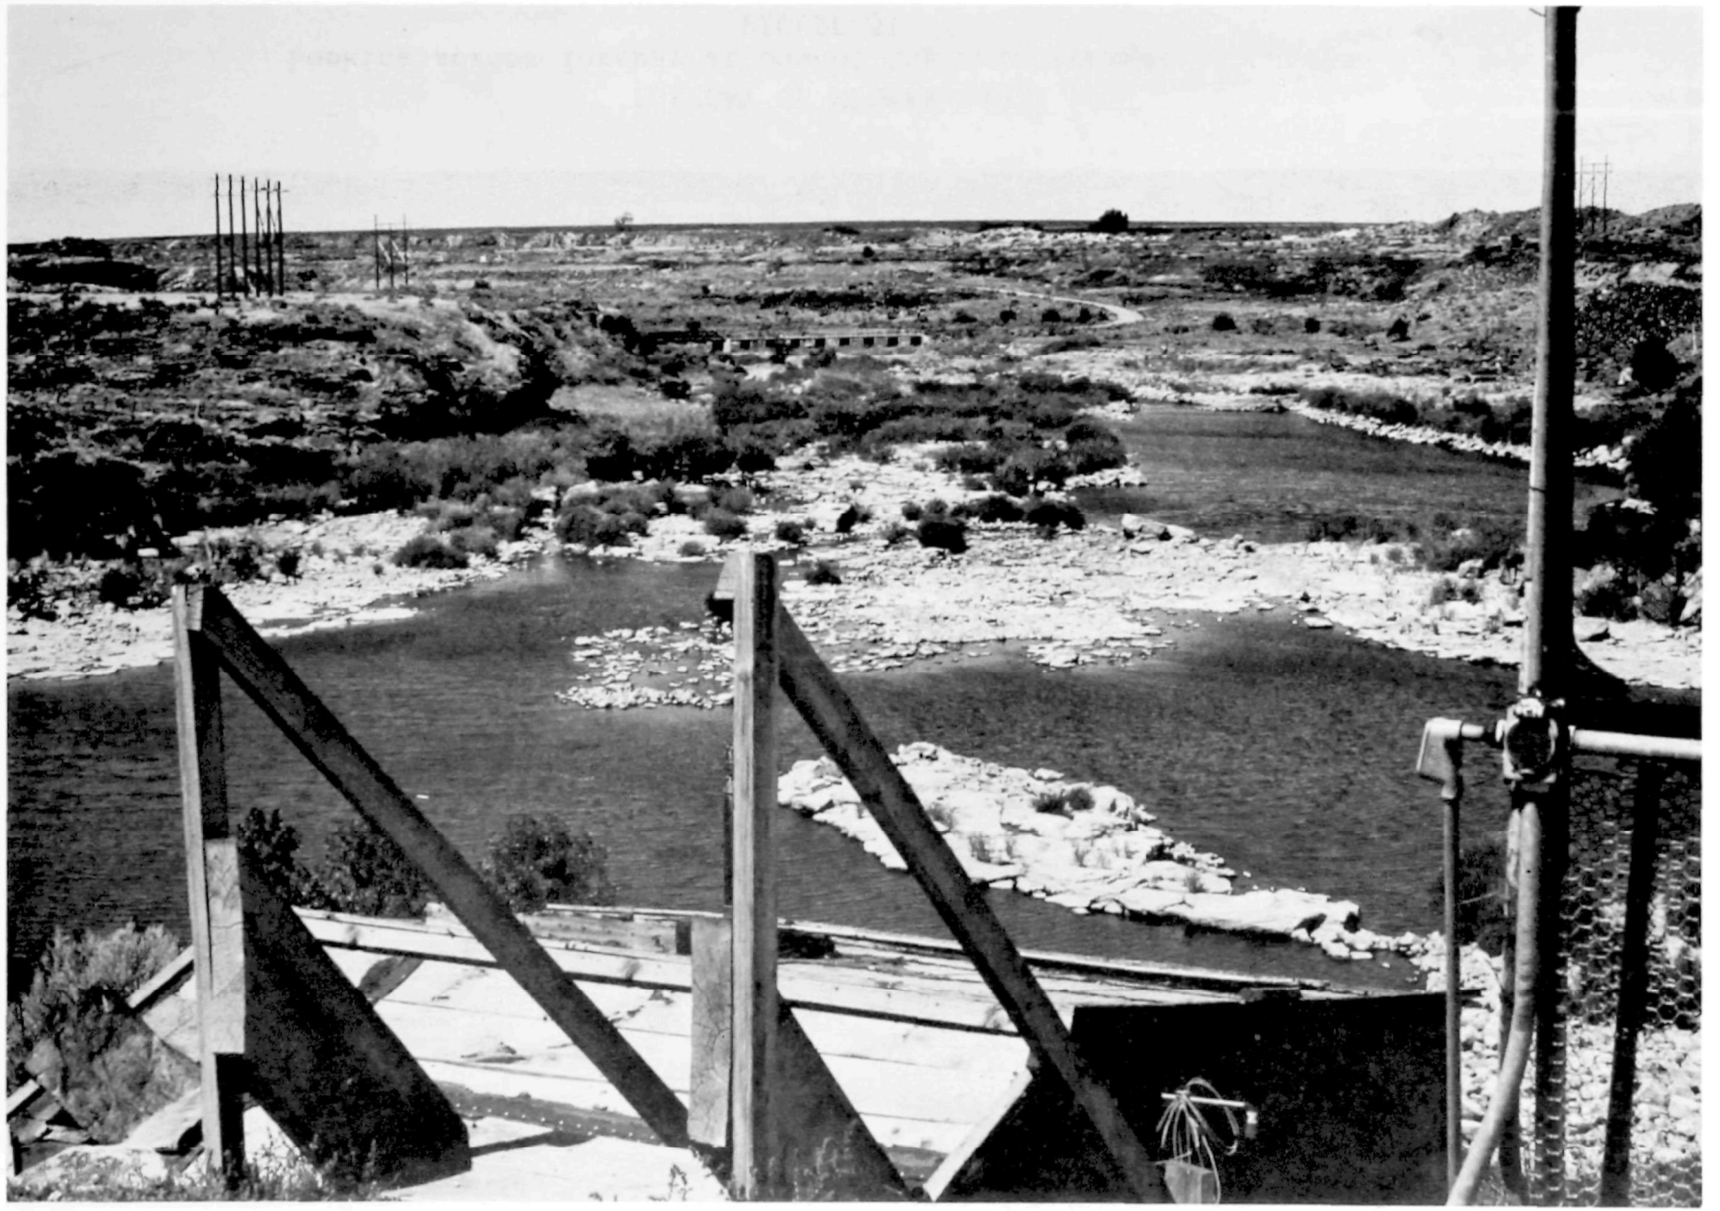
Preliminary planning indicated that a thermograph location below Milner Dam should be included in the RTRN. Upon investigation of the site on August 28, 1968, it was discovered that the Twin Falls Canal Company had diverted the entire Snake River behind Milner Dam into several irrigation ditches. FIGURE 50 shows the condition downstream from Milner Dam and FIGURE 51 shows one of the irrigation canal diversions behind Milner Dam. Because the river is diverted during the irrigation season, a thermograph sensor downstream of the dam would be setting either in a stagnant pool or open air during part of the year, thereby yielding erroneous temperature results. Another site further downstream should be investigated, possibly in the "1000 Springs" area or the vicinity downstream of the irrigation waste water return flow.

SNAKE RIVER JUST DOWNSTREAM OF MILNER DAM, IDAHO
Looking downstream from top of dam (flow completely shut off)
FIGURE 50

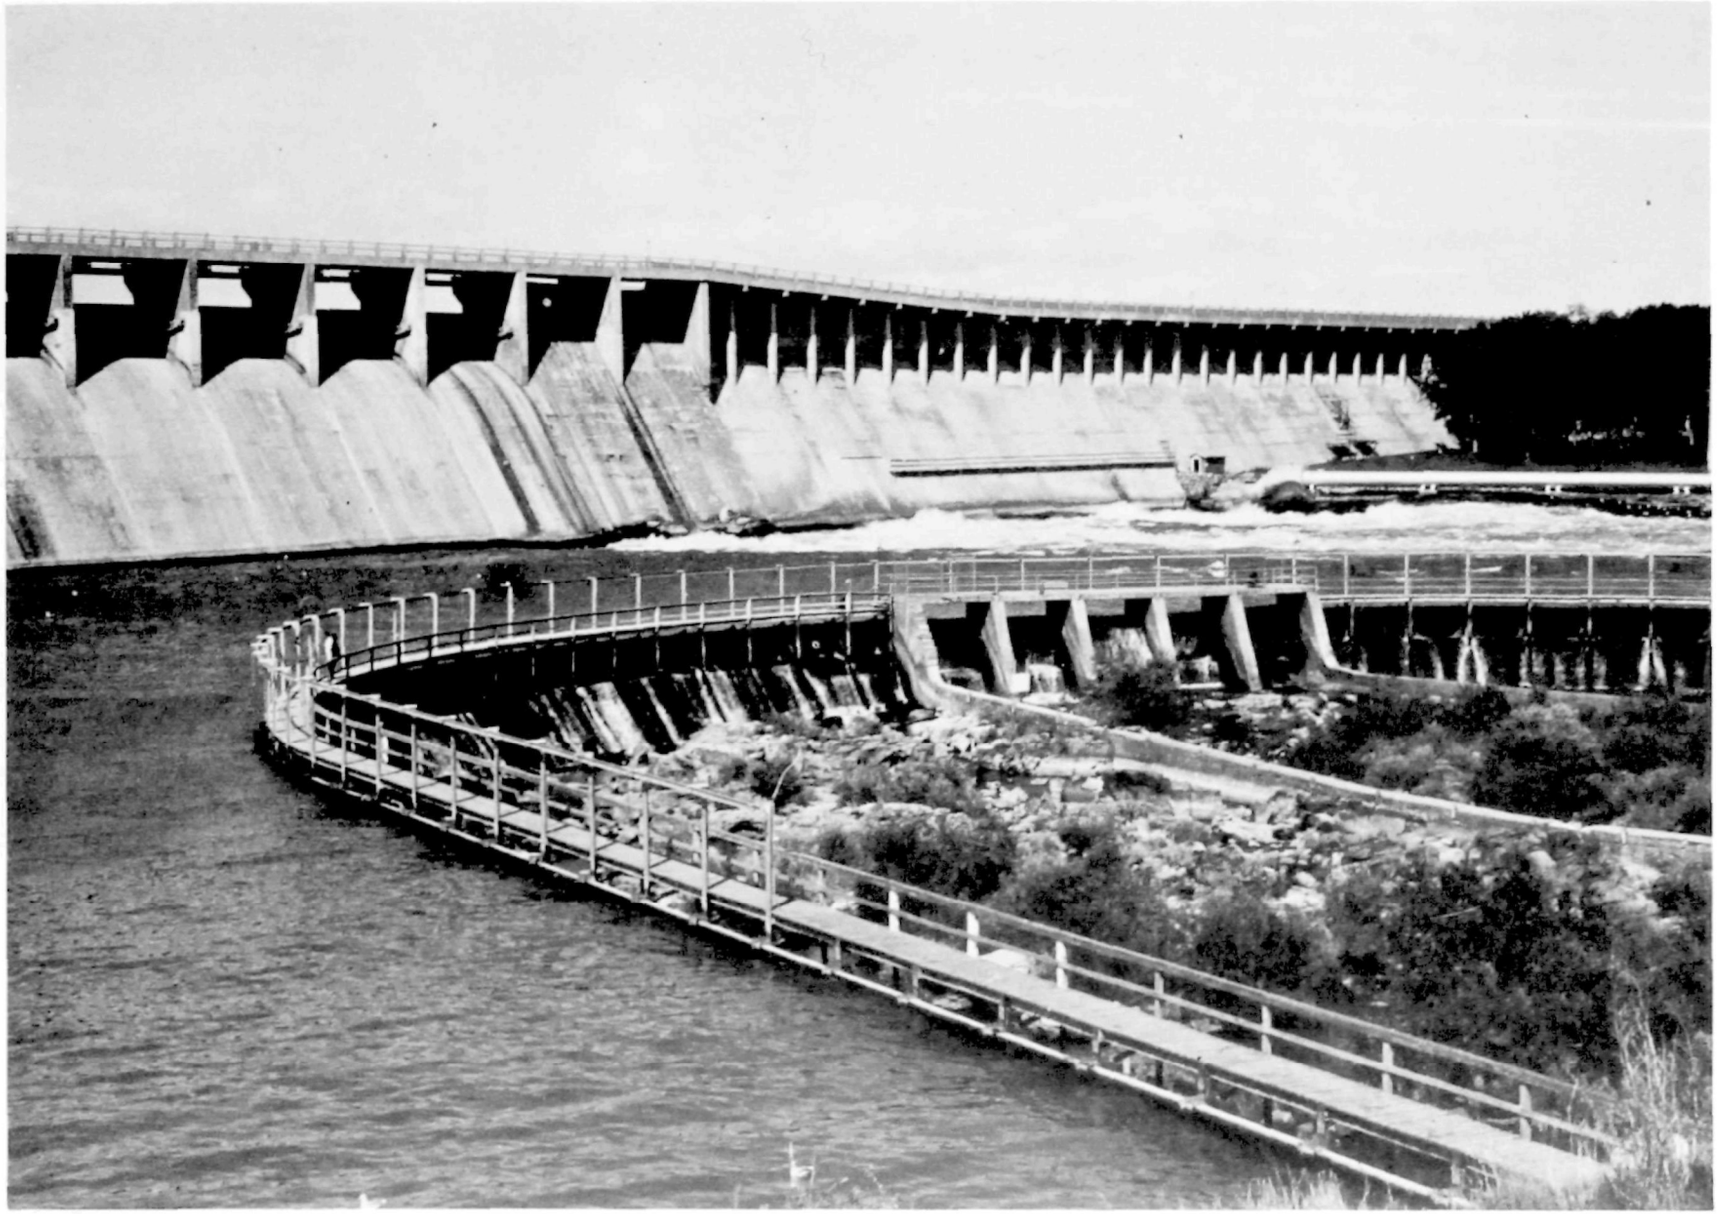
AMERICAN FALLS DAM ON THE SNAKE RIVER
Discharge is through conduits into secondary dam
FIGURE 53
