New Mine Sealing Techniques For Water Pollution Abatement

Halliburton Company
Duncan, Oklahoma 73553

Program Number 14010 DMO

March, 1970

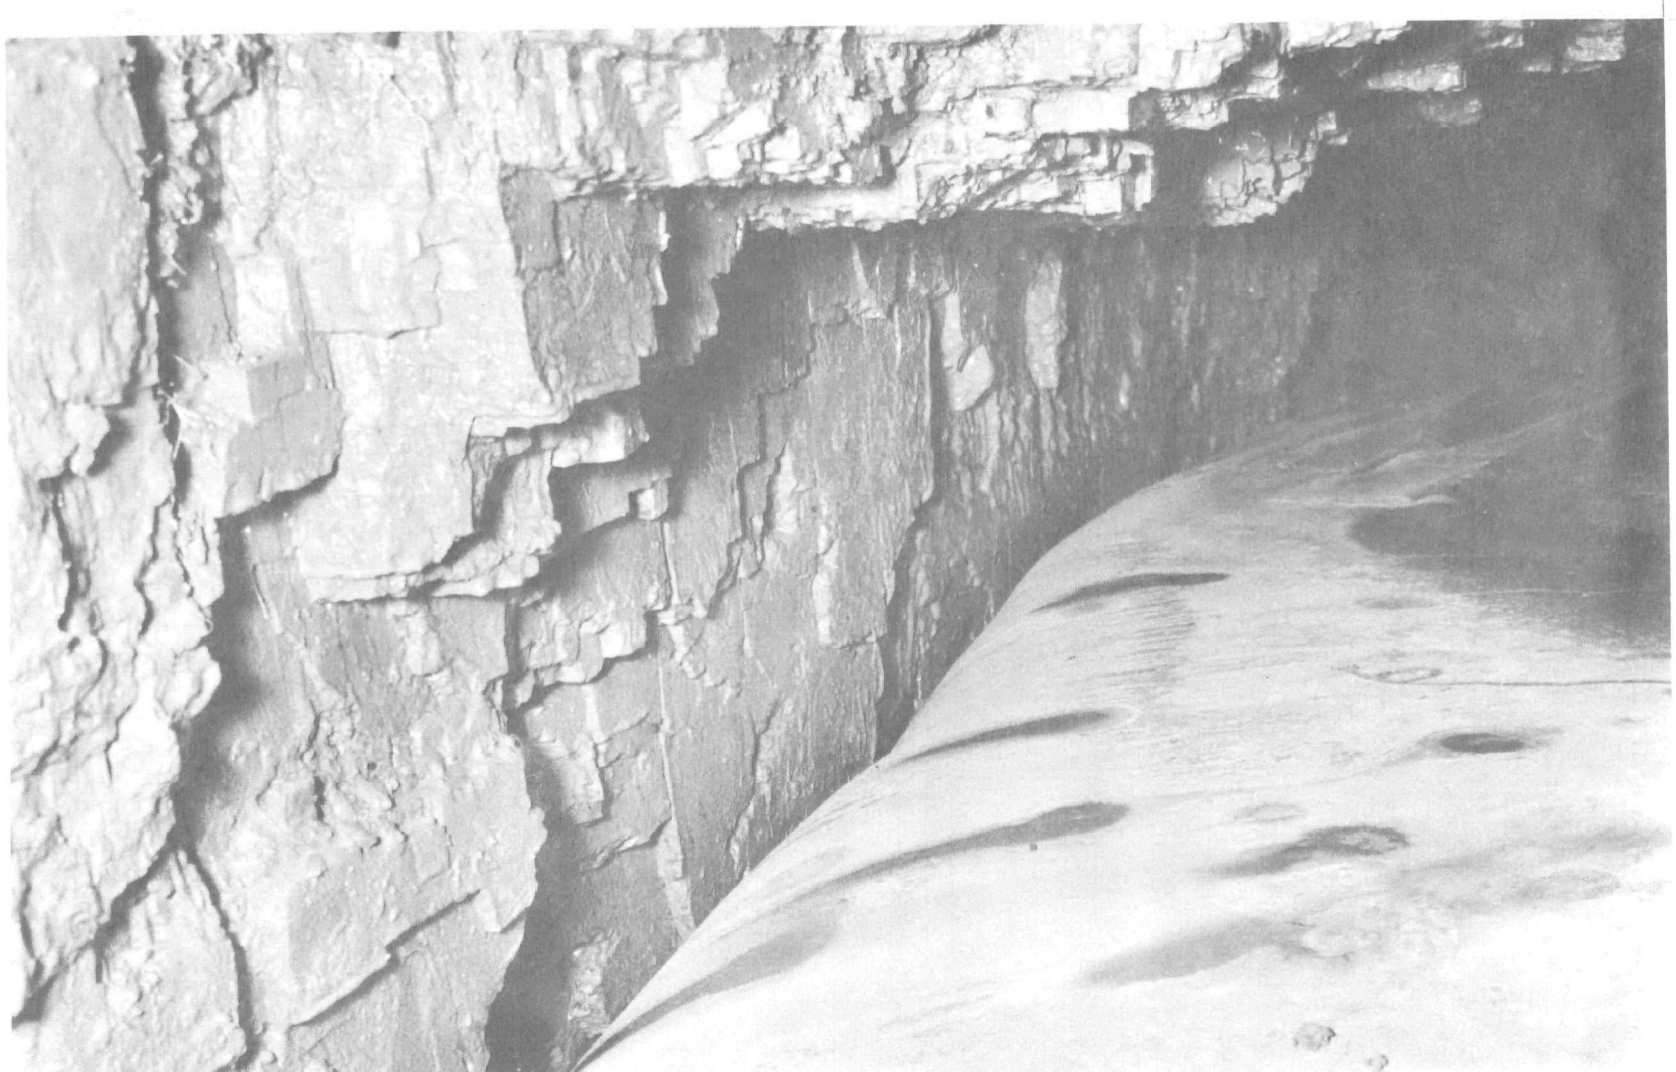
FIGURE 4 - VIEW OF FRACTURED COAL IN WALLS AND ROOF - MINE NO. 14-042A

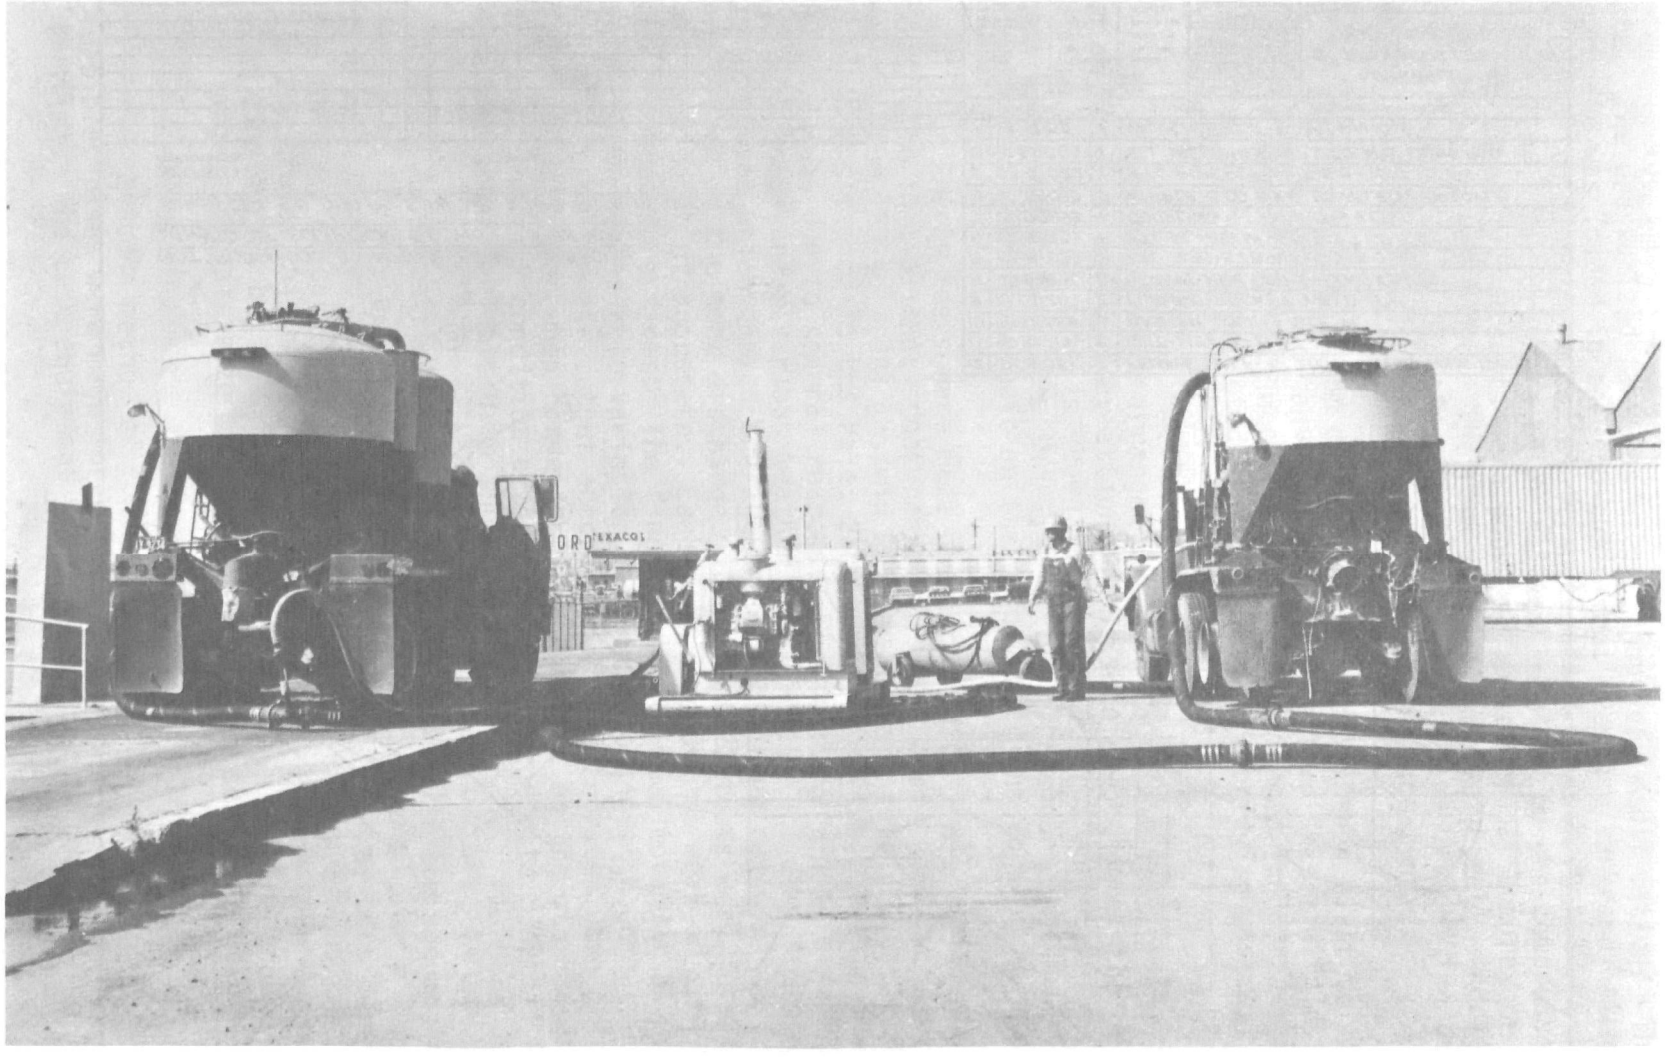
New tests were arranged, using a 160-cubic-foot pressure tank which had been modified by attaching the special bottom discharge manifold. A view of the test site is shown in Figure 16. The aggregate was moved back and forth between the two tank units. The amount moved was determined by weight of the unit on the left, which was located on a scale.

FIGURE 16 - PNEUMATIC CONVEYING TEST - 3/4-INCH AGGREGATE

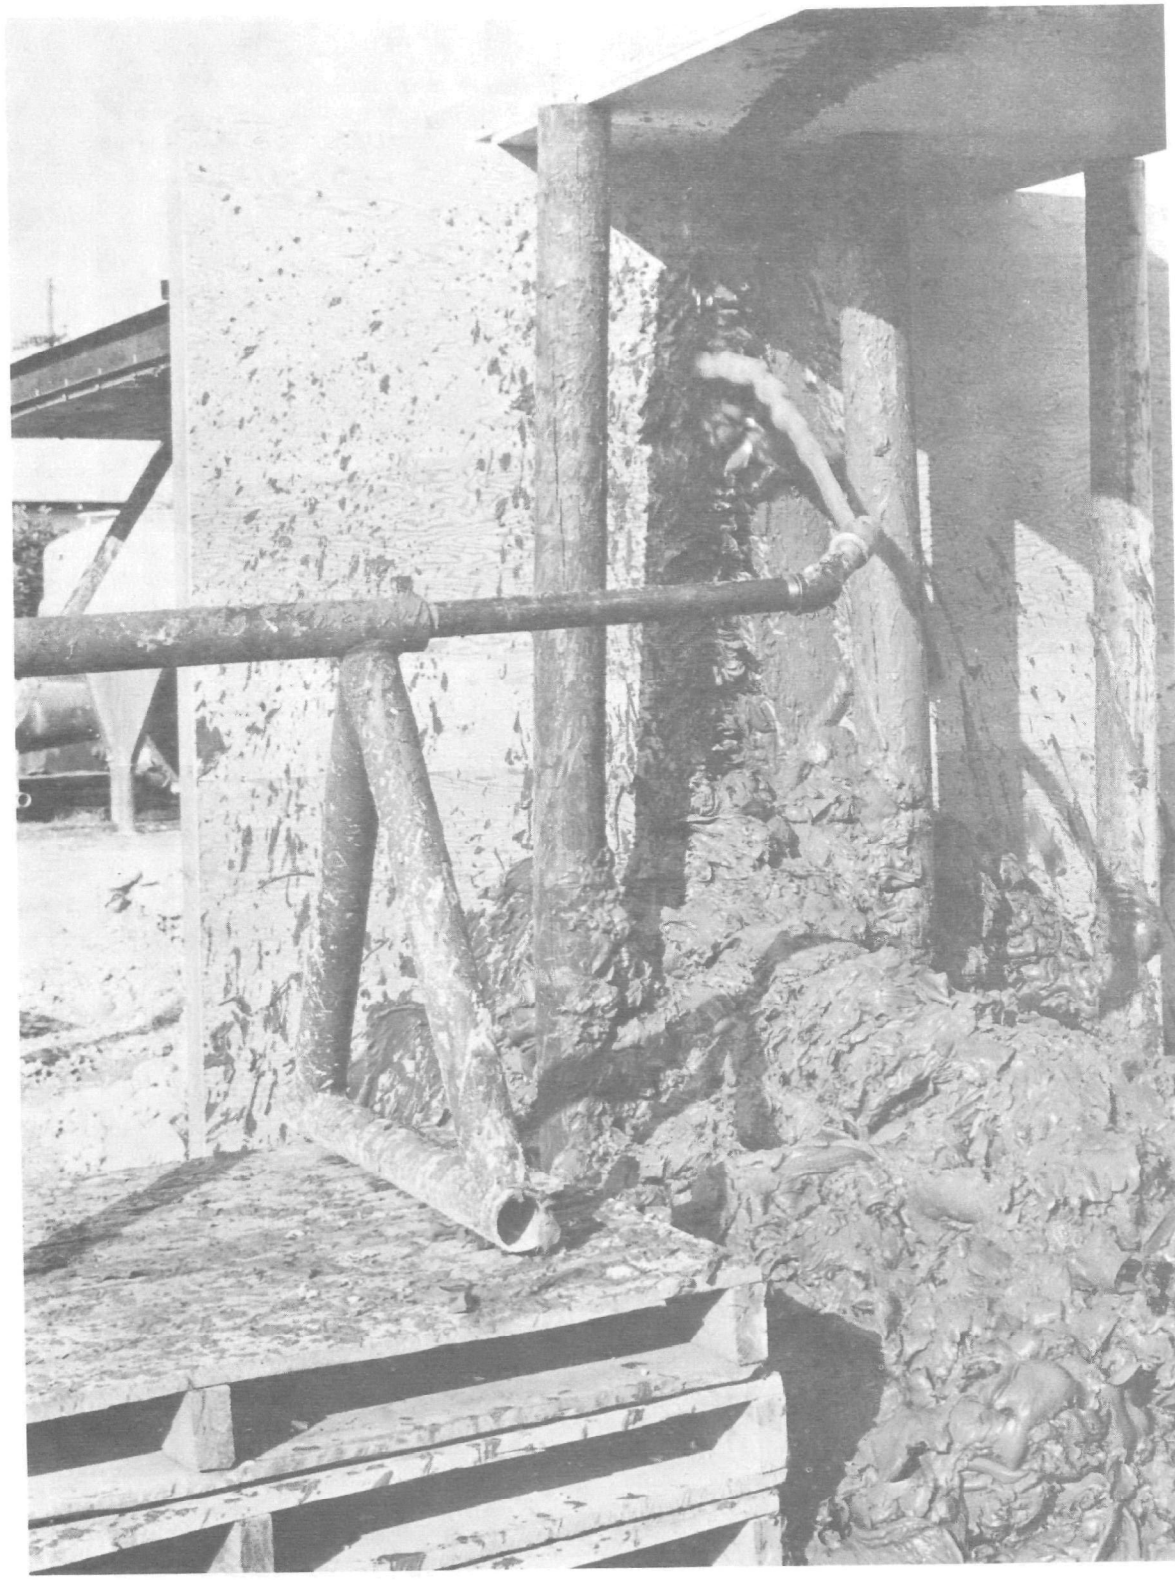
A simulated mine drift was built for a full-scale test. The drift, constructed of wooden framing and plywood, was 10 feet wide, 7 feet high and 8 feet long. Three wooden posts were set inside the drift on either side. A portion of the simulated mine drift is shown in Figure 20. This picture also shows the beginning of the bulkhead which was built in the opening.

FIGURE 20-SLURRY DISTRIBUTION IN BULKHEAD CONSTRUCTION-SIMULATED MINE TEST

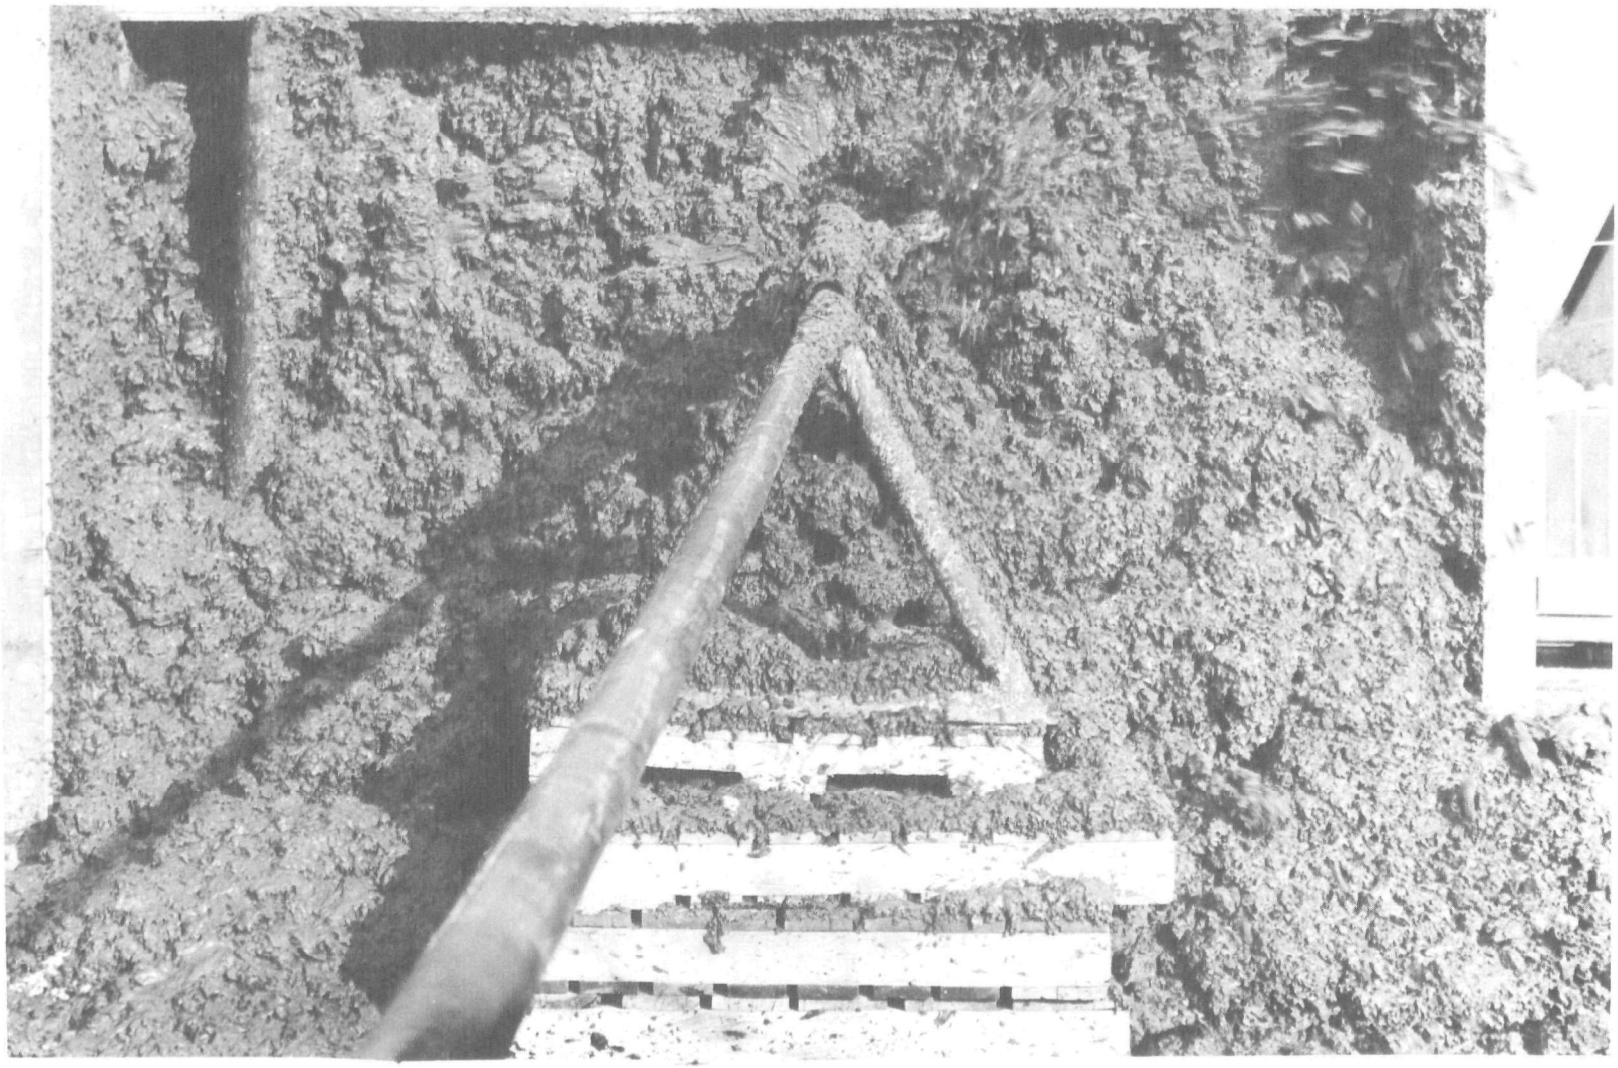
FIGURE 21 - COMPLETED BULKHEAD - SIMULATED MINE TEST

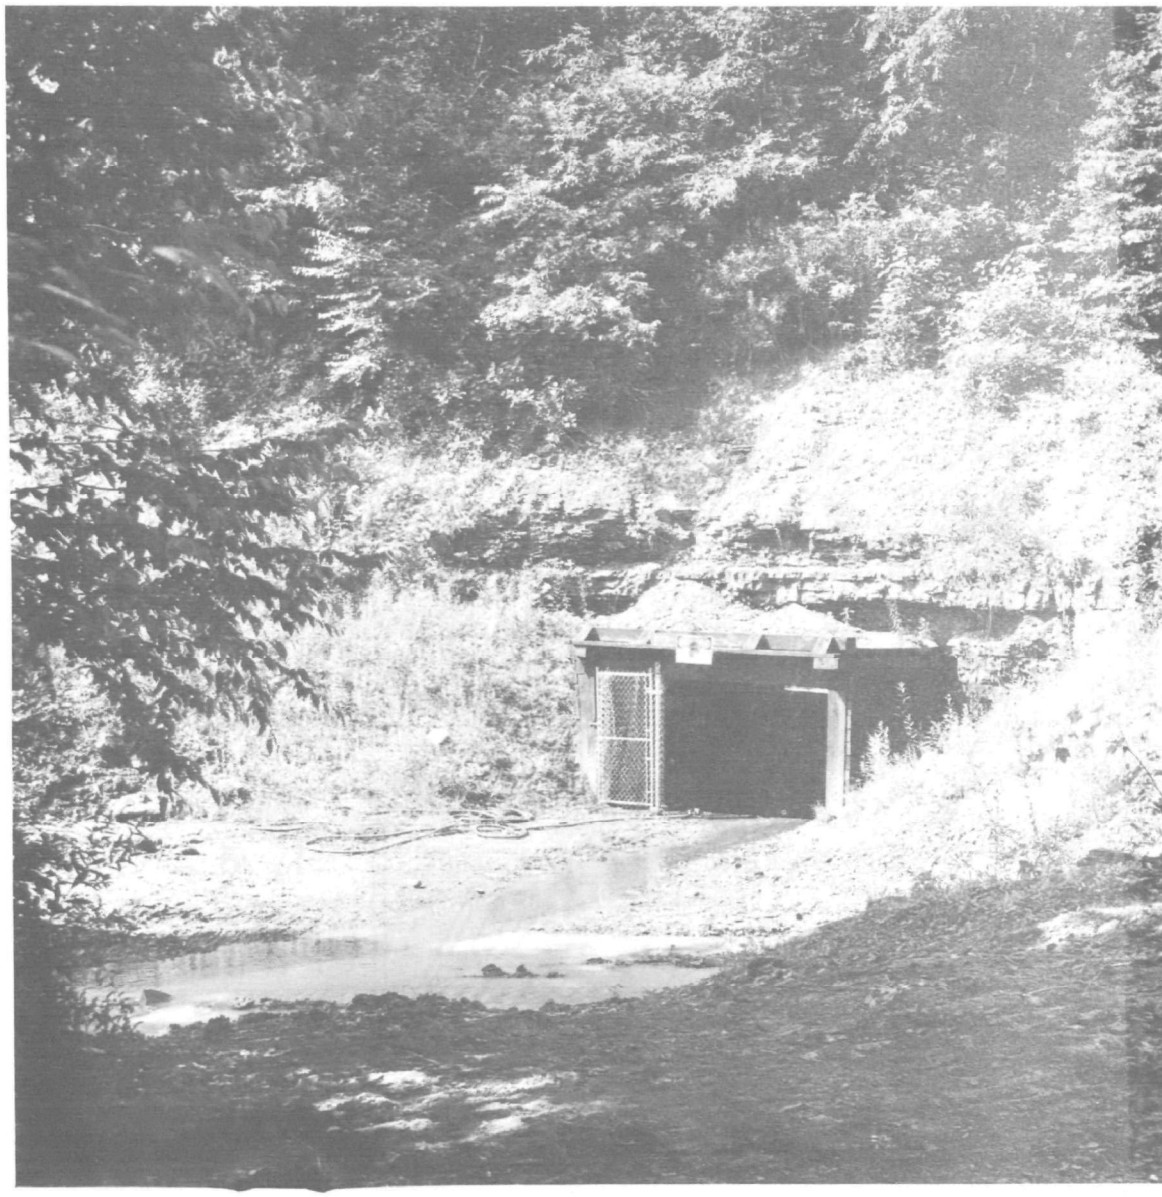
The two openings which were sealed were at one end of the Coalton No. 3 Mine, far from the main heading. These openings were originally driven out for use as air supply openings. Later these were used as entries. Since they were close to the stables in the town of Coalton, the horses were moved into the mine through one of these openings, and the other was used for a fanway. Opening No. 1 of Mine No. RT5-2, which was selected for the field test, was considered suitable because the site was easily accessible and provided sufficient room for the necessary equipment to be used in placing the mine seal. It also had a sound roof and good timbering and a water flow in excess of 50 gallons per minute. The coal beds have a slight dip and flooding of the entire section of the mine was thought to be possible. In addition to these qualifications, the natural drainage patterns surrounding this mine would tend to prevent the flooding of any populated area in case of leakage or failure of any opening in the mine. Other openings were known to exist and many of these were sealed only with a clay seal. A view of this opening prior to the field test is shown in Figure 51.

FIGURE 51 - VIEW OF MINE NO. RT5-2

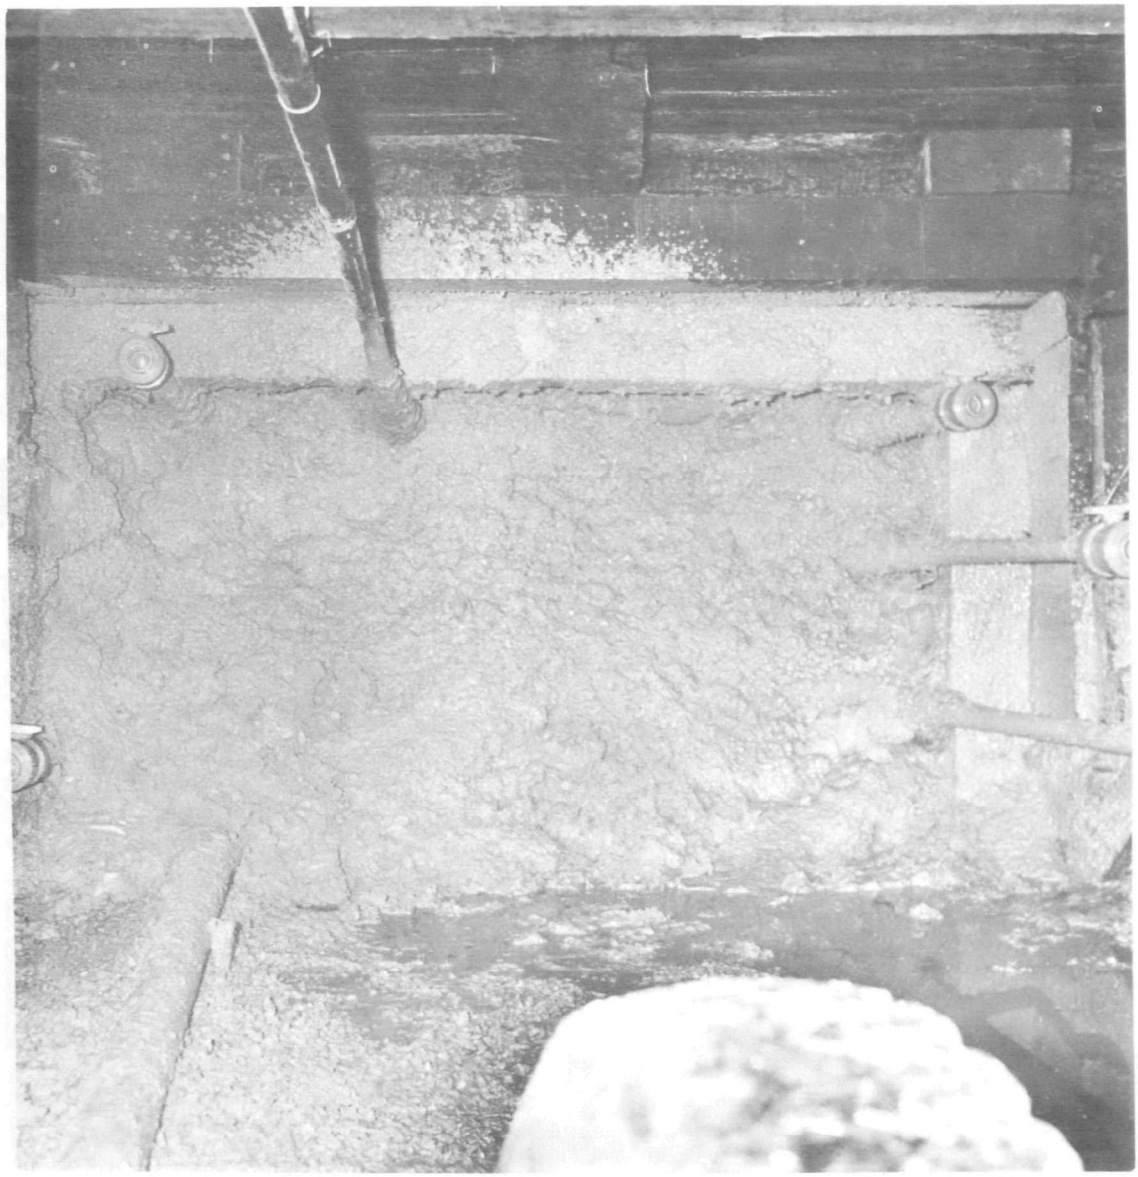
FIGURE 55 - COMPLETED FRONT BULKHEAD - MINE NO. RT5-2

The building of the seal in the drift mine, consisting of the rear bulkhead, placement of the grouting pipes and the aggregate, and the building of the front bulkhead, required two days. The grouting required about half of one day. The preparation had required several days prior to this. The completed seal was approximately 25 feet in length and is shown in detail on the drawing attached as Figure 56. The total cost for this seal, including site preparation cost of $1,079.00, was $9,463.00 for materials and equipment.

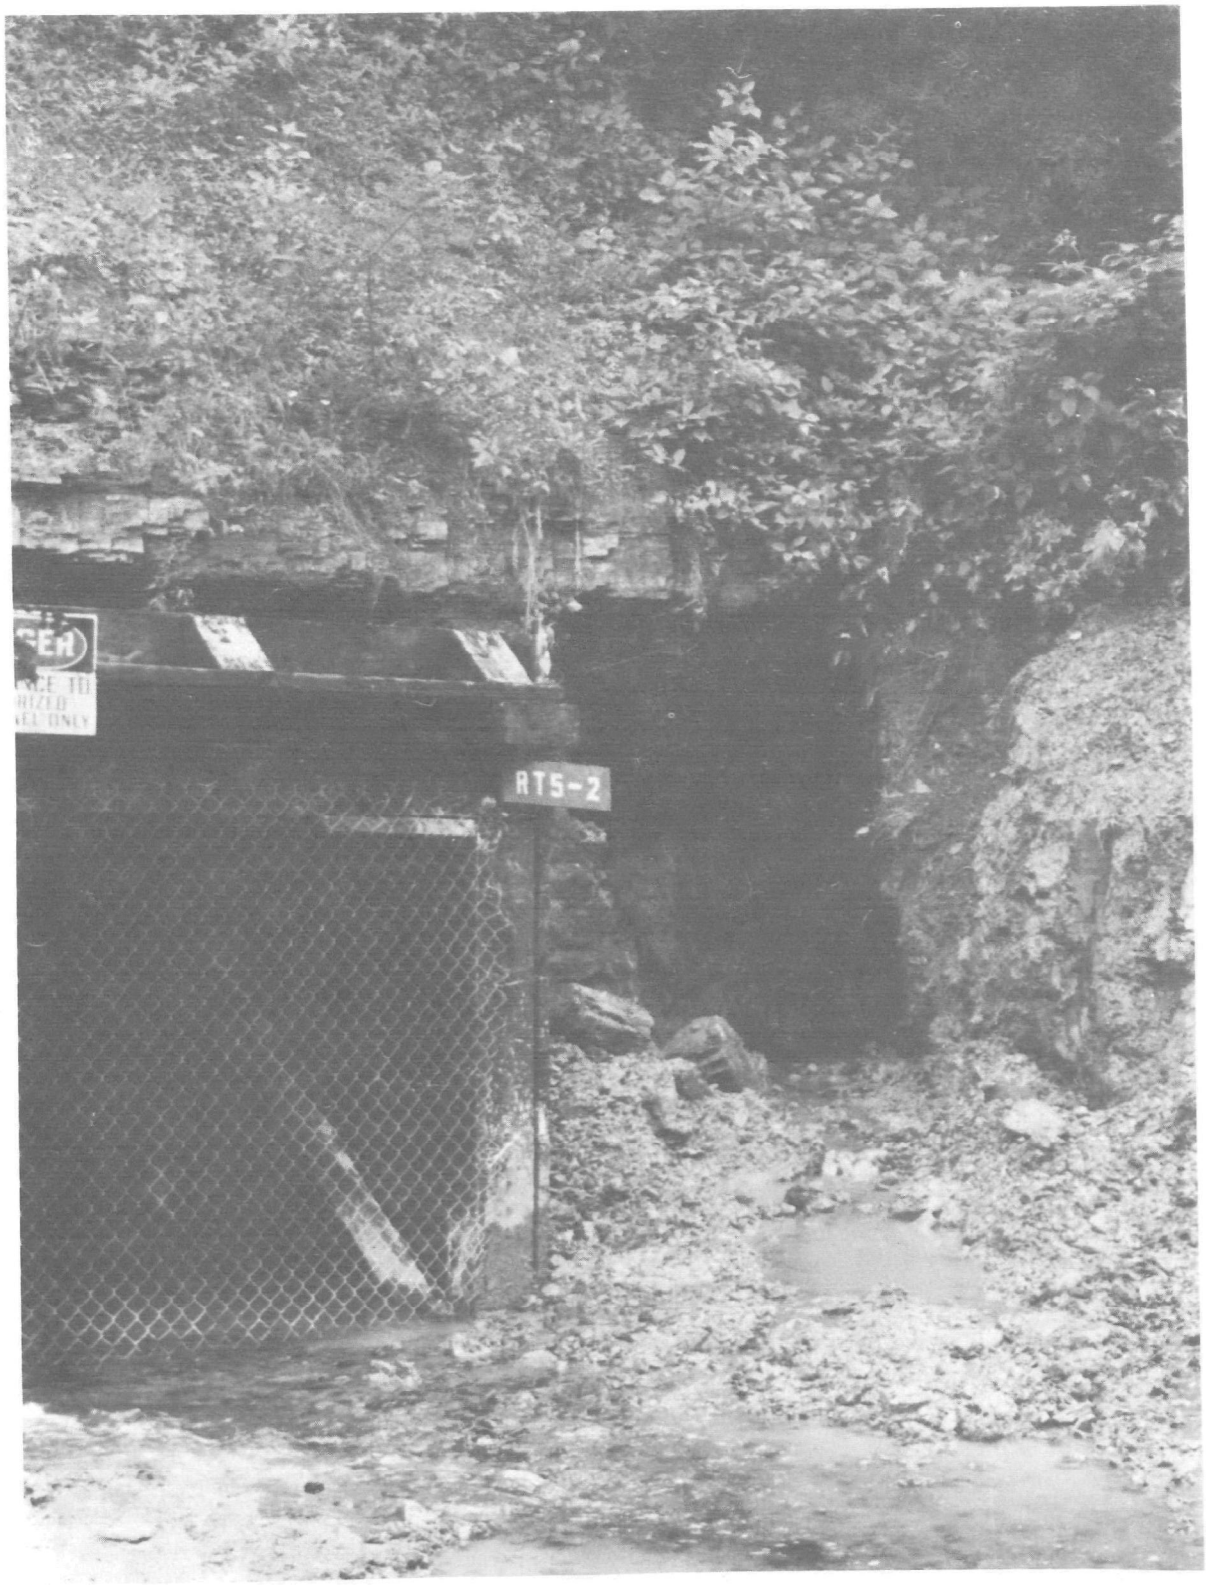
Hand digging into the back slope right of the portal confirmed the direction of the water source. Additional excavation with a backhoe disclosed an opening about 6 feet to the right of the main portal and the remains of a masonry seal. A view of this excavation is shown in Figure 57. The drain valve was then reopened to prevent further head buildup.

FIGURE 57 - OPENING EXCAVATED RIGHT OF MAIN PORTAL - MINE NO. RT5-2

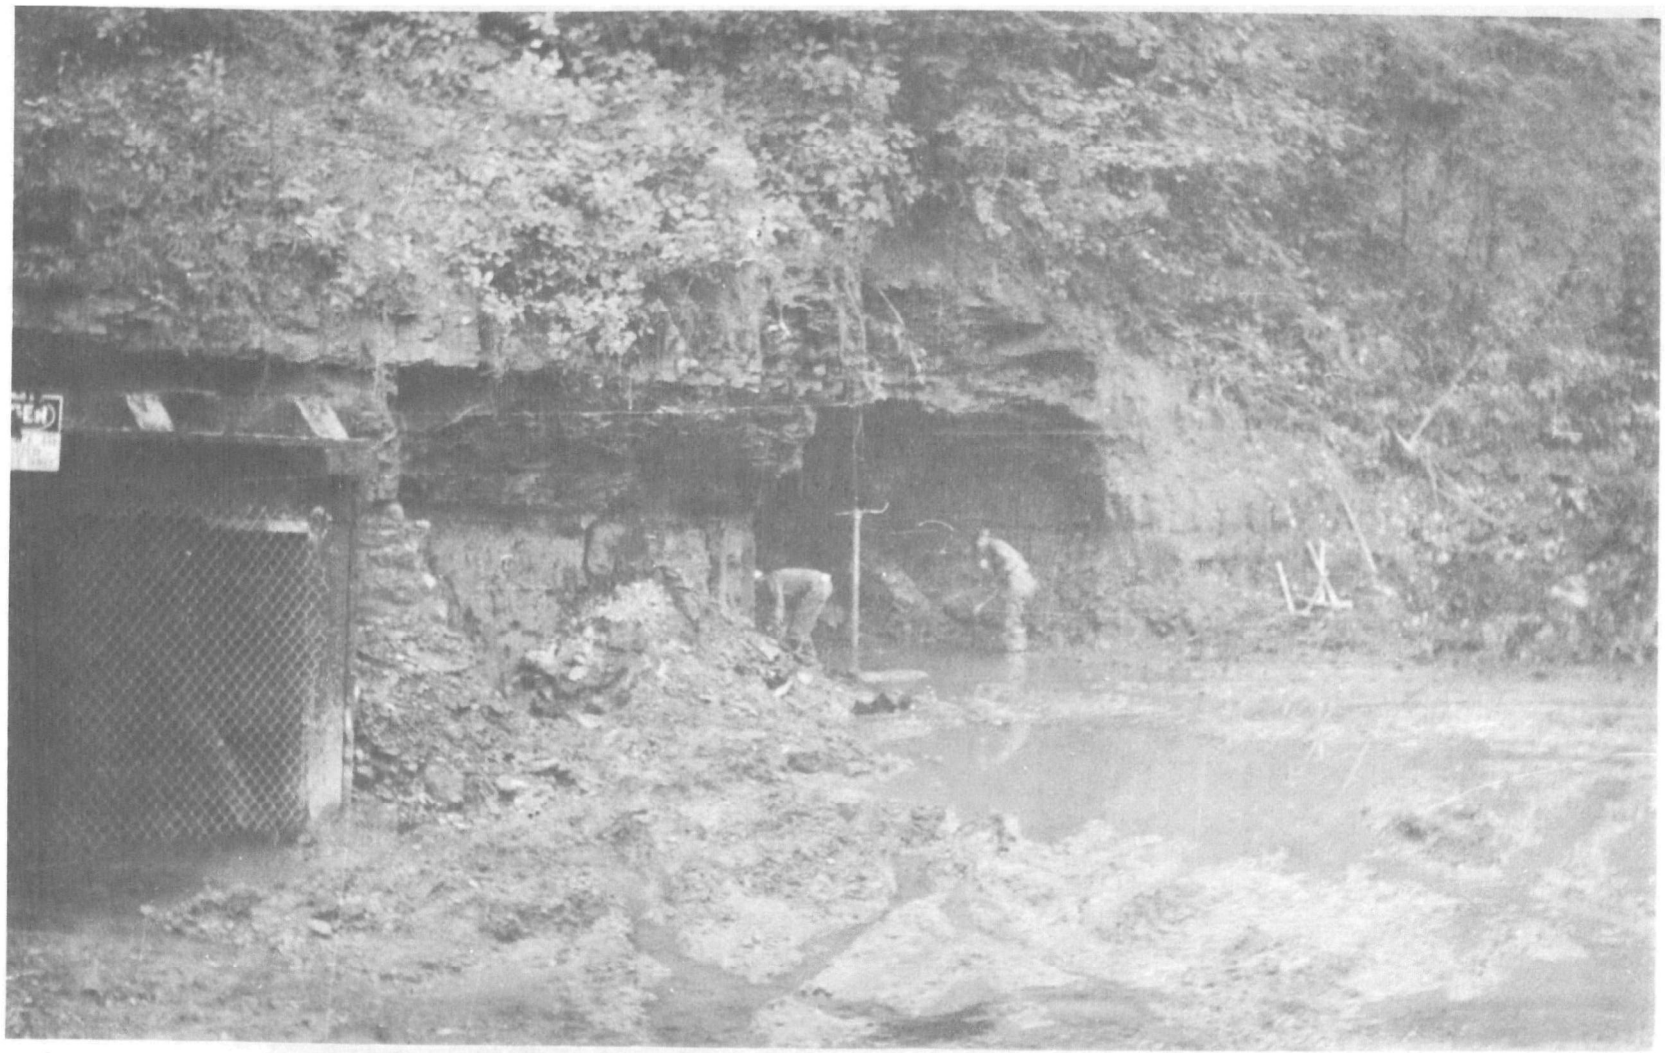
It was then decided to continue excavation to remove additional material and completely expose the opening that had been encountered. This opening, designated as Opening No. 2, was found to be 28 feet to the right of Opening No. 1. After cleaning the front side, the opening was determined to be 12 feet wide. It was filled to the top of the coal with debris from the roof fall, leaving only 2 to 4 feet of void space between the top of the debris and the new roof. The existing roof was of a fossiliferous shale and appeared to be in good condition. A view of this exposed opening is shown in Figure 58.

FIGURE 58 - OPENING NO. 2 AFTER EXPOSING FRONT - MINE NO. RT5-2

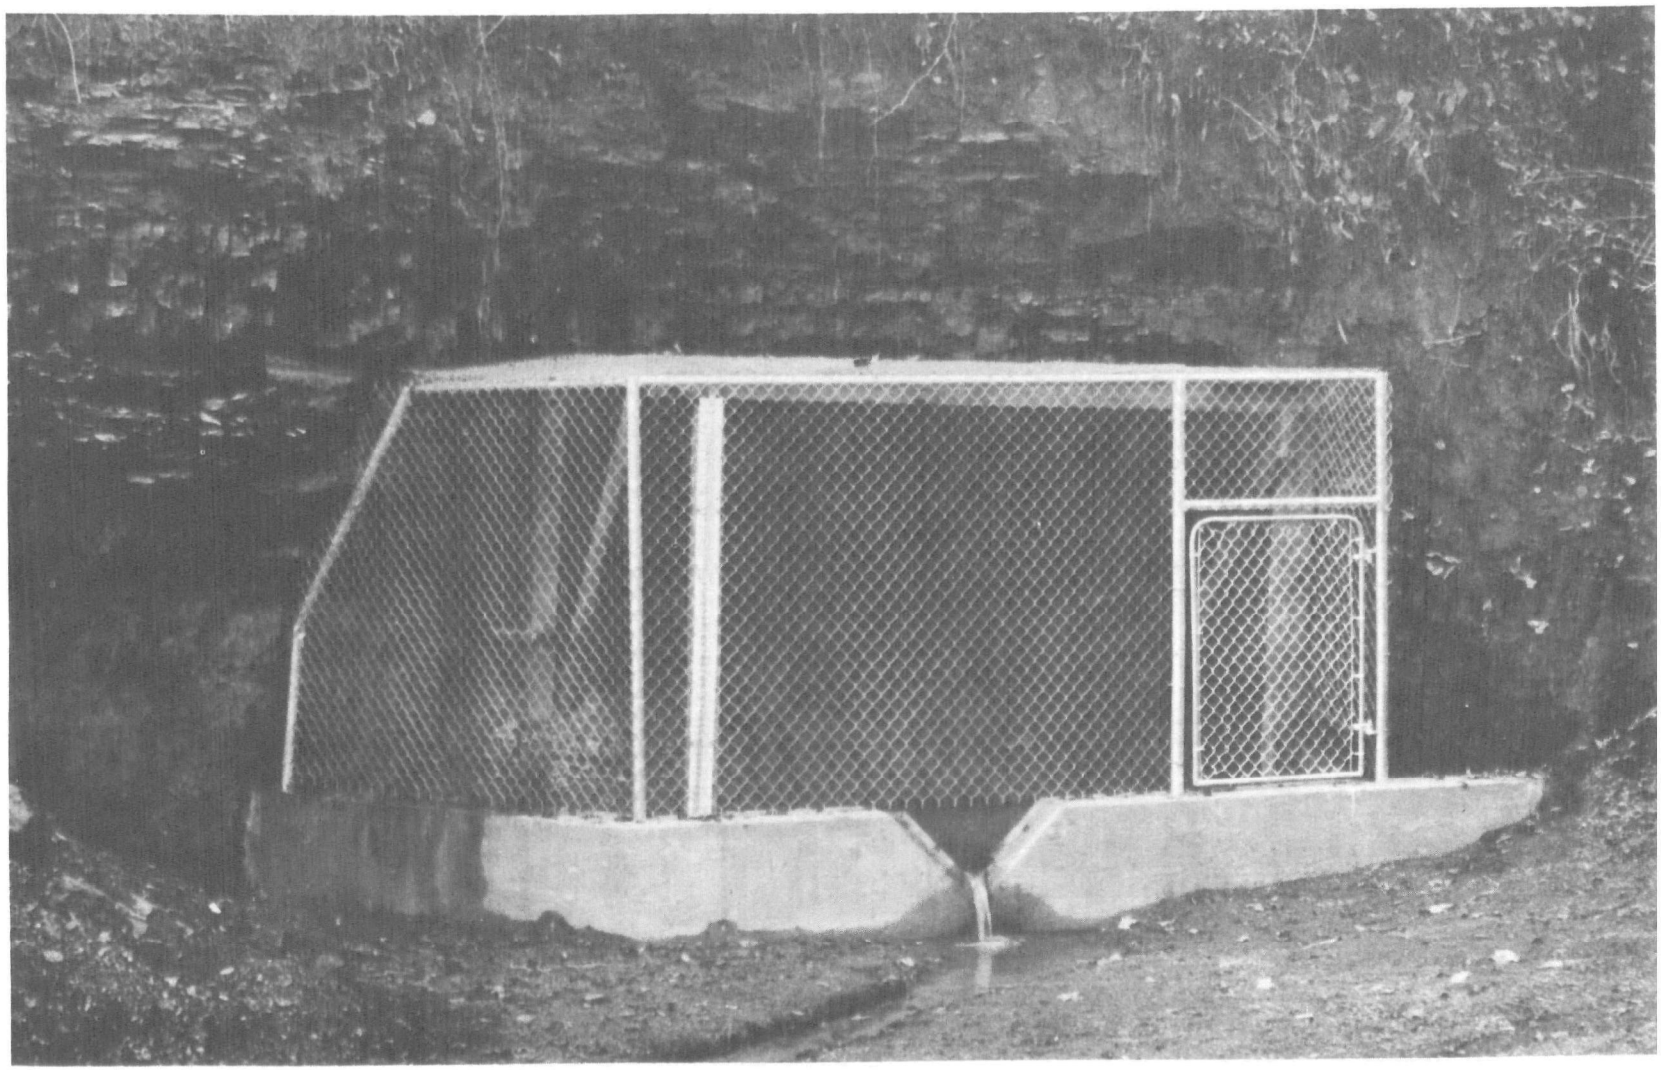
Since the area immediately in front of the mine was low and filled readily with water that came through the limestone, a retaining wall was built in front of the opening with a 90-degree weir installed to measure the flow rate. A view of the completed installation at Opening No. 2 is shown in Figure 62.

Additional information on the monitoring of the two openings after cessation of field work on the project has been furnished by the Norton FWPCA personnel. The head on the impounded water behind both seals has slowly increased, reaching 6.48 feet in Opening No. 2 and 4.74 feet at Opening No. 1 by December 30, 1969. The flow remains at 3.6 gpm through the limestone seal. Water quality likewise is similar to that reported in Table 31.

FIGURE 62 - COMPLETED INSTALLATION - OPENING NO. 2
