EPA-340/1-86-009a
May 1986

CEMS PILOT PROJECT:

Evaluation of Opacity CEMS Reliability and QA Procedures

James W. Peeler
CEM/Engineering Division
Entropy Environmentalists, Inc.
Research Triangle Park, North Carolina 27709

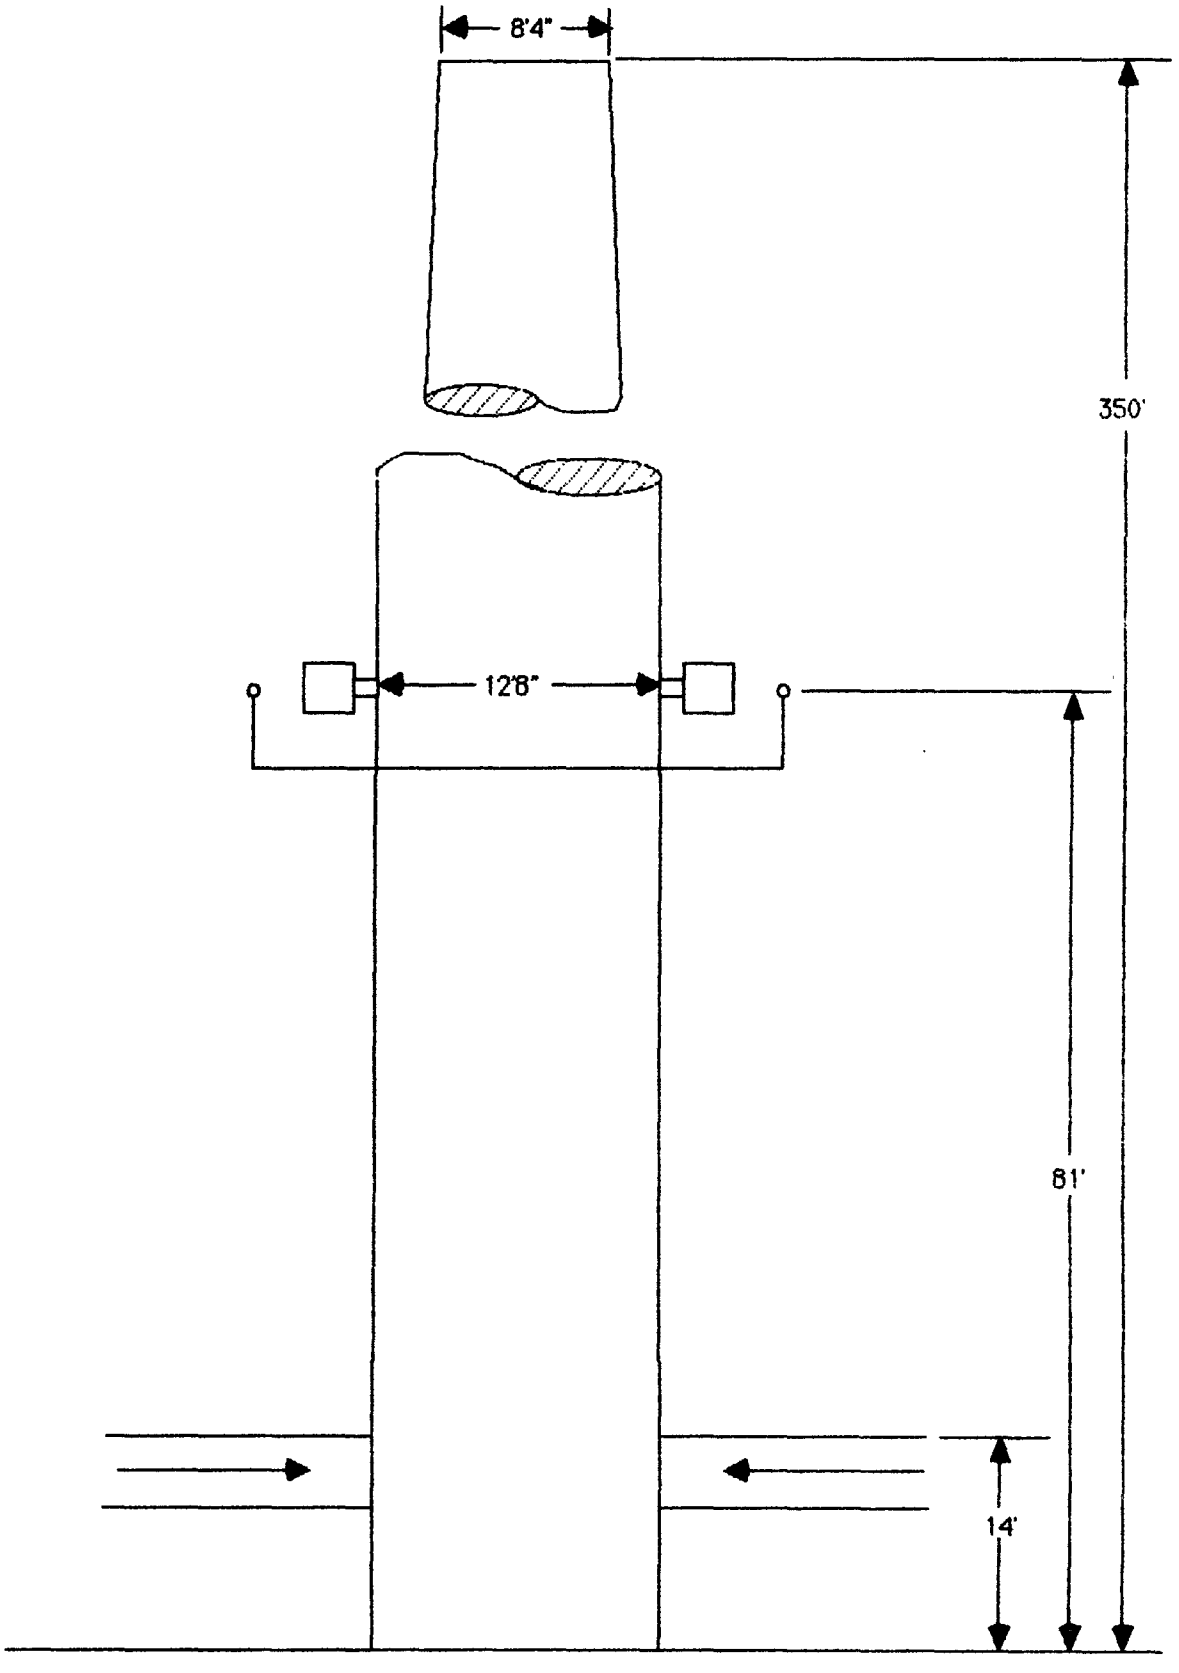
FIGURE 3-4. UNIT NO. 5 OPACITY MONITORING LOCATION

Units No. 3, 4, and 5 are each equipped with a separate Dynatron Model 1100 opacity monitoring system; however, only the performance of the Units No. 4 and 5 monitors were evaluated during this project. Units No. 4 and 5 represent different opacity monitoring applications, even though identical instrumentation is used for the two units. Unit No. 4 is a pressurized boiler, and the opacity monitor is located in a metal, horizontal, circular duct between the ESP and the stack (see Figure 3-3). Unit No. 5 is a balanced draft boiler; the opacity monitor is installed in the masonry exhaust stack (see Figure 3-4).

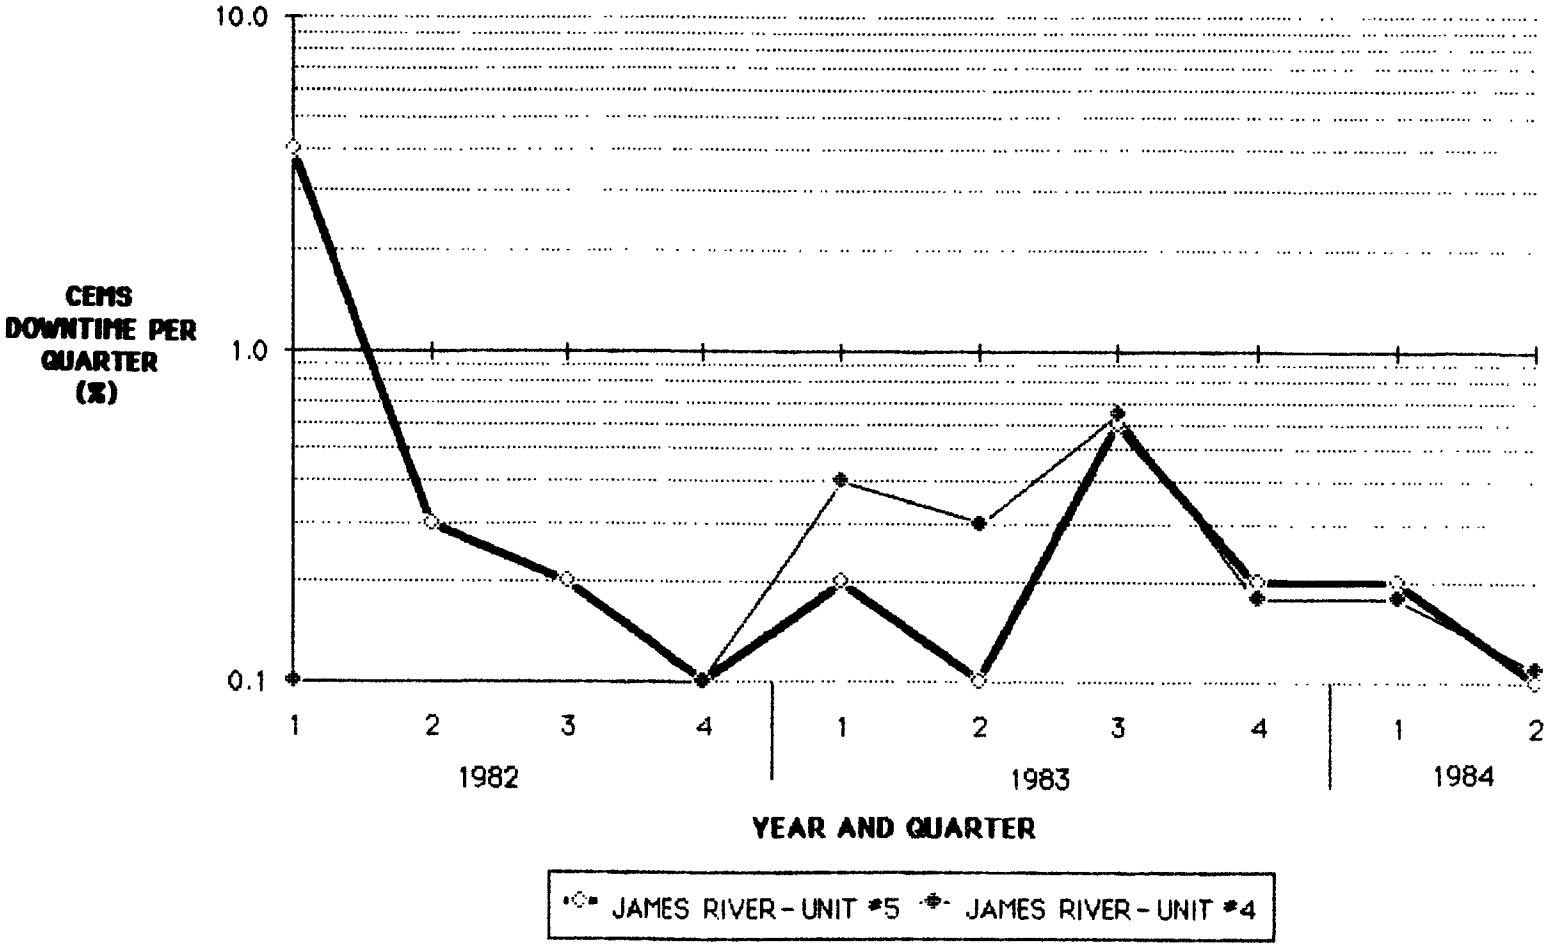
FIGURE 3-6. CEMS DOWNTIME - JAMES RIVER UNITS NO. 4 AND 5

As can be seen from Figure 3-6, CEMS downtime for both Units No. 4 and 5 decreased from a value of approximately 4% (85 hours), for the first quarter that data were reported, to a minimum level, which was consistently below 0.6% (14 hours), for all subsequent reporting periods. Thus, both of the opacity CEMS's at the James River Station achieved very high levels of monitor availability (i.e., greater than 99% during the field study). Almost all of the CEM downtime that has occurred at the James River Station is attributable to (1) cleaning of transmissometer windows, (2) changing chart recorder paper, (3) resetting of the data logger/timer, and (4) preventive maintenance/monthly monitor checks.

During the 1-year field study, there was some reduction in the reported frequency of window cleaning that slightly increased CEMS availability. However, offsetting these small gains, a small increase in CEM downtime was associated with the time required to perform the periodic QA checks (which include window cleaning). Overall, there is no indication that the time required to perform QA procedures detracted from the opacity CEMS's availability.

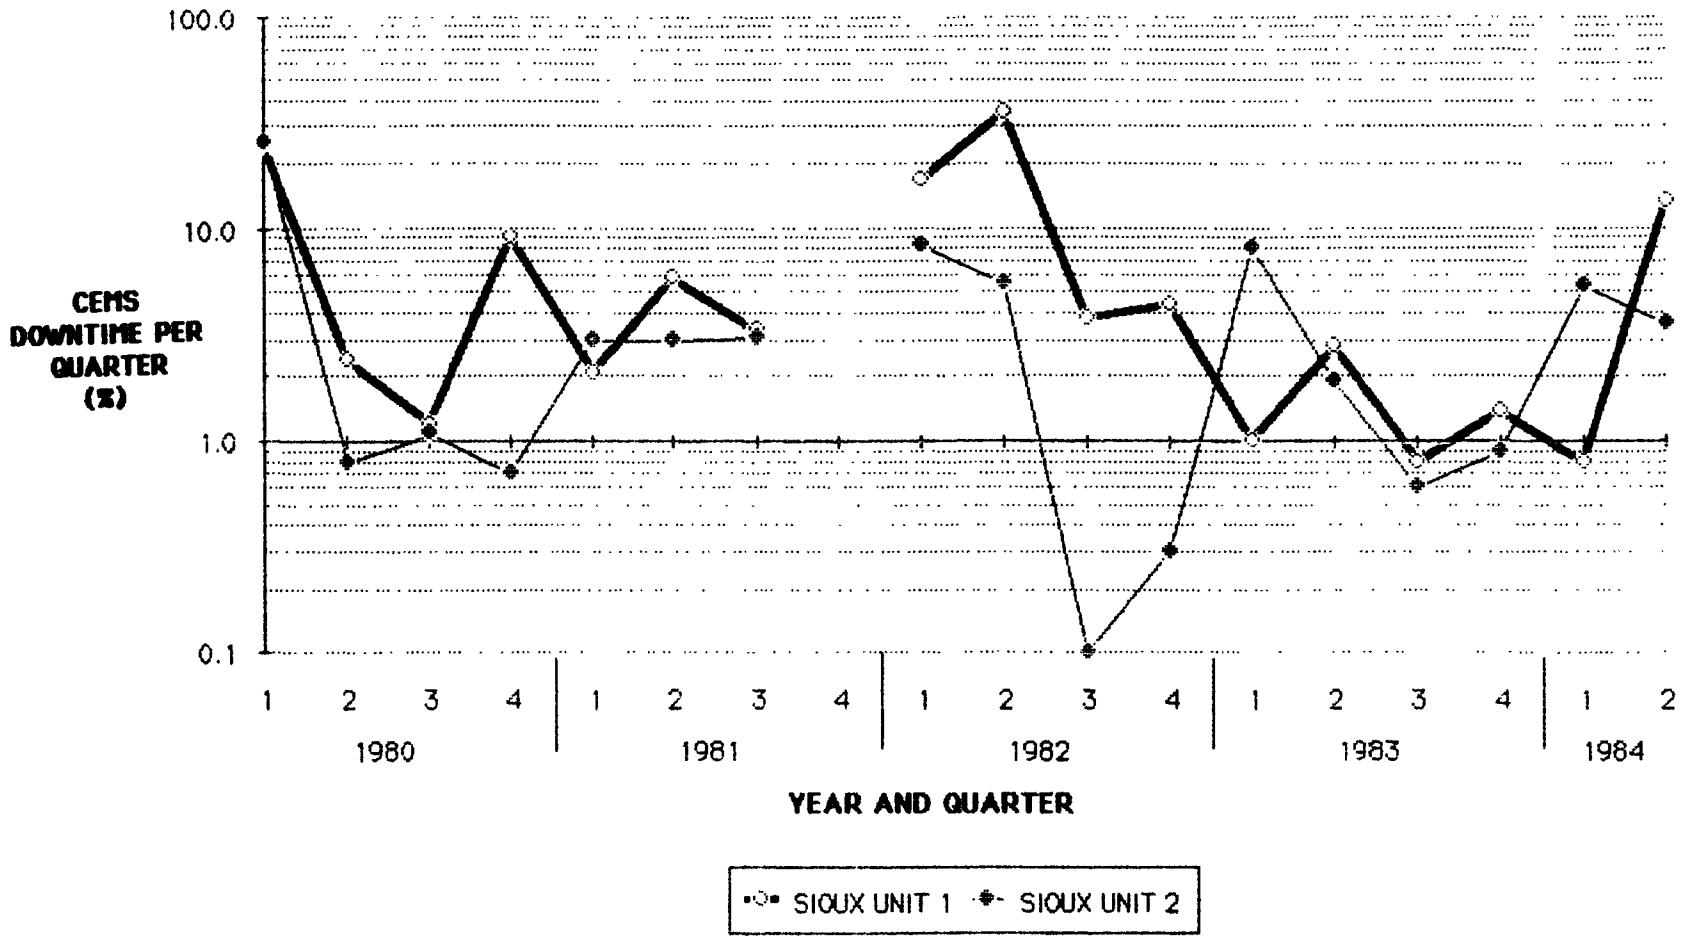
FIGURE 4-5. CEMS DOWNTIME - UNION ELECTRIC COMPANY, SIOUX STATION UNITS 1 AND 2

- o 48 hours: Computer stopped; replaced I/O circuit board.

- o 18 hours: Replace optical density circuit board and recalibrated.
- o 192 hours: Optical density circuit board defective; waiting on parts.
- o 48 hours: Computer stopped; replaced I/O circuit board after trying to reprogram computer.

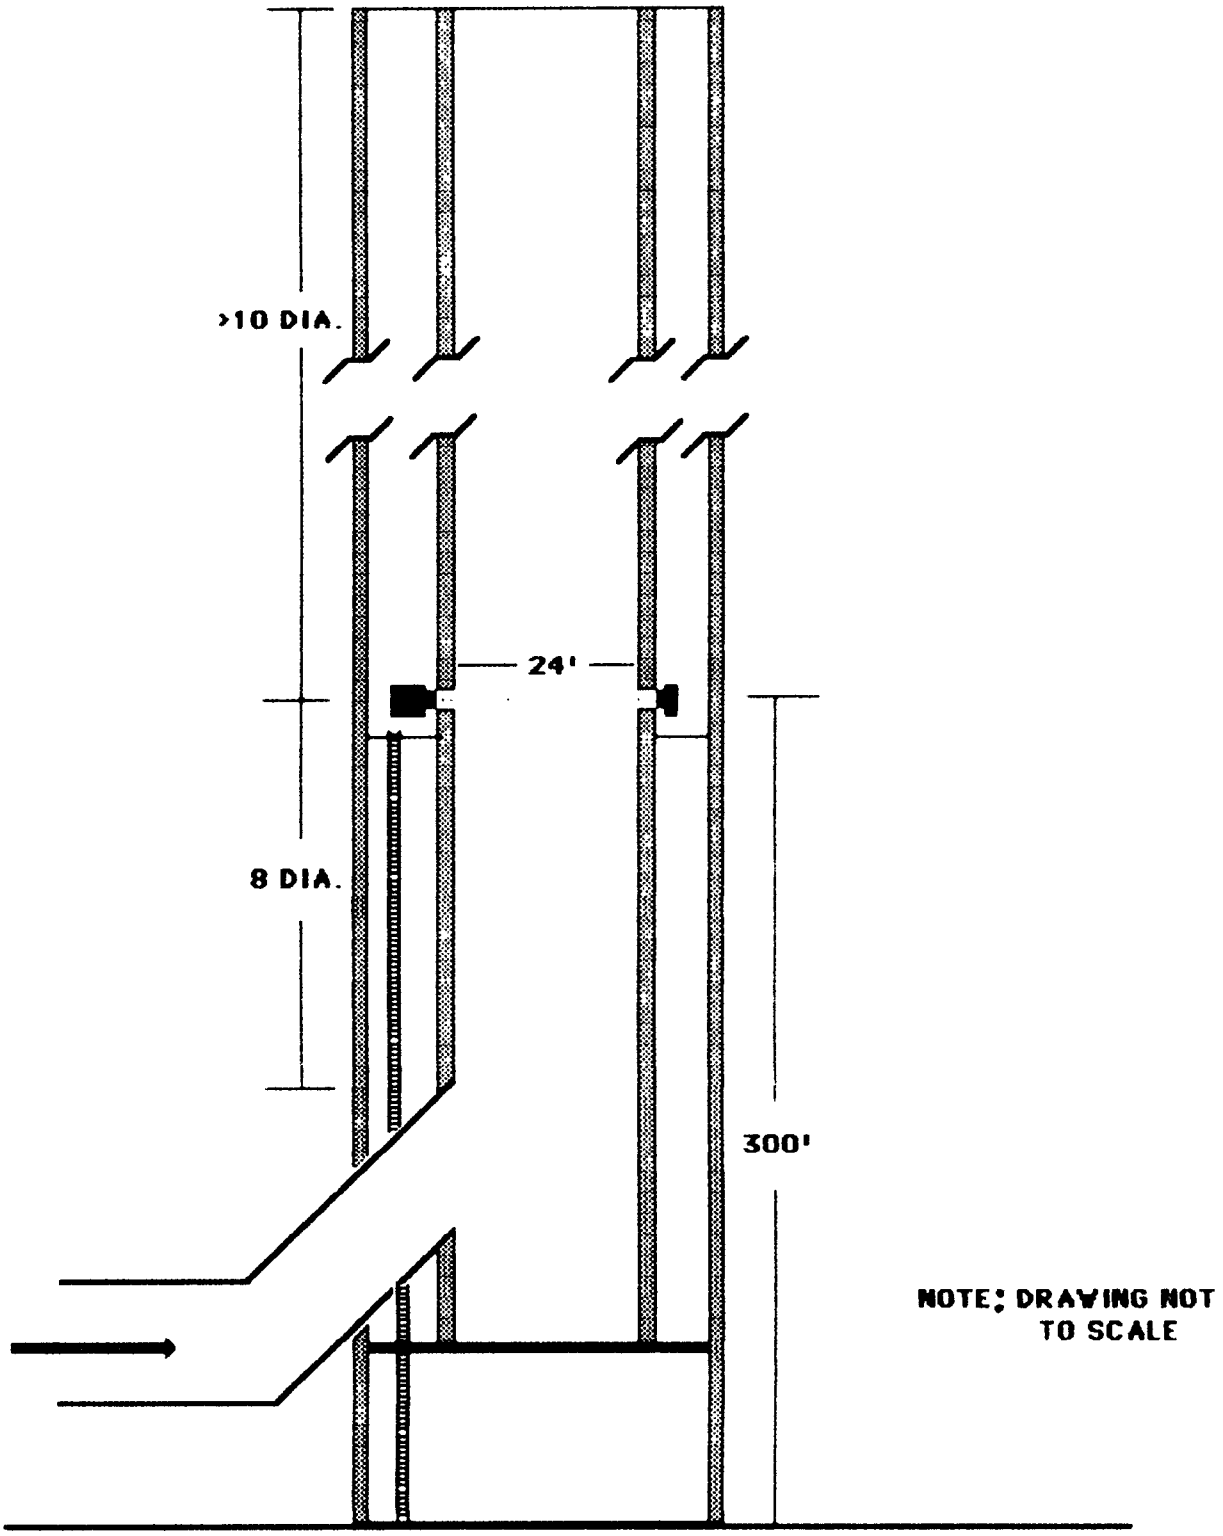
FIGURE 5-2 IATAN OPACITY MONITORING LOCATION

The Lear Siegler, Inc. (LSI) RM41 opacity monitoring system utilized at the Iatan Station consists of a single transmissometer (transceiver and retroreflector), a monitor control unit, and a strip chart recorder. The transmissometer is installed within the annular space between the stack shell and liner at approximately 280 feet above grade in the exhaust stack (see Figure 5-2). The opacity monitor measurement path passes through the centroid of the stack cross-section. The only means of access to the monitoring location is a series of ladders installed in the annular space between the stack wall and the stack liner.

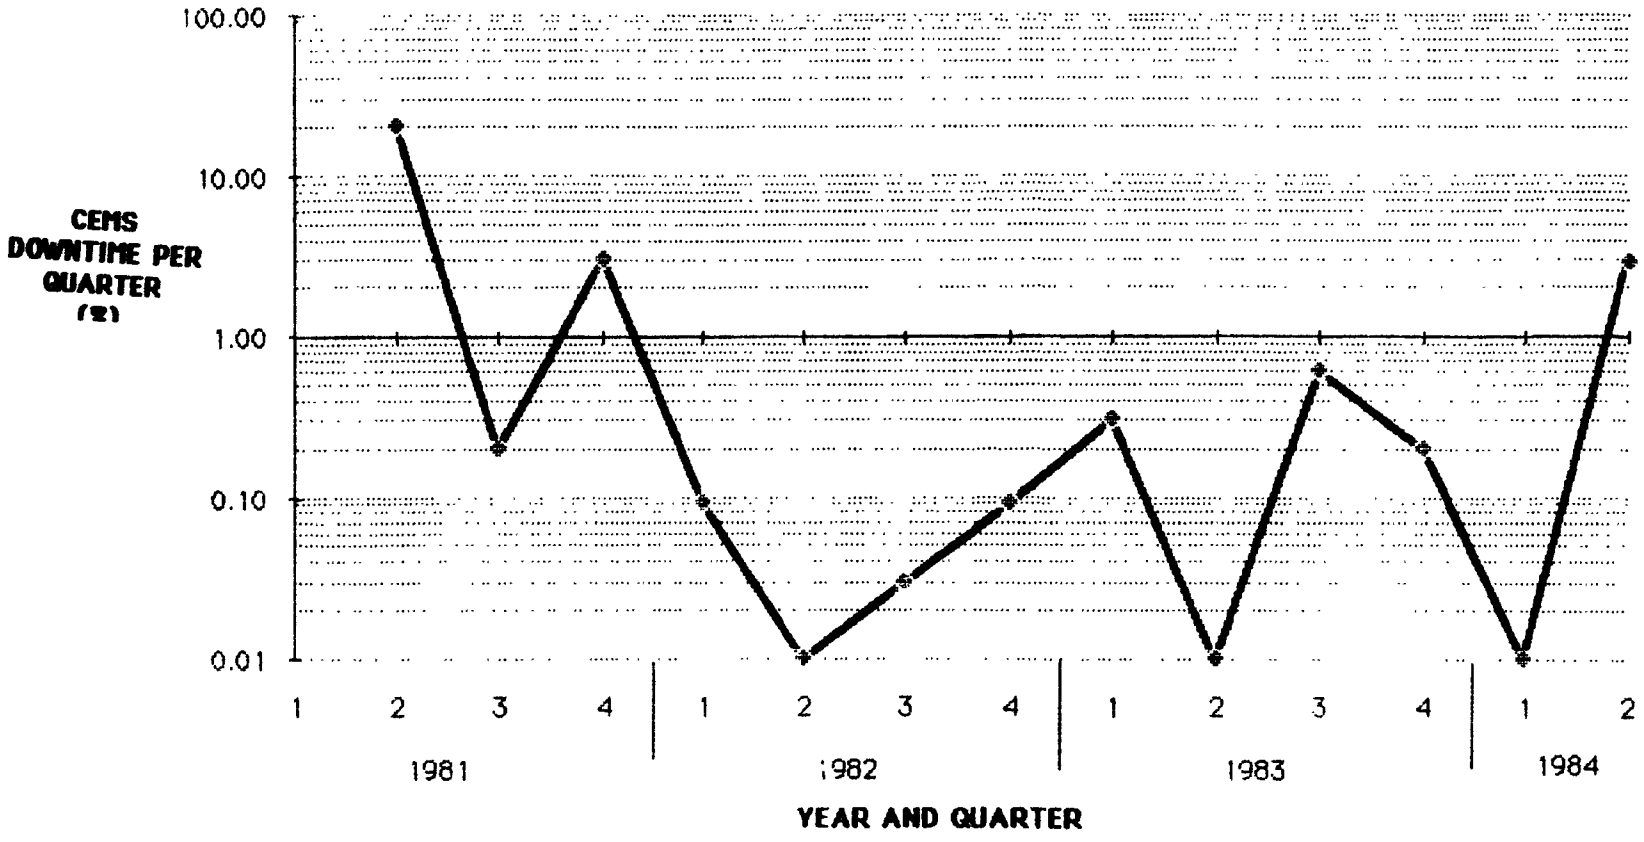
FIGURE 5-4. CEMS DOWNTIME - KANSAS CITY POWER AND LIGHT COMPANY, IATAN STATION

1. <u>The LSI opacity CEMS installed at Iatan achieved high levels of monitor availability during the study (i.e., greater than 97% for each calendar quarter)</u>.

(These availability results are expressed relative to the total number of hours in each calander quarter, since the opacity CEMS is operated even during boiler outages.)

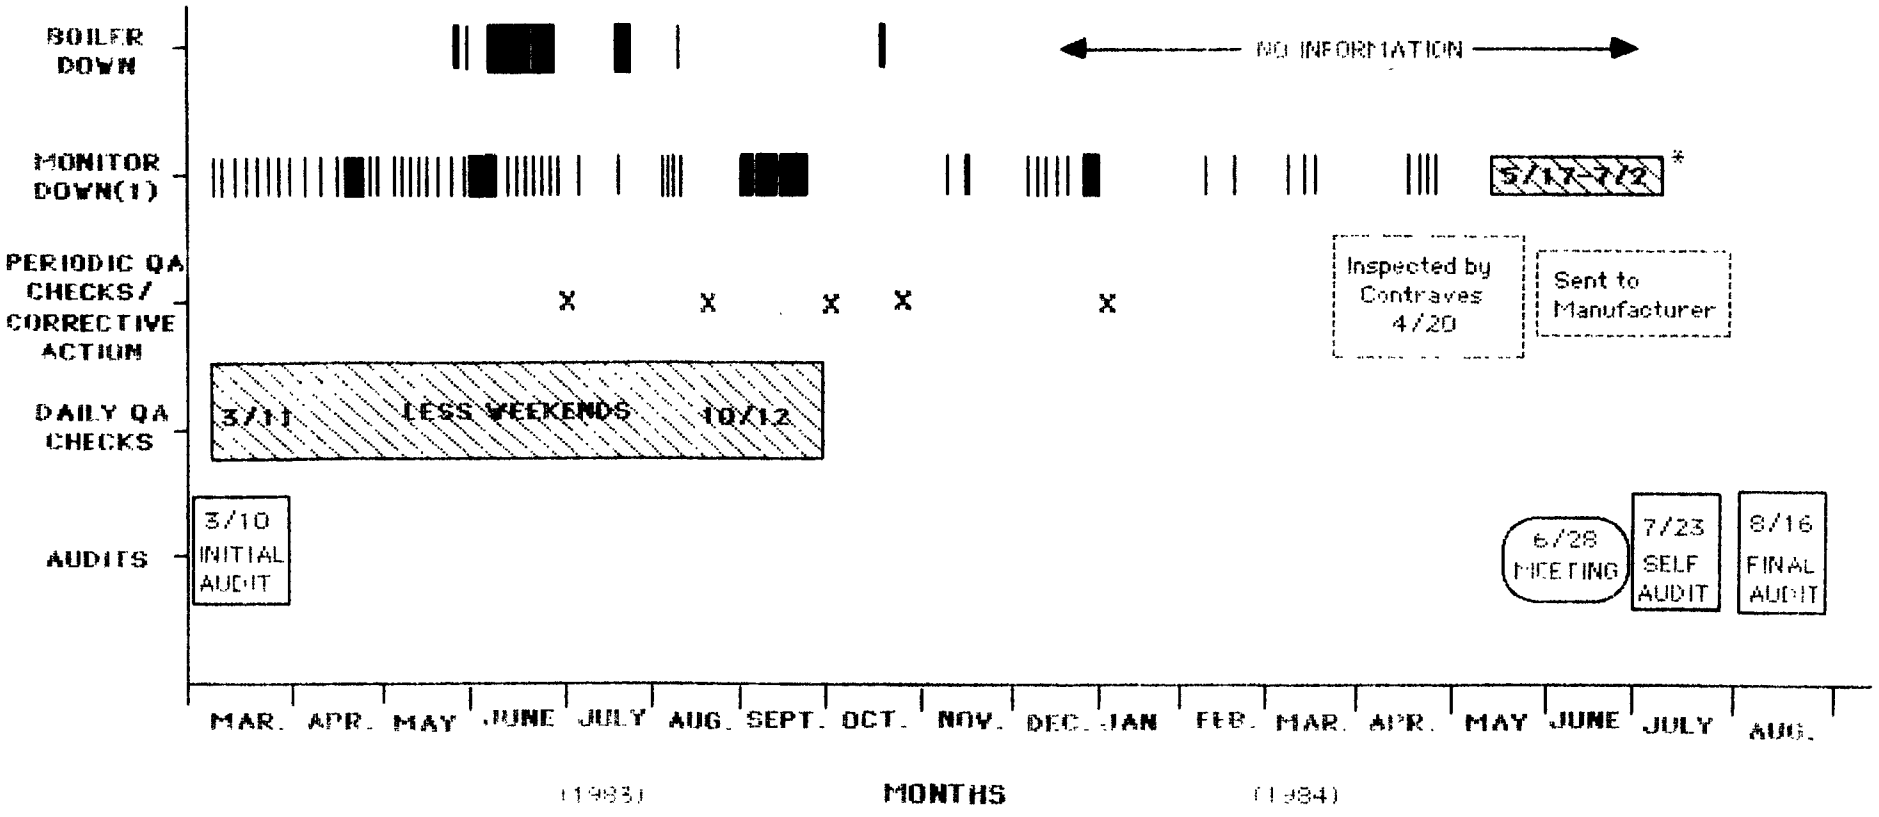
(1) Monitor downtime includes all instrument malfunctions, integrator problems and chart recorder downtime (see Section 6.6)

*Monitor shipped to manufacturer for repairs

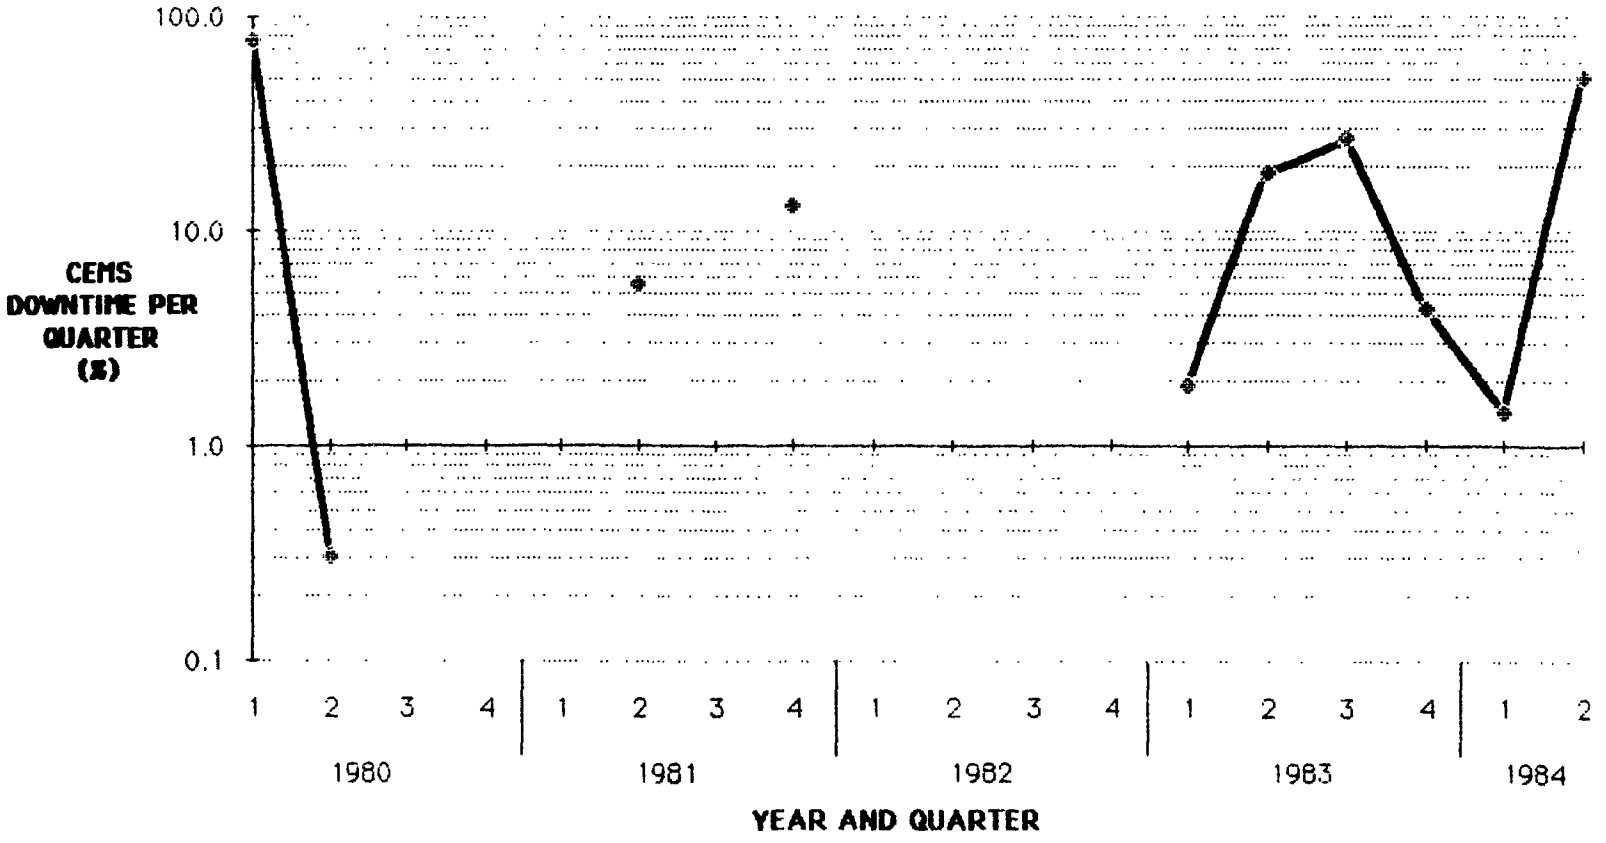
FIGURE 6-3. CEMS DOWNTIME - ST. JOSEPH LIGHT AND POWER COMPANY, LAKE ROAD UNIT NO. 5

1. The Contraves Goerz opacity CEMS installed at Lake Road Unit No. 5 did not achieve consistently high levels of availability during the study. CEM downtime varied greatly and significantly exceeded 10% for three reporting periods.
