THE 'MEEKER WELL' AND OTHER PHENOMENA IN THE VICINITY OF THE MEEKER DOME, RIO BLANCO COUNTY, COLORADO- A SUMMARY REPORT ON THE FEASIBILITY OF CONTROL OF SEEPAGE OF SALINE GROUND WATER

TECHNICAL SUPPORT BRANCH
SURVEILLANCE AND ANALYSIS DIVISION

U. S. ENVIRONMENTAL PROTECTION AGENCY
REGION VIII

DECEMBER, 1972

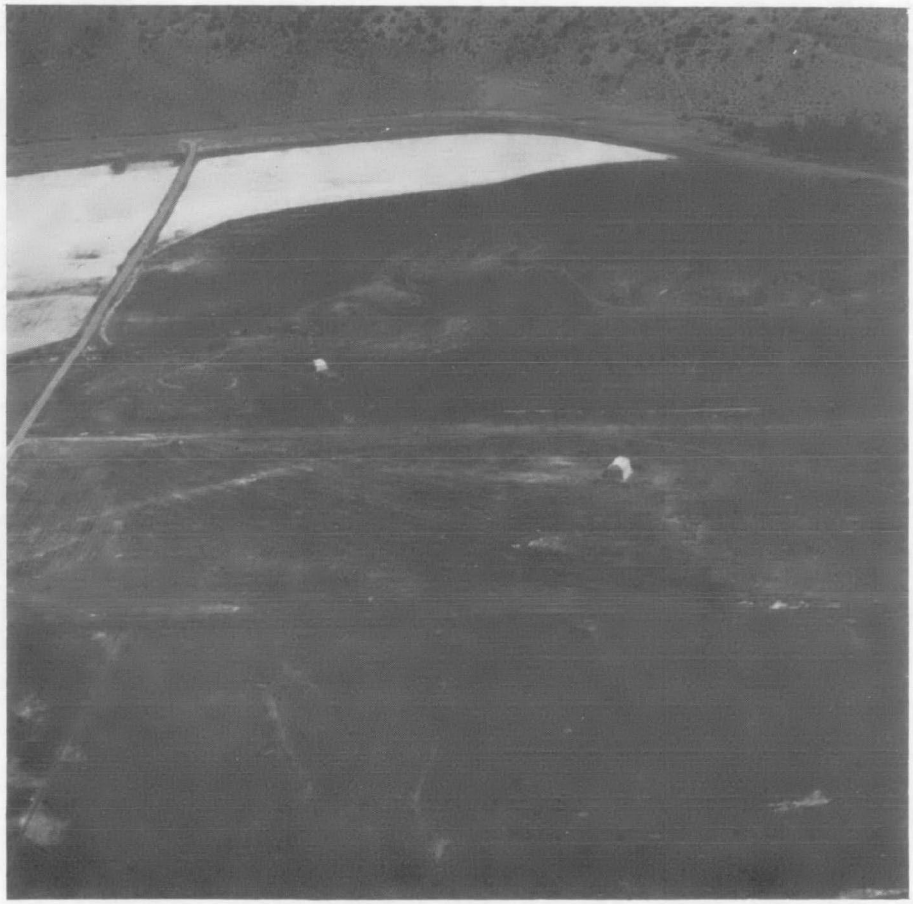
Photo 4 (185-1)

East end of Upper Prather Property.
Seepage Area #4 - August, 1972.

in Photos 4 through 6. Photographs 7 and 8 also show the Nelson property which has been referred to previously as Seepage Area 3. As noted, the color distinction between irrigated and non-irrigated land is great (Photograph 4; 185-1) though a true color photograph (Photograph 6b, 185-6) shows a somewhat similar distinction. Photos 5 and 6a (185-2 and 185-3) give the best portrayal of the impact of saline seepage on the tract of land between Colorado Highway 132 and Coal Creek. This dark area shows a definite downhill trend with a minor seep indicated to the east of the ranch road near its junction with the irrigation ditch. No indication of equally-stressed areas was found to the south of Coal Creek.

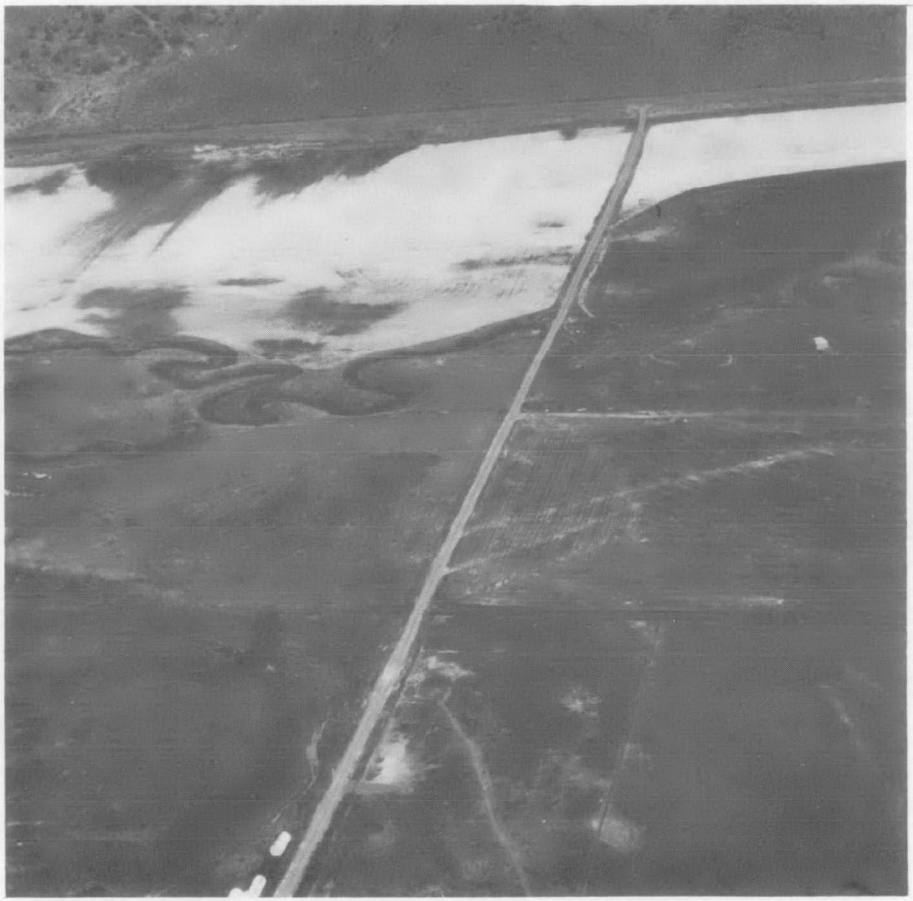
Photo 5 (185-2)

Upper Prather Property - Seepage Area #4.
Coal Creek below white area - August 1972.

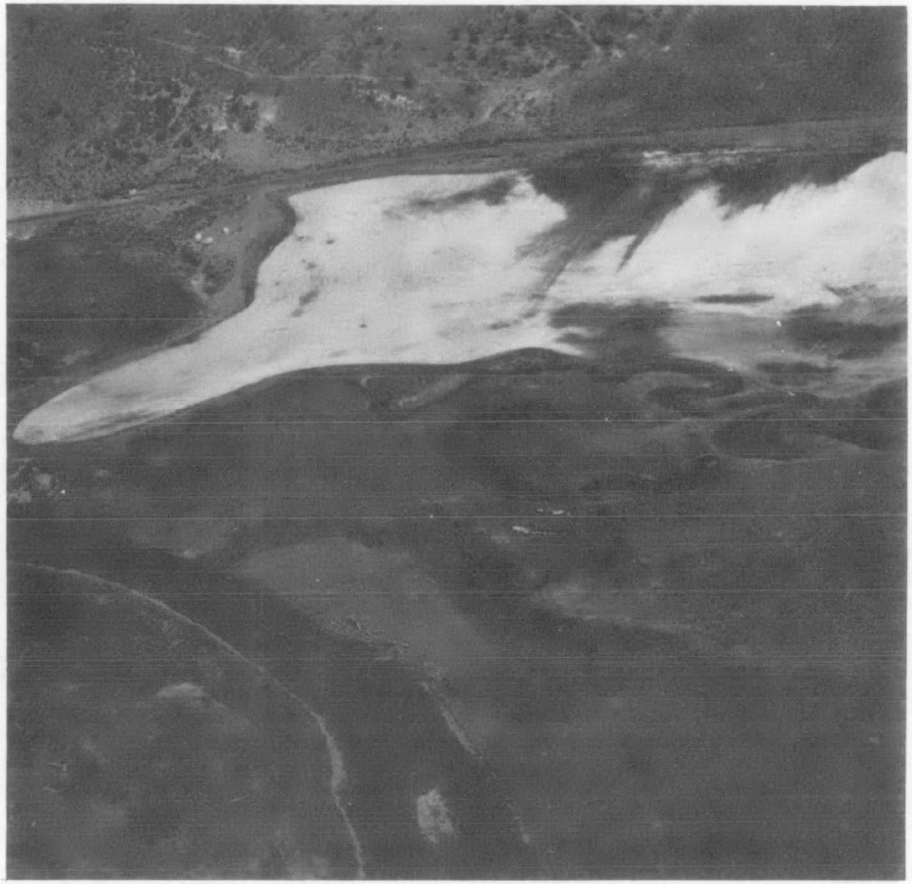
Photo 6a (185-3)

Upper Prather Property - west end. Seepage Area #4. Confluence of Coal Creek & White River - August, 1972
