WATER QUALITY INVESTIGATION RELATED TO SEAFOOD PROCESSING WASTEWATER DISCHARGES AT DUTCH HARBOR, ALASKA

ENVIRONMENTAL
PROTECTION
AGENCY
SURVEILLANCE AND
ANALYSIS DIVISION
SEATTLE, WASHINGTON
REGION X

Working Paper # EPA910/8-77-100

May 1977

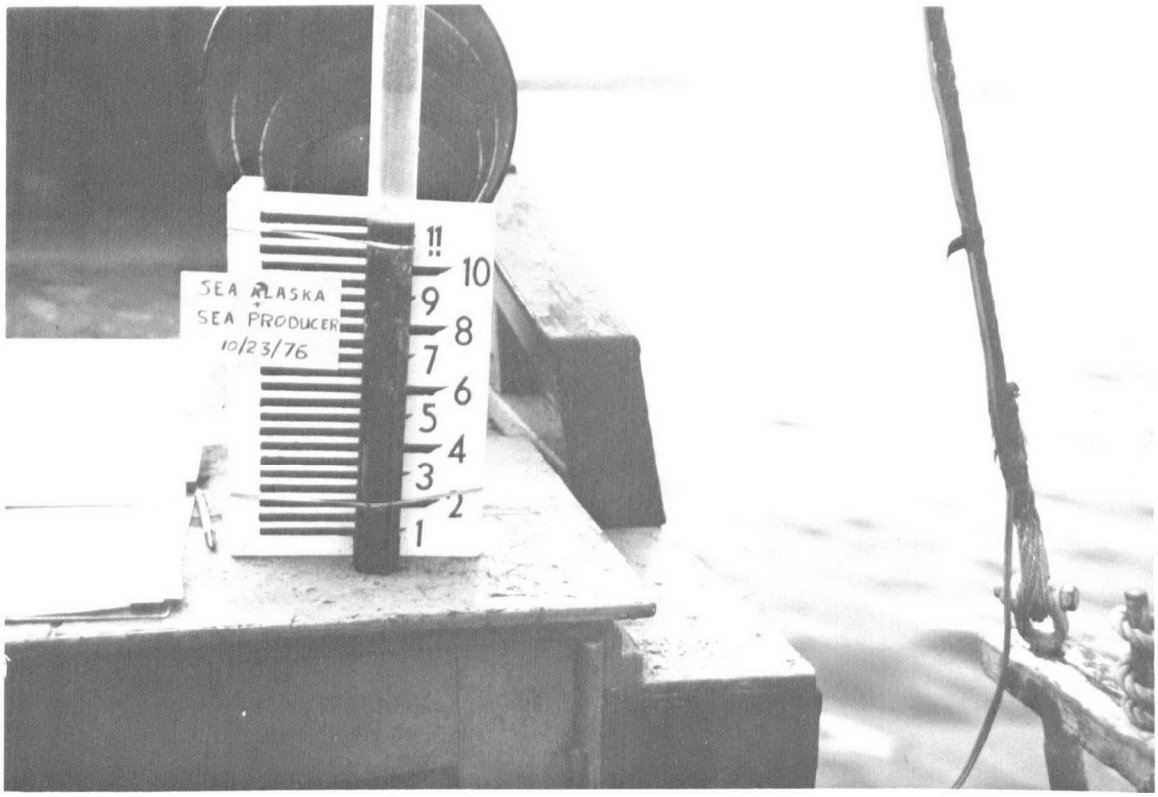
Extremely heavy deposits of crab waste from these processors surround this outfall. Divers observations indicated a conical mound of waste approximately 8 meters high and 12 meters wide at the base, tapering off to about 1 meter in depth at an eastern point of the 30 meter radius of the discharge. (Figure

These processors are located in a dead-end pocket of Dutch Harbor where there is apparently no current of any magnitude available to disperse the crab waste. Consequently an extreme build-up is expected to continue.

Figure Core sample taken at a point 30 meters from the M/V SEA ALASKA and M/V SEA PRODUCER discharge. Backboard is marked in inches.
