EPA-R2-72-091
NOVEMBER 1972

# A PRESSURE SEWER SYSTEM DEMONSTRATION

Italo G. Carcich
Leo J. Hetling
R. Paul Farrell

Project 11022 DQI

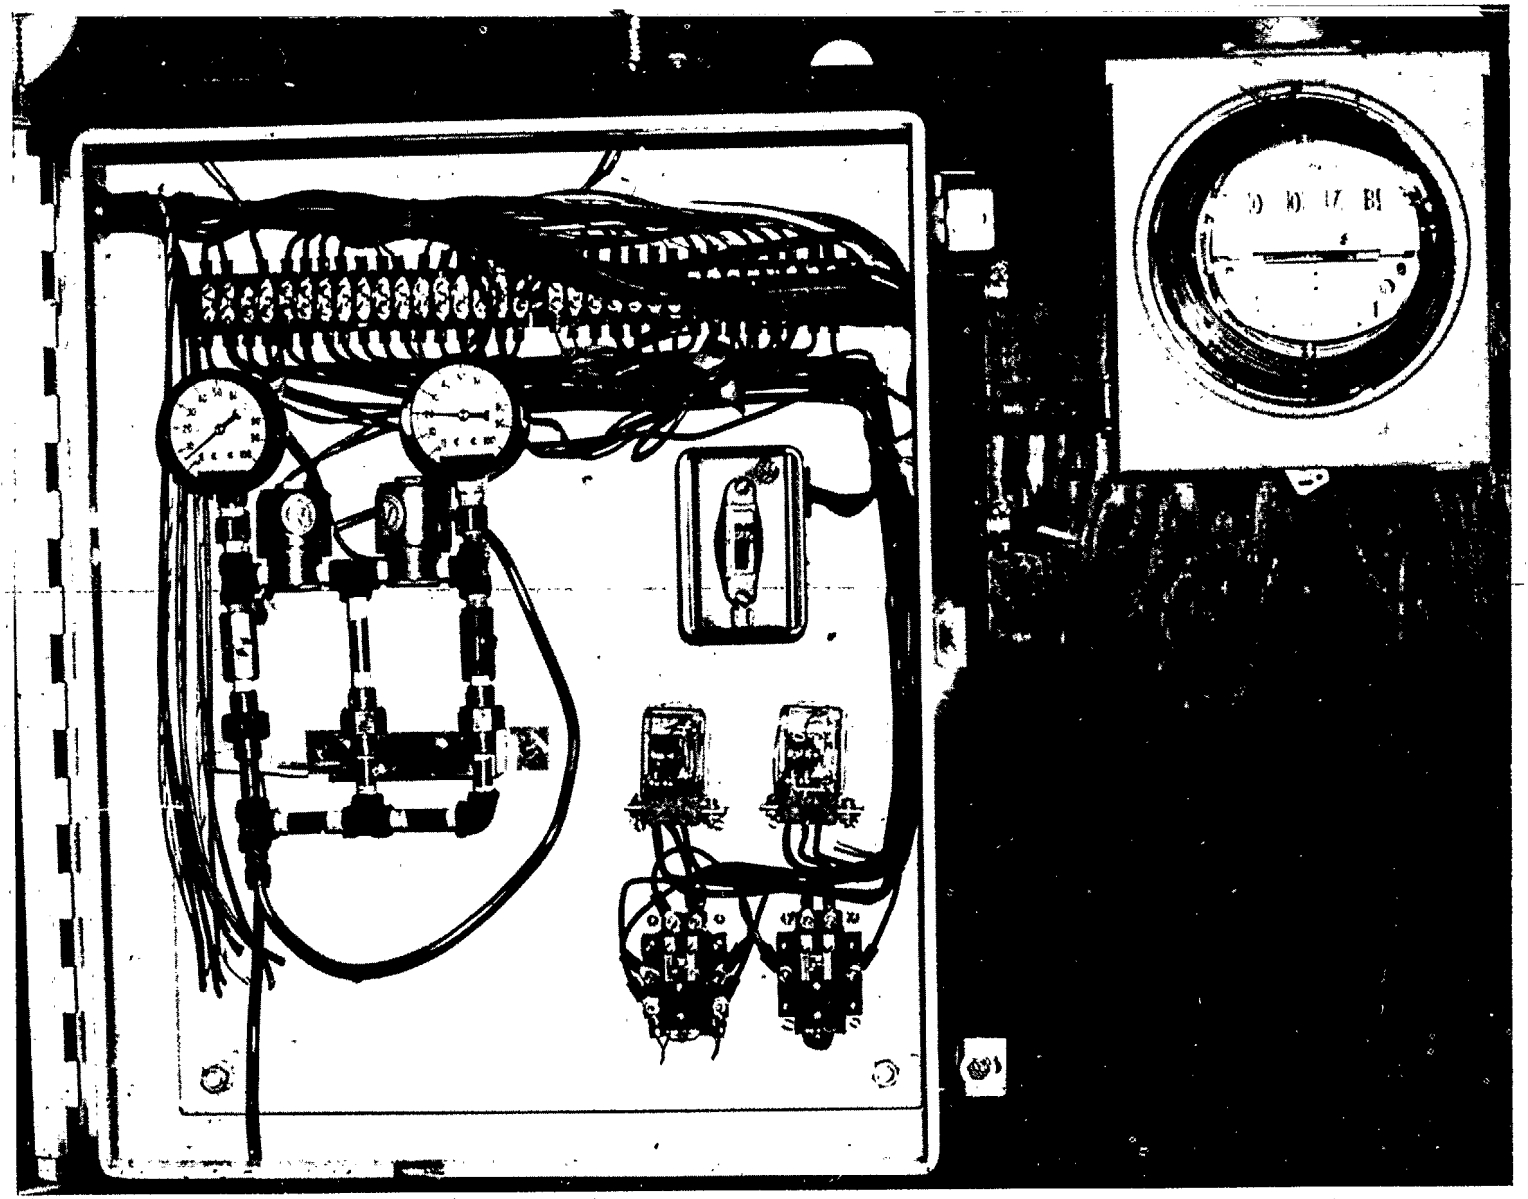
FIGURE 18
PHOTOGRAPH OF PRESSURE GAGES
INSTALLATION WITHIN TEST HOUSE

All of the instrumentation used to record the different parameters worked quite well with the exception of the pressure gages. Clogging of the small diameter copper tubing by the macerated sewage was a constant occurrence and the corrosive effect of sewage on the instrument check valves was extensive. Brass check valves originally used were replaced by stainless steel check valves but the clogging effect was not completely corrected. Therefore, the pressure gaging system was less than 100% operational (see Section VII for more details).

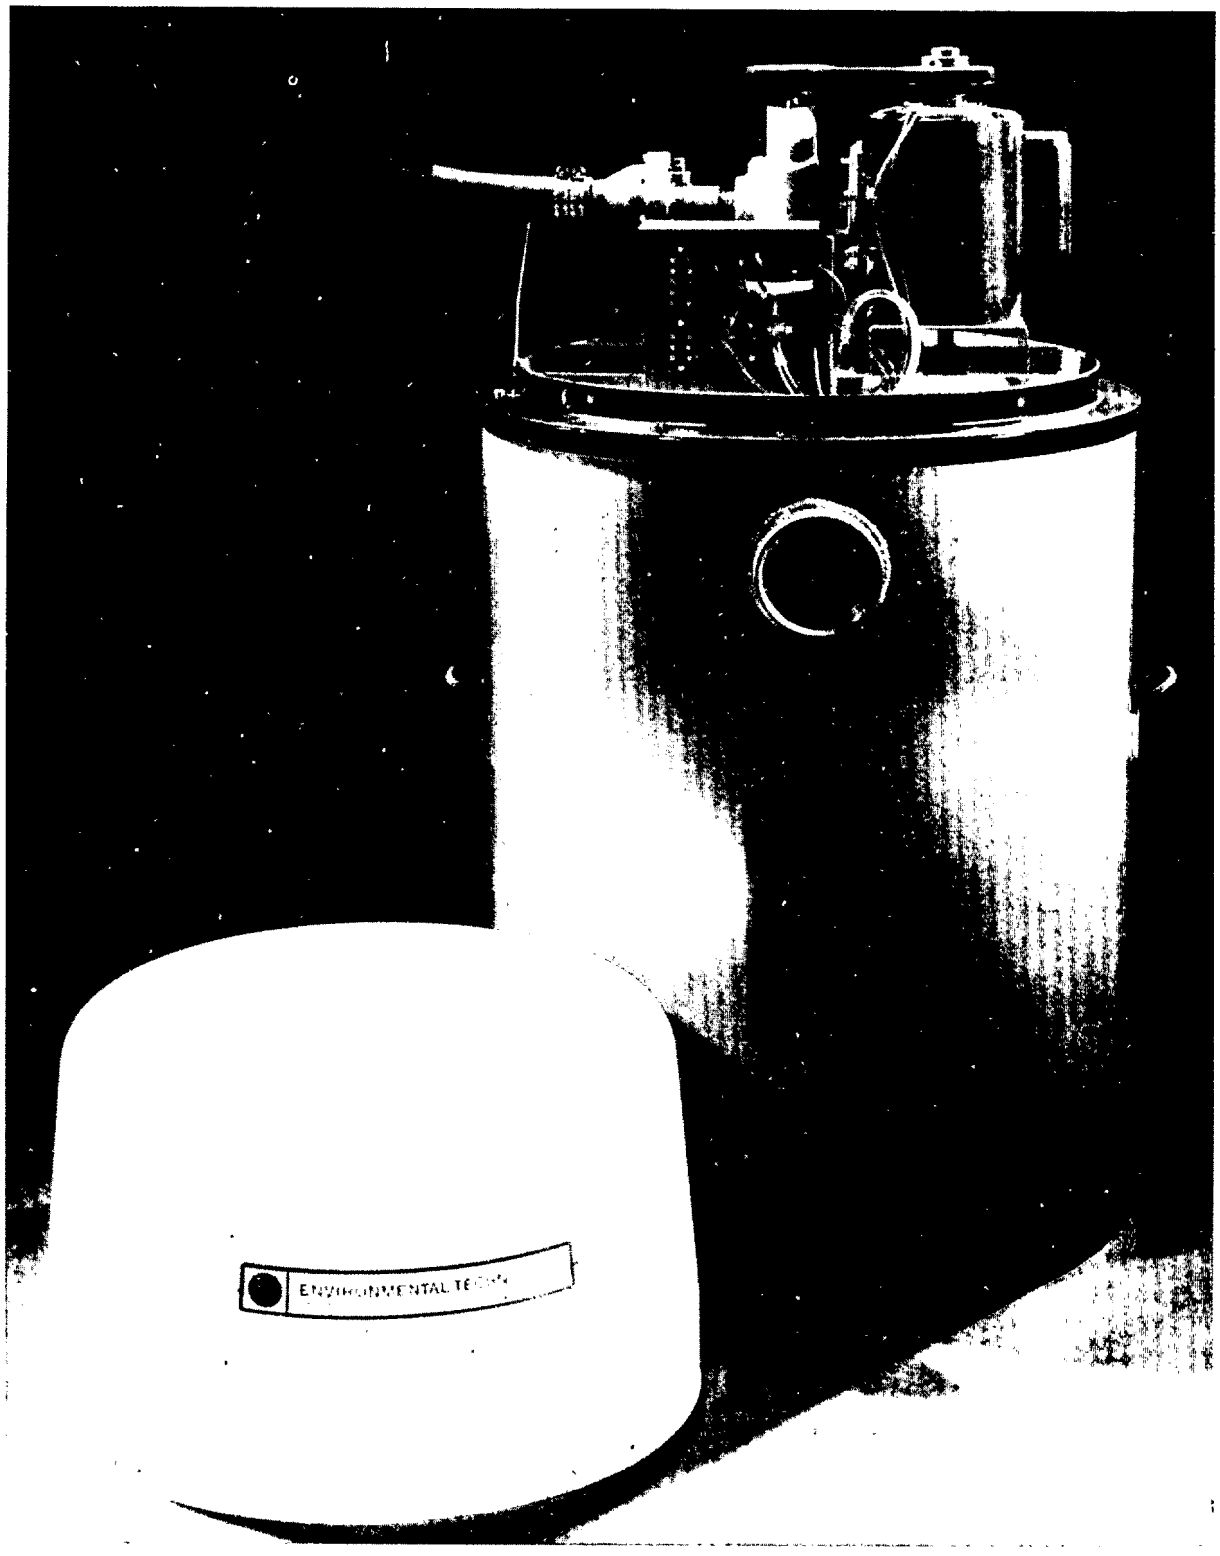
FIGURE 33

PICTURE OF PROTOTYPE MODEL

prototype units had the pump mounted on top of the tank, and therefore, subjected to a suction lift requirement of approximately 30 inches each time they started. Although similar pumps had been reported to work satisfactorily under considerably higher suction lifts, this Demonstration Project showed that if a large number of such pumps were called upon to operate under this suction lift condition repeatedly over a long enough period of time, there would be a very small (but in this instance significant) incidence of cases where they would fail to prime. Although this was certainly a low probability which might be considered acceptable in some applications, in a Grinder Pump even this very low failure rate was not considered tolerable. Therefore, the production design was arranged in a different mechanical configuration, assuring that the pump operated with a flooded suction and was, therefore, positively primed each time when called upon to start. This change also eliminated a long shaft, one bearing, and a coupling which had been the source of several failures in the prototypes. Epoxy coated steel tanks, which had been used in prototype units, were replaced by custom-molded fiber glass reinforced polyester (FRP) tanks, a material well known for its combination of high mechanical strength and corrosion resistance, even in wet or below grade applications. As noted in Section VI, this change in tank material offered the additional benefit of a lower noise level, which is especially desirable in indoor installations. The weakness of the level controls on the prototype was eliminated completely by the previously mentioned change to a diving bell of larger diameter, which was not subject to fouling by grease.

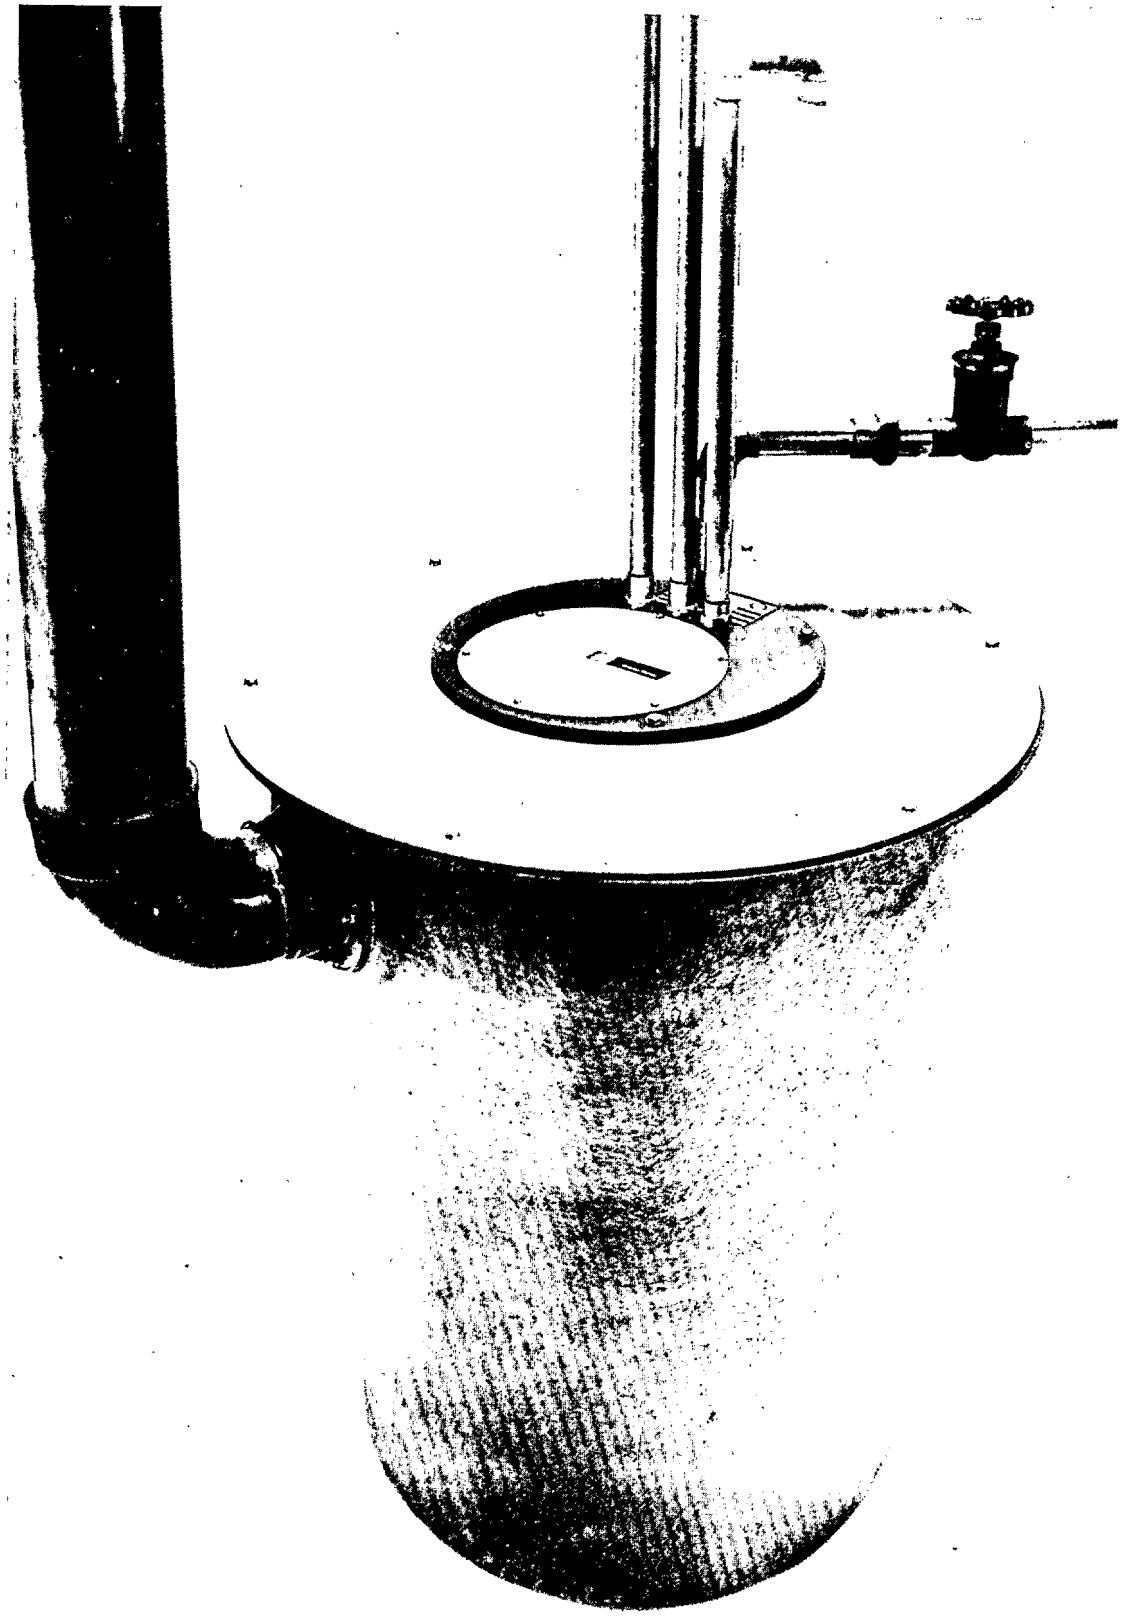
FIGURE 34

MODIFIED GP UNIT (FARRELL 210)

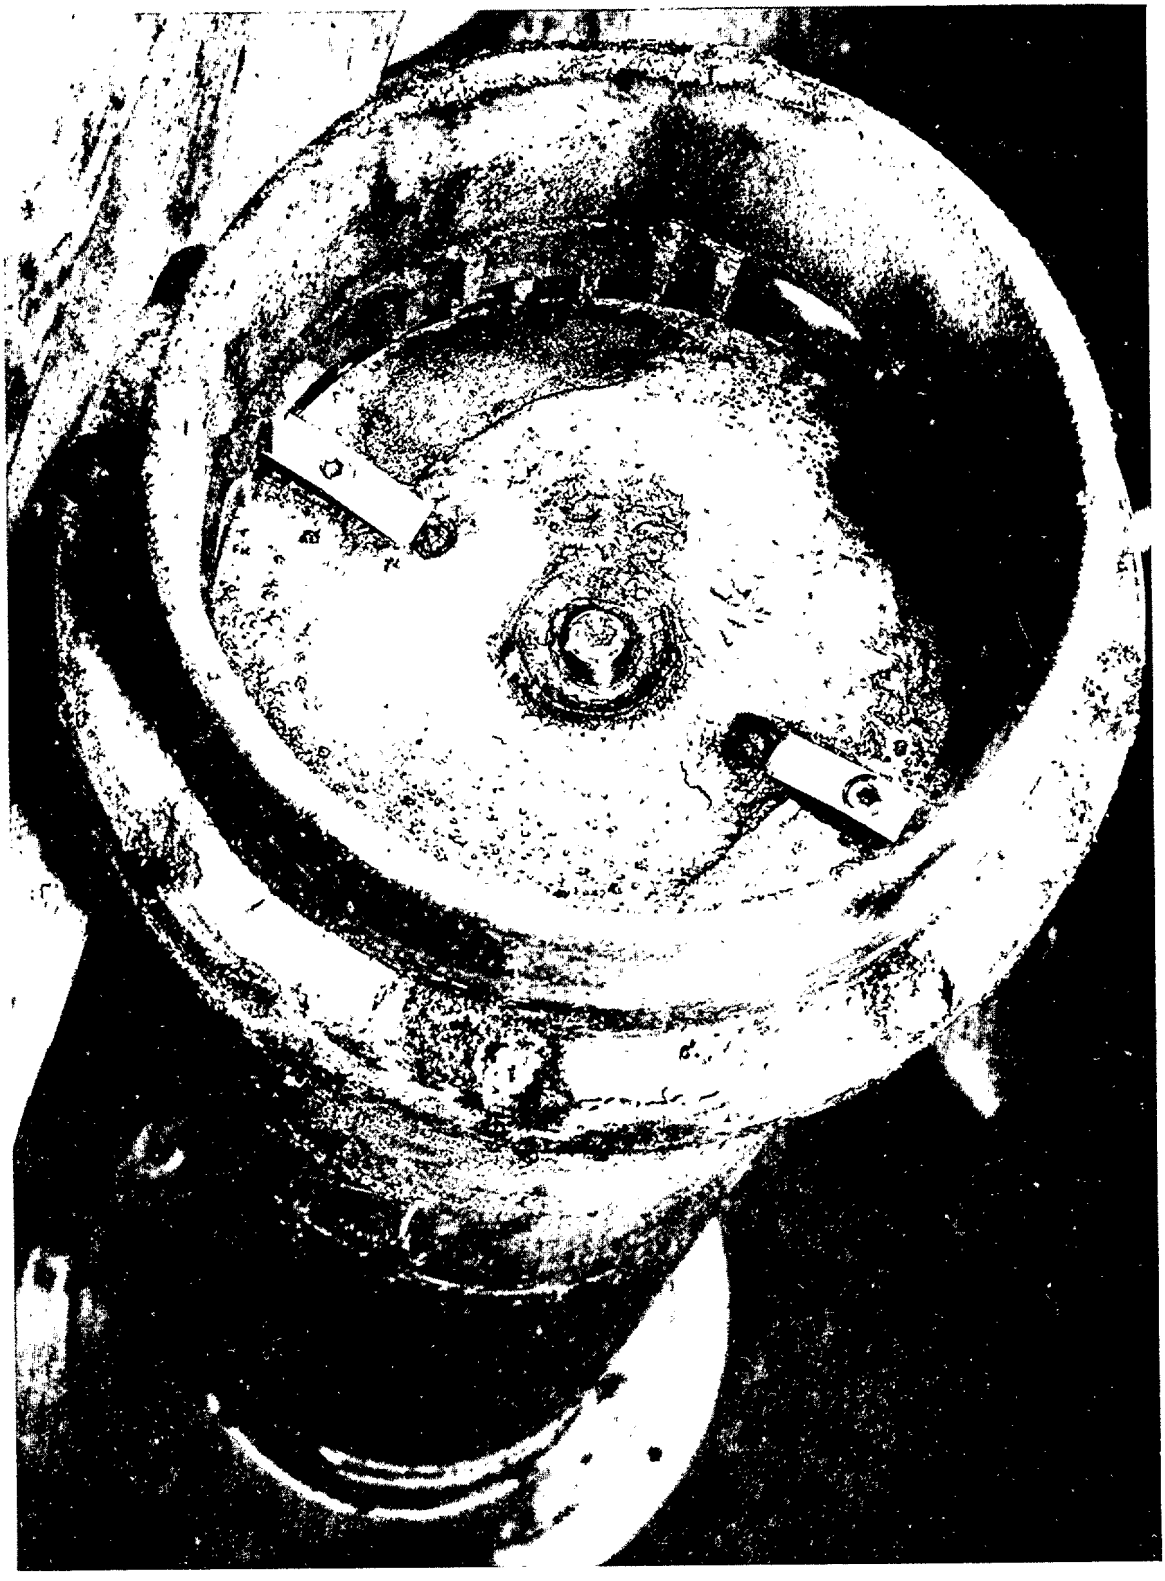
FIGURE 38A

GRINDING ELEMENT

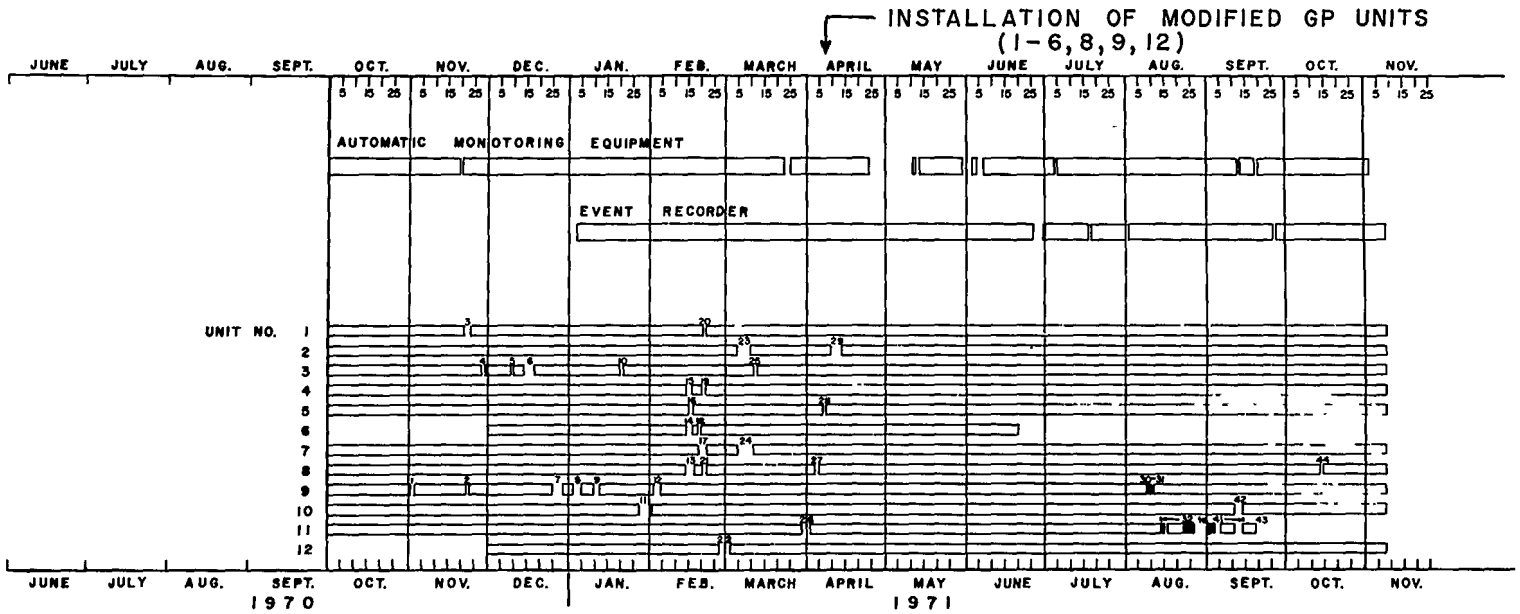
FIGURE 41

PERFORMANCE RECORD OF GP UNITS AND MONITORING EQUIPMENT

The bar graph (Figure 41) has these malfunctions enumerated and Appendix D describes each occurrence. Basically, all of the 44 malfunctions can be placed into four specific categories:

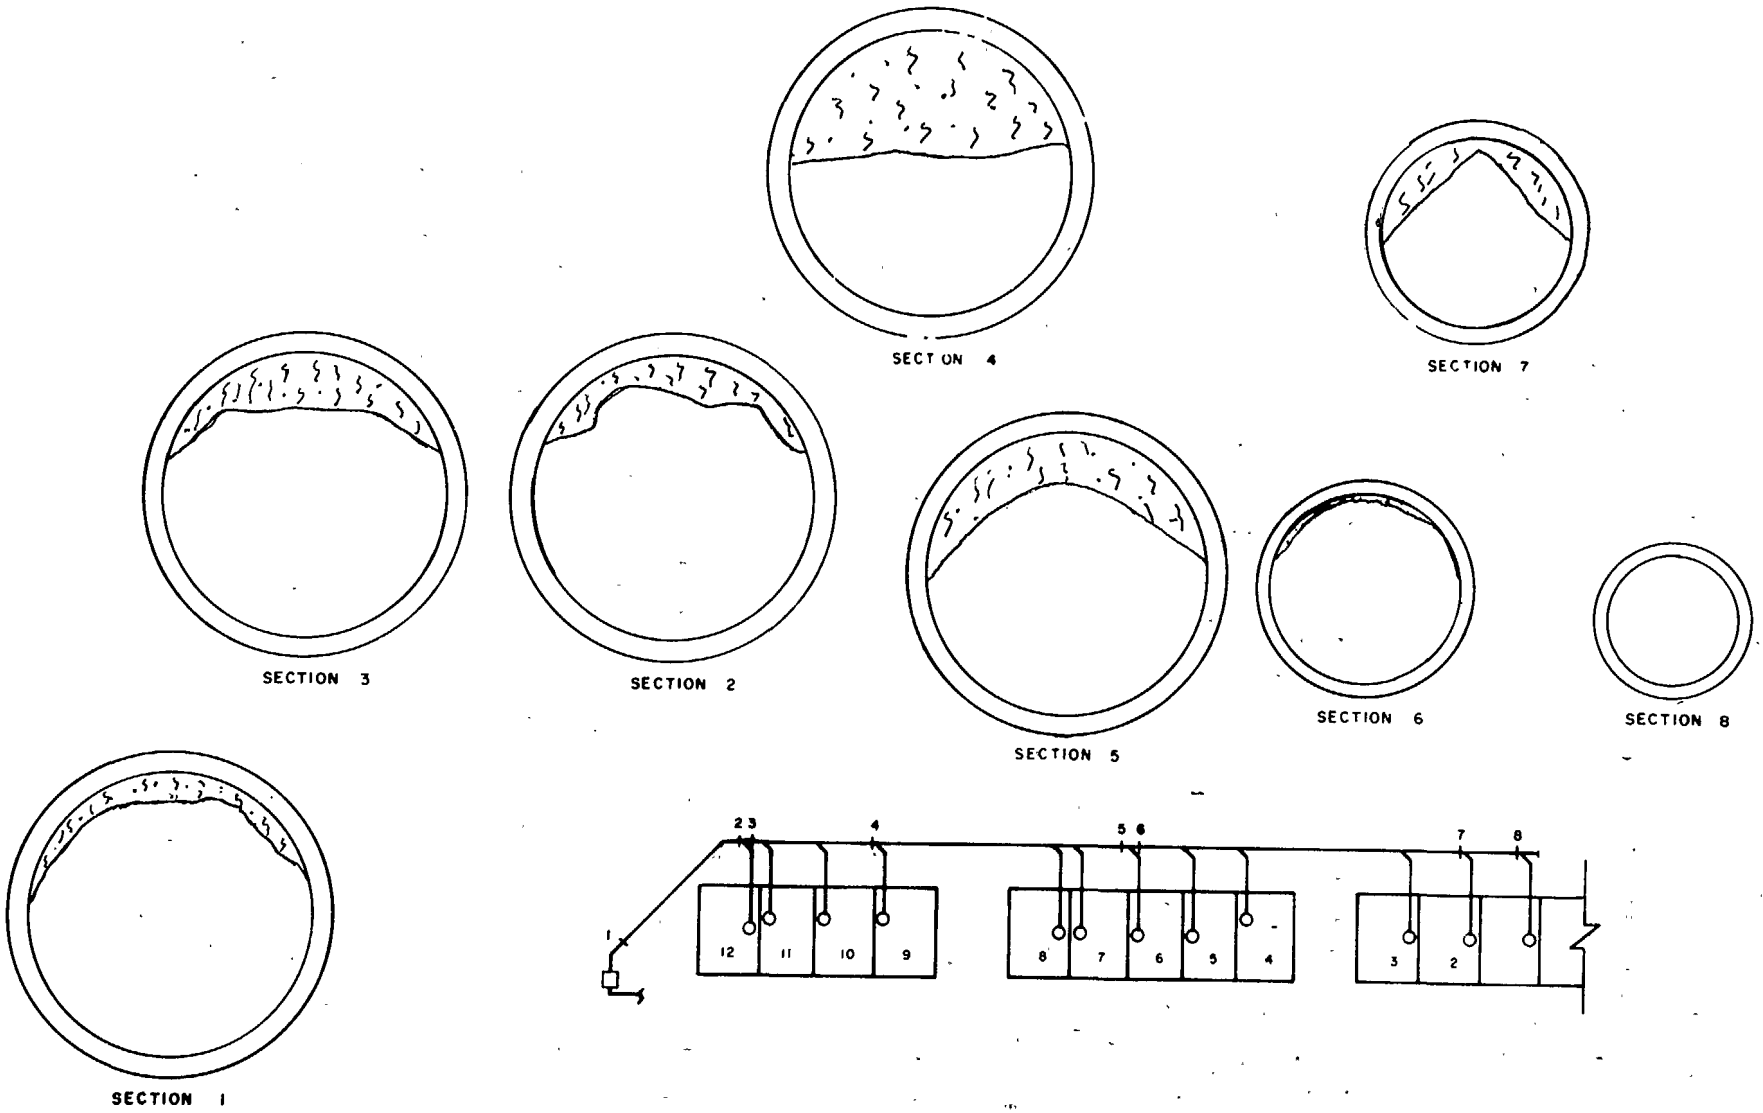
FIGURE 60

GREASE ACCUMULATION WITHIN PRESSURE SEWER MAIN

12. The hydraulic characteristics of a pressure sewer system are critical. Careful design of pressure mains and laterals will prevent excessive grease accumulations, as experienced in this demonstration project, and produce a much more economical system. Grease accumulations were extensive in certain lengths of the pressure main, primarily due to oversizing. The minimum scouring velocities, as recommended by the ASCE task force, were not high enough to prevent grease from accumulating. Velocities in the range of 2 fps to 5 fps might have prevented grease accumulation from occurring.

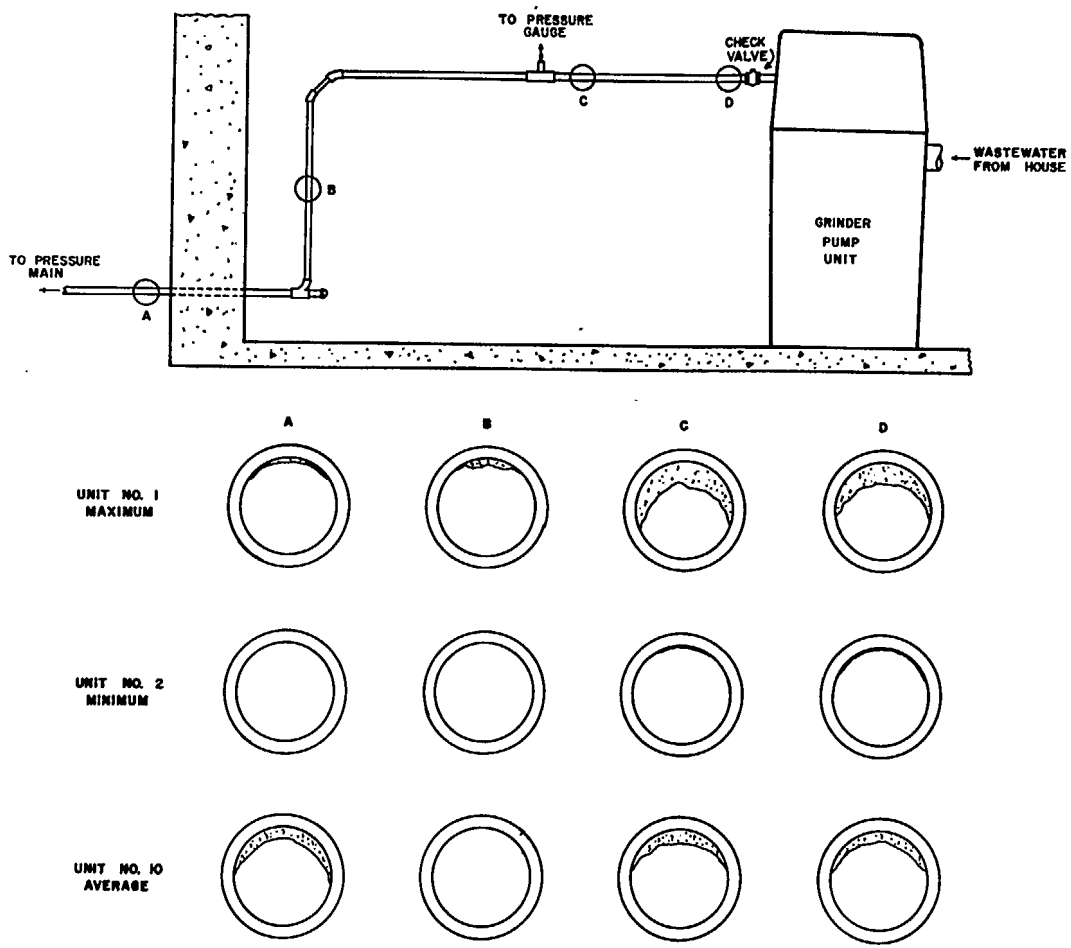
FIGURE 61
GREASE ACCUMULATION IN PRESSURE LATERALS

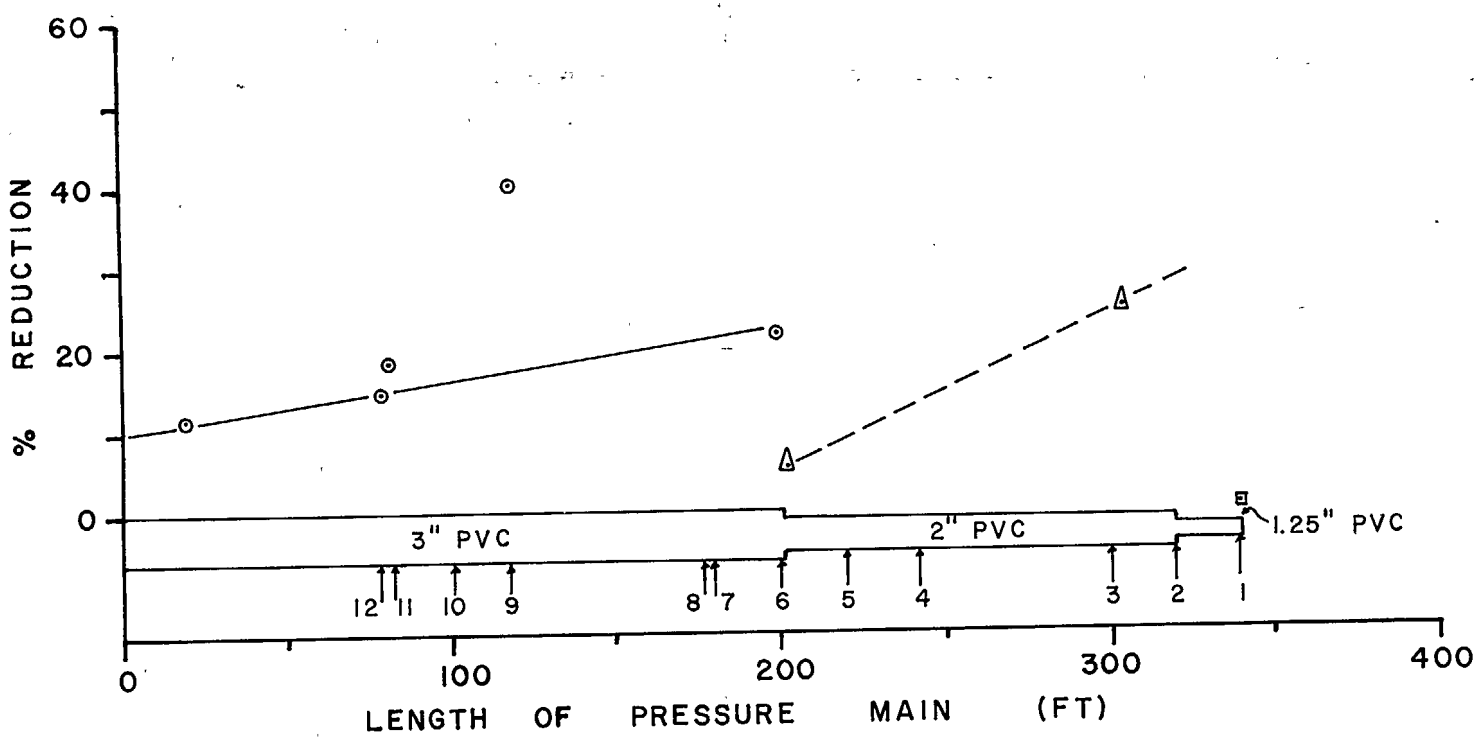
FIGURE 62 PERCENT REDUCTION OF CROSS-SECTIONAL AREA WITHIN THE PRESSURE MAIN
